NASA Technical Memorandum TM 103815

Debris/Ice/TPS Assessment And Photographic Analysis For Shuttle Mission STS-38

November 15, 1990

Shuttle mission STS-38 was launched at 6:48 p.m. EST 11/15/90

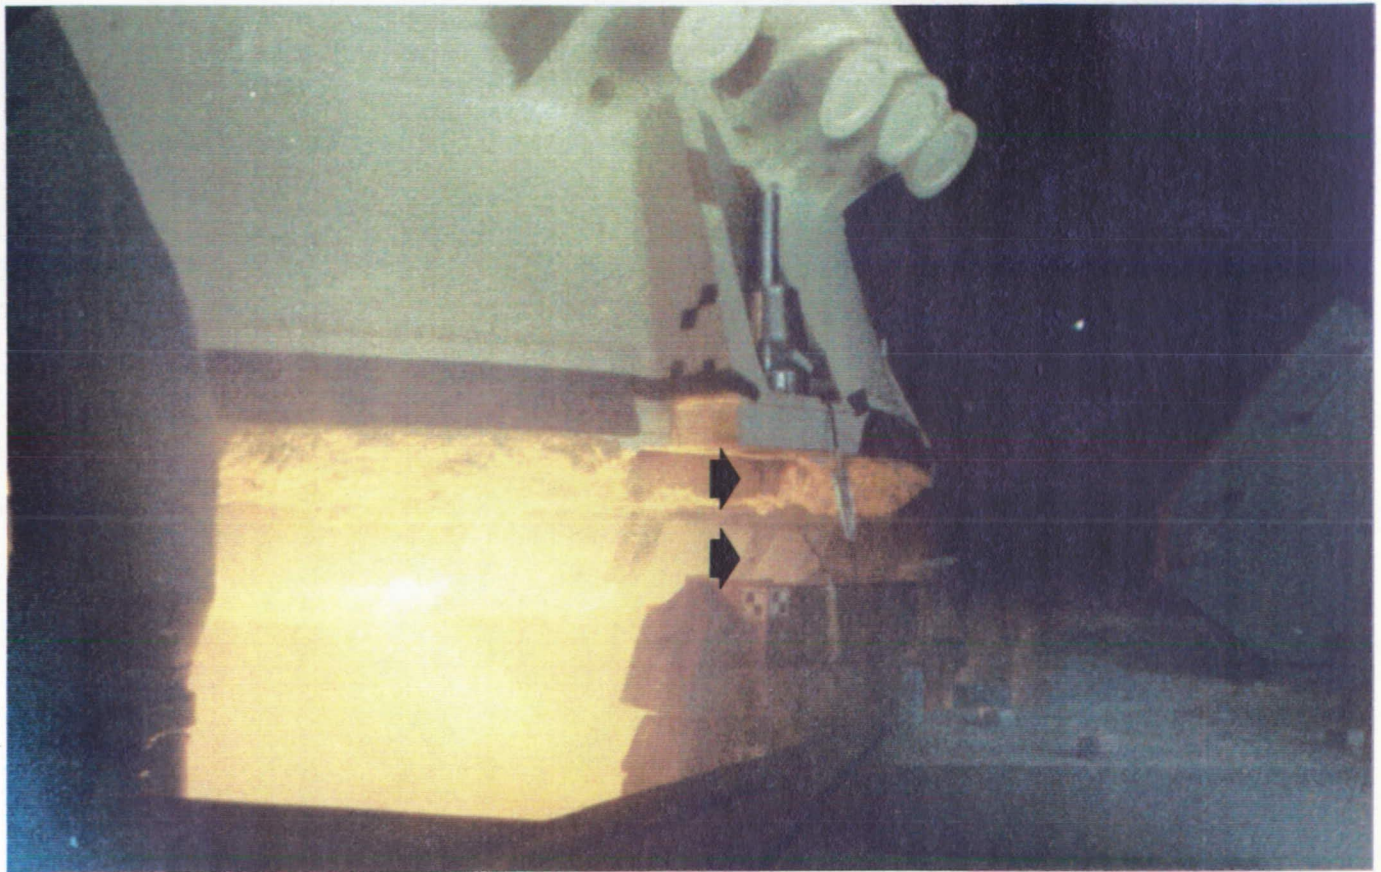
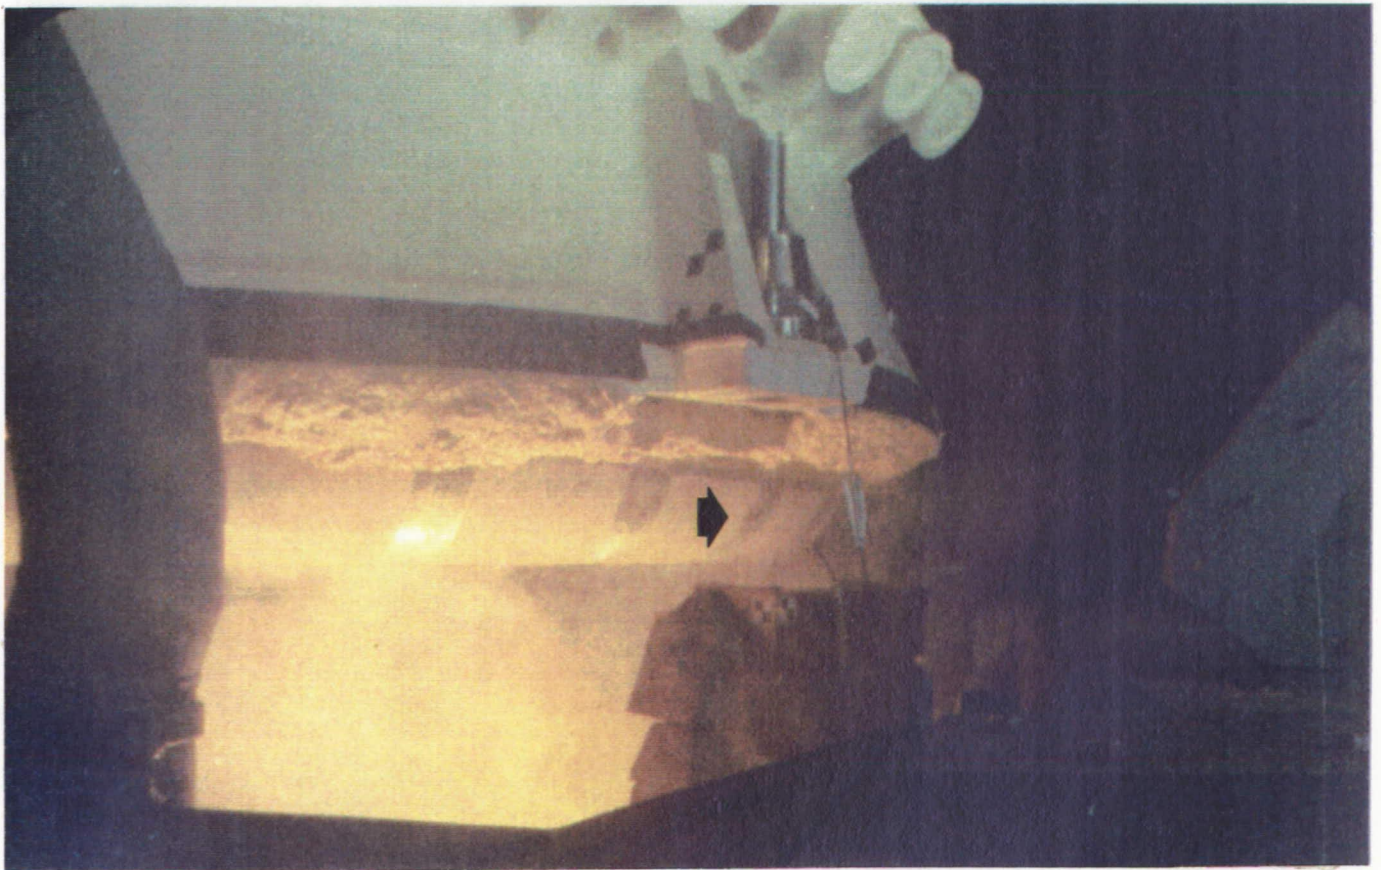
Three ordnance fragments fell from the RH SRB aft skirt HDP #1
DCS/stud hole shortly after liftoff

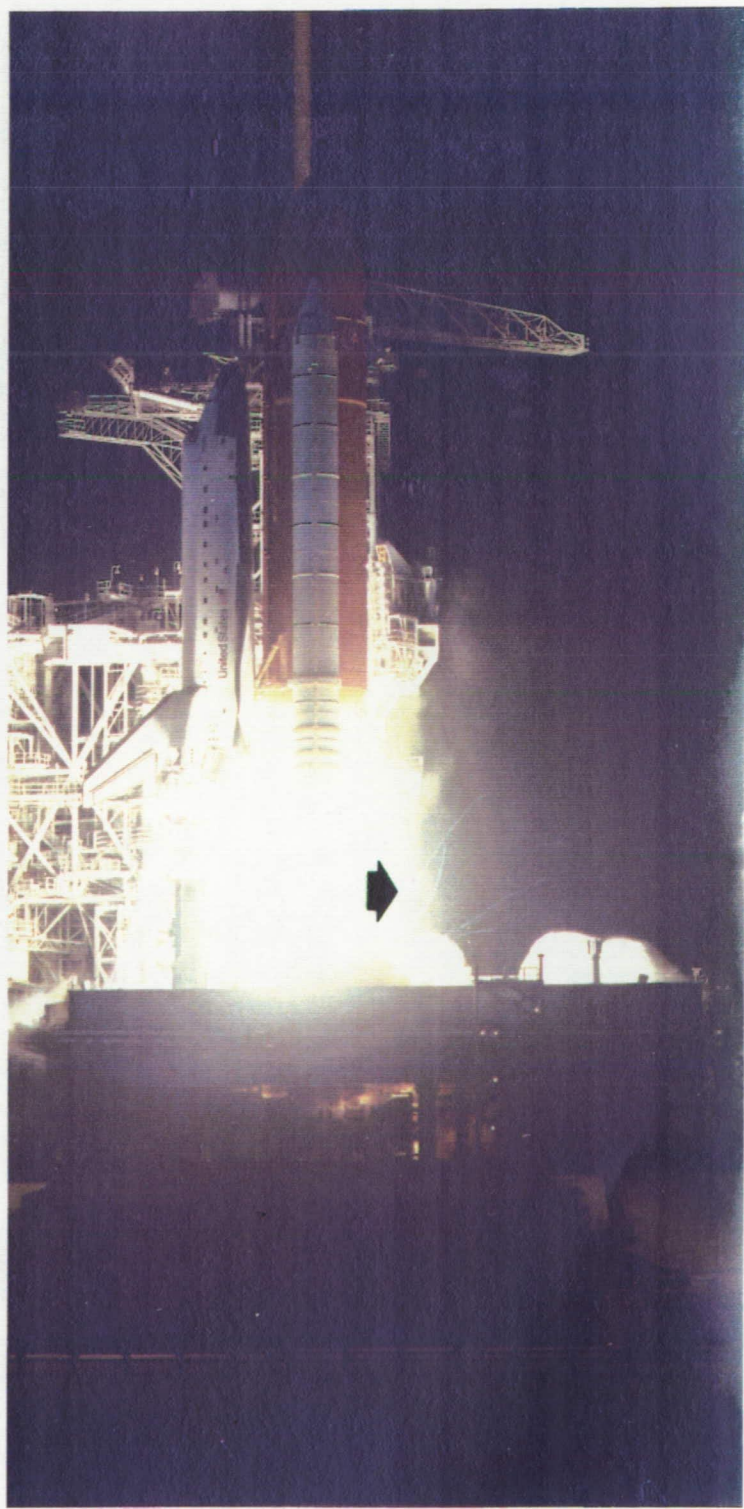
Numerous particles were ejected out of the SRB exhaust holes after T-0 as the vehicle attained 30 feet altitude. Five of the particles trailed smoke and may be pieces of burning SRB throat plug material. Charred pieces of throat plug are commonly found on the pad after launch.

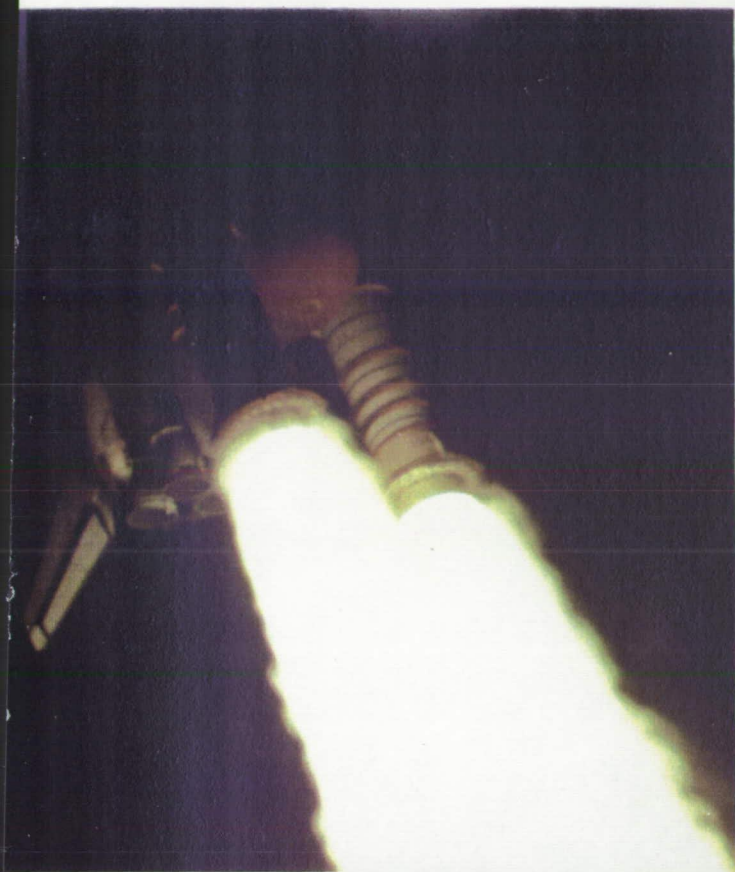
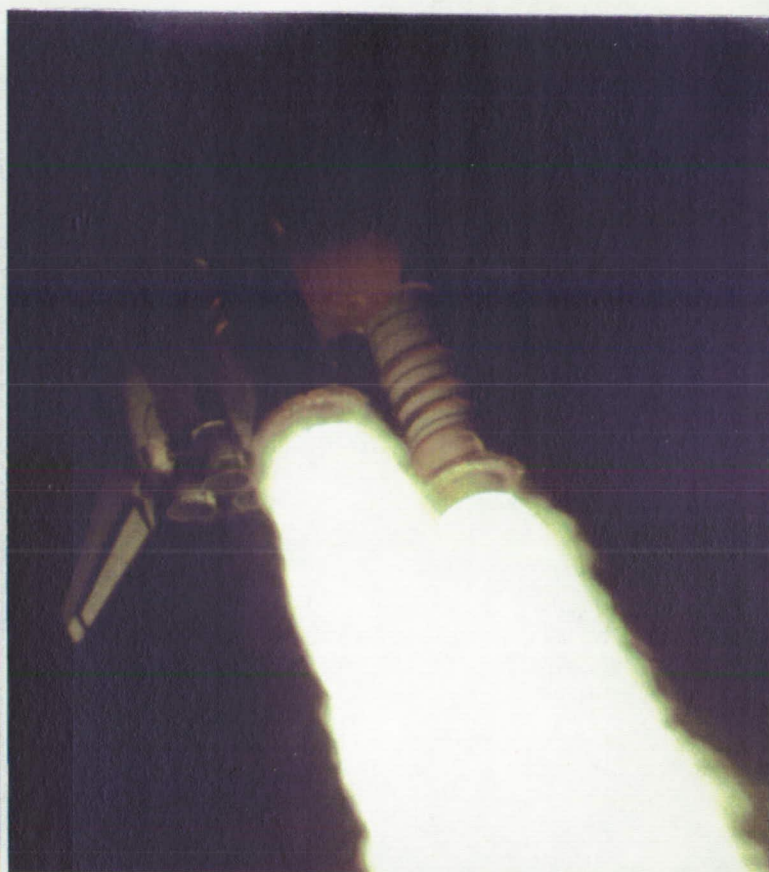
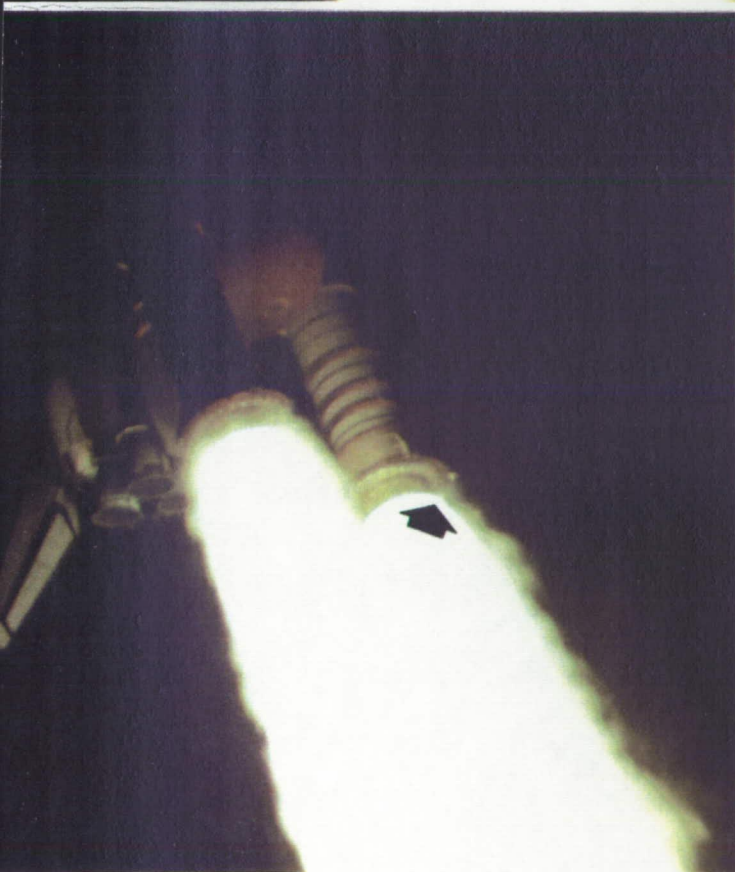
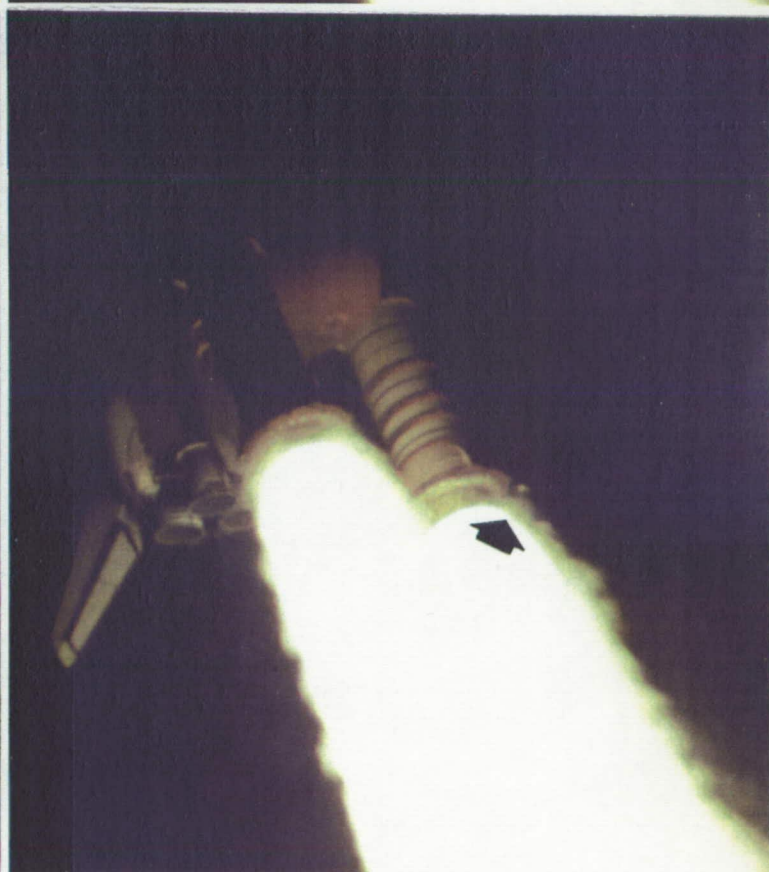
Possible loss of thermal curtain material from the LH SRB aft skirt -Z side. Tracking footage shows the piece of material appeared to come loose near the nozzle extension, moved out toward the aft ring, and then separated from the aft skirt.

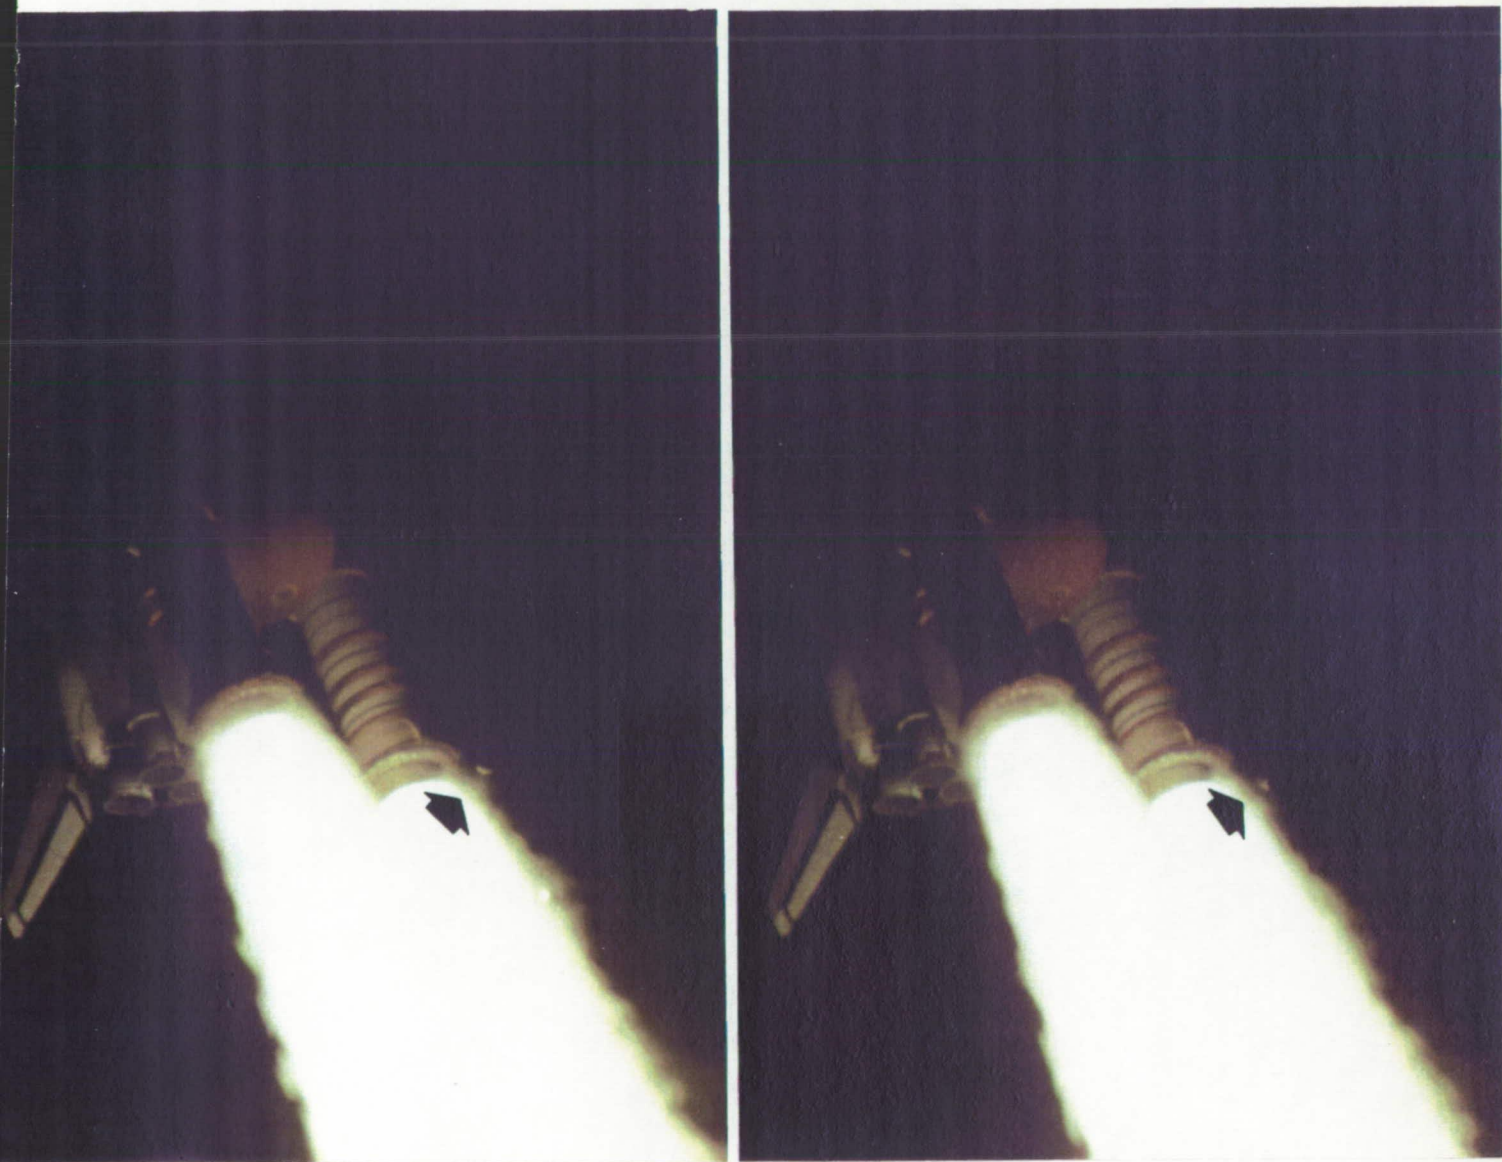
Possible loss of thermal curtain material from the LH SRB aft skirt -Z side at 34 seconds MET. The piece of material was lost against the SRB exhaust plume and could not be tracked further.

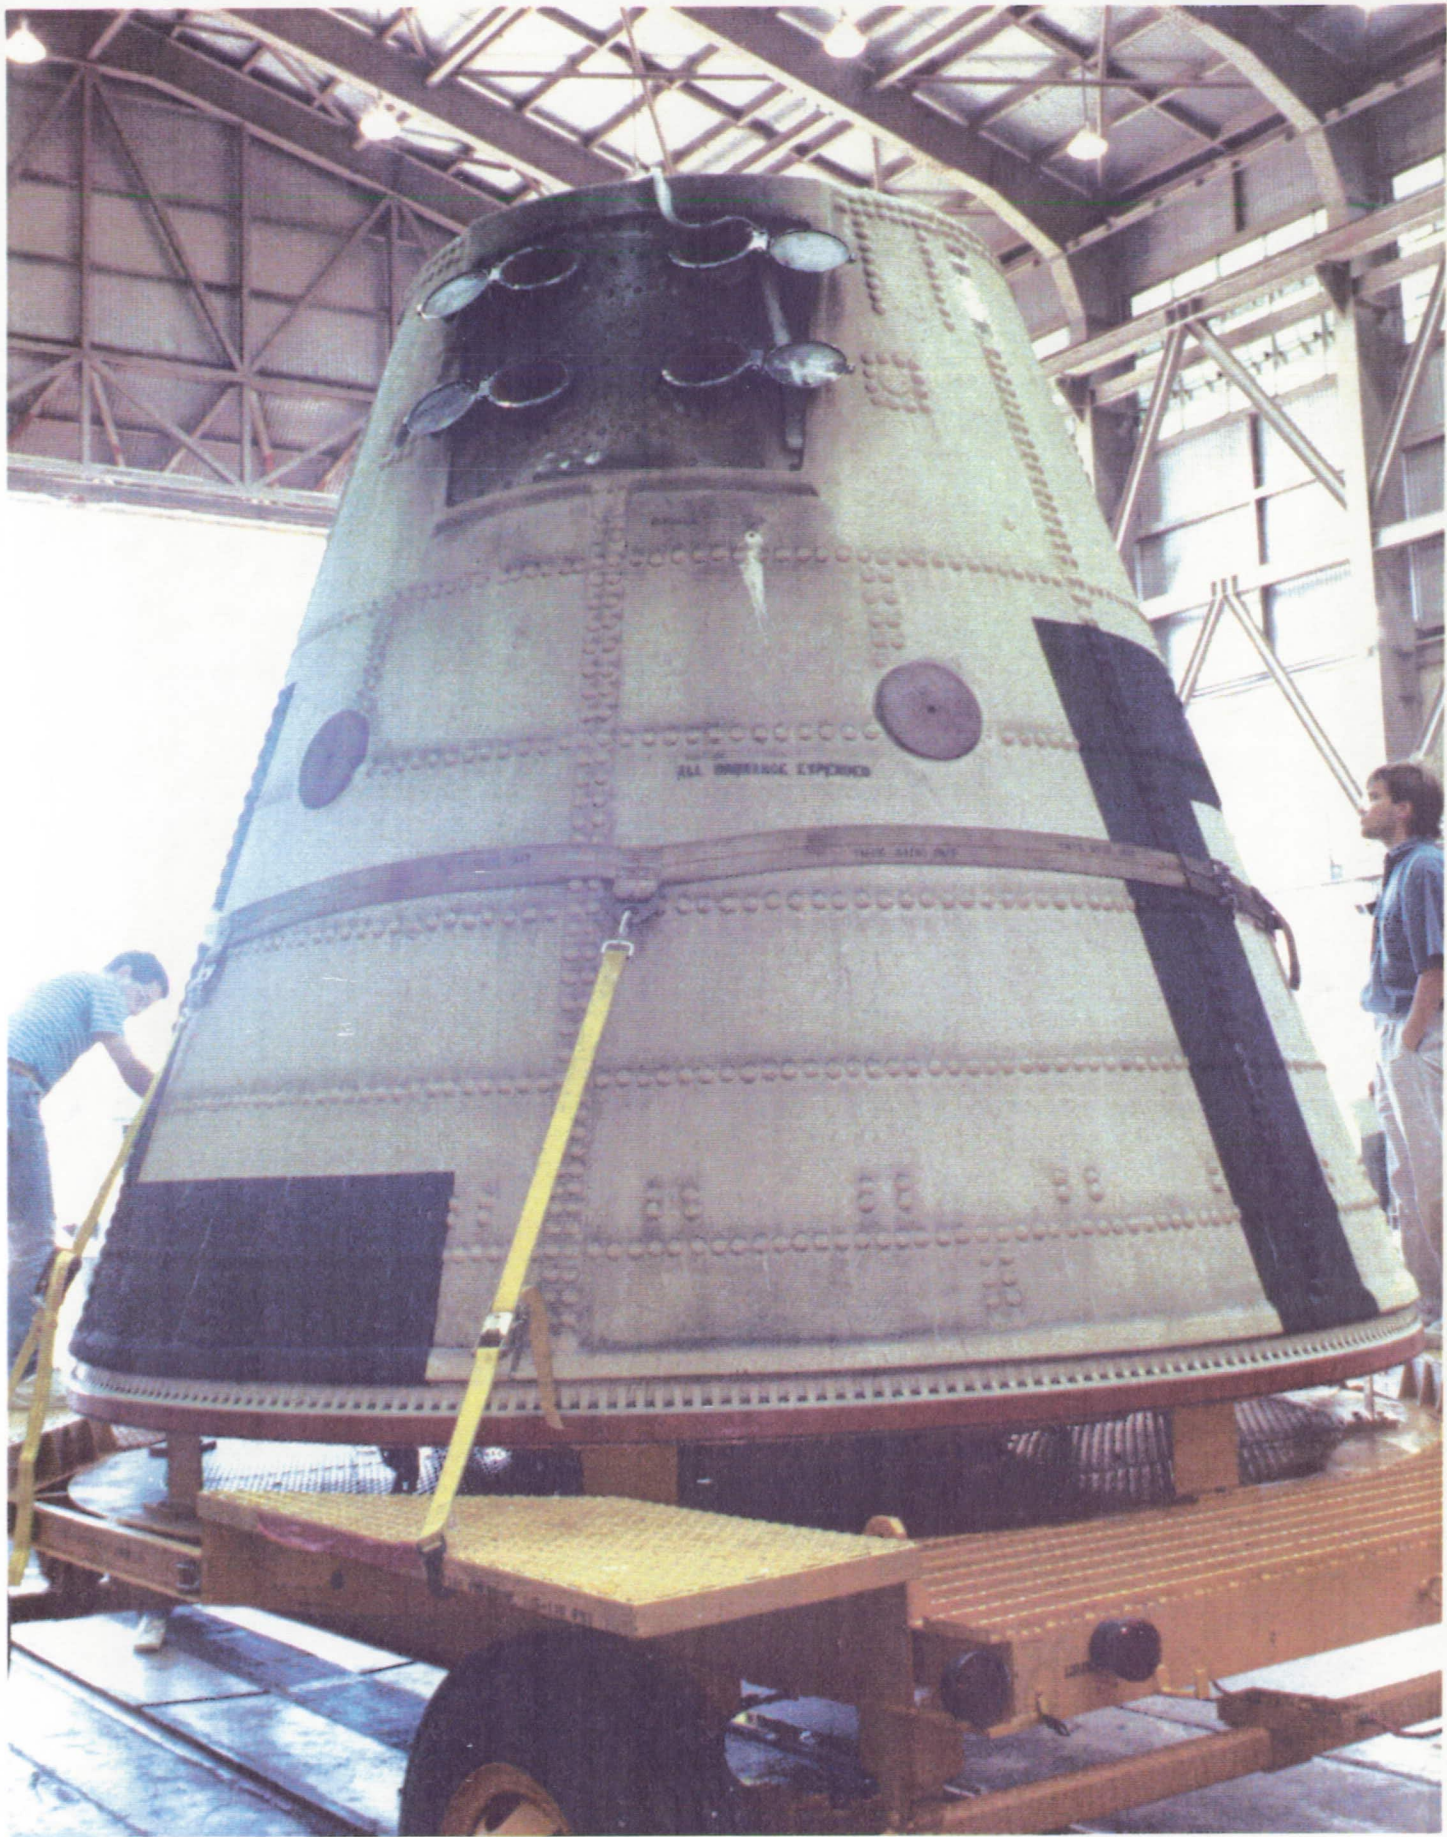
Post flight condition of the RH SRB frustum. There were 56 MSA-2 debonds over fasteners, but no areas of missing TPS

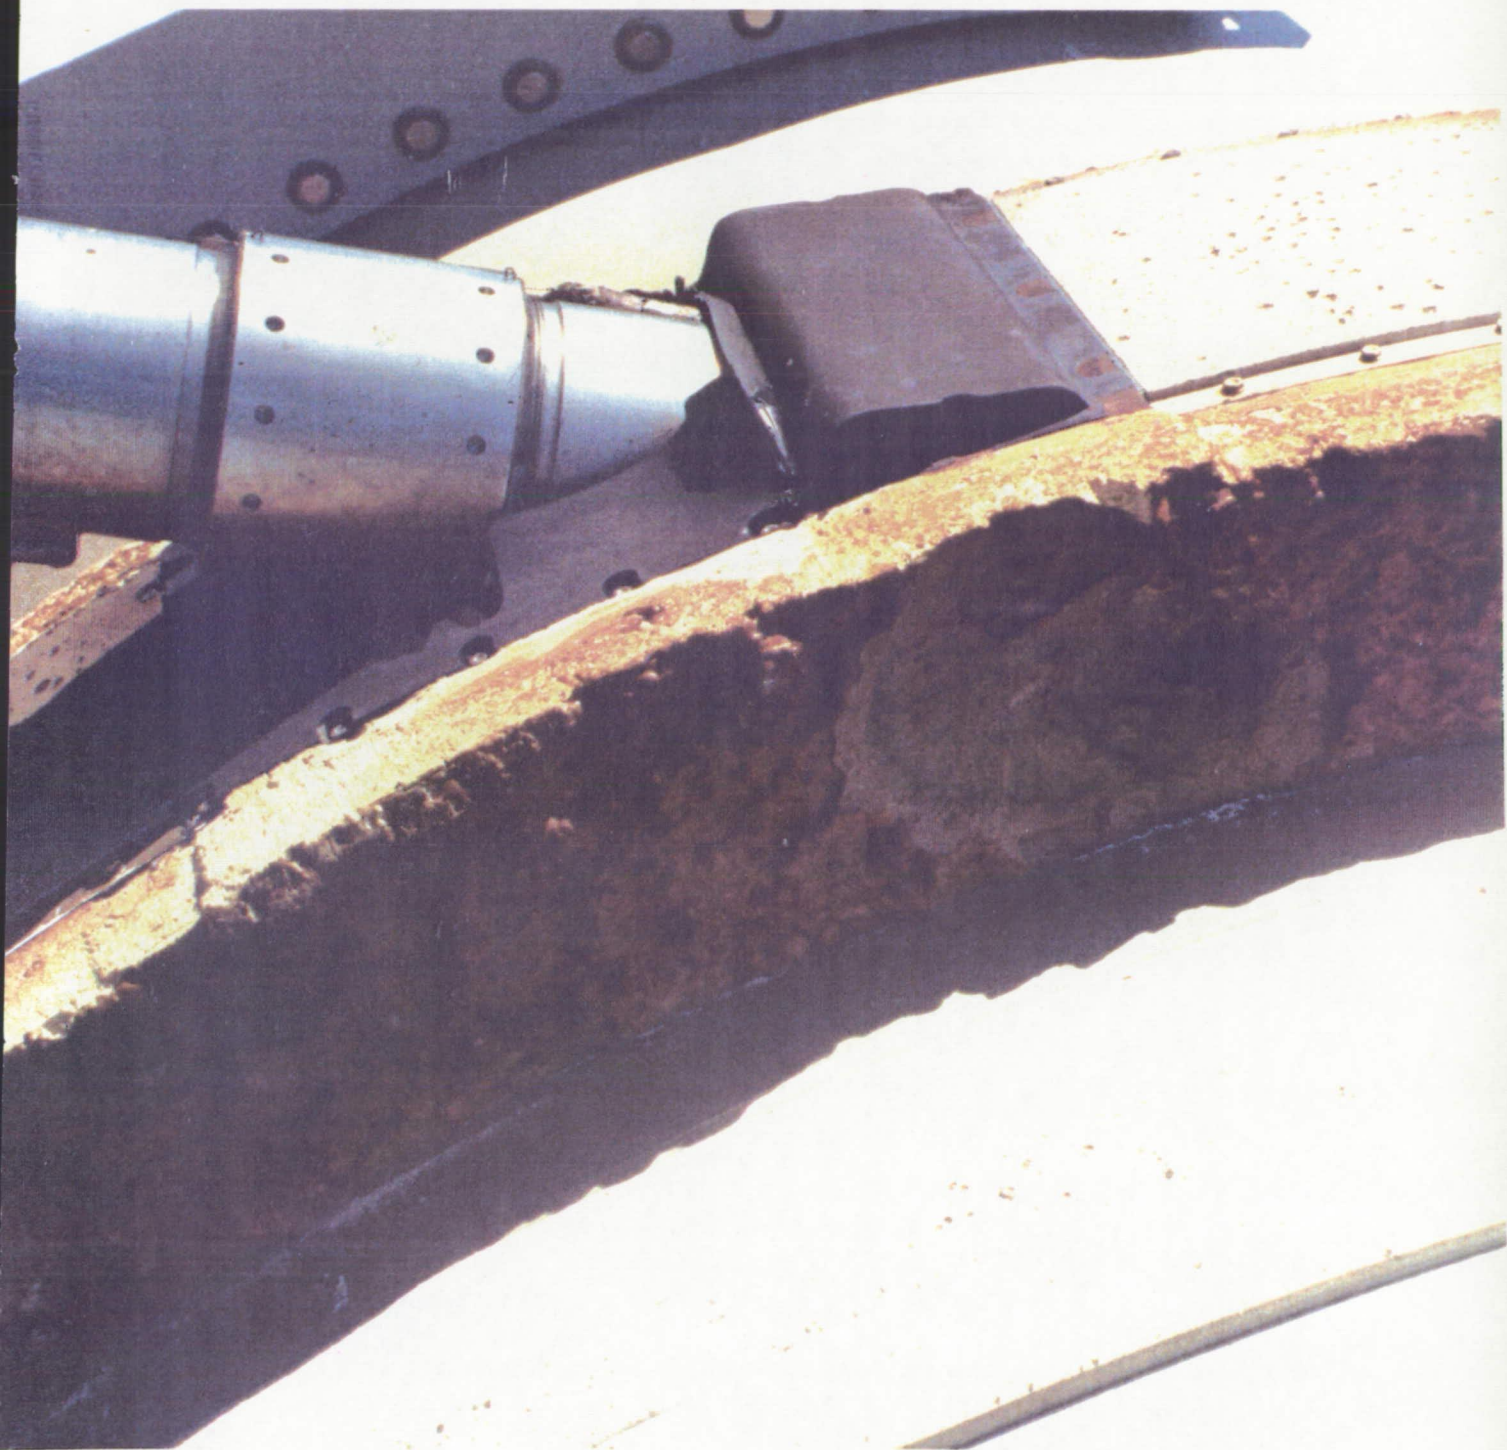
An IFA was taken against an 8-inch instafoam divot on the forward side of the ETA ring near the lower EB strut

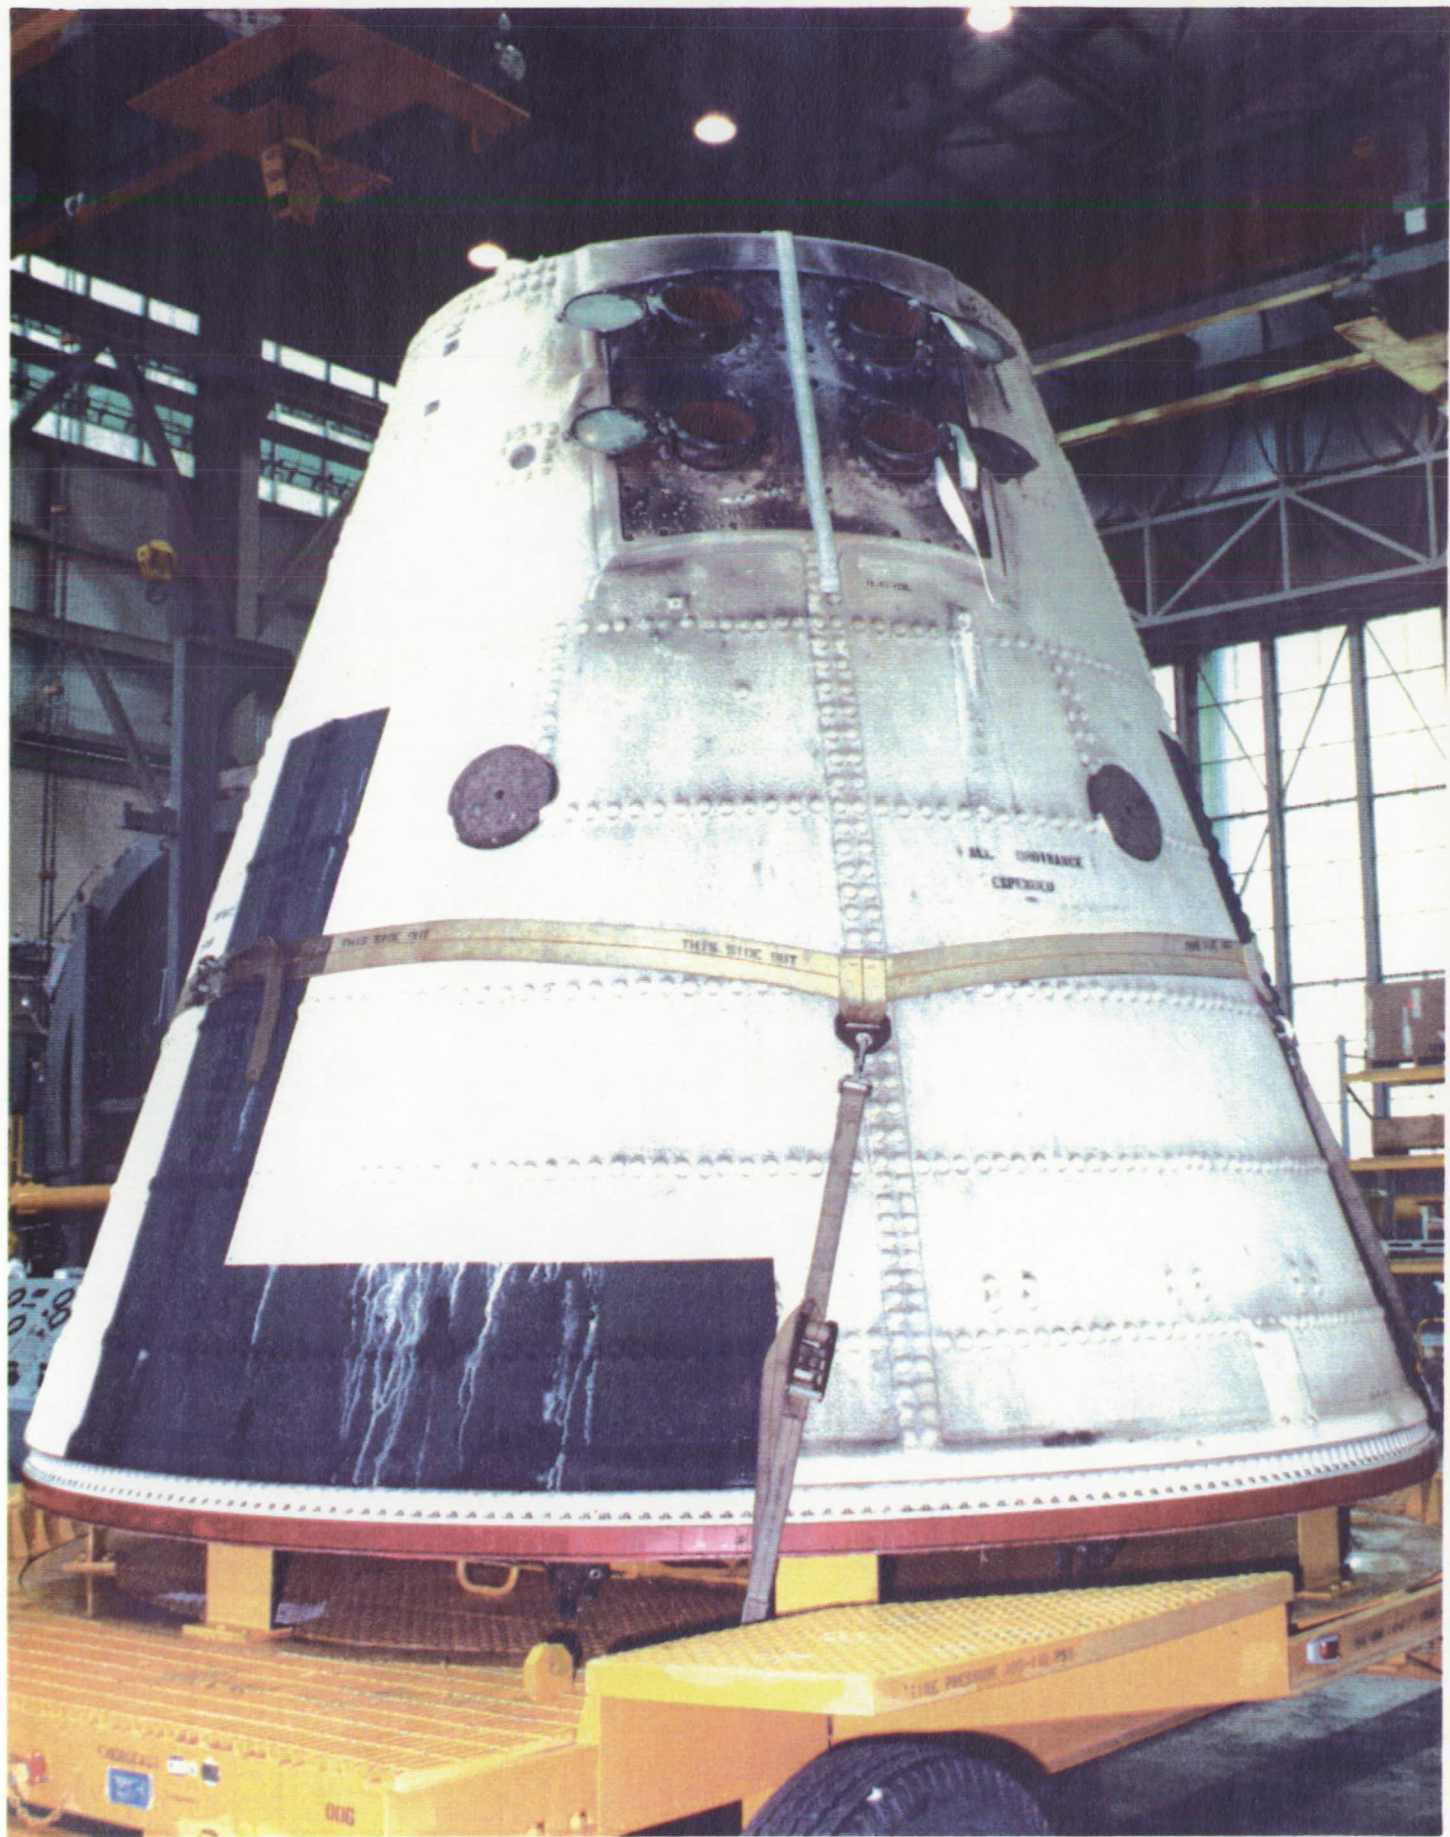
Post flight condition of LH SRB frustum. There were 54 MSA-2 debonds over fasteners, but no areas of missing TPS.

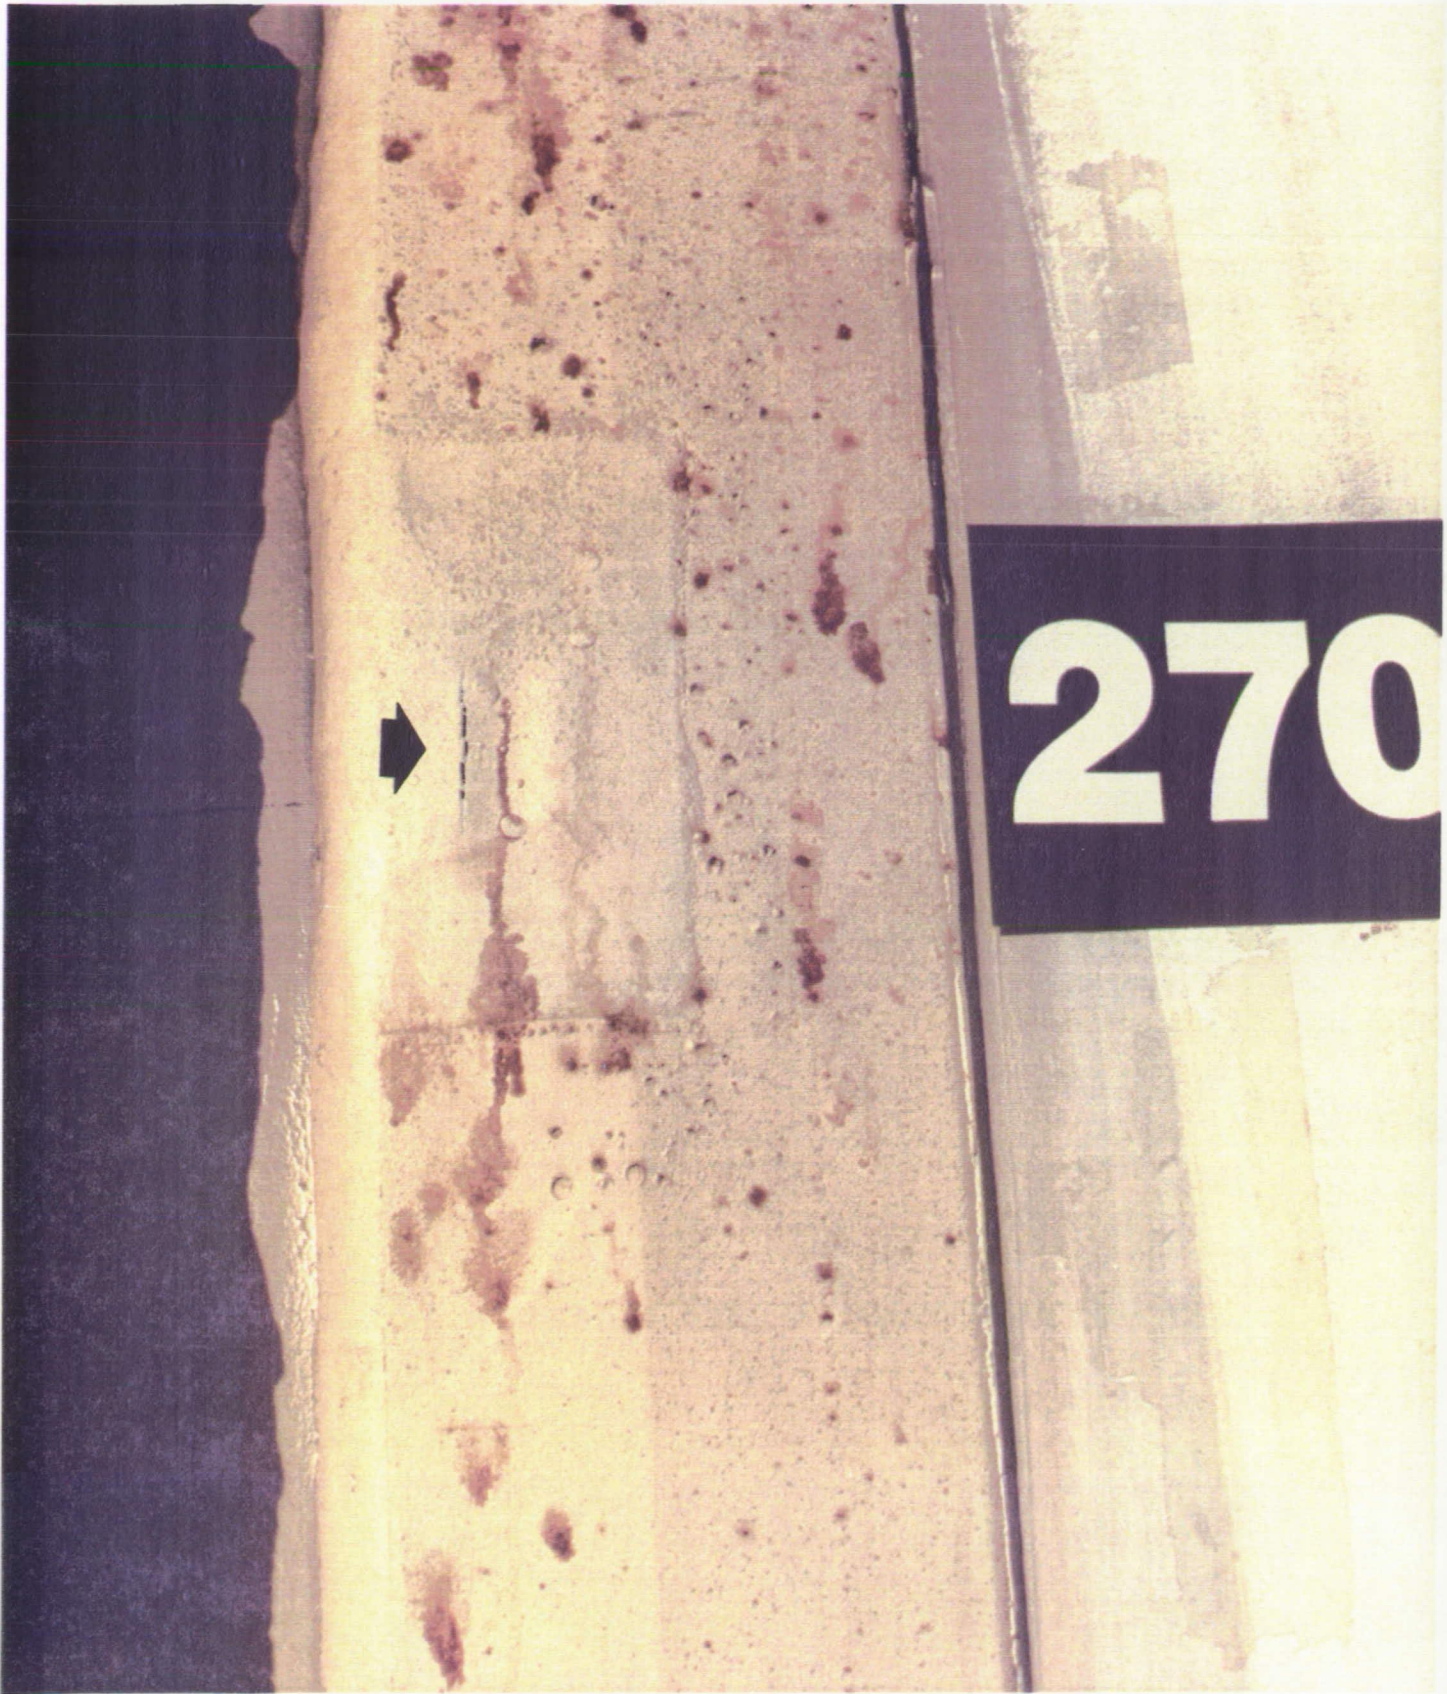
A 2.6-inch crack occurred in the K5NA closeout on the left
aft field joint trunnion

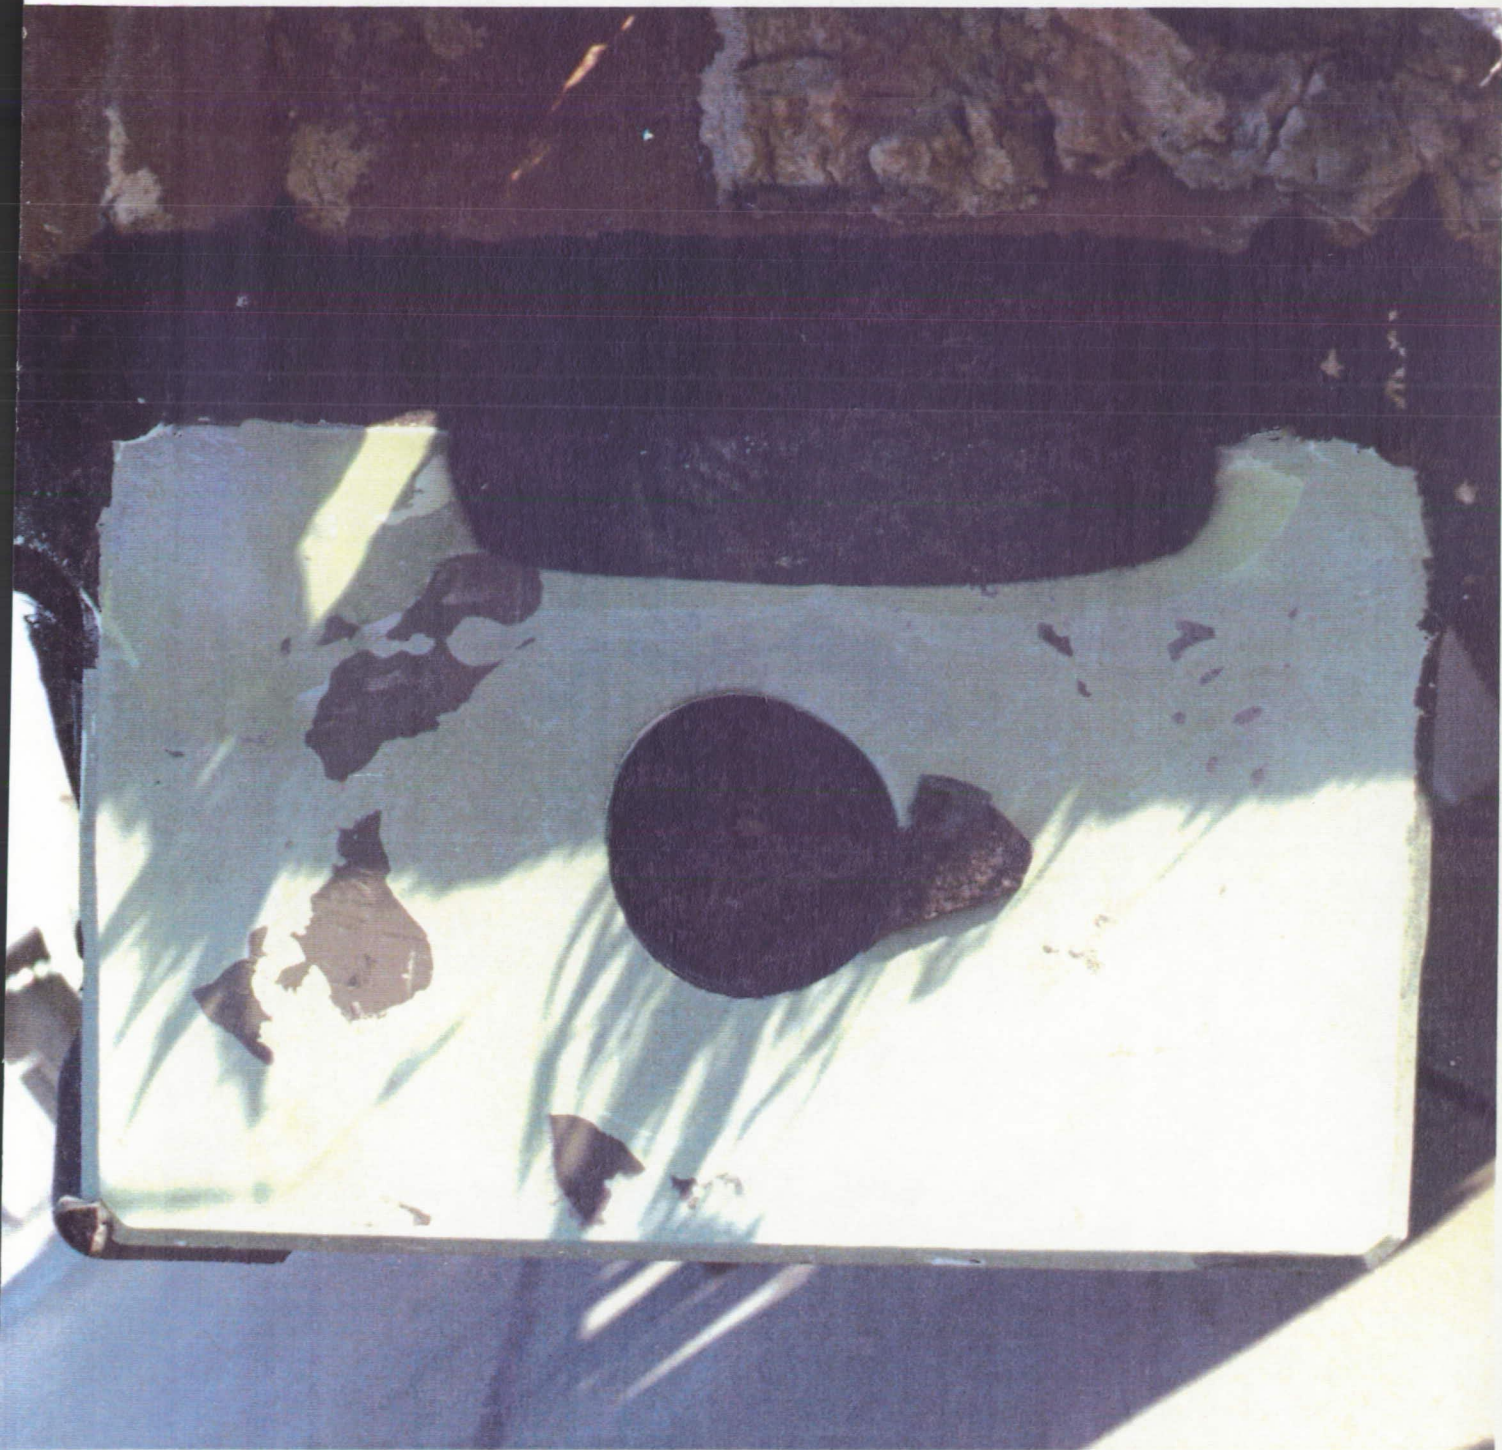
All DCS plungers were properly seated. Aft skirt HDP #7 was missing Epon shim from the inboard side of the foot and the substrate was sooted. A 9"x2" piece of HDP #8 aft face shim material was missing prior to water impact. The thermal curtain attach structure and aft skirt aft ring were inspected for damage caused by the suspected loss of a thermal curtain 34 seconds into flight, but no unusual damage was visible. Water impact may have altered any remaining evidence. Instafoam was missing from the aft ring around the aft skirt feet, HPU exhaust horns, and the SRB T-0 umbilical.

A 9" x 2" piece of HDP #8 aft face EPON shim material was
missing prior to water impact

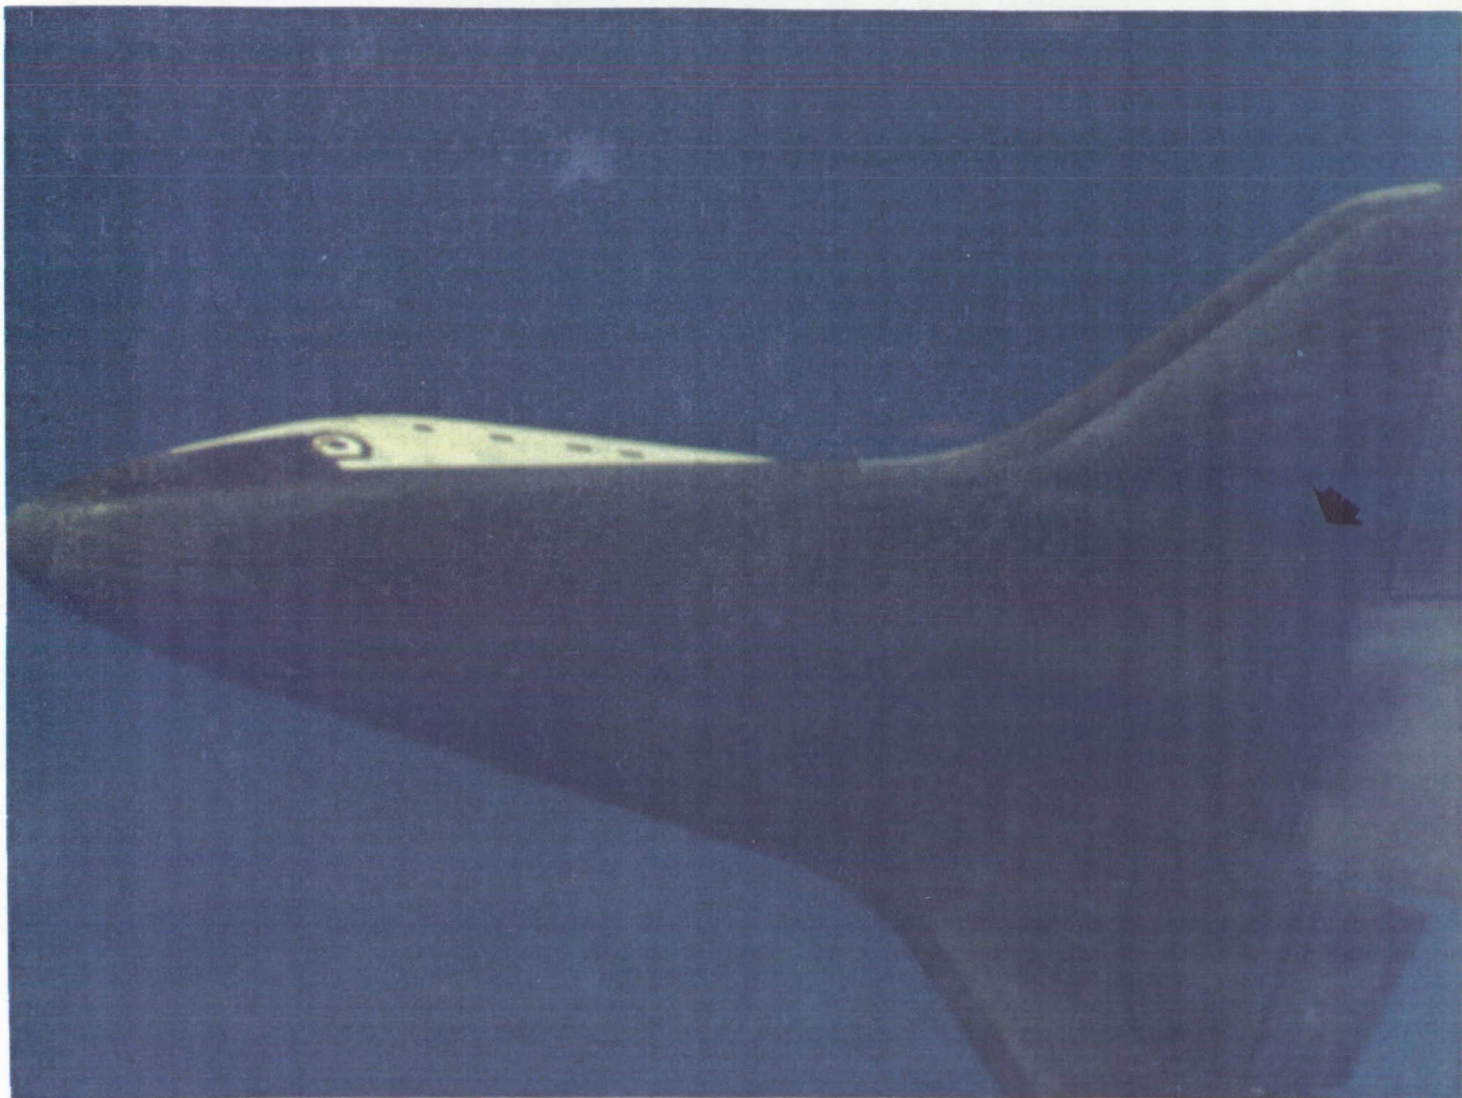
Overall view of lower surface tiles as Orbiter passes over the camera position. Note tile damage just visible near the ET/ORB LH2 umbilical area
