NASA Technical Memorandum TM 103815

Debris/Ice/TPS Assessment And Photographic Analysis For Shuttle Mission STS-38

November 15, 1990

Shuttle mission STS-38 was launched at 6:48 p.m. EST 11/15/90

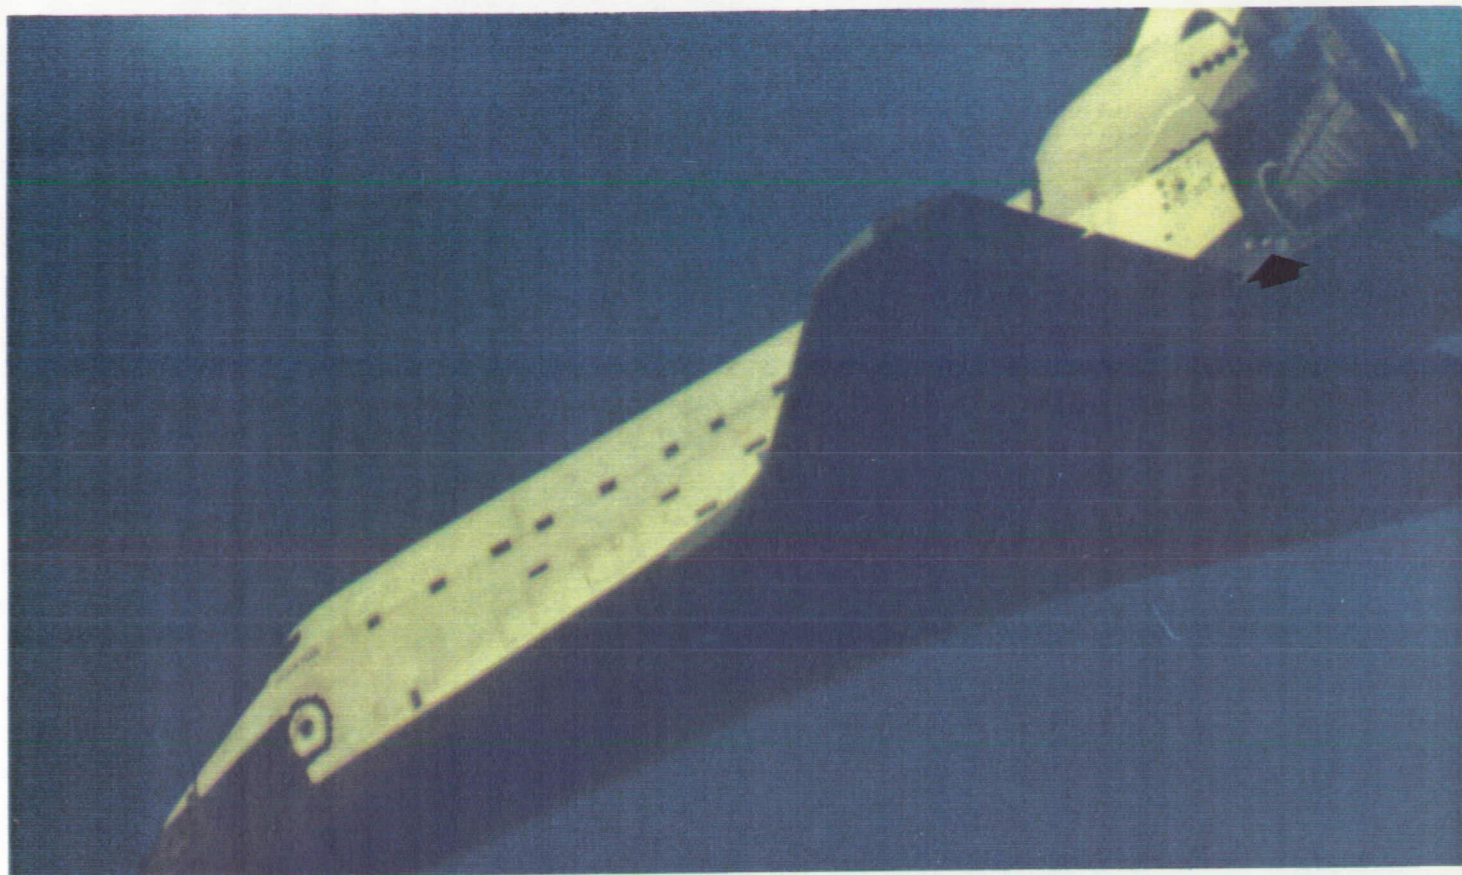
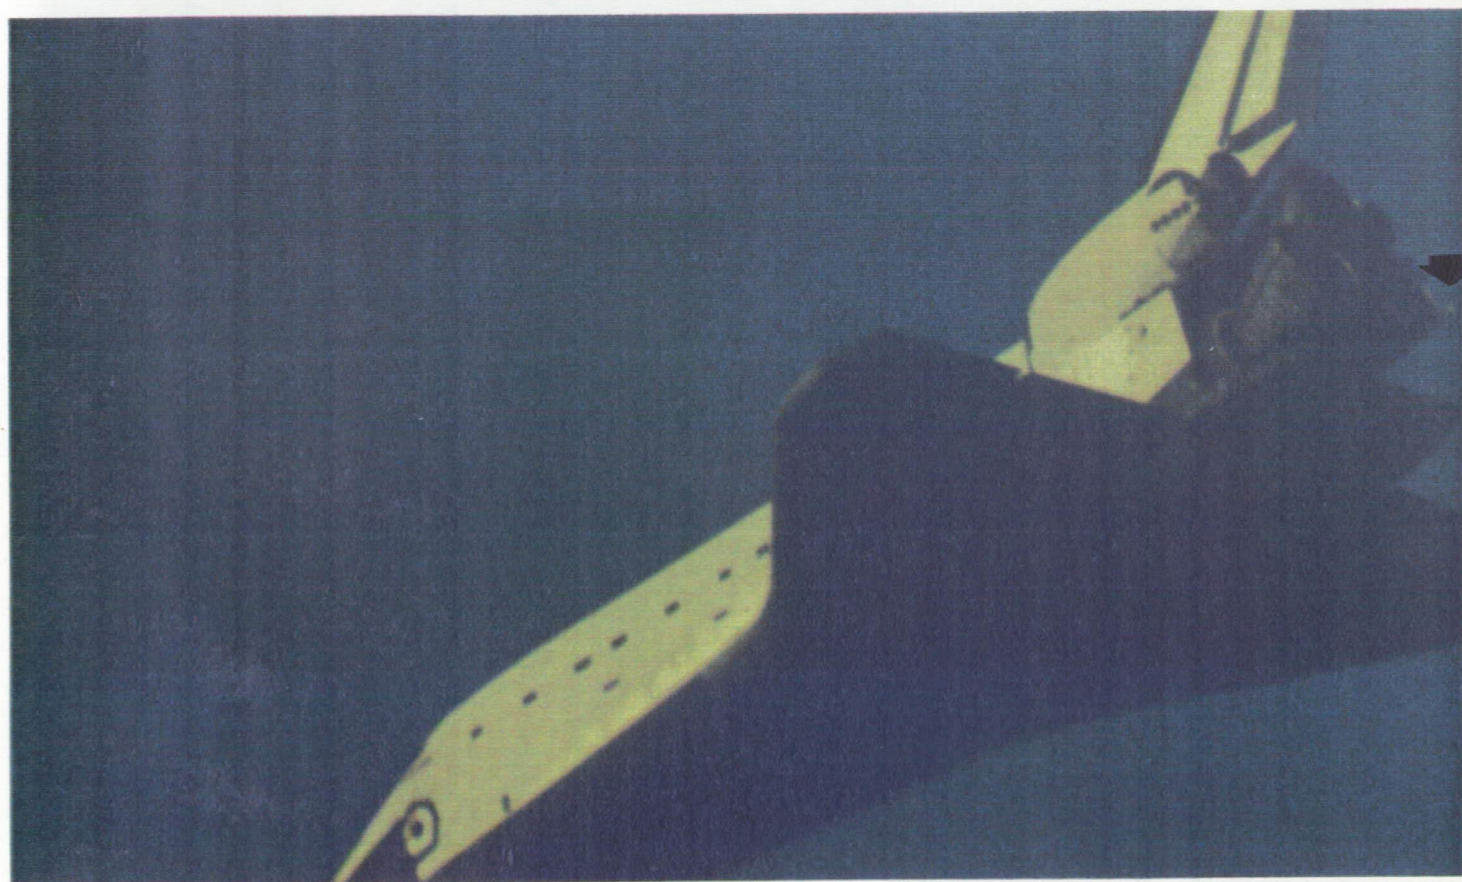
Two pieces of SSME closeout blanket, above the body flap near SSME #2 and outboard of SSME #3, fell aft during final approach

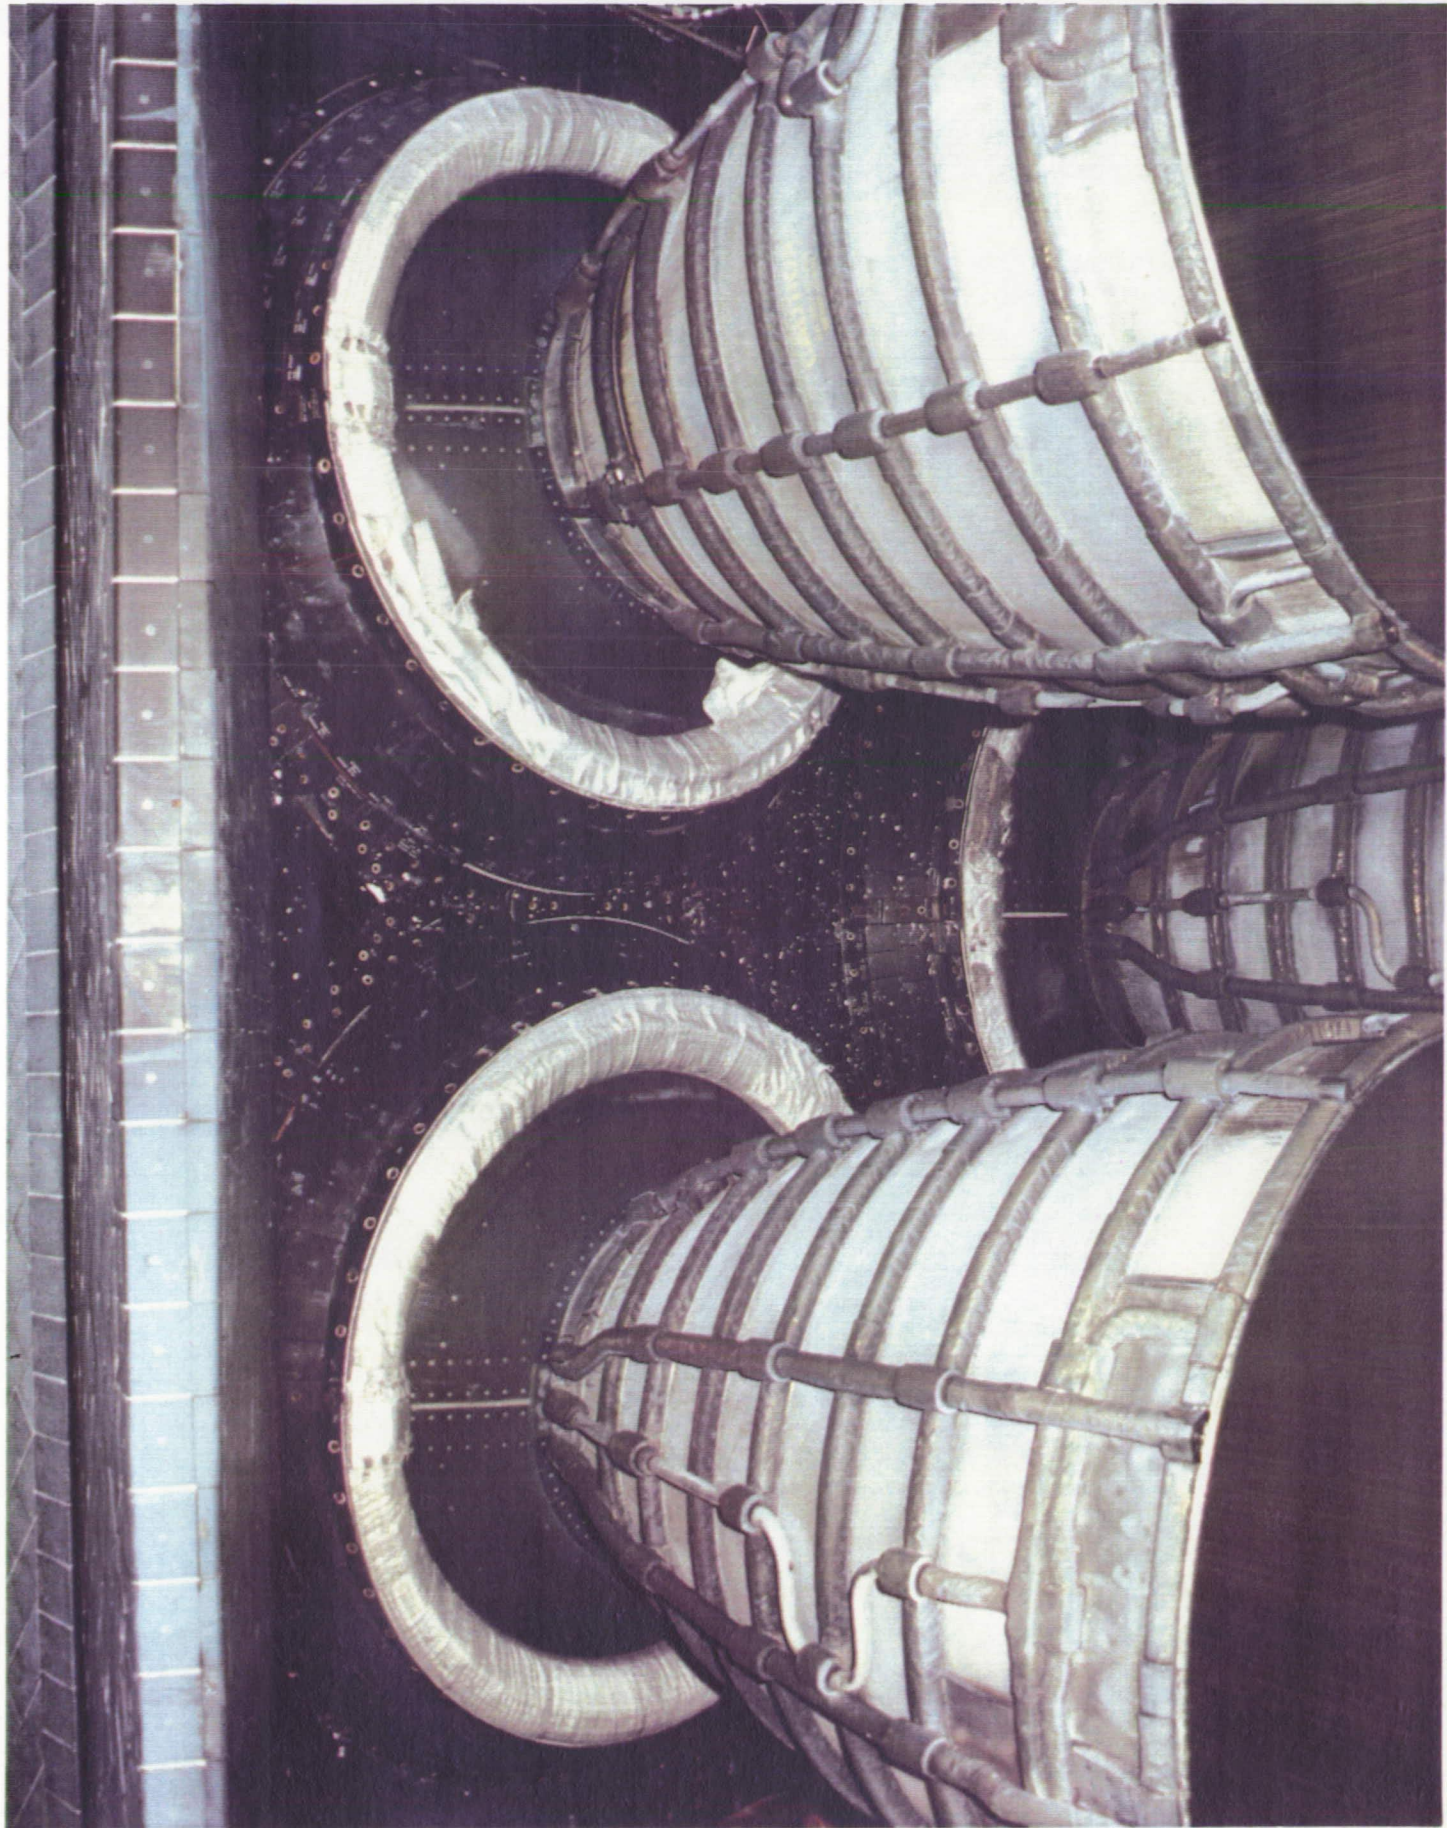
Overall view of SSME's. Damage to the base heat shield tiles was average with approximately 150 sites. All three SSME closeout beta blankets were frayed in localized areas.

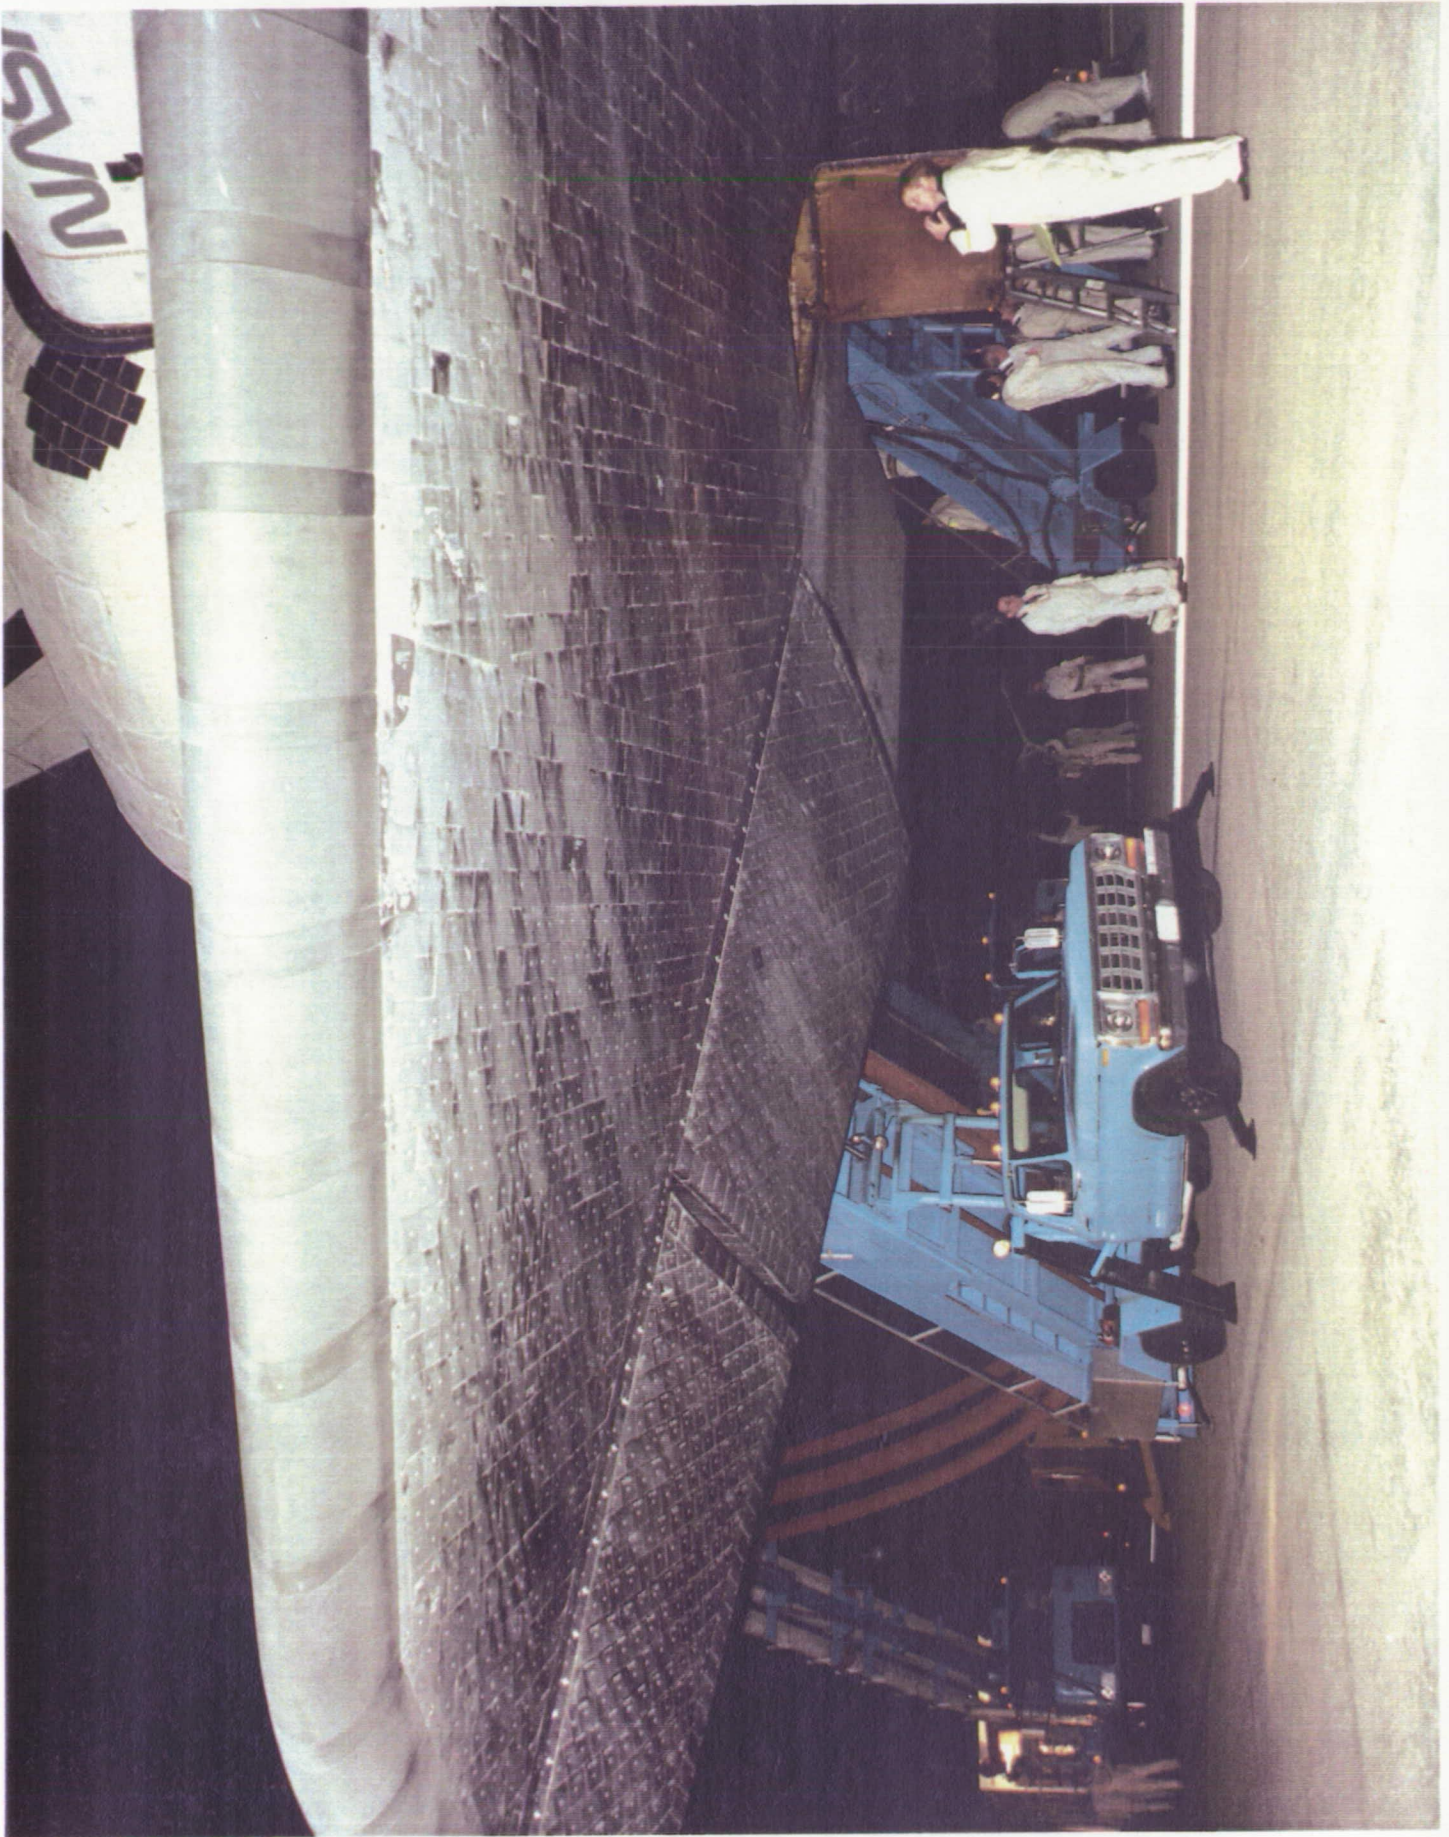
Lower surface tiles sustained a total of 70 hits with 7 of those damage sites measuring greater than or equal to 1 inch.
140

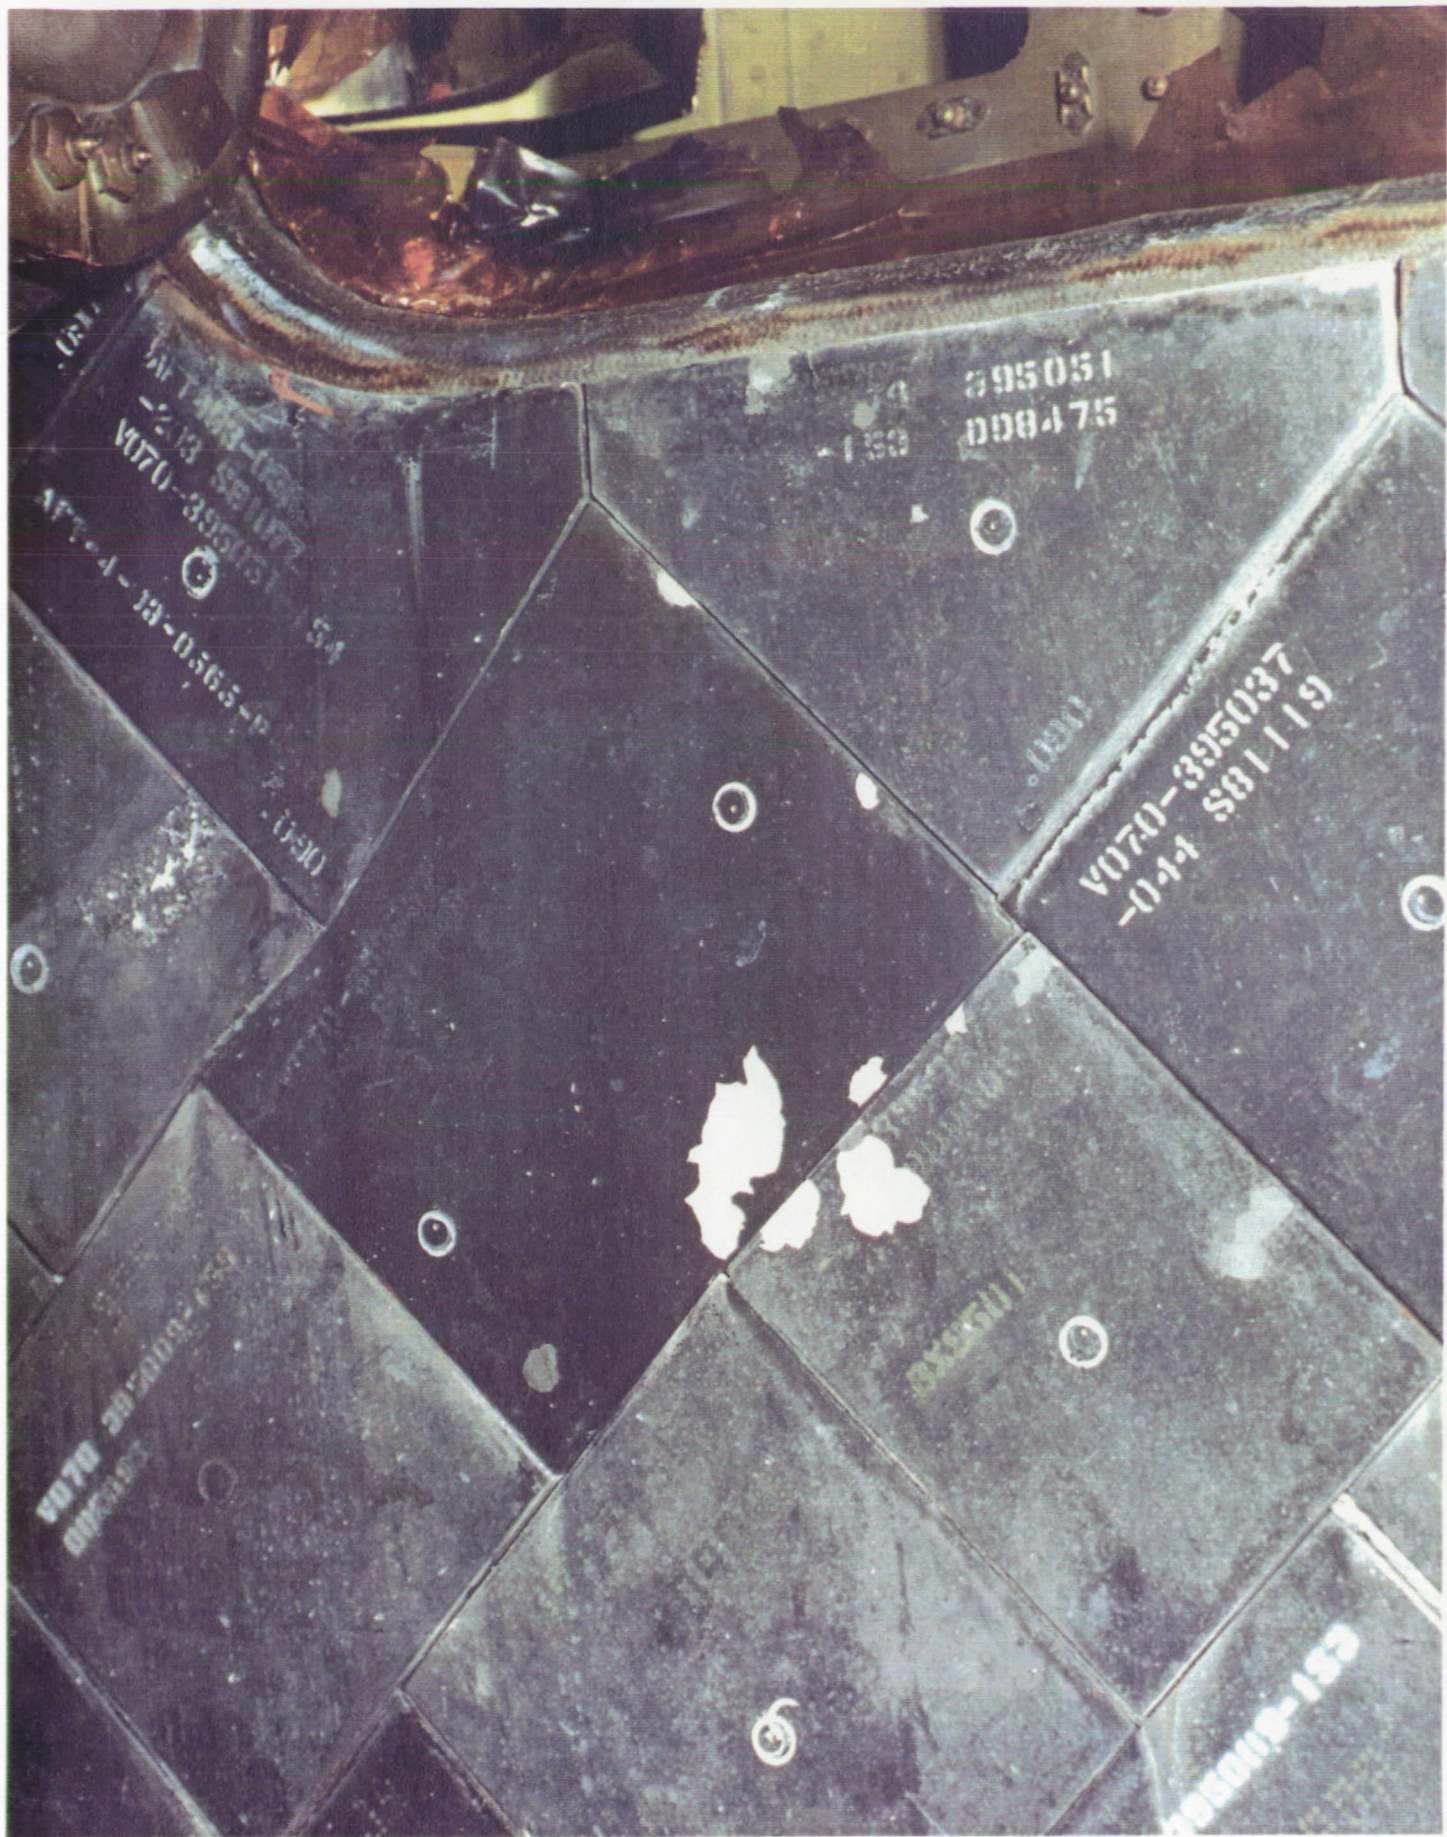
Typical debris impact damage to lower surface tiles near the
ET/ORB LH2 umbilical

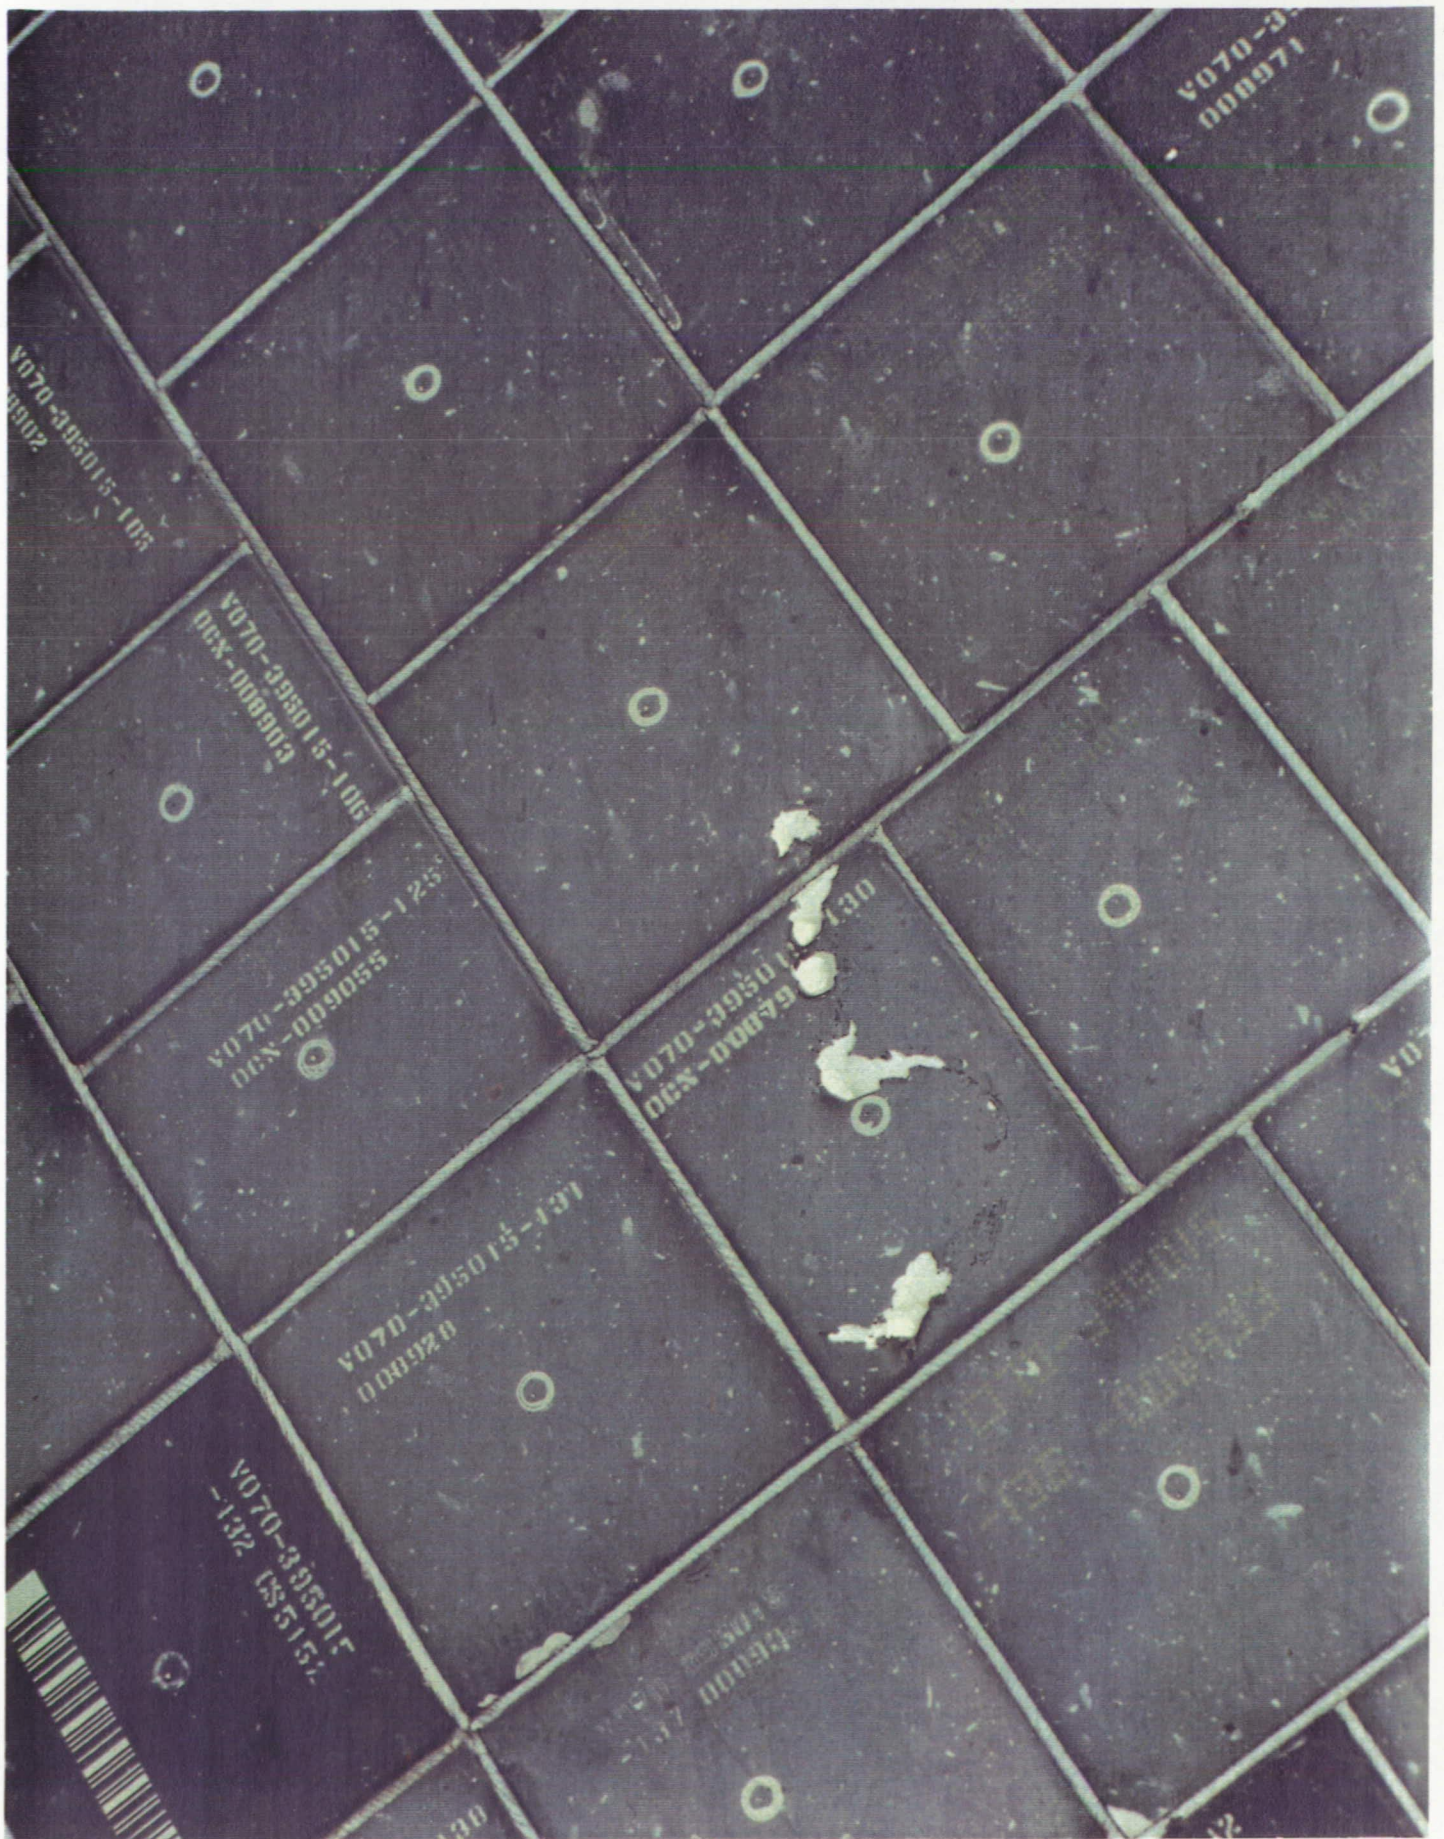
A total of 18 hits occurred on the body flap lower surface.
Some of the damage sites reached depths of 1/4 to 1 inch.

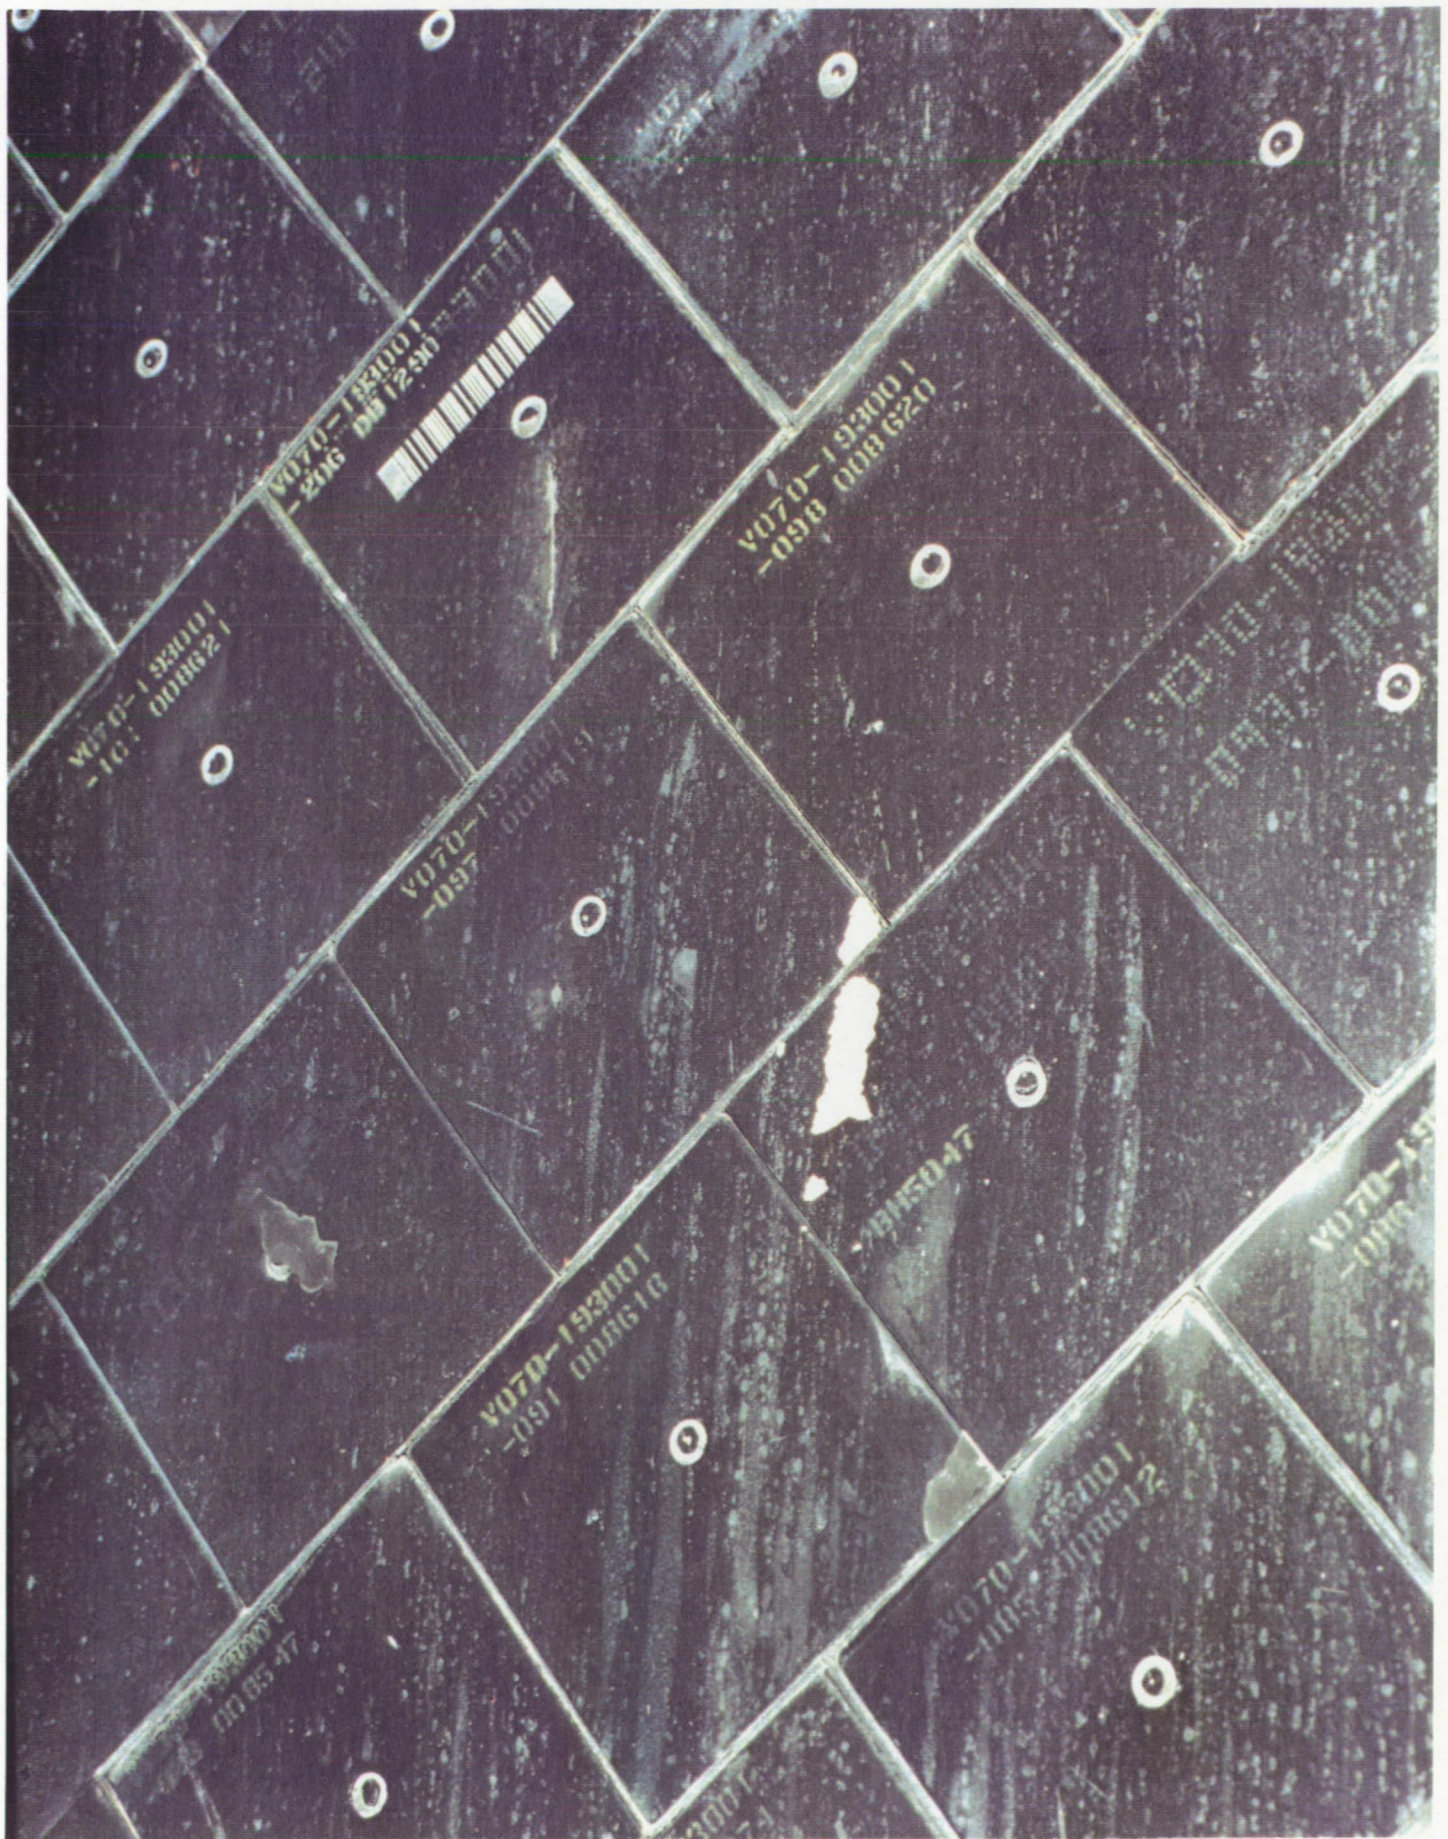
Typical debris impact damage to lower surface tiles

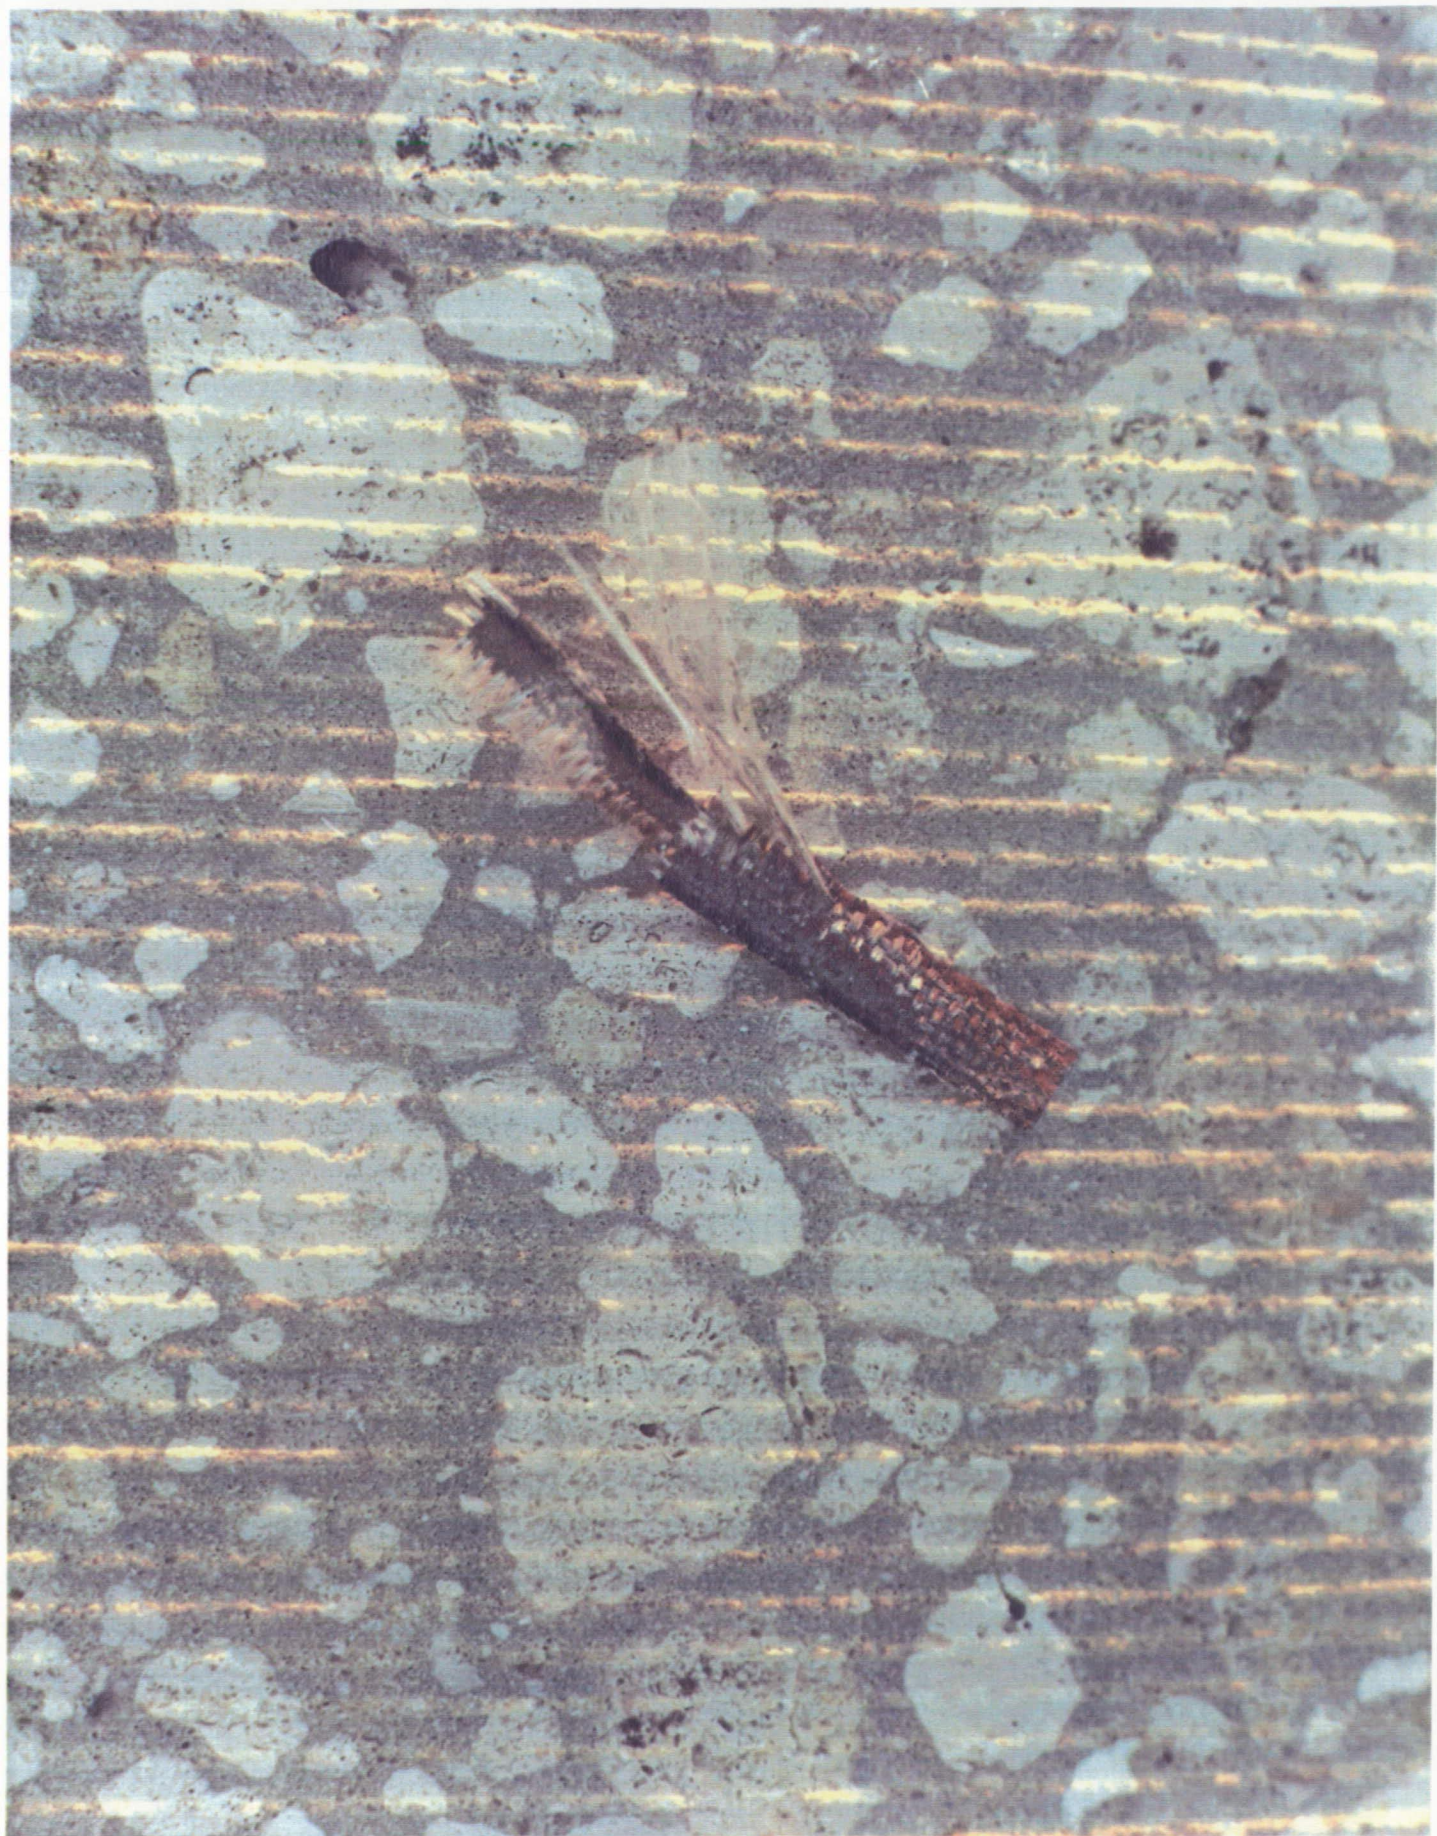
One 3" x 1/2" piece of Ames gap filler was found on the runway
50 yards south of Marker 14 near the runway threshold
