TWR-17544 Vol IV

FLIGHT SET 360H005 (STS-28)  
SEALS FINAL REPORT

February 1990

Flight Set 360H005 (STS-28)  
SEALS FINAL REPORT  
Volume IV

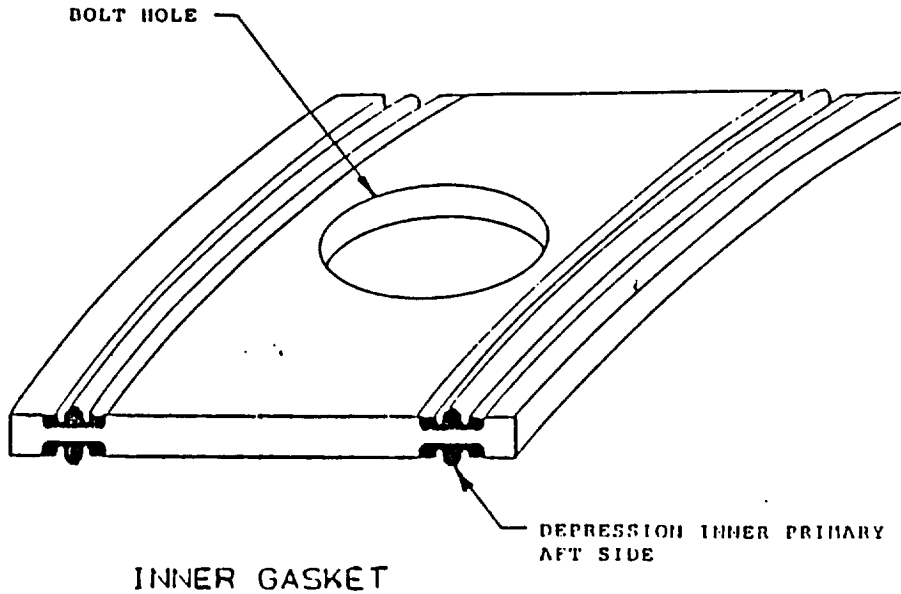
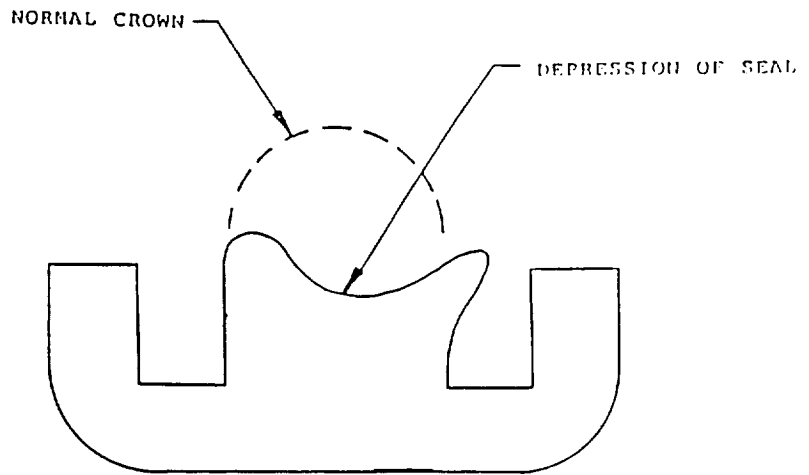
Figure 11  
Indentation on Right Hand Inner Igniter Gasket

The post-flight inspection of both motors showed the seal components to be in excellent condition except for the indentation found on the inner primary seal of the right hand inner igniter gasket, aft face (see Figure 11). Detailed inspection results, and inspections performed by the O-ring Inspection Team can be found in Section 5.0 of this report.

the inner gasket outer retainer edge at 270 degrees. An indentation was observed in the crown of the inner primary seal at 220 degrees on the aft face. The indentation was approximately 0.10 inch long by 0.025 inch wide. The indentation slowly rebounded after disassembly. Dissection of the area revealed two small subsurface voids. Additional inspection criteria was implemented to find these type of voids prior to assembly in the joint. All stat-o-seals from the inner joint bolts were damaged during disassembly.
