NASA
Technical Memorandum 4195

Evaluation of Composite Components on the Bell 206L and Sikorsky S-76 Helicopters

Donald J. Baker

AUGUST 1990

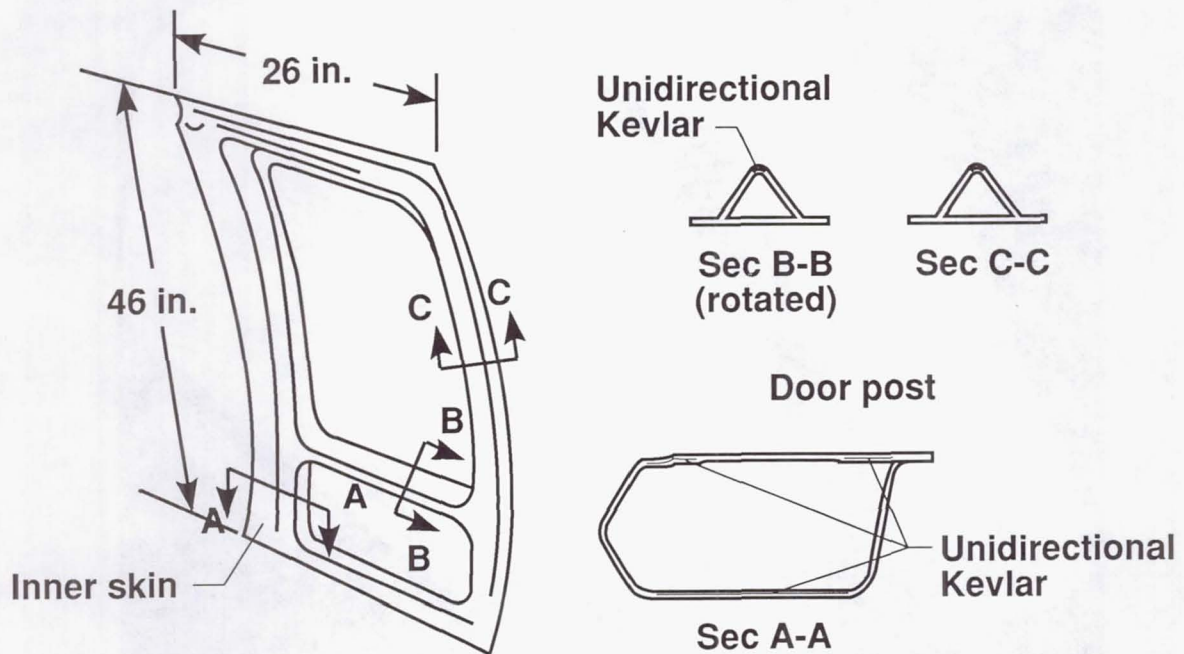
The litter door has had very few problems with the composite material skins. However, a major problem occurred with the metal hinges that are used to hold the cabin door. The hinges were under-designed and failed in service when someone pushed the cabin door open too far. New high-strength hinges have been installed and the litter doors are back in service.

Buckling occurred in the outer skin of the litter door on four helicopters parked in the Southwest United States desert during the summer. The probable cause of buckling is the thermal mismatch between the Kevlar-49/epoxy skins and the plexiglass window. This window was bonded to the exterior skin. The coefficient of thermal expansion of the plexiglass window is 4.5×10^{-6} in/in/°F, and the coefficient of thermal expansion for the Kevlar/epoxy

Figure 2. Bell 206L Kevlar/epoxy litter door.

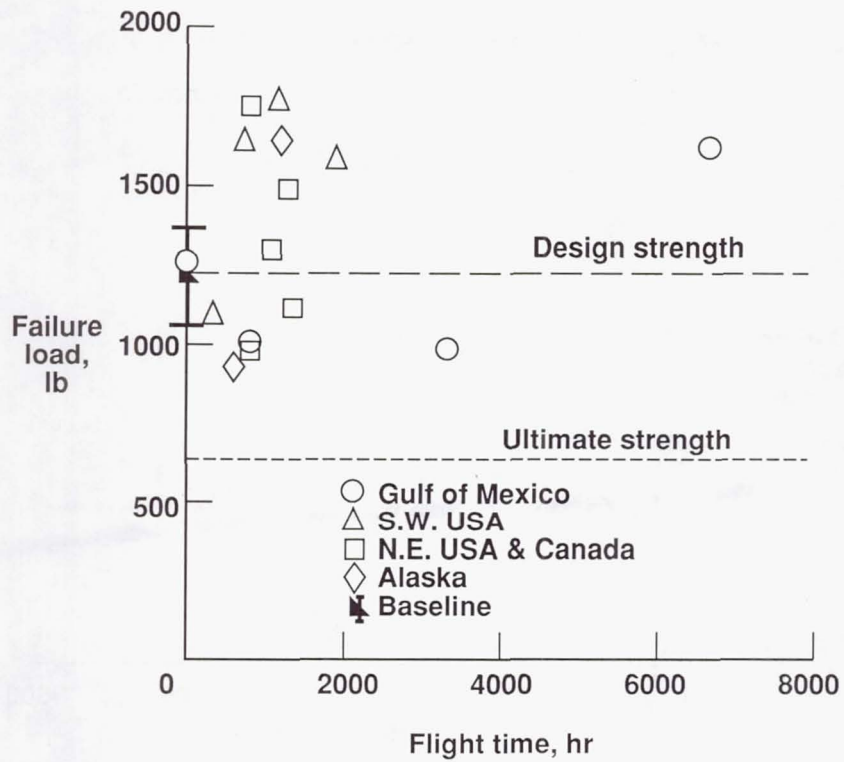
Failure loads (table 1) for 15 litter doors vary from 901 to 1768 lb. These failure loads are the total loads on the door including the hinge reaction from the cabin door. Failure loads as a function of flight hours are shown in figure 9. Each open symbol represents the failure load for a different exposure area. Also shown in figure 9 are two strength requirements, ultimate strength and design strength. The ultimate strength is the usual strength that an aircraft component must meet or exceed at all times. The design strength shown is the strength that an unconditioned component (as-fabricated) must meet or exceed. The design strength is intentionally greater than the ultimate strength and is the product of the ultimate strength and the environmental factor determined from the environmentally conditioned material coupon specimens (ref. 2). This strength is shown for reference only since the components tested are between as-fabricated and fully conditioned. The solid symbol represents the average baseline failure load (reported in ref. 2), which is the average of five components selected at random from the production lot of 45 components. The range of failure loads for the baseline tests is also shown in the figure. All litter doors had failure loads that exceeded the ultimate strength requirement of 635 lb (ref. 2), and nine of the doors had failure loads that exceeded the design strength of 1229 lb. It is acceptable for the failure load of doors that have been environmentally exposed to be below the design strength as long as the load is higher than the ultimate strength. Failure loads do not appear to be a function of exposure time. Initially in the postservice testing (ref. 3),

Figure 9. Failure load of litter doors after exposure.

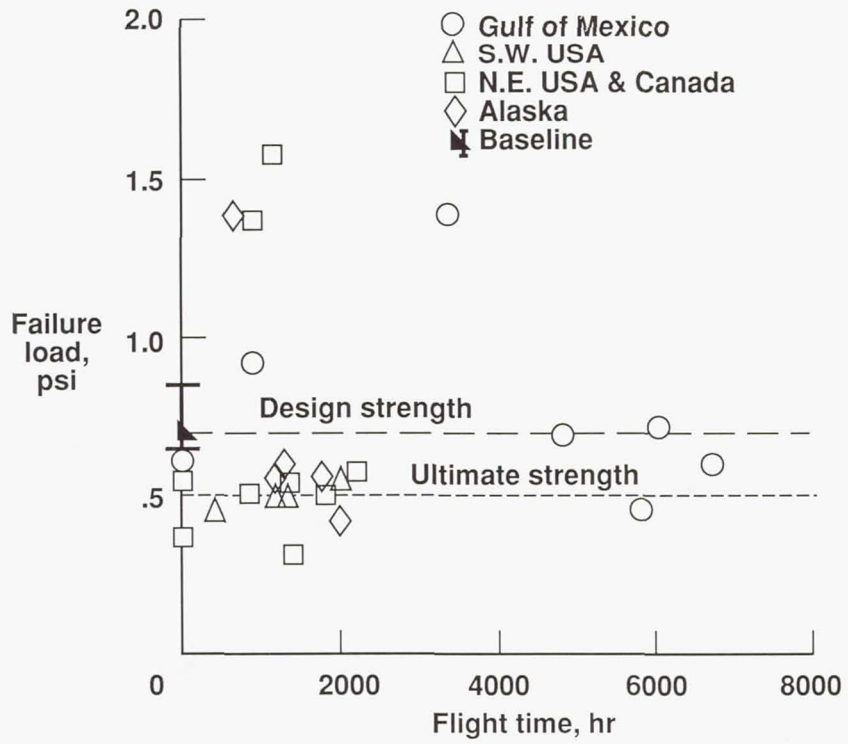
Failure loads (table 2) for 26 baggage doors vary from 0.32 to 1.57 psi, and service times for the doors vary from 386 to 6750 hours. Failure loads as a function of flight hours are shown in figure 11. Each open symbol represents the failure load for a different exposure area. The solid symbol represents the average baseline strength. These baggage doors are the components that developed large disbonds and have been removed from service. Most of the test points represent baggage doors that have some disbond between the core and the outer skin. Twenty-one of the doors had failure loads that were below the design strength of 0.70 psi, and nine doors had failure loads that were below the ultimate strength requirement of 0.50 psi (ref. 2). The stiffness of the baggage door as a function of the flight hours is shown in figure 12. The stiffness was determined by measuring the deflection at the center of the door as the loads were applied. The disbonds do not appear to affect the stiffness as much as the strength. The baggage doors that have been tested have accumulated a total of 51 798 hr of flight service.

Figure 11. Failure load of baggage doors after exposure.

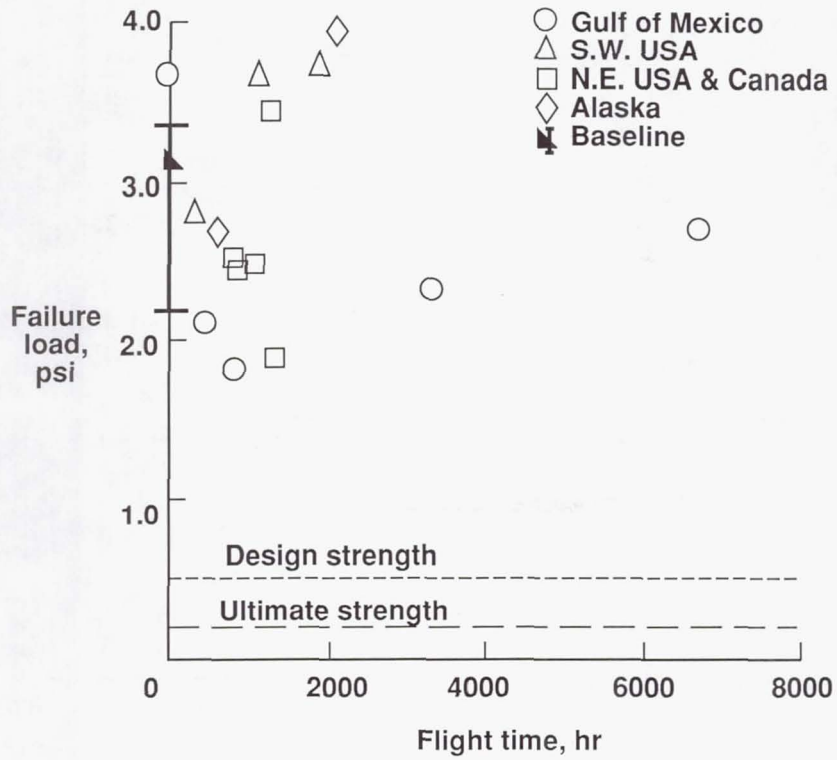
Failure loads (table 3) for 15 forward fairings vary from 1.80 to 3.93 psi, and service times for these components vary from 386 to 6750 hr. Failure loads as a function of flight hours are shown in figure 13. Each open symbol represents the failure load for

a different exposure area. Failure loads vary from 1.80 to 3.93 psi and exceed the design strength of 0.49 psi (ref. 2) by more than a factor of 3. Failure loads for forward fairings tested to determine the baseline strength (ref. 2) varied from 2.2 to 3.4 psi. Failure loads for 8 of the 15 forward fairings tested are between 2.2 and 3.4 psi. The large scatter in the failure load could be the result of variations in the fabrication process. Considerable variation could result from putting down the single ply of Kevlar fabric (style 281) on a compound contoured surface. The lay-up requires cutting and overlapping the fabric at many places to prevent wrinkling on the surface. The stiffness of the forward fairing as a function of the flight hours is shown in figure 14. The stiffness was calculated using measurements for the deflection of the upper surface at a point 14.5 in. from the aft end as the load was applied. The stiffness of all fairings, except one, exceeded the stiffness of the certification fairings. The fairings that have been tested accumulated a total of 23 730 hr of flight time.

Figure 13. Failure load of forward fairings after exposure.

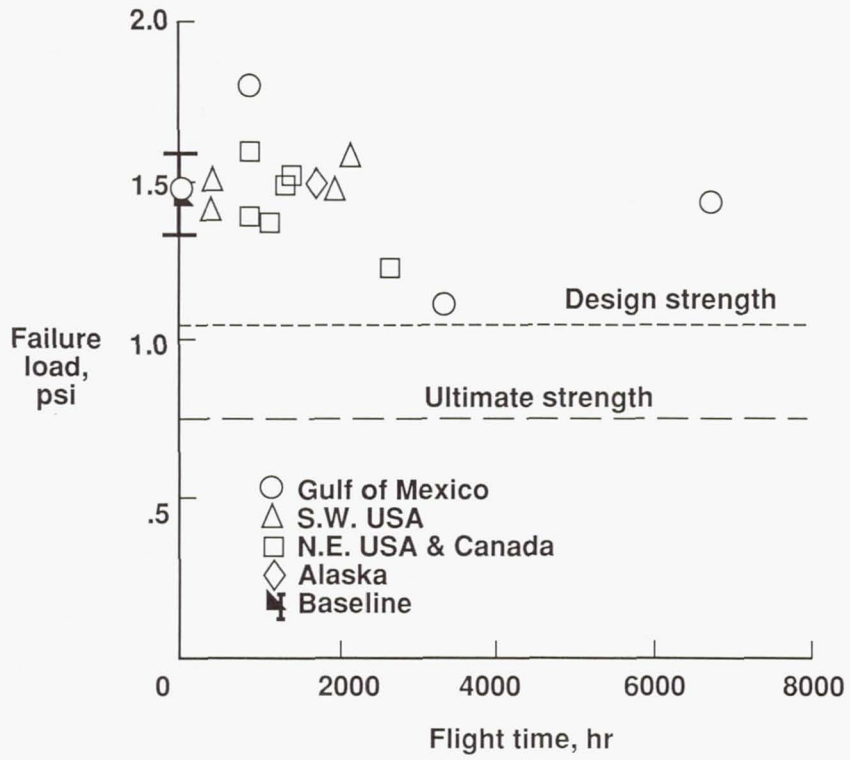
Failure loads (table 4) for 15 vertical fins vary from 1.12 to 1.80 psi, and service times for these fins vary from 385 to 6750 hr. Failure loads as a function of flight hours are shown in figure 15. All fins exceed the design strength of 1.05 psi. Failure loads for 12 of the 15 fins are between 1.35 and 1.57 psi, which is the range of failure loads for the baseline tests (ref. 2). One fin that was struck by lightning is identified in table 4. The fin was damaged at the top with no damage in the structural box. This fin failed at 1.23 psi with no apparent effect from the lightning strike. The environment does not appear to affect the failure load of the vertical fins. The stiffness of the vertical fin as a function of flight time is shown in figure 16. Stiffness was calculated using measurements for the tip deflection as the simulated aerodynamic load was applied. The certification deflection data for the fin are not available. The vertical fins that have been tested have accumulated 26 139 flight hours.

Figure 15. Failure load of vertical fins after exposure.

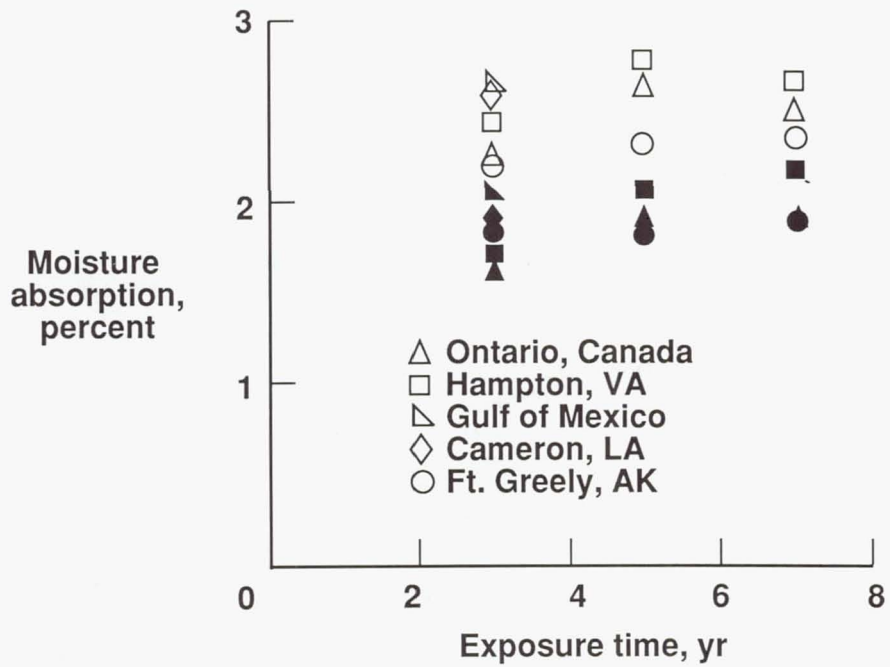
Moisture absorption data for the Kevlar-49/F-185 material are shown in figure 20. This figure indicates that painted specimens absorb more moisture than the unpainted specimens. Actually, the painted specimens absorb up to 0.63 percent (average) more moisture than the unpainted specimens. Moisture absorption data for the Kevlar-49/LRF-277 material are shown in figure 21. The trend in this material

Figure 20. Moisture absorption of Kevlar-49/F-185 composite material. Solid symbols represent unpainted specimens.

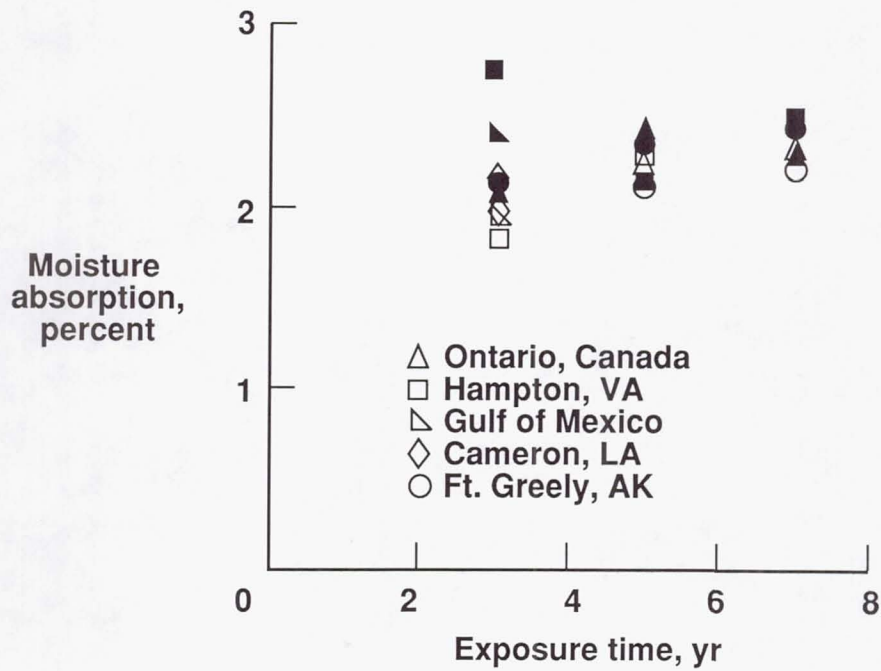
is the opposite from the other two Kevlar materials in this program. For the Kevlar-49/LRF-277 material the unpainted specimens absorb more moisture than the painted specimens. By the seventh year of exposure the unpainted specimens are approaching an equilibrium condition of 2.3 percent moisture absorption.

Figure 21. Moisture absorption of Kevlar-49/LRF-277 composite material. Solid symbols represent unpainted specimens.

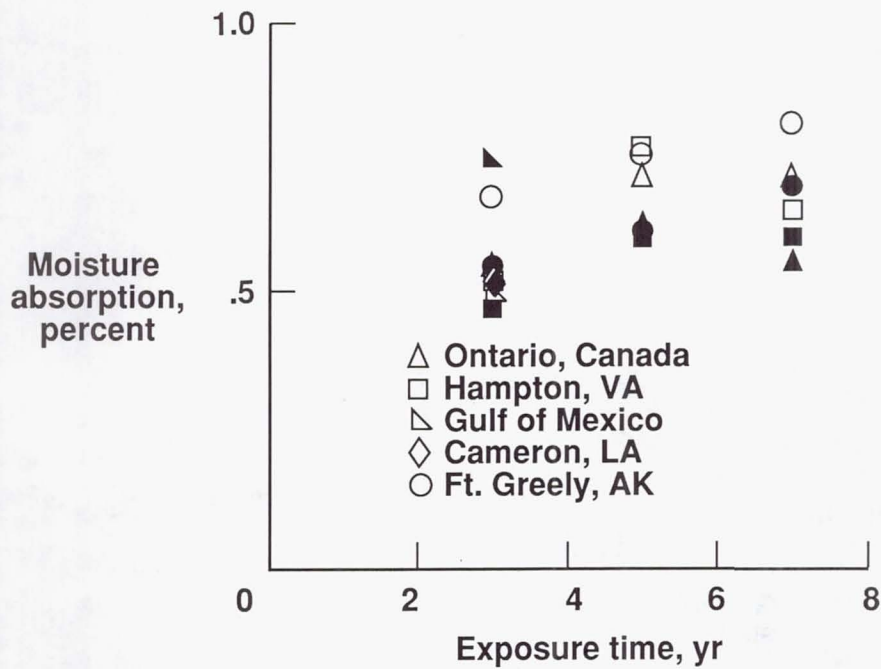
Moisture absorption data for the T-300/E-788 graphite/epoxy material are shown in figure 22. The 0.74-percent absorption for a 3-year exposure at the Gulf of Mexico does appear high. There is no method to determine if this high moisture absorption would continue in the Gulf of Mexico since the rack was destroyed before the removal of specimens after 5 years of exposure. No trend is evident after 3 years of exposure. After 5 and 7 years of exposure the painted specimens absorbed approximately 0.10 percent more moisture than the unpainted specimens, the same trend followed by two of the Kevlar/epoxy systems. Kevlar-49/epoxy materials absorb four to five times more moisture than graphite/epoxy materials because the Kevlar fibers absorb moisture. The average values, for each material, compare well with published values for other Kevlar/epoxy and graphite/epoxy systems (ref. 1).

Figure 22. Moisture absorption of T-300/E-788 graphite/epoxy composite material. Solid symbols represent unpainted specimens.

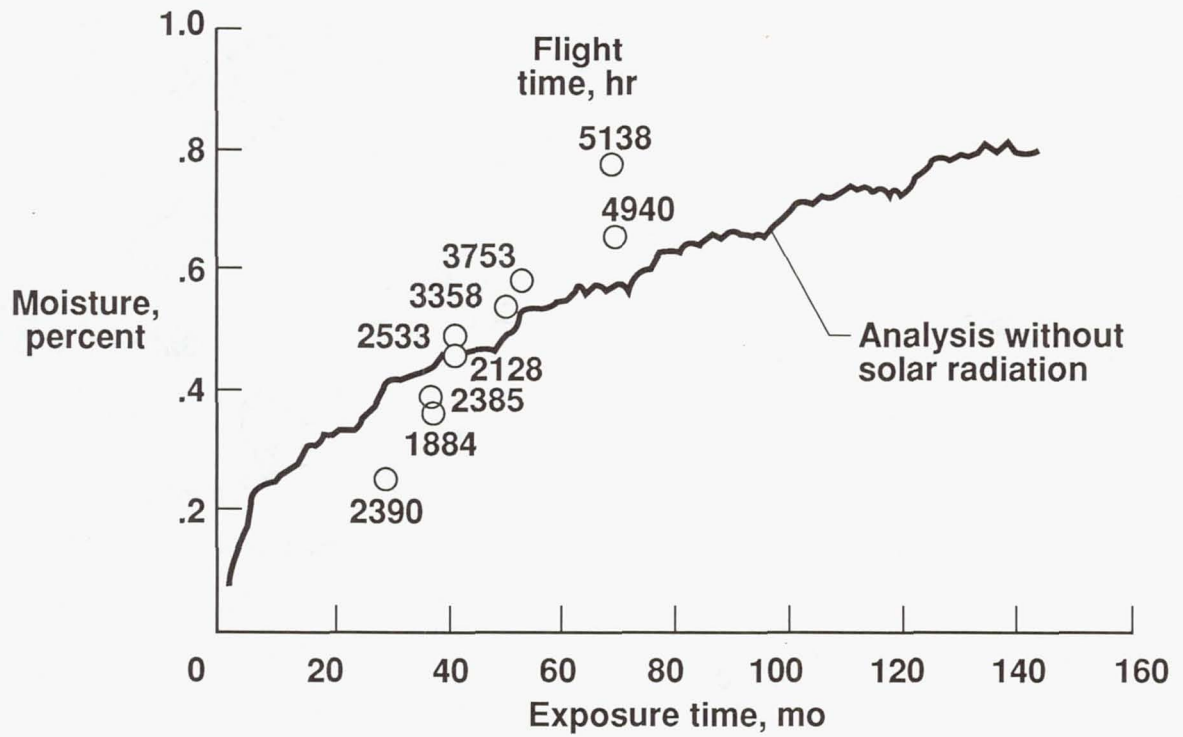
A predicted moisture-time profile (ref. 6) for the tail rotor spars (ref. 5) operating in the Louisiana Gulf Coast region is shown in figure 31. Weather data from Lake Charles, Louisiana, were used in predicting the absorbed moisture. Measured moisture values (table 7) are shown in figure 31 on a plot of percent moisture as a function of exposure time. As can be seen in figure 31, the measured moisture values are below the predicted moisture values for the low exposure time (30-40 months), whereas the measured moisture values are for an exposure time of 70 months higher than the predicted values.

Figure 31. Measured and predicted moisture content for S-76 tail rotor spars exposed at Lake Charles, Louisiana.
