TWR-17270 VOL. VI

QM-6 FINAL PERFORMANCE EVALUATION REPORT  
IGNITER

JULY 1990

The Space Shuttle Redesigned Solid Rocket Motor (RSRM) static test of Qualification Motor (QM-6) was conducted 20 April 1988 at Morton Thiokol, Inc., Space Operations. The QM-6 was a full scale, full duration test.

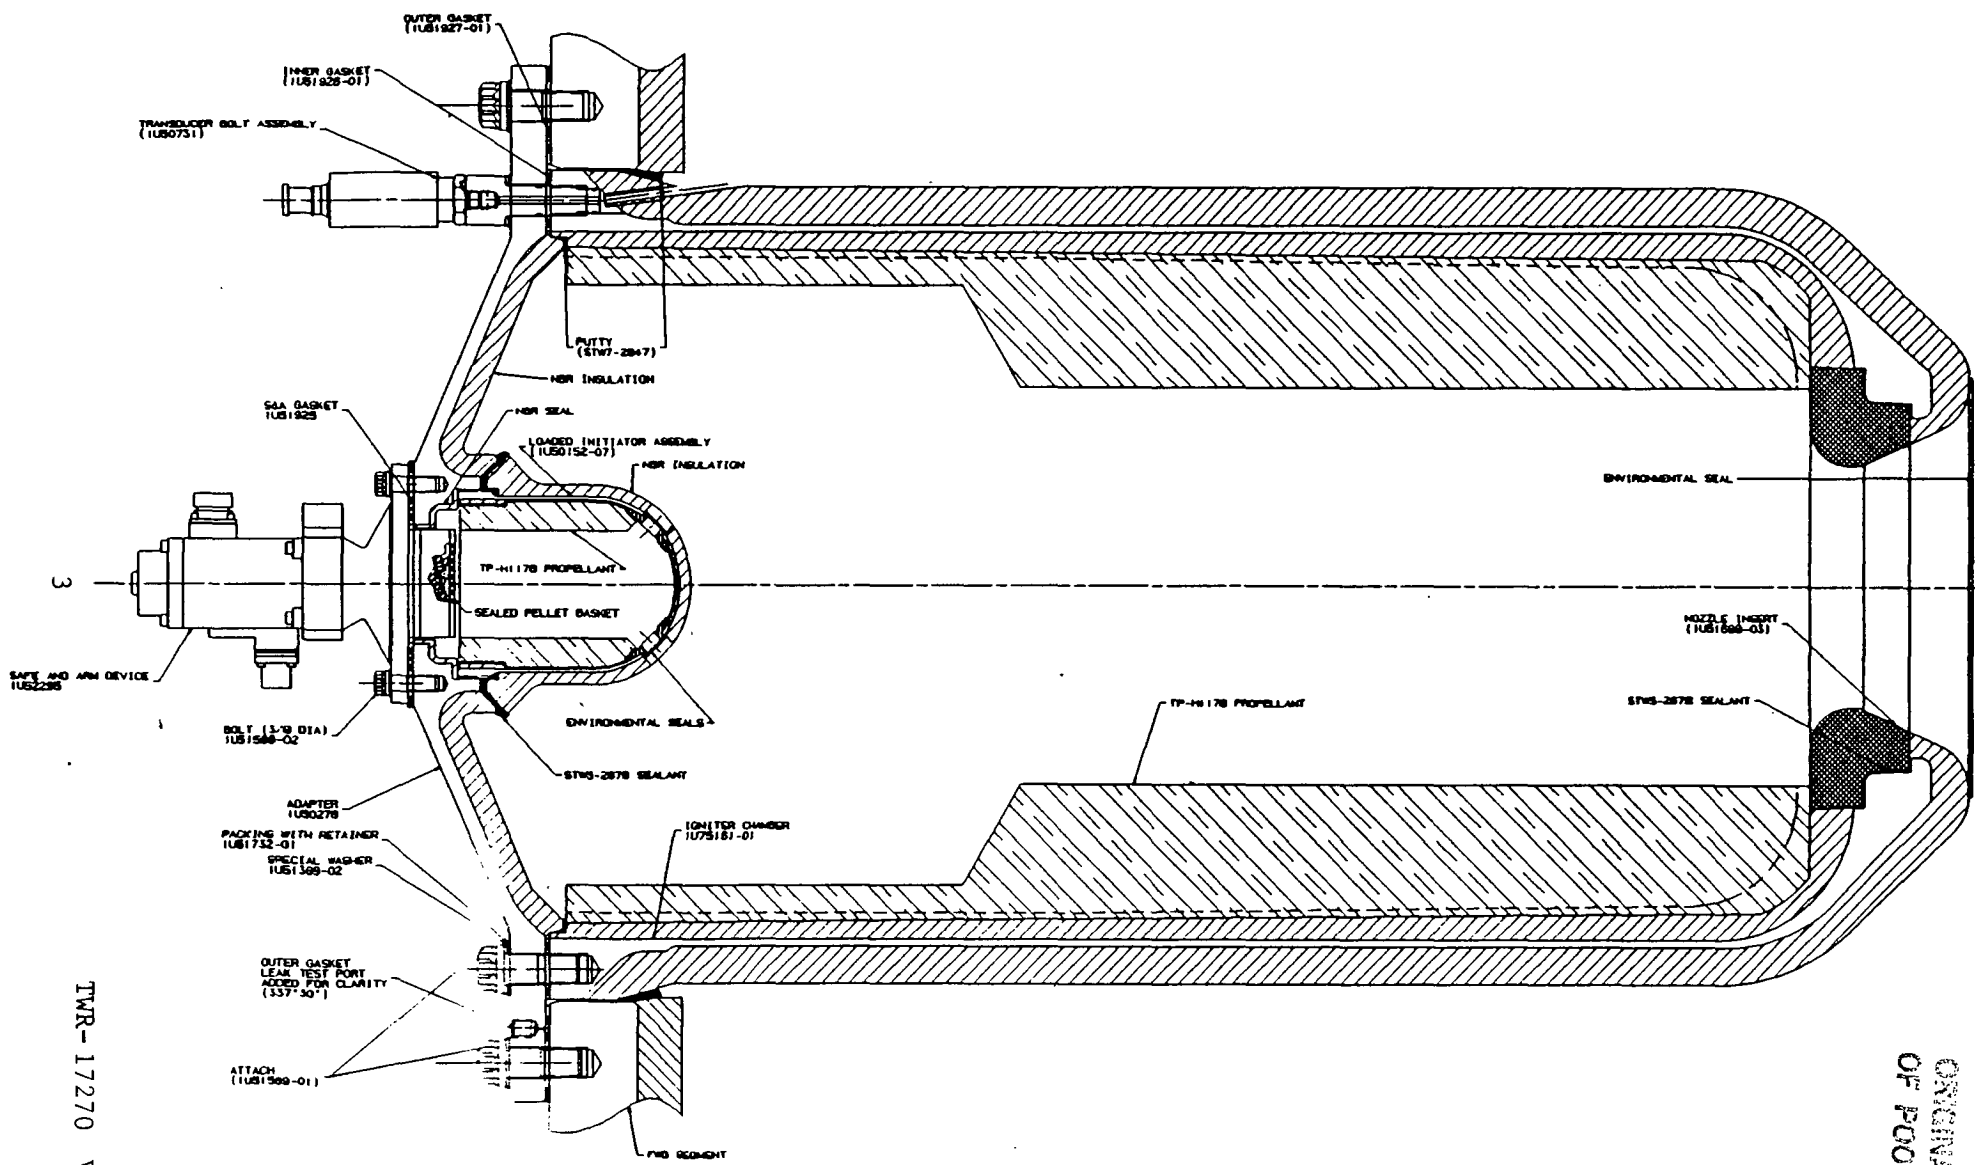
FIGURE 1. IGNITER CROSS SECTION

The overall performance of the igniter components was excellent. Figure 1 illustrates the Igniter and S & A seals and components. The igniter performance was within specified limits as shown in Figure 2. No damage or heat affected areas were noted except for minor seal damage which probably occurred during disassembly.

The sealing elements of the igniter functioned as expected with no evidence of erosion or blowby.

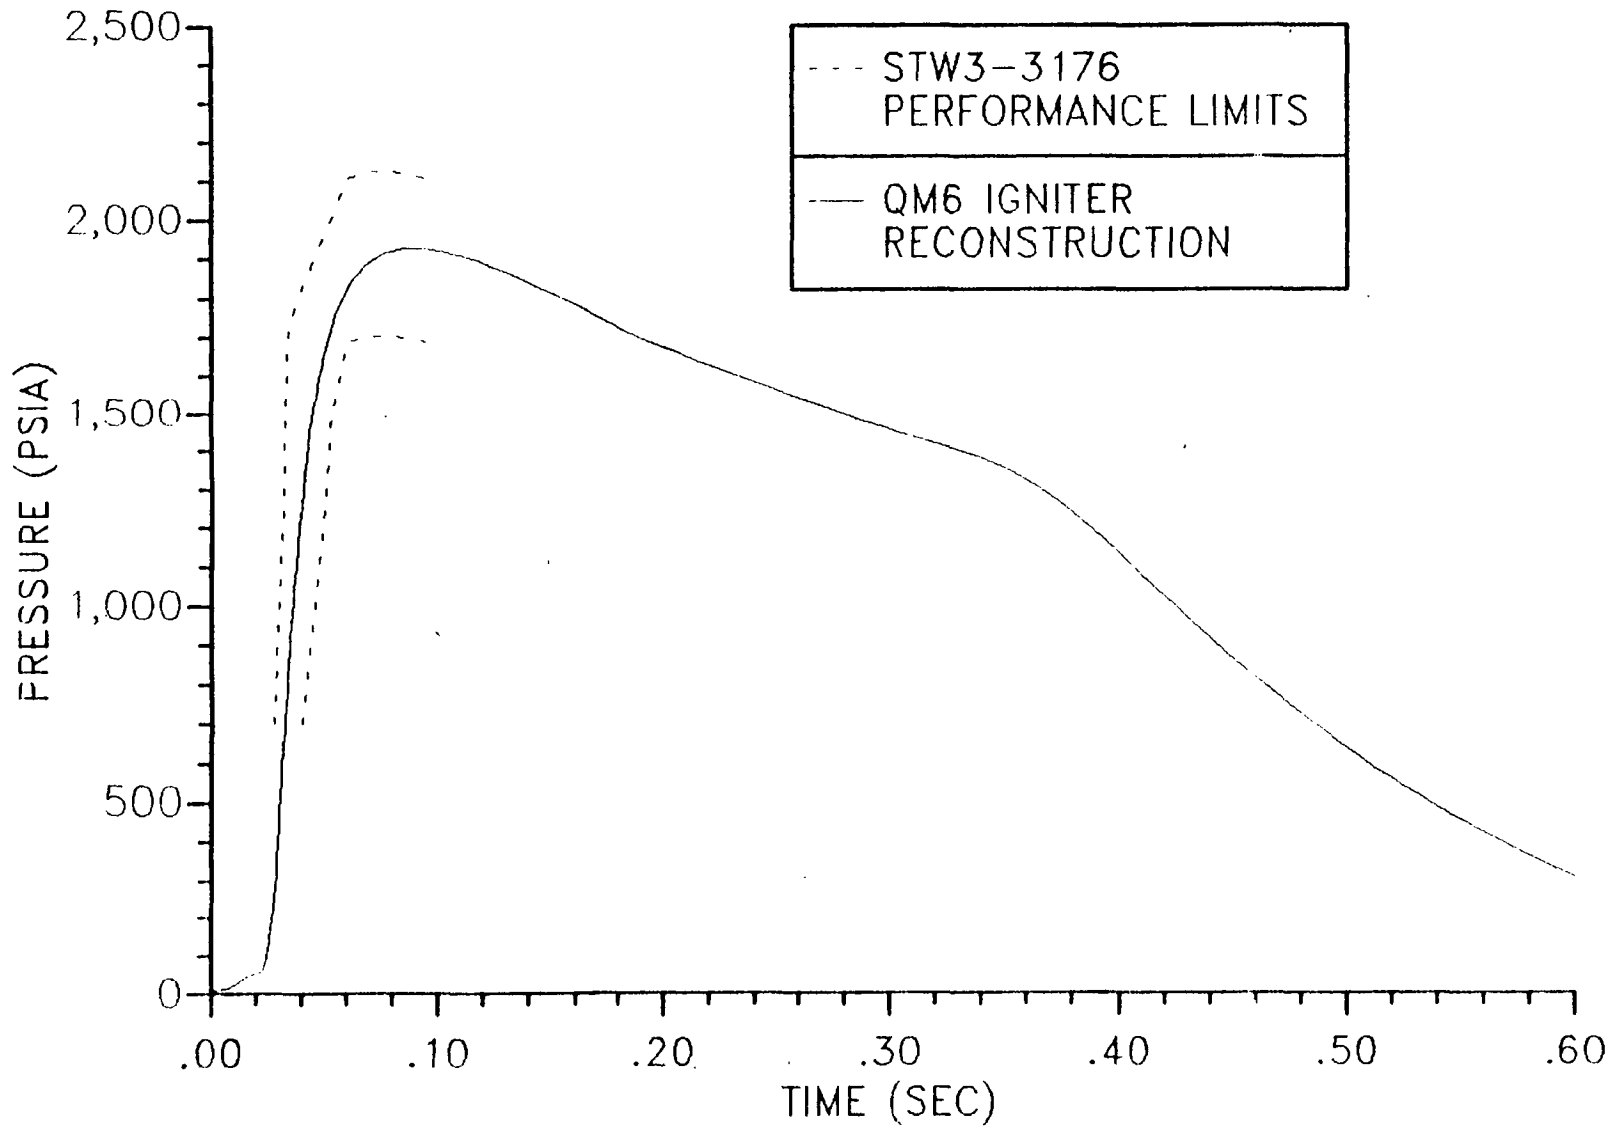
FIGURE 2. IGNITER PERFORMANCE & SPECIFICATION LIMITS

QM-6 IGNITER RECONSTRUCTION  
AT 80 DEG F

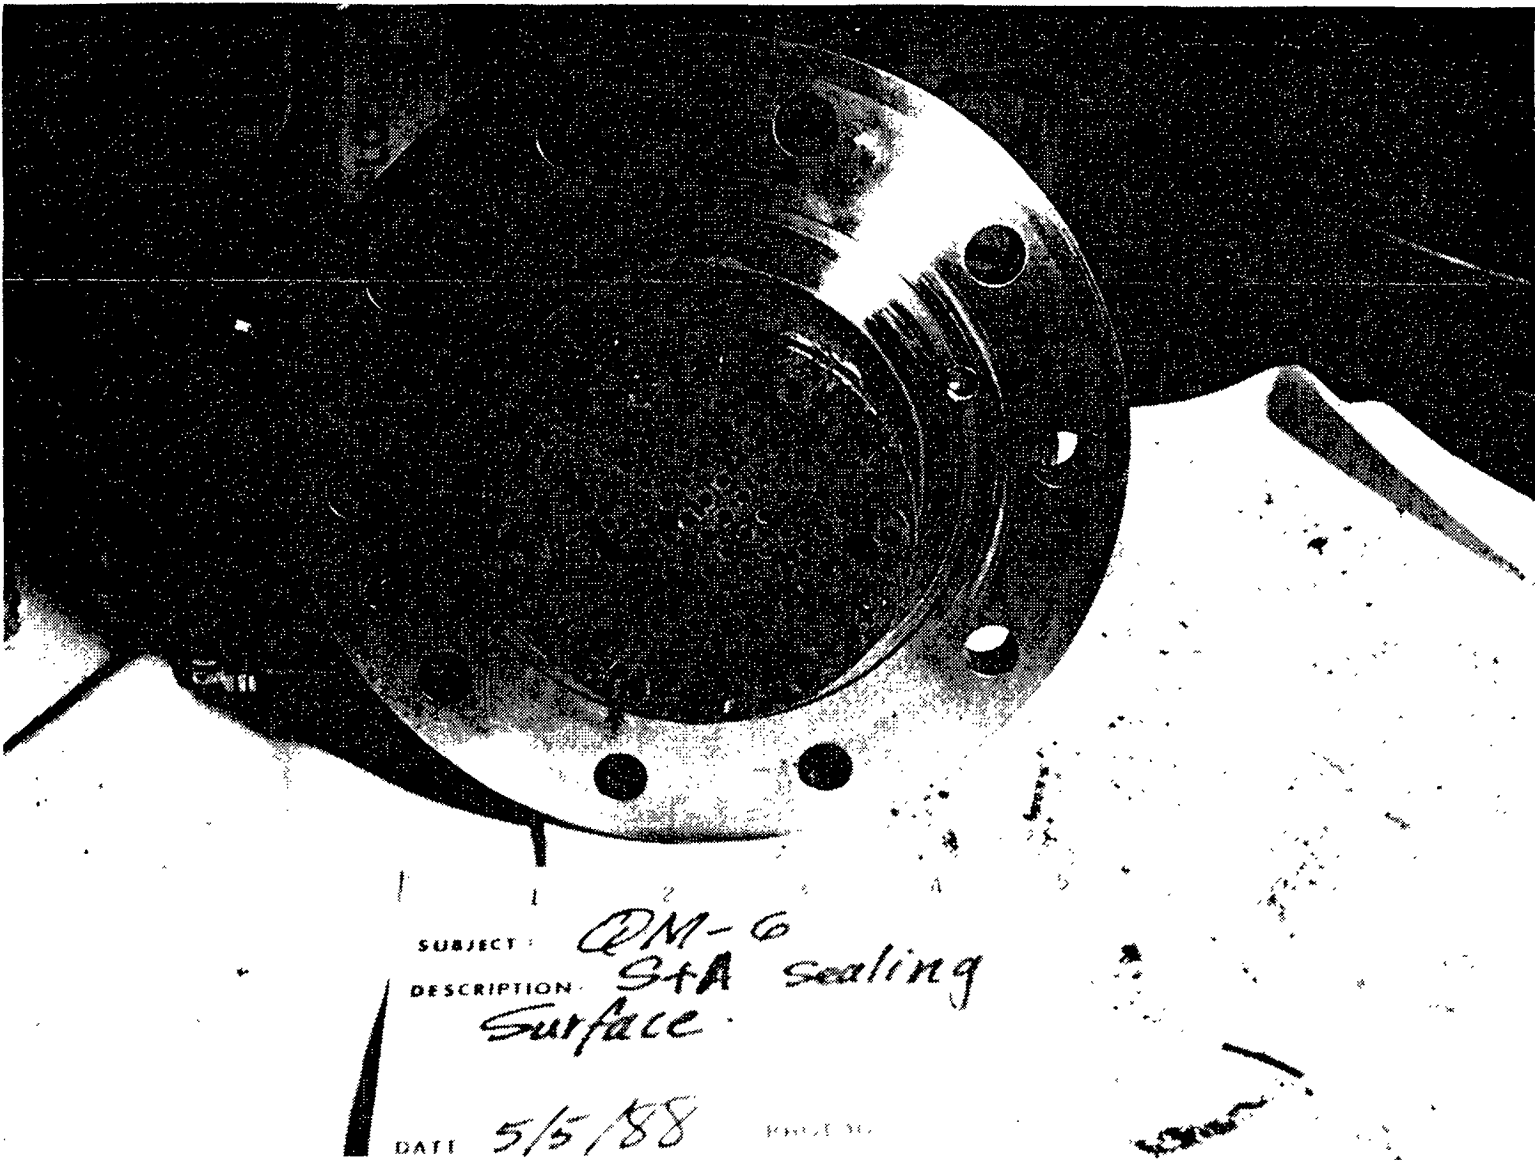
FIGURE 3. S&A SEALING SURFACE

The Safe and Arm-to-igniter joint was disassembled on 5 May 1988. The S&A gasket and both S&A and igniter adapter sealing surfaces were thoroughly inspected, revealing no damage, erosion, or heat effect (see Figures 3 and 4). There was no soot to, or past the primary seal. The sealing surfaces of the joint were in excellent condition (see page A-1).

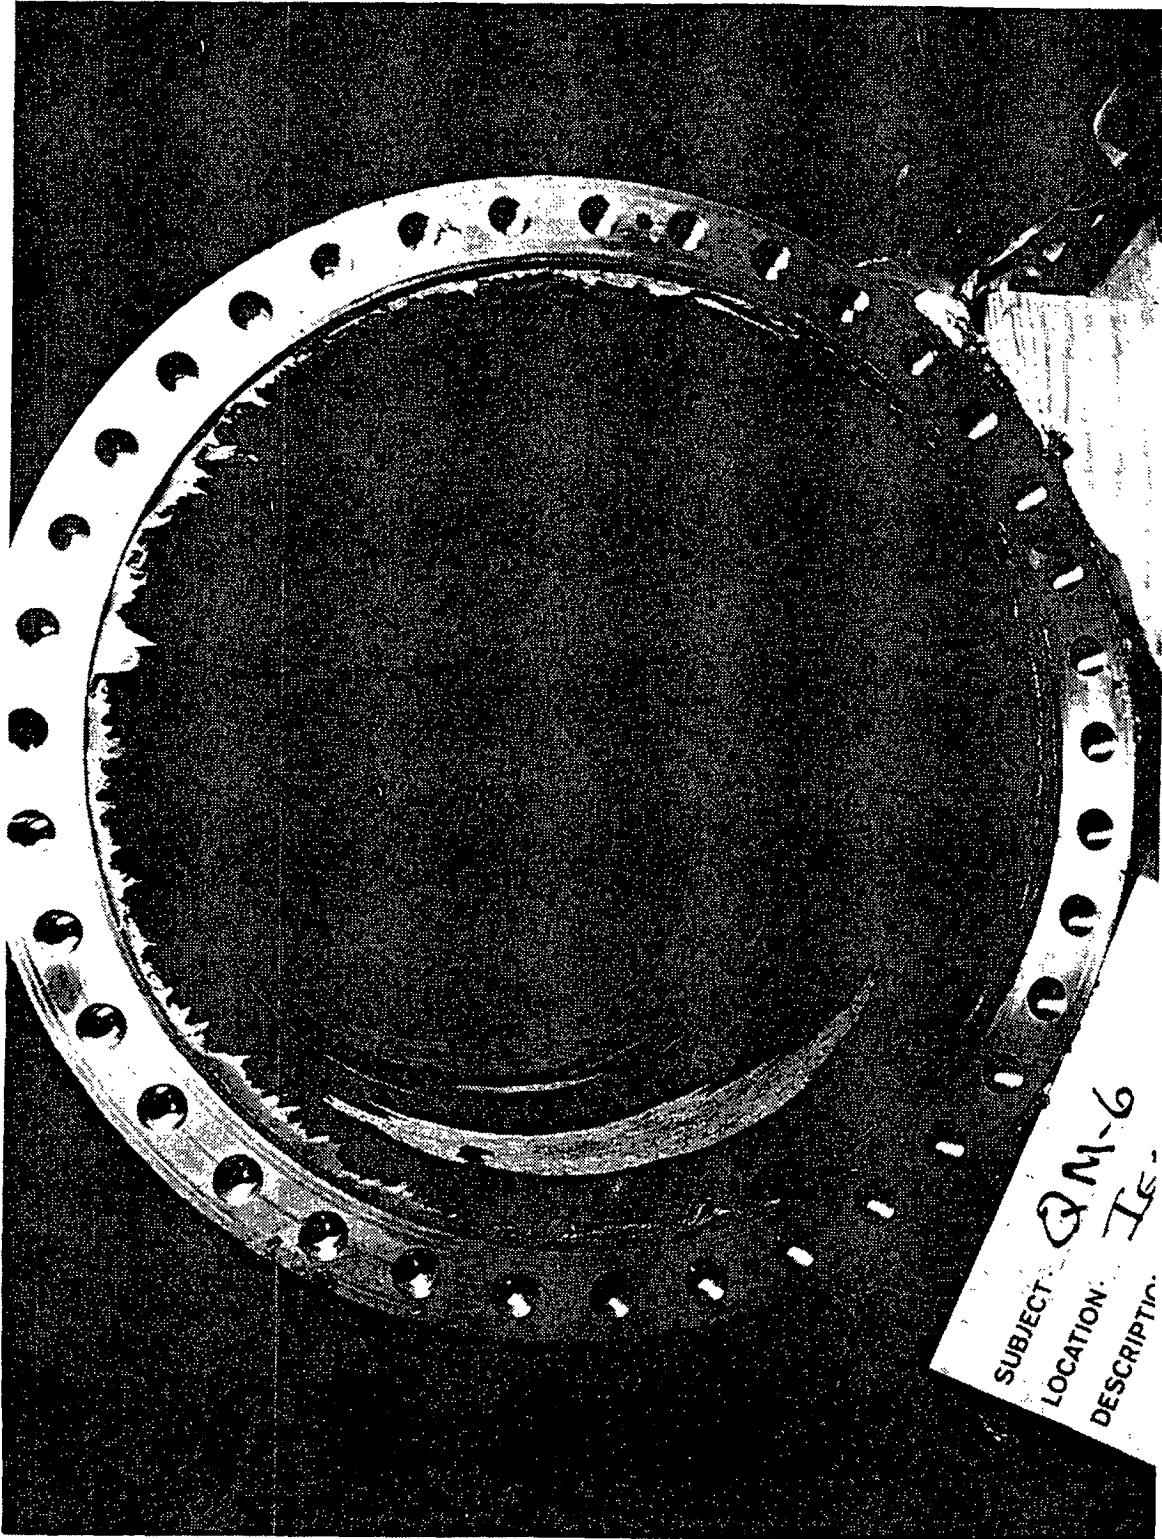
FIGURE 5. IGNITER CHAMBER

The igniter adapter-to-chamber joint was disassembled on 3 June 1988. Inspection of the inner gasket revealed no damage, heat effect, or soot to or past the primary seal (see Figures 5 and 6). Light soot was found on the outside edge of the gasket, covering the entire circumference. The sealing surfaces were free of soot and in excellent condition (see pages A-6 through A-11).

No structural damage or heat affect was noted on any metal components. Light corrosion was found on the adapter sealing surface. No bolts showed signs of yielding or damage. Figures 5 and 10 are pictures of the igniter case after disassembly (see page A-21).

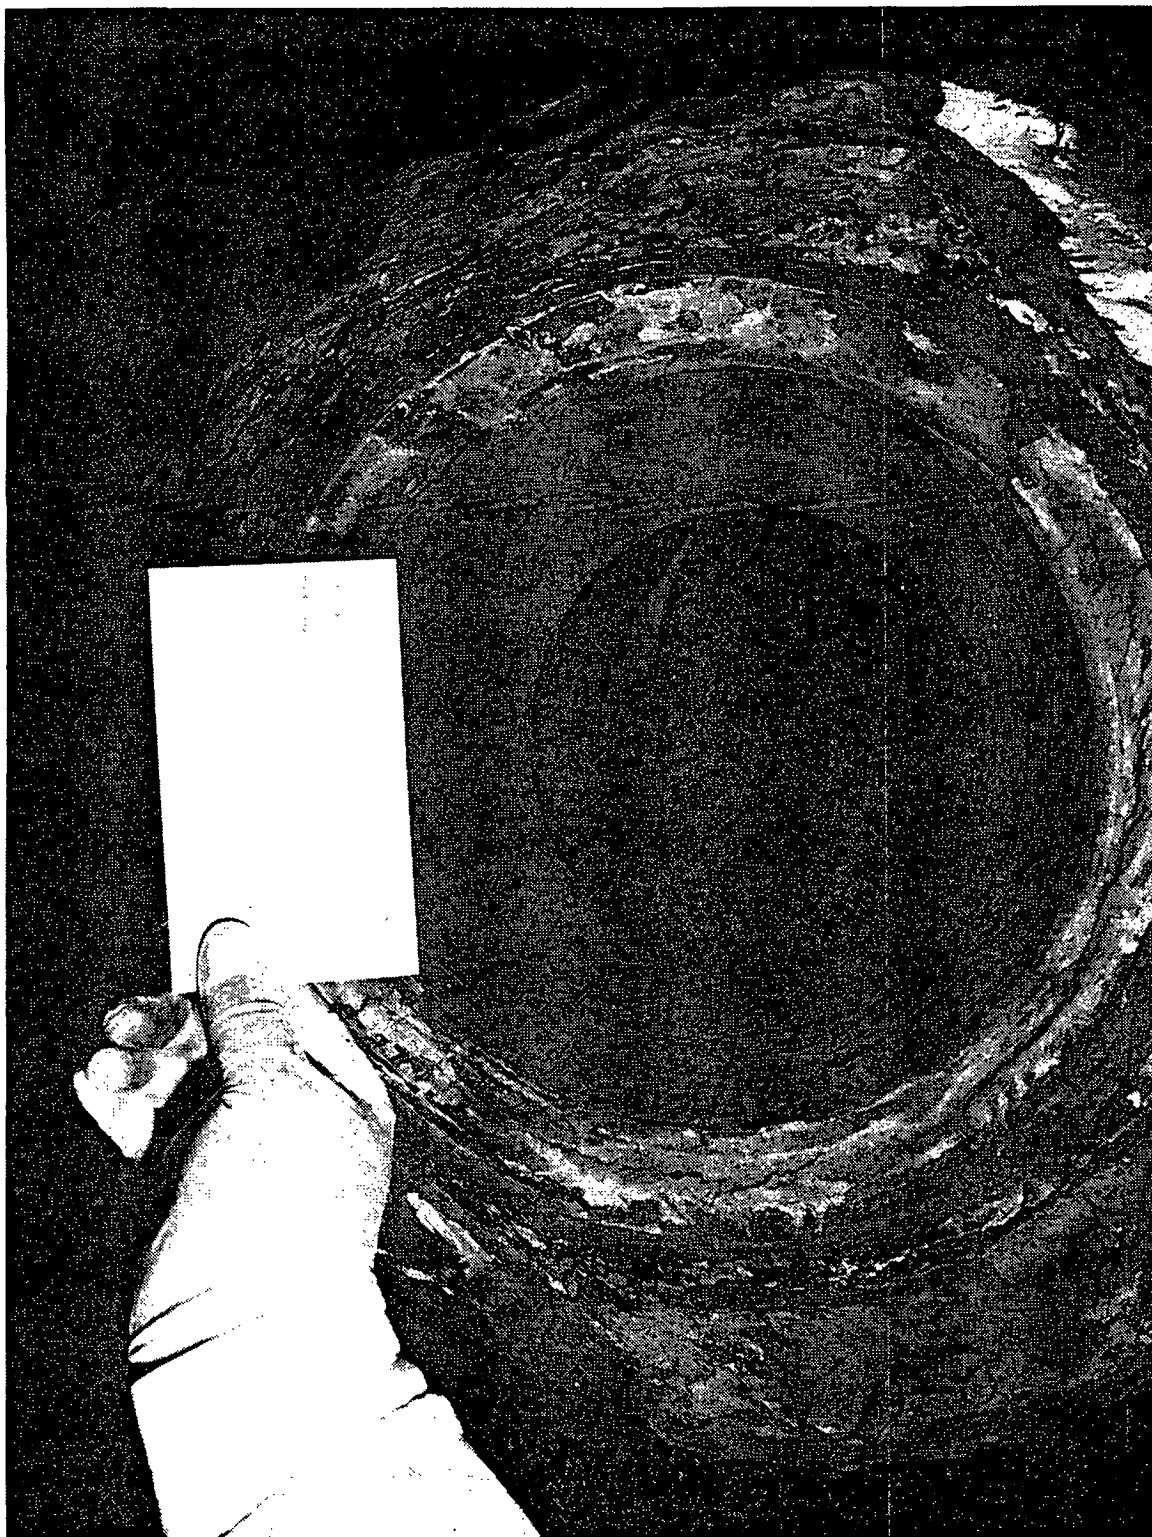
FIGURE 13. NOZZLE INSERT

nozzle throat measurements are as follow:

Position	Measurement
0 degrees	5.976 in.
60 degrees	5.980 in.
120 degrees	5.960 in.

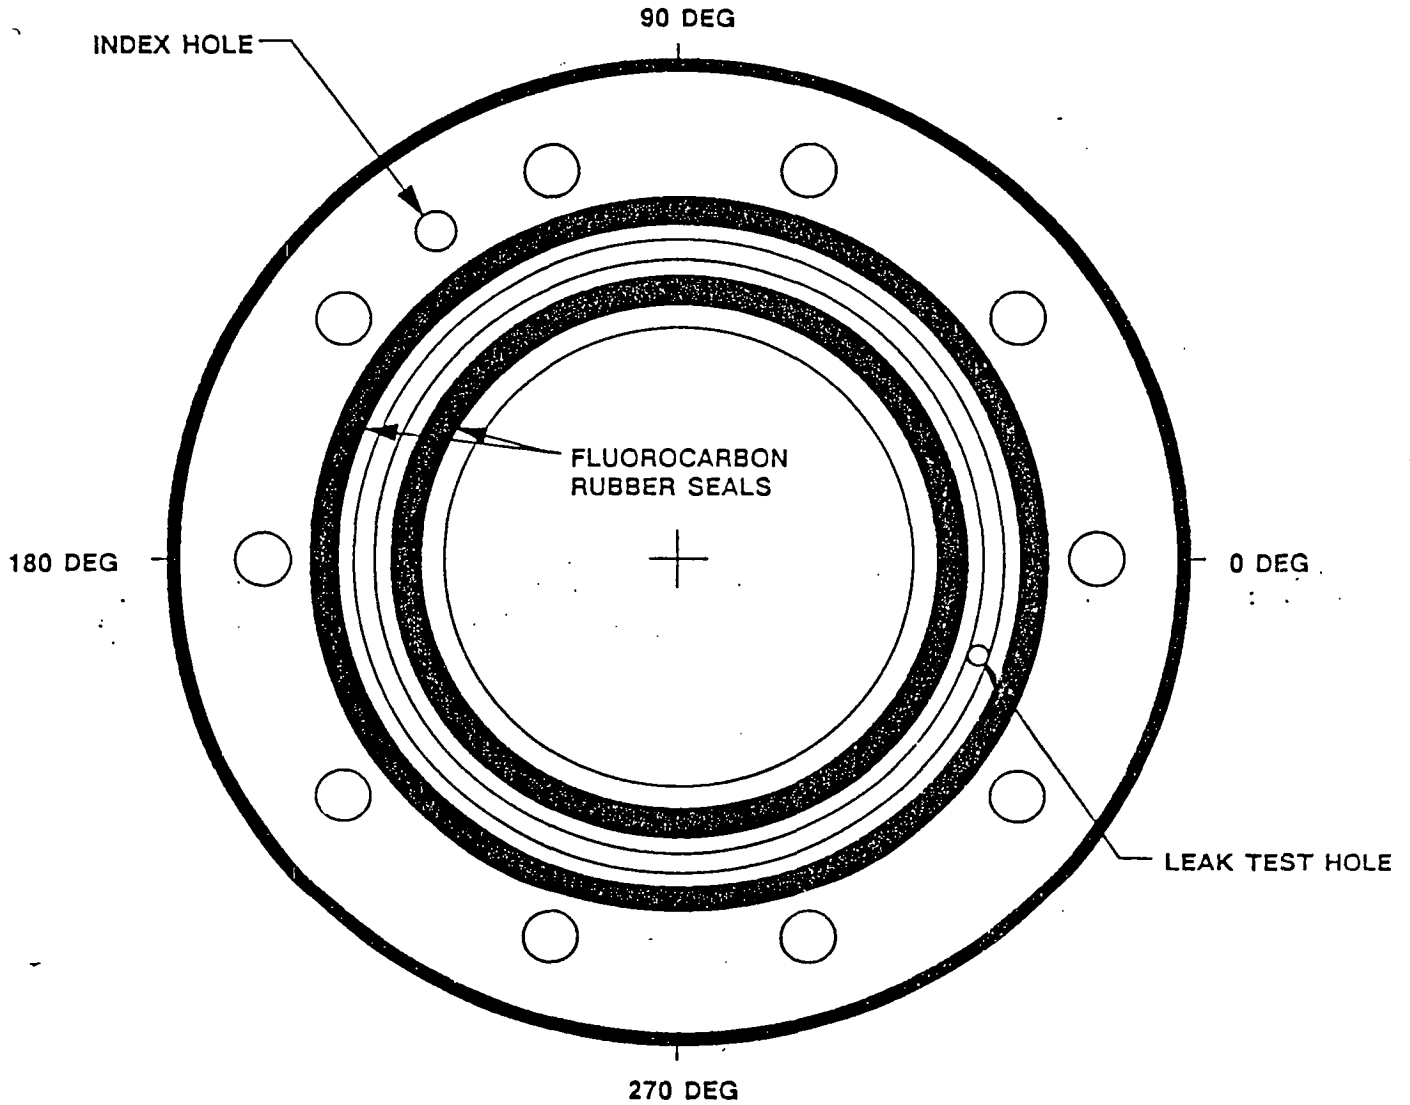
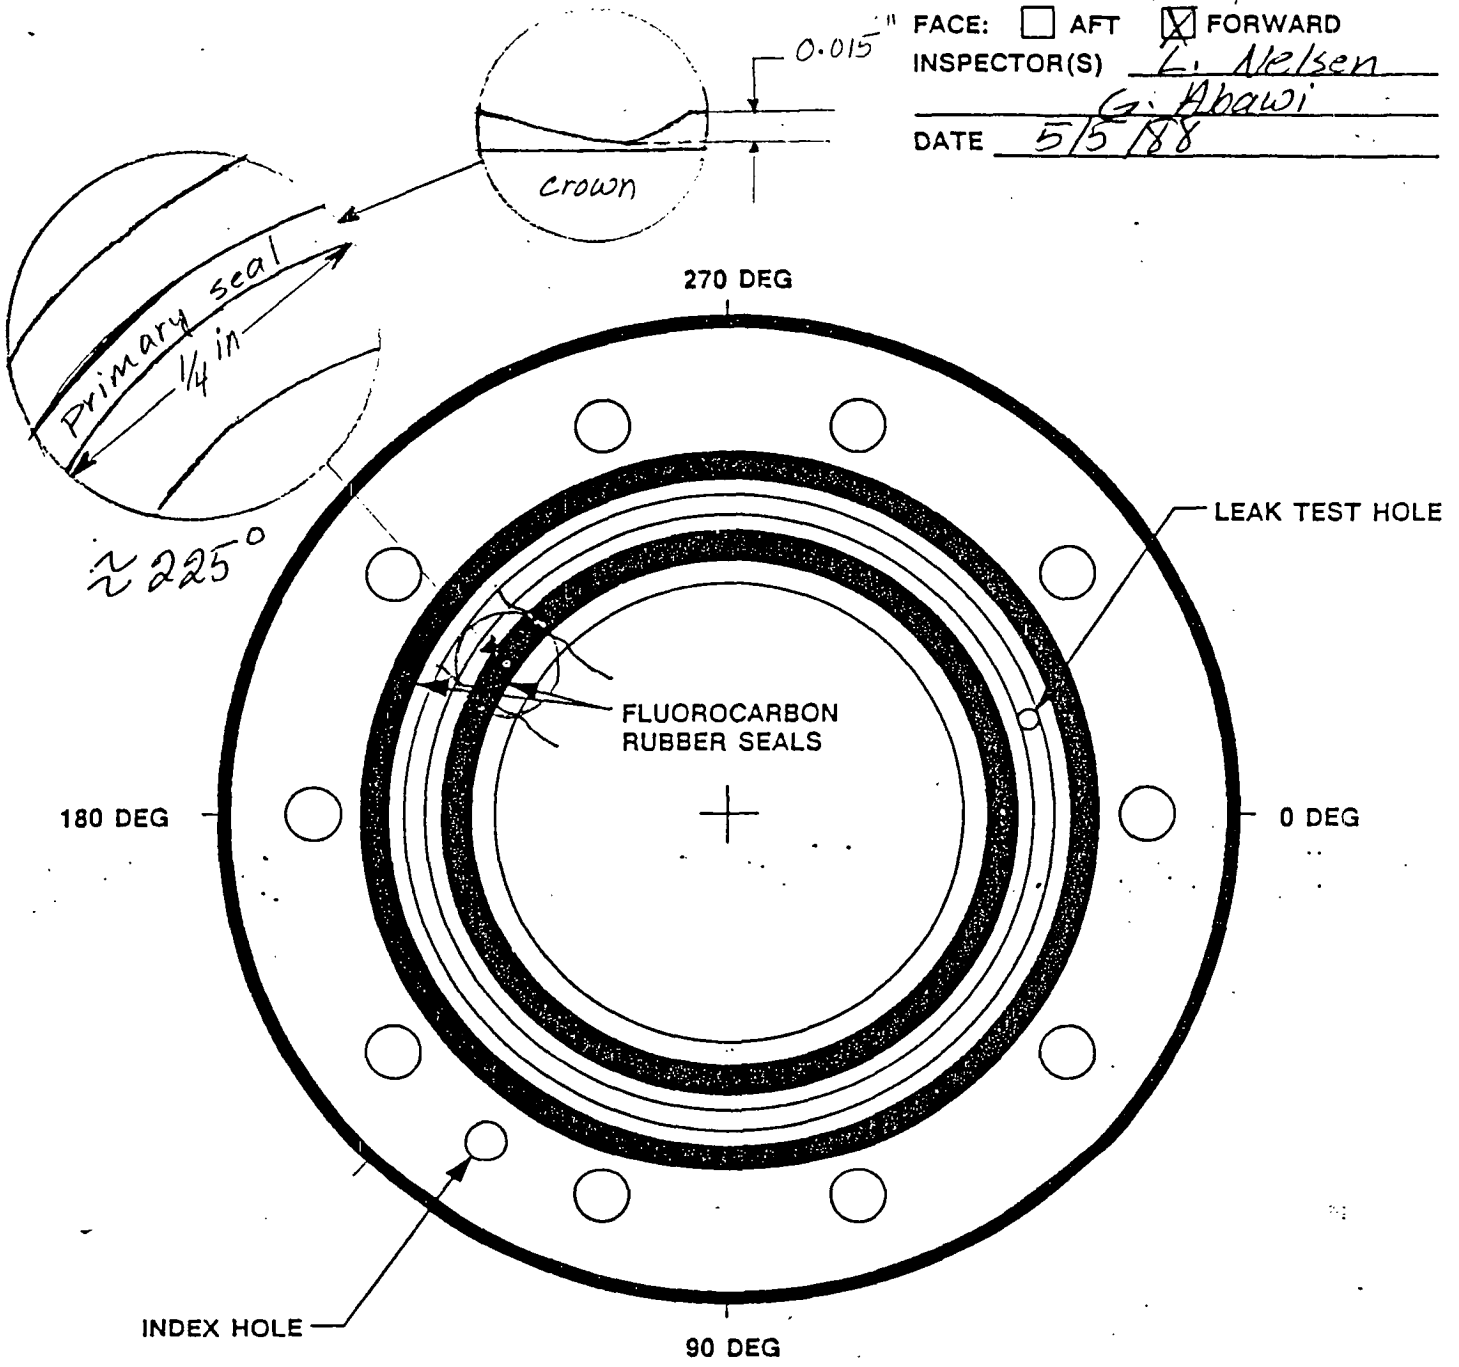
At 225 degrees, a depression of approximately 0.25 in. long, and 0.015 in. deep was found in the crown of the primary seal of the S&A gasket (see pages A-3 through A-5). Thiokol laboratory analysis showed that a combination of mold defect and gas entrapment were the cause of the depression.
