TWR-17591, Volume IV

QM-8 FINAL PERFORMANCE EVALUATION REPORT - SEALS

June 1989

***Thiokol* CORPORATION**
SPACE OPERATIONS

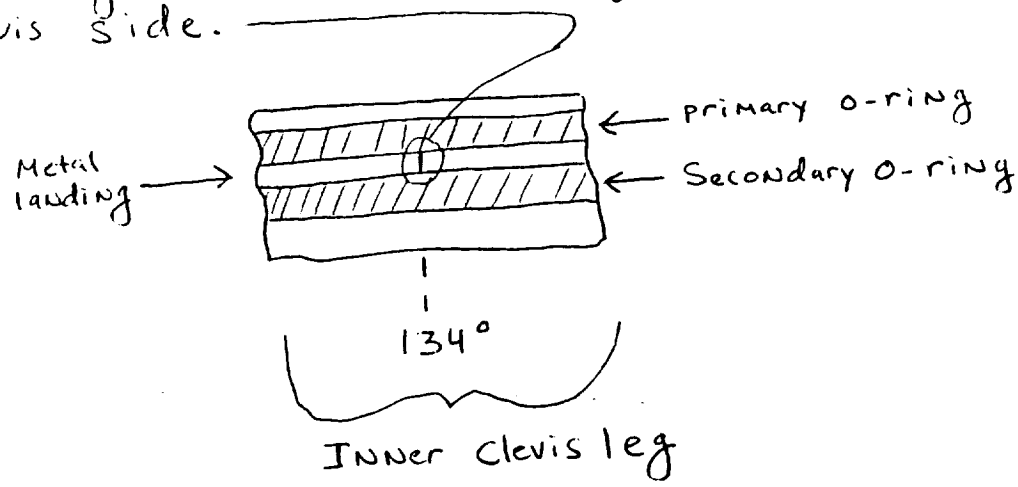
1. Very light thin line of corrosion on the landing between the o-ring grooves at 134° clevis side.

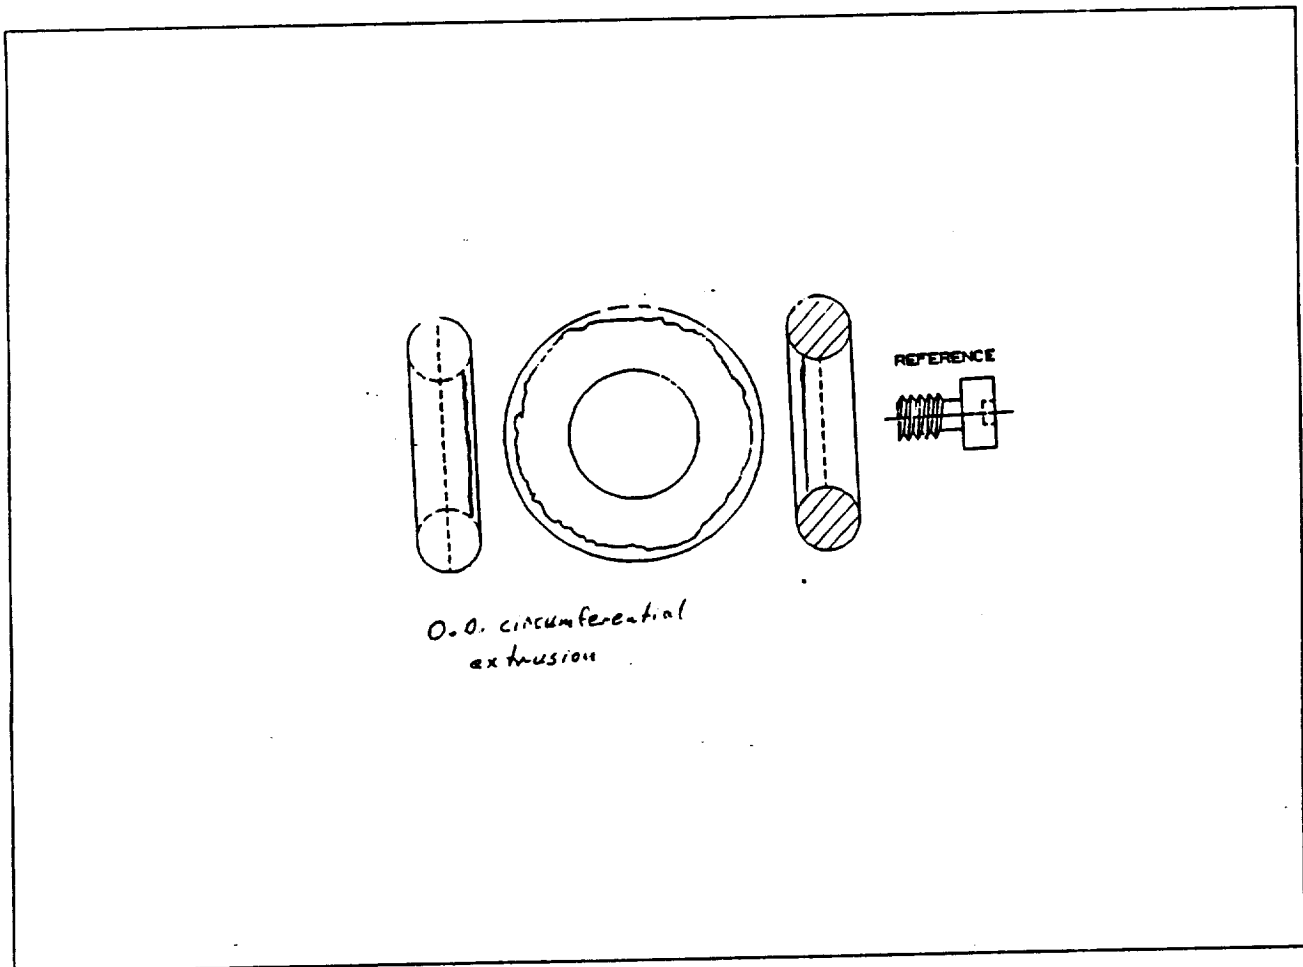
O.O. circumferential
extrusion

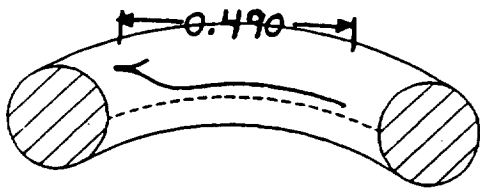
I.O. CIRCUMFERENTIAL CUT
