NASA Technical Memorandum TM 102790

# Debris/Ice/TPS Assessment And Photographic Analysis For Shuttle Mission STS-31R

Charles G. Stevenson  
NASA/Kennedy Space Center

April 24, 1990

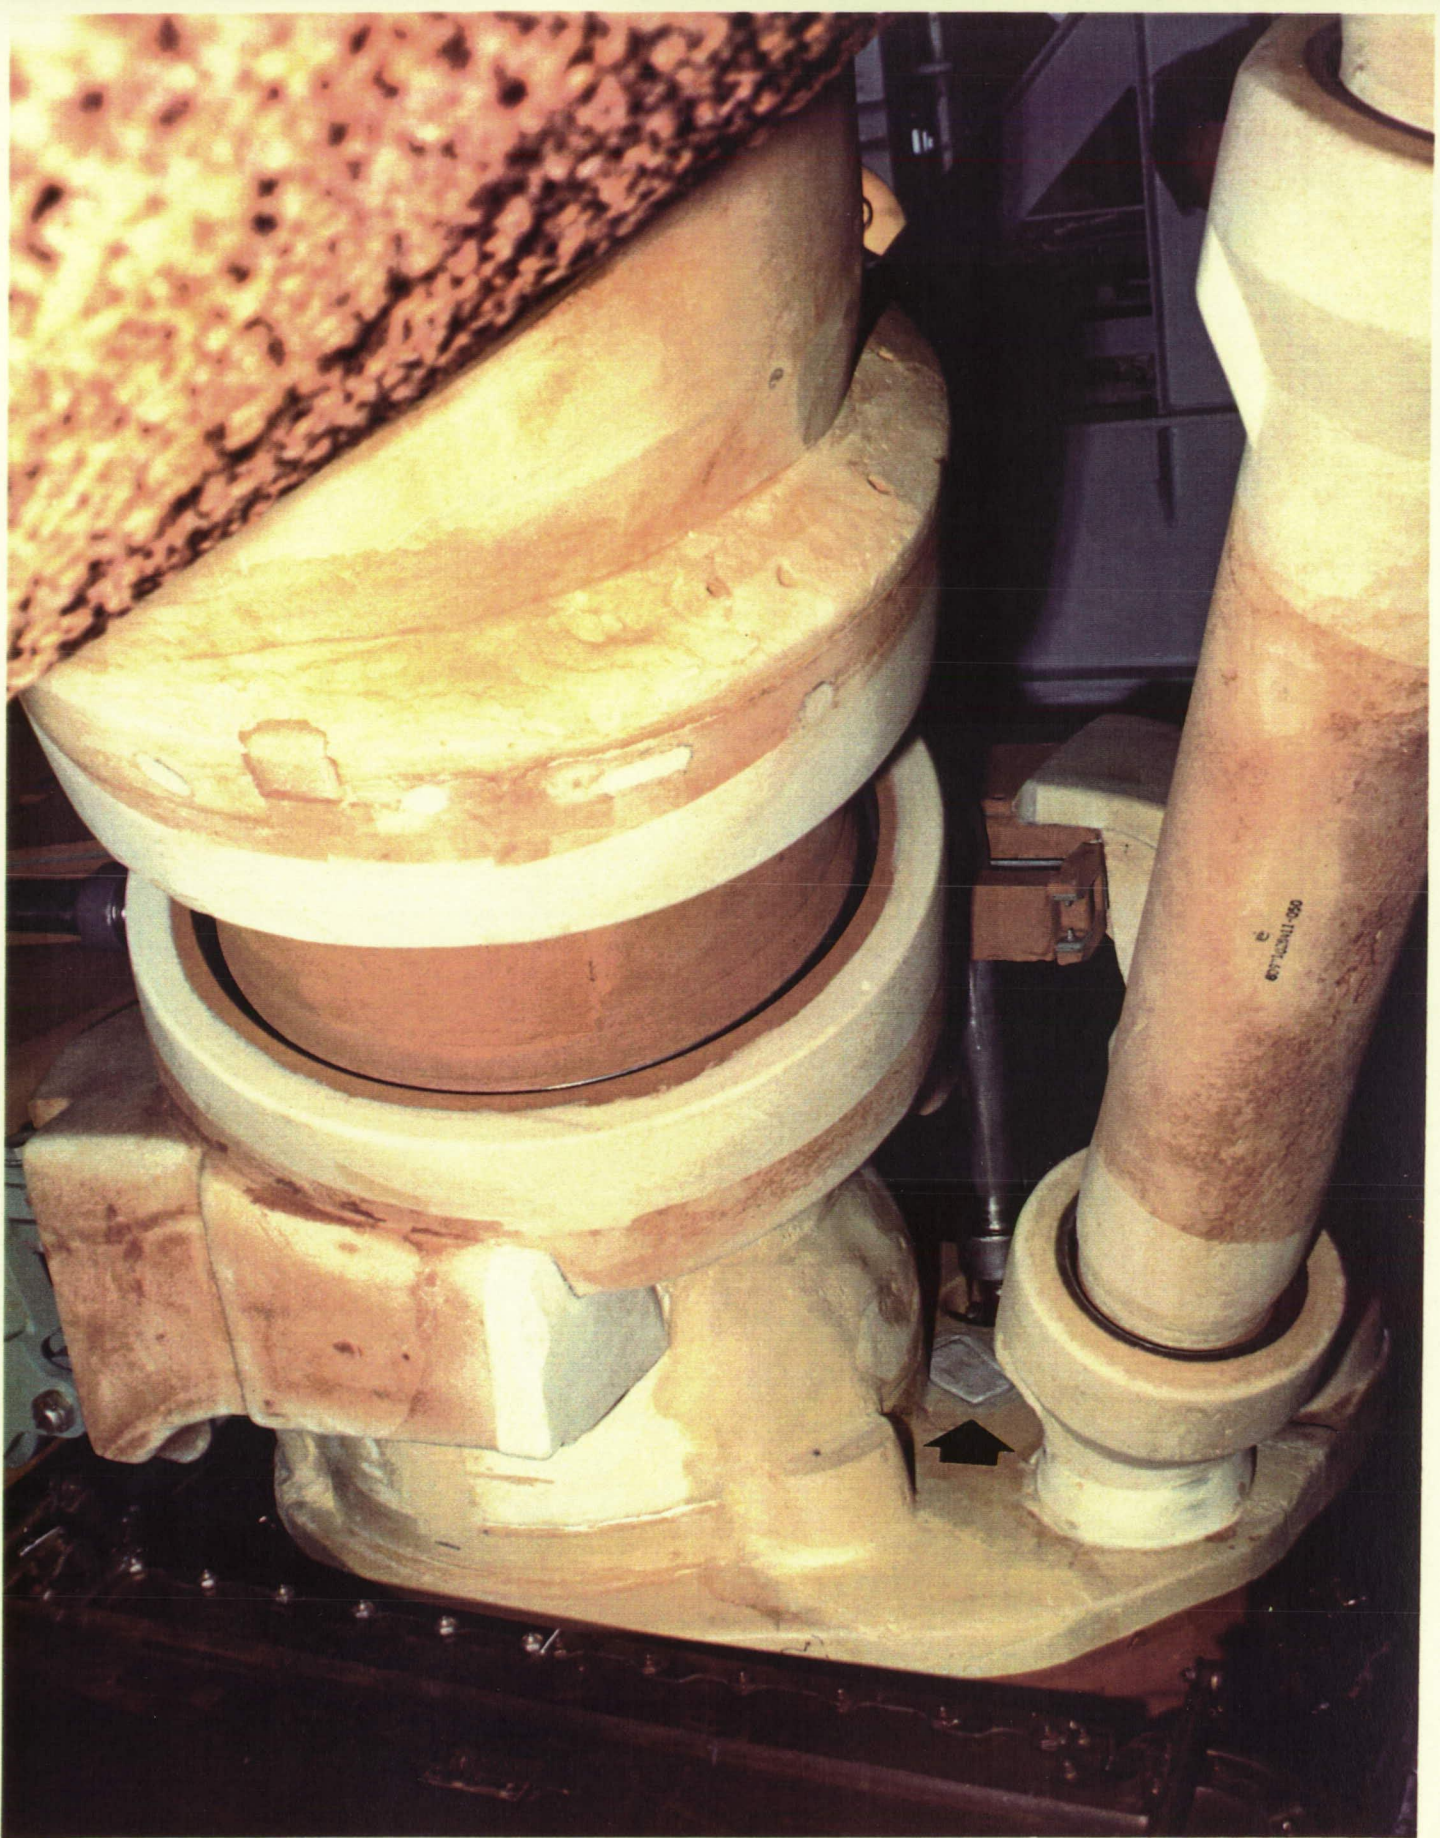
Overall view of LH2 ET/ORB umbilical. Note PDL foam plug in flapper valve actuator torque tool port closeout (arrow)

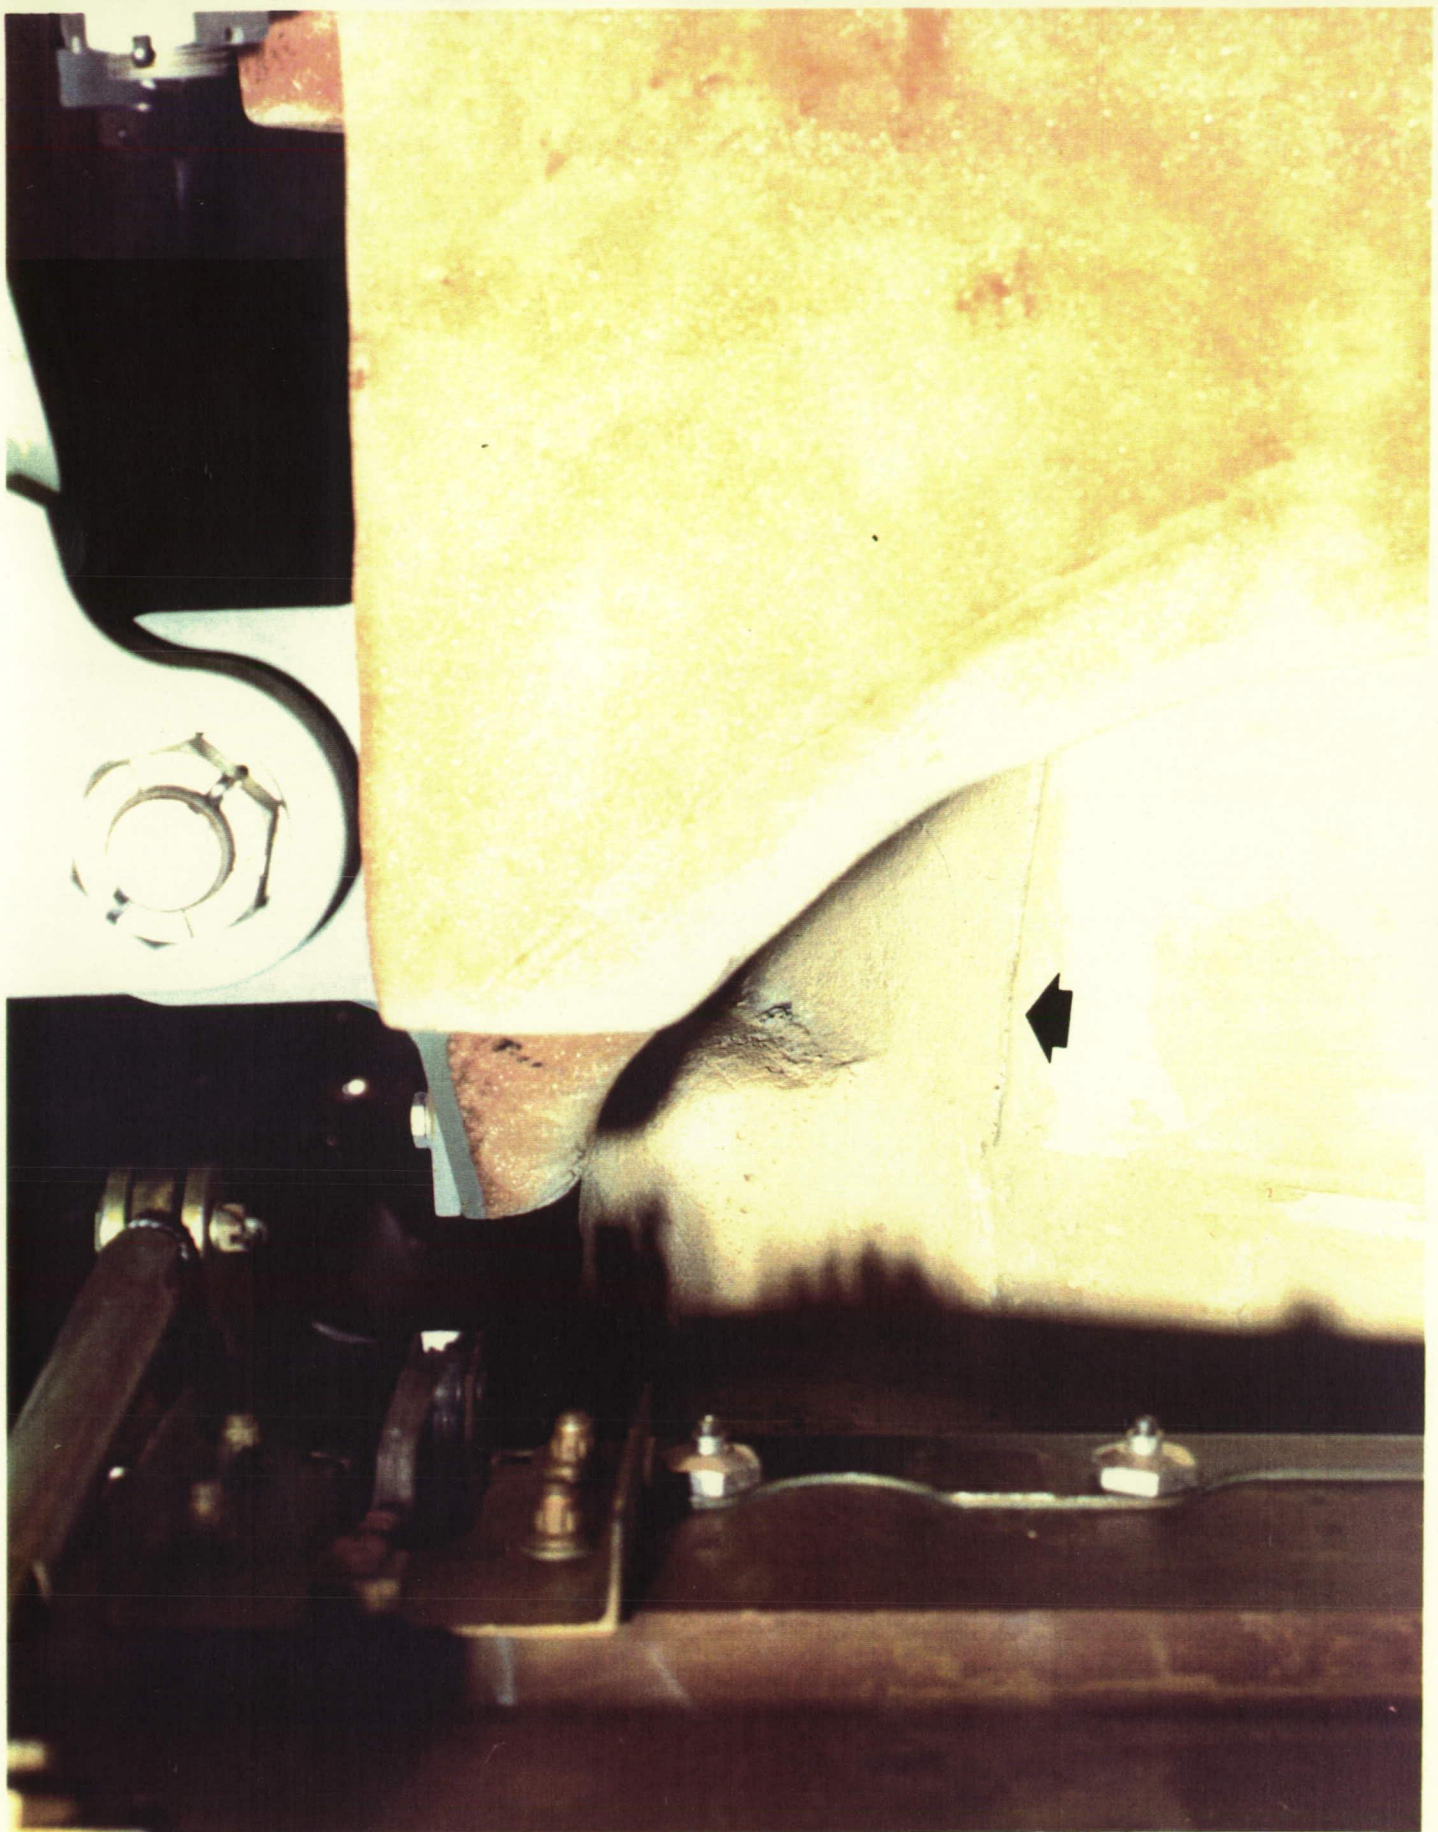
TPS interface at fwd inboard area of LH2 ET/ORB umbilical may result in a thermal short when vehicle is cryo-loaded

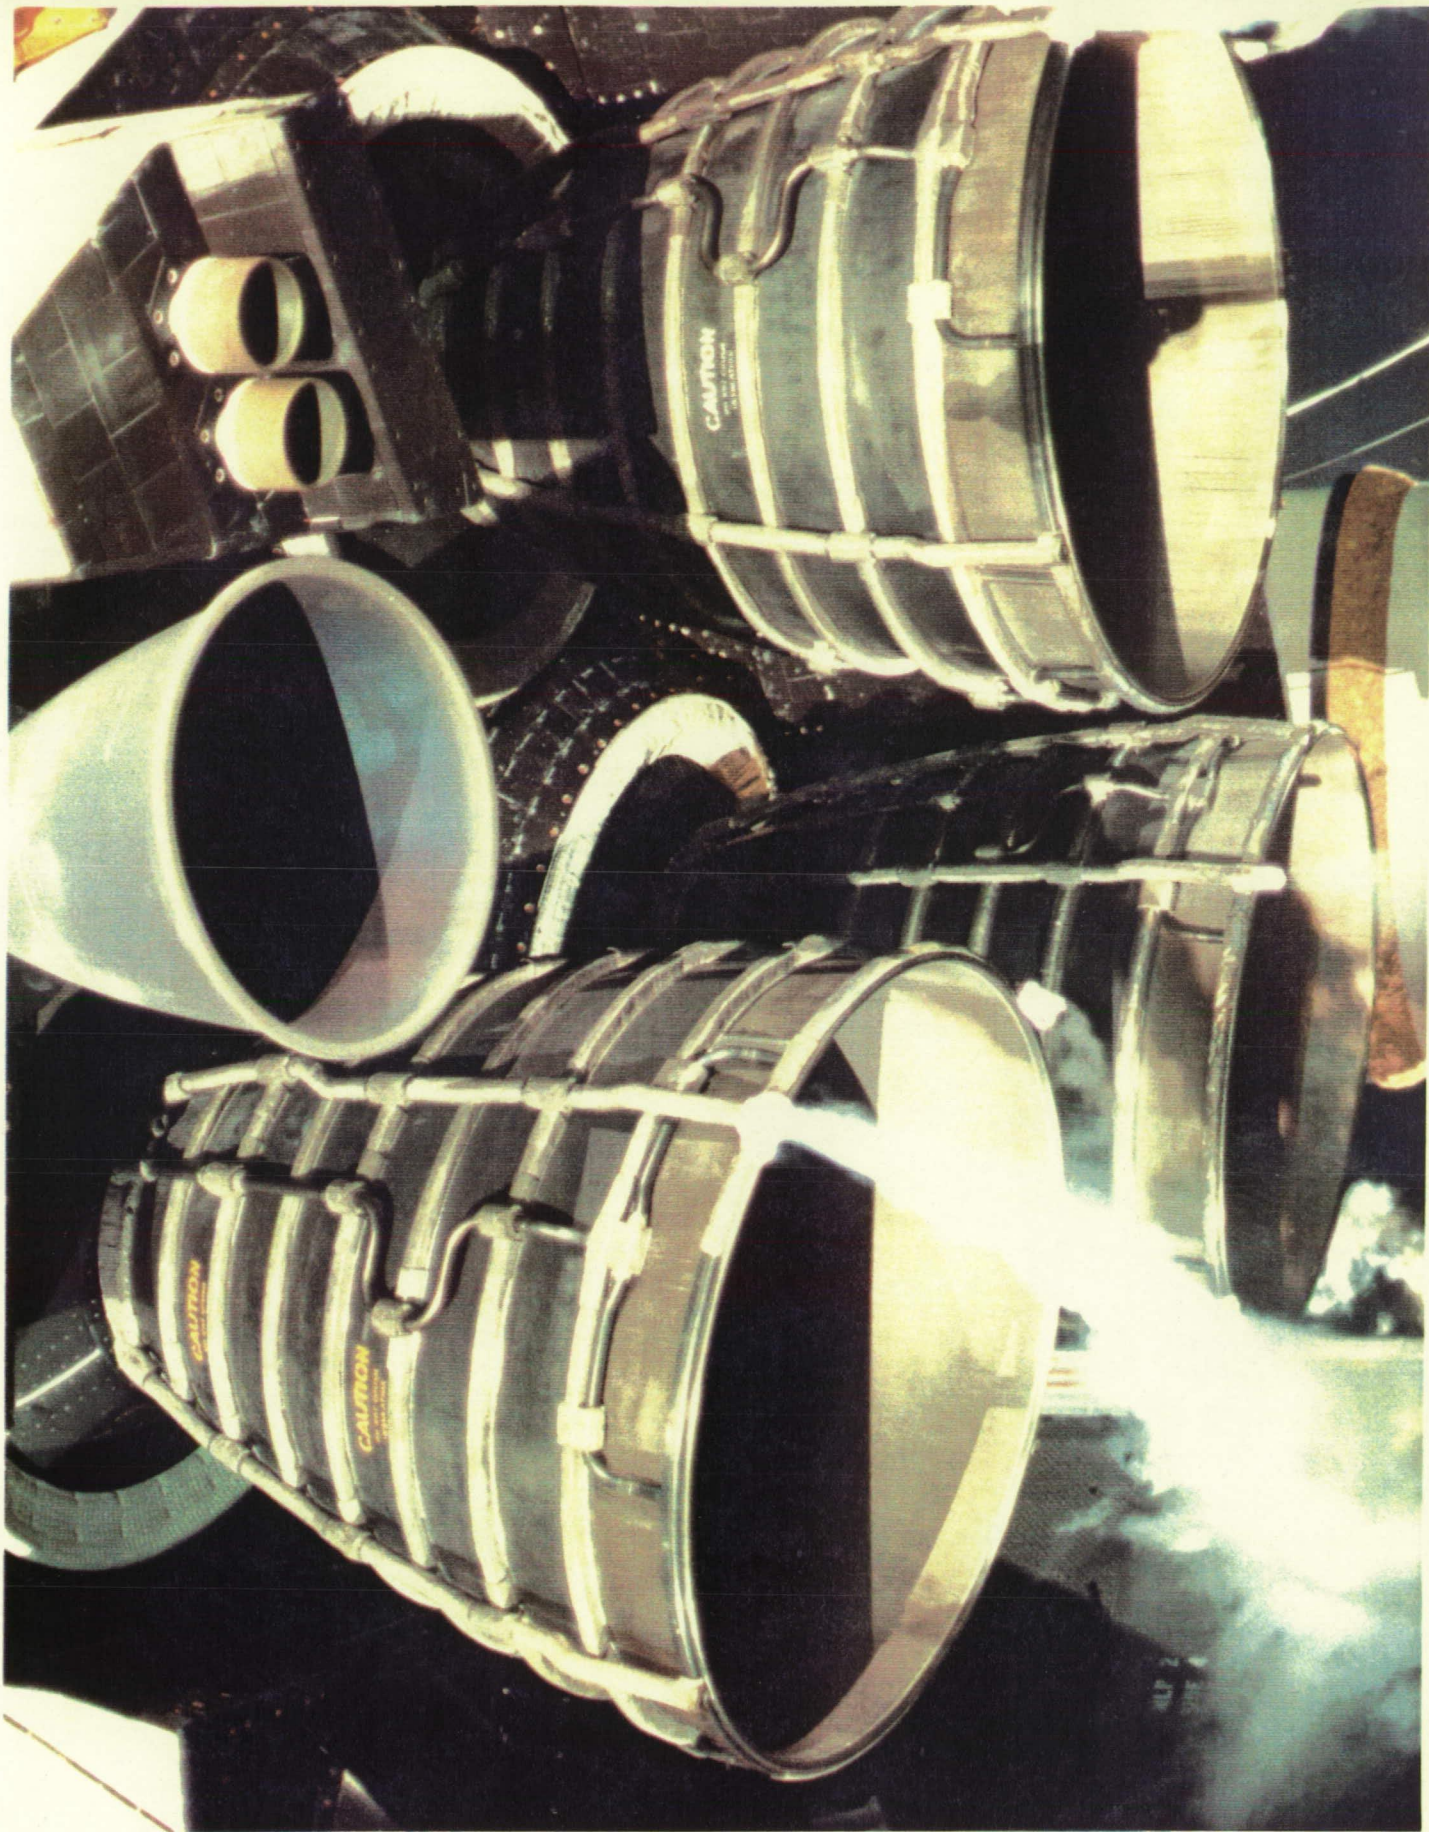
Less than usual amount of ice/frost formed at the main engine  
to heat shield interfaces

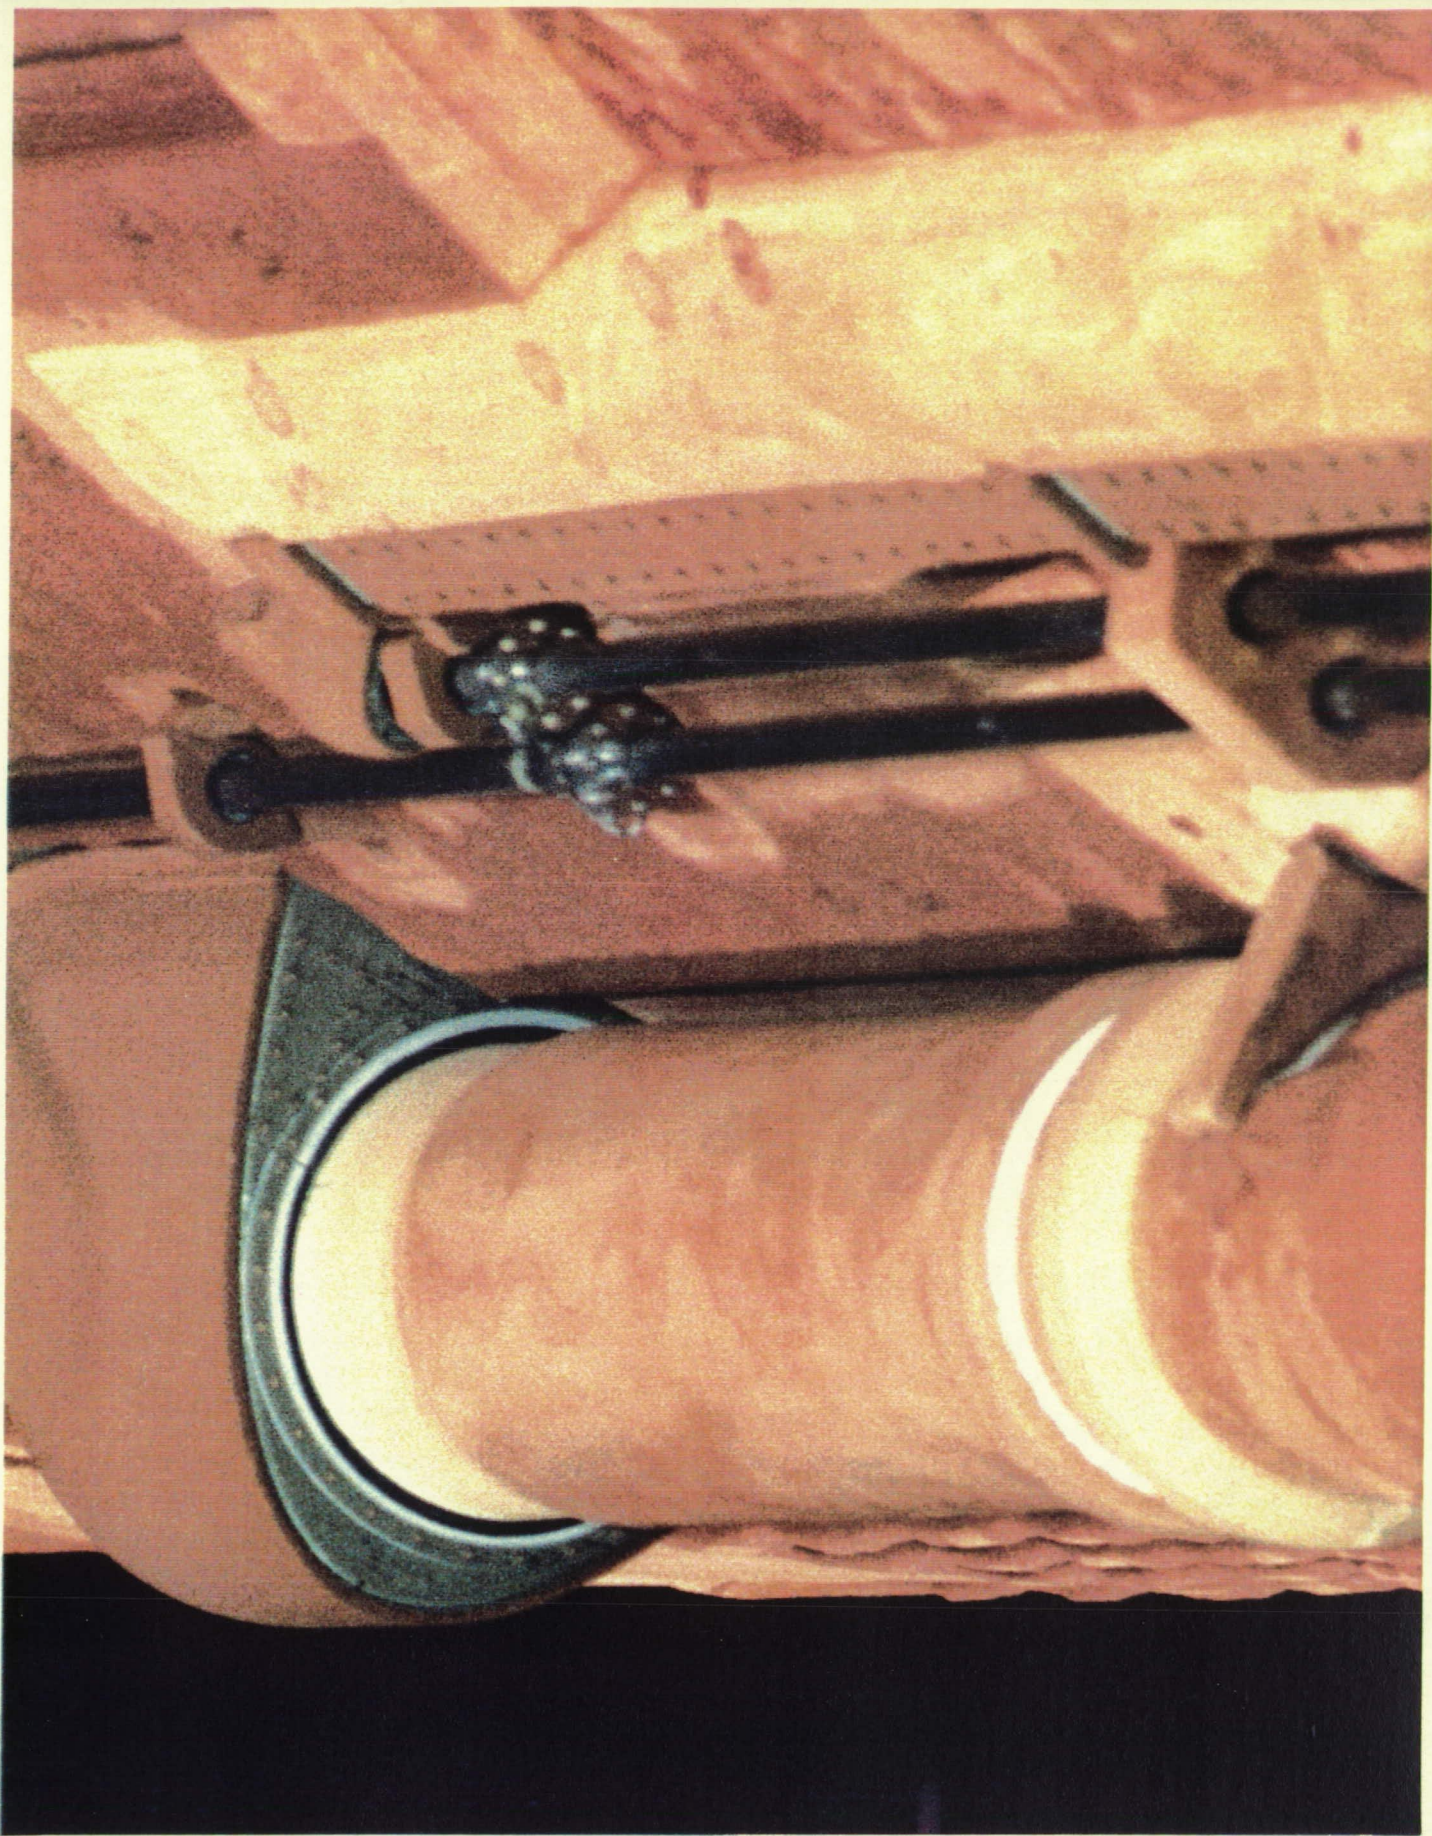
Typical amounts of ice/frost accumulated in the L02 feedline  
support bracket and upper bellows

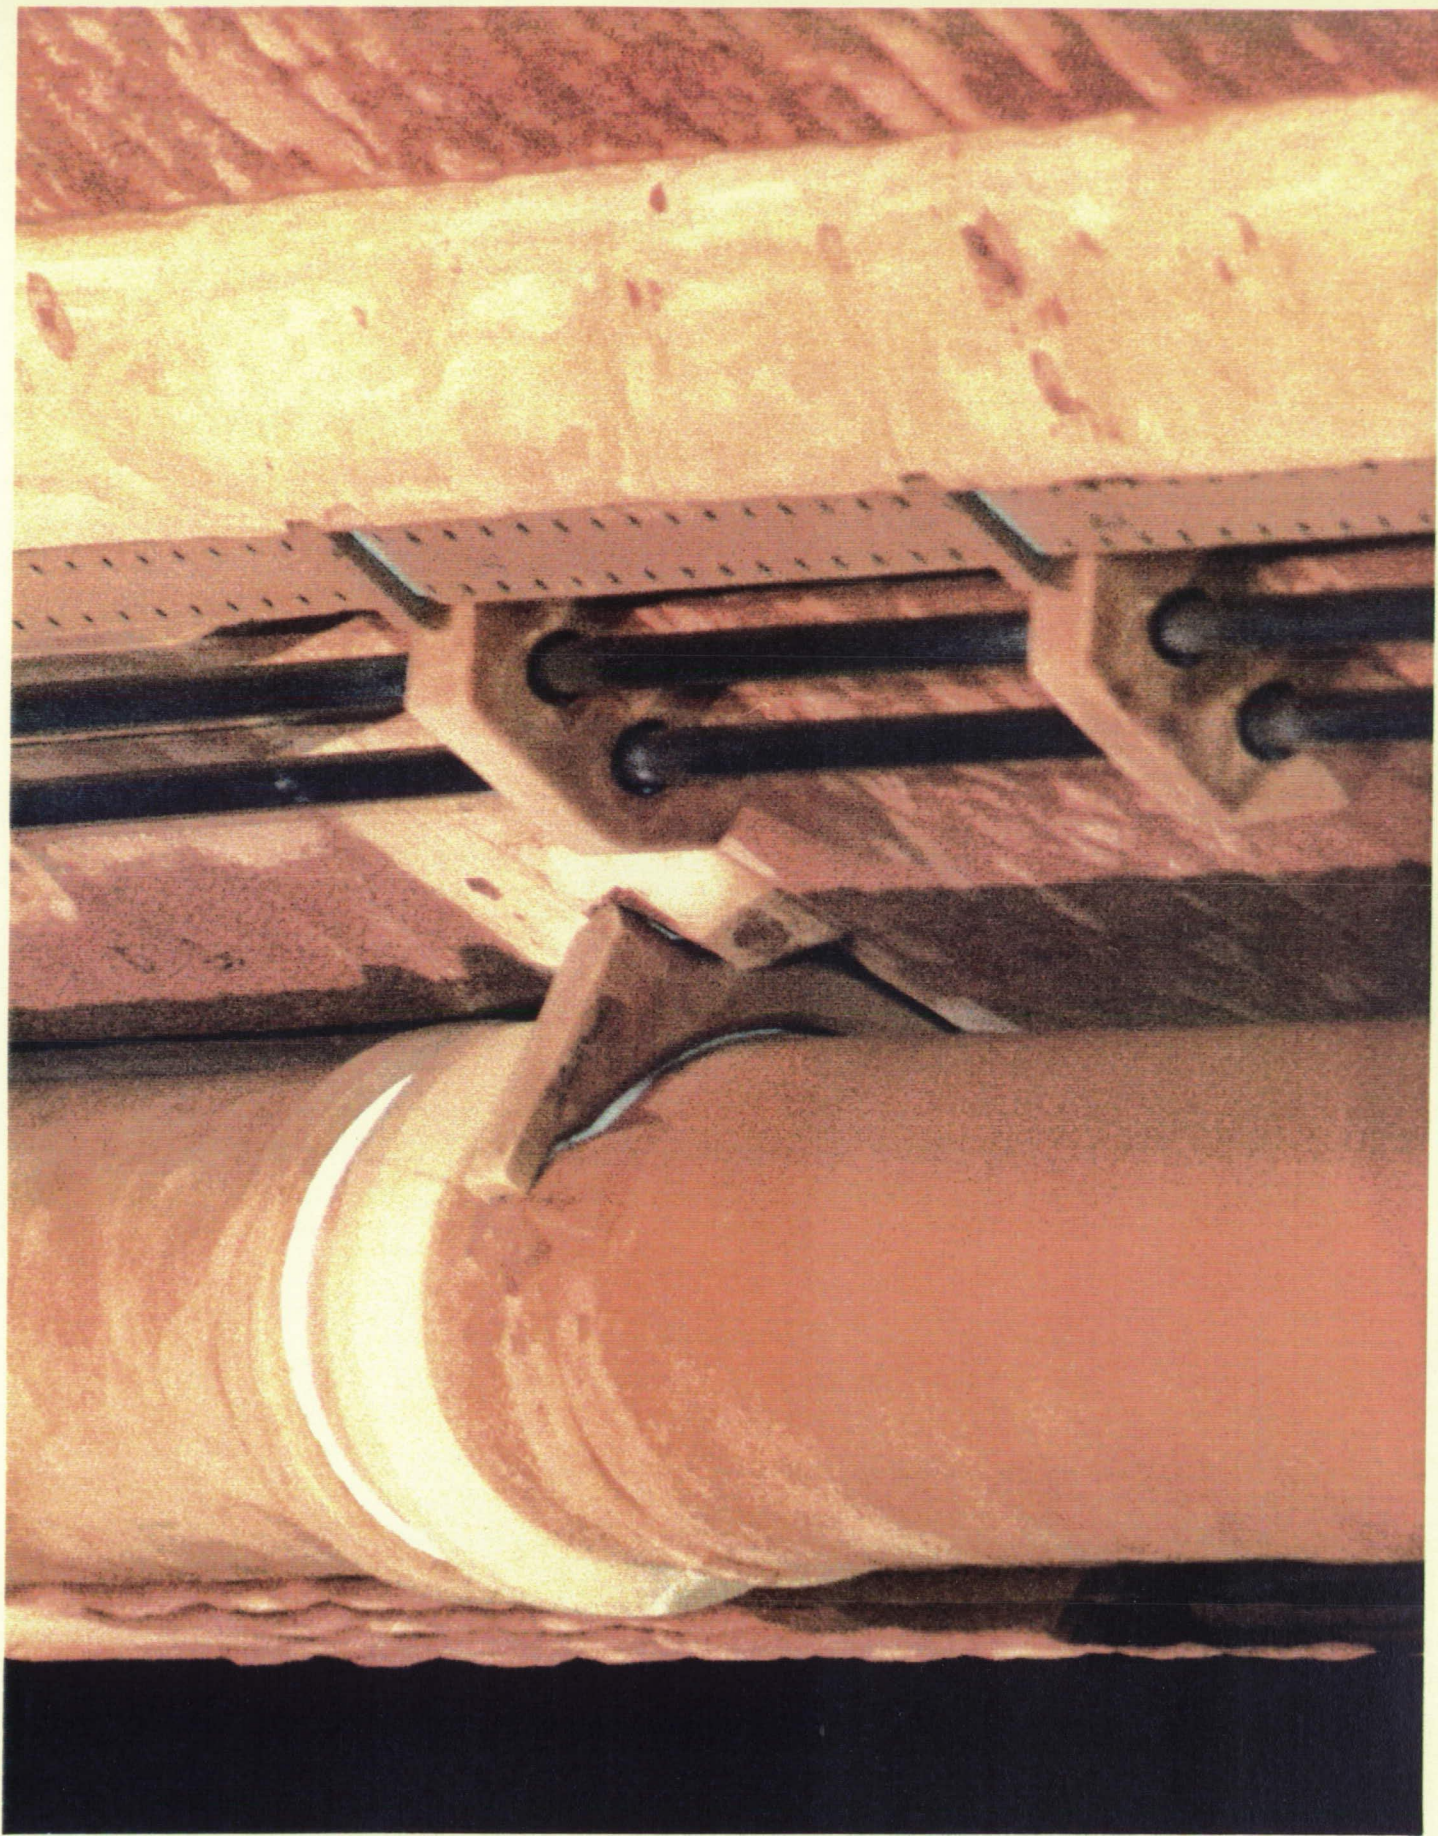
Typical amounts of ice/frost had formed in the L02 feedline support brackets and bellows

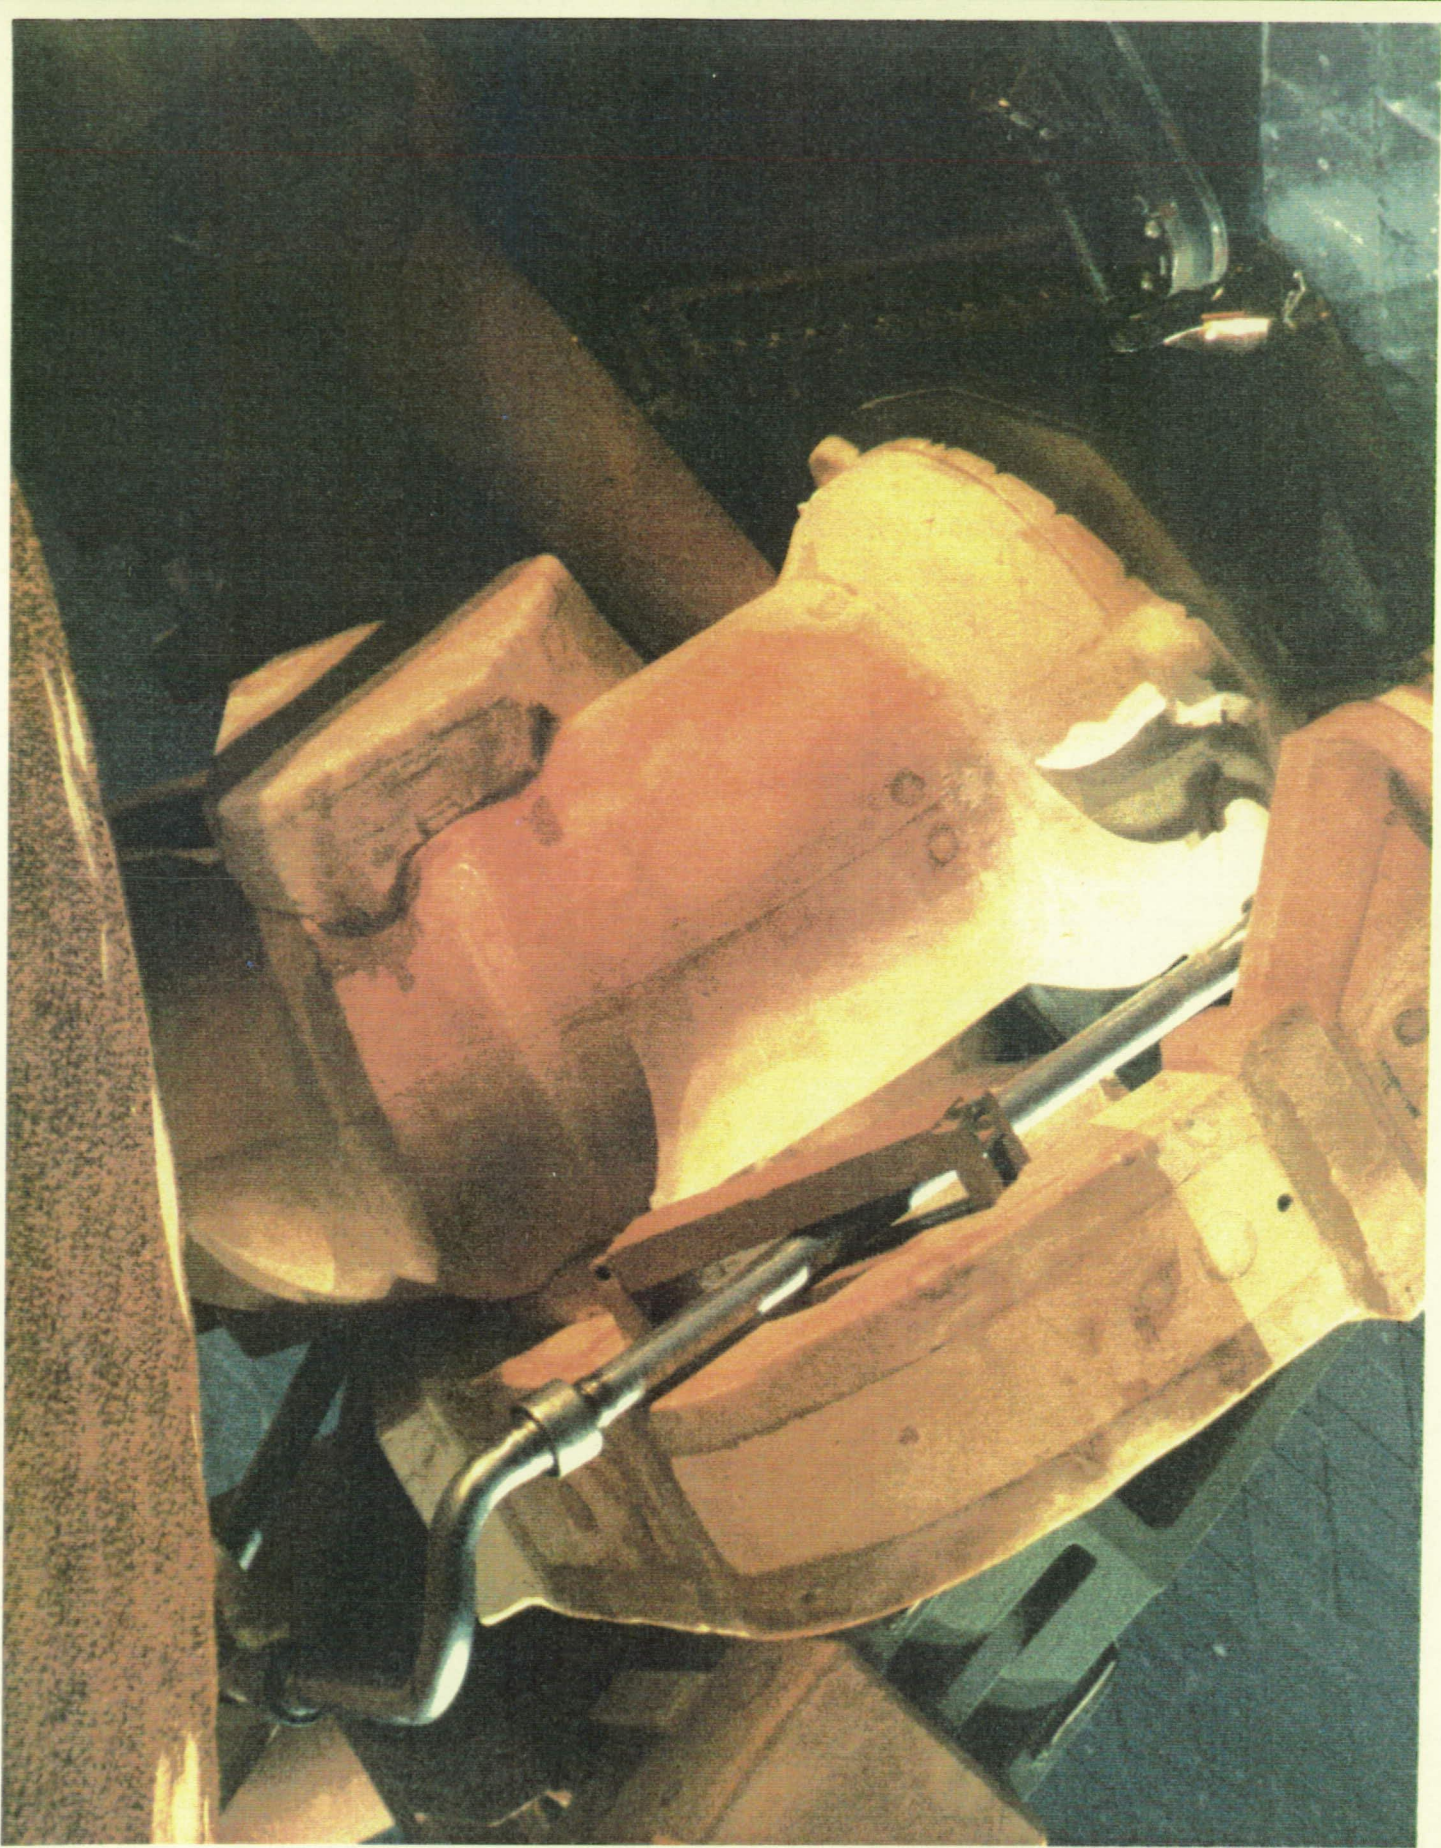
Ice/frost accumulation on the LO2 ET/ORB umbilical occurred on the aft and inboard sides, and on the purge vents

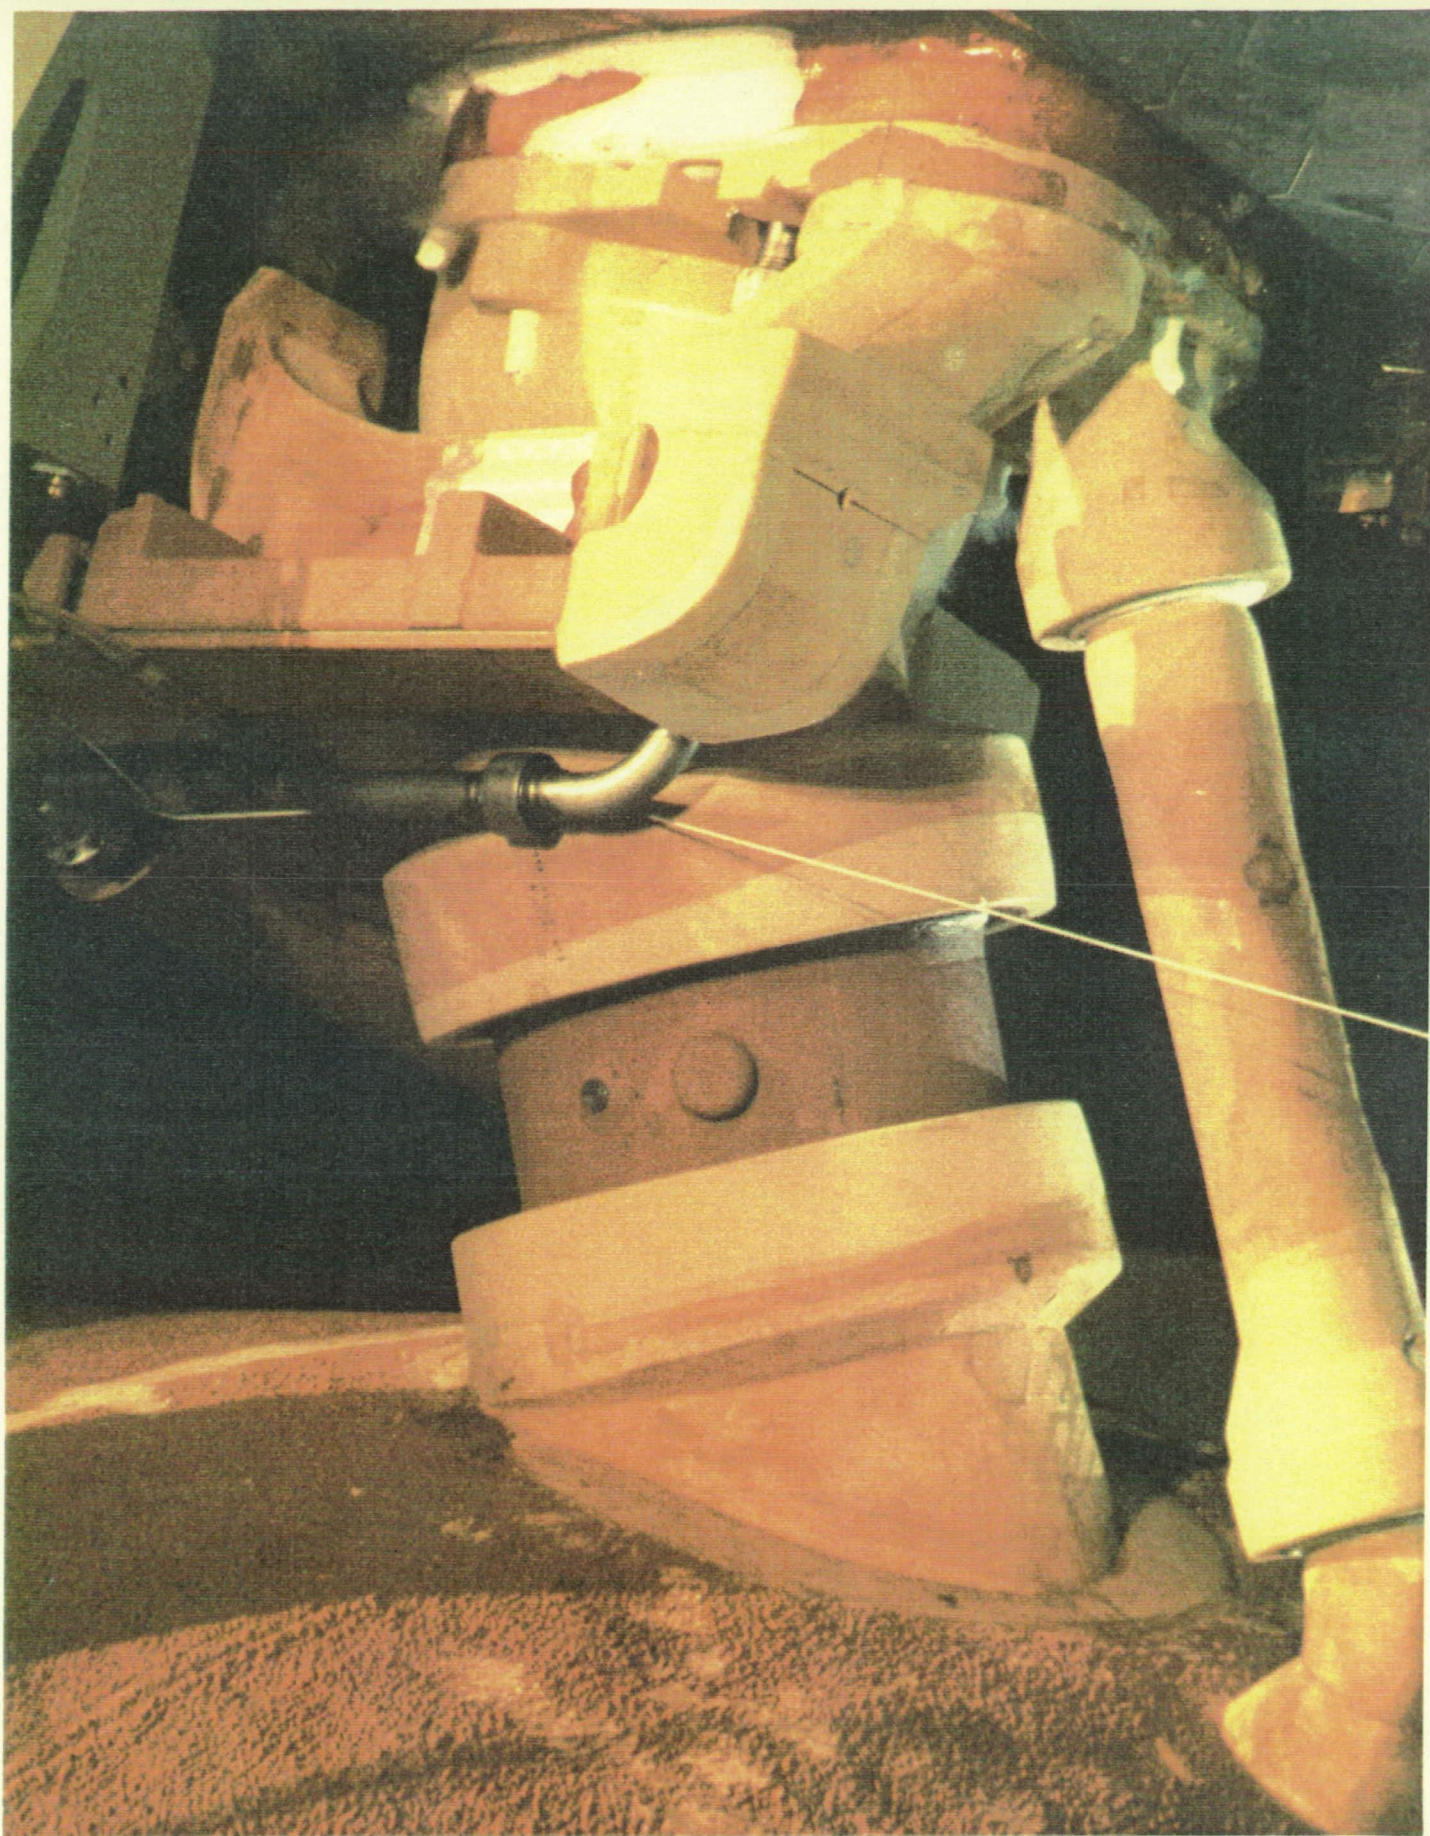
Ice/frost accumulation on the top and outboard sides of the LH2 umbilical was typical. Note frost fingers on purge vents.

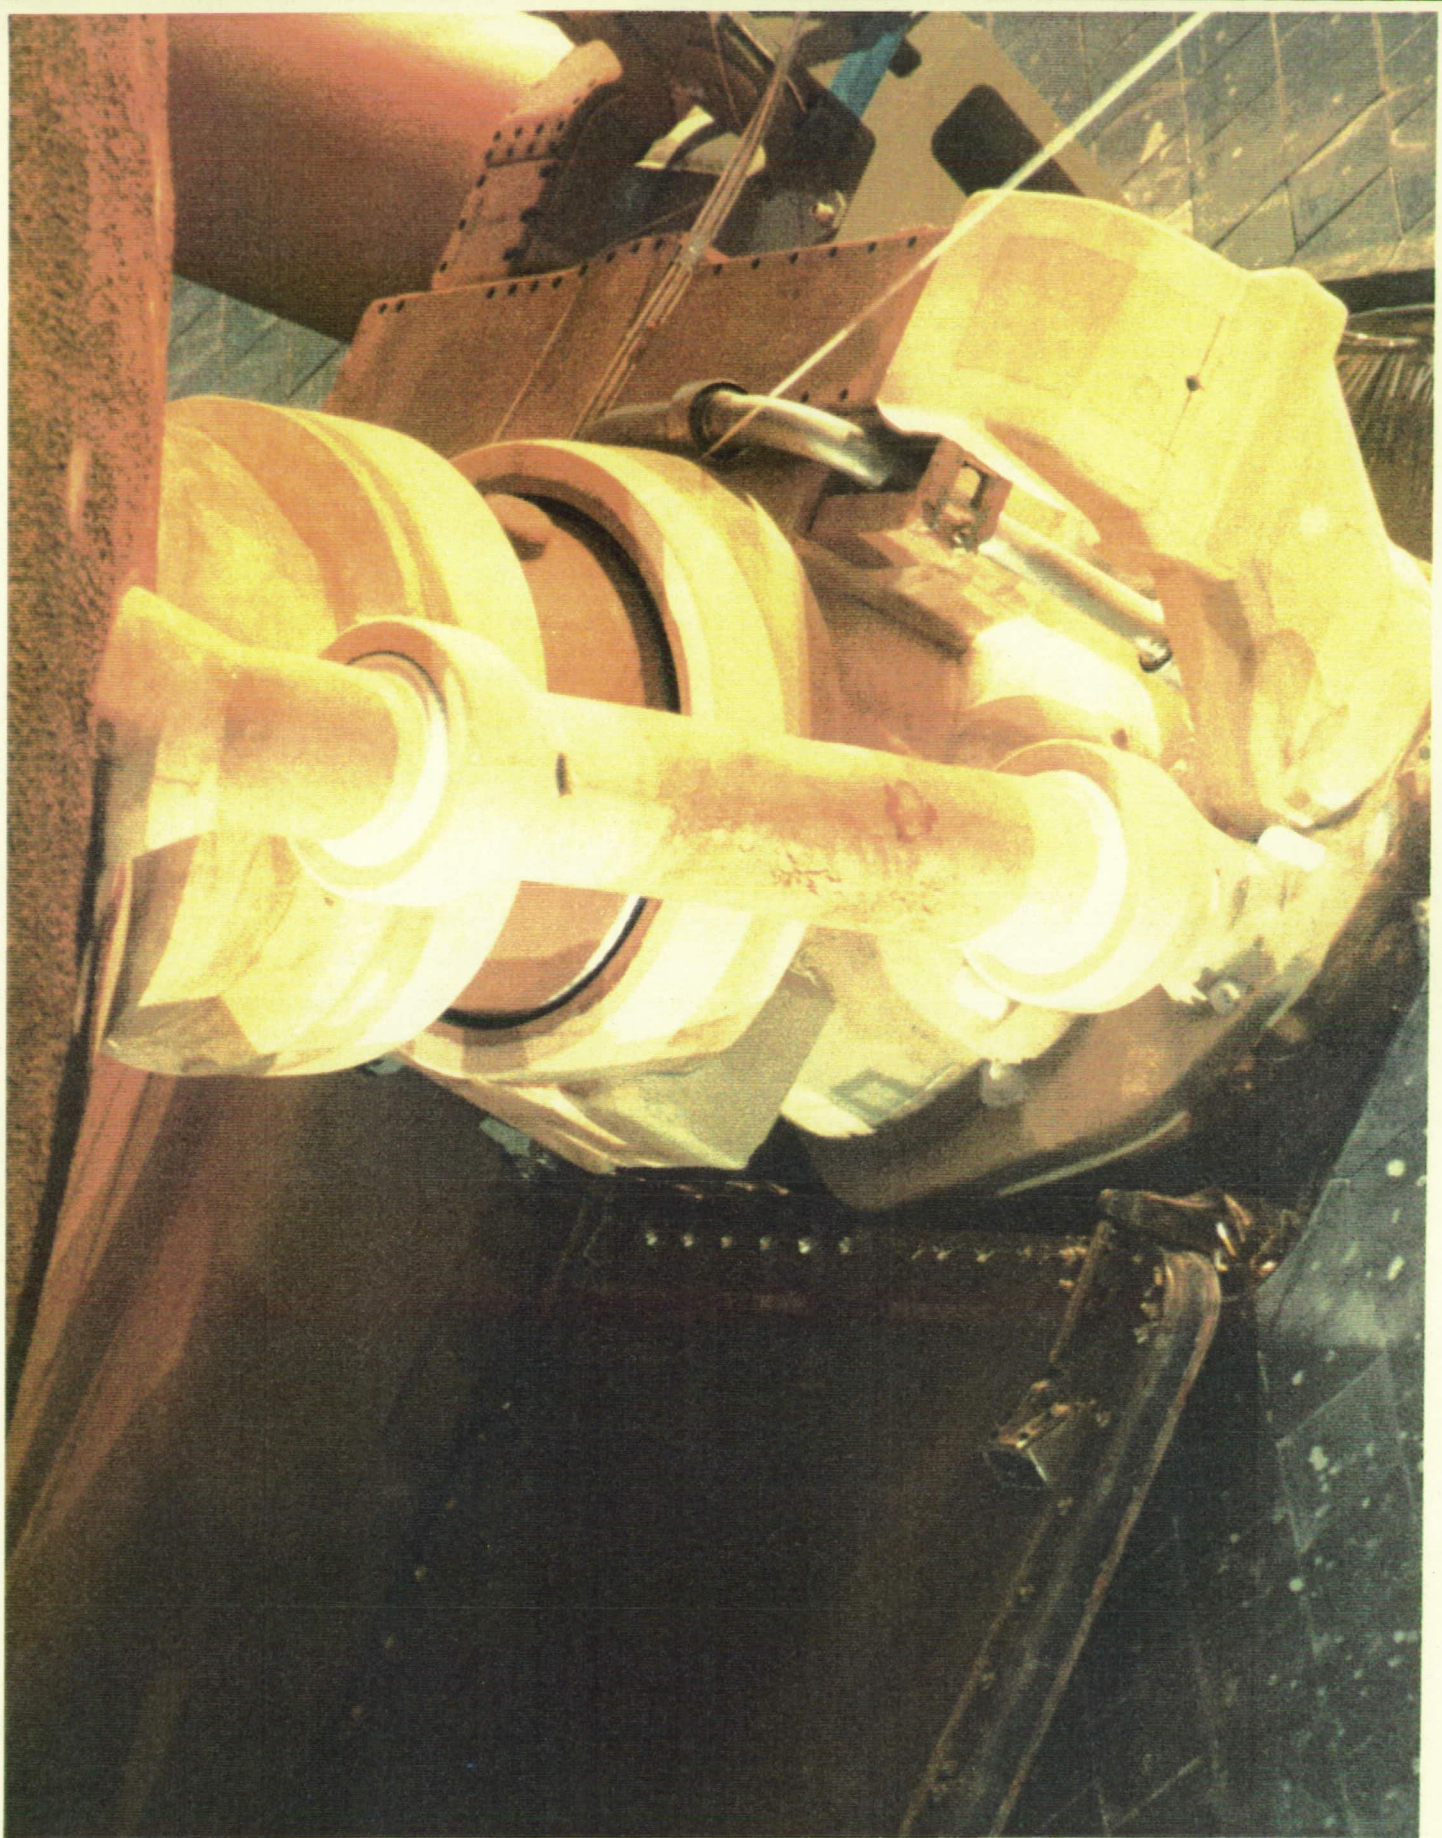
Normal amounts of ice/frost had formed in the LH2 recirculation line bellows. No ice was present in the LH2 feedline bellows.
