NASA Technical Memorandum TM 102790

# Debris/Ice/TPS Assessment And Photographic Analysis For Shuttle Mission STS-31R

Charles G. Stevenson  
NASA/Kennedy Space Center

April 24, 1990

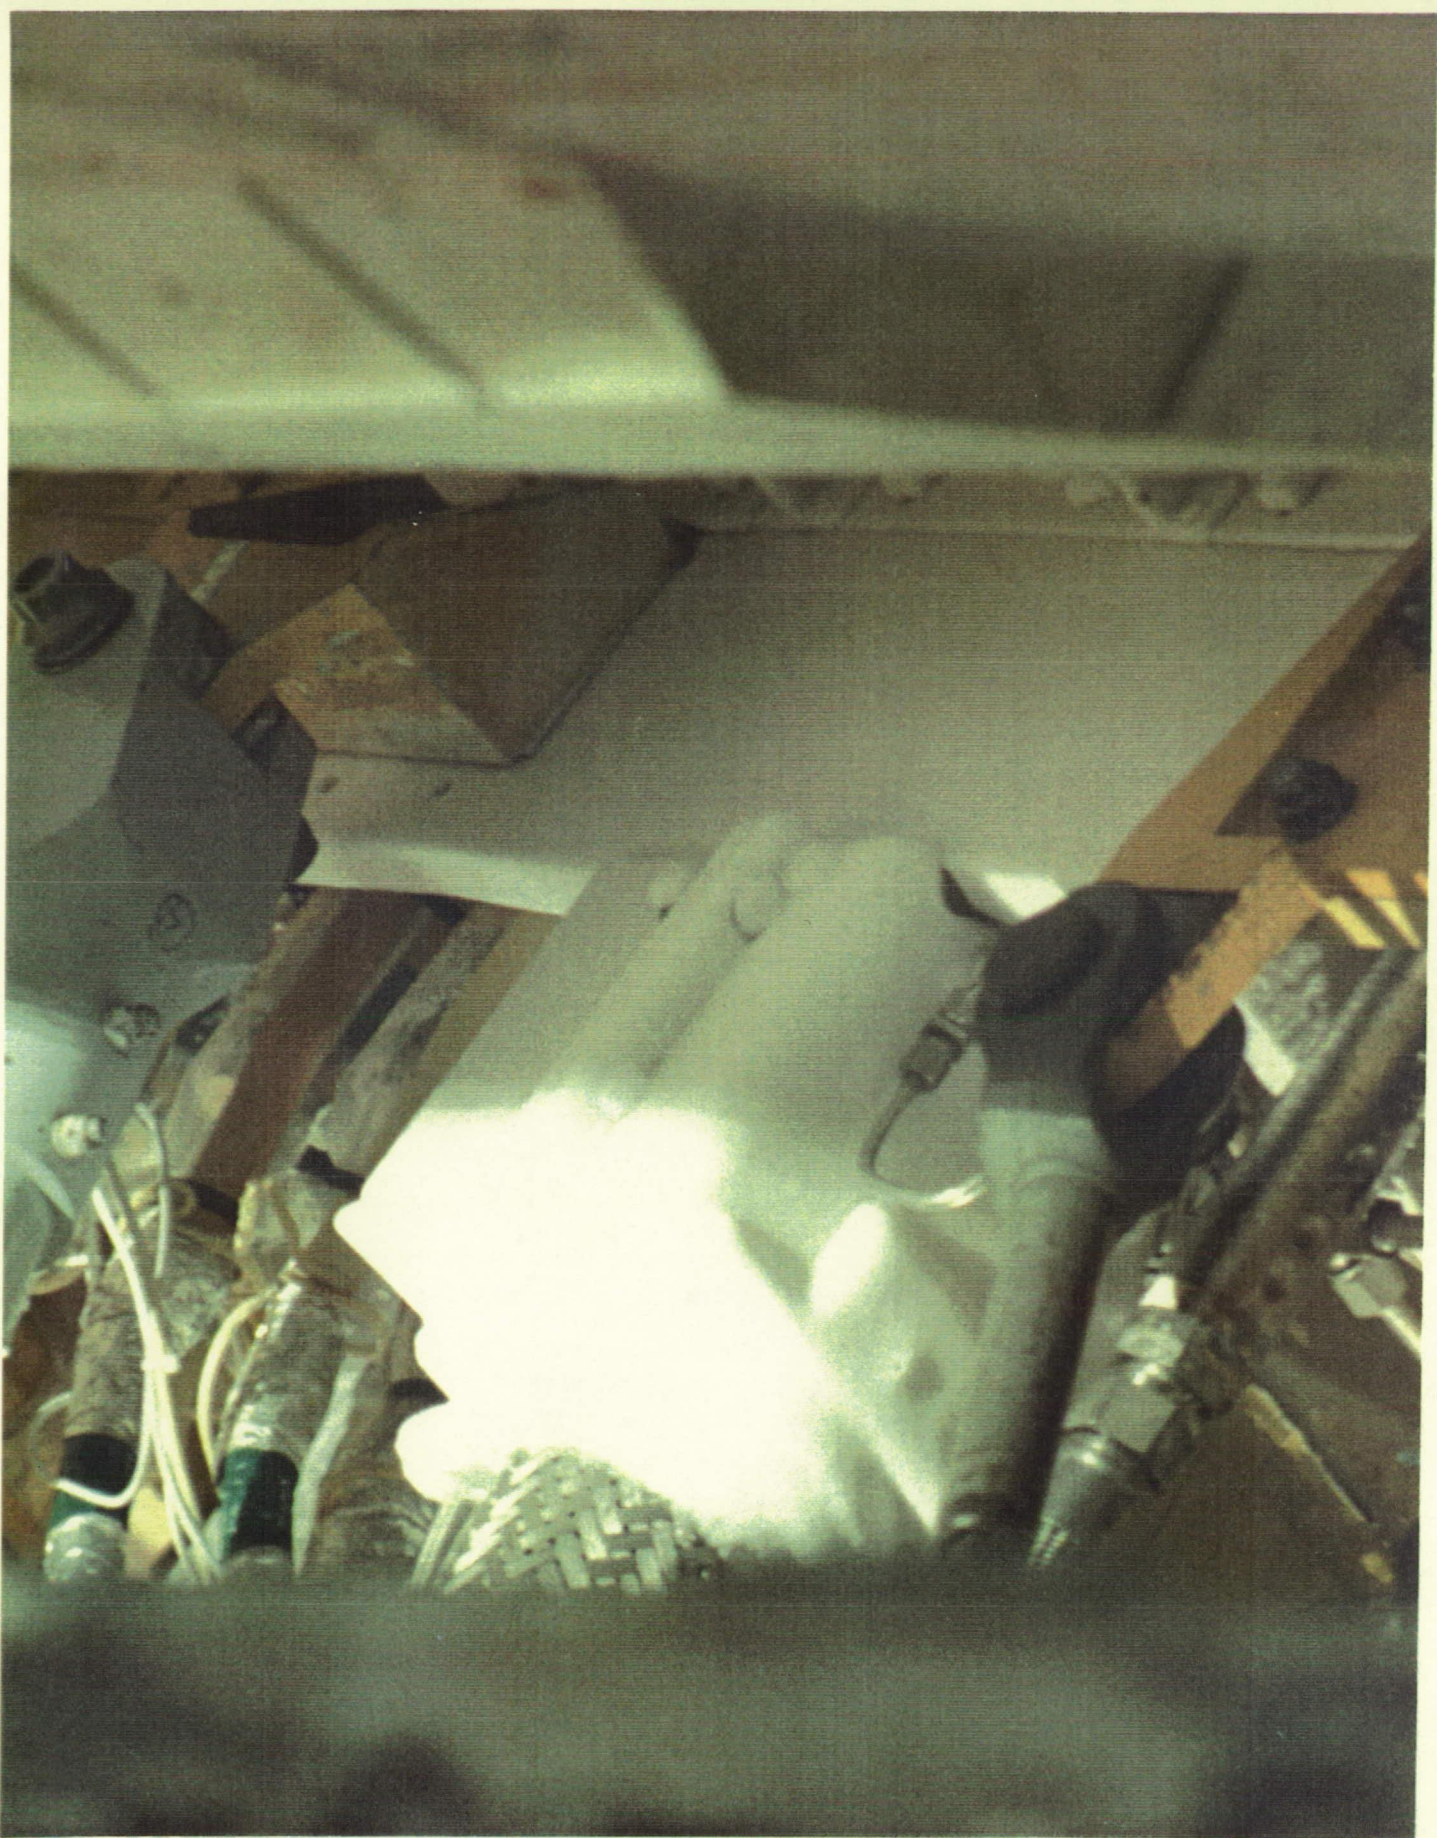
Ice/frost typically covers the 1-1/2 inch high point bleed QD  
purge shroud

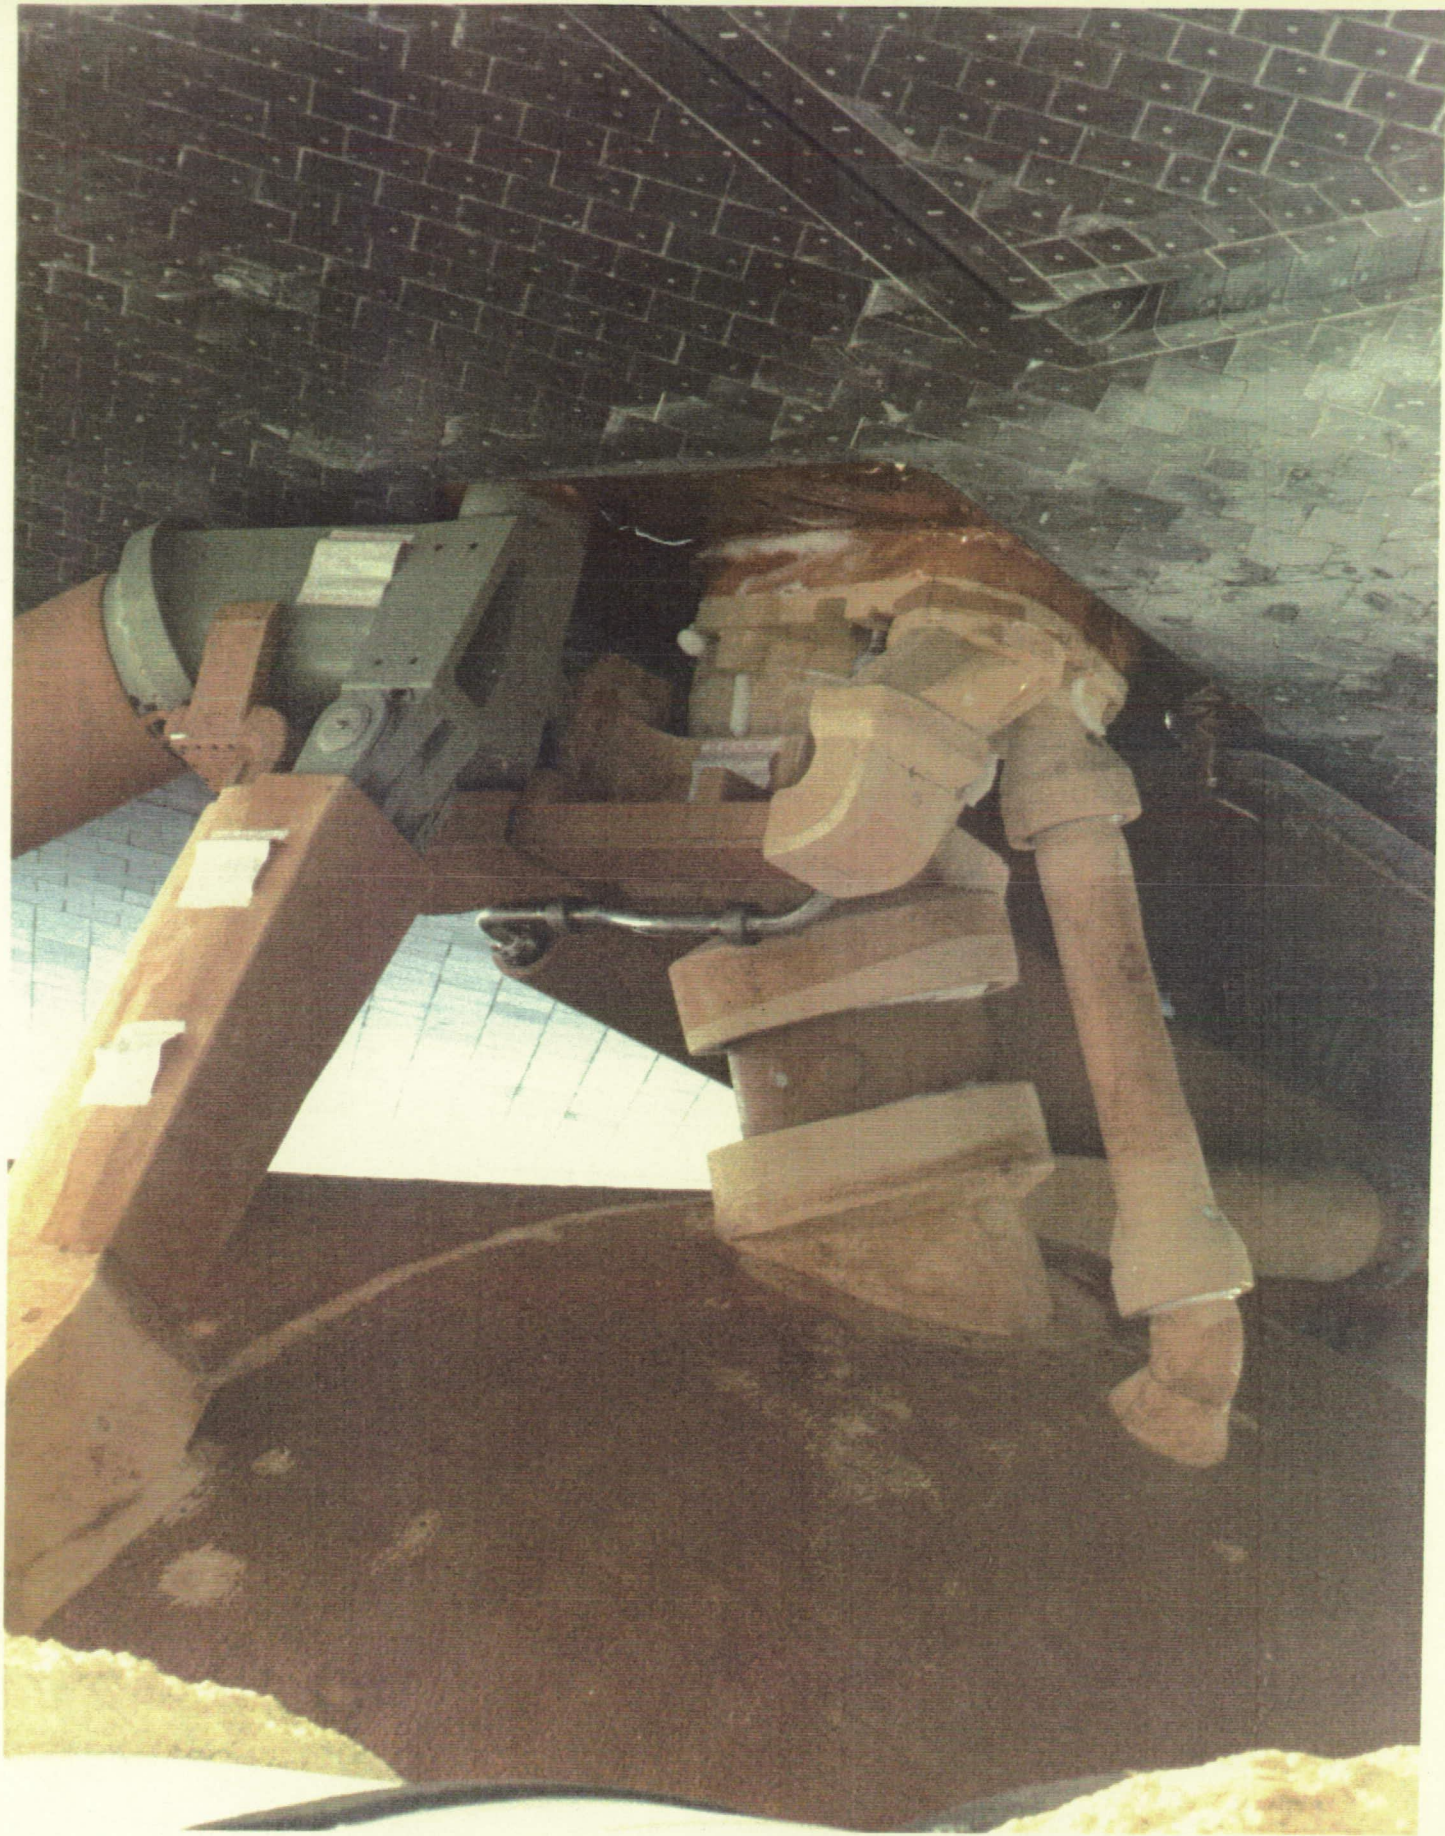
Hard ice is still present on the LH2 umbilical outboard side, purge vents, feedline and recirc line bellows after ET drain

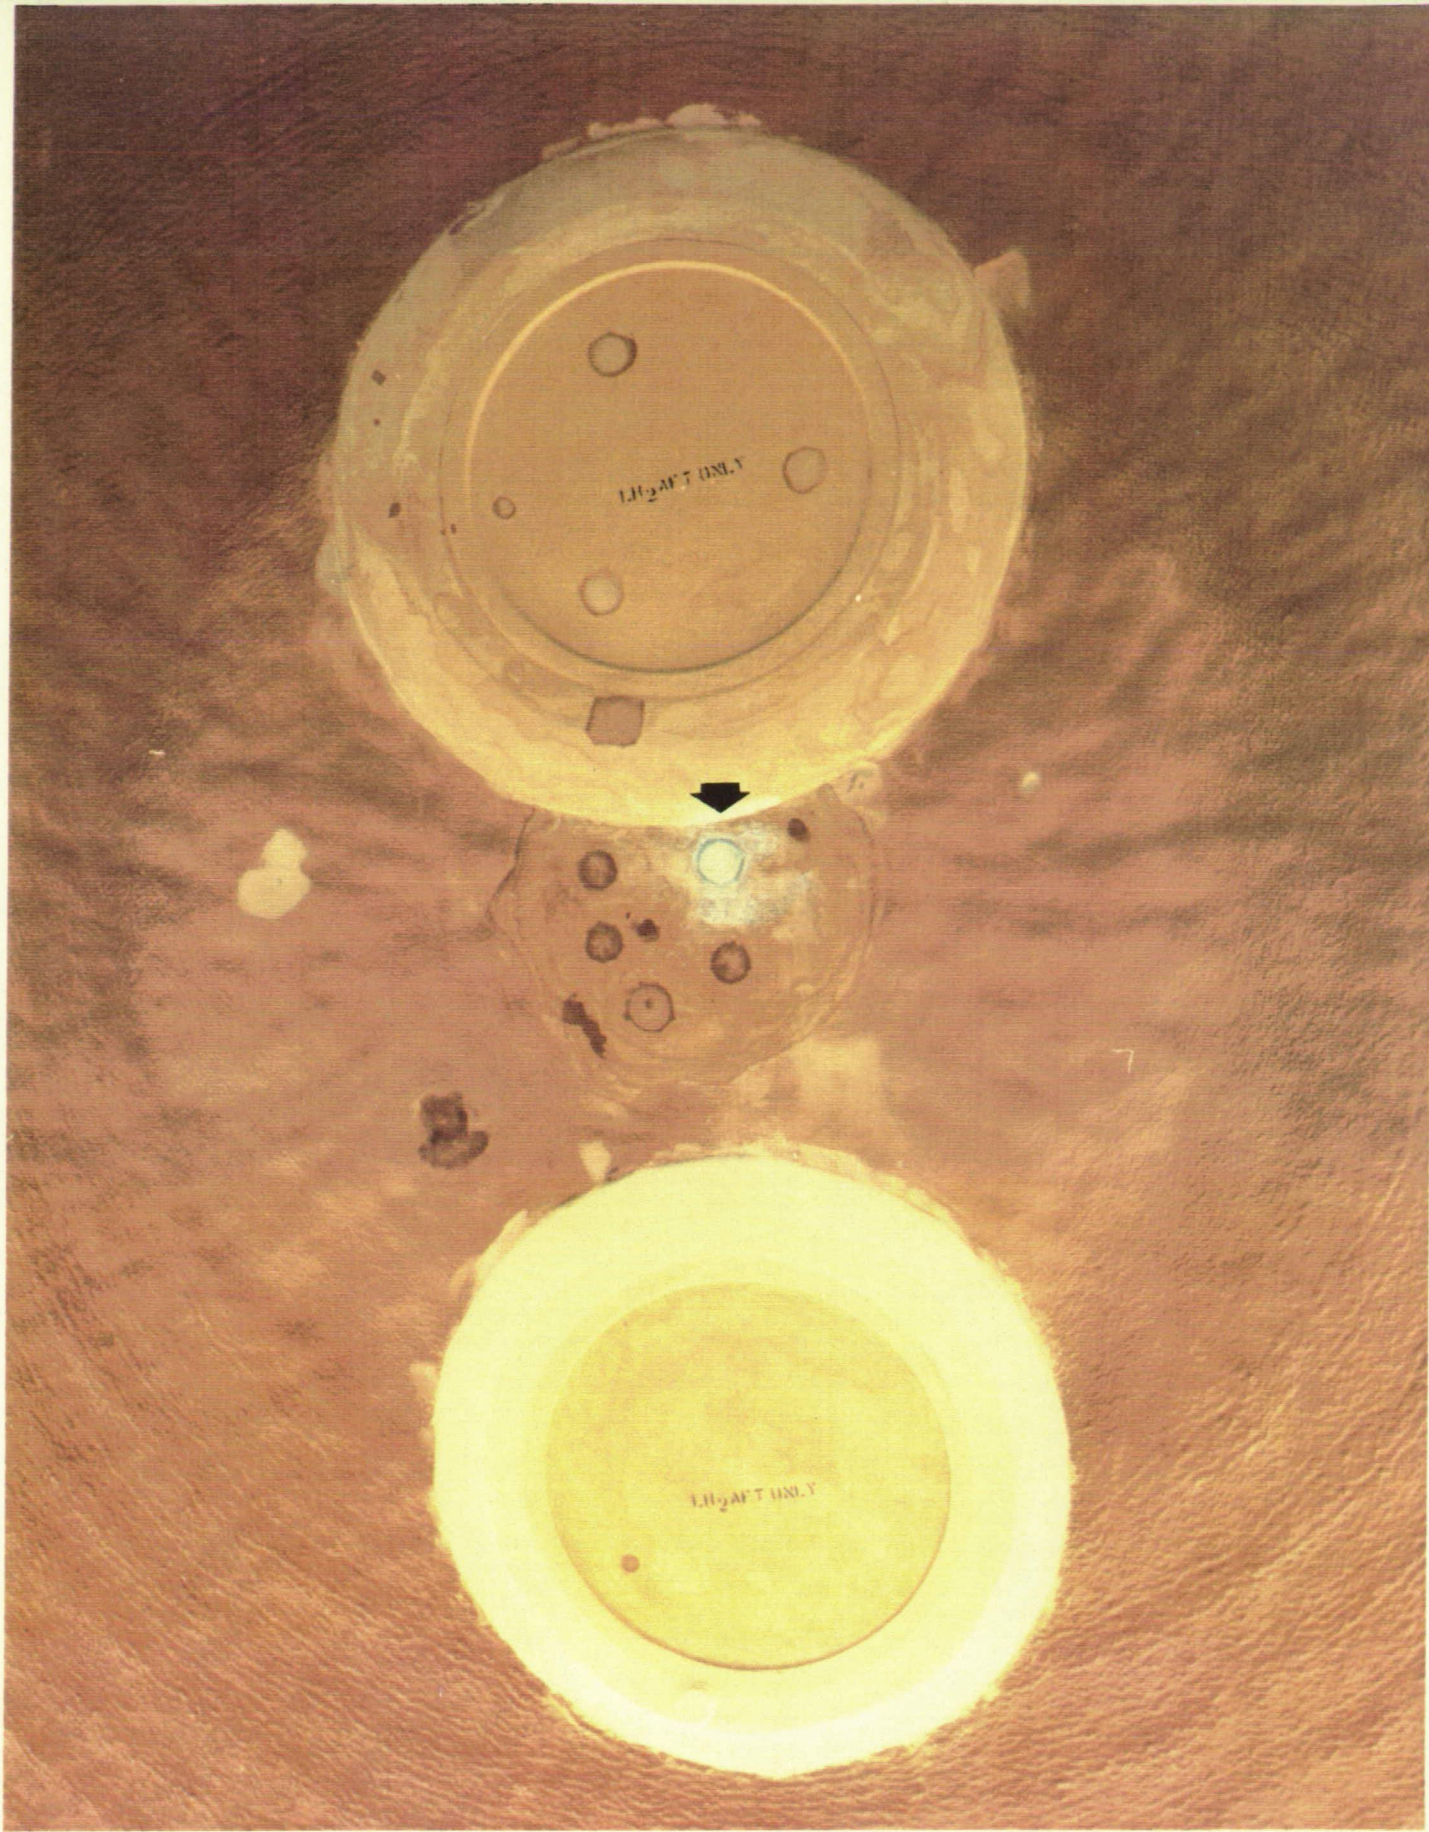
During the reinstallation of the hydrogen detection system tygon tubing for the second launch attempt, a 3-inch diameter foam repair in the LH2 tank aft dome apex was discovered to be missing. This condition was repaired per PR ET-34-TS-0044 prior to launch.

3-inch diameter repair on the ET aft dome apex fell out after drain and was repaired prior to the second cryo-load

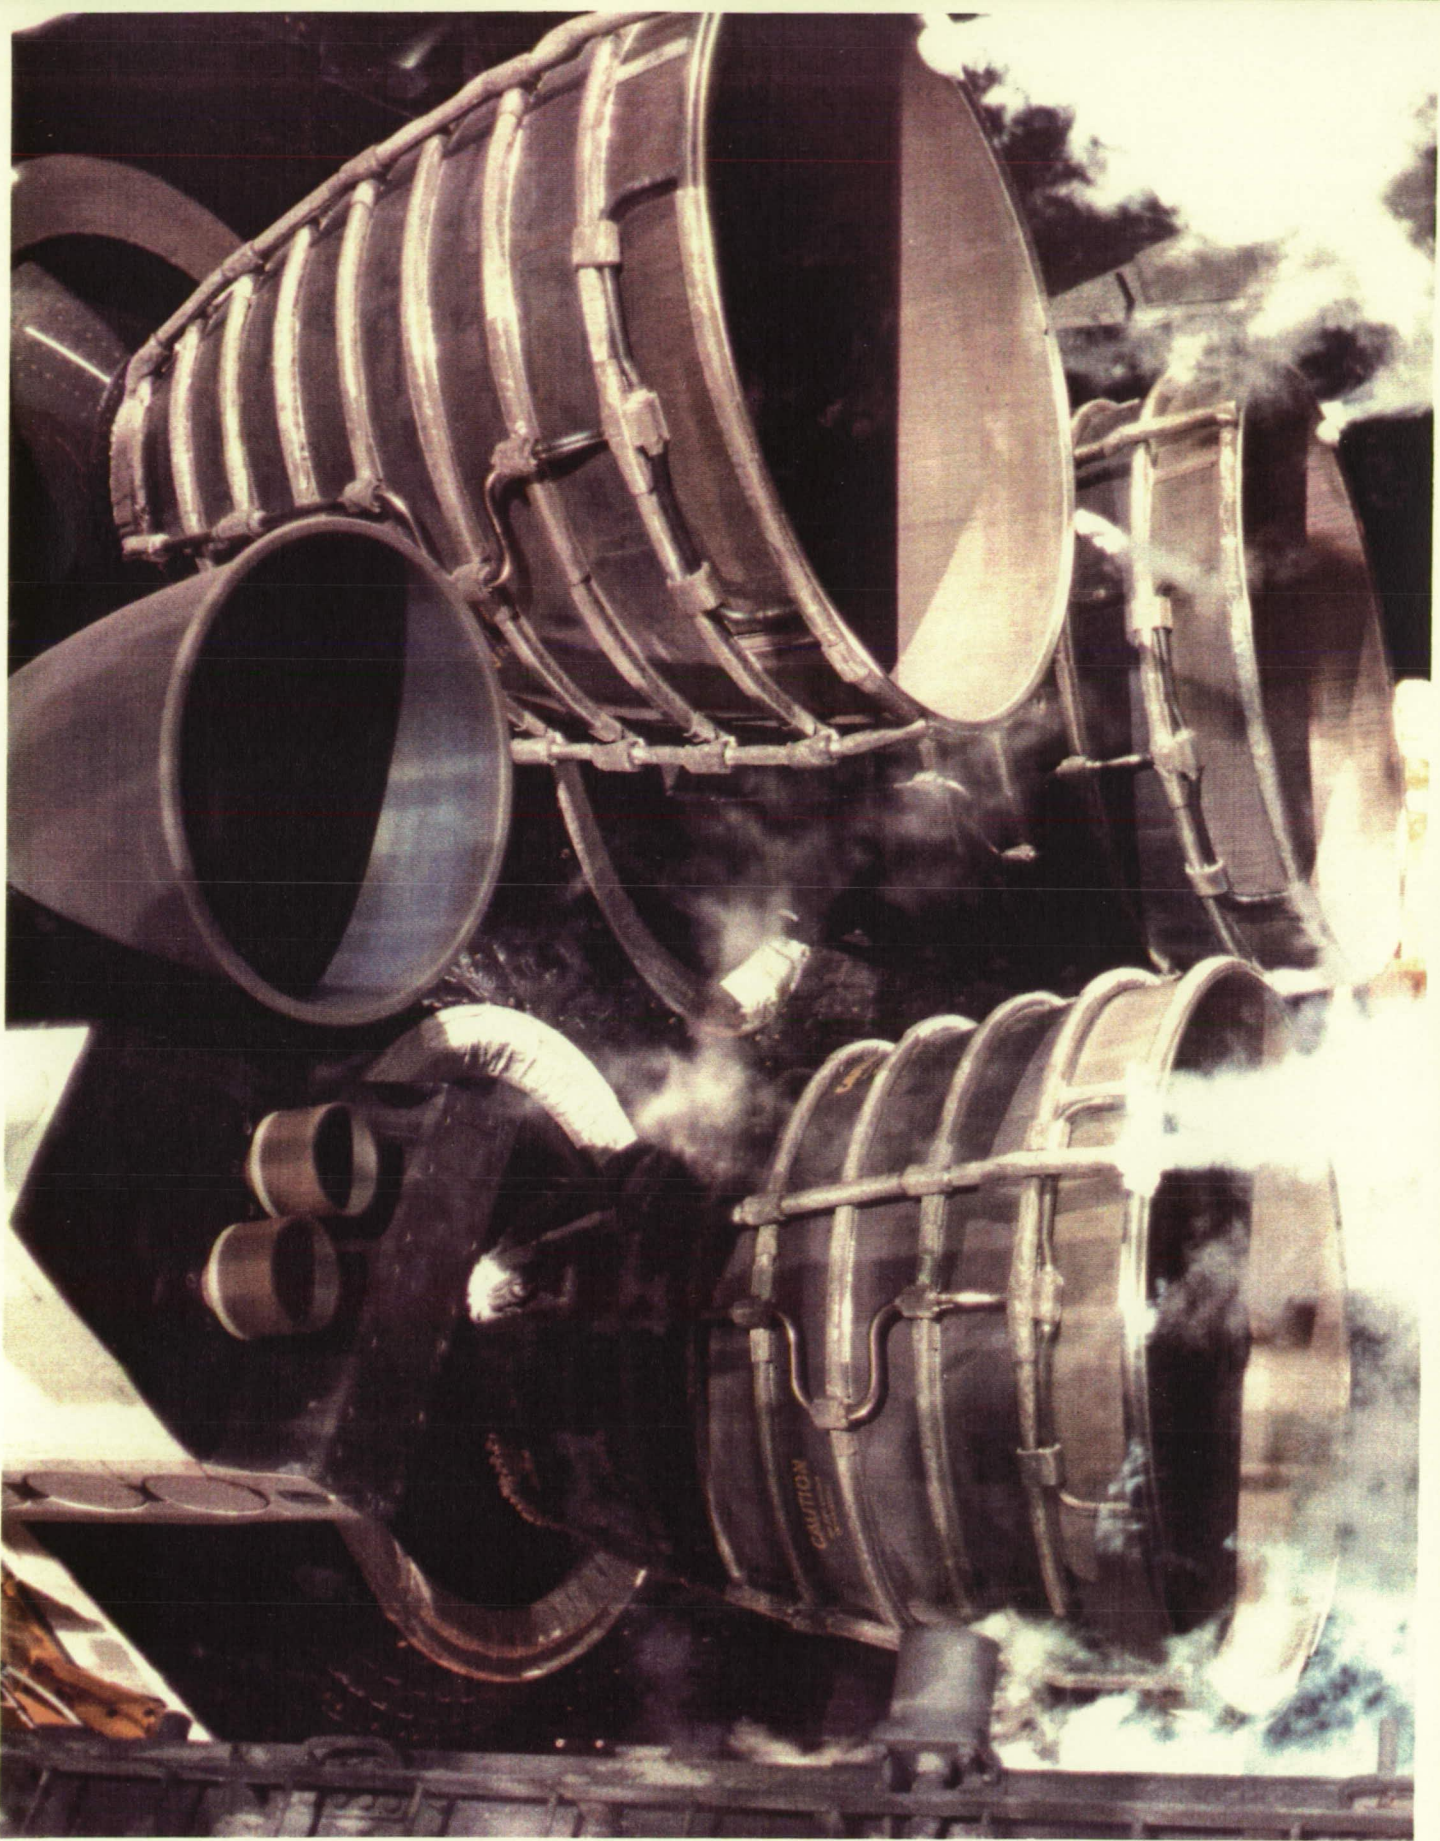
Overall view of SSME's. Note appearance of ice/frost at the SSME #2 engine mounted heat shield interface.

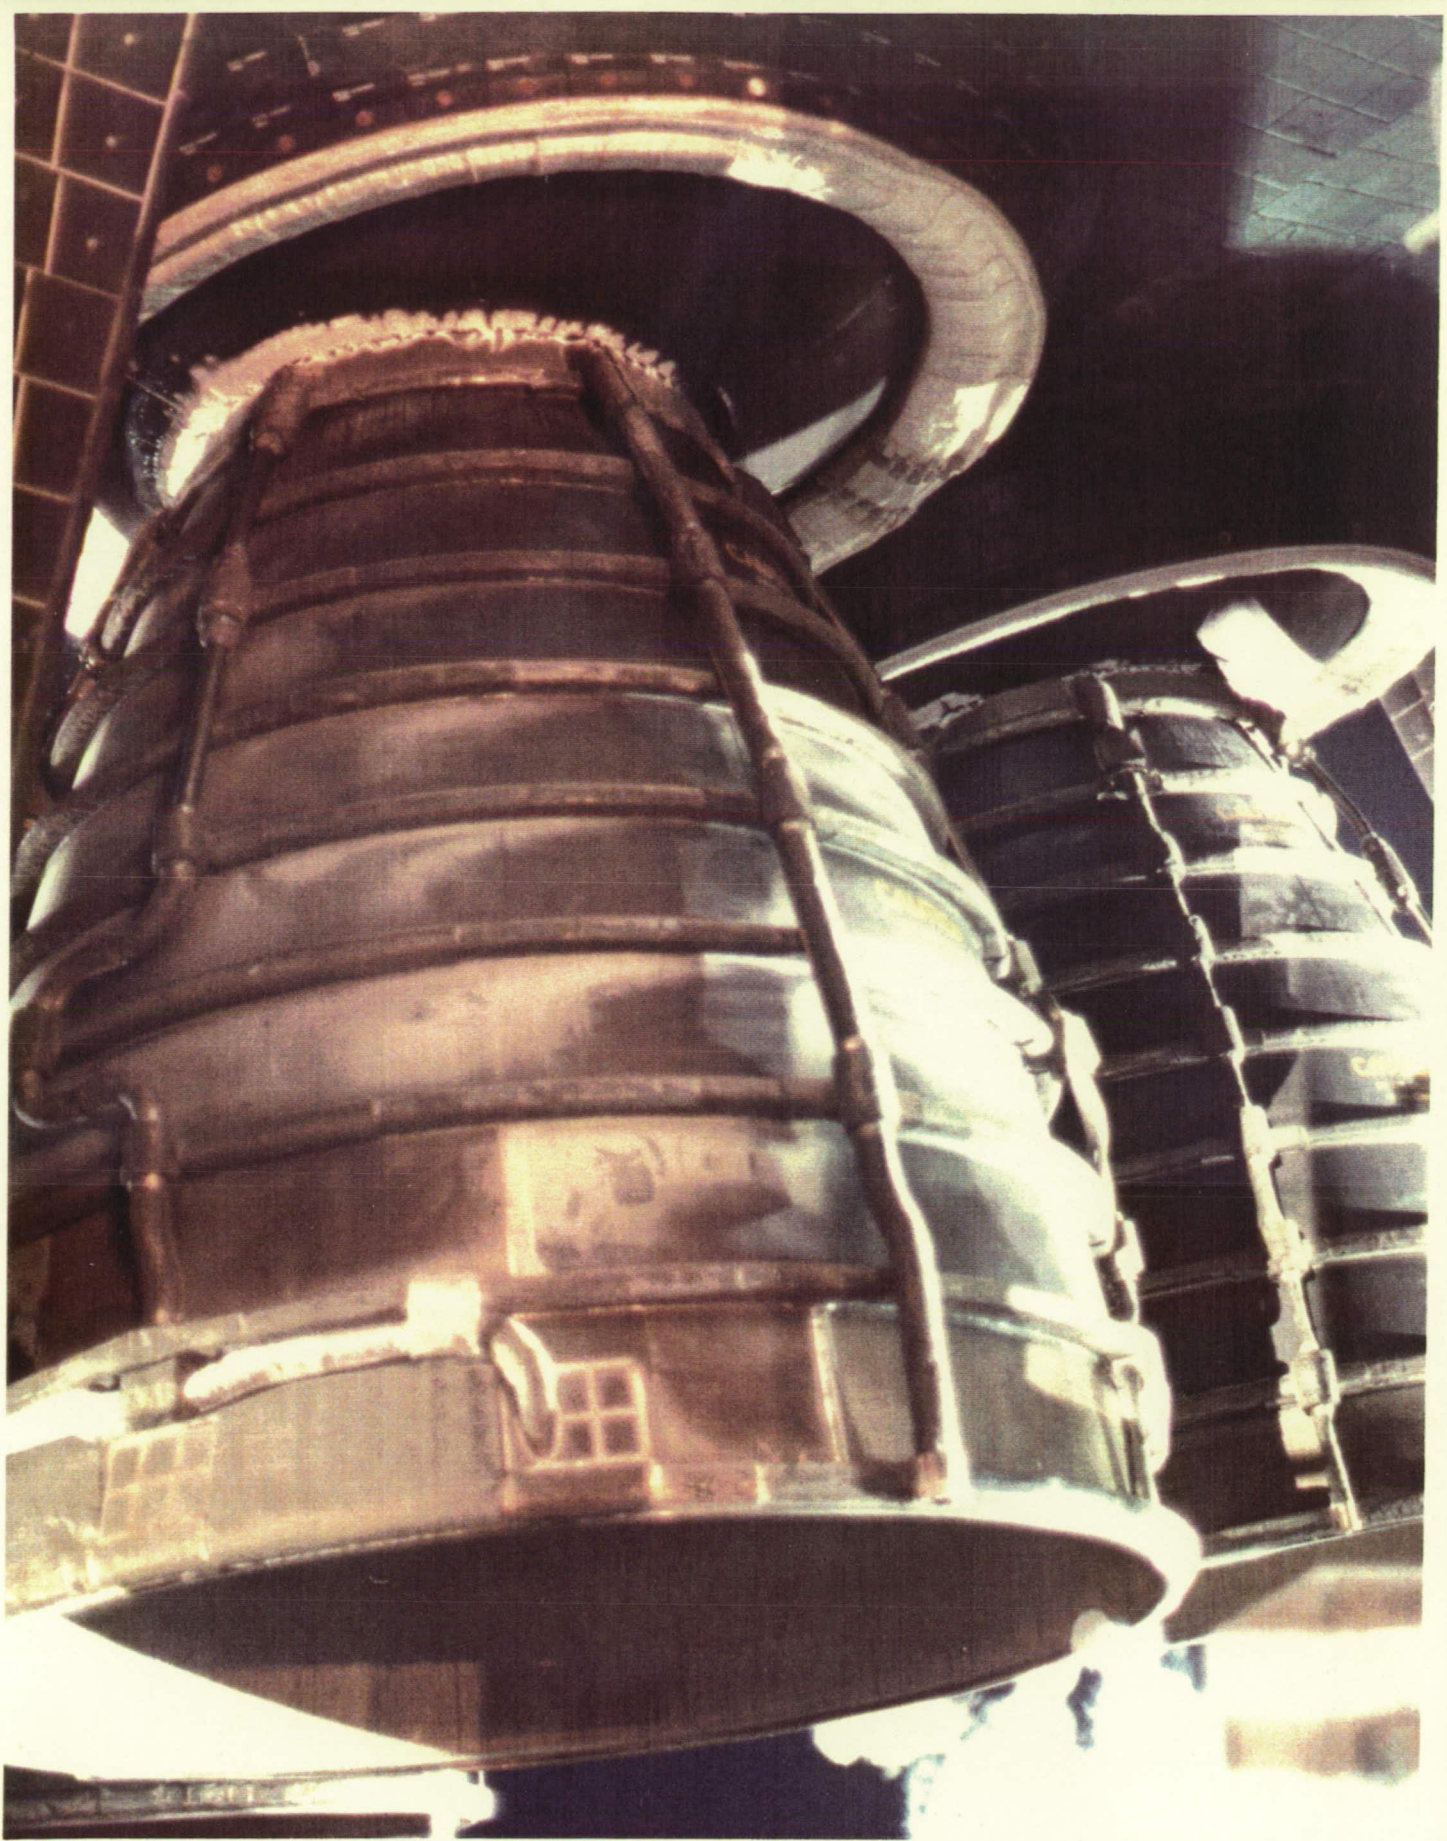
Typical ice/frost has formed at the SSME #1 and #2  
nozzle to engine mounted heat shields

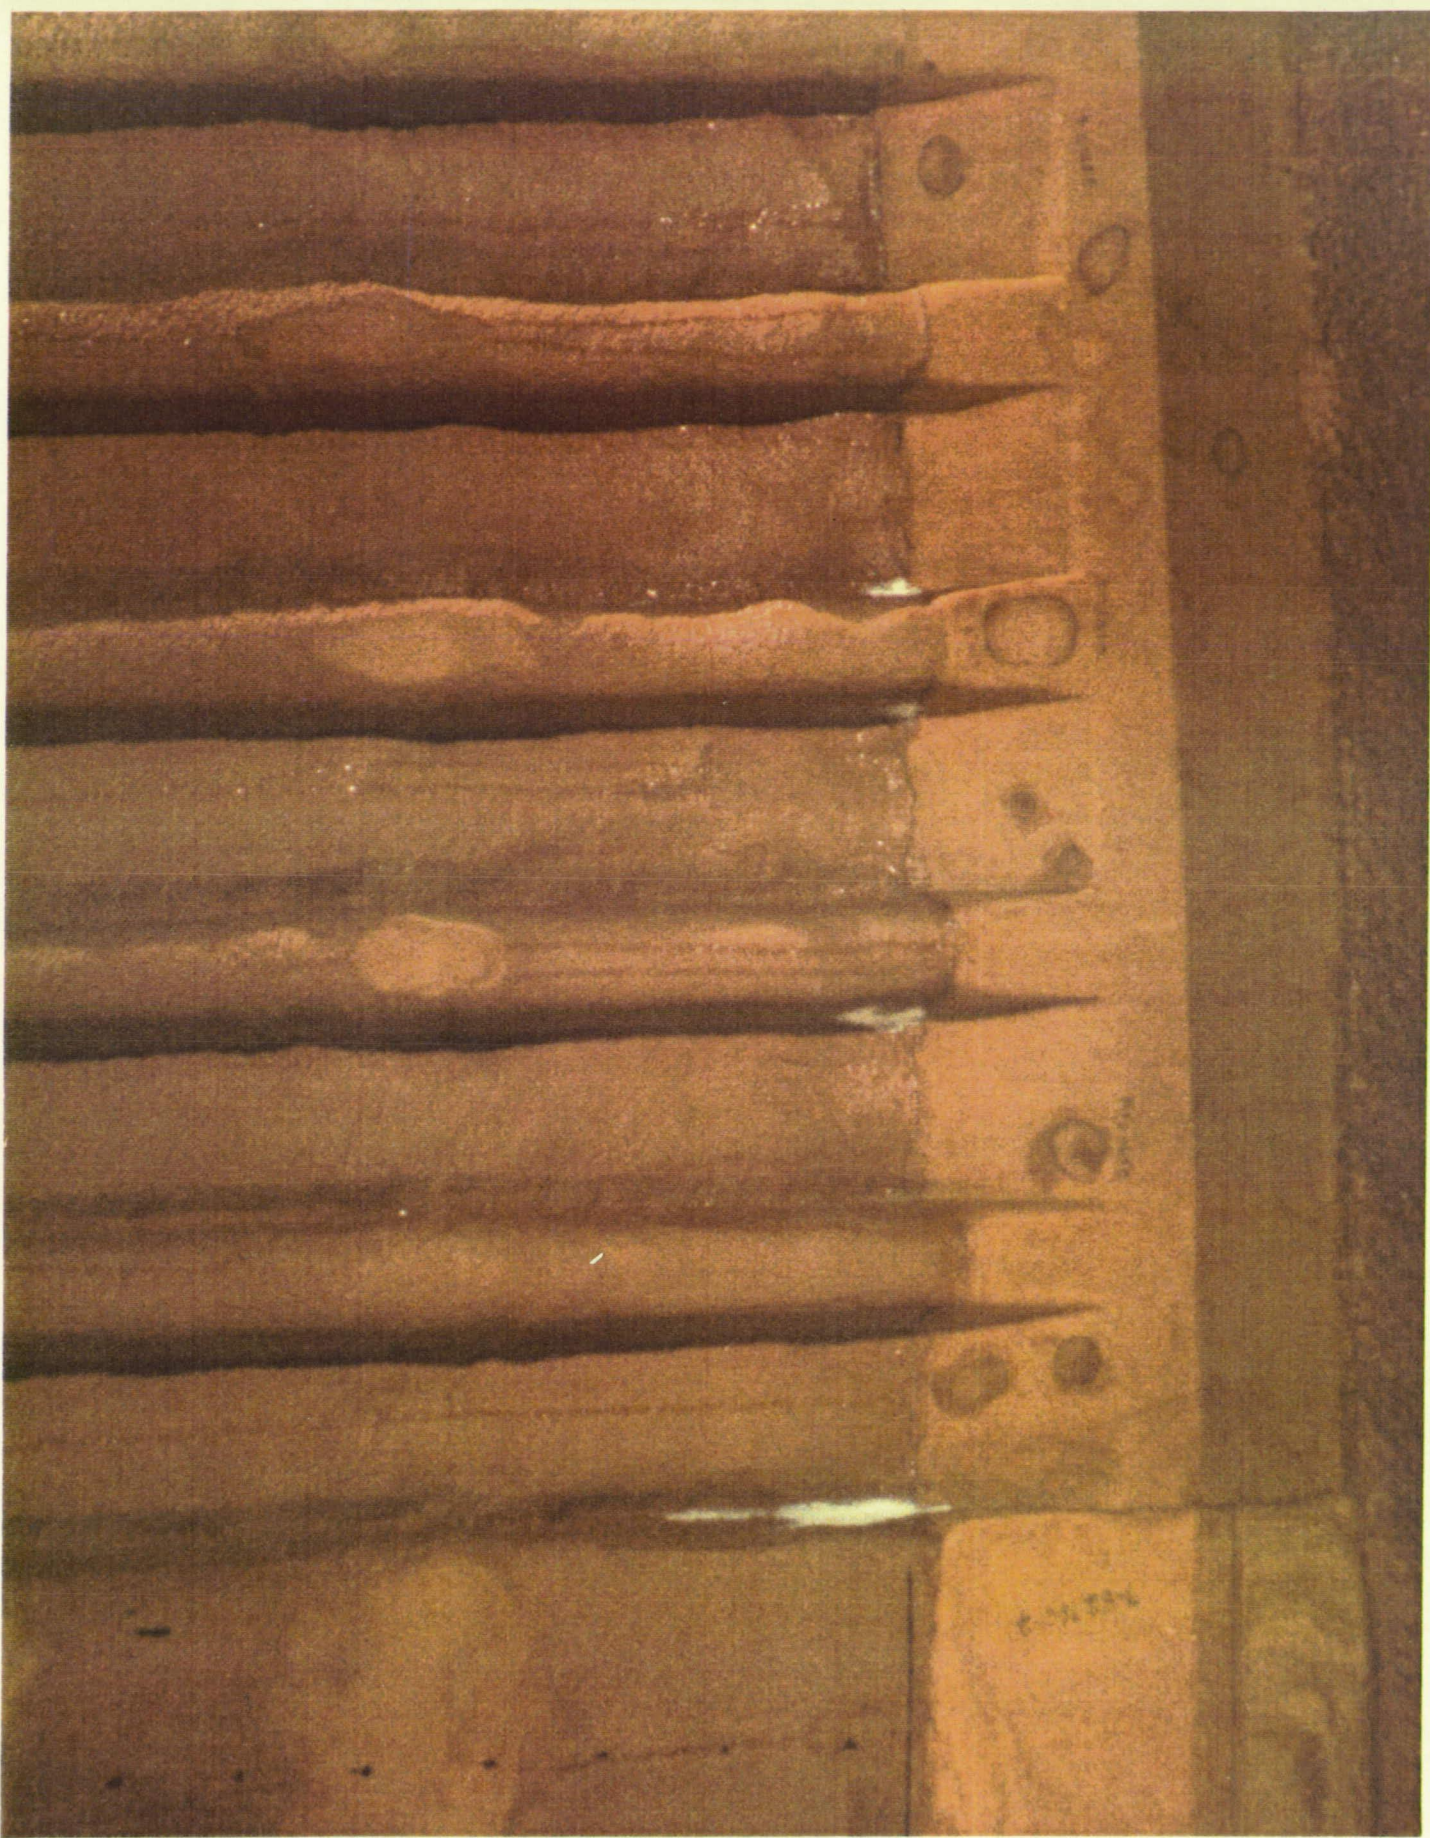
Frost accumulations in the intertank stringer valleys occurred on the -Z side of the tank

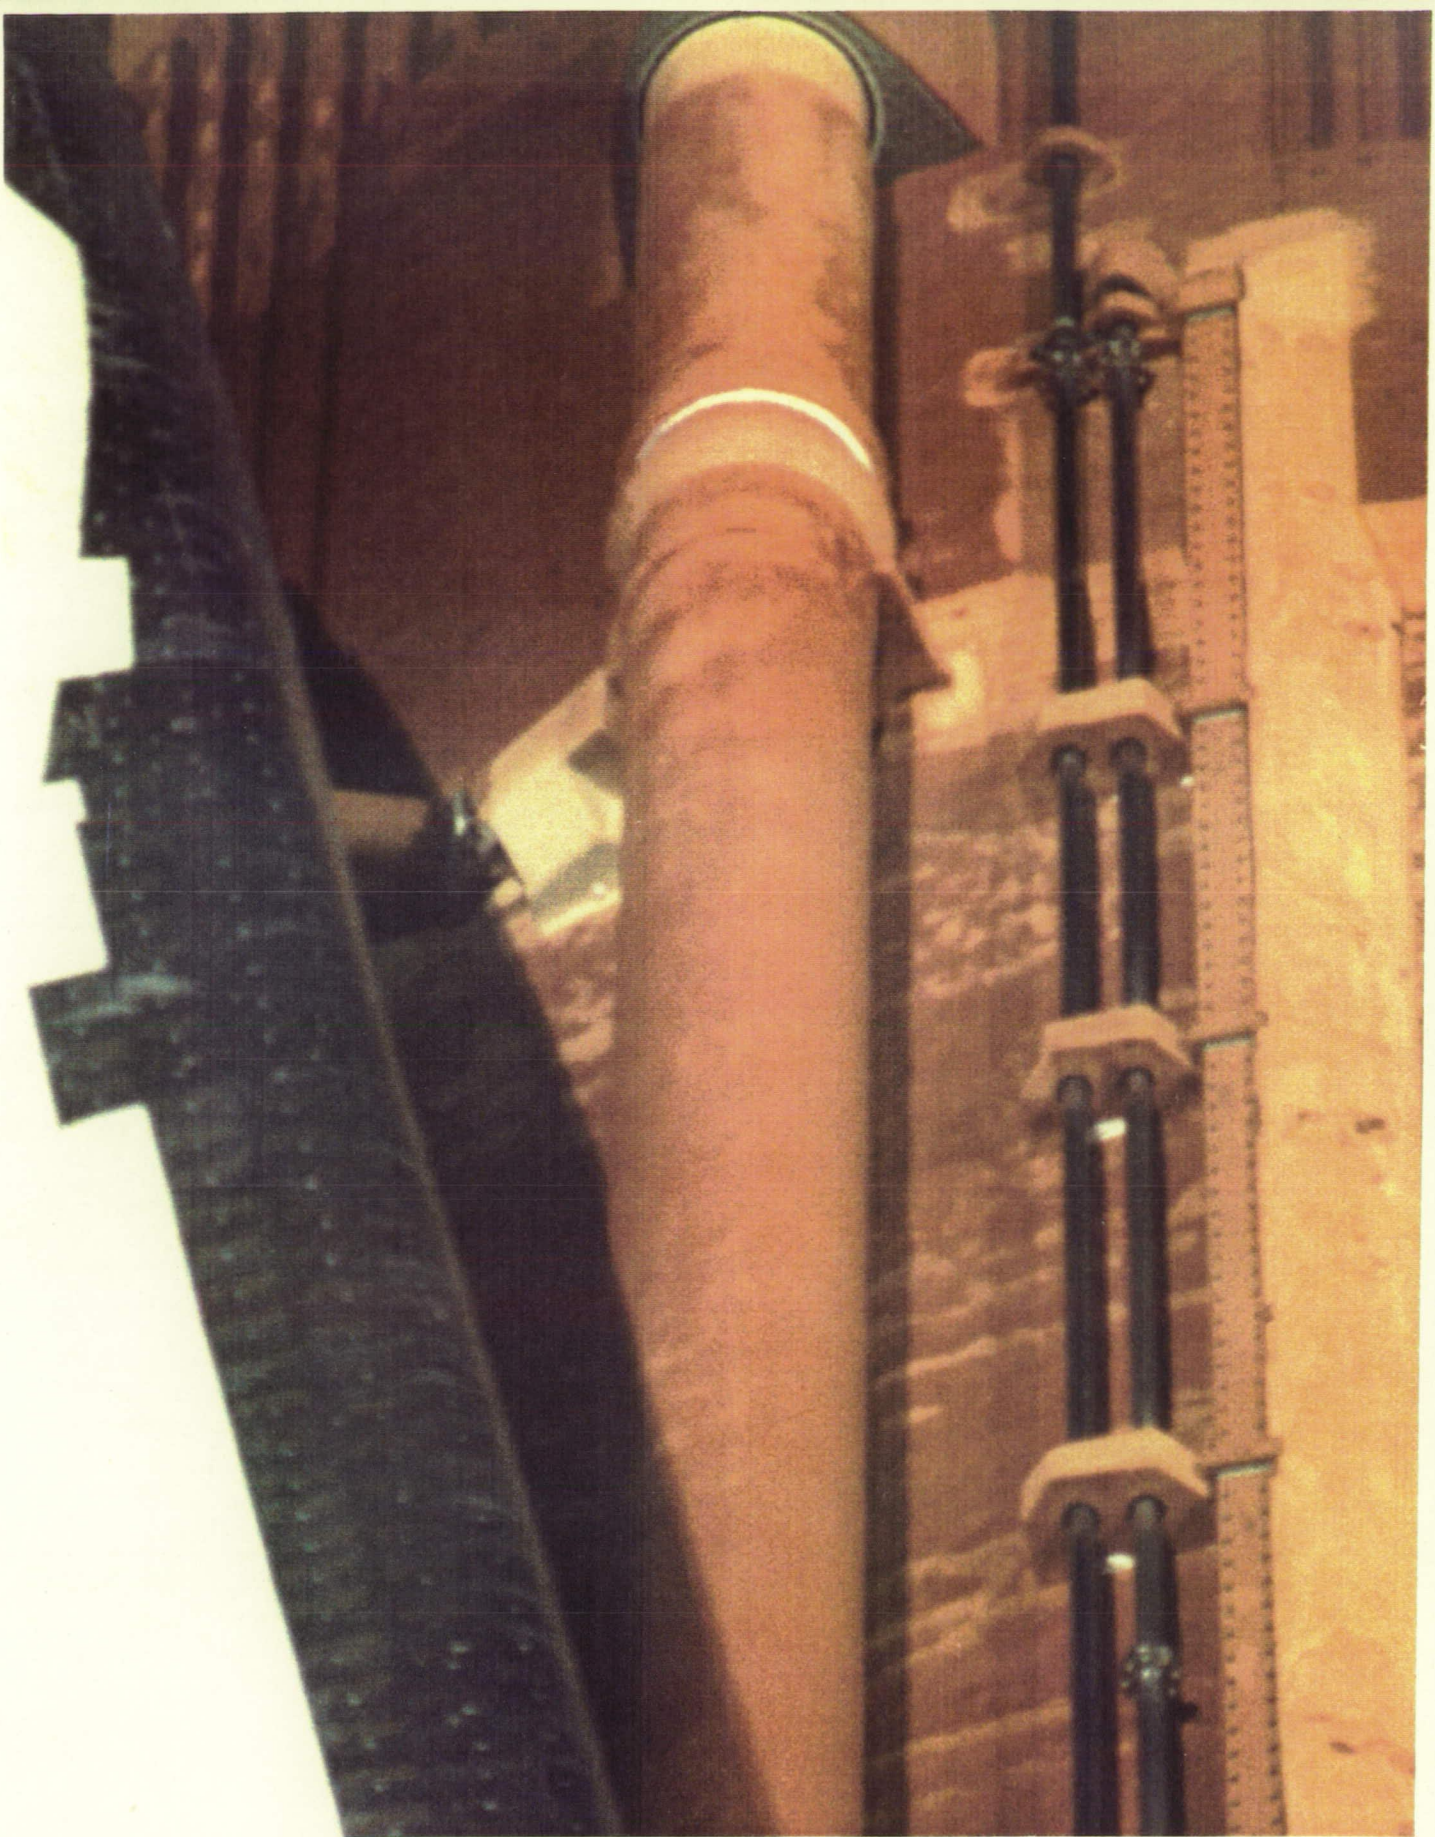
Typical amount of ice formed in the L02 feedline upper bellows.  
Ice/frost also formed along aft sides of the ice/frost ramps.

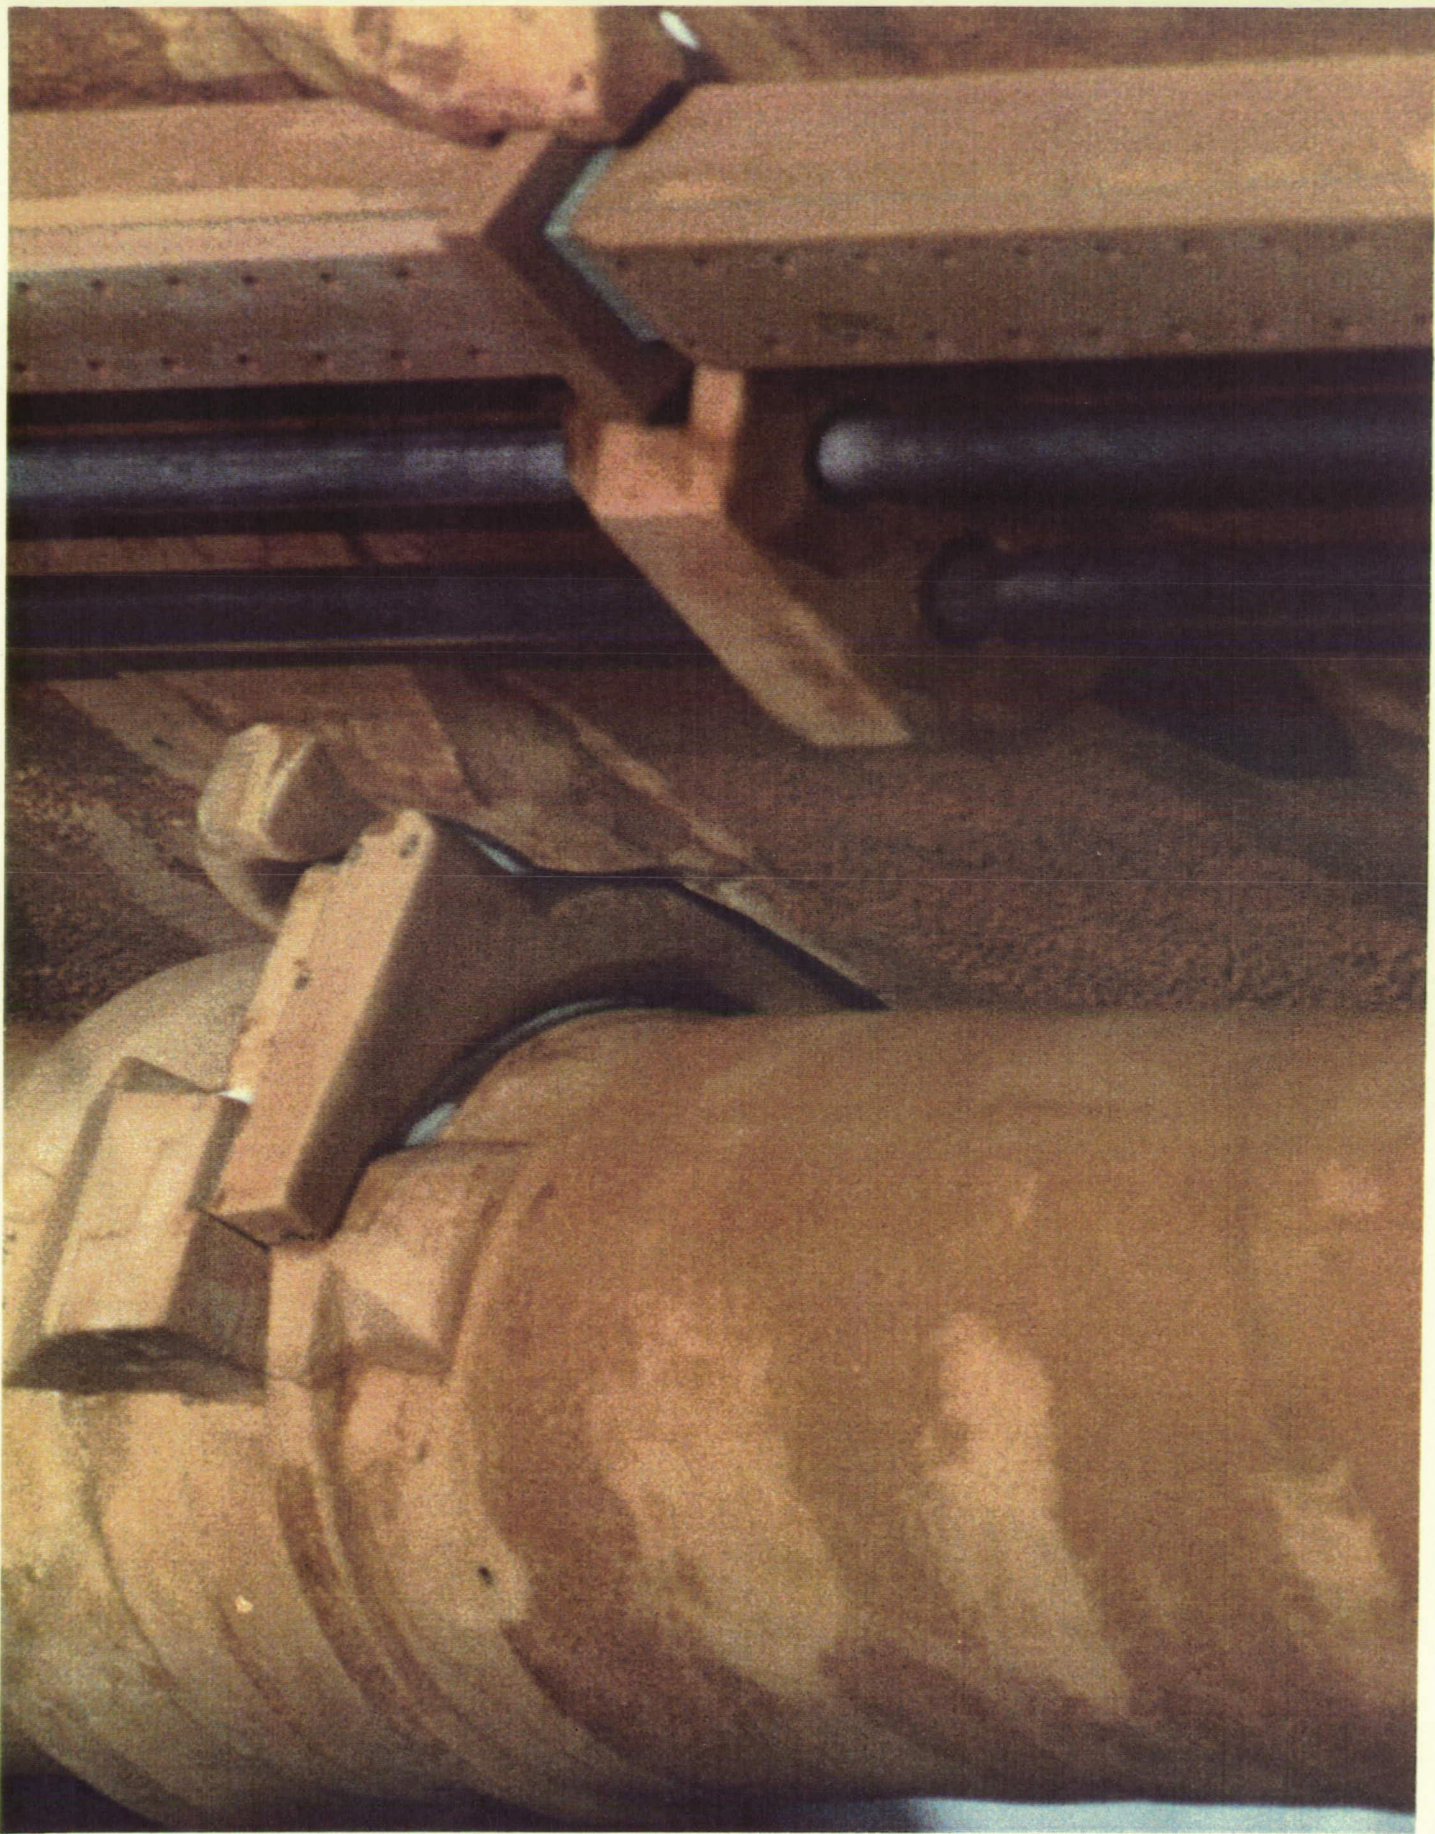
Typical accumulation of ice/frost in the L02 feedline support bracket. Note frost spot along aft side of ice/frost ramp.
