NASA Technical Memorandum TM 102790

# Debris/Ice/TPS Assessment And Photographic Analysis For Shuttle Mission STS-31R

Charles G. Stevenson  
NASA/Kennedy Space Center

April 24, 1990

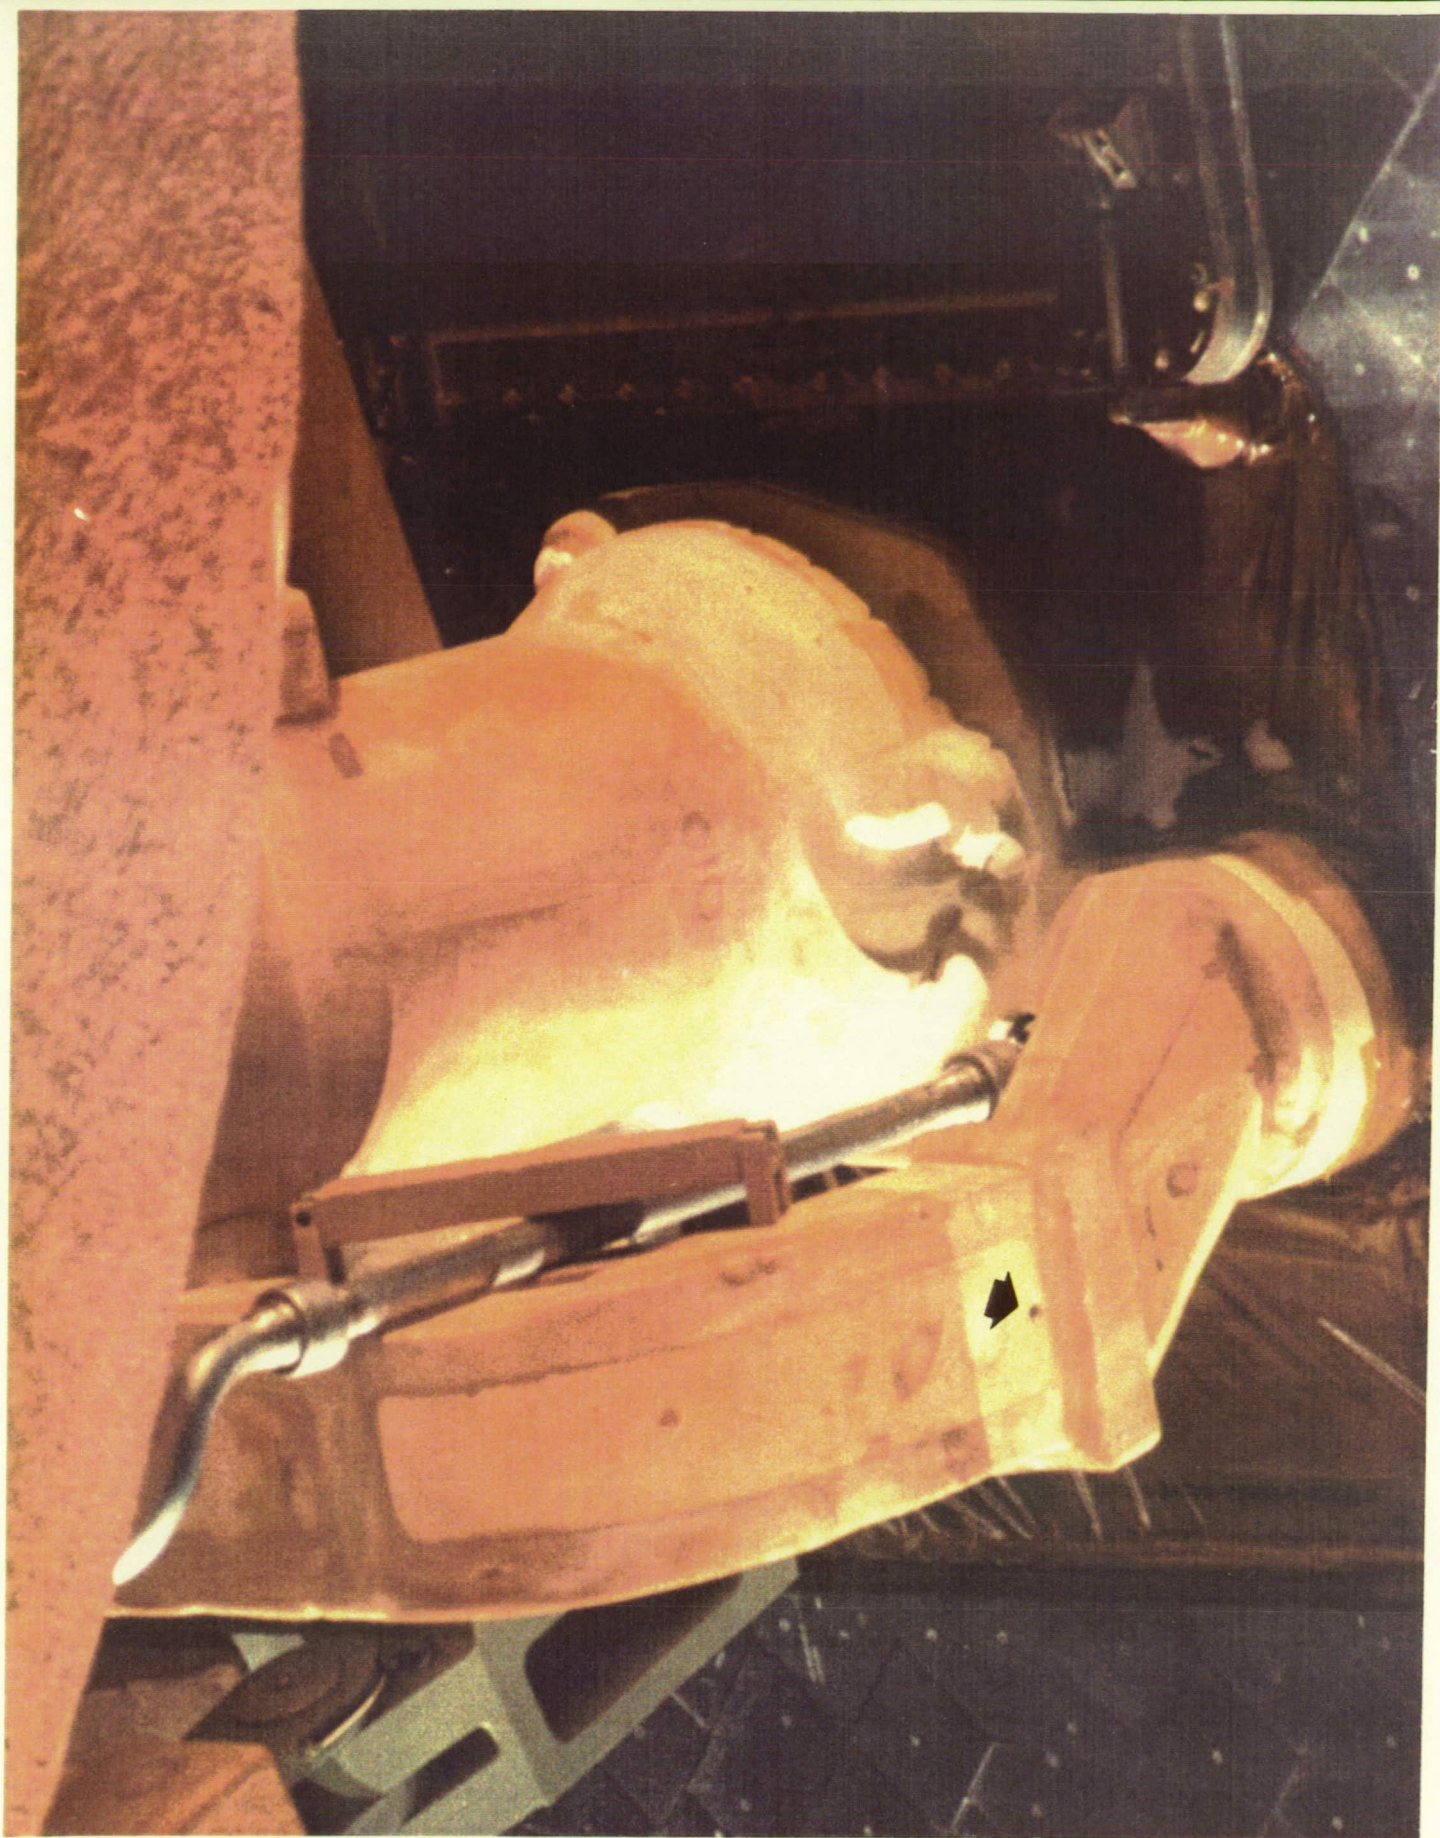
Normal appearance of ice/frost on the purge vents and aft side of the LO2 ET/ORB umbilical. Cable tray vent hole is clear.

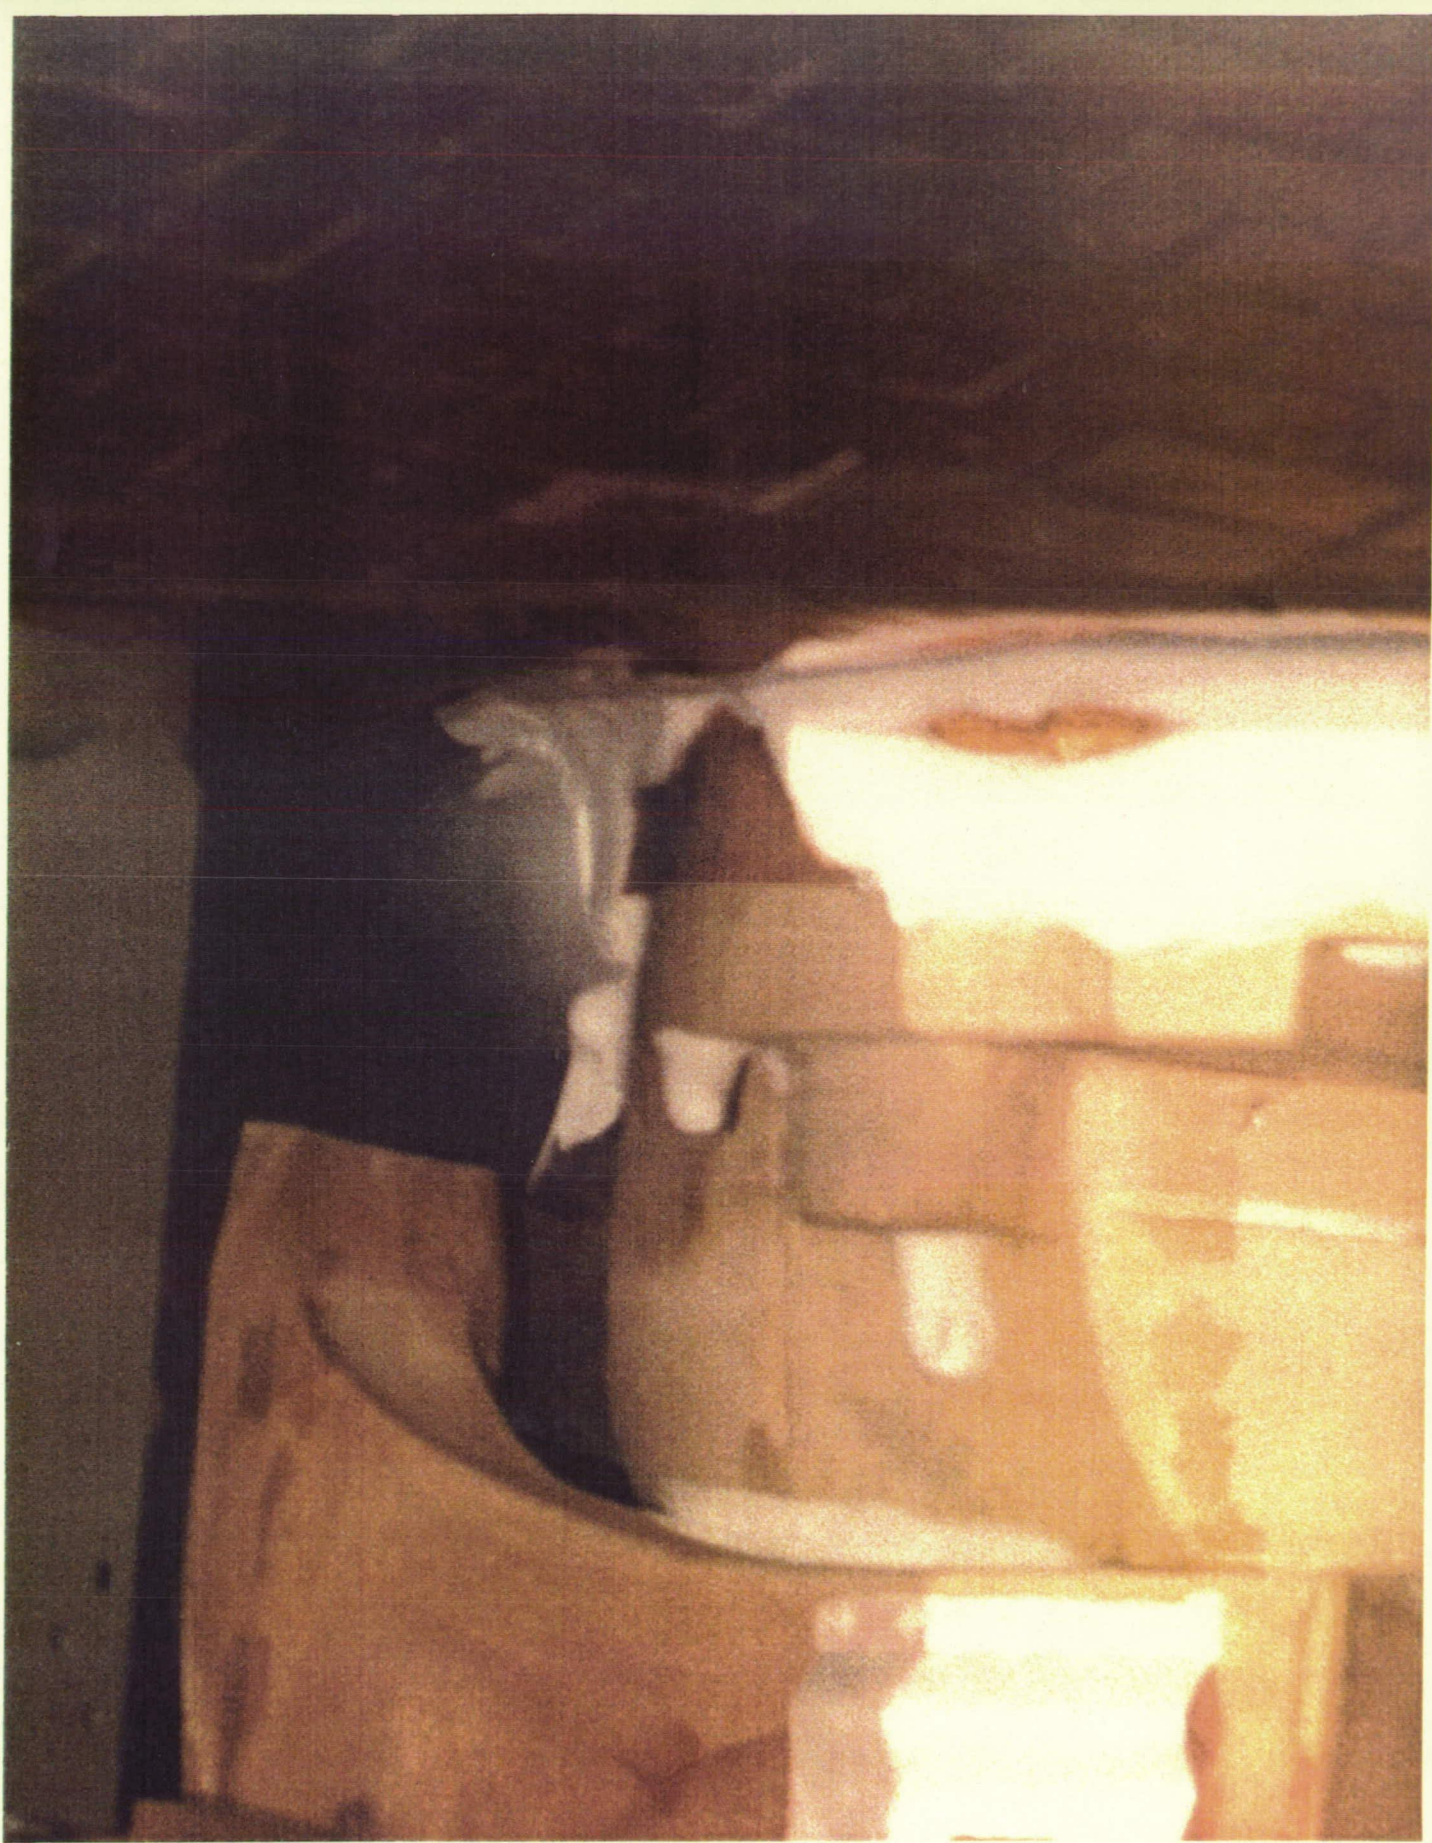
Ice/frost has formed on the purge vents, around the LH2 feedline, and on the top and side of the LH2 umbilical

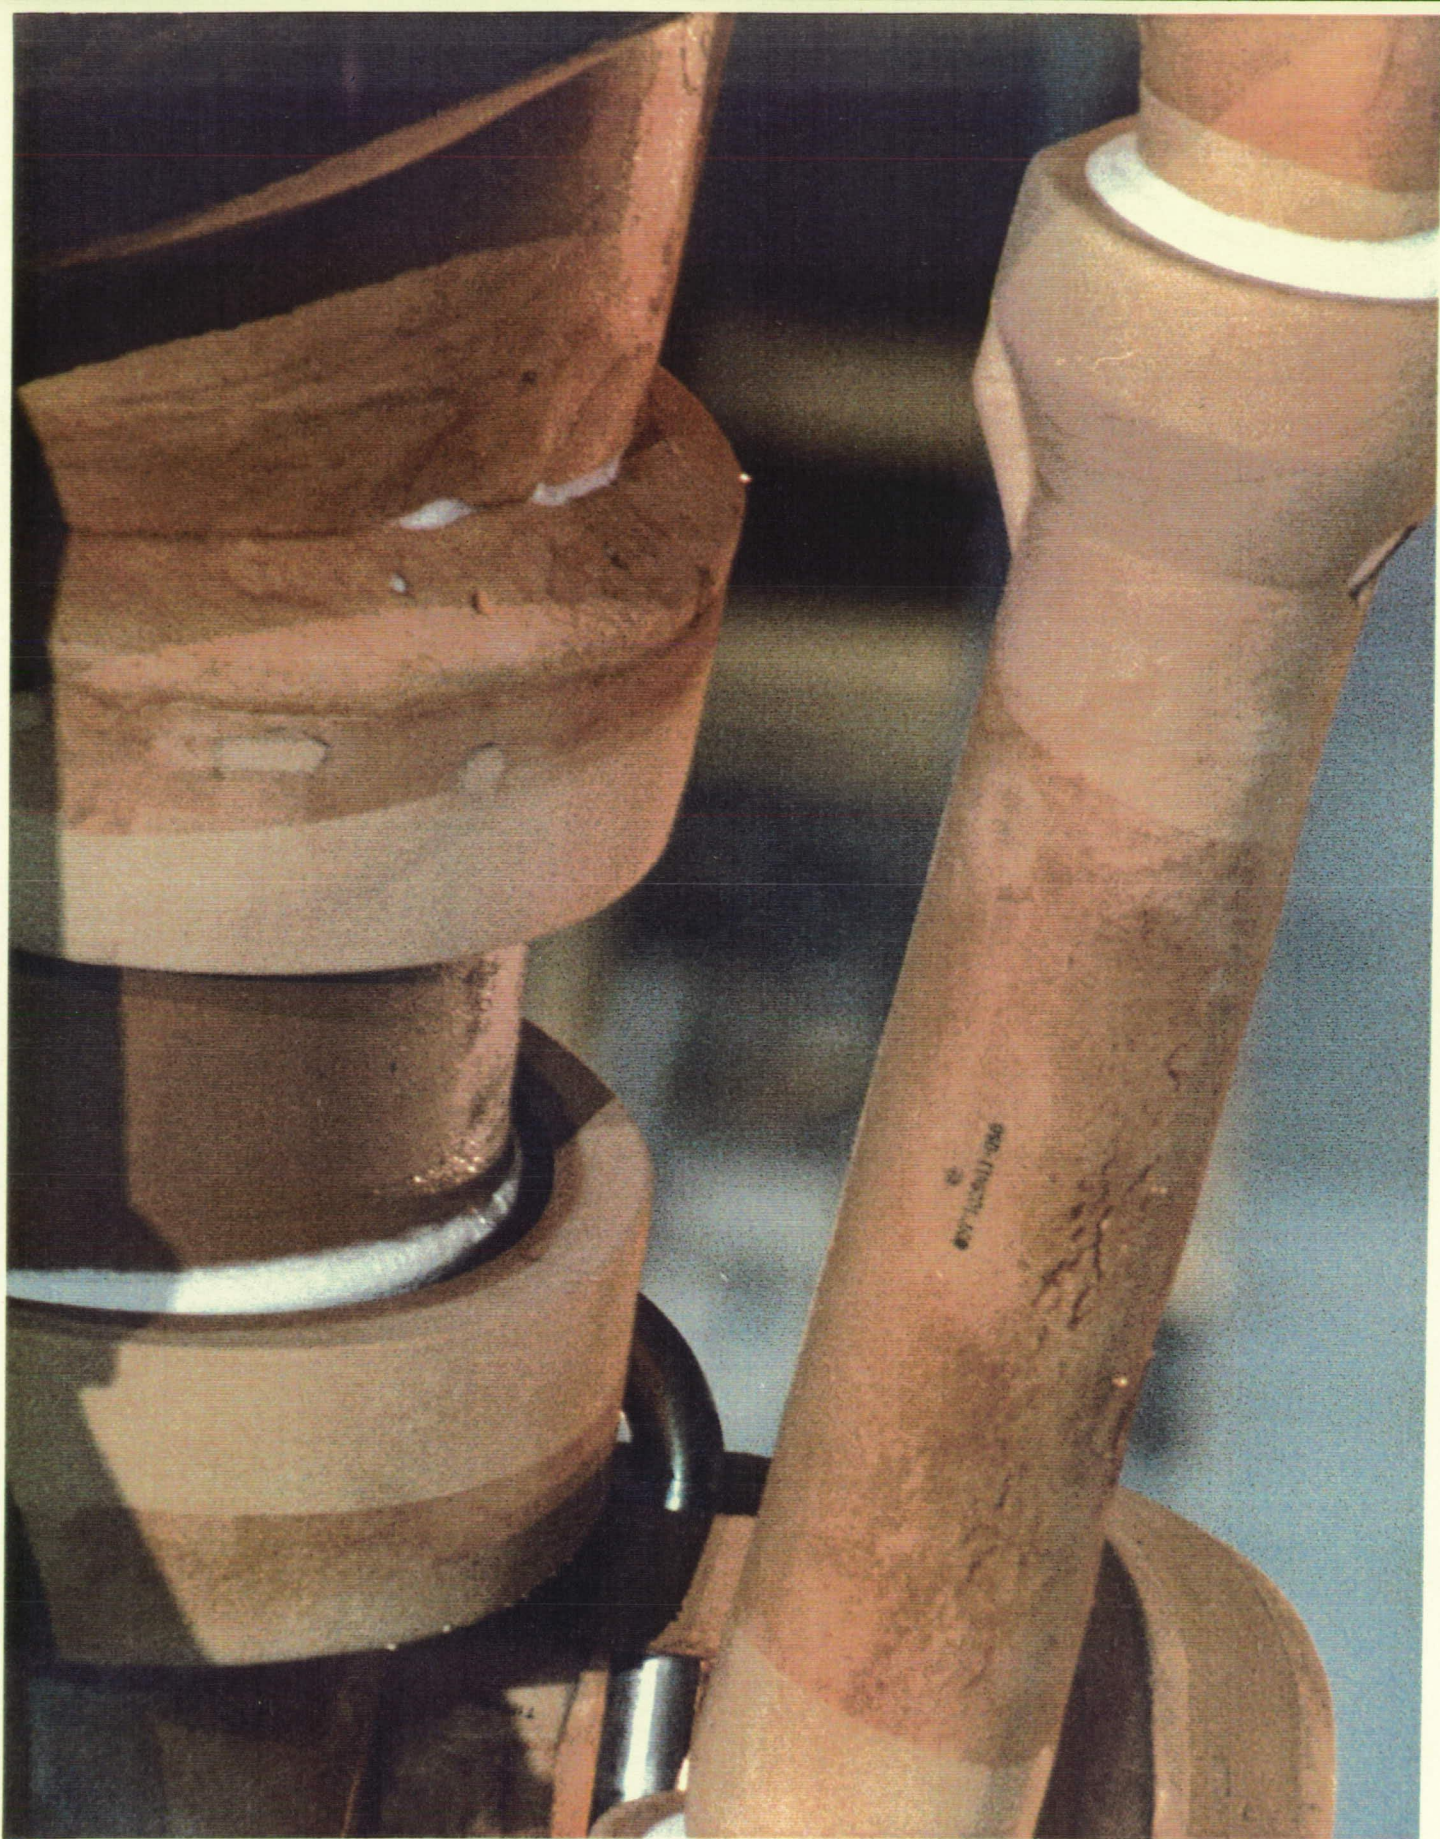
Ice/frost in the LH2 feedline and recirculation line bellows is normal. Two frost spots formed on the F/L flange closeout.

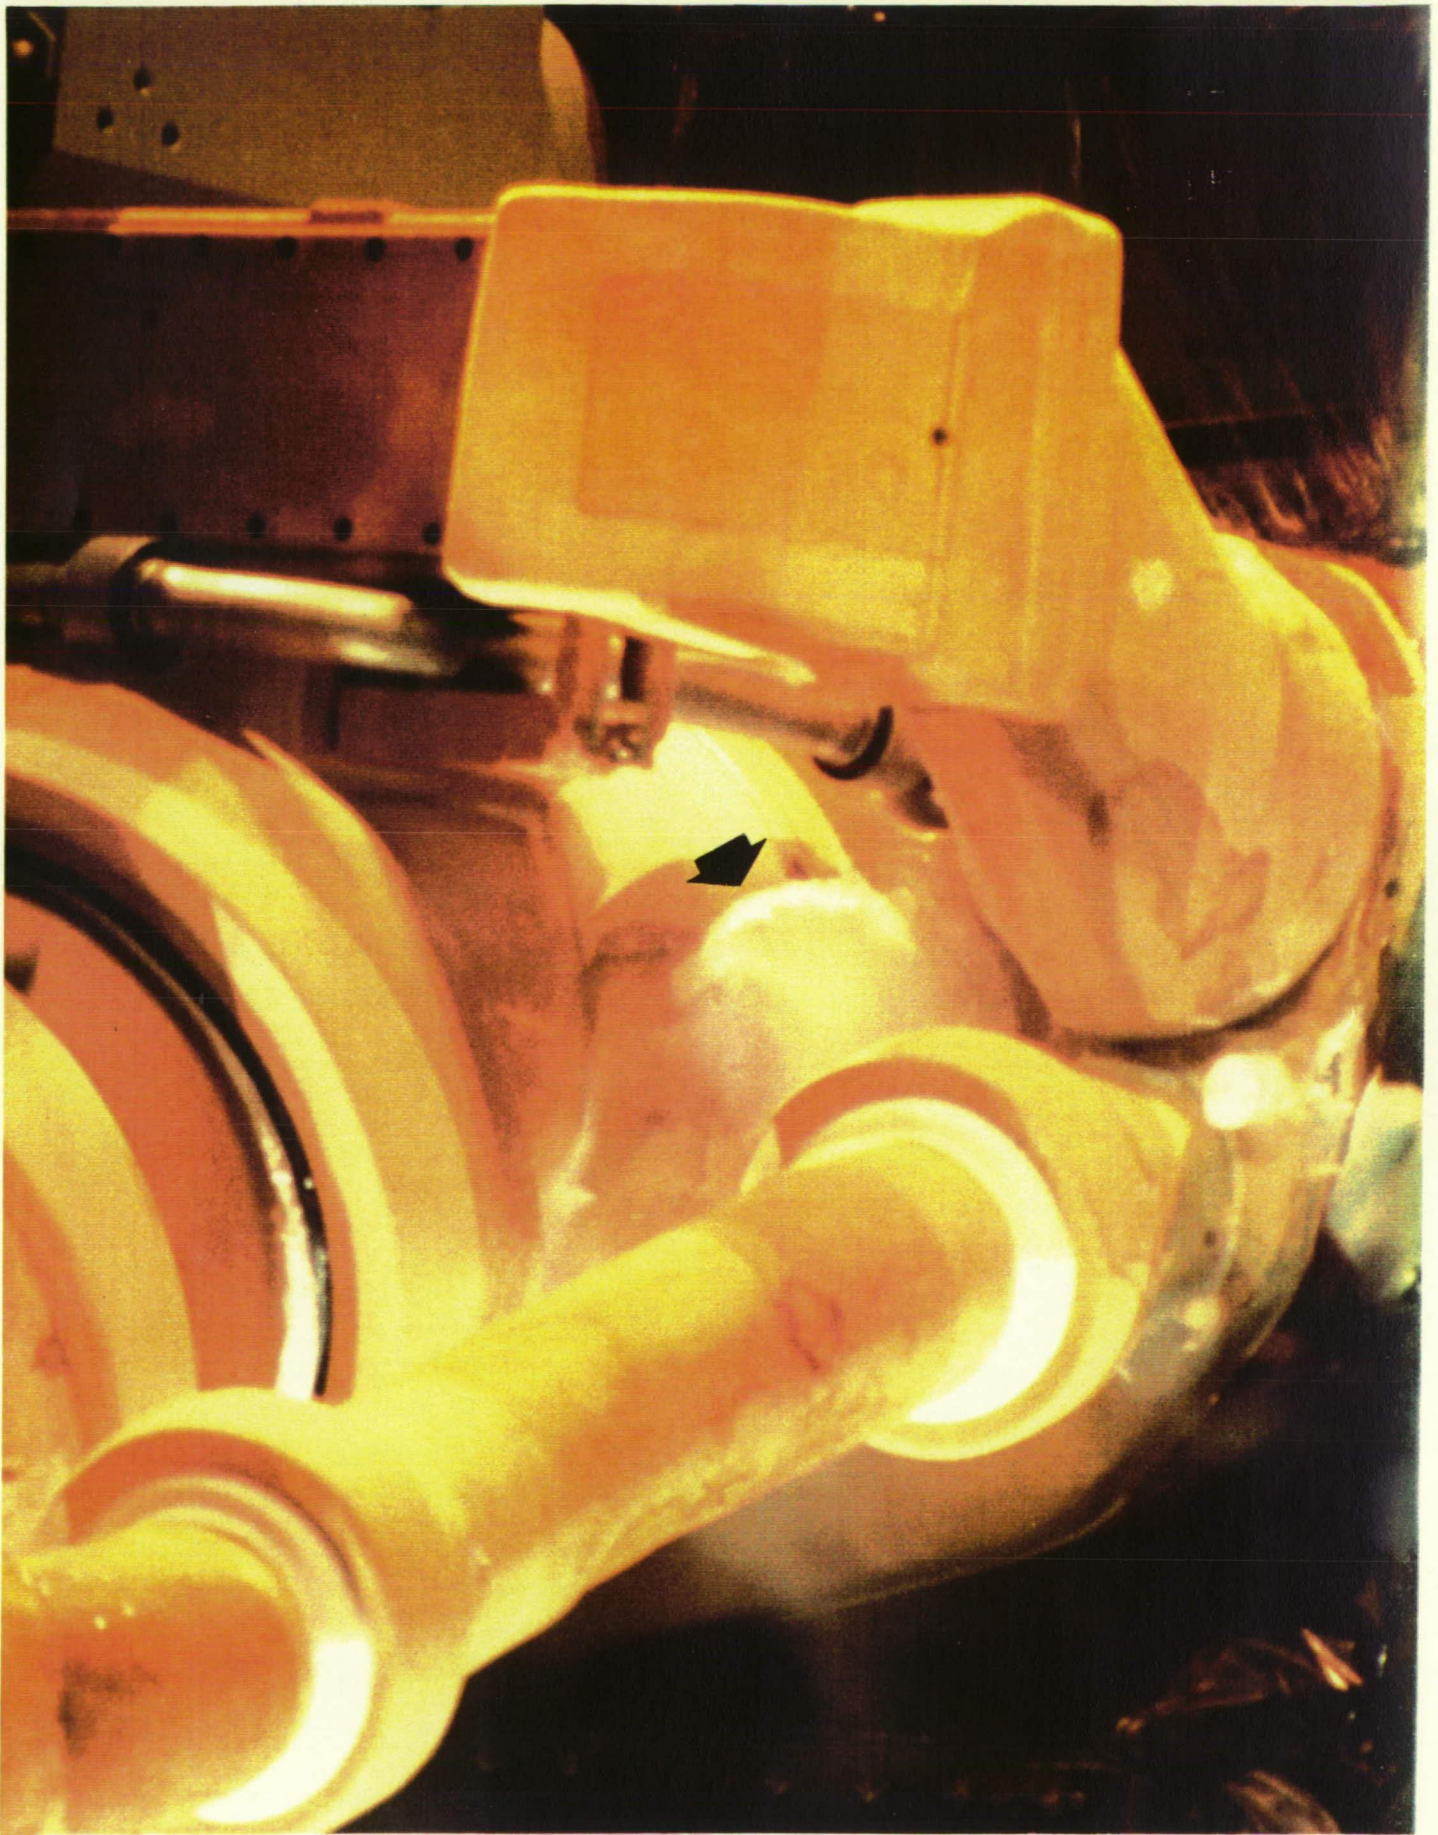
An LCC waiver was granted for the 10"x10"x1" ice/frost covering the flapper valve actuator port PDL plug closeout

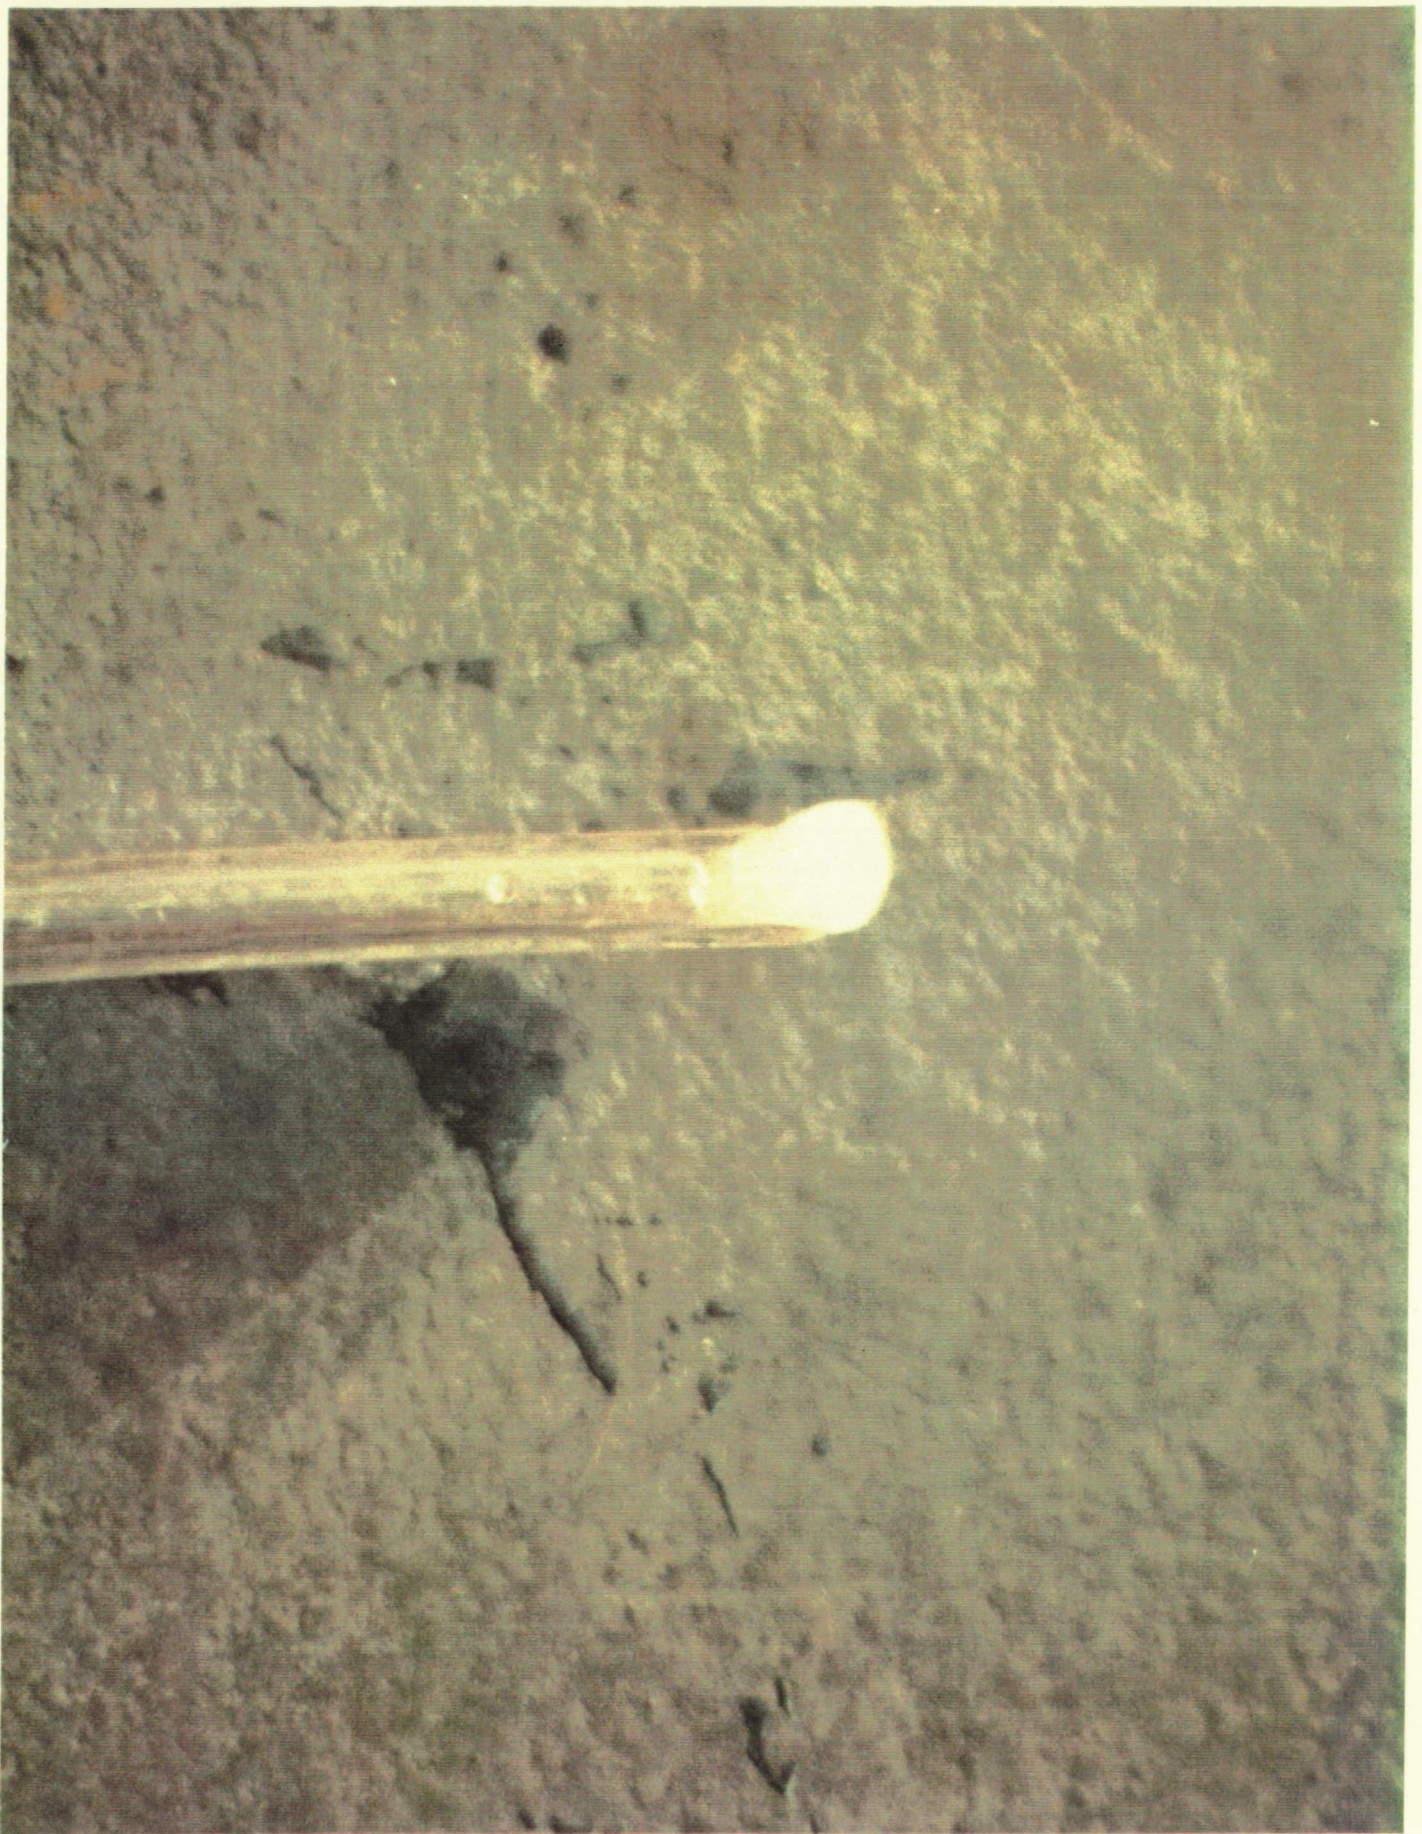
The ET/ORB hydrogen detection sensor tygon tubing was removed with no damage to the vehicle. However, the outboard tube had drooped close enough to the umbilical for ice to form around and in the end of the tube to a depth of 1-1/2 inches.

The hydrogen detection system tygon tubing drooped and became plugged when ice formed on top of the LH2 ET/ORB umbilical

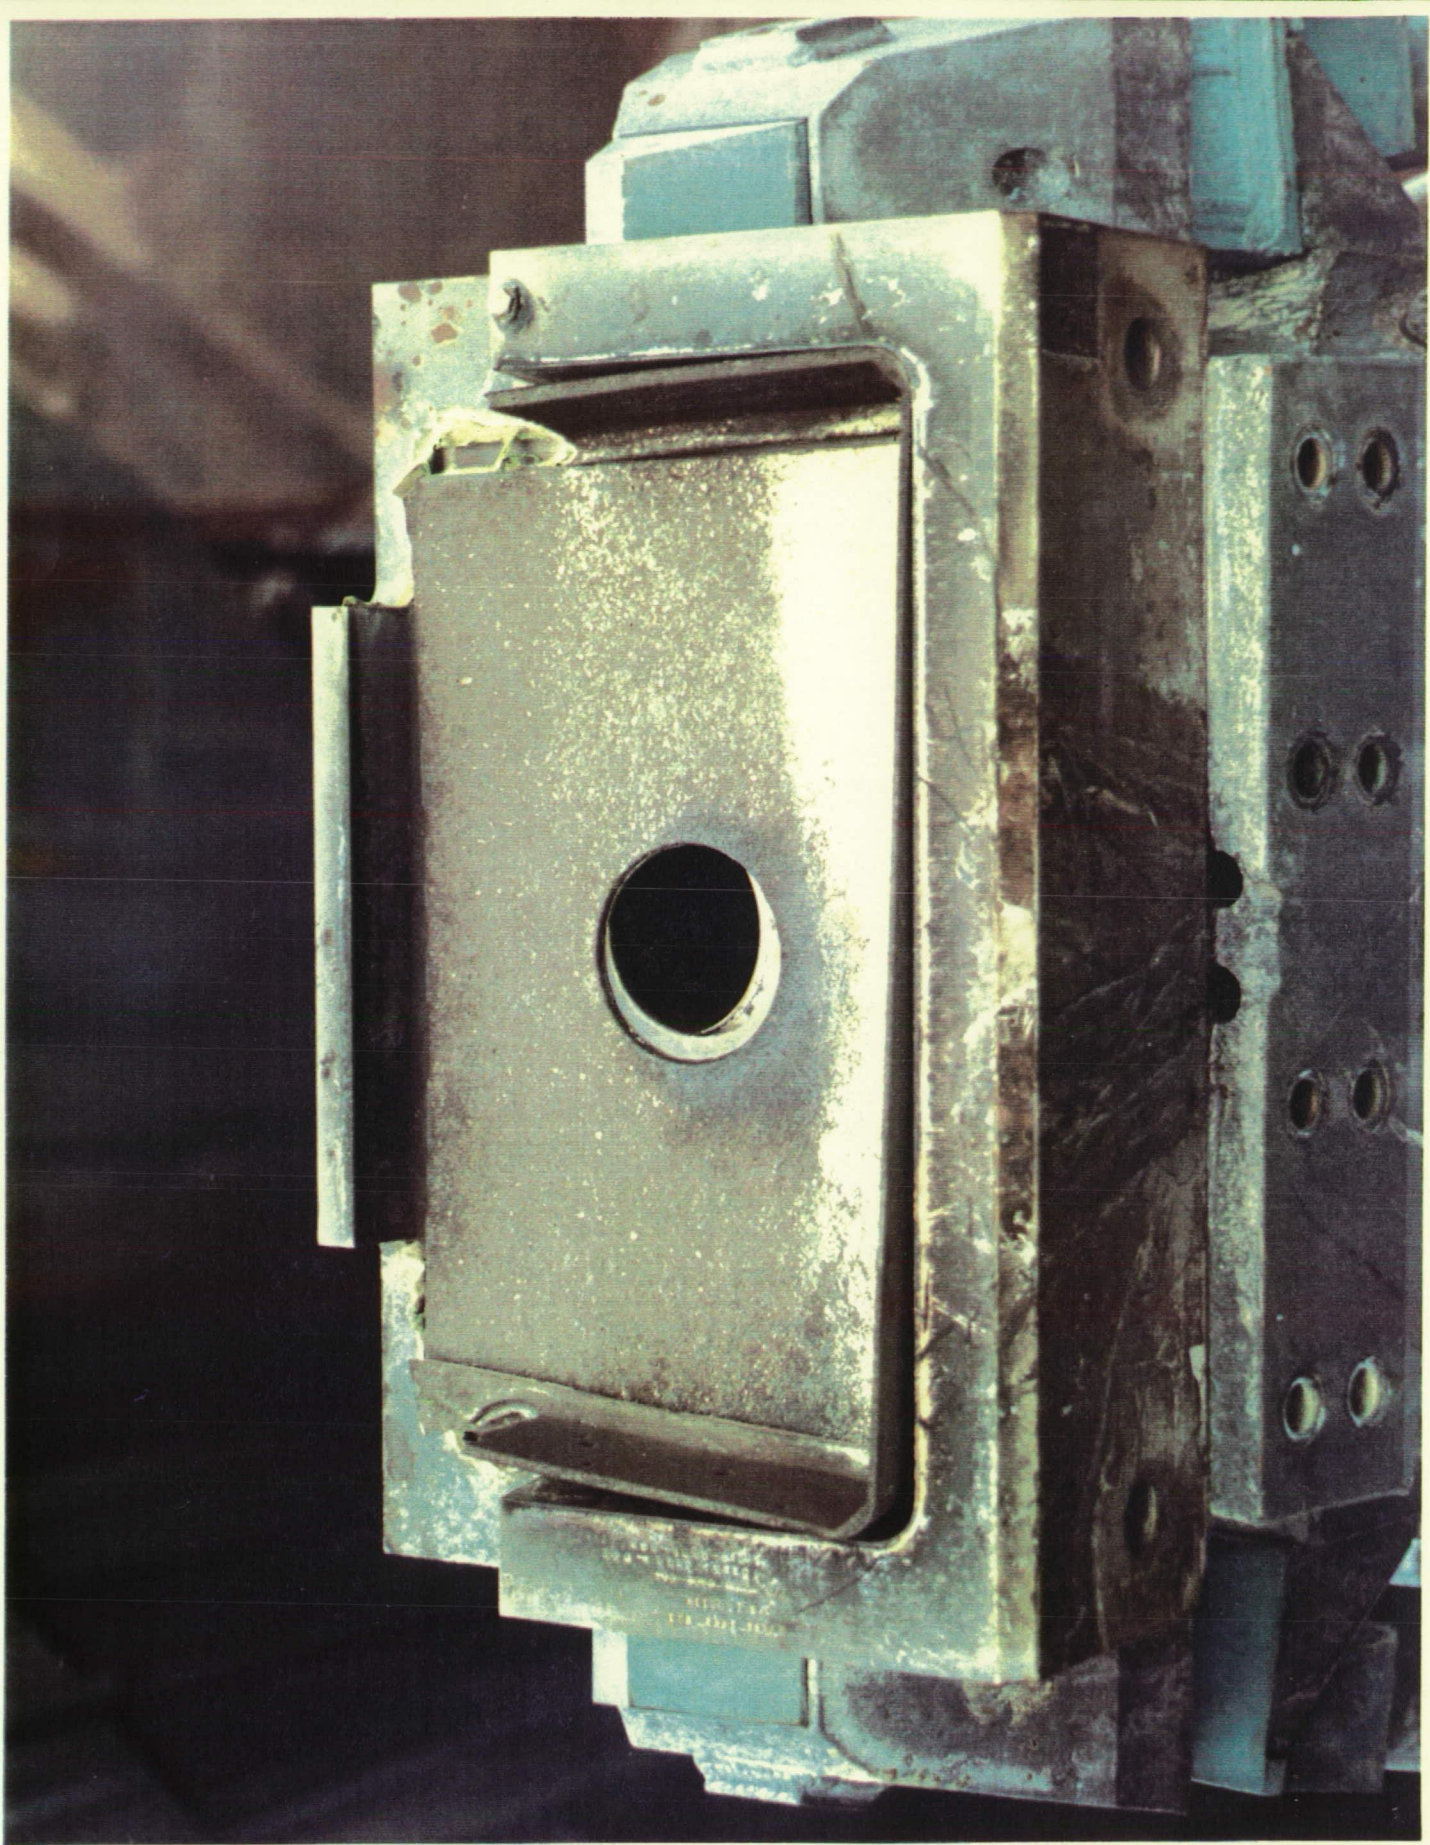
HDP #1 Epon shim material was 100 percent debonded

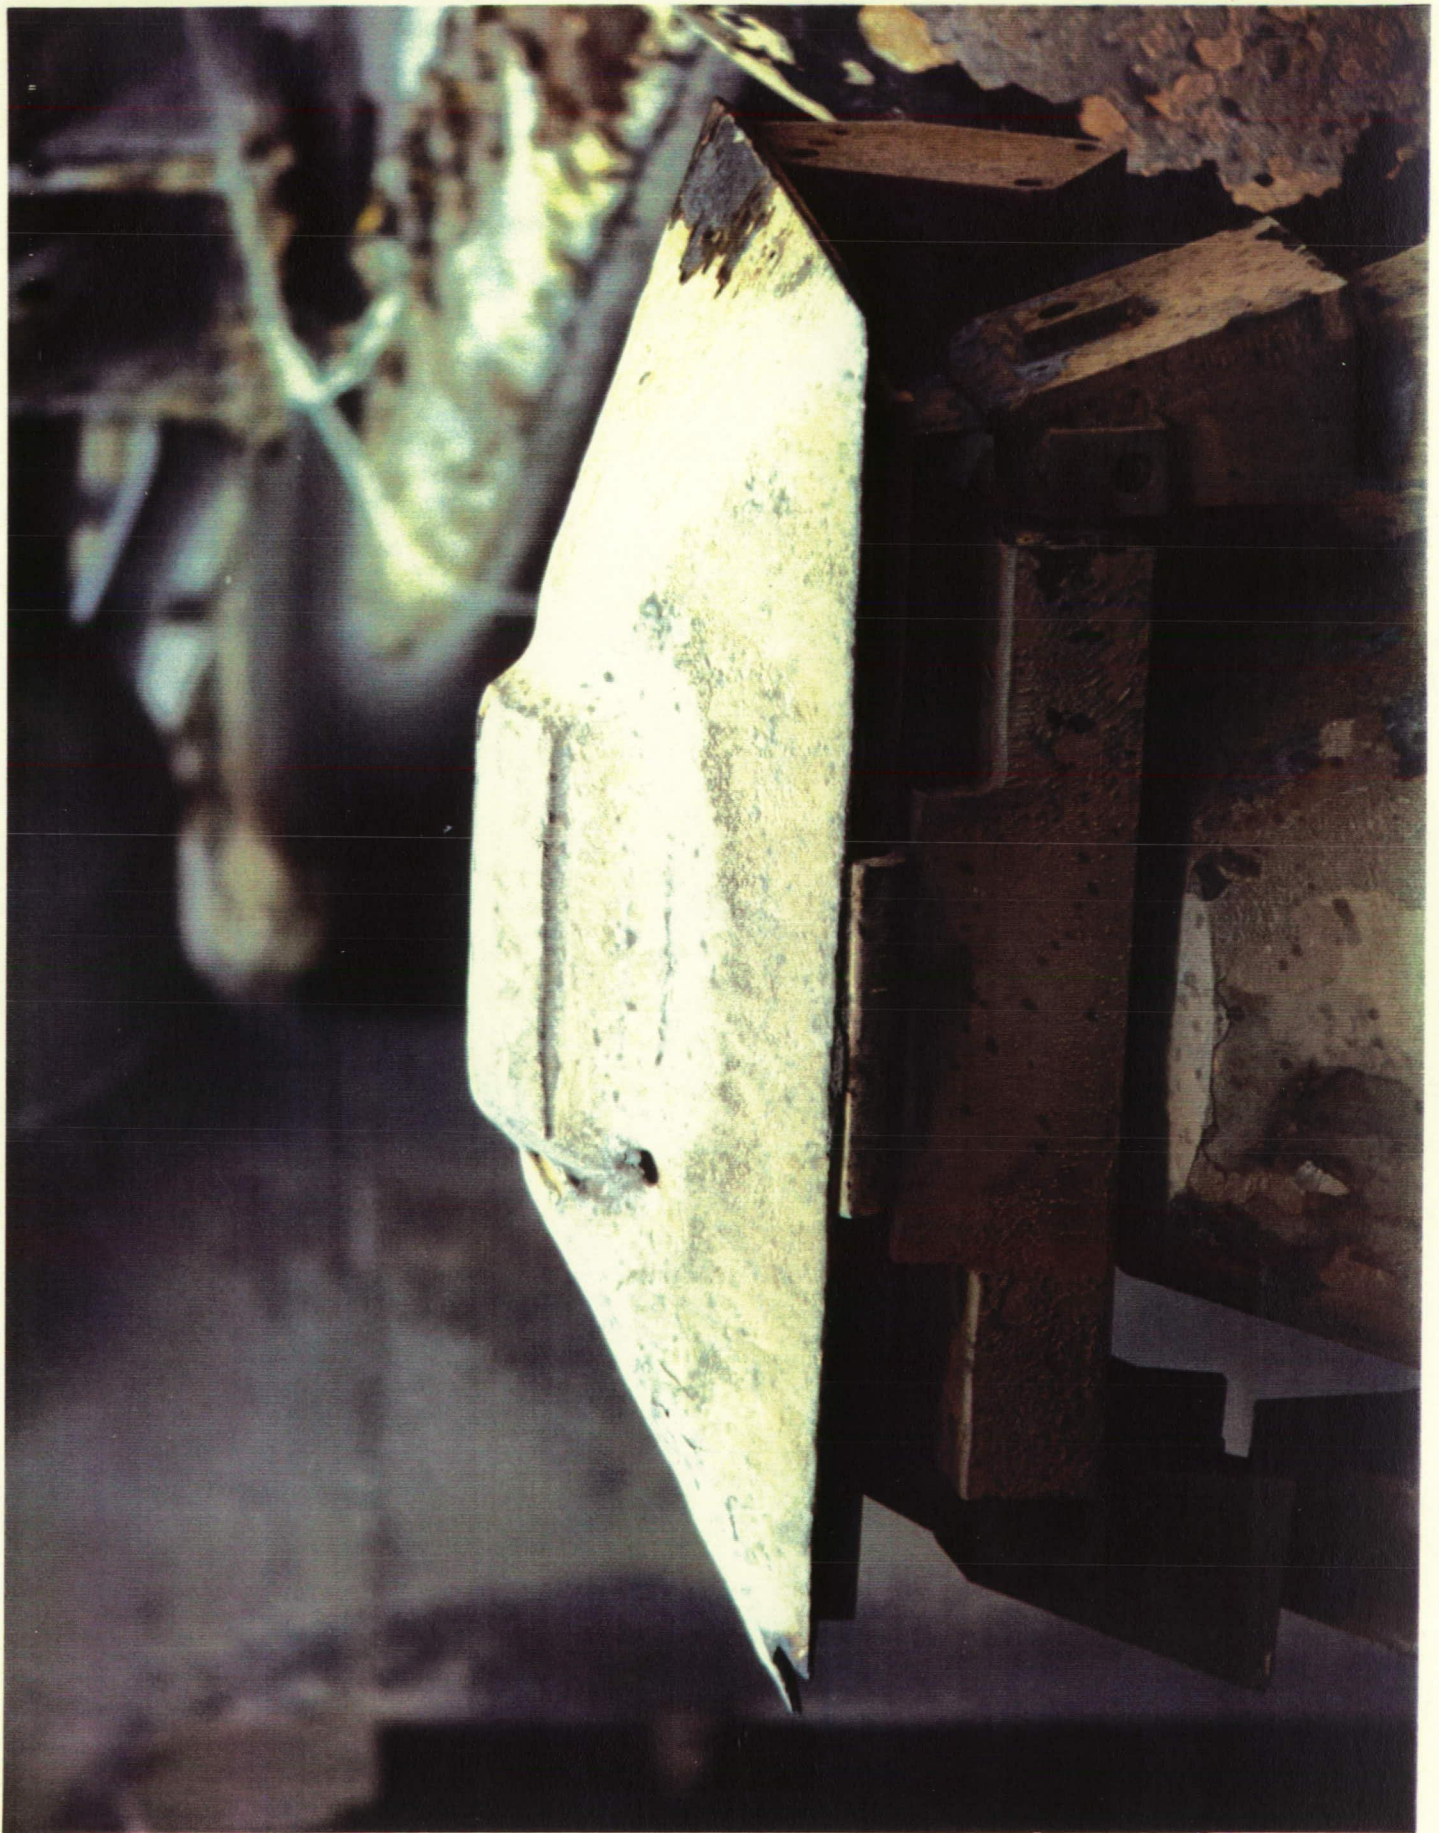
A post launch debris inspection of Pad 39B was performed after launch. No flight hardware or TPS material was found. The doghouse blast covers on holddown posts #4 and #8 exhibited minor erosion. Otherwise, launch damage to the holddown posts was minimal. No signs indicative of stud hang-up were visible. No fragments from HDP debris containers were found. The facility GH2 vent line had latched properly and had no loose cables. Overall, the facility sustained minimal damage.

The SRB plume caused erosion (center and corner) and a 1.5 inch crack in the HDP #4 doghouse blast cover

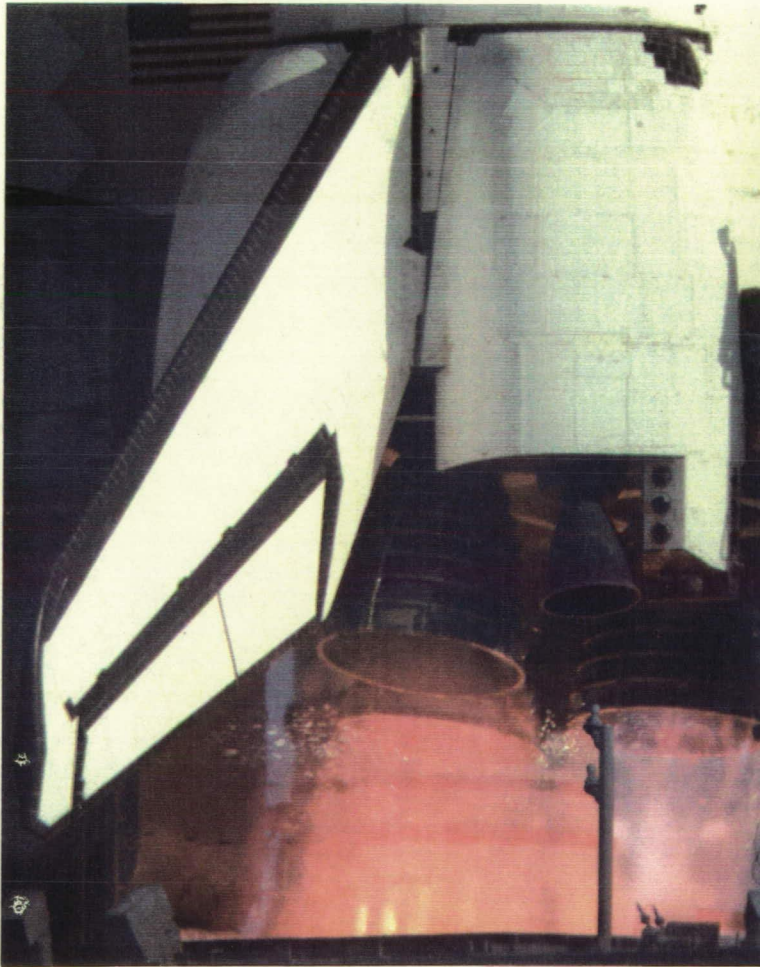
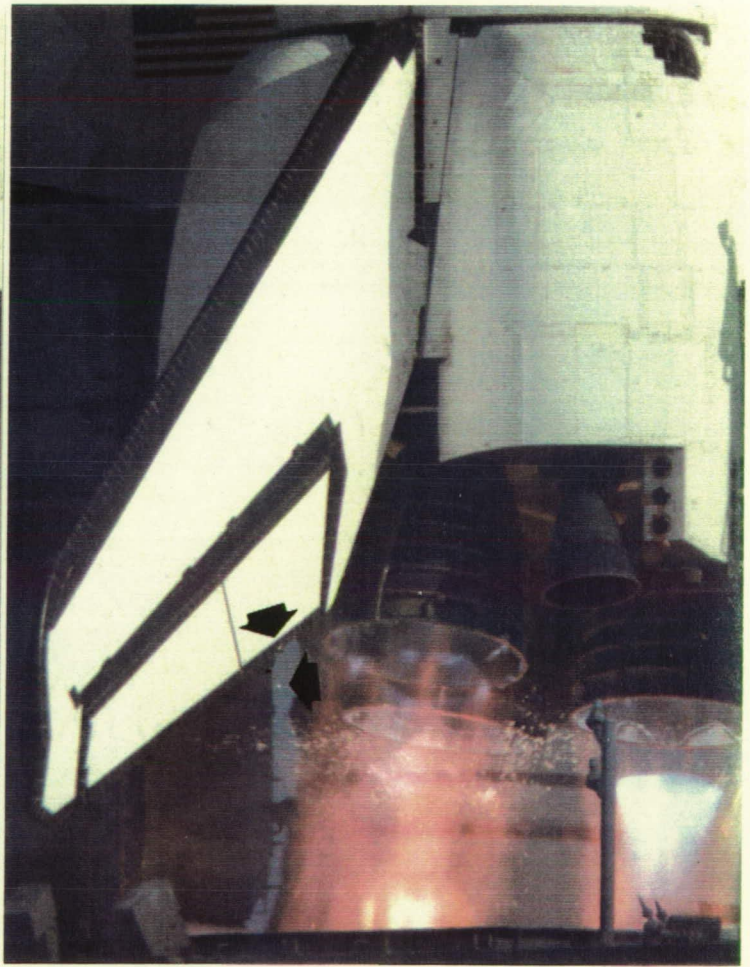
Before/after view of rudder speed brake as SSME ignition  
acoustics/vibration cause a 2-1/2" chip in a tile (E-76)

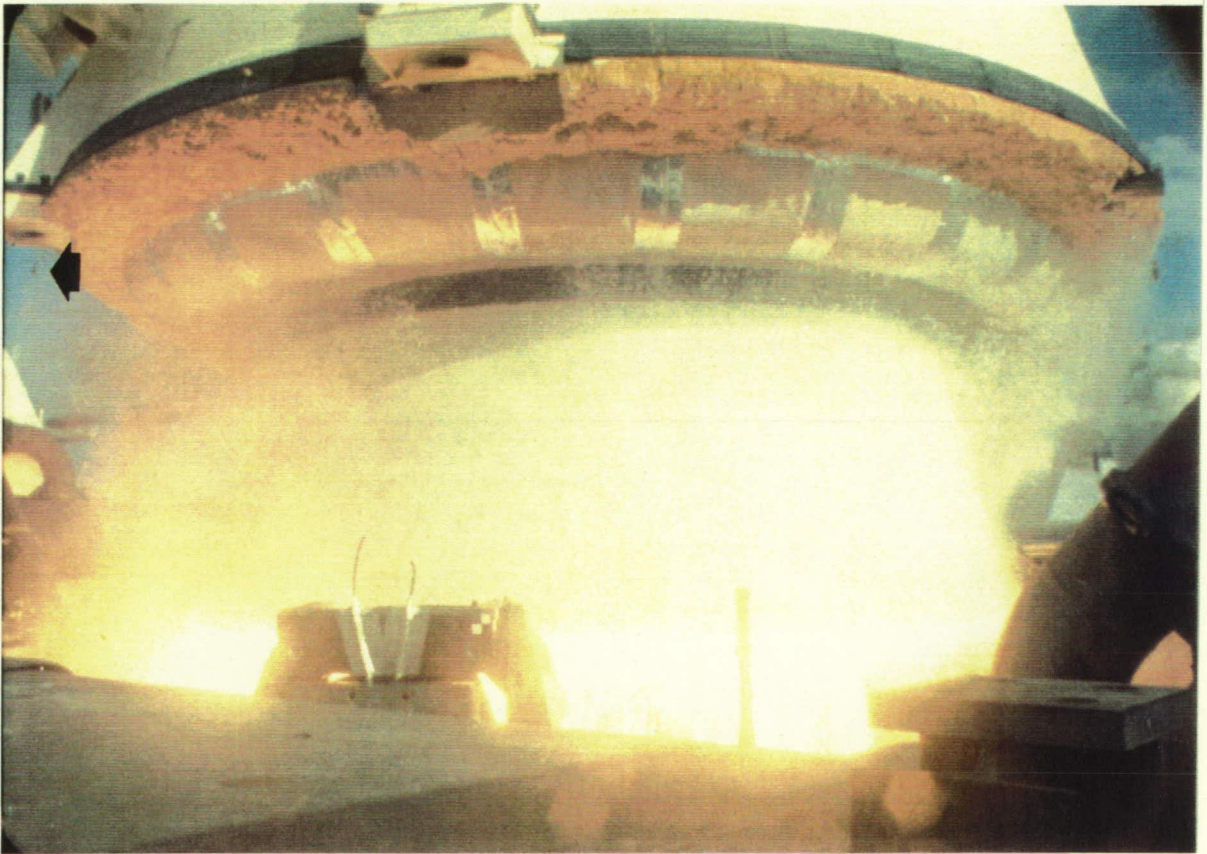
An ordnance debris fragment falls from the RH SRB HDP #1  
stud hole shortly after liftoff (E-8)

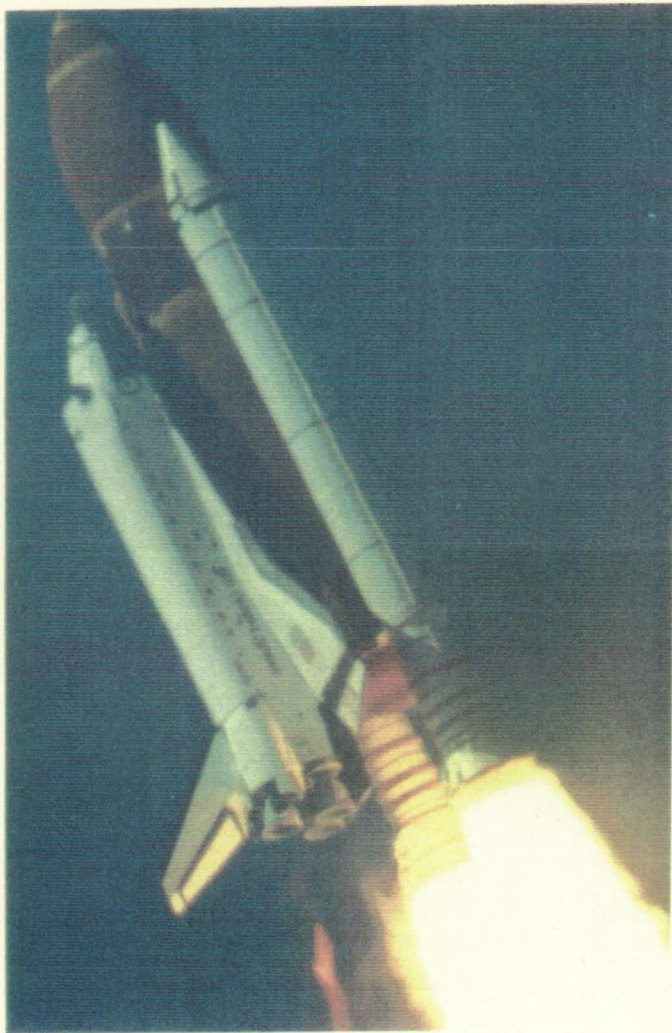
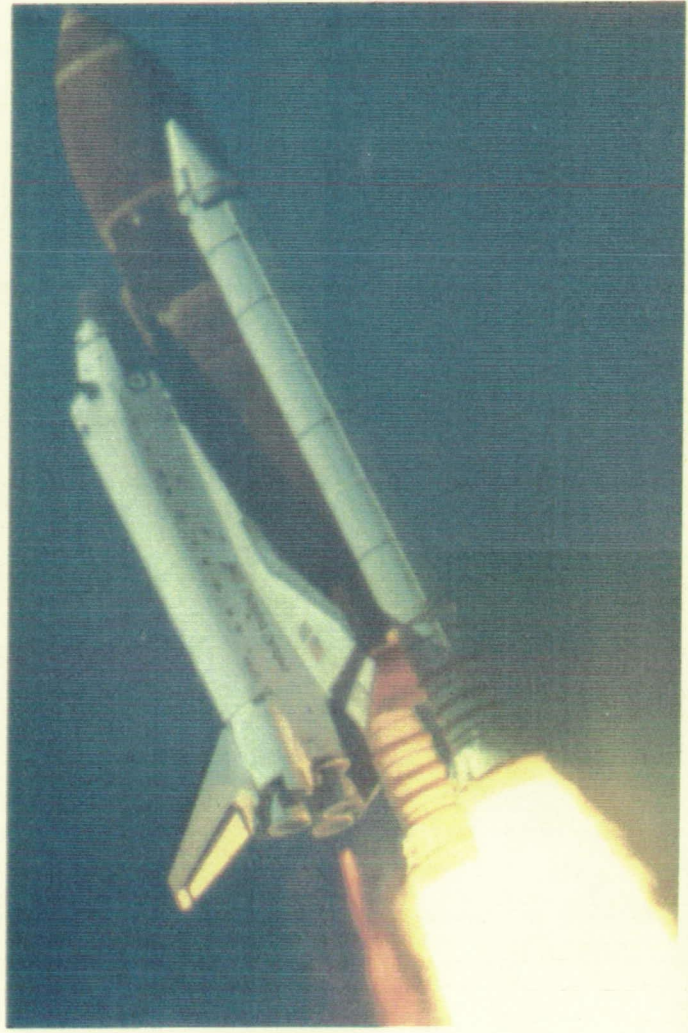
Orange flashes continue to occur in the SSME plumes during ascent (E-212) and may be caused by debris
