NASA Technical Memorandum TM 102790

# Debris/Ice/TPS Assessment And Photographic Analysis For Shuttle Mission STS-31R

Charles G. Stevenson  
NASA/Kennedy Space Center

April 24, 1990

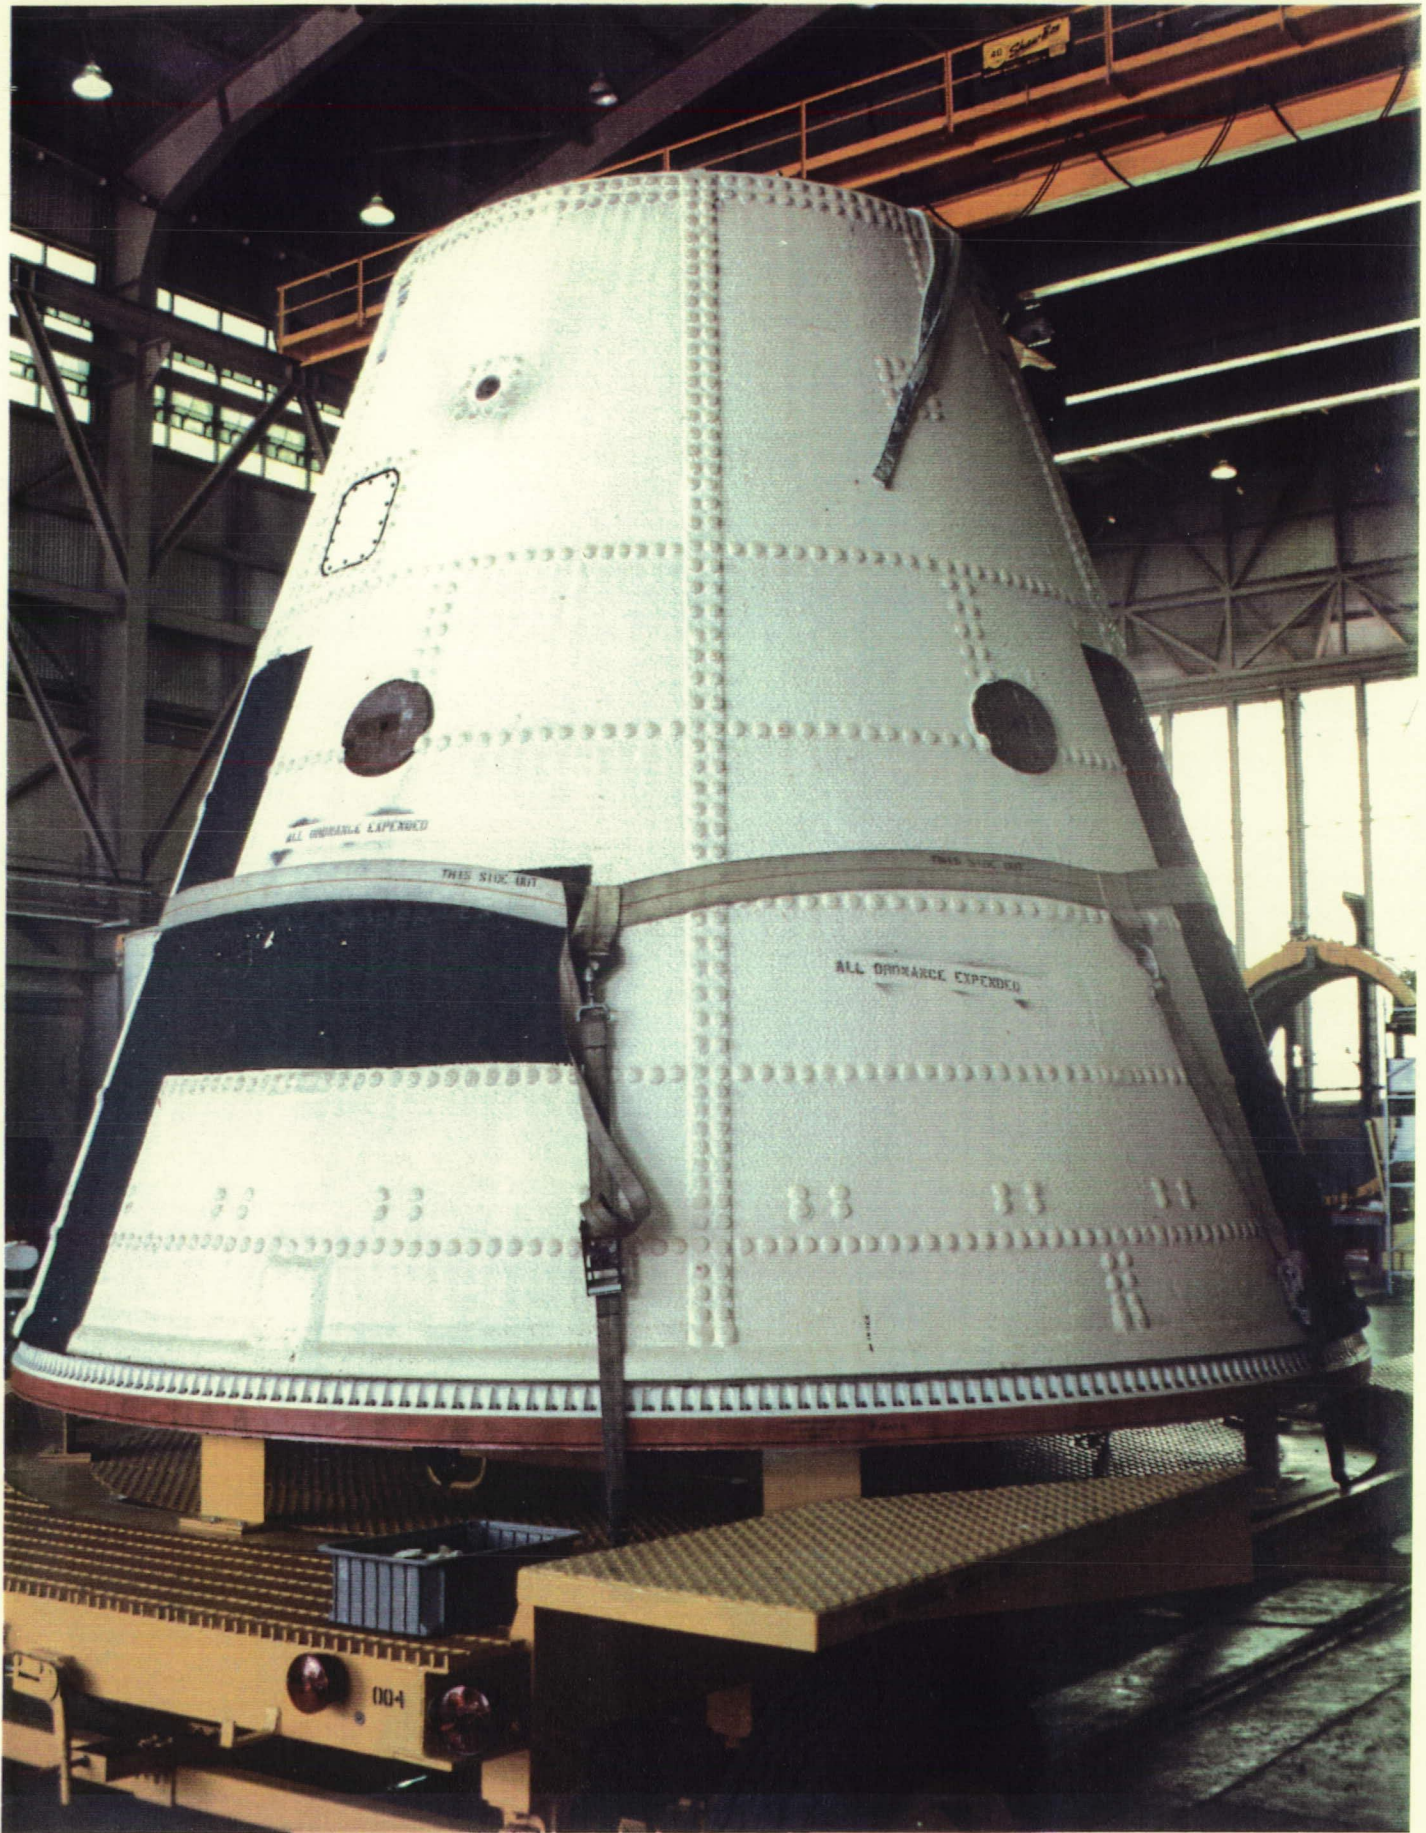
Post flight condition of RH frustum. There were 5 debonds over fasteners, but no areas of missing TPS.

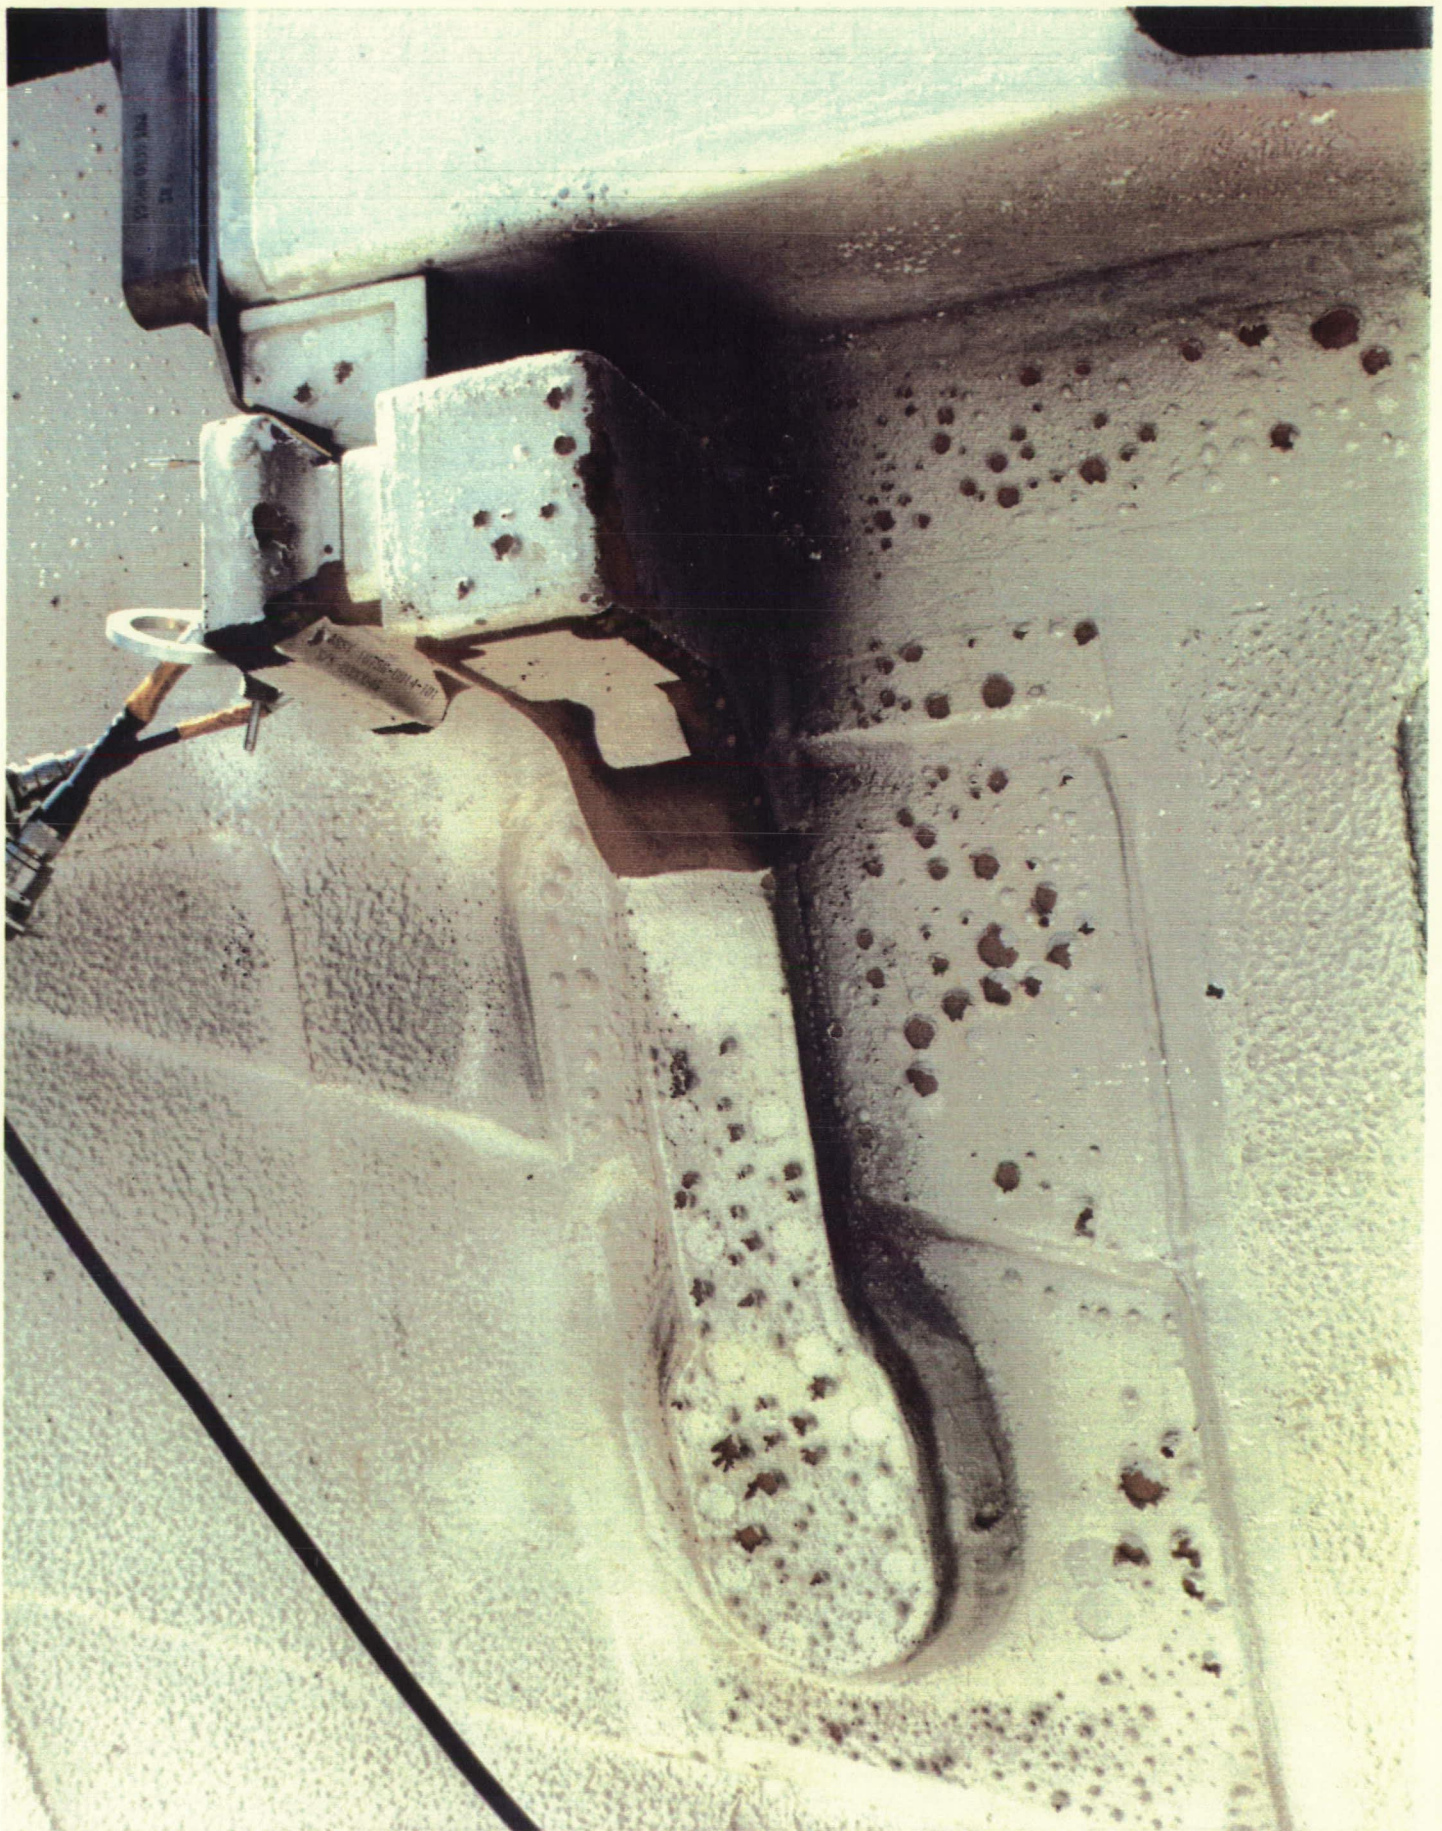
Localized areas of Hypalon paint blistered with some layers of  
MSA-2 adhering to the paint

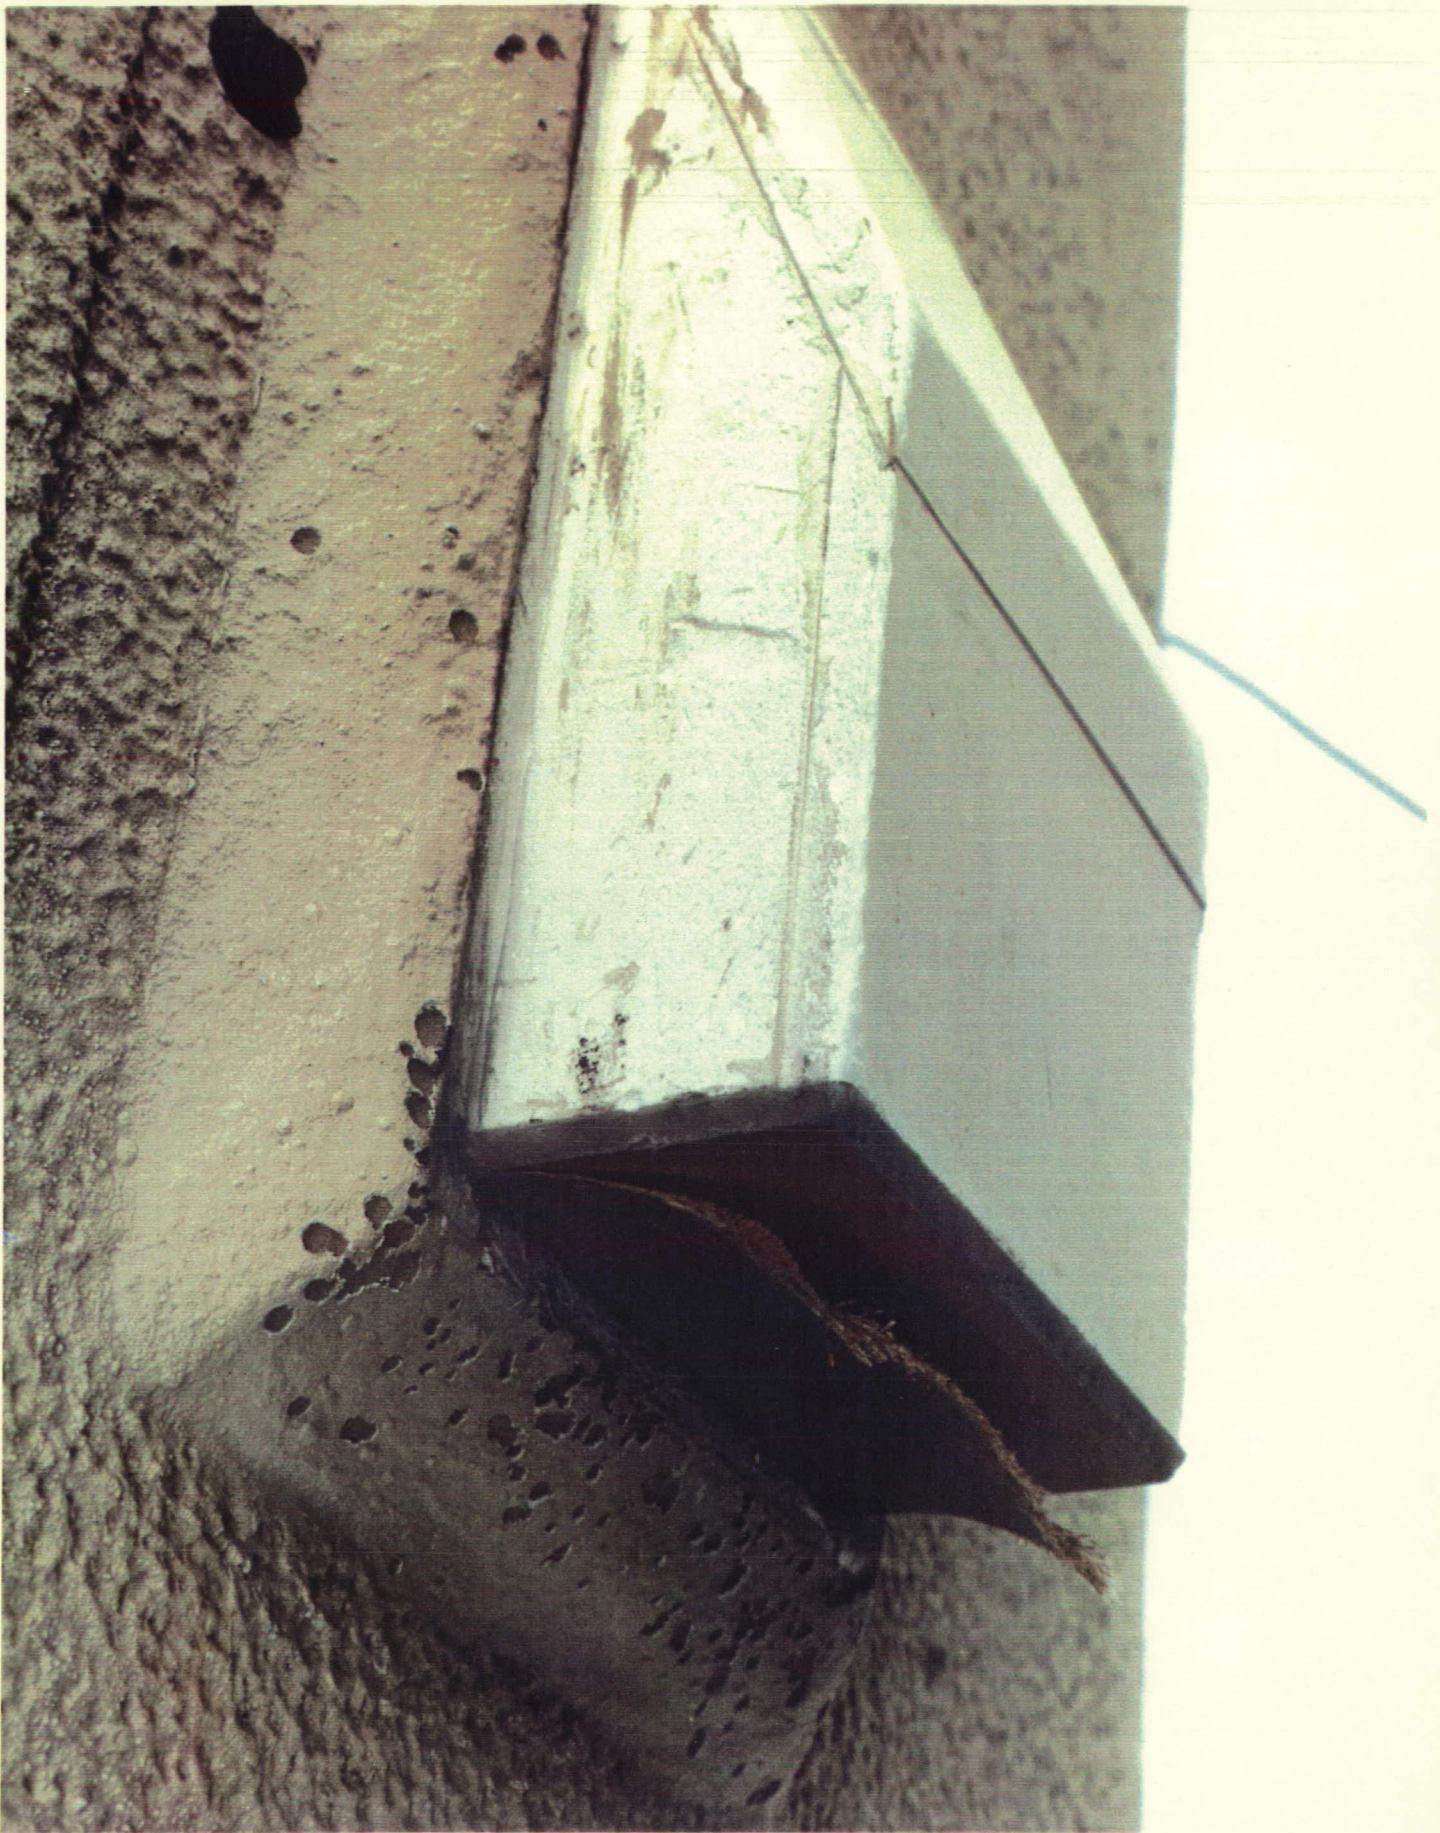
The phenolic plate on the -Z RSS antenna had some delaminated layers

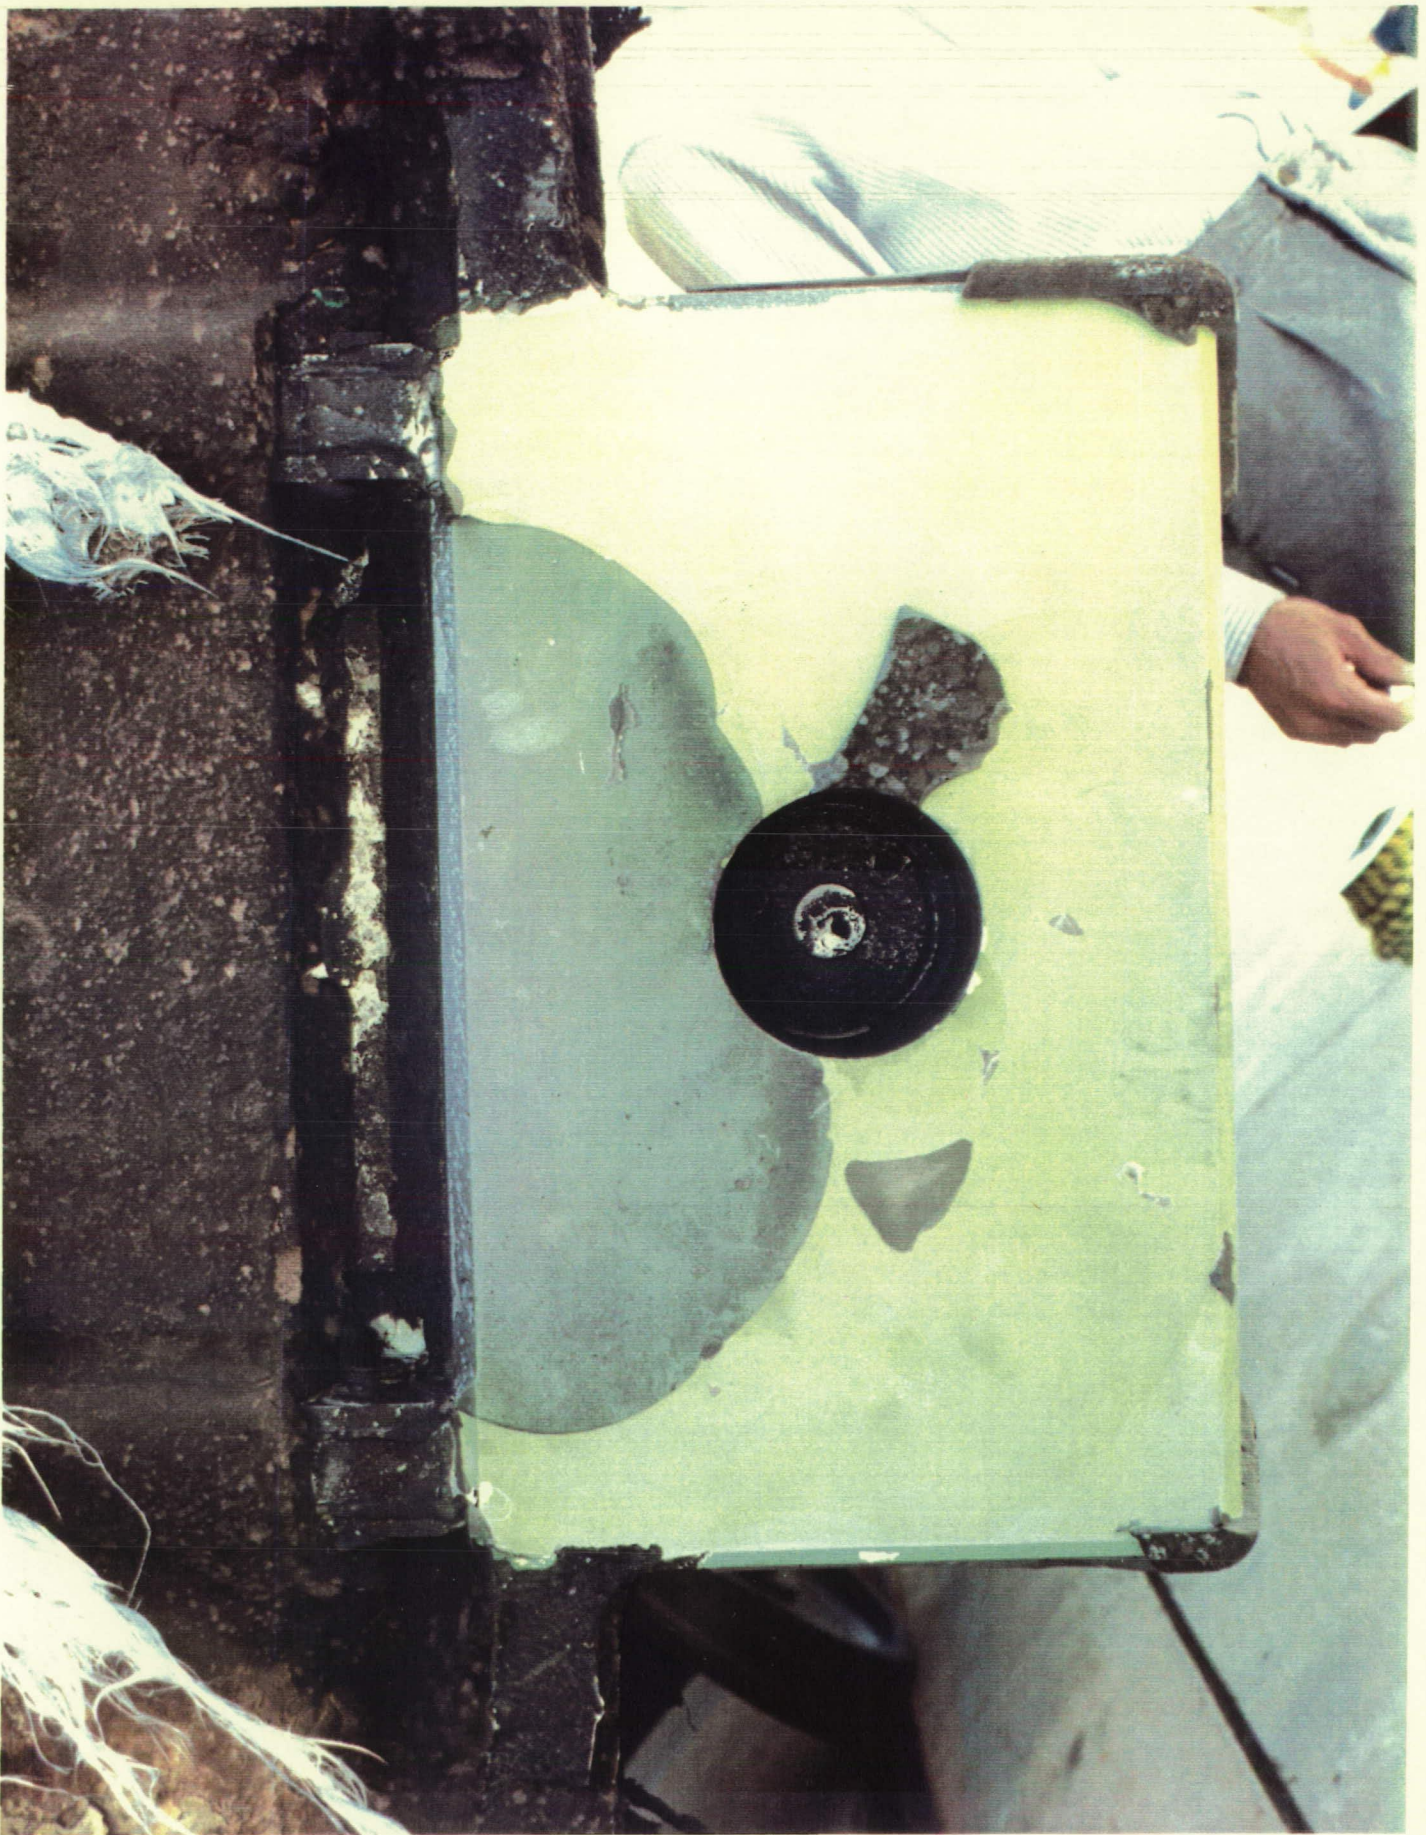
Some of the Epon shim material on HDP #4 was missing prior  
to water impact

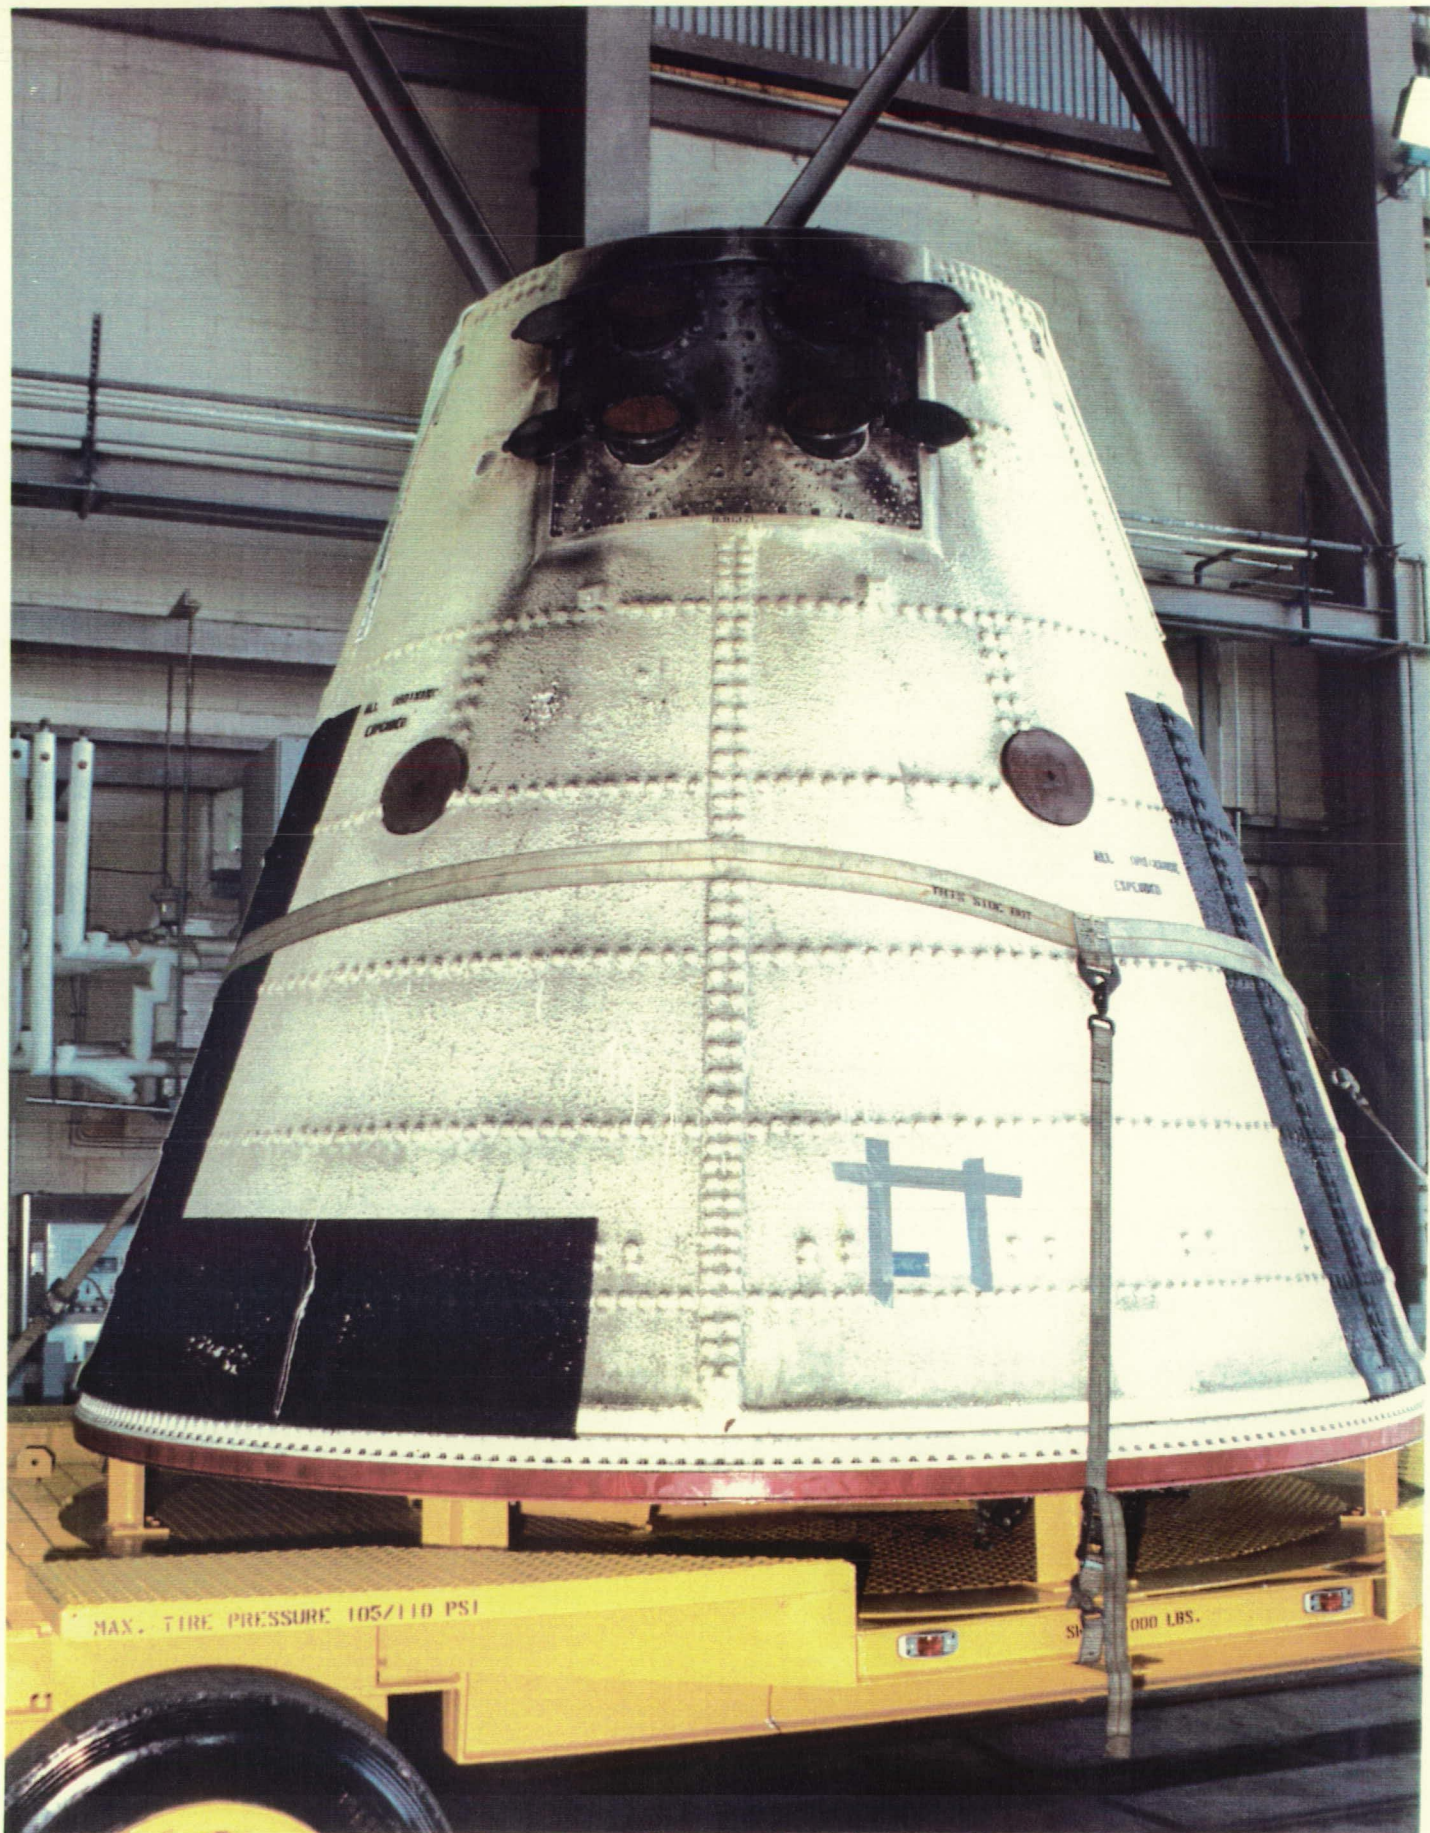
Post flight condition of the LH frustum. There were 7 debonds over fasteners, but no areas of missing TPS.

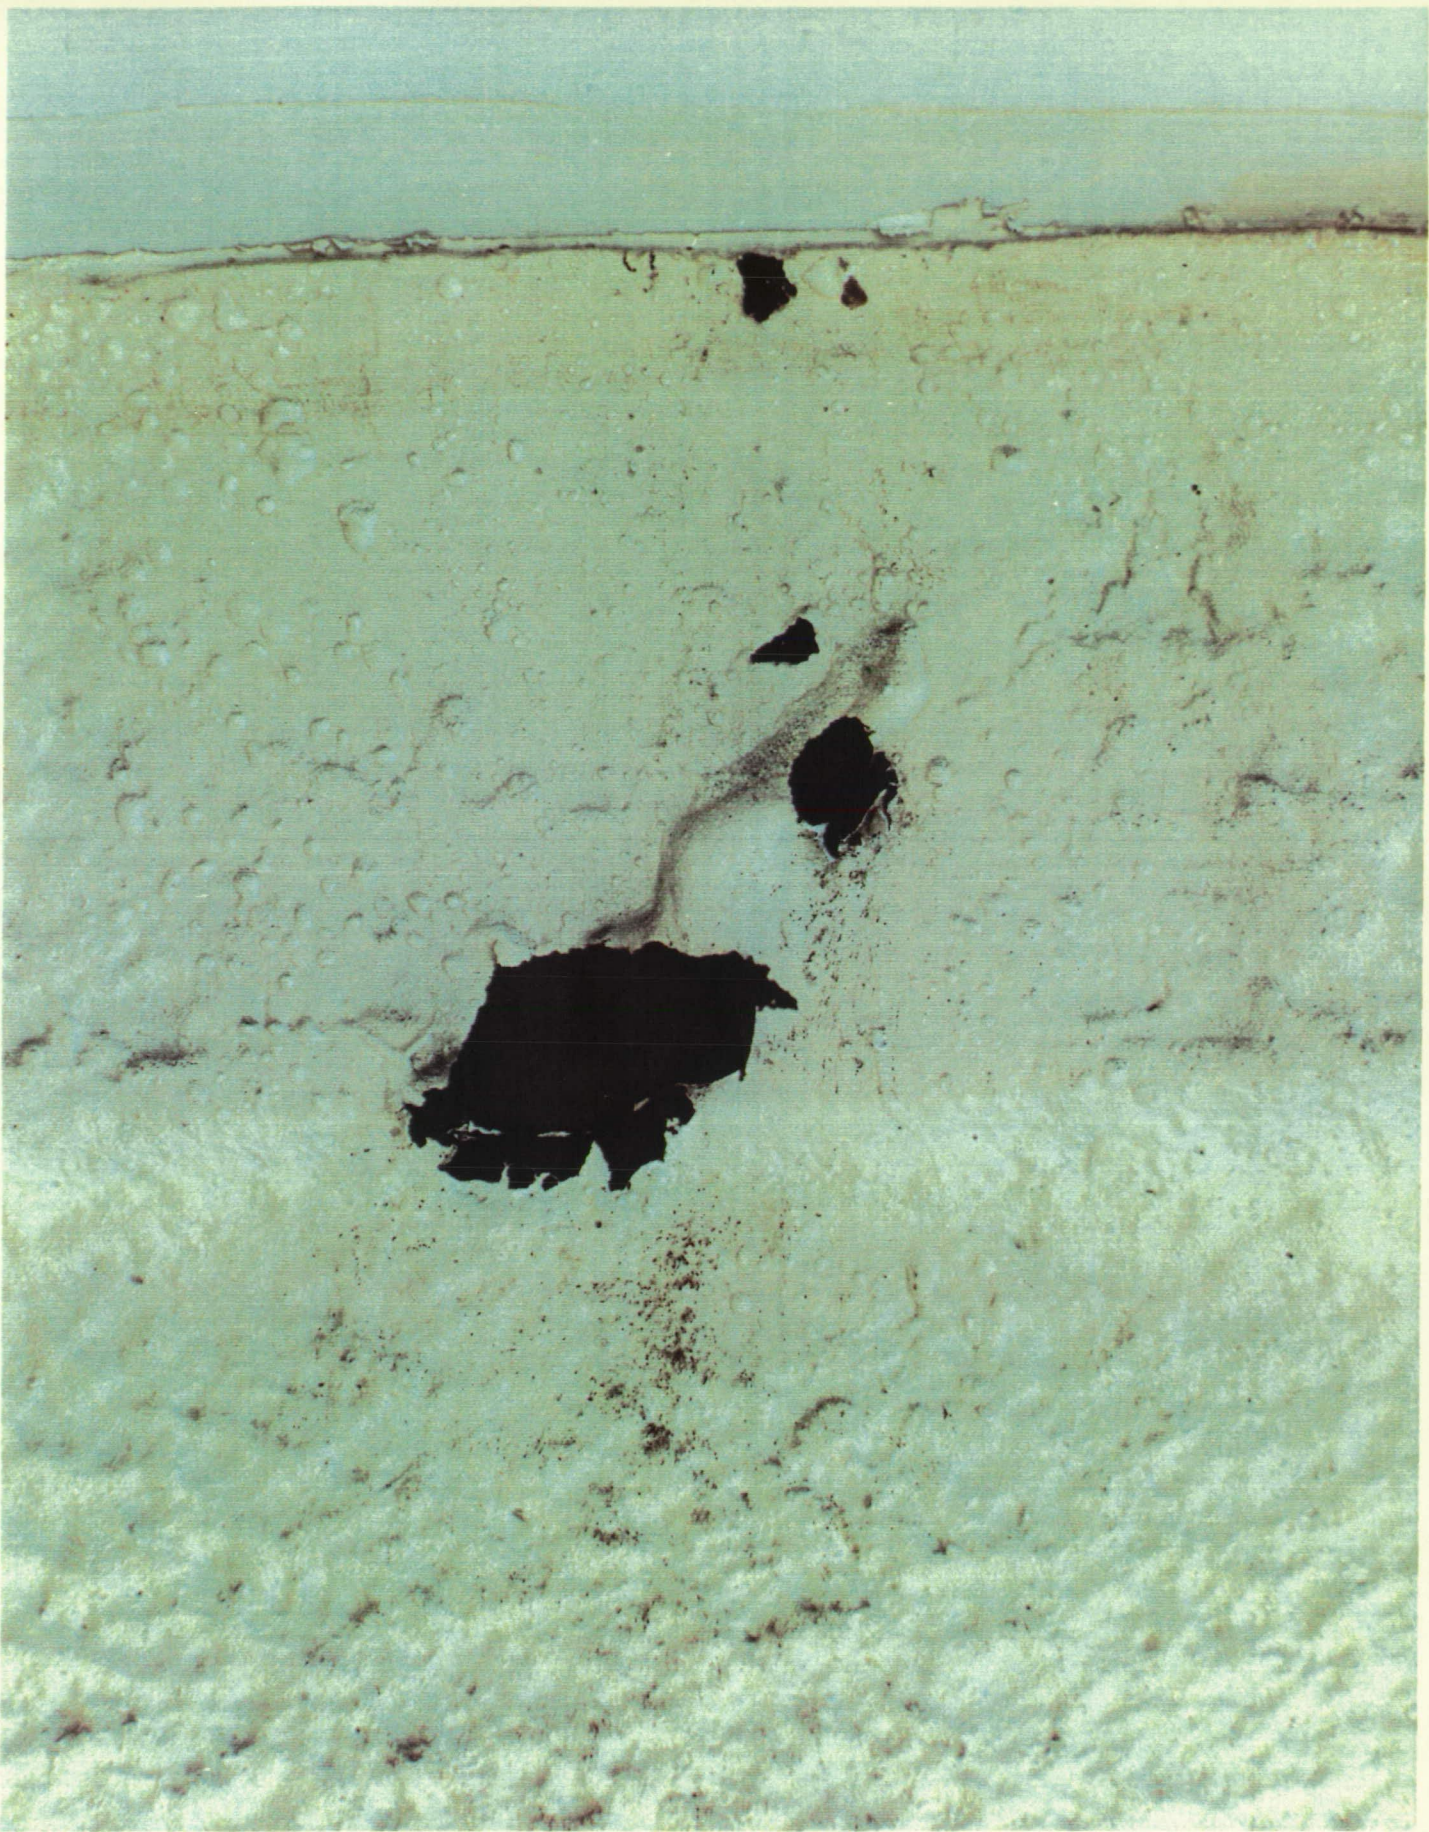
Layers of MSA-2 adhering to Hypalon paint blisters increases the mass of the paint chips and causes tile damage

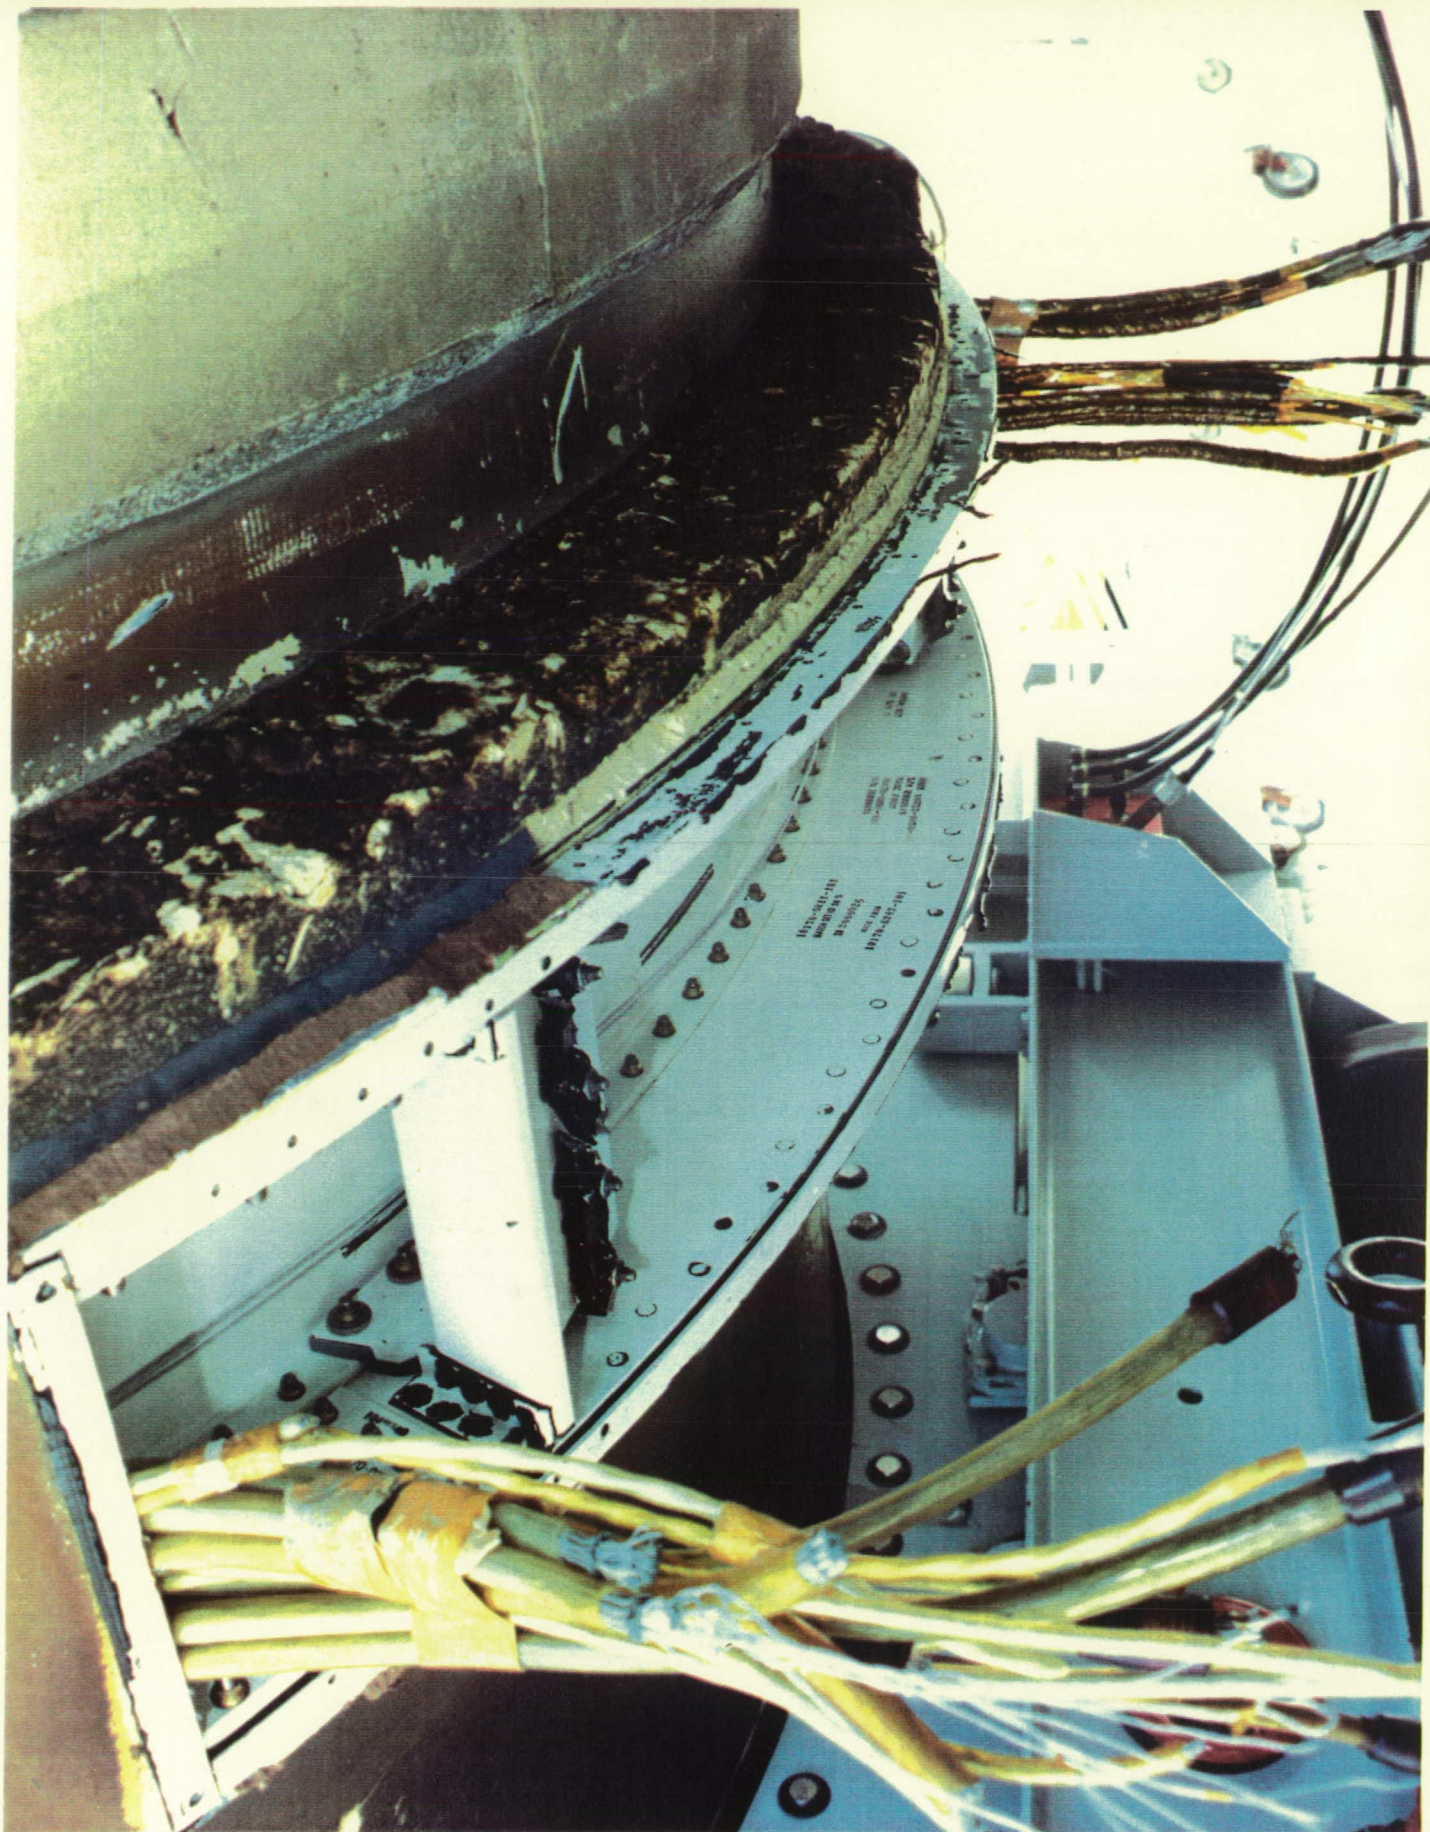
Loss of the LH IEA from the ETA ring at water impact was not attributed to any debris issues

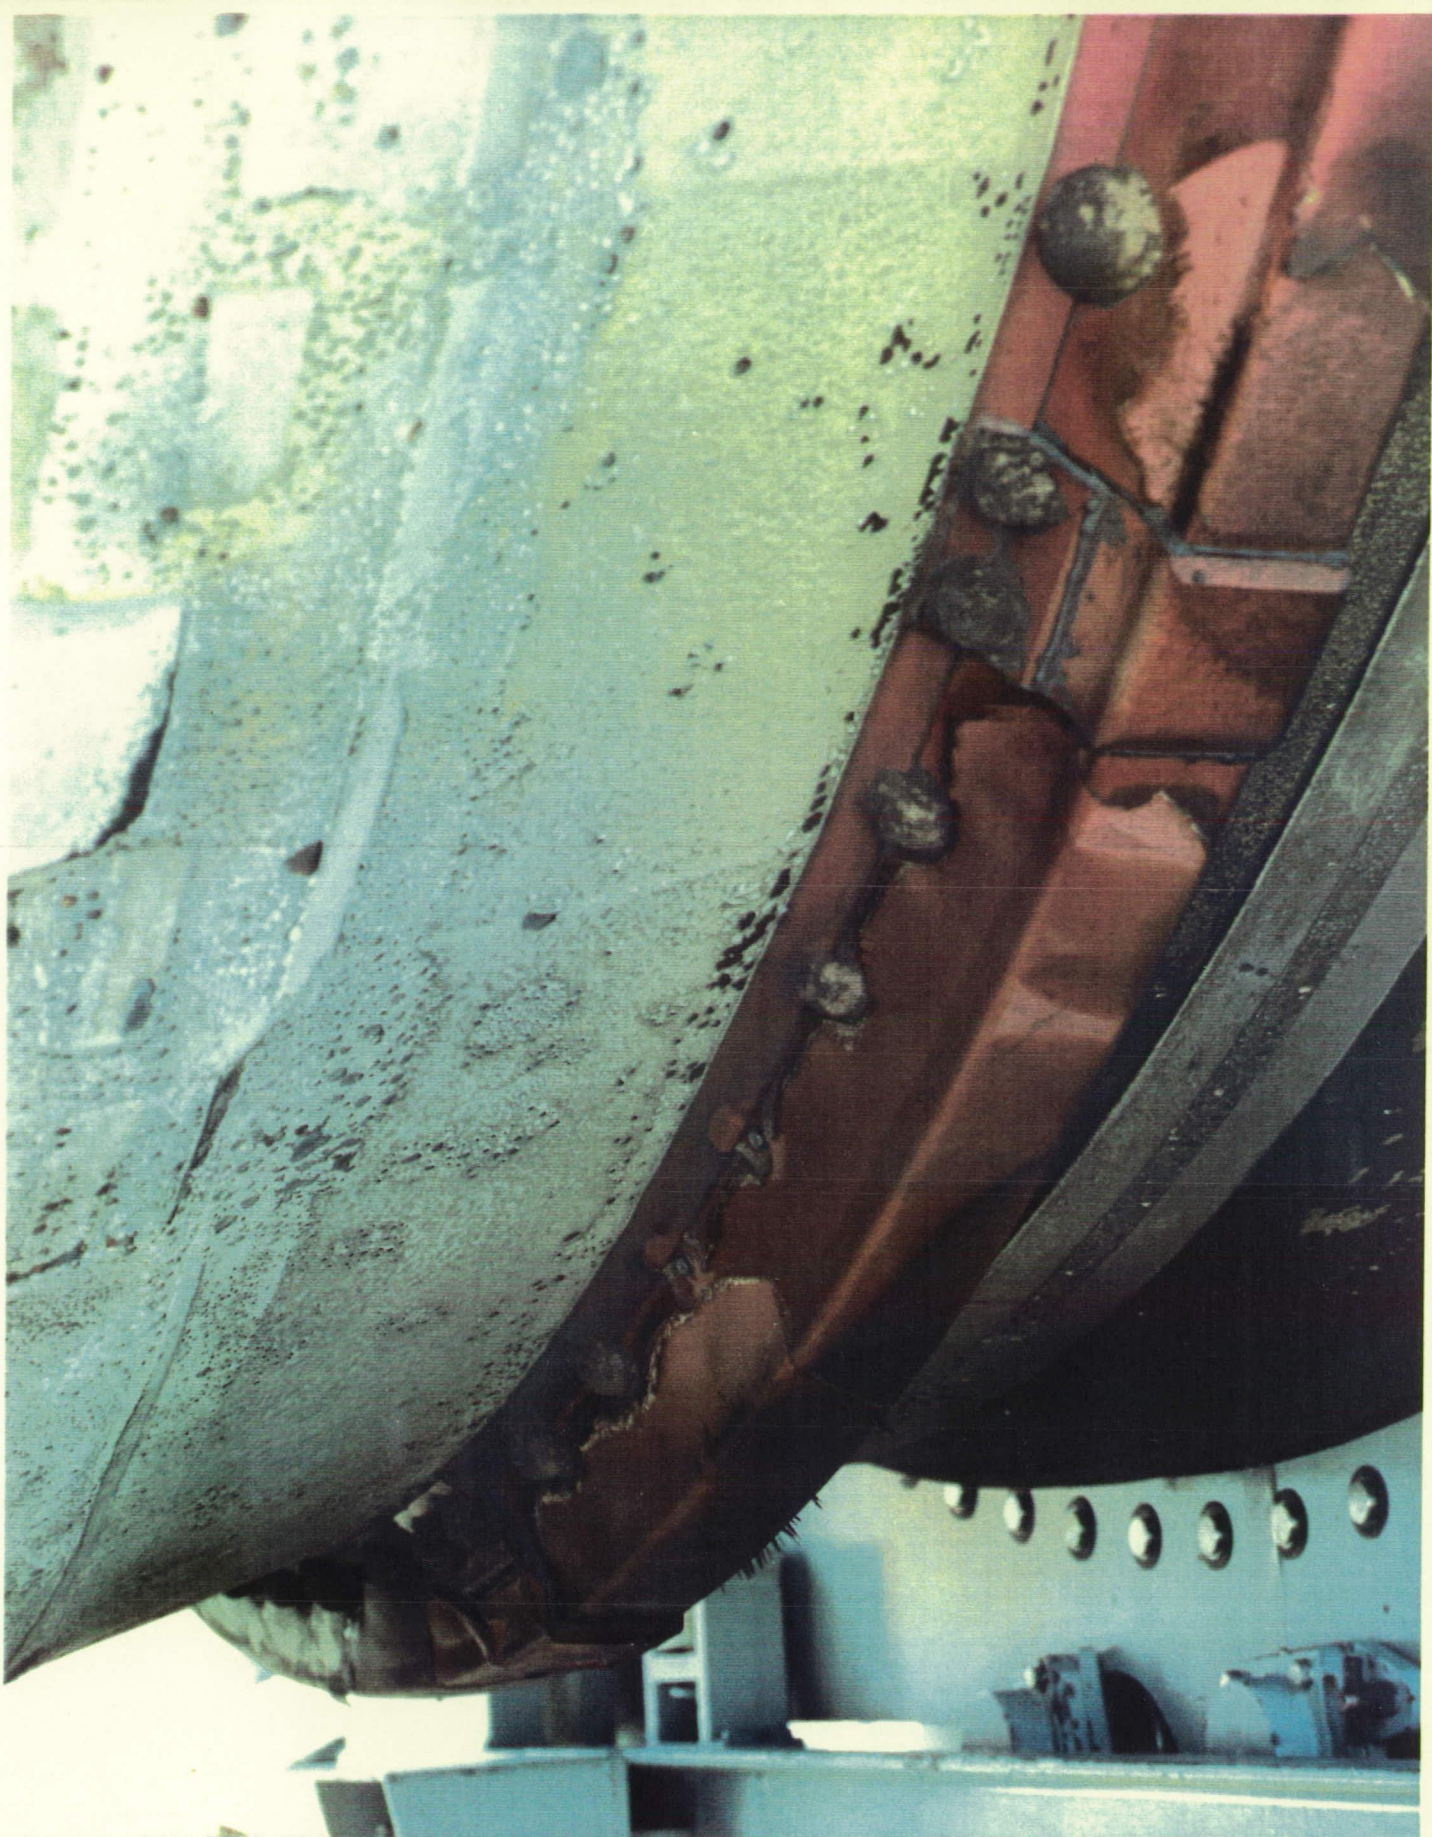
Phenolic material on the kick ring delaminated at several locations. K5NA protective domes were missing from boltheads.
