NASA Technical Memorandum TM 102790

# Debris/Ice/TPS Assessment And Photographic Analysis For Shuttle Mission STS-31R

Charles G. Stevenson  
NASA/Kennedy Space Center

April 24, 1990

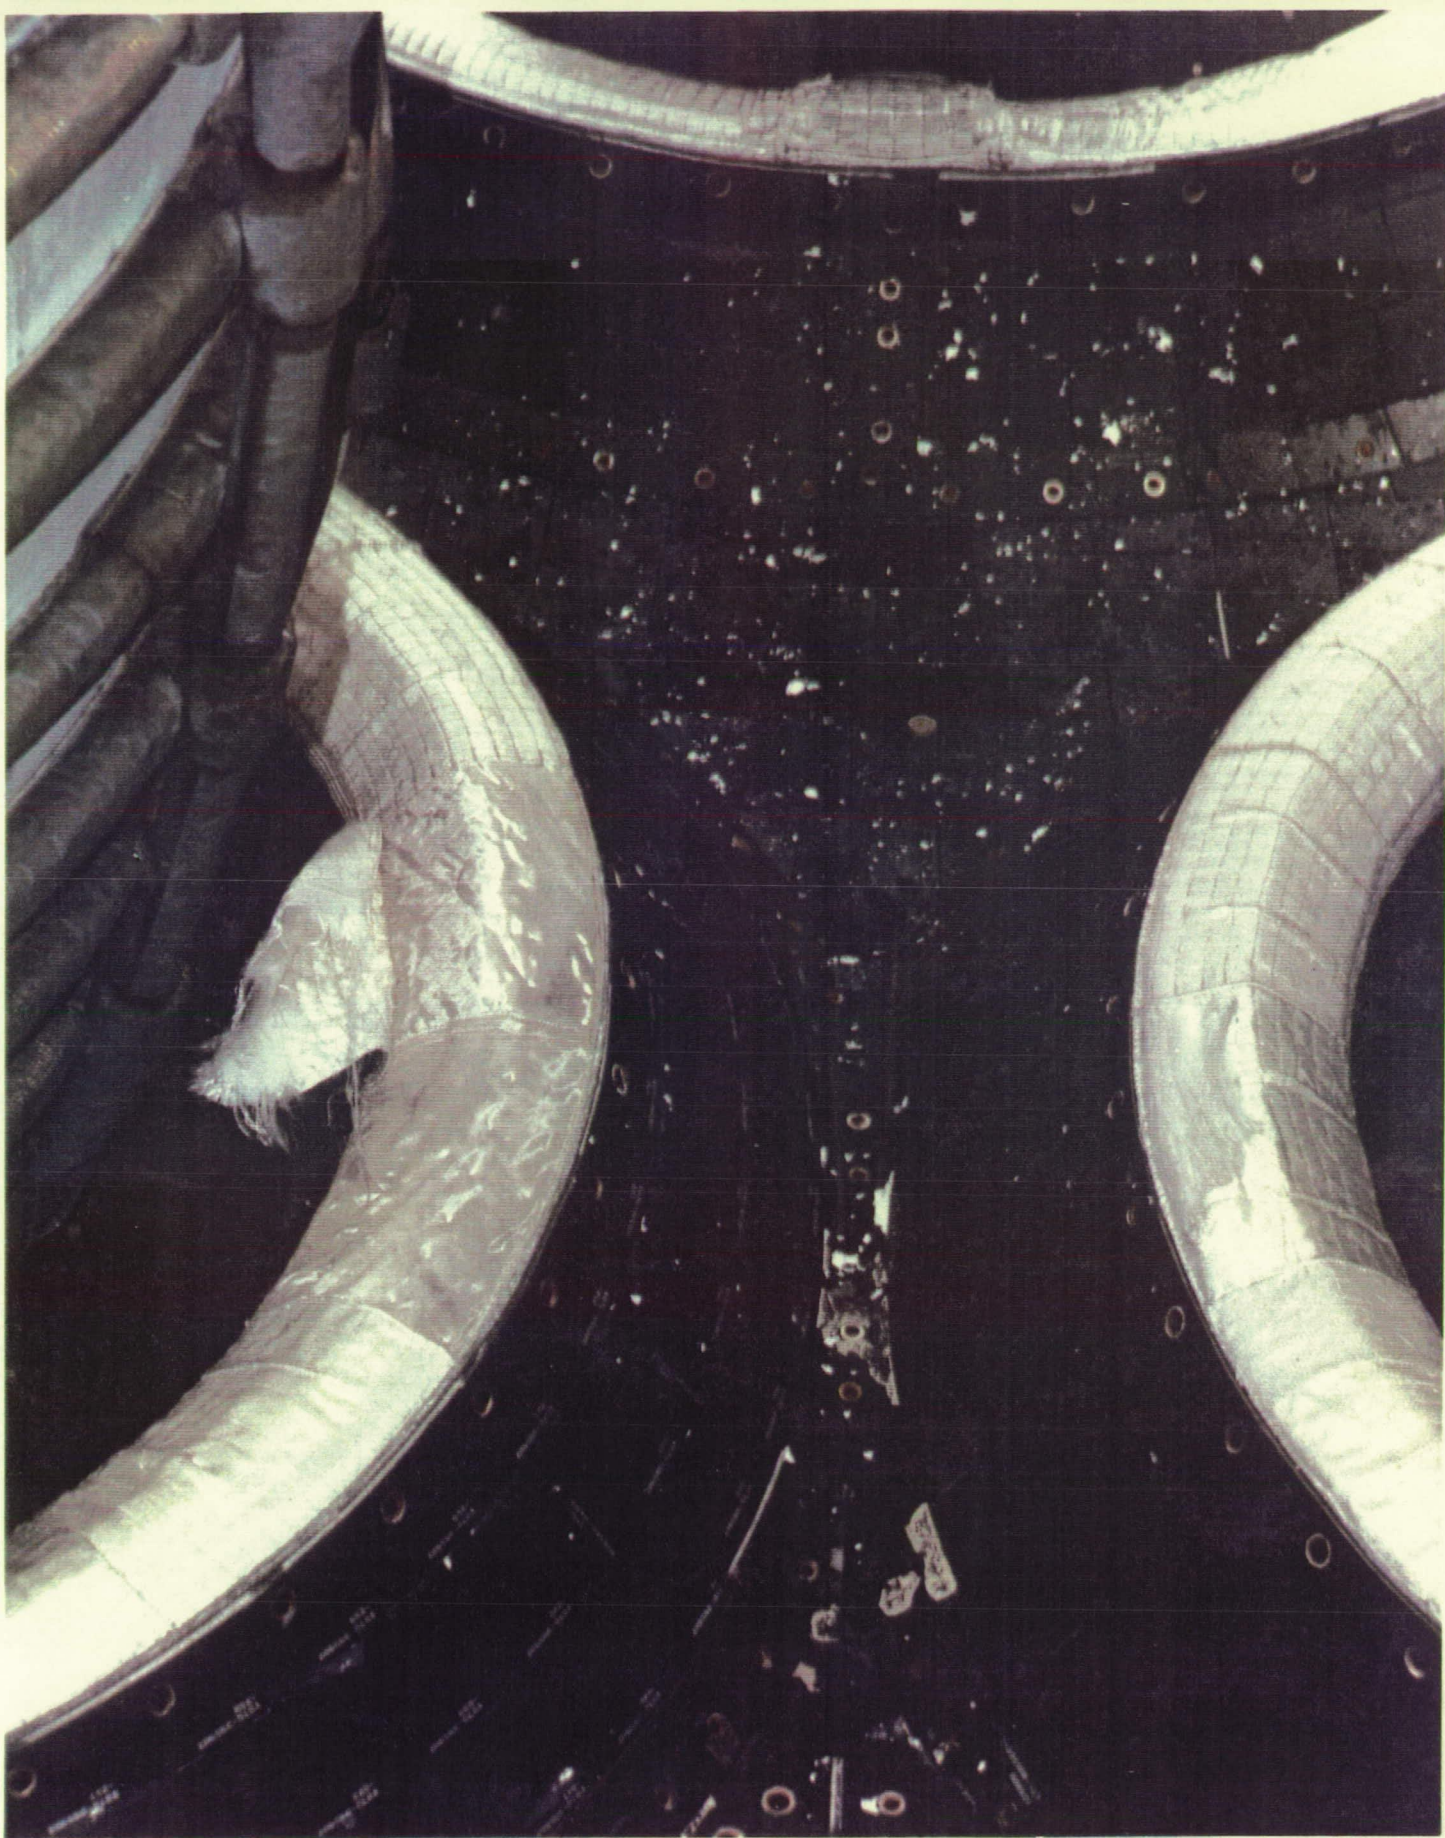
A 1-foot section of SSME #2 closeout blanket was peeled back and an adjacent 1-foot section (top layer) was missing

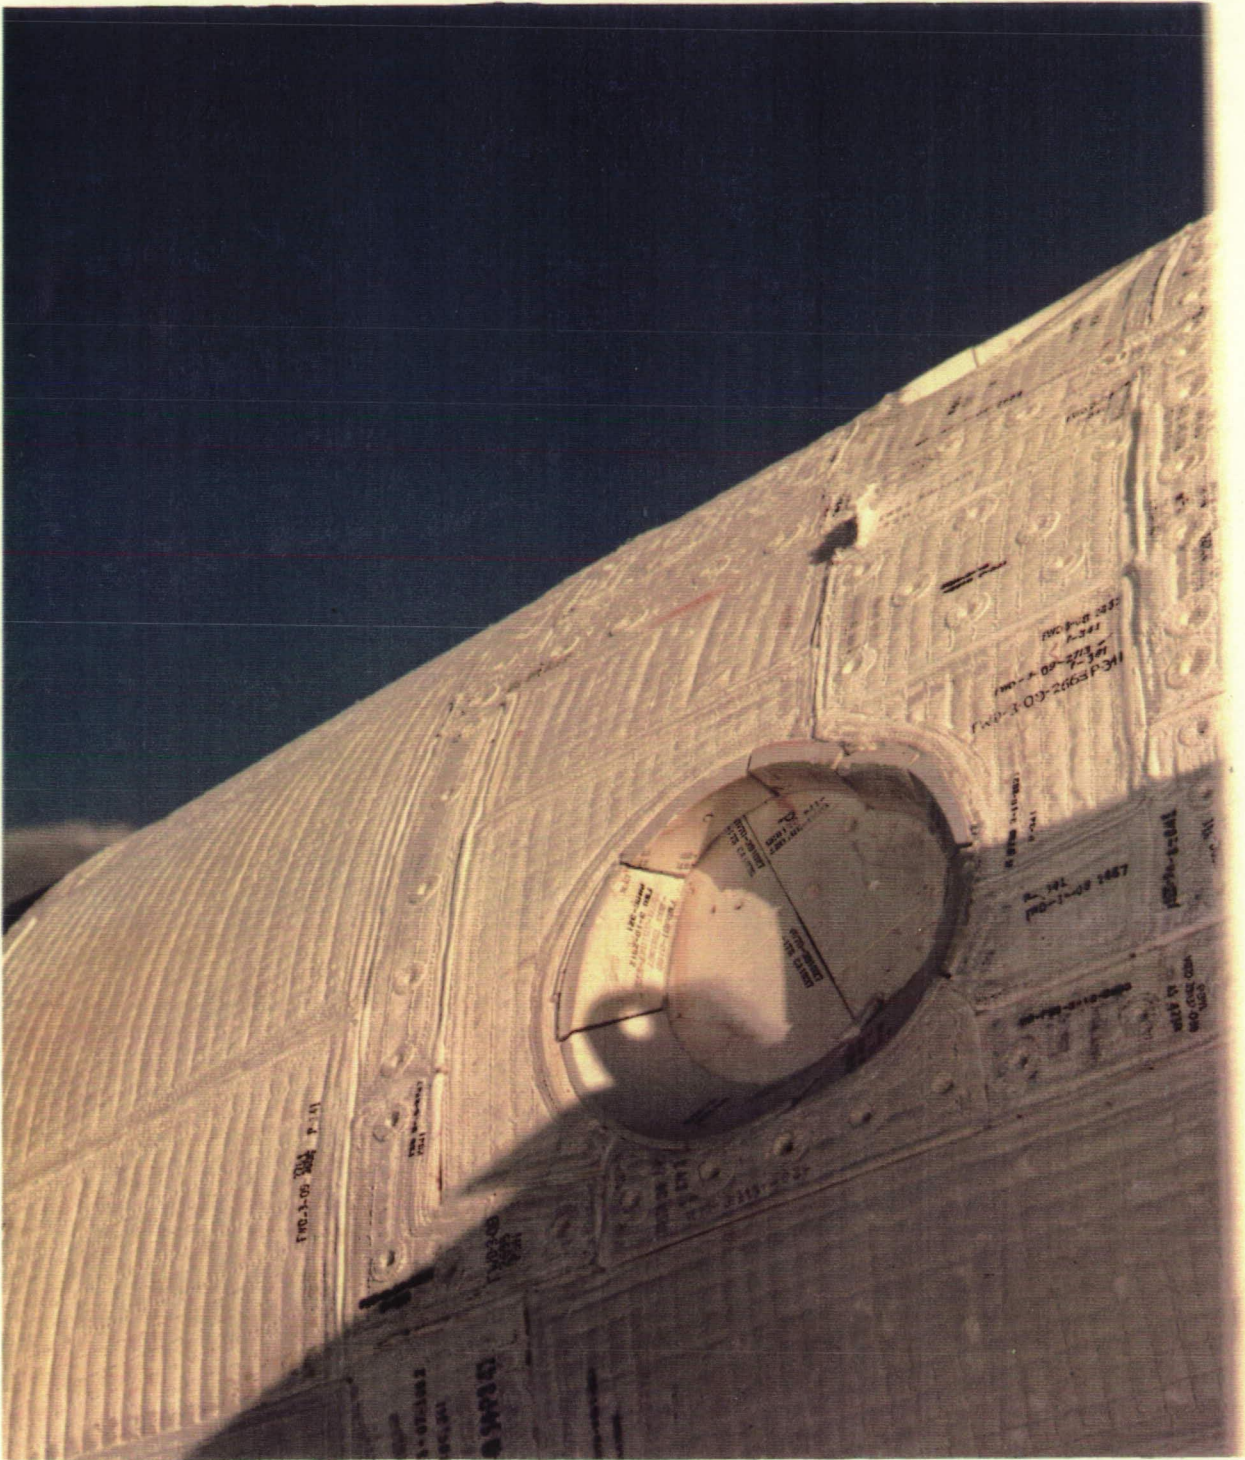
A 3"x3" tile corner was broken and loosely attached in the Y star tracker cavity

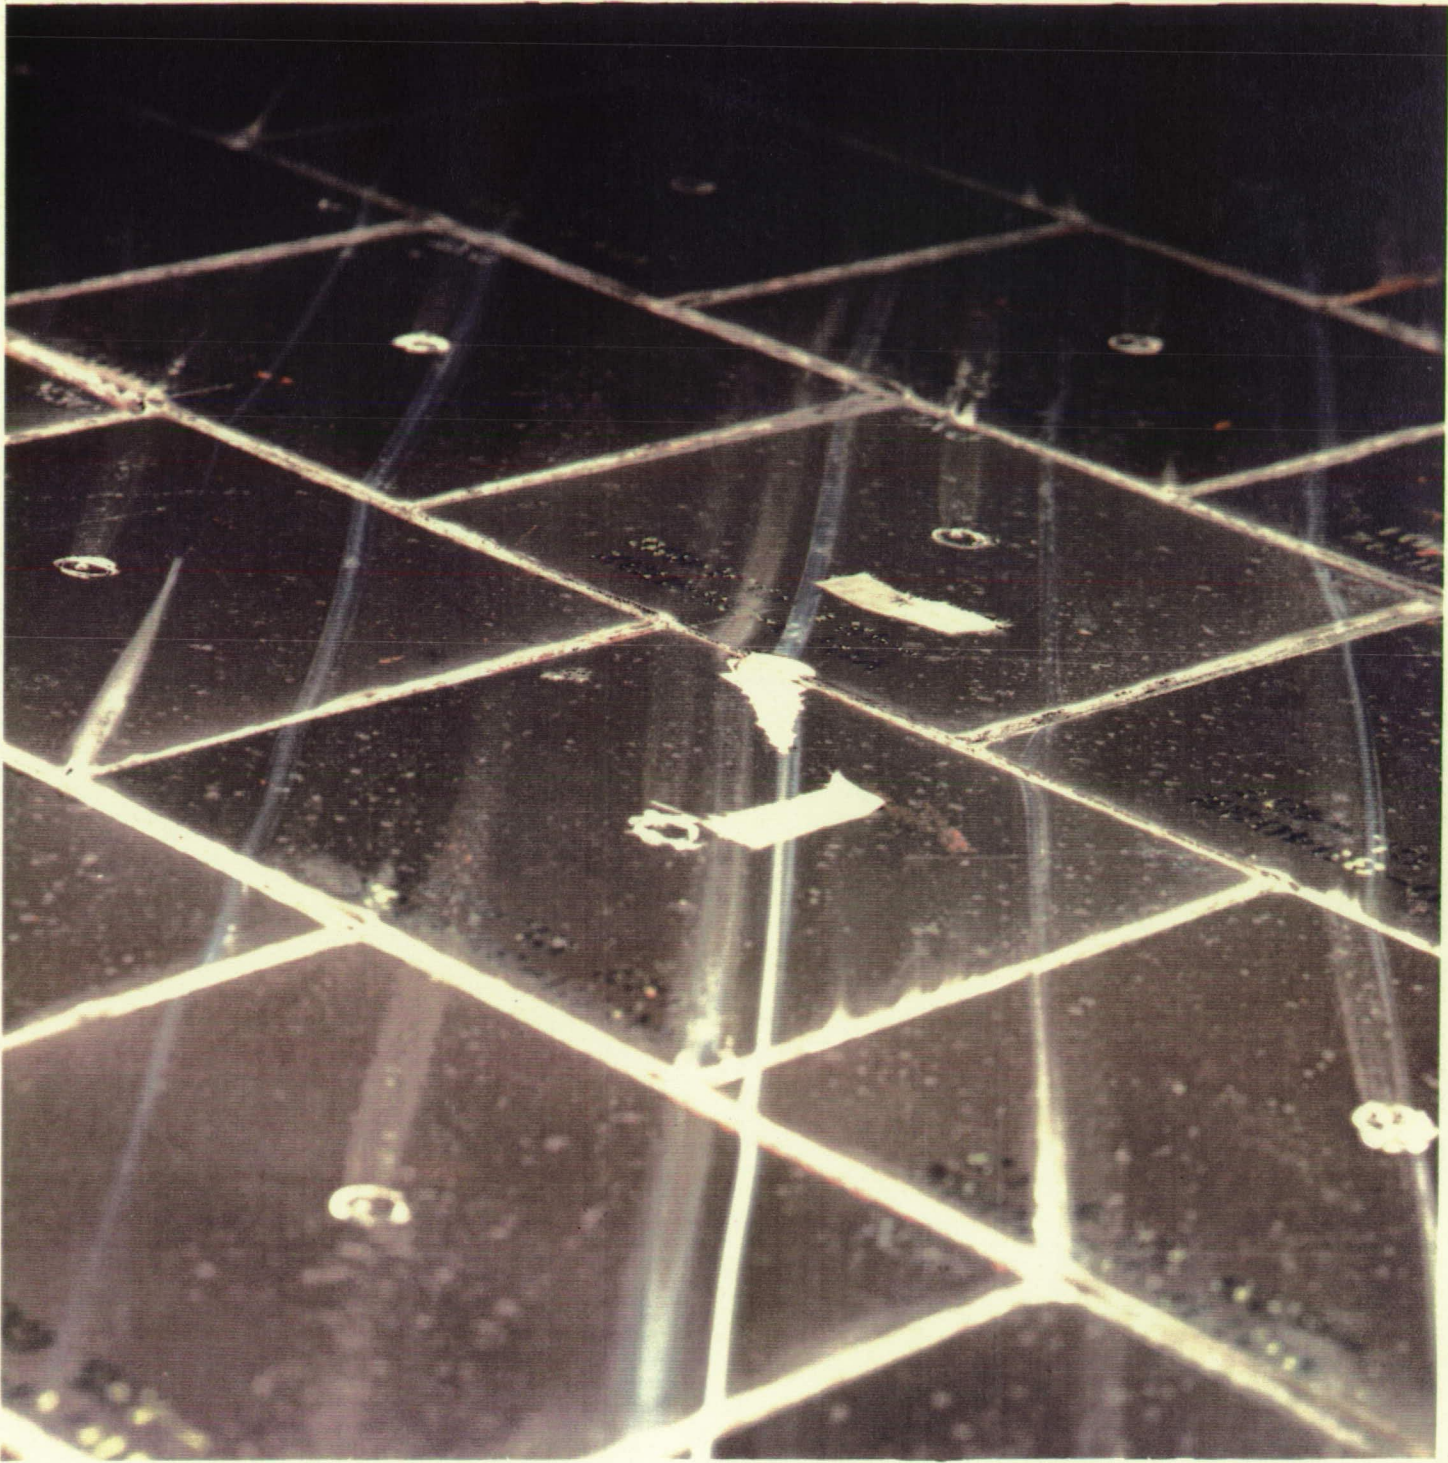
Typical debris impact damage to lower surface tile

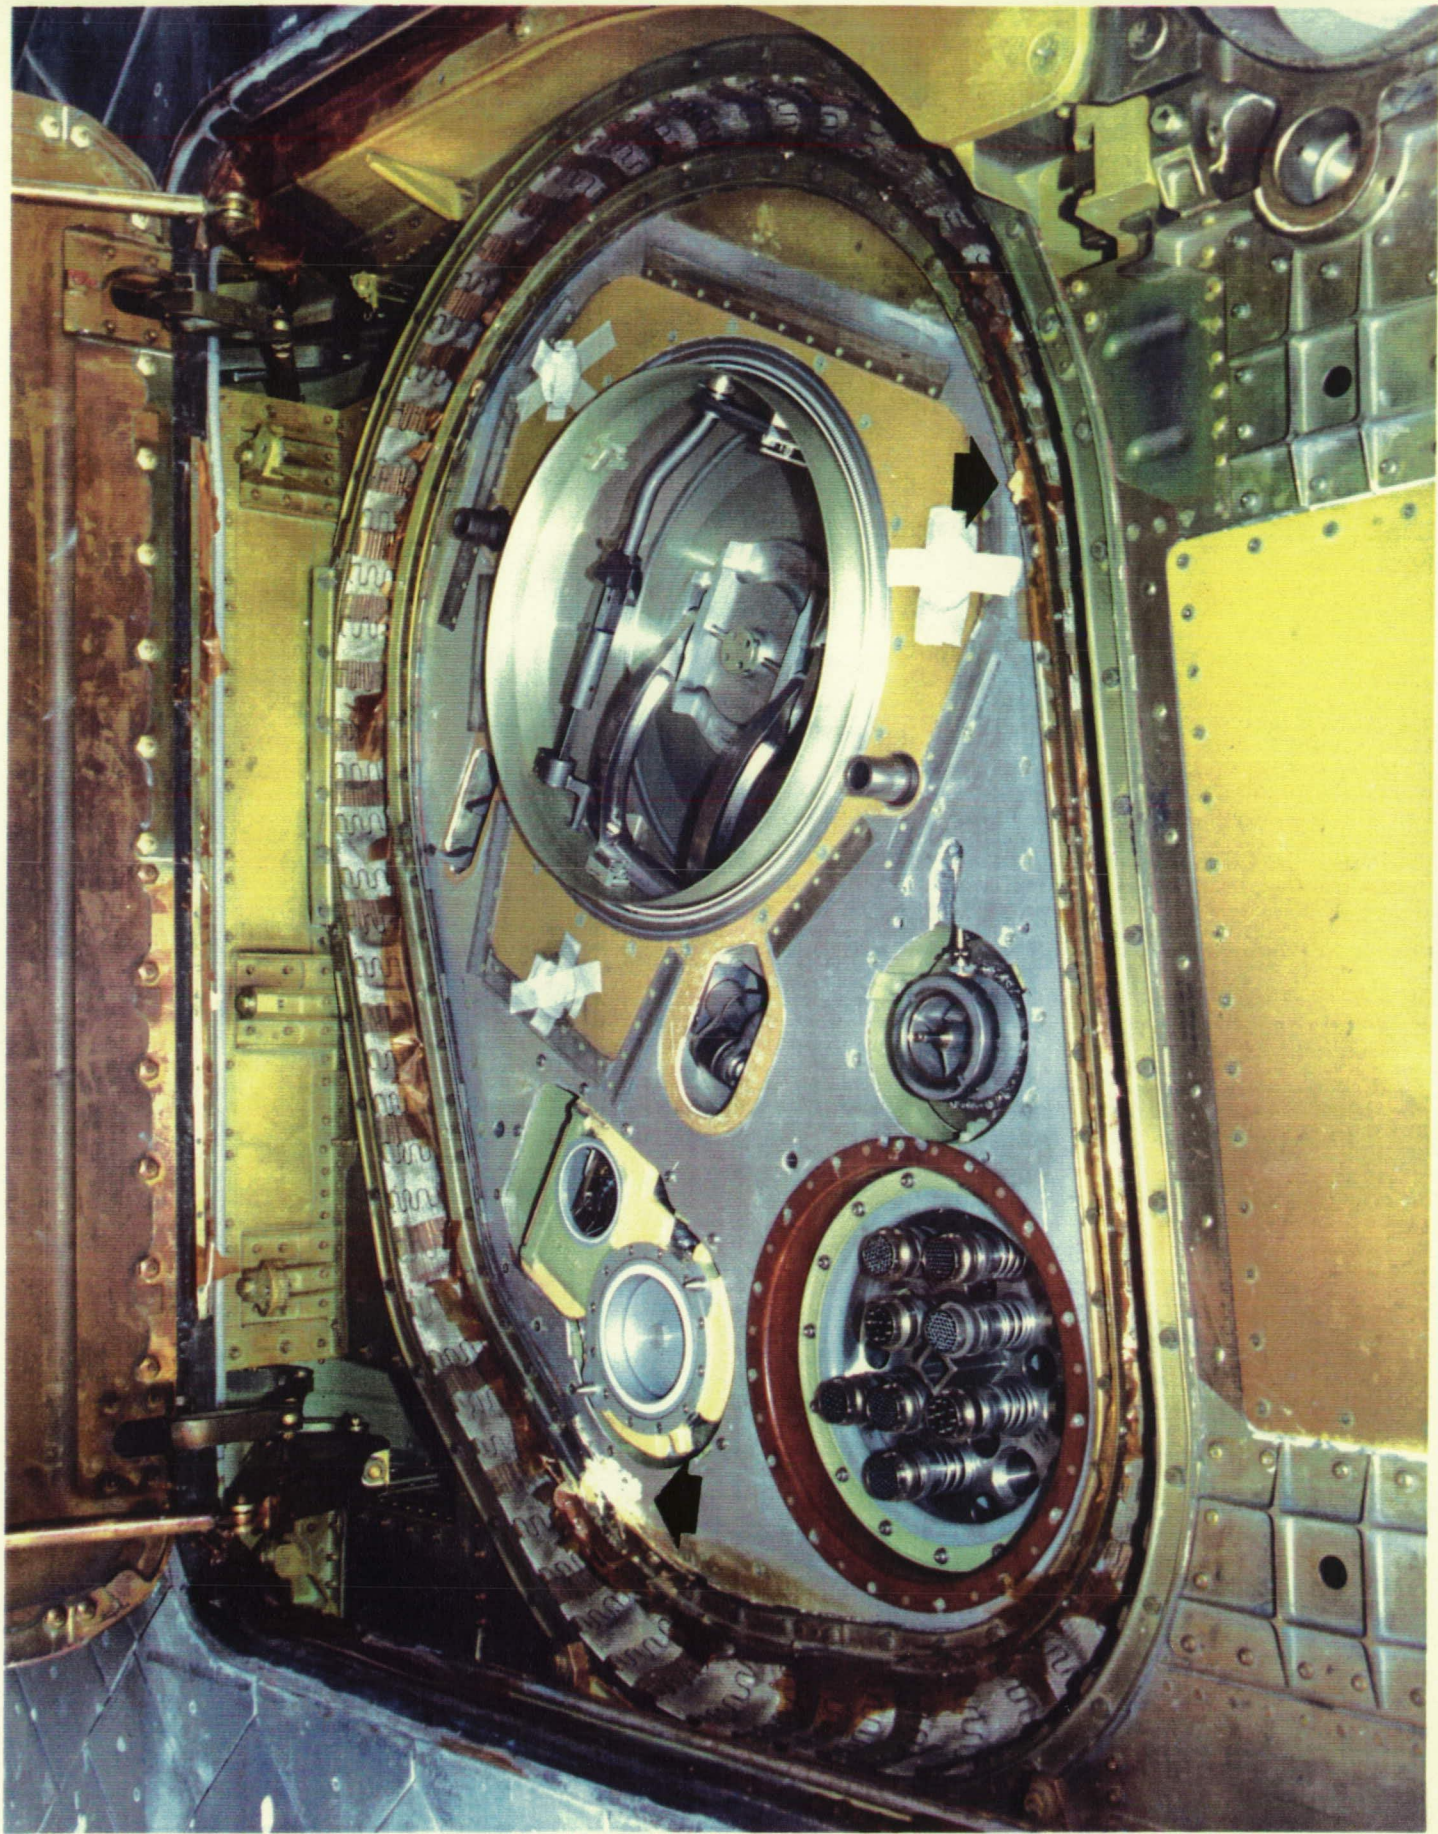
Post flight condition of the LH2 ET/ORB umbilical. Note closeout foam intrusion along interface (arrows)

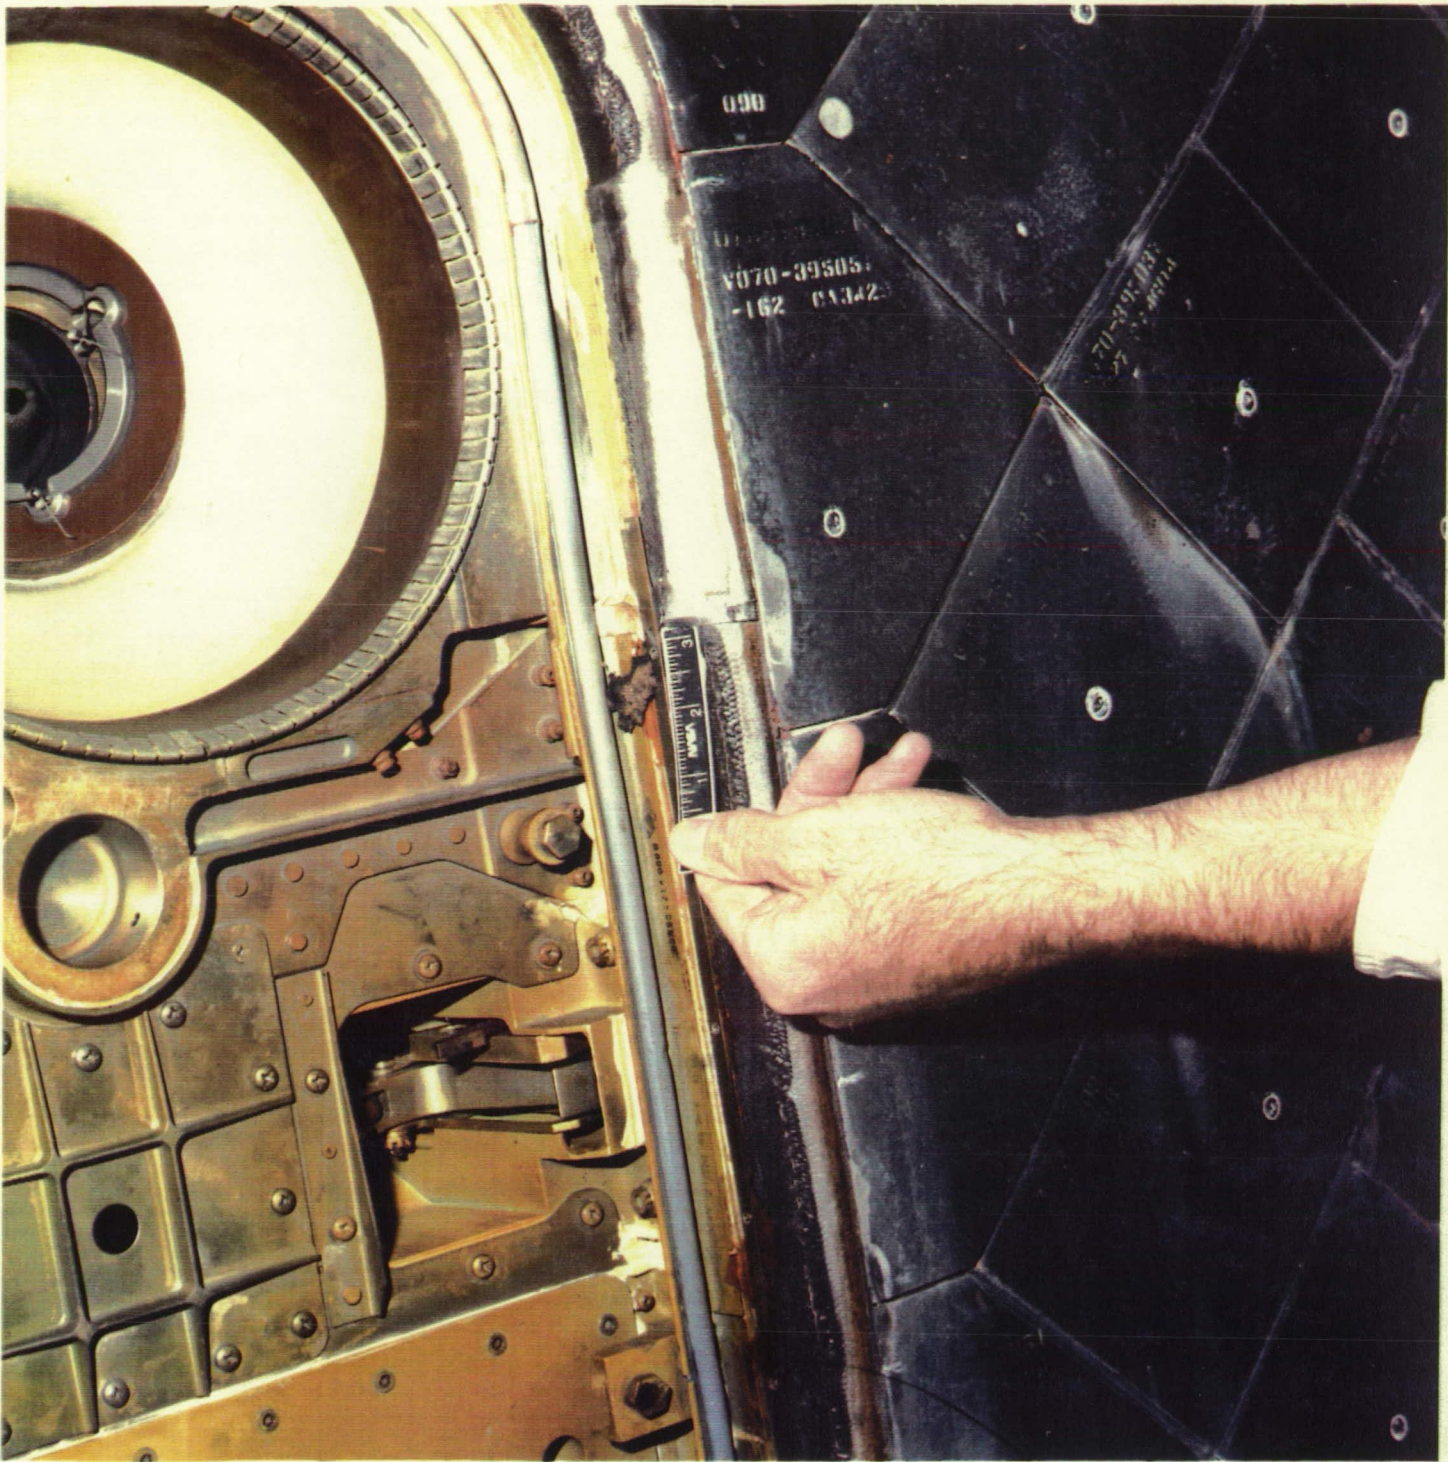
Brown/black-colored foreign material was removed from the LH2  
ET/ORB umbilical for laboratory analysis

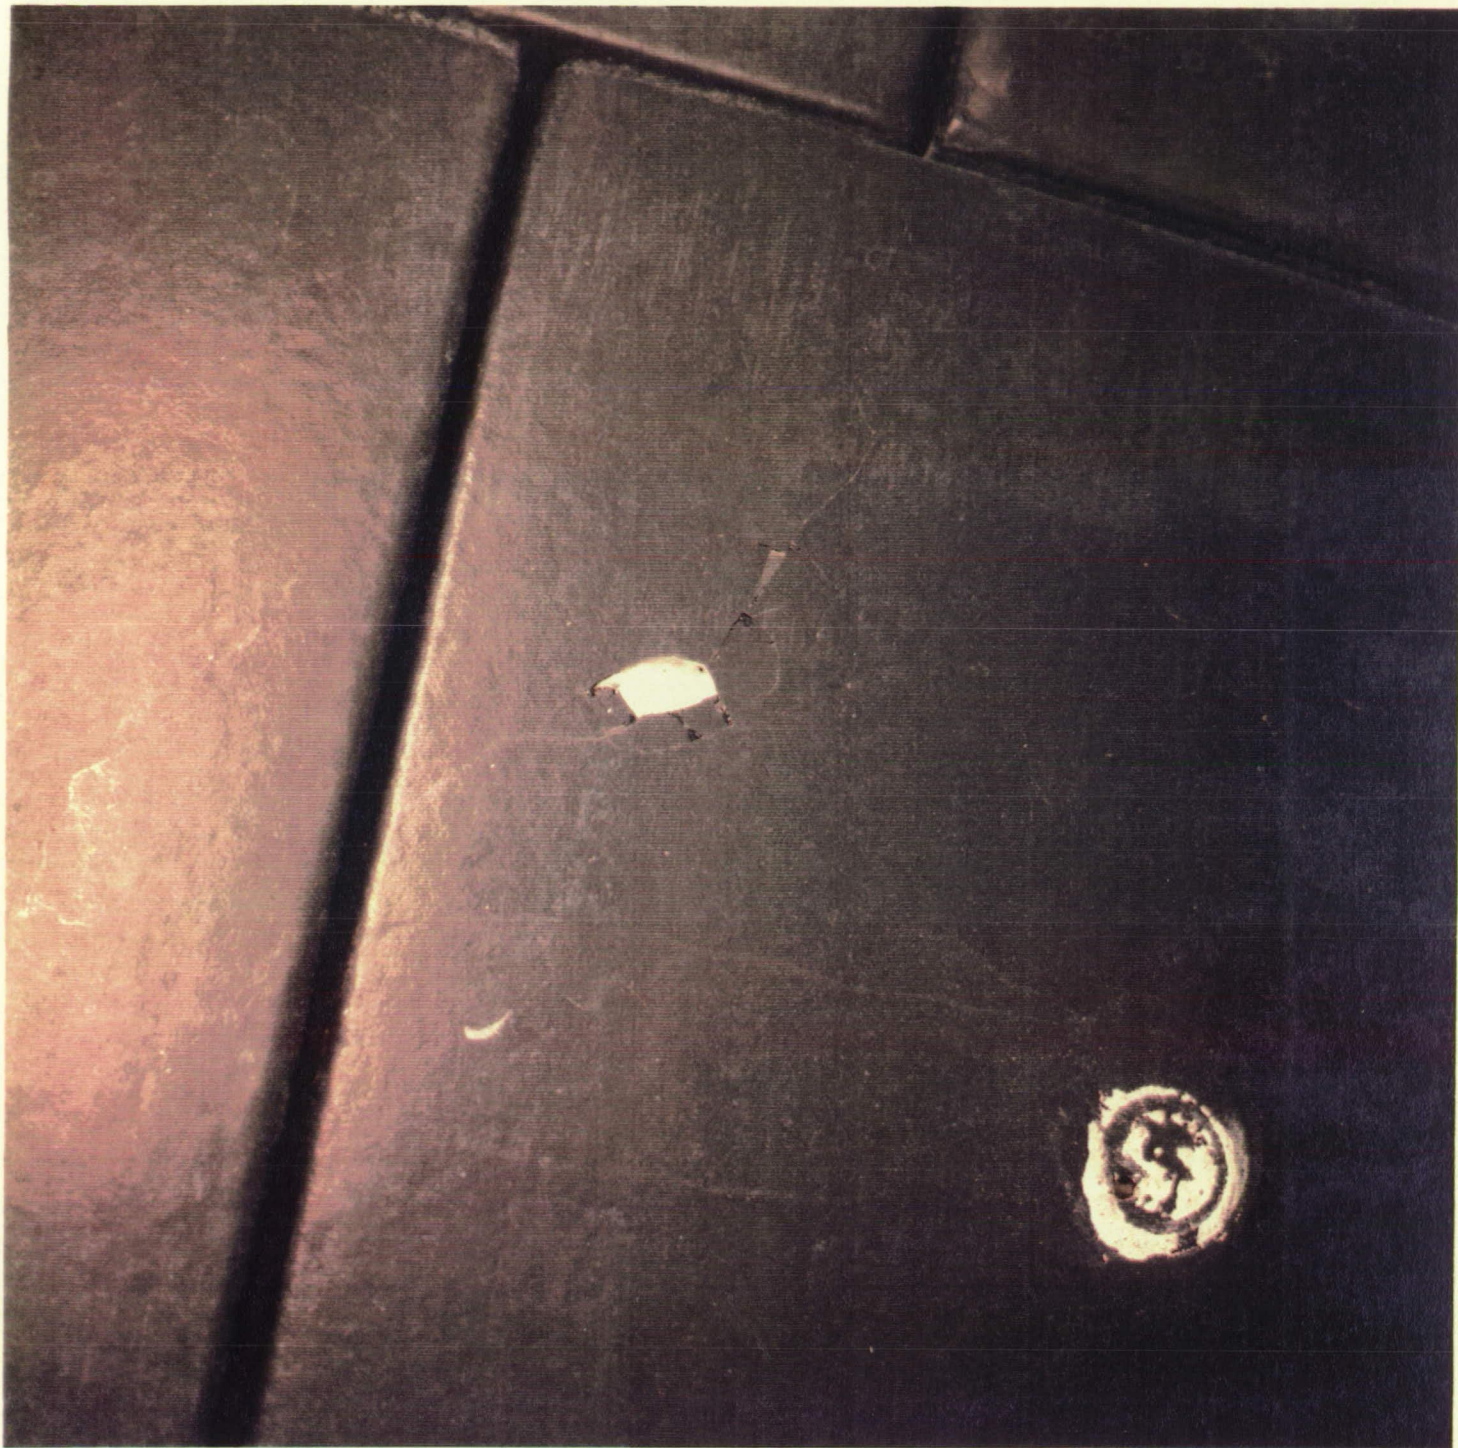
Analysis of dark residue in tile damage site cavity  
revealed tile material and landing site products  
152
