**NASA Technical Memorandum 102681
USAAVSCOM Technical Report 90-B-003**

Behavior of Composite/Metal Aircraft Structural Elements and Components Under Crash Type Loads--What Are They Telling Us?

Huey D. Carden, Richard L. Boitnott, and
Edwin L. Fasanella

May 1990

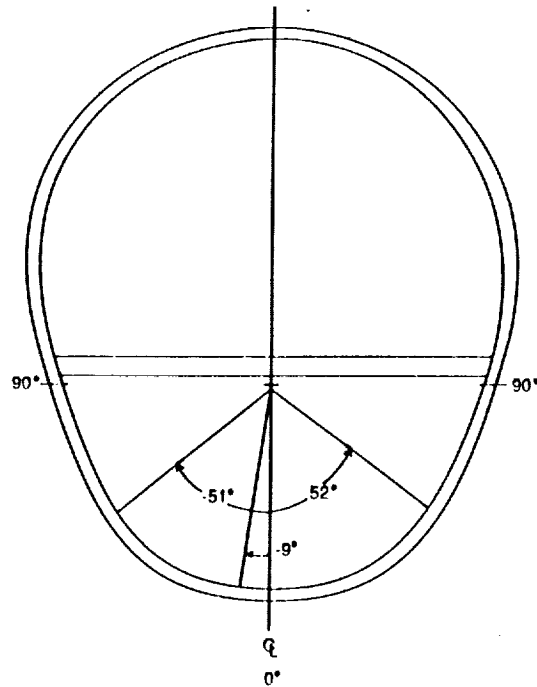
(c) Angular location of failures.

Dynamic tests.- Structural damage of the transport aircraft structures resulting from the 20 ft/s drop tests is shown in figure 8(a) and (b). The damage to the transport sections was confined to the lower fuselage below the floor level. Under the vertical impact of 20 ft/s, all seven of the frames ruptured near the bottom impact point. Plastic hinges formed in each frame along both sides of the fuselage about 50 degrees up the circumference from the bottom contact point (See figure 8(c)). The crush of the lower fuselage was approximately 22-23 inches at the front end and 18-19 inches at the rear for the section taken from forward of the wing location (figure 8(a)) whereas for the aft section (figure 8(b)) the crushing was about 14 inches in front and 18 inches in the rear. Although the aircraft structures are metal and the failures discussed above involve plastic deformations with some tearing of the metal rather than brittle fractures, the general observed failure pattern and locations for the transport fuselage sections will be shown to be quite similar to the results of the composite frames and subfloors discussed later.

Figure 8. - Structural damage to metal aircraft structures resulting from impact tests.

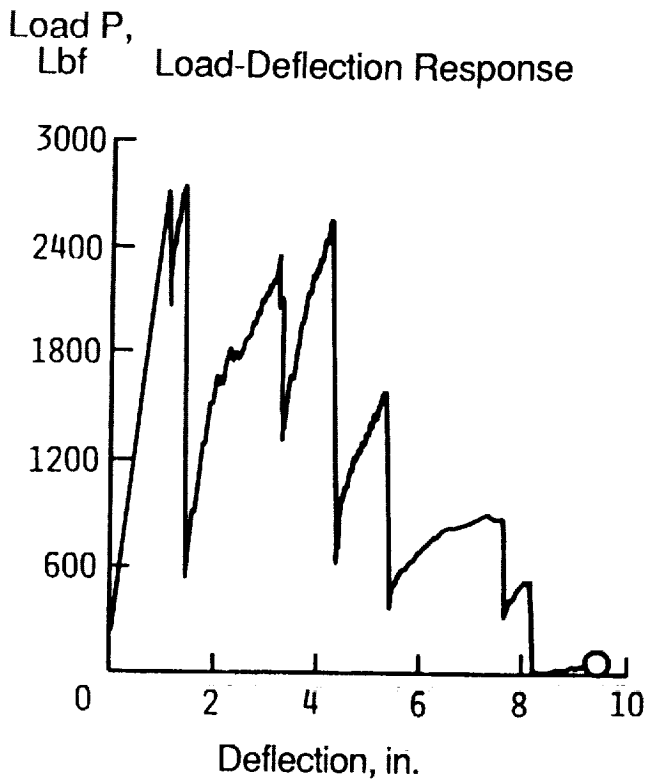
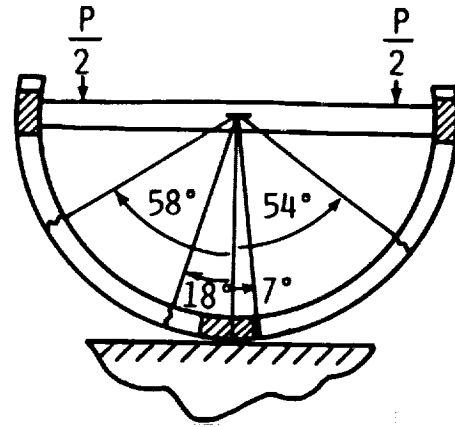
(b) Load-displacement and failure locations.

Static tests.- Results from the static test of a semi-circular frame with a Z cross-section²⁷ are presented in Figure 11. A photograph of the static test apparatus in figure 11(a) shows that the splice plate was at the load point. Consequently, the frame failed just outside the doubler splice plate area by a complete fracture across the Z-section. Load-deflection data and the location of failures of the frame are shown in figure 11(b). The load-deflection data show a saw-toothed behavior of loading and unloading. The load increased linearly until initial failure, then falls off to under 600 pounds force. Subsequent loading of the frame after initial failure was at a new, reduced stiffness. Second and third fractures occurred up the side again at about 54 and 58 degrees under continued loading as may be noted in the sketch at the right of figure 11(b). Photographic data in figure 10(c) shows that the initial failure was induced by a local buckling of the frame which occurred at about 18 degrees from the bottom loading point outside the splice plate area.

Furthermore, a comparison of the analytical cases (figure 12(a)) with the actual static load-deflection of the Z-section (figure 11(b)) indicates very similar load-deflection behavior patterns as discussed above. Although the Z-frame had no skin, if the ends jam together (as they did in several cases), the boundary is effectively between the skin stiffened case and a guided boundary. Thus, the predicted maximum moment location in the simple beam-frame model at about 50 degrees (See figure 12(b)) agrees well with the 54 and 58 degree failure locations in the experiment with the Z-section frame.

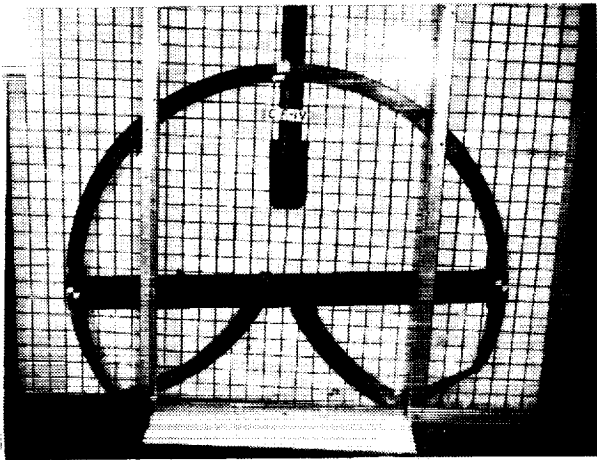
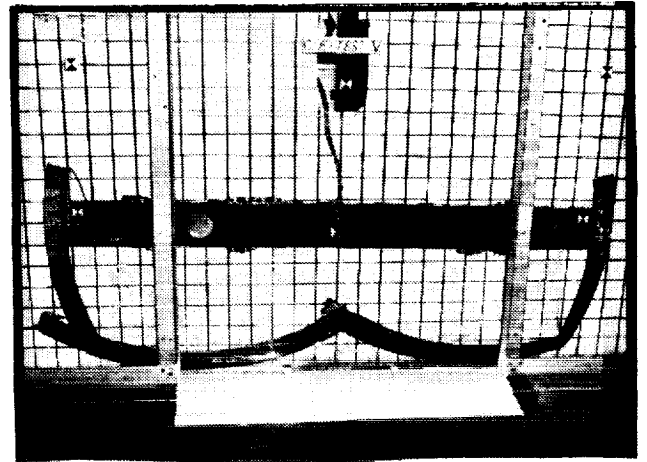
(a) Photographs of failed frames.

Dynamic tests.- Results from reference 29 on the dynamic studies of the response of composite frames are shown in Figure 13. Photographs of the failed Z-frames in the drop apparatus are shown in Figure 13(a). It should be noted, the splice plates joining the segments of the frame are 45 degrees up the circumference from the point of impact. As shown in figure 13(b), complete failures (fractures) of the Z-section frames occurred at the bottom and approximately 60 degrees from the bottom. It appears that the presence of the splice plates moved the top failure points up a few degrees (to about the 60 degree locations).

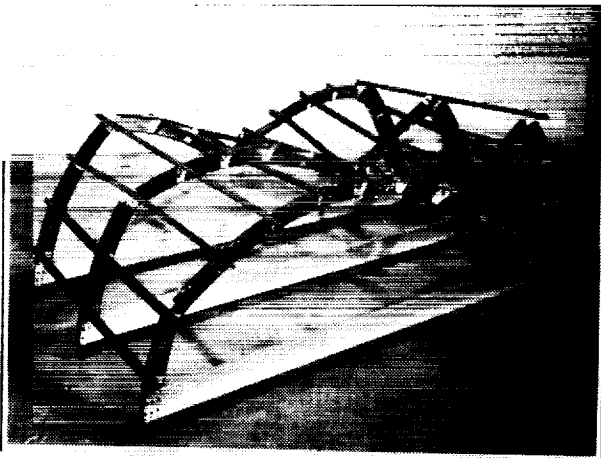
(a) Failed composite skeleton subfloor.

Static tests.- Experimental results³⁰ of the skeleton subfloor specimen following a static test are shown in Figure 14. As noted in figure 14(a) and (b), failures on the three Z-section frames occurred at 13 discrete locations. Unlike the unnotched single Z-frame, the failures in this specimen occurred at notches (which served as stress risers) in the frame through which the stringer passed. However, as shown in figure 14(b) the failures were still near the point of load application (approximately 11 degrees) and at other circumferential locations of approximately 45 to 67 degrees. In the absence of skin material, twisting and bending out-of-plane occurred with the frames. The stringers had only a minimal effect on the subfloor response and that was to maintain the lateral spacing of the three Z-frames.

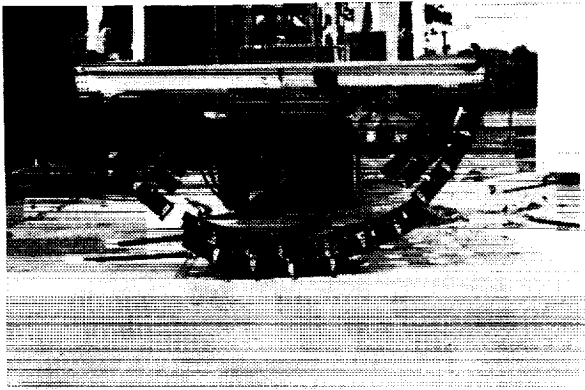
(a) Failed composite skeleton subfloor.

Dynamic tests.- A photograph of a skeleton subfloor after an impact test onto a concrete surface at 20 feet per second is shown in Figure 15. In the dynamic test of the skeleton subfloor, fractures were produced at notches in the frames (Figure 15(a)). The locations, shown in figure 15(b), were also near the point of impact (about 11 degrees because of the splice plate) and at three other locations up the circumference of the frames (55 degrees and 78 degrees) totalling 15 fractures for all three frames. The impact energy exceeded the energy absorbed by the local fractures and the floor bottomed out during the impact. The normalized circumferential strain distribution measured on the flange of the front frame during the dynamic test just before first failure is shown in Figure 15(c). A comparison of the measured distribution to the predicted moment distribution of Figure 12(b) and (c) shows essentially identical shape between the single frame and skeleton frame distributions. Maximum values at 0 degrees and at approximately 50 to 55 degrees for the experiment agree well with the analytically predicted locations on the frame.

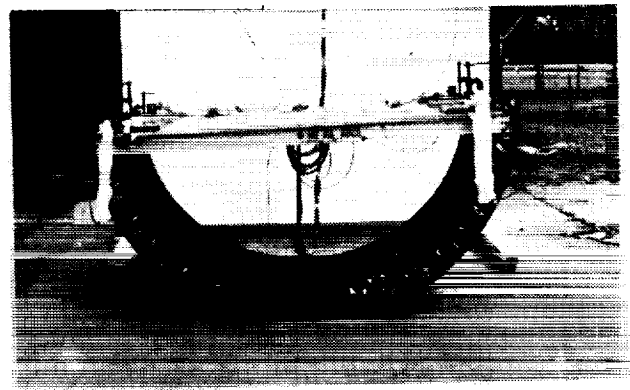
(a) Failed composite skinned subfloor.
Frame A (Front)

Impact results for the subfloor with skin after an impact of 20 feet per second are shown in Figure 16. A photograph of the subfloor specimen after the test is shown in Figure 16(a). Points of failure of the frames in this specimen are indicated in figure 16(b). Again the points of failure are at or near the impact point (within 12 degrees) and circumferentially at about 56 degrees up both sides of the frame on the middle and back frame and 45, 12 and 22.5 degrees on the front frame. It was observed that the subfloor impacted first on the front area which possibly explains the 12 and 22.5 degree fractures being different from the other locations. Again all three frames were involved in the failures. Some delamination of the frames from the skin was evident but the skin remained intact. Normalized strain distribution (just prior to first failure) measured on the skin at the location of the front frame during the dynamic test showed essentially identical shape as the single frame and skeleton frame distributions. As was the case for the skeleton subfloor maximums at 0 degrees and at approximately 50 to 55 degrees for the experiment agree well with the analytically predicted locations on the frame.

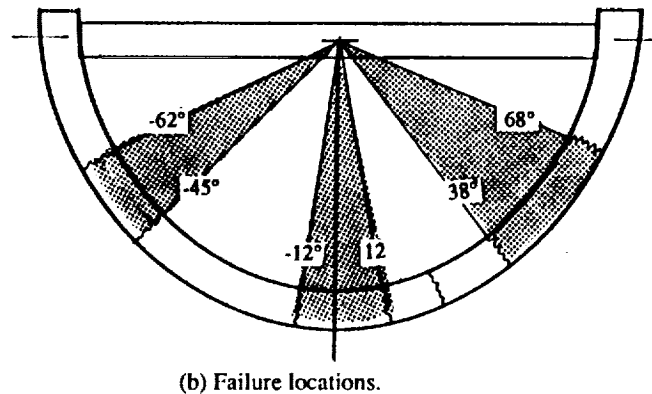
The response behavior determined during the studies of full-scale aircraft sections, fuselage frames, and subfloors are summarized in figure 18. Normalized moment distribution on a representative frame of the various specimens are shown in Figure 18(a). Figure 18(b) shows the failure locations which were noted from static and dynamic tests. The visual impression is quite striking among the various specimens. The structures all share in common the generally circular or cylindrical shape, the normal loading situations, and what appears to be a similar pattern of failure behavior. Analytical models of frame structures under vertical loads have moment distributions which have maximums at the point of loading and at approximately 45 to 50 degrees (depending on boundary conditions) around the circumference from the ground contact point. Failures of the structures were noted at these same locations. Such observations may help dynamists gain a clearer understanding of what to expect from such structures in crash loading situations, may guide designers of new structures to account for the vertical crash loads, and allow increased energy absorption to be included in the new designs. Additionally, the observations may help analysts to model the aircraft structures more adequately for predicting the failure responses and behavior under crash situations. The latter task is a difficult and challenging one, not only for composite structures but for metal structures as well. Studies are currently underway to improve the analysis capabilities of current codes and to add composite elements to finite element libraries such as the DYCAST program. In addition, new analysis approaches are being explored through grants to universities as an extension of NASA Langley Research Center's in-house efforts.

Figure 18. - Comparison of non-dimensional analytical moment distribution predicted by finite element frame model and observed failure locations on metal and composite fuselage components and structures.
