NASA Technical Memorandum 102661

Failure of the ERBE Scanner Instrument Aboard NOAA 10 Spacecraft and Results of Failure Analysis

May 1990

Langley Research Center
Hampton, Virginia 23665-5225

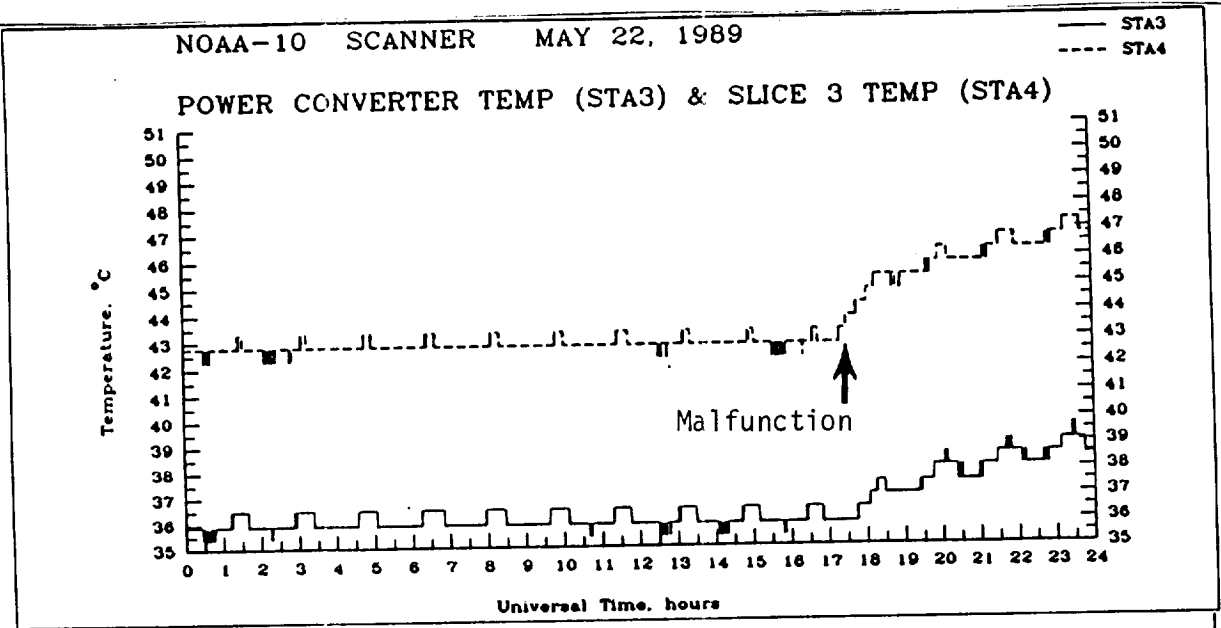
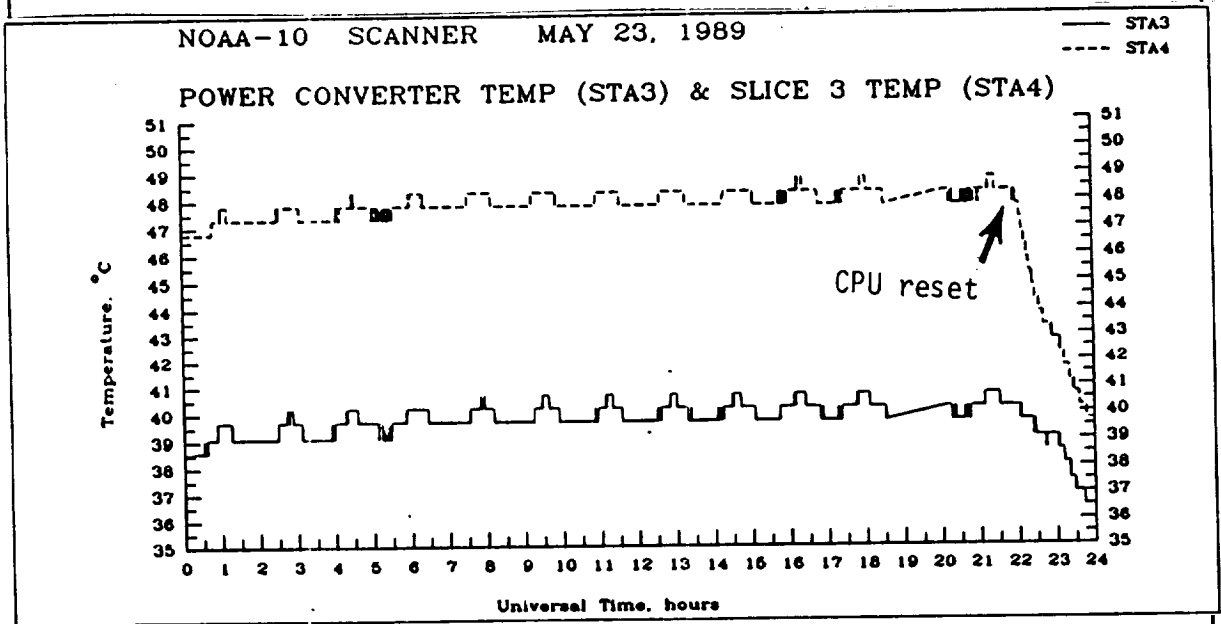
Instrument Temperatures Following Malfunction
Figure 1

At 17:03 Universal Time on May 22, all values in the primary output data (DIG A) of the scanner instrument on NOAA-10 went to zero. The bilevel data (DIG B) and several instrument temperatures and voltages (analog), which are output on a different data buses than that of the DIG A data, remained valid. The DIG B data indicated that the scanner elevation motor power remained on after the malfunction, and figure 1(a) shows how two of the instrument analog temperatures began to increase at the time of the malfunction.

sequence, the elevation motor power was apparently turned off automatically, and the DIG A data again reverted to zero values. Elevation position data, transmitted following a subsequent CPU Reset, indicates that the scanner elevation beam appeared to have achieved position lock at the normal Earth scan space-look position. Several times on May 23 and 24, the instrument was sent CPU Reset commands, followed by normal Earth scan mode commands. In every case, the instrument response was identical to the response received the first time these commands were sent on May 23. On May 26, a CPU Reset command, only, was sent to the instrument, and no other commands were sent until May 31. The DIG A data remained valid, and instrument housekeeping and radiometric data showed typical responses to the in-orbit heating environment during this five-day period.

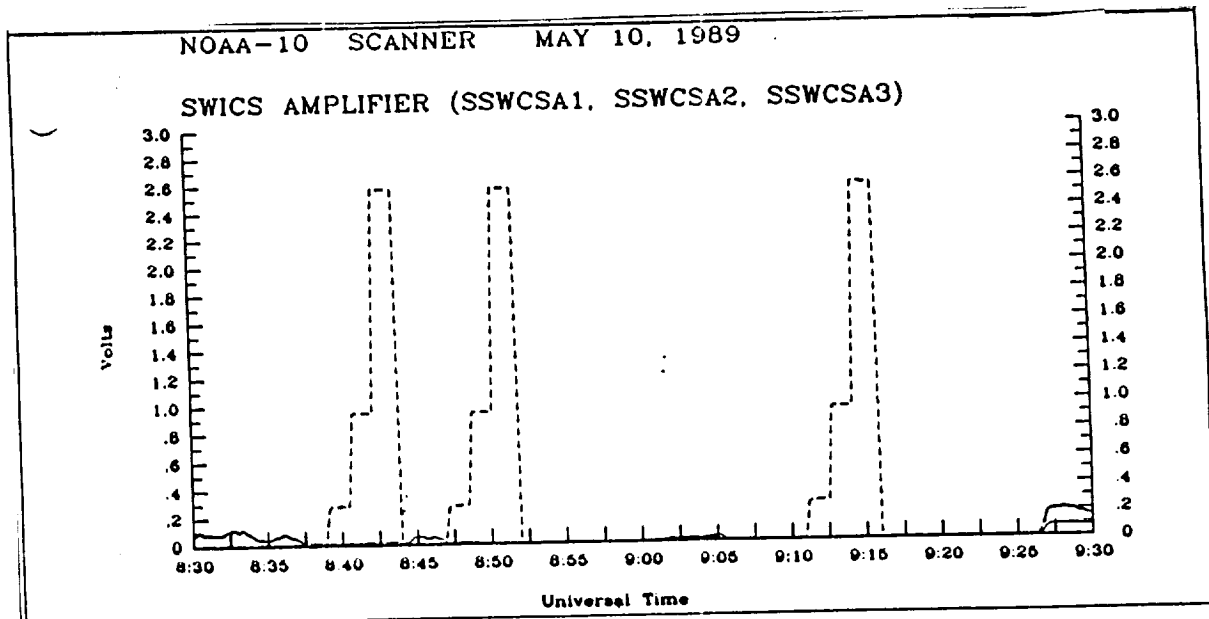
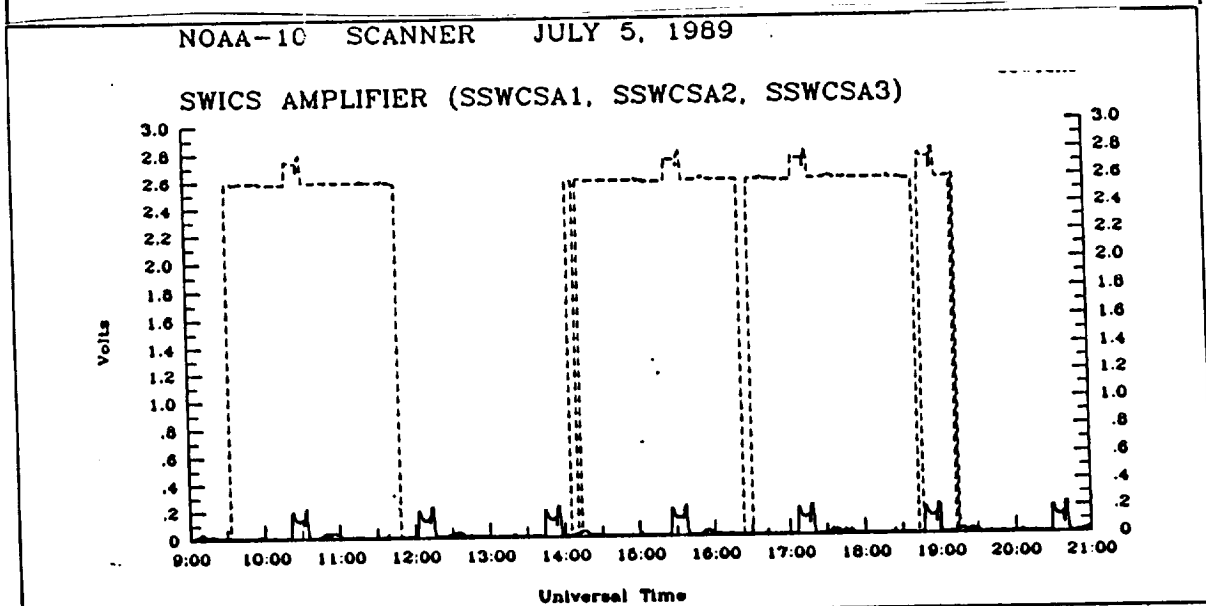
Internal Calibration Response
Before and After Malfunction
Figure 2

The automated internal calibration sequence command (Hex command code 8A1) stored in the NOAA-10 spacecraft computer command table is issued routinely every two weeks. However, July 5 was the first calibration date after the malfunction for which the output of the complete calibration sequence was available in the DIG A data stream. The DIG A data were invalid when the first sequence was issued on May 24 (no CPU Reset command was in effect), and the command sequences on June 10 and June 26 were interrupted by CPU Reset commands which were issued prior to completion of the

sequences. The CPU Reset commands were issued from the ground when it appeared that the internal calibration sequence had terminated abnormally. The instrument responses have been identical for all internal calibration sequence commands issued since July 5. Table 4a compares the instrument responses during a typical calibration before and after the malfunction. Figure 2 shows typical SWICS amplifier output for normal and abnormal sequences. A total of 13 mode commands (including the internal calibration sequence command) are issued during both normal and abnormal command sequences, but the commands and the relative times at which they are executed are incorrect for the abnormal sequence. The level #3 modulated SWICS command is seen to be turned on and off 6 different times during the nearly 10-hour execution period of the abnormal command sequence.

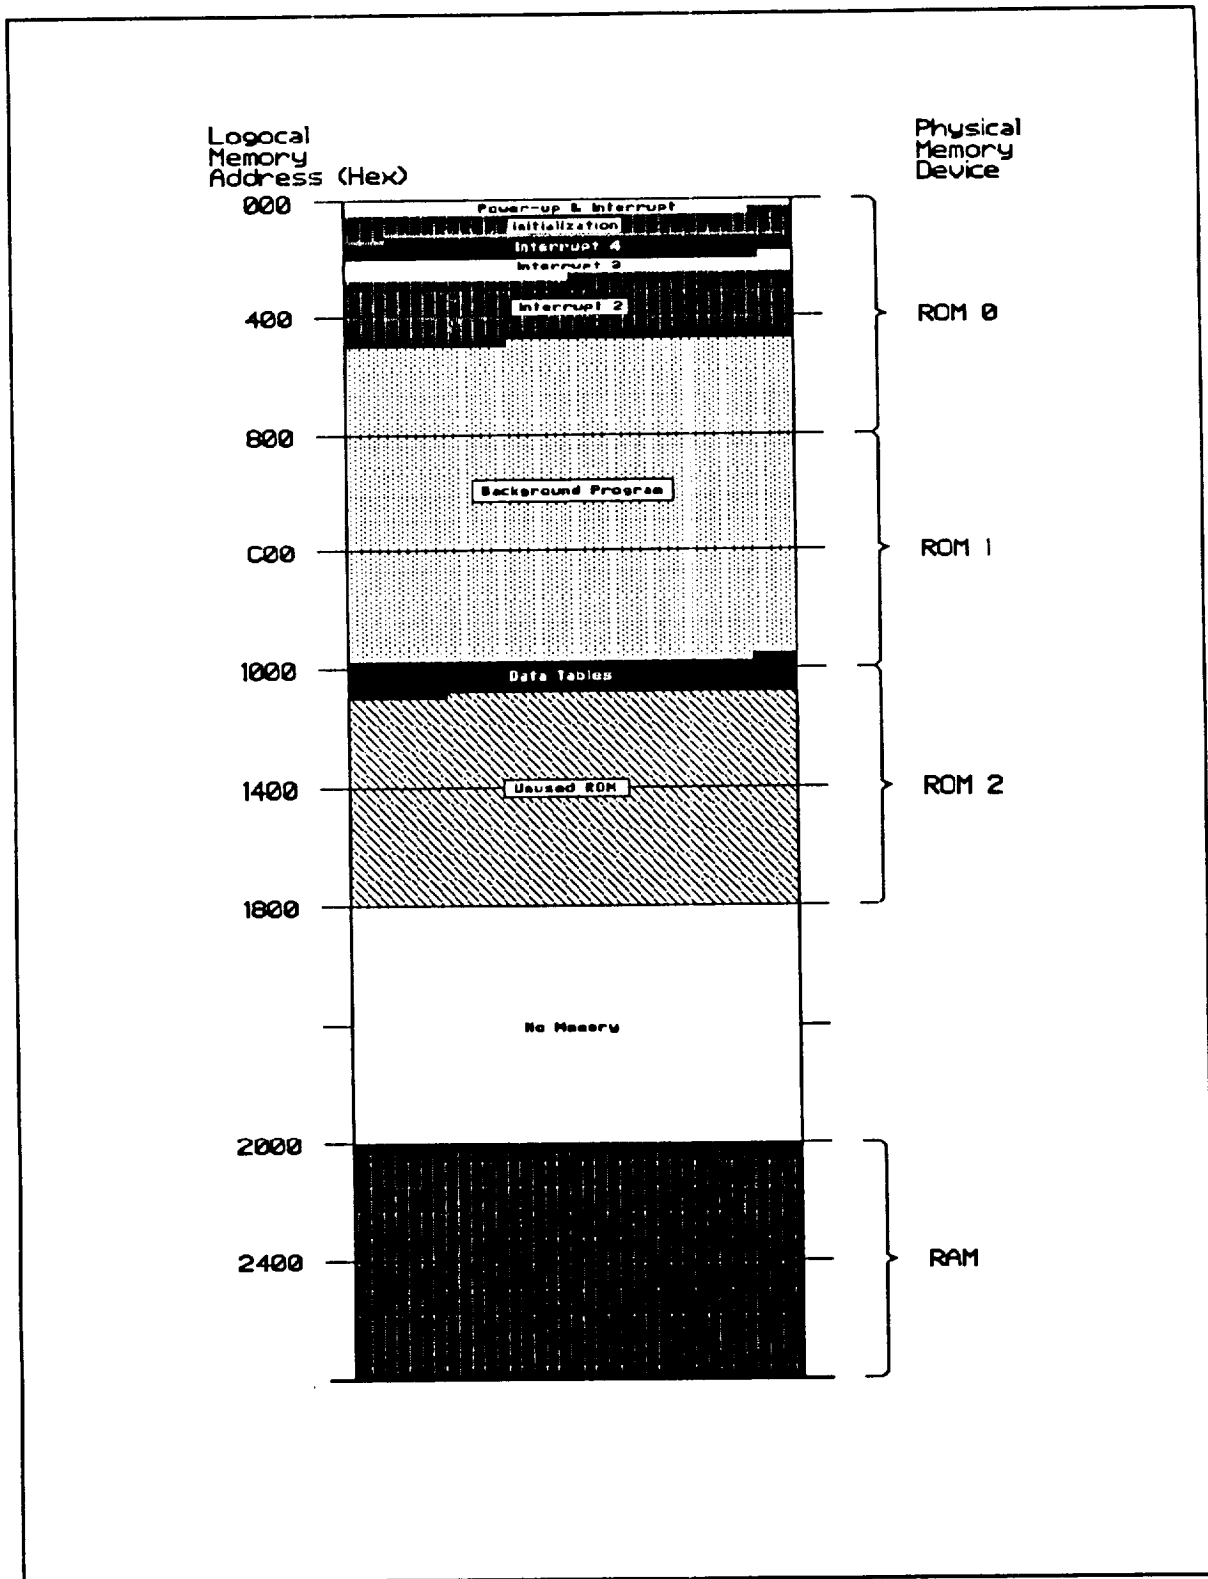
ERBE Scanner Memory Map
Figure 3

The CPU Reset command causes a hardware reset of the microprocessor; which in turn causes all internal registers to be cleared and a restart of the firmware code. The ROM code initialization causes the RAM memory to be cleared and initialization of selected scanner hardware including removal of power from the elevation motor drive circuit. The fact that the processor responded to a reset instruction and normal data transfers were restored, indicated that the spacecraft command and data transfer circuitry, spacecraft 1.2M Hz clock, counter and interrupt circuits are functioning normally, and that the microprocessor, ROM, and RAM memories are functioning normally for at least a substantial portion of the instruction set and memory area. Initialization, data acquisition, and telemetry transfers require proper operation of substantial portions of the background program as well as interrupts 3 and 4, and use large variable blocks in the RAM memory. See memory map figure 3.

The fact that the only commands which produced anomalous or failure condition were internal sequence commands, prompted a review of the manner in which these commands were executed and their relative location in memory. The routines responsible for execution of these commands showed no apparent unique common code or instructions, but the tabular information used by both of these routines was determined to be the sole contents of the high ROM chip (A2A1-U50).
