NASA Technical Memorandum 102679

Unique Failure Behavior of Metal/Composite Aircraft Structural Components Under Crash Type Loads

Huey D. Carden

May 1990

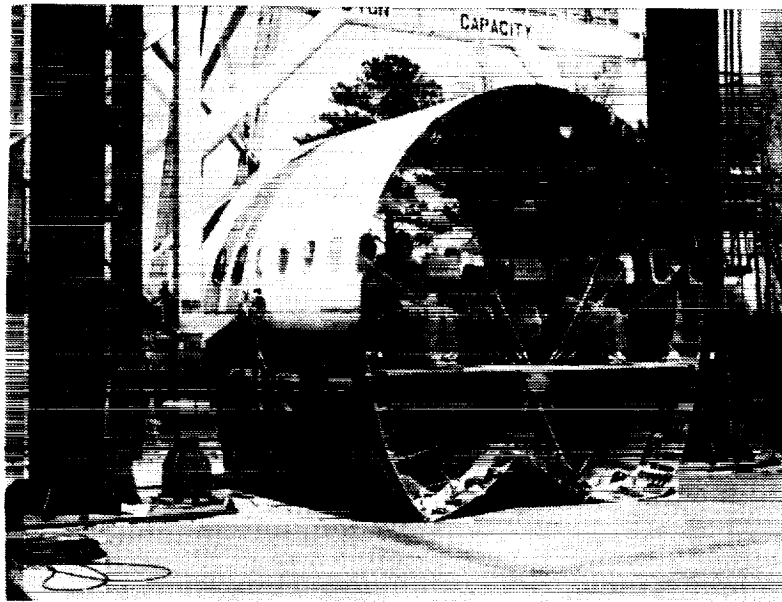
(a) Section from forward of wing.

Dynamic tests.- Structural damage and behavior of the transport aircraft structures resulting for the 20 ft/s drop tests is shown in figure 8(a) and (b). The damage to the transport sections was confined to the lower fuselage below the floor level. Under the vertical impact of 20 ft/s, all seven of the frames ruptured near the bottom impact point. Plastic hinges formed in each frame along both sides of the fuselage at about 50 degrees up the circumference from the bottom contact point (See figure 8(c)). The upward movement of the lower fuselage was approximately 22-23 inches at the forward end and 18-19 inches at the rear for the section taken from forward of the wing location (figure 8(a)) whereas in the section from aft of the wing location (figure 8(b)) the crushing was about 14 inches forward and 18 inches in the rear. Although the aircraft structures are metal and the failures discussed above involve plastic deformations with some tearing of the metal rather than brittle fractures, the general observed failure pattern and locations for the transport fuselage sections will be shown to be quite similar to the results of the composite frames and subfloors discussed later.

Figure 8. - Structural damage to metal aircraft structures.

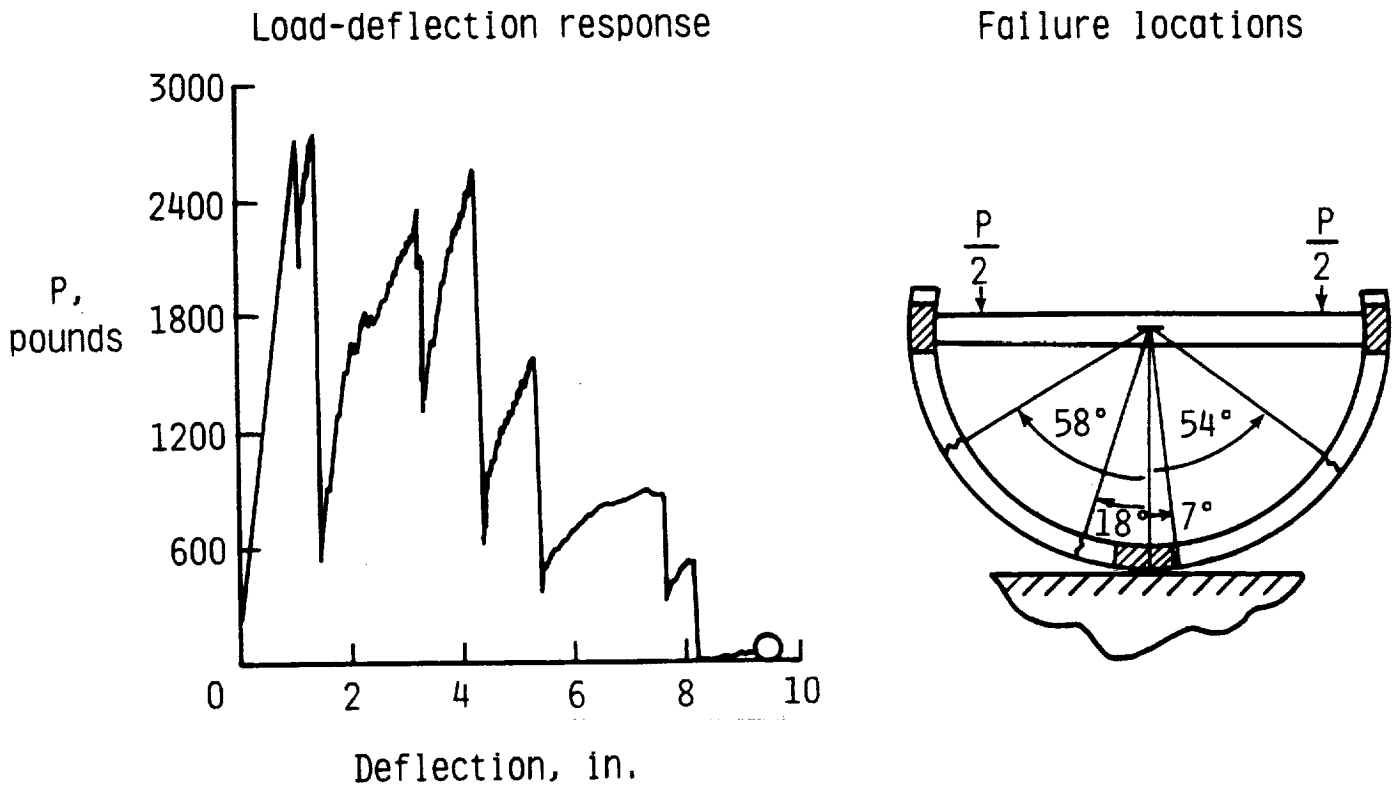
(b) Load-displacement and failure locations.

Static tests.- Figure 11 presents static results from reference 25. A photograph of the static test apparatus in figure 11(a) shows that the splice plate was at the load point, thus, the frame failed just outside the doubler splice plate area by a complete fracture across the Z-section. Load-deflection data and the location of failures of the frame are shown in figure 11(b). The load-deflection data show a saw-toothed behavior under the essentially linear behavior of the frame up to initial failure, and subsequent loading of the frame after failure being at a new, reduced stiffness for the frame as a result of that failure(s). Photographic data in figure 11(c) shows that the initial failure was induced by a local buckling of the frame

which occurred at about 18 degrees from the bottom loading point outside the splice plate area. Second and third fractures occurred up the side again at about 54 and 58 degrees under continued loading as may be noted in the sketch at the right of figure 11(b). The sequence of events was: local buckling near the splice plate induced out of plane deformations which led to a fracture of the section, the ends then remained in contact (jammed together under the compressive loads in the frame), the point of fracture moved vertically essentially in a guided manner until two additional fractures occurred farther up the frame.

Figure 11. - Static results from tests of single composite Z-frame.

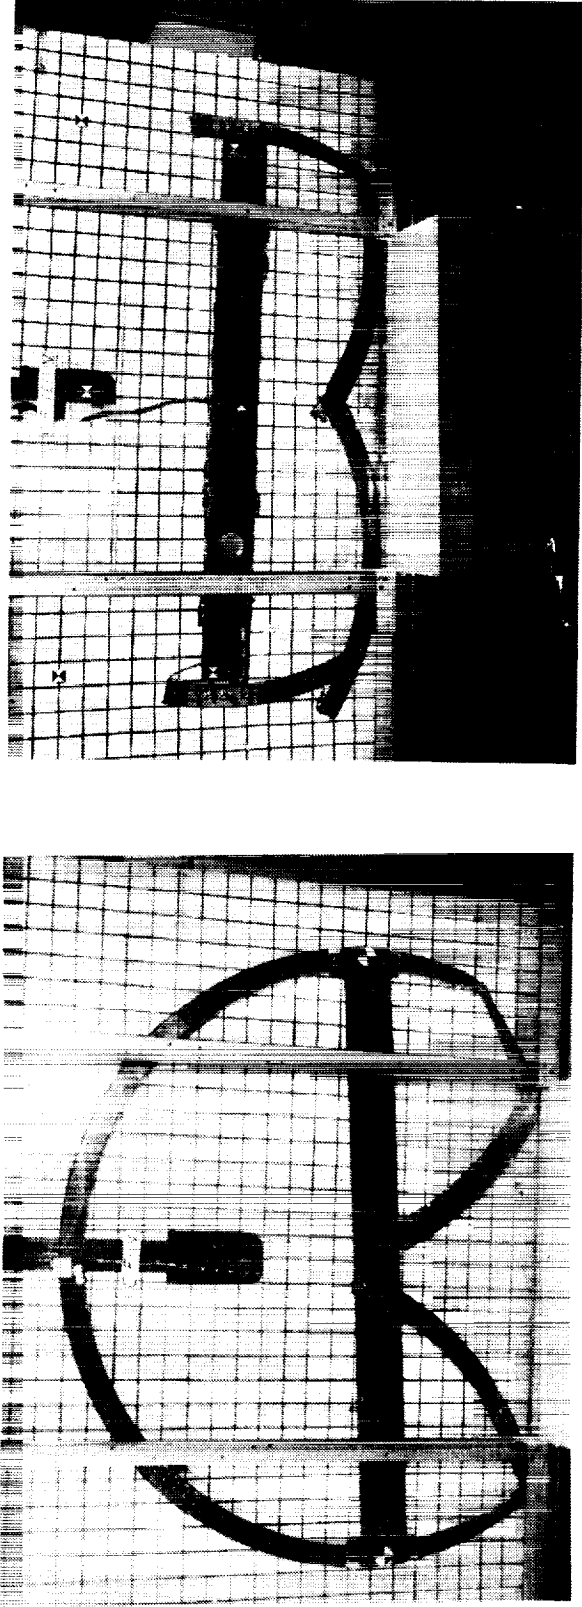
(a) Photographs of failed frames.

Dynamic tests.- Figure 13 presents results from reference 26 on the dynamic studies of the response of composite frames. As noted in figure 13(a) or (b), the splice plates joining the segments of the frame are 45 degrees up the circumference from the point of impact. As shown in figure 13(b) complete failures (fractures) of the Z-section frames occurred at the bottom and approximately 60 degrees from the bottom. Potentially, it appears that the presence of the splice plates may have influenced the locations by moving the top failure points up a few degrees to about the 60 degree locations.

Figure 13. - Behavior of composite Z-frame under dynamic loads.

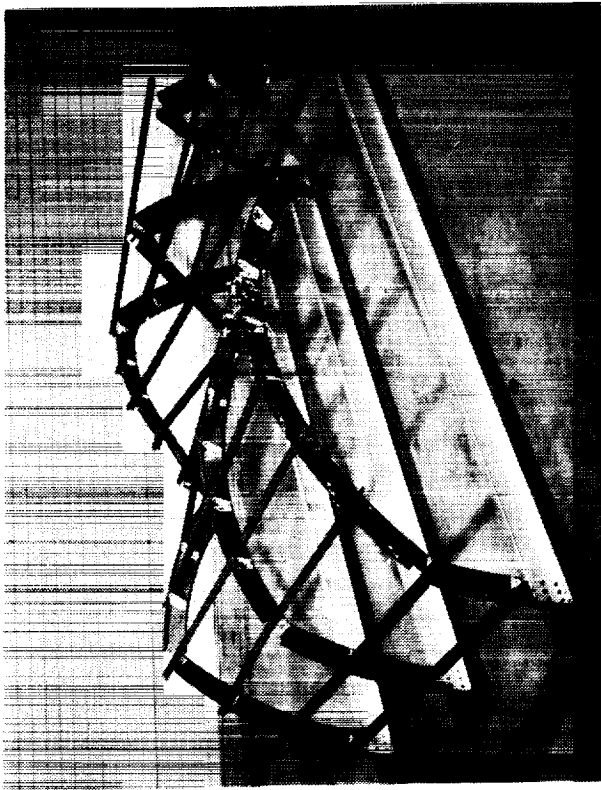
(a) Failed skeleton subfloor.

Static tests.- Figure 14 presents experimental results (Reference 27) of the skeleton subfloor specimen following a static test. As noted in figure 14(a) and (b), failures on the three Z-section frames occurred at 13 discrete locations. Unlike the unnotched single Z-frame, the failures in this specimen occurred at notches (which served as stress risers) in the frame through which the stringer passed. However, as shown in figure 14(b) the failures were still near the point of load application (approximately 12-14 degrees) and at other circumferential locations of approximately 55 degrees. In the absence of skin material, twisting and bending out-of-plane occurred with the frames. The stringers had minimal effect on the subfloor response with the exception of maintaining the lateral spacing of the three Z-frames.

Figure 14. - Behavior of composite skeleton subfloor under static loading tests.

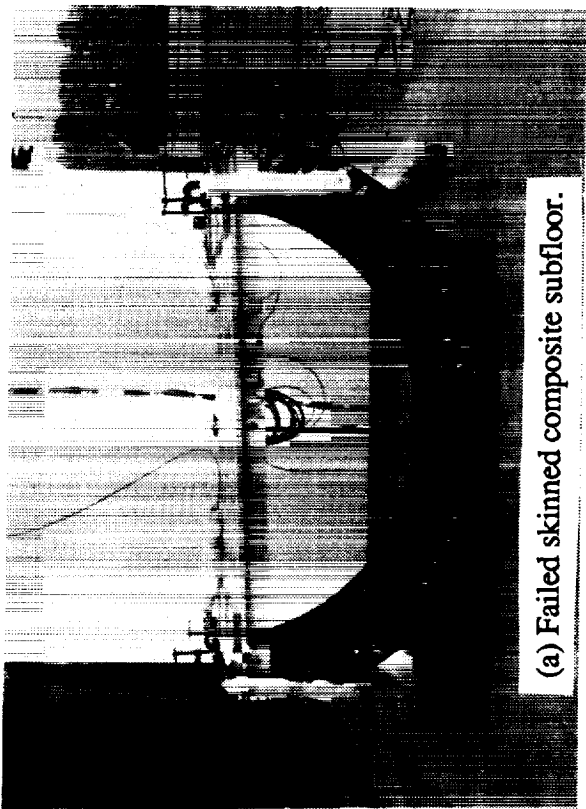
Figure 16 presents impact results for the subfloor with skin after an impact of 20 feet per second. Figure 16(a) is the

subfloor specimen after the test. Points of failure of the frames in this specimen are indicated in figure 16(b). Again the points of failure are at/near the impact point (within 12 degrees) and circumferentially at about 56 degrees up both sides of the frame on the middle and back frame and 45, 12 and 22.5 degrees on the front frame. It was observed that the subfloor impacted first on the front area which possibly explains the 12 and 22.5 degree fractures being different from the other locations. Again all three frames were involved in the failures. Some delamination of the frames from the skin was evident but the skin remained intact. Figure 16(c) is a normalized strain distribution (just prior to first failure) measured on the first (end) frame during the dynamic test. A comparison of the distribution to the moment distribution of Figure 12(b) and (c) and the strain distribution in Figure 16(c) shows essentially identical shape as the single frame and skeleton frame distributions. As was the case for the skeleton subfloor maximums at 0 degrees and at approximately 50 to 55 degrees agree well with the analytically predicted locations on the frame.

Figure 16. - Behavior of skinned composite subfloor under dynamic loading tests.

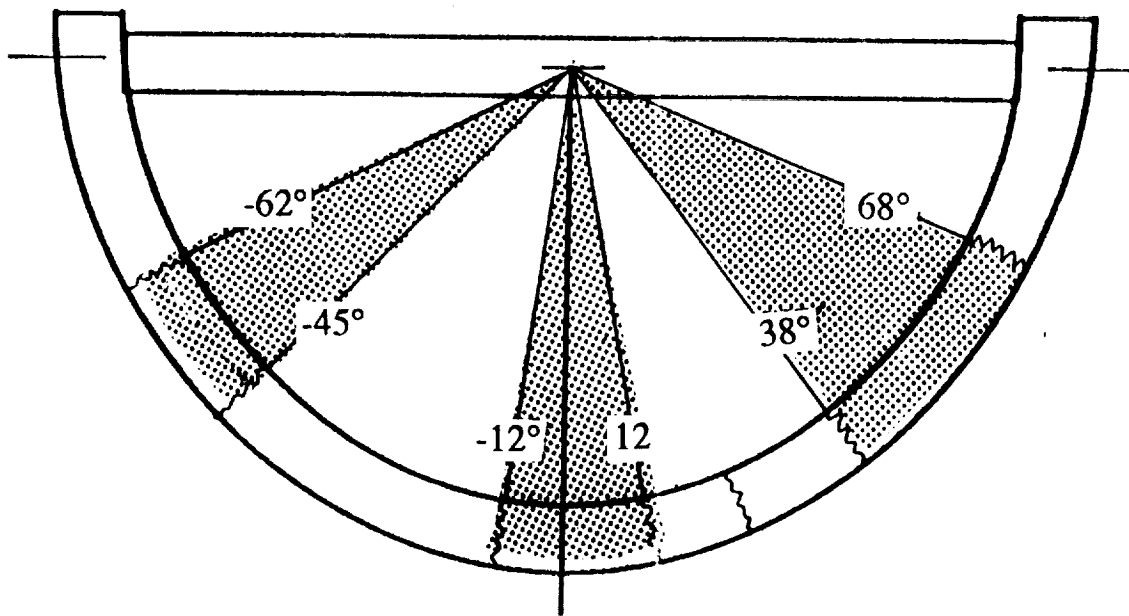
(b) Failure locations.

The response behavior determined during the studies of full-scale aircraft sections, fuselage frames, and subfloors are summarized in figure 18. Figure 18(a) shows normalized moment distribution on a representative frame of the various specimens and Figure 18(b) shows the failure locations which were noted from static or dynamic tests. The visual impression is quite striking among the various specimens. It is suggested that from the results of simpler frames to the more complex subfloors and full-scale sections, a strong similarity is evident in the failure behavior of the structures. The structures share in common the generally circular or cylindrical shape, the normal

loading situations, and what appears to be a similar pattern of failure behavior. Analytical models of frame structures under vertical loads have moment distributions which have maximums at the point of loading and at approximately 45 to 50 degrees (depending on boundary conditions) around the circumference from the ground contact point. Failures of the structures were noted at these same locations. Such observations can help dynamists gain a better understanding of what to expect from such structures in crash loading situations, can guide designers of new structures to better account for the vertical crash loads, and allow better energy absorption to be included in the new designs. Additionally, the observations can help analysts better model the aircraft structures for predicting the failure responses and behavior under crash situations. The latter task is a difficult and challenging one, not only for composite structures but for metal structures as well. Studies are currently underway to improve the analysis capabilities of code and to add composite elements to finite element libraries such as the DYCAST program. In addition, new analysis approaches are being explored through grants to universities as an extension of NASA Langley Research Center's efforts.

Figure 18. - Comparison of nondimensional analytical moment distribution predicted by finite element frame model and observed failure locations on metal and composite fuselage components and structures.
