JPL Publication 89-35

Galileo Report 1625-429

# Magellan/Galileo Solder Joint Failure Analysis and Recommendations

September 15, 1989

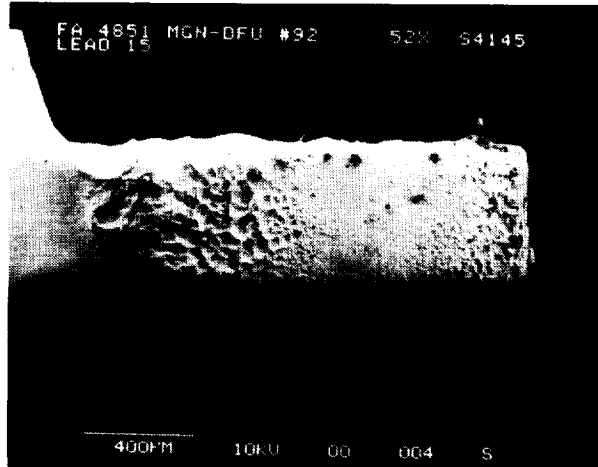
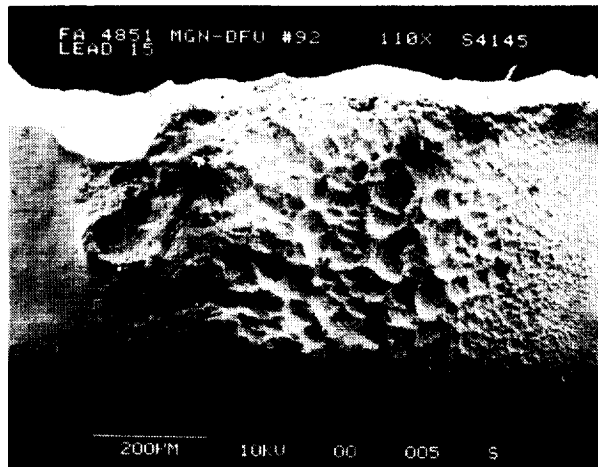
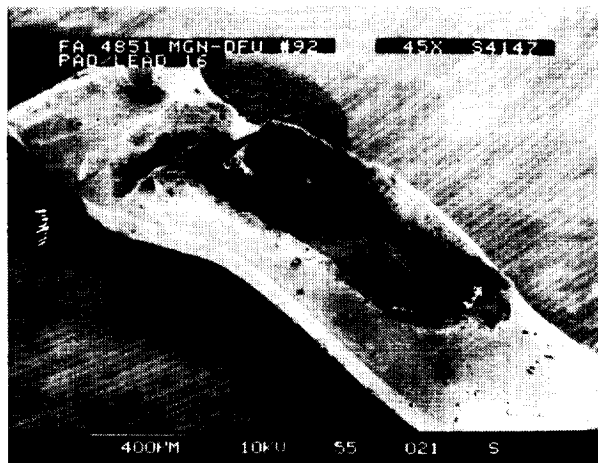
In the subsequent scanning electron microscope (SEM) analyses of the failed leads, the solder fracture surfaces displayed good lead wetting and good elongation at break (Fig. 5). This indicates that the solder joints themselves were not at fault, but that excessive forces are the most likely cause of failure. Another interesting finding was that all of the leads on the opposite side (pins 1 to 8) of the failed DIP were in excellent condition as shown in Fig. 6.

Fig. 5. SEM photographs showing good solder fracture properties of foot and pad from failed (pin 15 and 16) solder joints

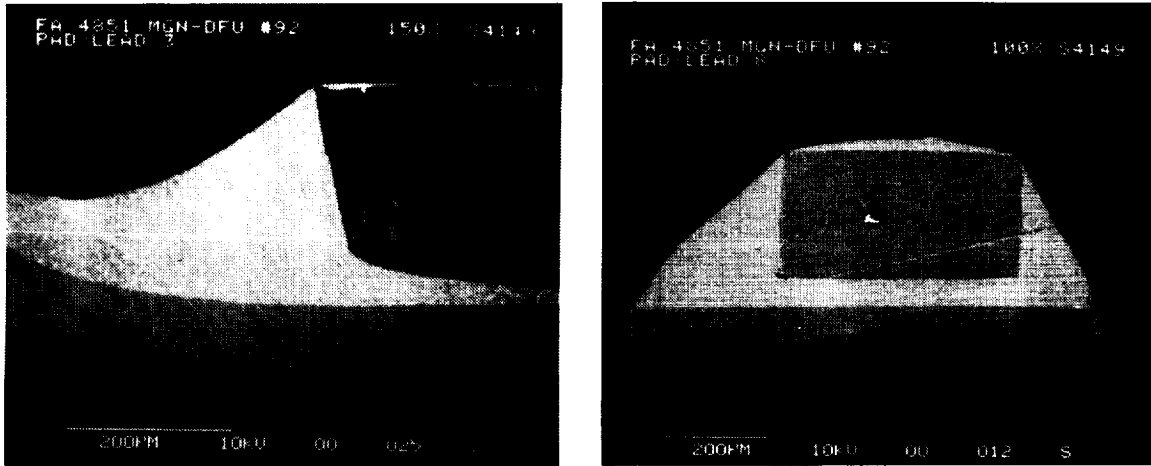
Fig. 6. SEM cross-sections showing excellent solder joints on opposite side (pins 3 and 8) of DFU part that failed open-circuit

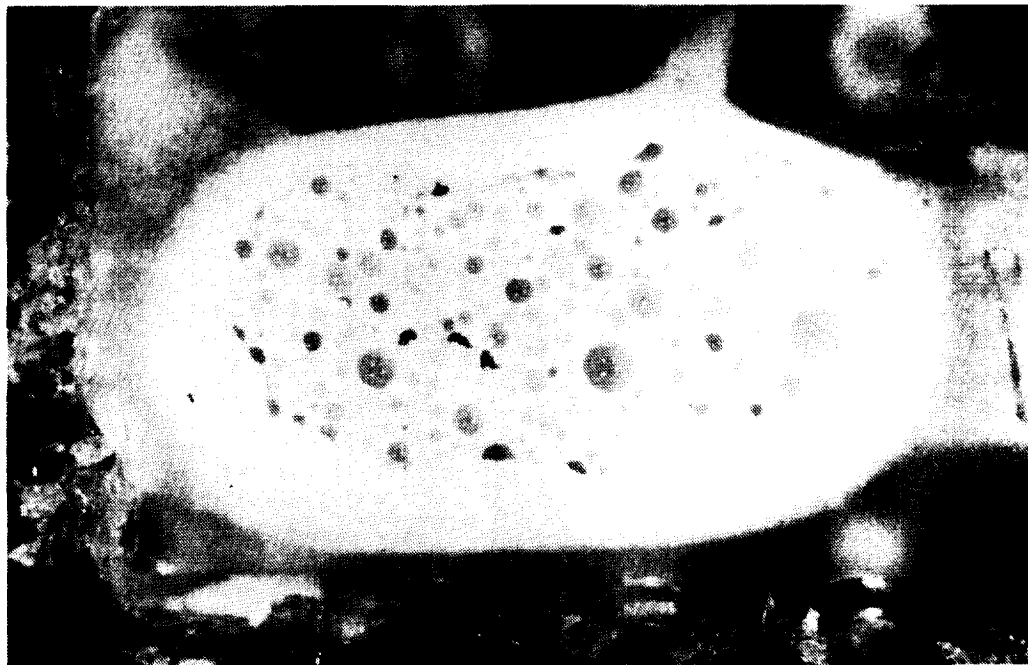
Fig. 11. Foamy nature of alumina-filled Solithane under flight DIP

flight part. Although it was determined that most of the observed foaming is due to air entrapped during mixing, entrained moisture (either adsorbed from the air during mixing, or desorbed from the alumina filler powder) can cause a chemical reaction with the Solithane that produces CO<sub>2</sub> gas evolution similar to that in a rising cake [4]. Although this application technique leaves the solder joints easily inspectable, which was the reason behind its original choice, **the high level of stressing associated with this process as it is presently implemented makes it unsuitable for further use.**

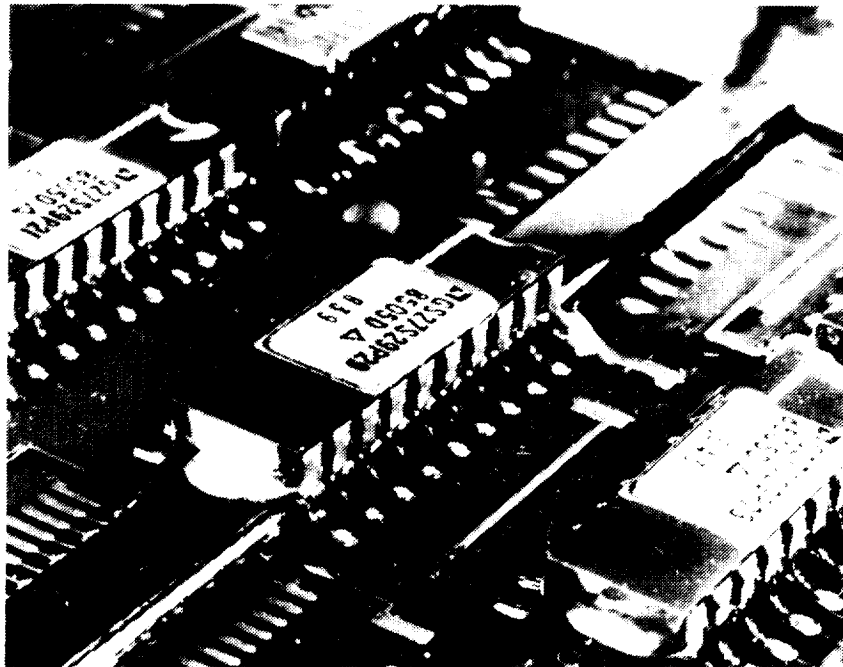
Copper Heat Sinks beneath DIPs - This construction, shown in Fig. 13, behaved almost identically to the alumina spacers--modest stressing with the stress propagating along the foot, but generally stopping short of the toe region. **Like the alumina spacers, this construction technique is considered marginal, but acceptable for flight environments with minimal thermal cycling. Research should be carried out to further reduce the modest levels of observed stressing with this construction.**

Fig. 13. DIPs mounted over 0.060" copper heat sinks

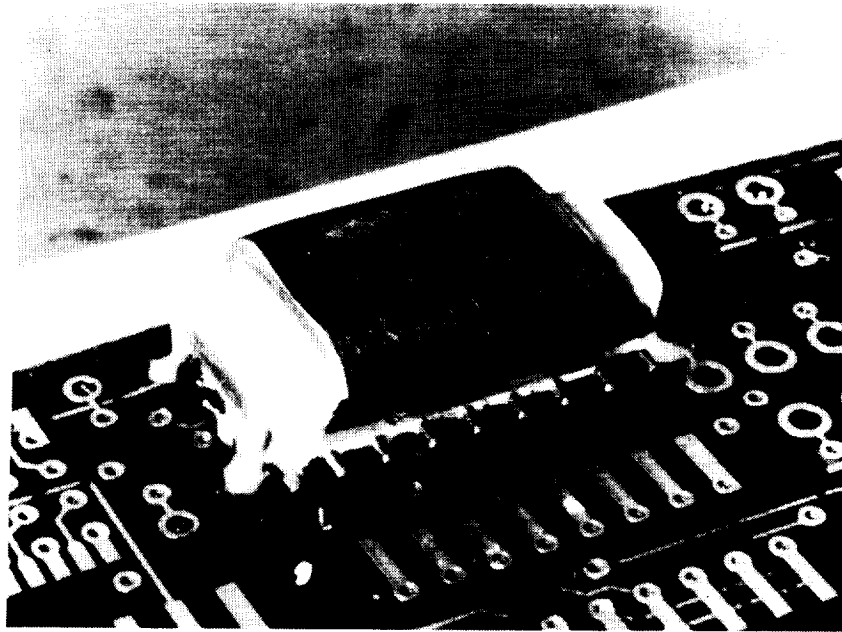
Radiation Shields - This construction, shown in Fig. 14, exhibited no significant solder-joint stressing, i.e. it was similar to the post applied alumina-filled Solithane. Inspection of the solder-joint heels was obscured by alumina-filled Solithane that extrudes from beneath the package.

Fig. 14. DIP mounted with Tantalum radiation shield

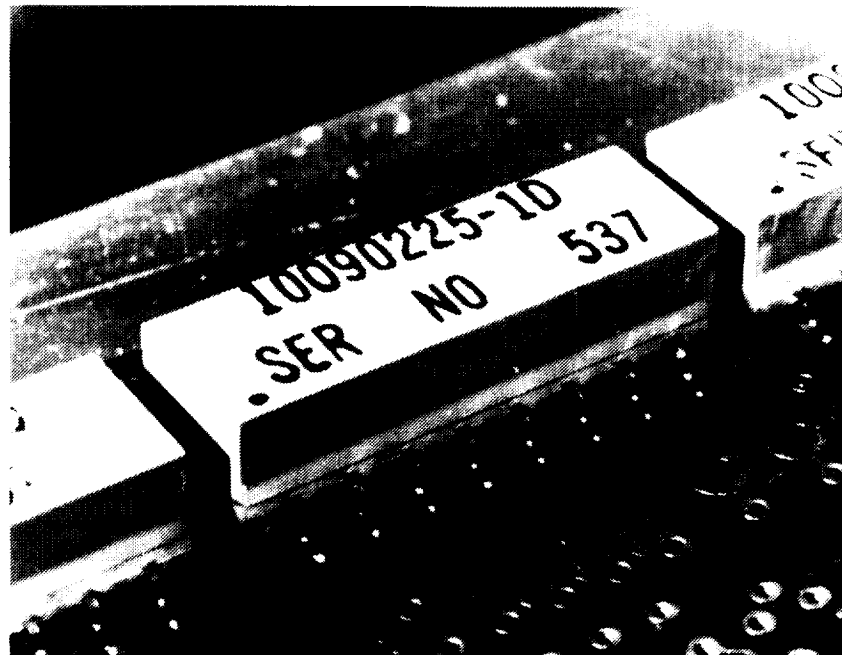
Interface Transformers - Interface transformers, shown in Fig. 15, are packaged in a special 16-pin DIP with a different high-compliance lead bend as compared to conventional IC DIPs. As a result, the package sits much closer to the board (only 0.020" to 0.030" gap) and can accommodate some vertical (normal to the board) motion. Although heavy stressing of end leads (typically pins 1, 8, 9 or 16) was sometimes observed, the problem could not be reproduced in testing. Most flight interface transformers were found to be free of stressing. It is suspected that the random cracking of end leads with this construction may be caused by the manner in which the leads were held during soldering; it is well known that if leads are held down (elastically deformed) during soldering, they are likely to subsequently crack due to creep-rupturing of the solder under the applied spring load as the leads attempt to return to their unstressed position. This type of failure is generally of a random nature (individual isolated leads), and the crack generally initiates at the toe and progresses toward the heel.

Fig. 15. JPL DIP interface transformer package

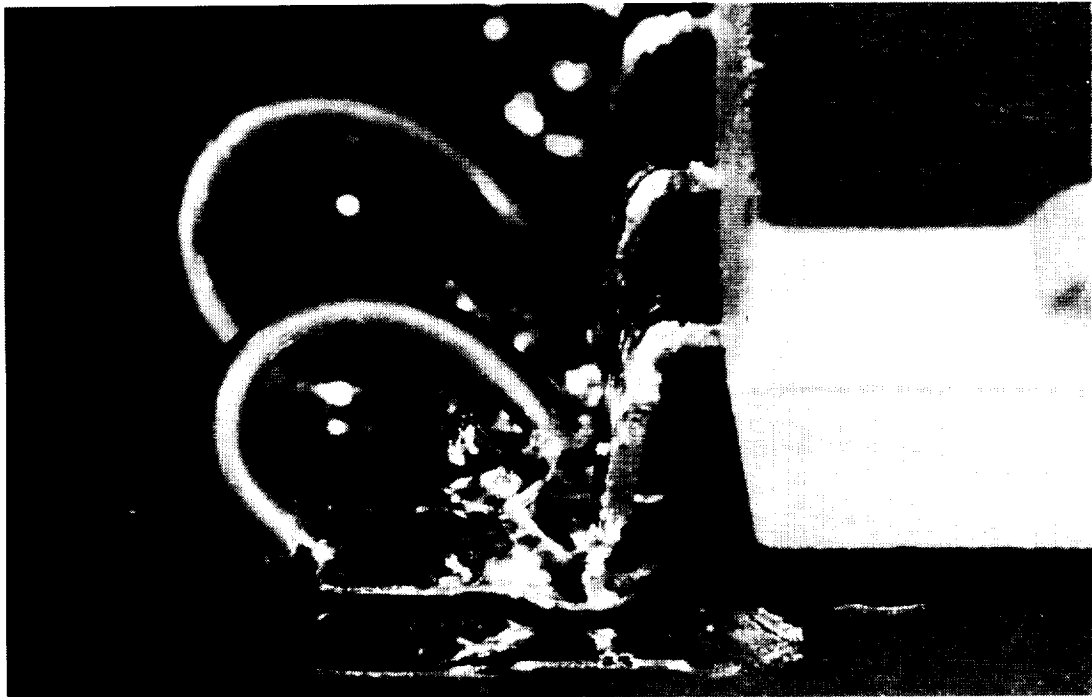
Fig. 17. Application of hay-wire strain relief loops on Magellan DIPs

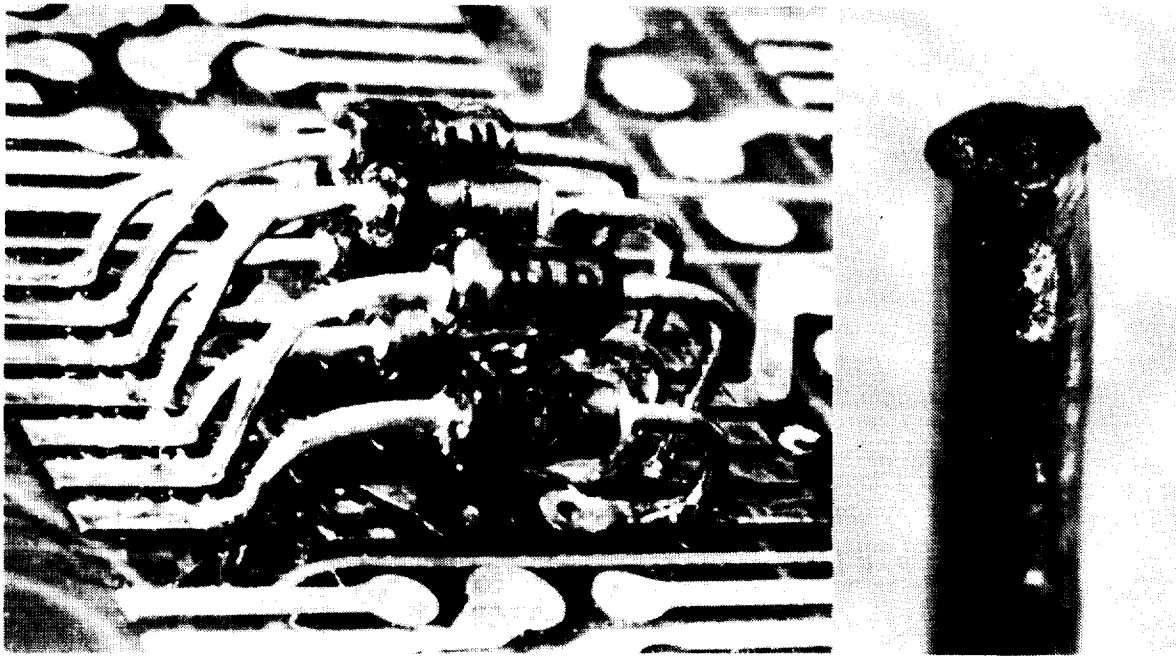
Fig. 27. Stub-mounted diodes used as substitute for unavailable diode flat-pack, and example of failed lead with no solder fillet

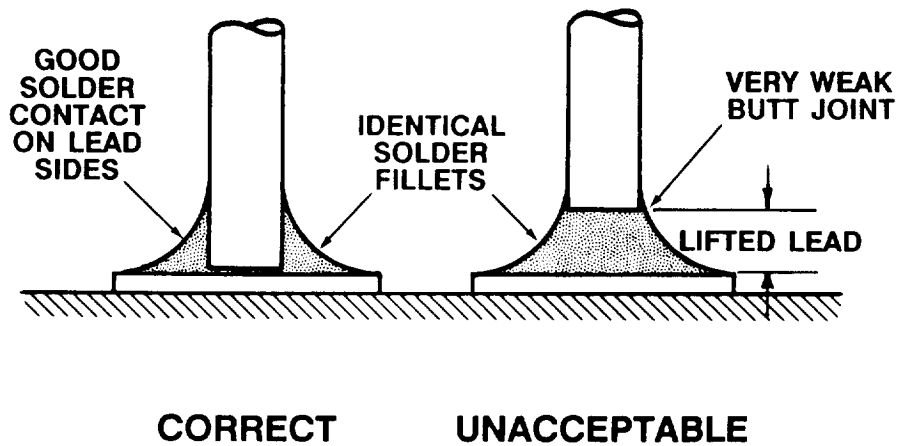
Fig. 28. Problem of poor inspectability of solder fillet on stub-mounted lead
