TWR-19899

Qualification of Improved Joint Heaters Final Test Report

14 September 1989

Thiokol CORPORATION
SPACE OPERATIONS

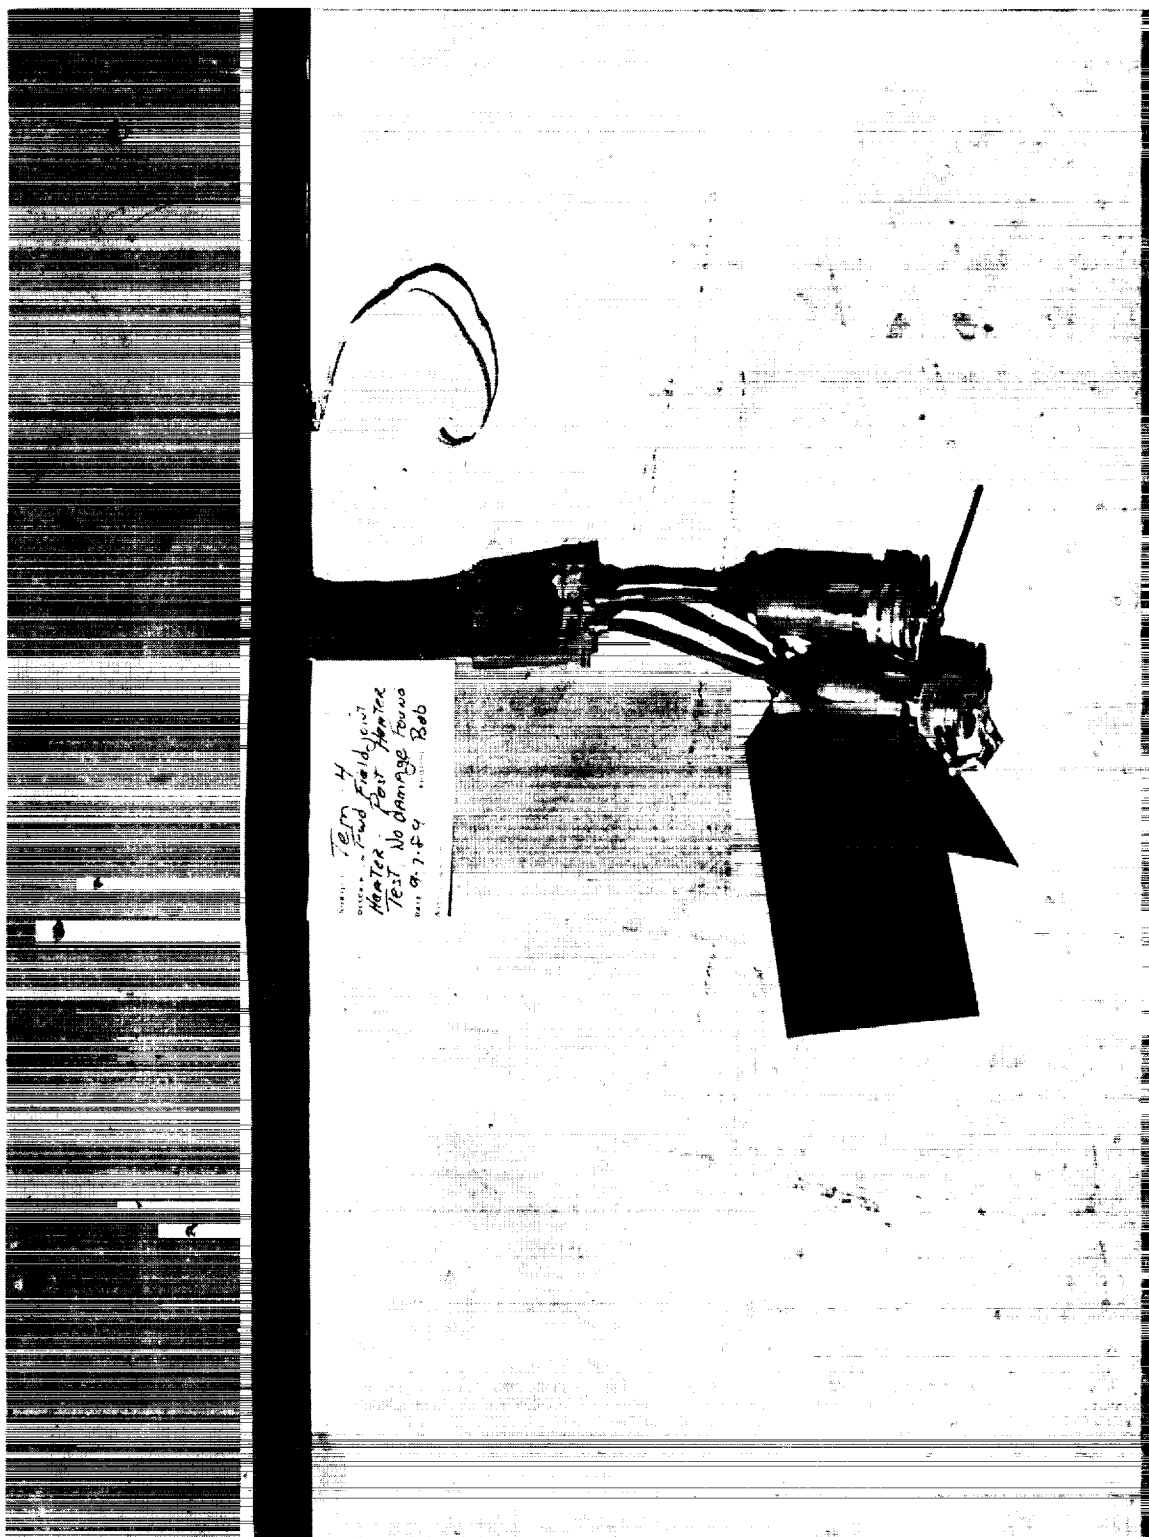
Figure 4. Field Joint Heater (Post-Test)

For the field joint heater disassembly, a section of extruded cork was first cut away to provide access to the Kevlar® straps and moisture seal. Both Kevlar® straps were then cut and an axial cut was made through the moisture seal. The moisture seal (and cork) was then stripped circumferentially from the motor. This exposed the heater for inspection and removal. The heater was inspected prior to removal and no anomalies were observed. The heater was then carefully removed and cleaned to remove the residual heat transfer cement. After cleaning, the field joint heater was inspected and no discolorations or any other anomalies were found (Figure 4).

TEMP. H
FIELD JOINT
HEATER POST HEAT
TEST NO DAMAGE FOUND
DATE 9-7-89
BY Bob
