NASA Technical Memorandum TM 102153

Debris/Ice/TPS Assessment And Photographic Analysis For Shuttle Mission STS-34

November 1989

October 18, 1989

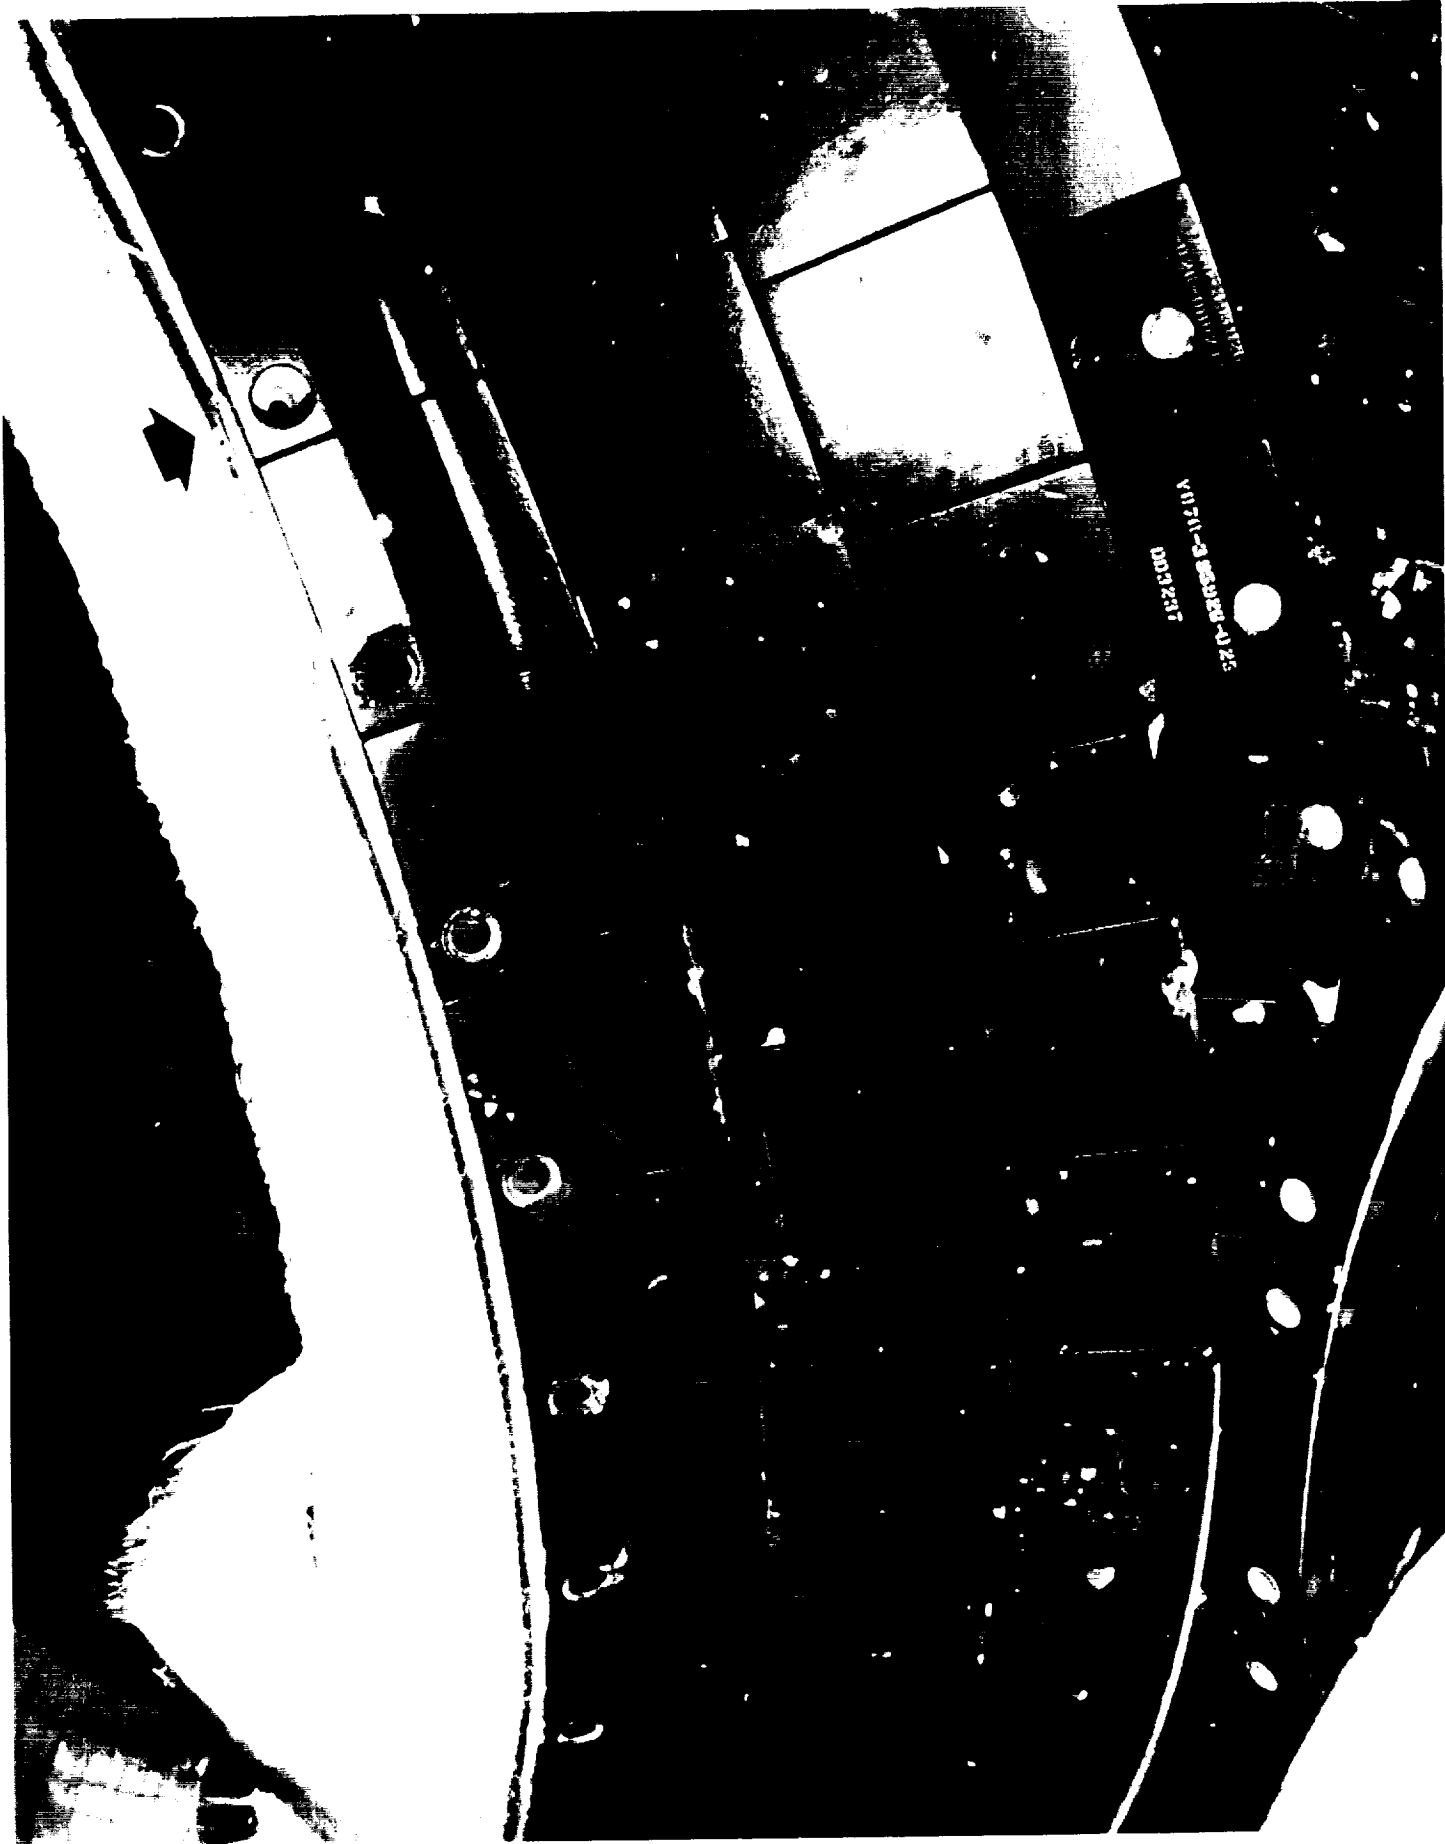
A bolt washer and retaining insert were missing from
SSME #2 carrier panel

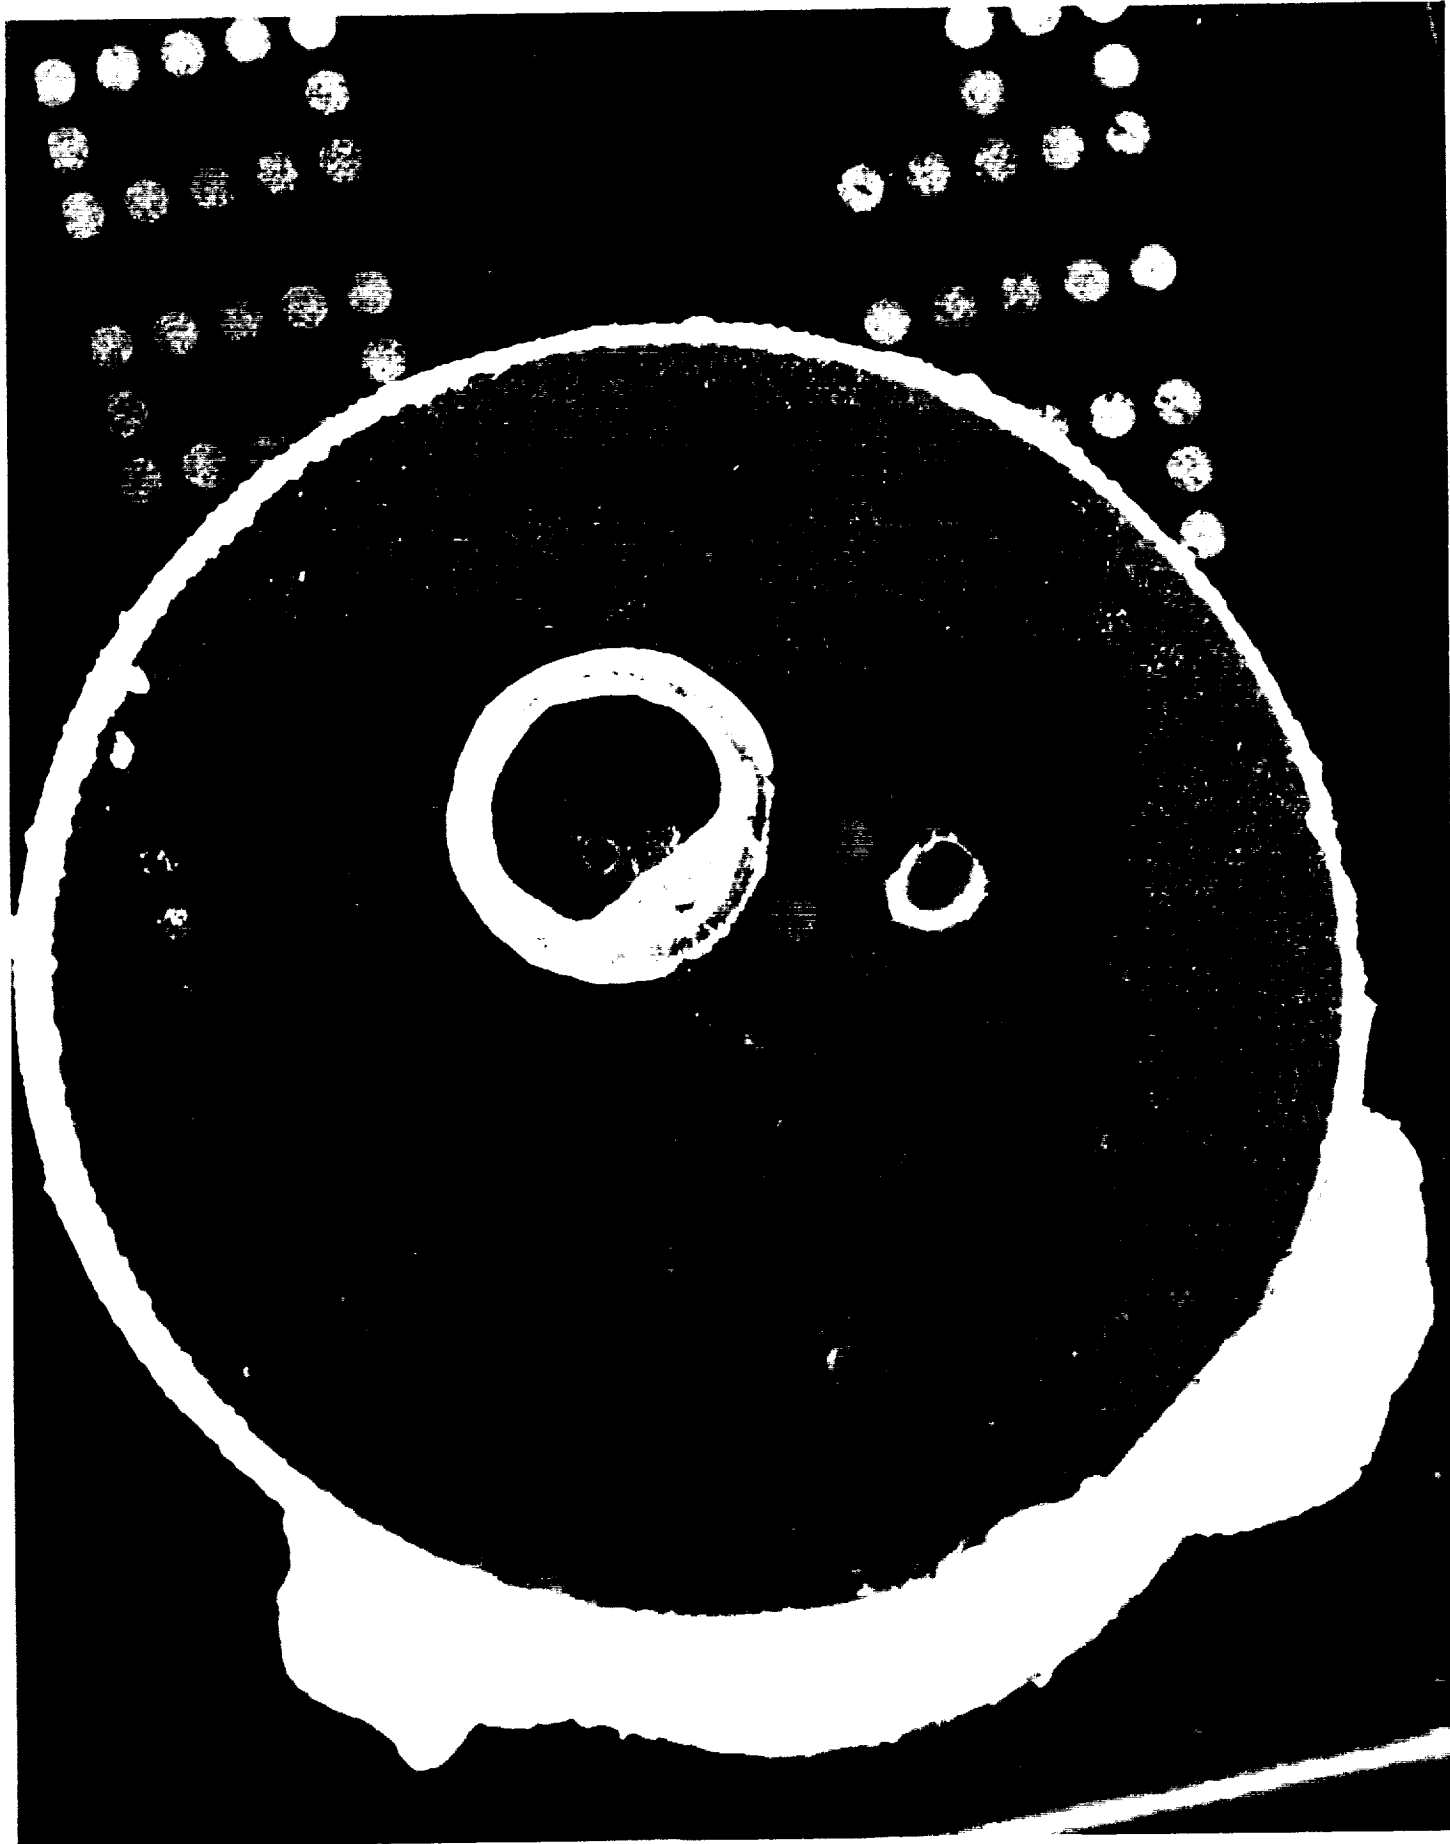
On-orbit micrometeorite impact in a tile repair area

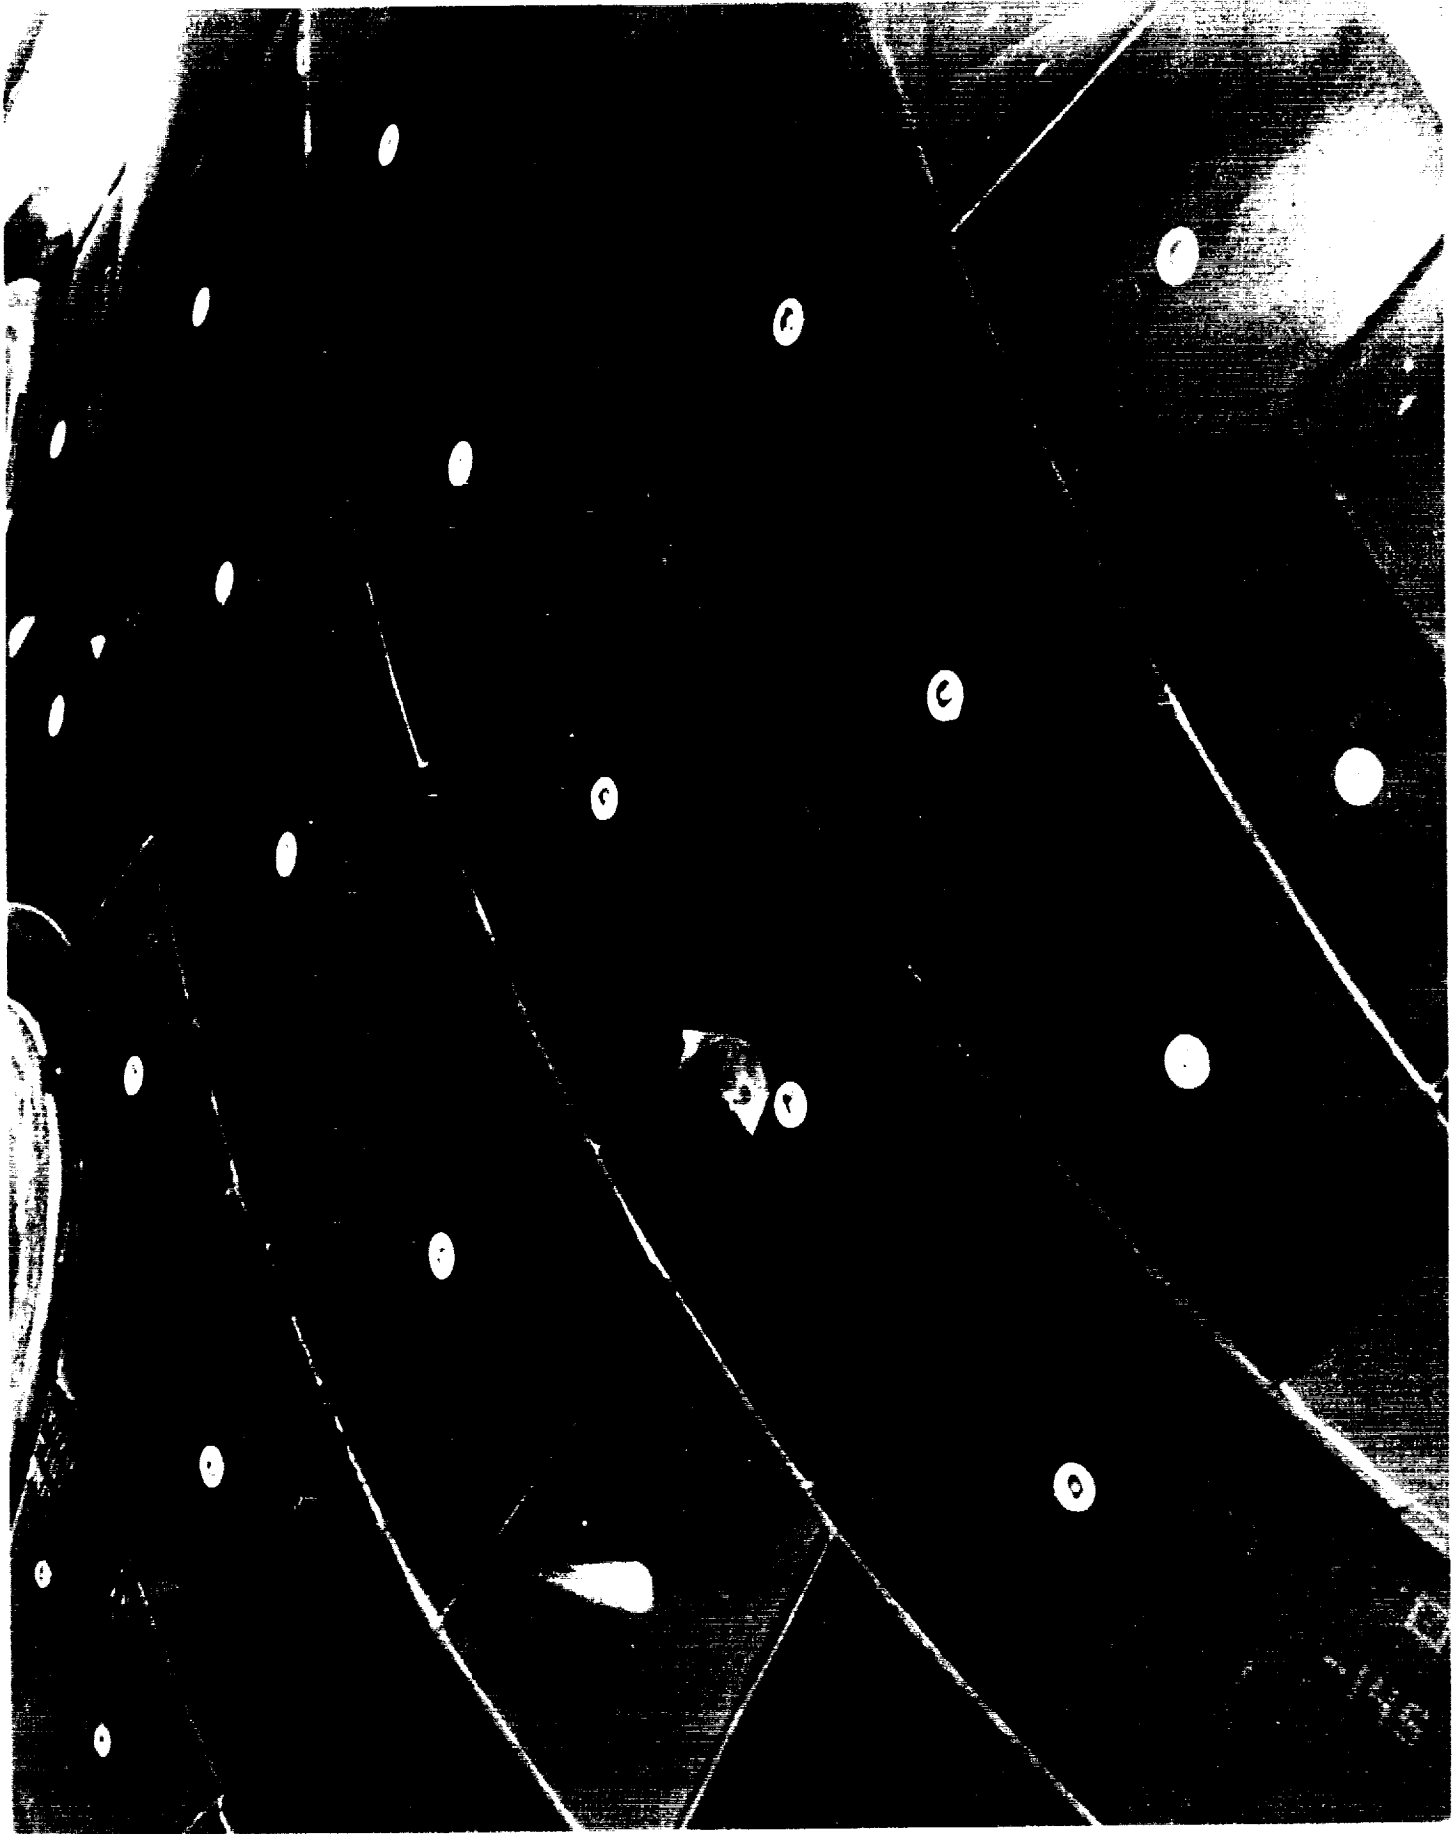
Piece of tape adhering to forward RCS tile
