# RETURNED SOLAR MAX HARDWARE DEGRADATION STUDY RESULTS

Jack J. Triolo  
Gilbert W. Ousley  
Goddard Space Flight Center

## ABSTRACT

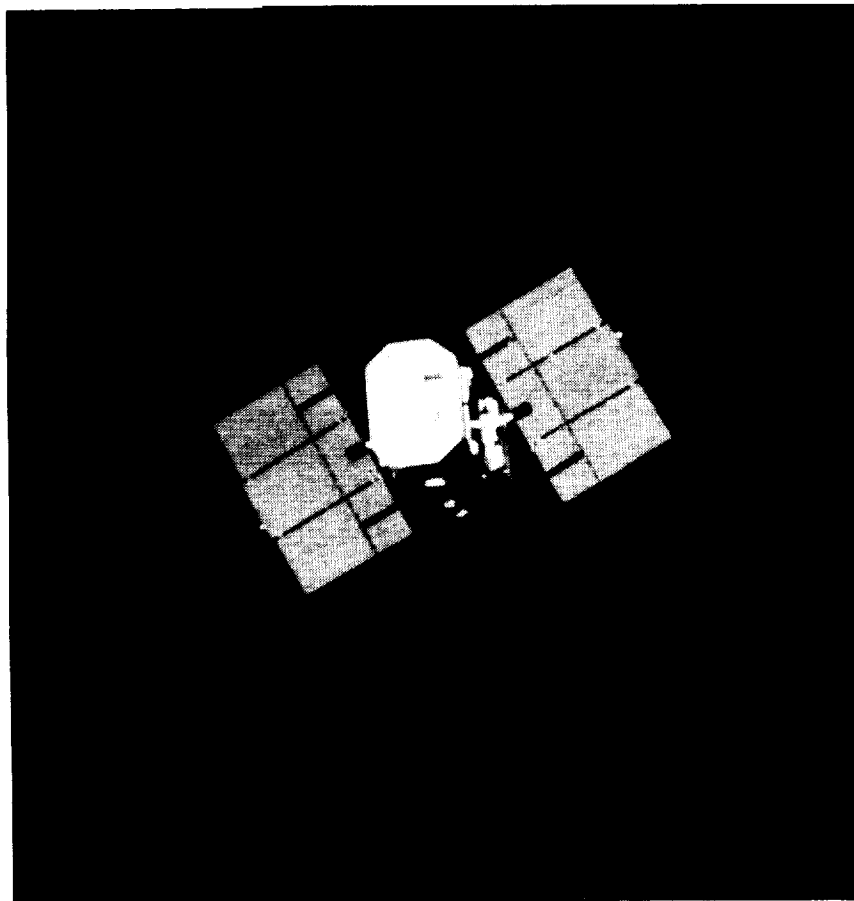
SMM as seen by the Sun in the post-failure attitude (15° wobble).

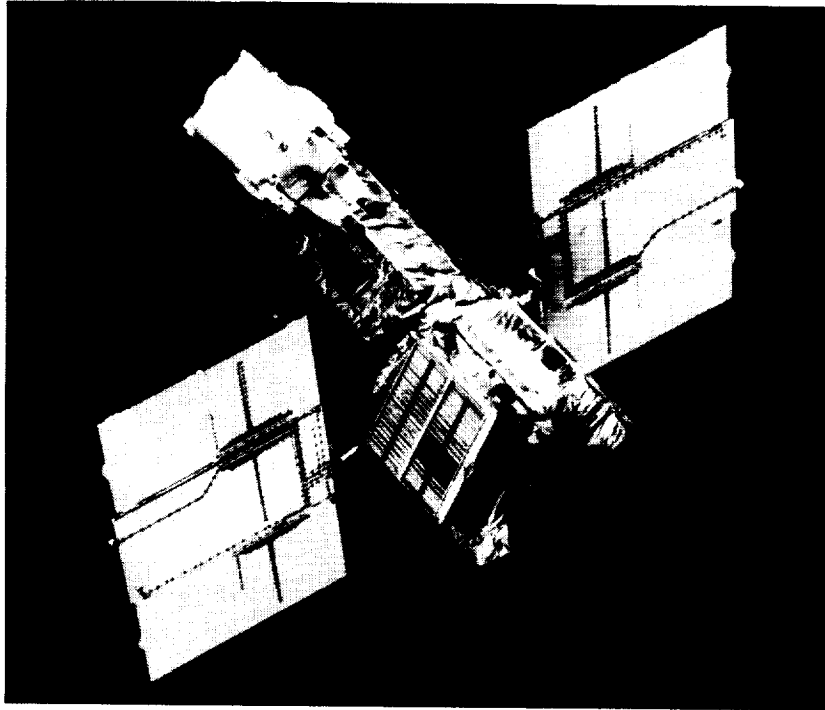
View of MACS module after unsuccessful dock attempt. Most louvers are closed. Degradation of the bottom-facing trim (Teflon) can be seen.
