NASA Technical Memorandum 101418

Failure Analysis of a Stirling Engine Heat Pipe

March 1989

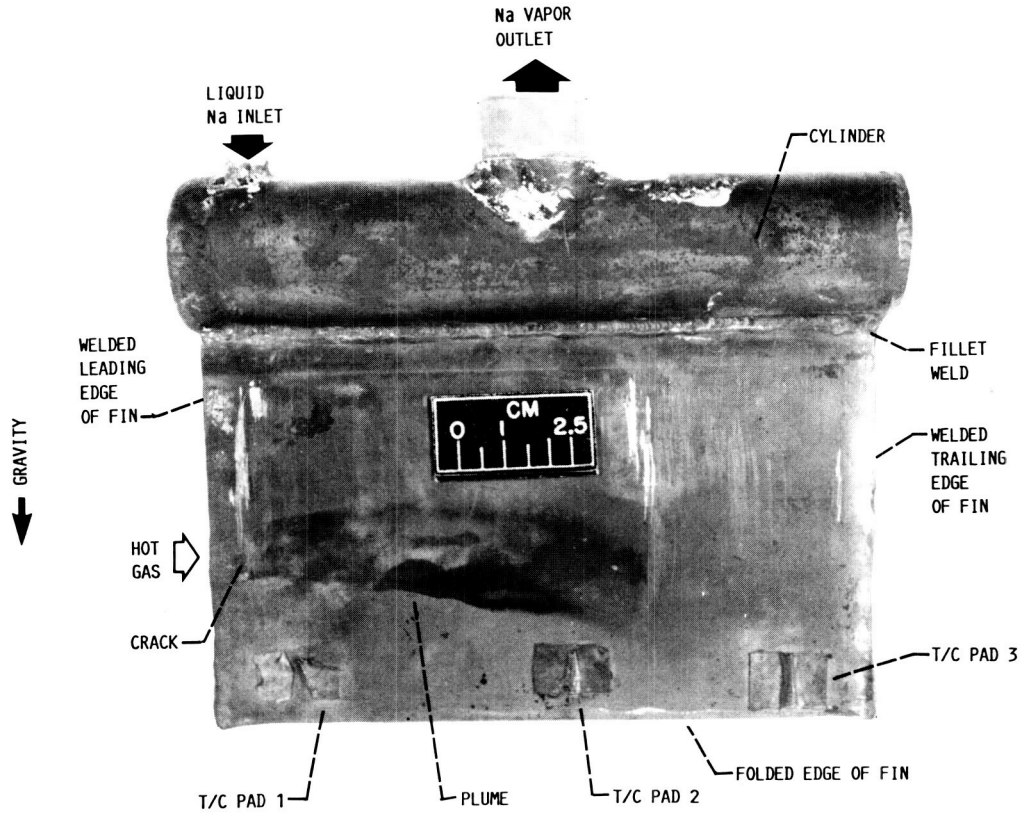
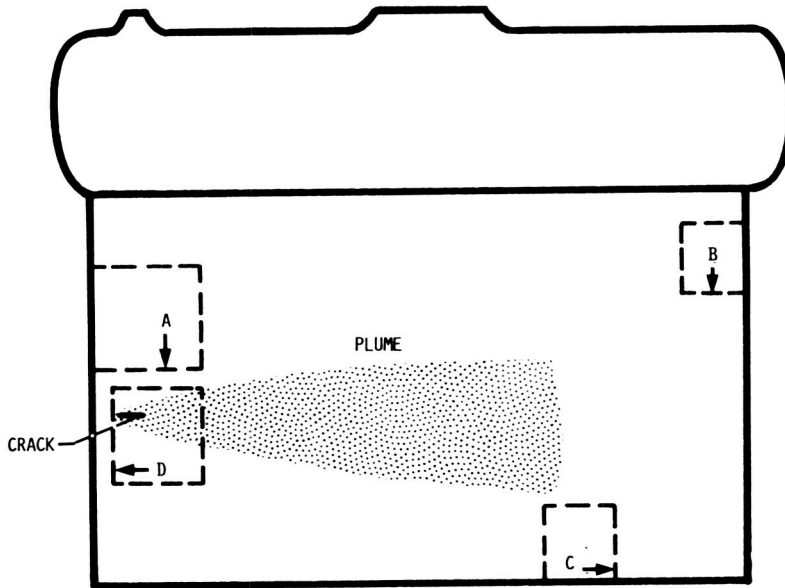
A photograph of the outer surface of the through-the-wall crack (from fig. 1) is shown in figure 3(a). Cracking, which initiated at the inner surface, extended through the thickness to the outer surface about 2.3 mm from the leading edge. The total length of the crack at the outer surface was about 4.3 mm. At cross-section A-A (fig. 3(b)), the crack does not quite extend to the outer surface. But, a little further back from the leading edge it did reach the outer surface and permitted air to enter the heat pipe. The air-contaminated Na coolant and corrosion products leaked to the outer surface and deposited a residue there (fig. 3(b)).

FIGURE 1. - EVAPORATOR PORTION OF A FINNED CYLINDER HEAT PIPE SHOWING CRACK LOCATION WHERE THE Na WORKING FLUID LEAKED TO THE ATMOSPHERE. LOCATIONS AND VIEWING DIRECTIONS FOR METALLOGRAPHIC EXAMINATION ARE SHOWN ON THE SKETCH.

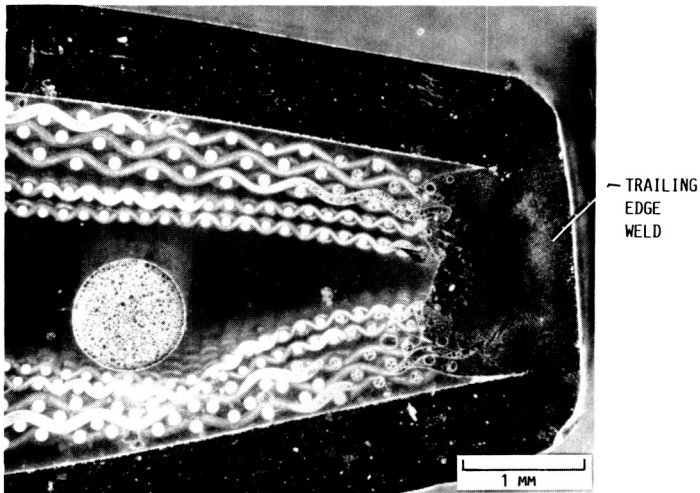
At the trailing edge, location B in figure 2, no corrosion of the wick or fin was evident. Thus, the wick exhibits an as-fabricated appearance. As shown at location C in figure 2, continuity of the wick at the folded edge of the fin permitted complete access of the Na coolant to this region of the fin. No corrosion was evident at location C.

LOCATION B. TRAILING EDGE SHOWING WELD PENETRATION INTO WICK AREA.

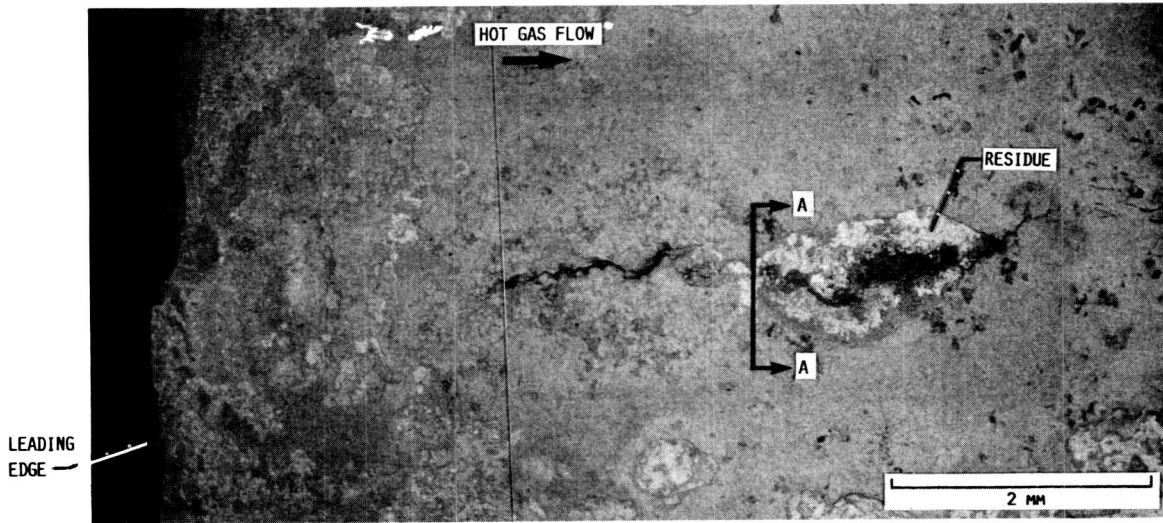
(a) EXTERNAL SURFACE OF THE FIN WITH CRACK NORMAL TO THE WELDED LEADING EDGE.

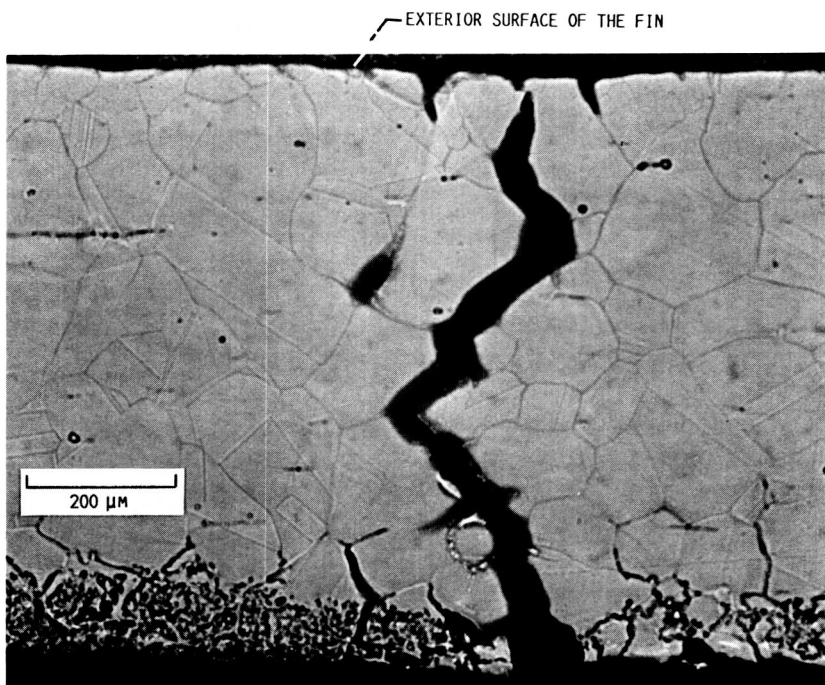
The intergranular nature of the corrosion cracking is evident in figure 4. The crack developed in the area of general corrosion at the inner surface of the fin and proceeded to the outer surface. Since the pressure within the fin was below atmospheric pressure, a slight tensile stress would be produced at the inner surface and it would contribute to a stress corrosion effect. Severe corrosion of the Type 316 wick materials also occurred near the overheated leading edge of the fin. At location A, shown in figure 5, the intergranular attack resulted in disintegration of the wire screen. It was not surprising to find the severe corrosion of fin and wick materials since the localized area at the leading edge of the fin was estimated to have been operating at about 1350 K. Under these conditions the Na was in the gaseous rather than the liquid state. At much lower temperatures in pumped Na loops, Devan (ref. 1)

(a) CROSS SECTION OF THROUGH-THE-WALL INTERGRANULAR CRACK IN THE FIN.

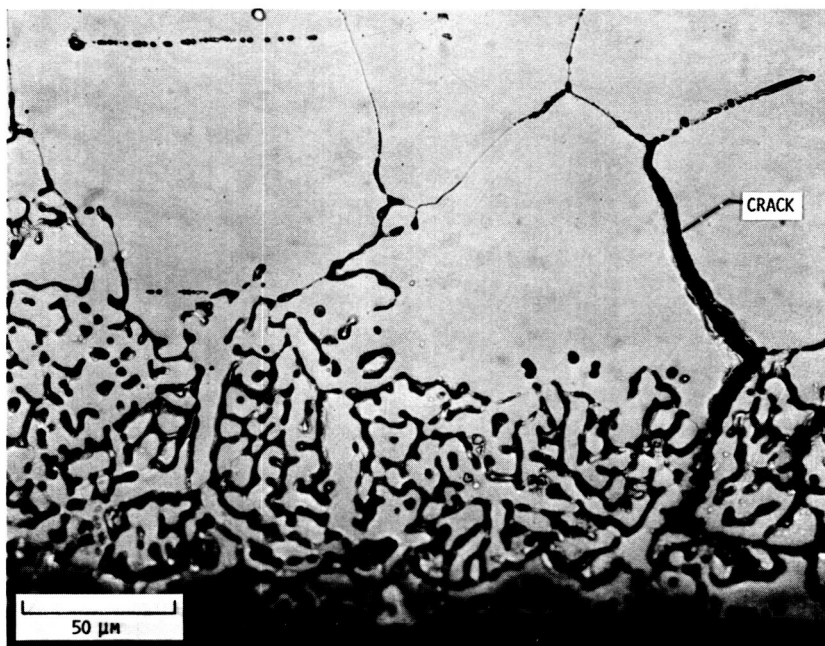
(b) CORRODED AREA AND INTERGRANULAR CRACKING AT INNER SURFACE OF THE FIN.

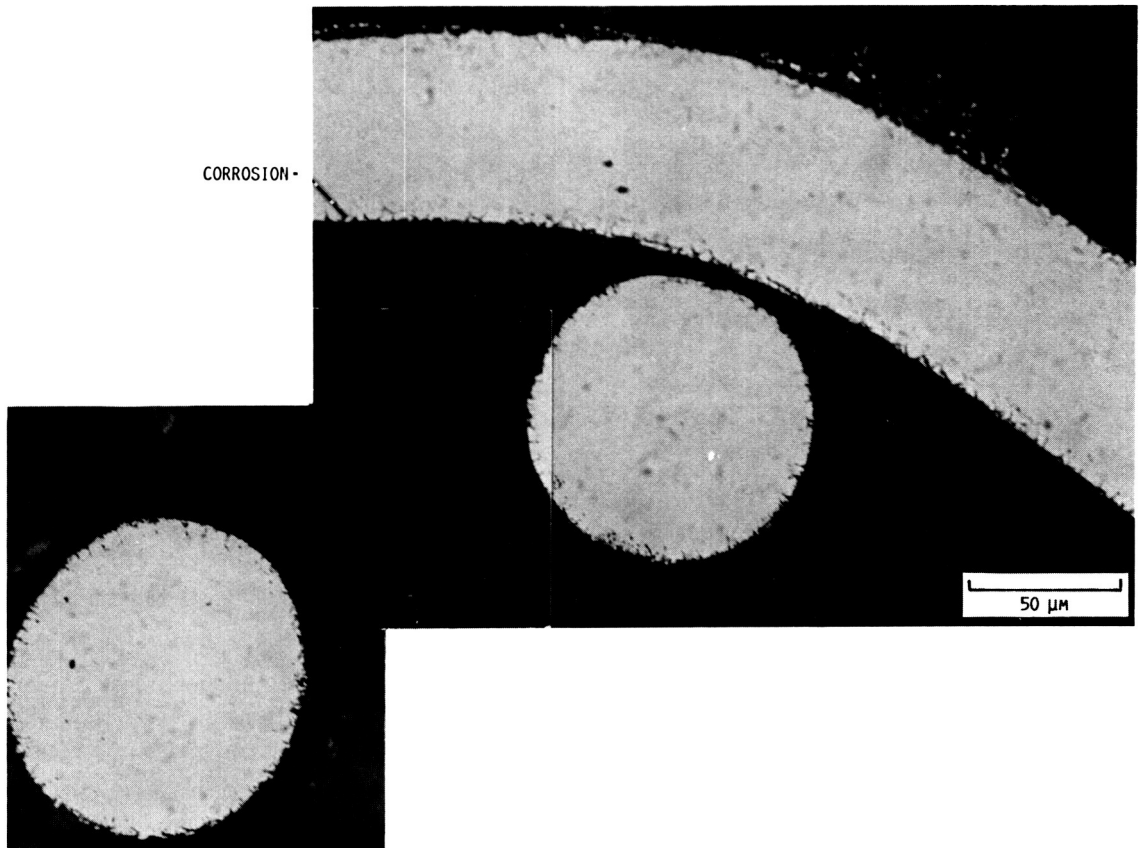
At location B (fig. 5) at the trailing edge, intergranular corrosion also occurred, but only to a depth of 10 μm in both the Type 316 wire screen and in the Inconel 600 fin. A lesser degree of attack (5 μm deep) took place at the folded side of the fin (see location C in fig. 5). Even though the extent of corrosion is very slight these results show that Inconel 600 and Type 316 stainless steel are susceptible to corrosive attack at the 1073 K design temperature.

LOCATION C. INTERGRANULAR CORROSION TO A DEPTH OF ONLY 5 μm IN THE TYPE 316 STAINLESS STEEL SCREEN LOCATED AT THE FOLDED SIDE OF THE FIN.
