NASA CR-179645

**VOLUME II  
MATERIALS FOR ADVANCED TURBINE ENGINES  
(MATE) - PROJECT 4  
EROSION RESISTANT COMPRESSOR AIRFOIL COATINGS  
FINAL REPORT**

**UNITED TECHNOLOGIES CORPORATION  
Pratt & Whitney  
Engineering Division**

**Prepared for  
National Aeronautics and Space Administration  
Lewis Research Center  
Contract NAS3-20072 - Project 4**

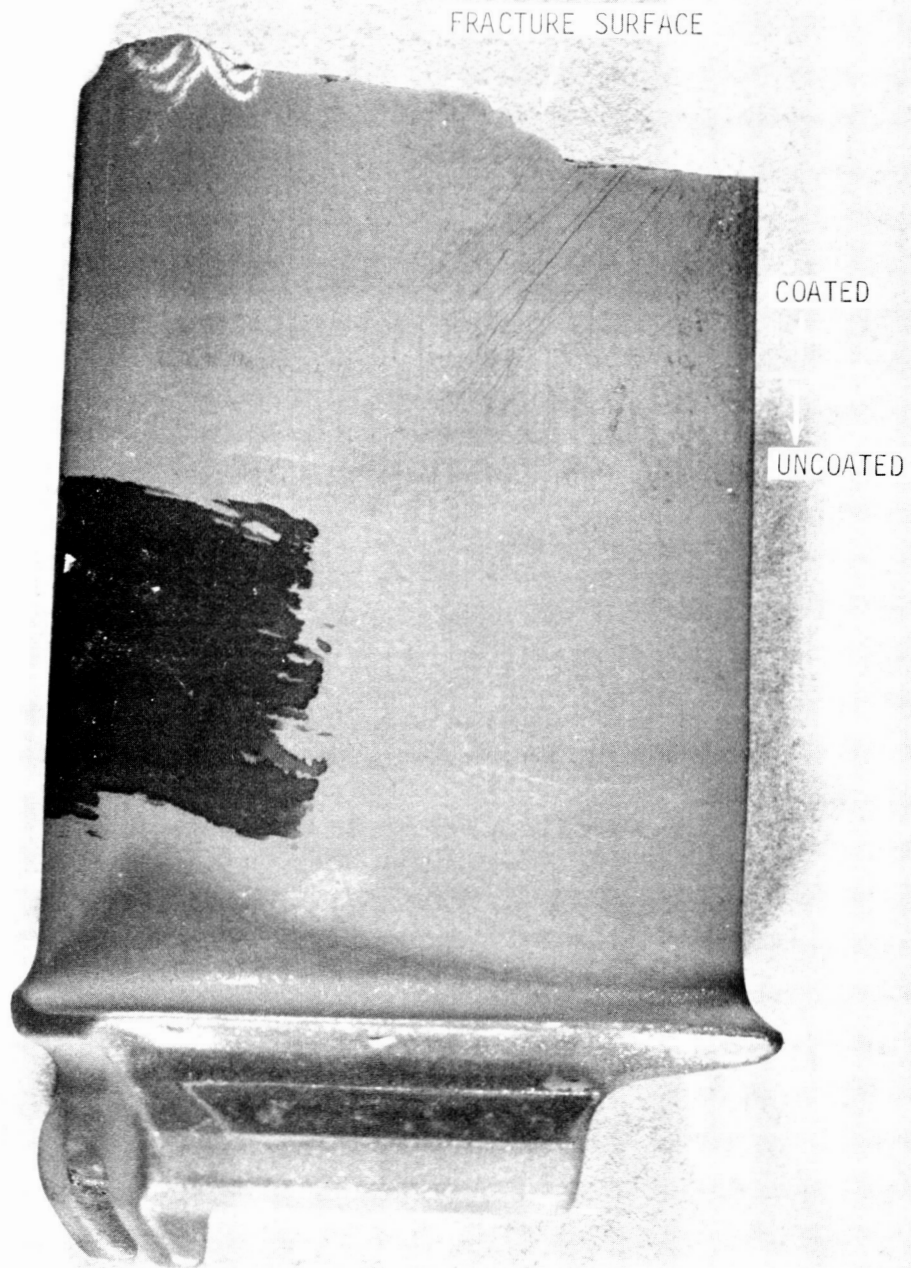
One Gator-Gard plasma spray coated 88WC-12Co eighth stage AMS 4928 compressor blade fractured transversely through the airfoil approximately 1 1/2" above the root platform (Figure 8). Binocular and scanning electron microscope examinations revealed fatigue which progressed from a Gator-Gard coated airfoil surface approximately 0.01 - 0.03" from the trailing edge (Figure 9). Metallographic examination of a longitudinal section through the airfoil at the fatigue origin revealed a transgranular fracture path.

Figure 8 JT8D Engine Operated 8th Stage AMS 4928 Compressor Blade Showing Fracture in Gator-Gard Plasma Sprayed 88WC-12Co Coated Airfoil Region

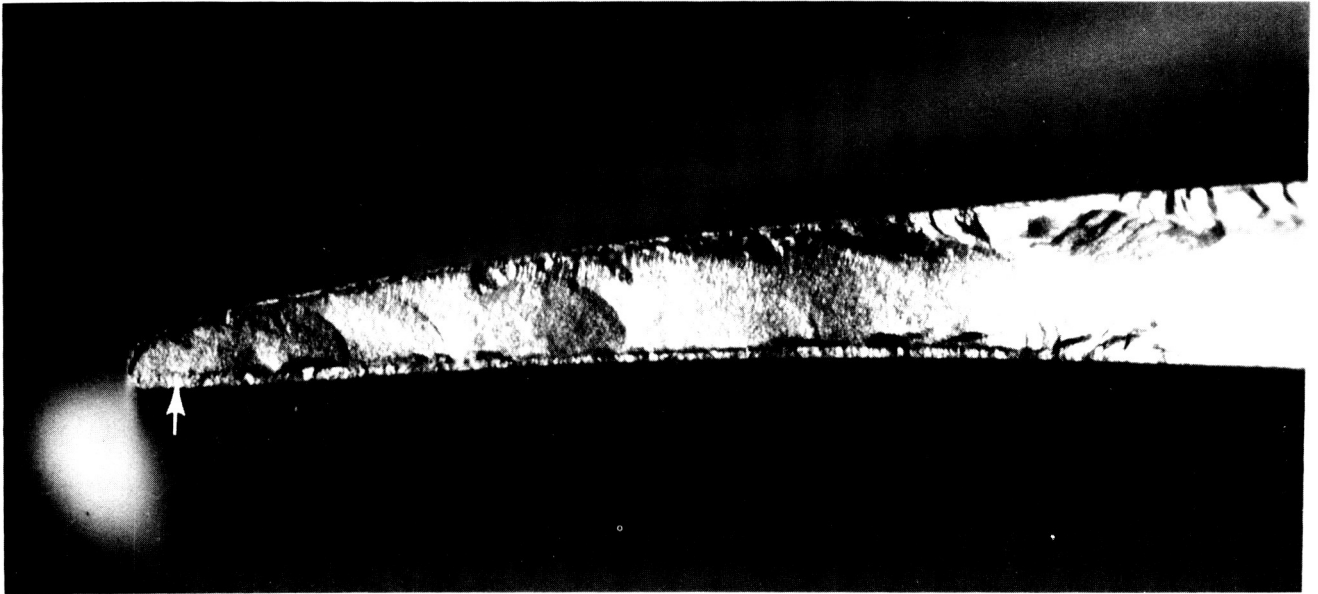
Figure 9 JT8D 8th Stage Engine Operated AMS 4928 Compressor Blade Gator-Gard Plasma Sprayed with 88WC-12Co Showing Transverse Fatigue Fracture Through Coated Area From Origin Near Trailing Edge (Arrow)

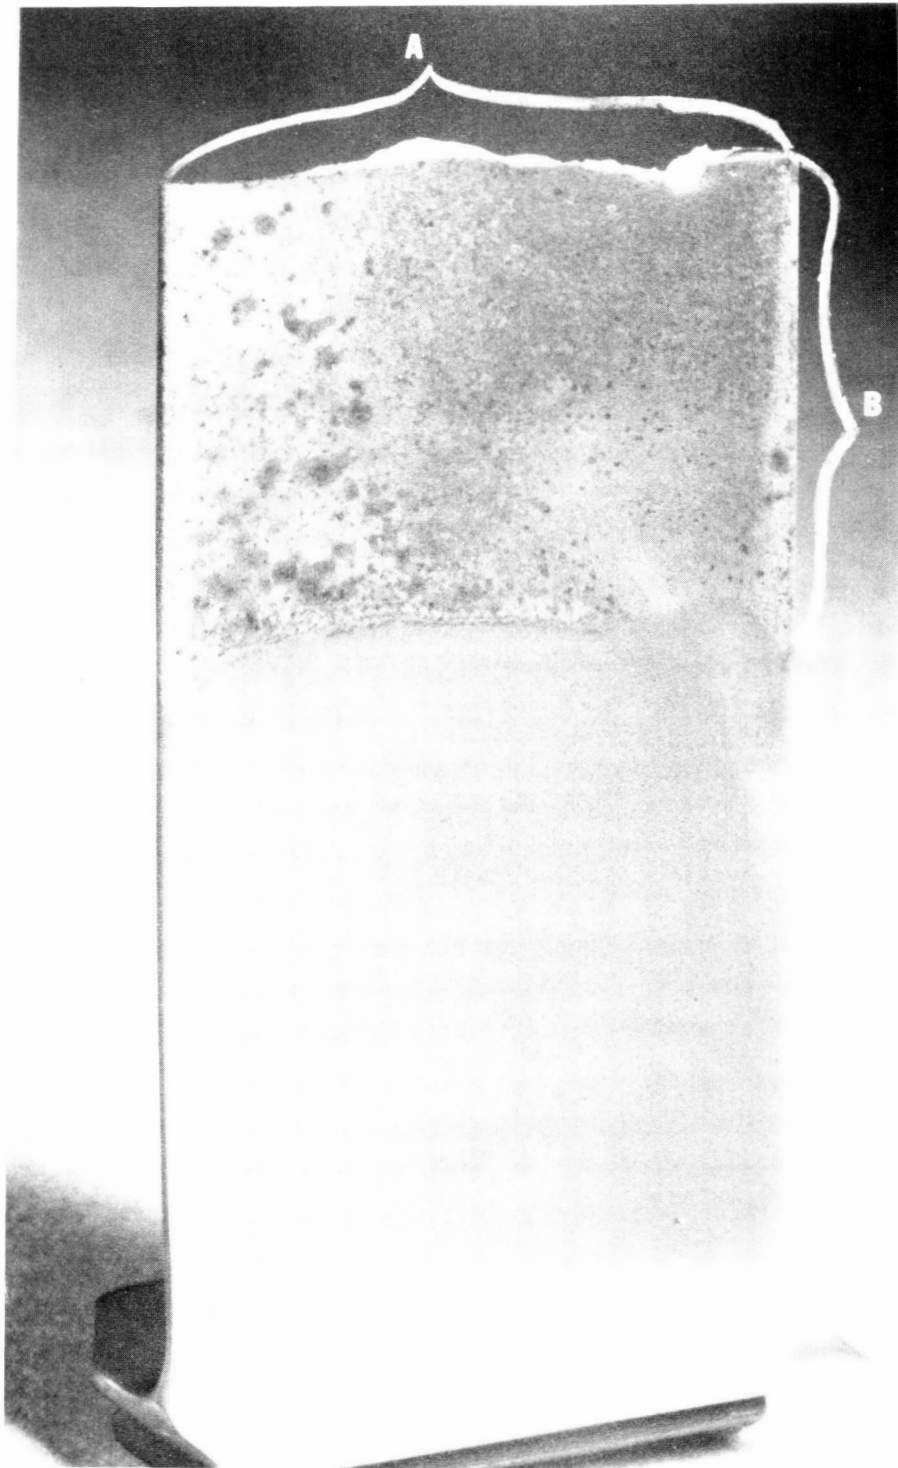
One Gator-Gard plasma spray coated 88WC-12Co seventh stage AMS 4928 compressor blade fractured through the airfoil approximately 2 5/8" above the root platform (Figure 10).

Figure 10 JT9D 7th Stage Engine Operated AMS 4928 Compressor Blade Showing Fracture (Bracket A) in Gator-Gard Plasma Sprayed 88WC-12Co Coated Airfoil Region (Bracket B)

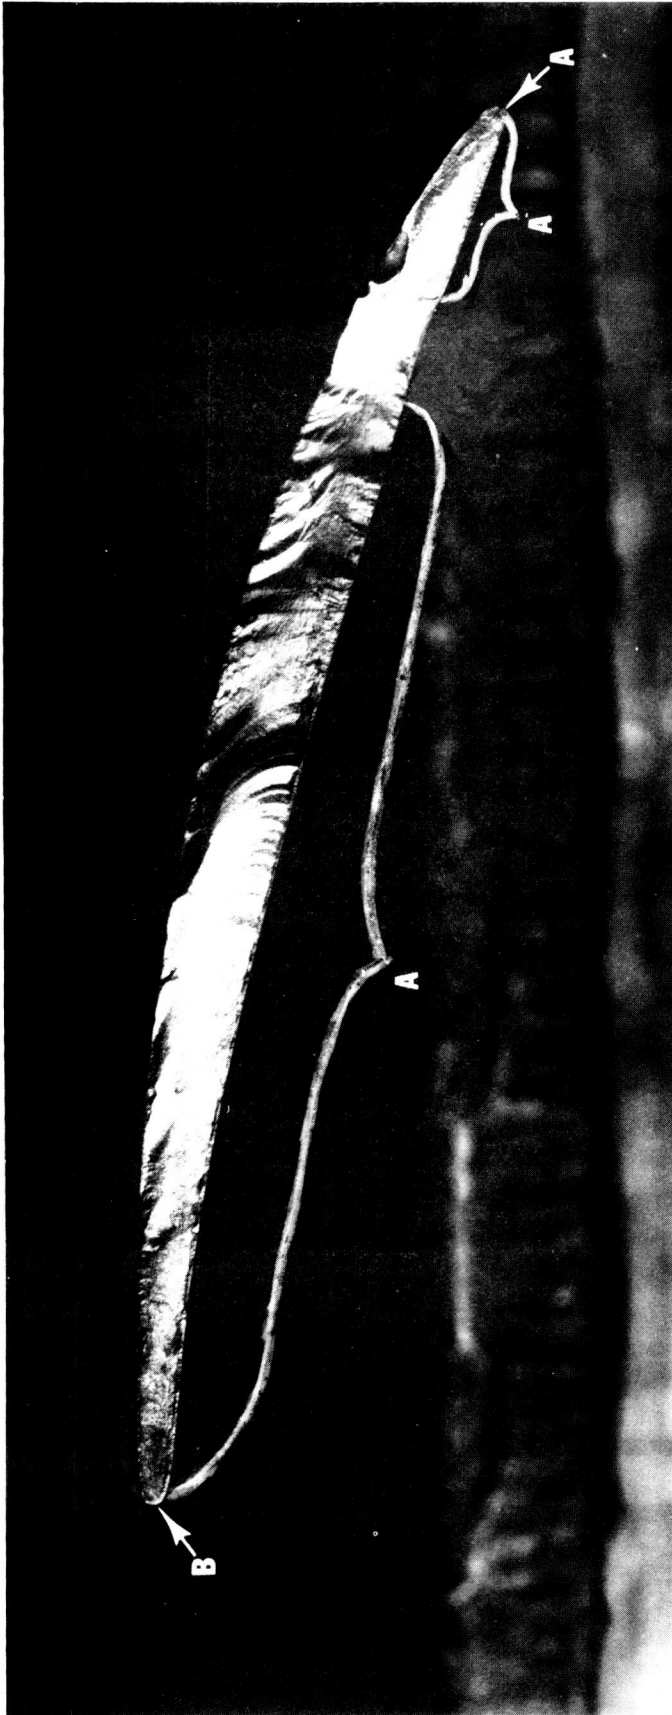
Binocular and scanning electron fractographic examination of the JT9D seventh stage airfoil fracture surface revealed high cycle fatigue (HCF) which had progressed for approximately 7/8" from an origin at the trailing edge surface, and for approximately 5/32" from an origin in vicinity of the leading edge (Figures 11 and 12); rubbed leading edge fracture surface precluded identification of the exact origin location. Fracture terminated in tensile overload between the extremities of the two HCF progressions.

Figure 11 Fracture Surface of JT9D 7th Stage AMS 4928 Engine Operated  
Compressor Blade Gator-Gard Plasma Spray Coated With 88WC-12Co  
Showing High Cycle Fatigue (Brackets A) Originating at Leading Edge  
(Arrow A) and Trailing Edge (Arrow B)

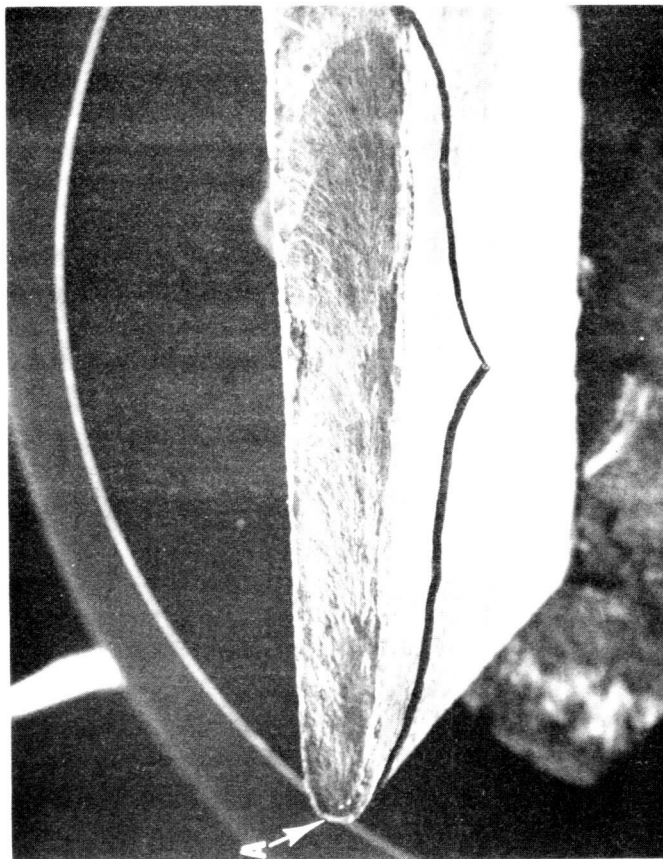
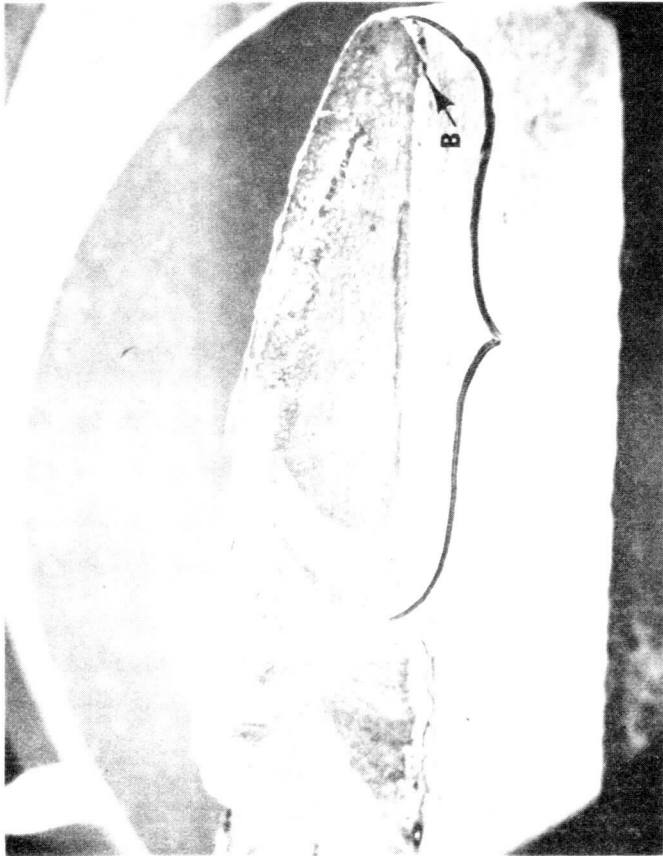
Figure 12 Scanning Electron Fractographs of JT9D AMS 4928 Engine Operated Airfoil Trailing Edge (left) and Leading Edge (right) Fracture Surfaces, Showing High Cycle Fatigue (Brackets) From Origins at Trailing Edge (Arrow A) and in Vicinity of Leading Edge (Arrow B).

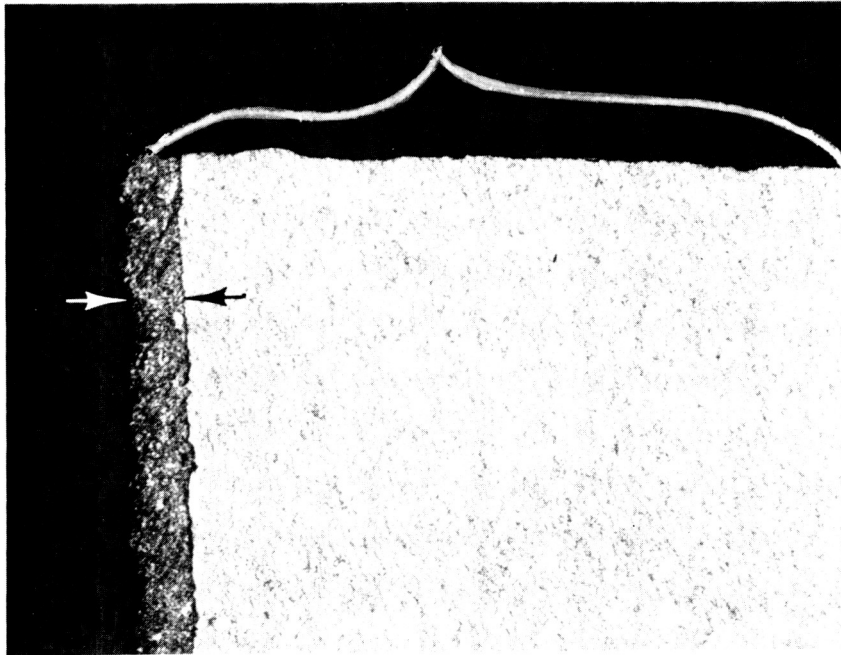
Metallographic examination of plasma coated sections through the leading and trailing edges revealed transgranular HCF fracture paths; there were no apparent material or processing defects at the fatigue origins (Figure 13). Examination of a transverse section through the airfoil, inboard of the fracture, revealed that the coating conformed to the thickness requirement of 25 to 63 microns (1 to 2.5 mils). Coating microstructure was similar to the coating tested in Task VI.

Figure 13 Planar Section Through Trailing Edge of JT9D Engine Operated Fractured Blade Showing a Transgranular, High Cycle Fatigue Fracture Path (Bracket ) and Gator-Gard Plasma Sprayed 88WC-12Co Coating (Between Arrows). A Similar Fracture Path Was Evident at Leading Edge.
