NASA TM-100344

STS-26 SOLID ROCKET BOOSTER POST FLIGHT STRUCTURAL ASSESSMENT

By David A. Herda and Charles J. Finnegan

November 1988

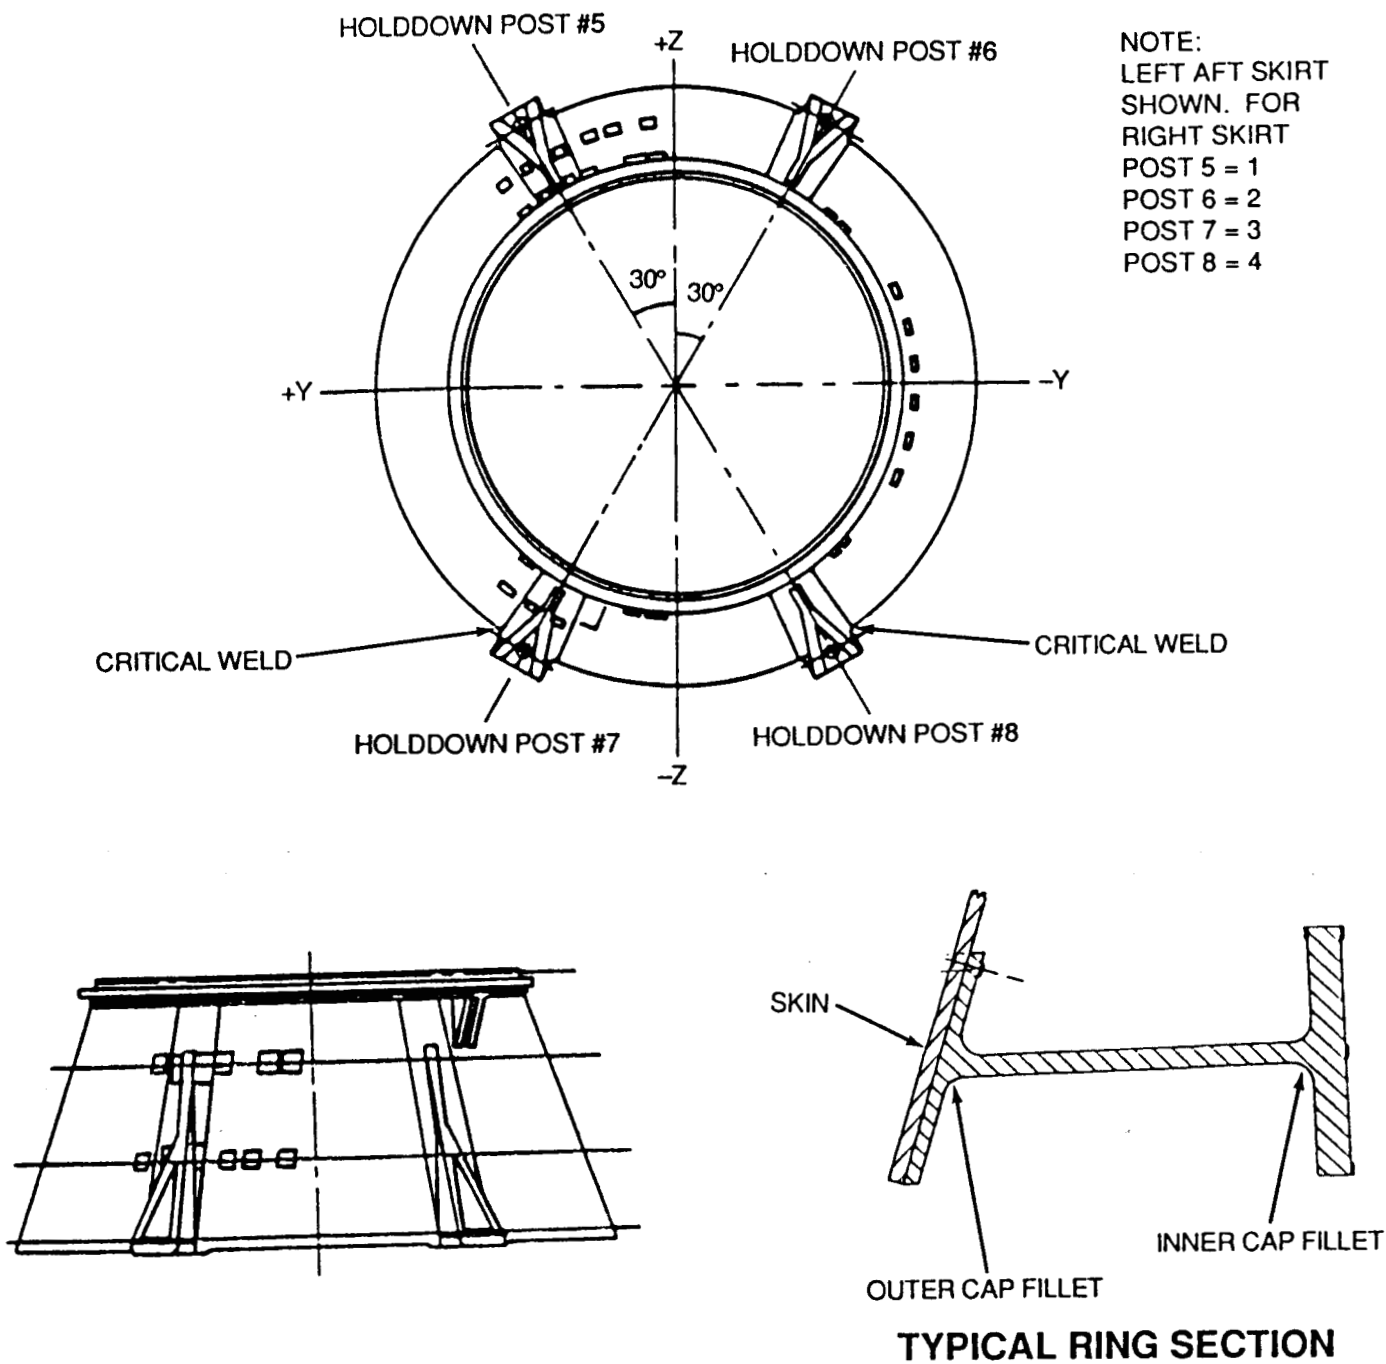
Figure 1. Aft Skirt structure.

3.1.1 Aft Skirt Structure (Reference Figure 1)

1) Post-to-Skin Welds – Insulation was removed from the lower portions of the weld areas so that they could be inspected. No cracks were observed in any of the weld regions. A slight meridional scratch was noticed on the left side of post No. 7 on the left aft skirt however. The scratch was located adjacent to the weld/forging interface at approximately the elevation of the aft ring centerline. This was reported and subsequent non-destructive evaluation (NDE) will determine if this presents a problem.

2) Interior Rings – The aft side inner and outer flange-to-web fillets were inspected for cracking and/or deformation. No cracks or obvious deformation were observed. A paint crack approximately 8-in. long in the aft ring inner cap fillet at Rib No. 48 of the left skirt was found. This indicates that yielding or excessive deformation may have occurred. United Space Boosters, Inc. (USBI) agreed to request that further NDE be performed in this area. Gouges were also observed in the outer cap fillet of the right skirt at Rib No. 14. They appeared to be due to assembly or TPS removal and USBI agreed to document them on a problem report.

3) Ring-to-Skin Fasteners – Sealant caps were in place over all of the fasteners. There was no evidence of sheared bolts on any of the rings.

4) Gussets – Each gusset was visually checked and showed no sign of buckling.

5) Horizontal and Vertical Tabs – The connections of the hold-down post tabs to the aft ring were checked and no sheared fasteners were found.

6) Forging – The footpad holes showed no signs of broaching (caused by improper stud ejection) and the tension post footpads showed no obvious signs of dishing.

7) Kick Ring Bolts – All of the inner and outer kick ring bolts were in place. Sealant covered each bolt, thus precluding further inspection.

8) Forward Ring Weld – Foam covered the inside surface of the weld and insulation covered the outside, thus preventing an inspection.

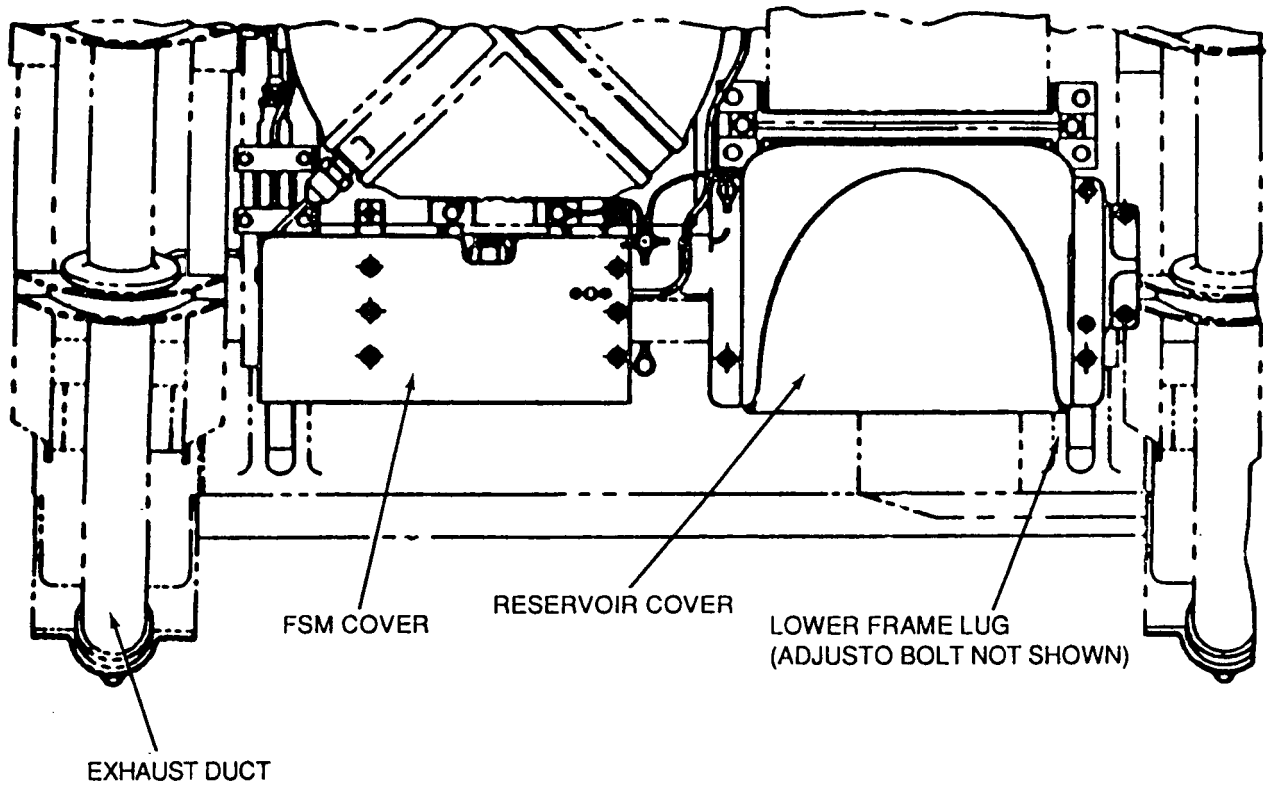
Figure 2. Thrust Vector Control System hardware.

3.1.2 Thrust Vector Control (TVC) System (Reference Figure 2)

The TVC hardware was inspected and no signs of structural damage were found. Particular attention was given to the adjusto bolts and lugs that secure the lower frames to the aft ring; the fuel supply module (FSM) guard and attach brackets; the hydraulic reservoir guard and attach brackets; and the exhaust duct.

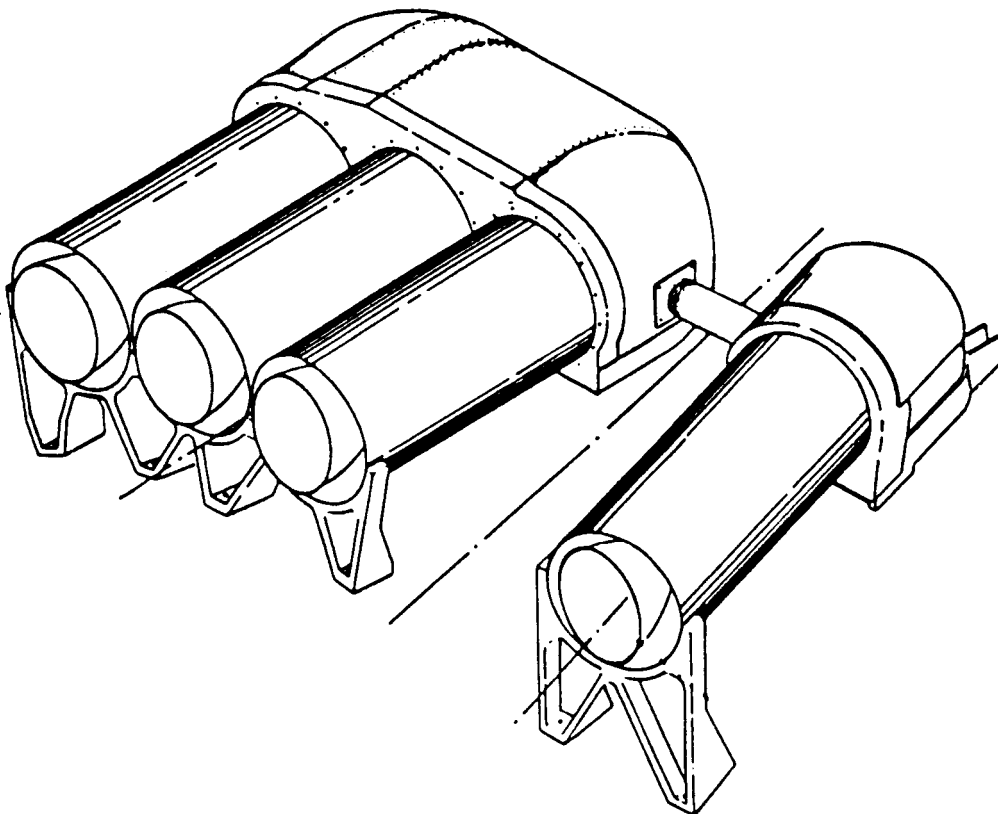
Figure 3. Aft Booster Separation Motors mounted on Aft Skirt.

3.1.3 Aft Booster Separation Motors (BSMs) (Reference Figure 3)

The aft BSM support structure was inspected and no damage to the frames was observed. All bolts were also in place.

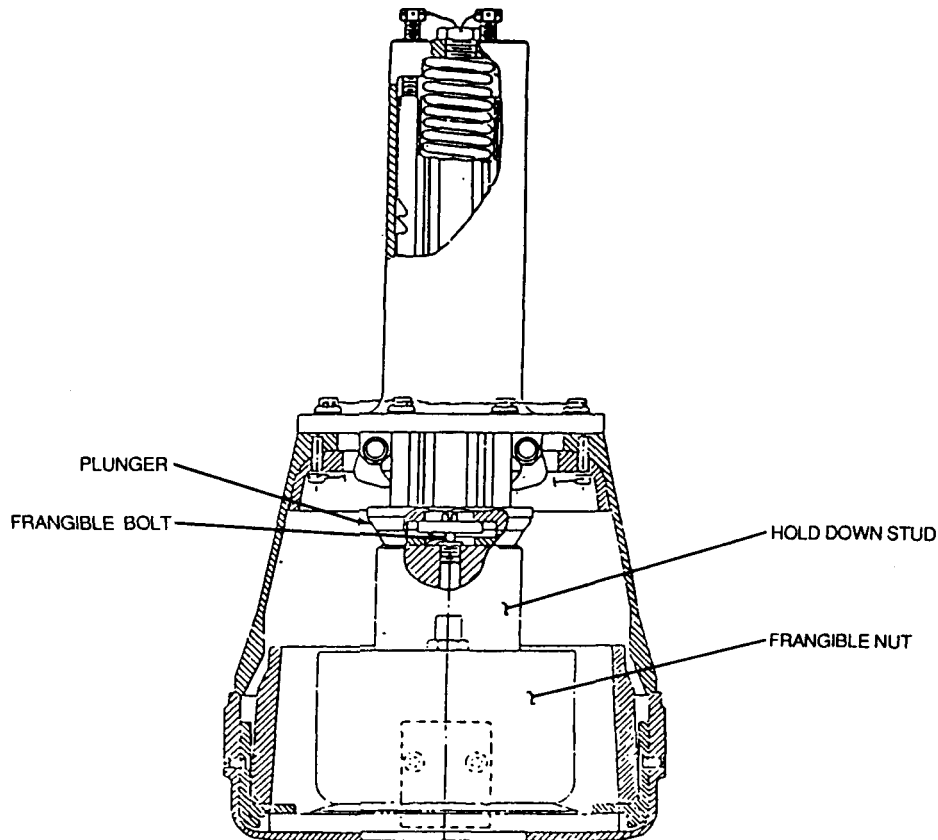
Figure 4. Blast Container with debris containment device.

3.2 Blast Container (Reference Figure 4)

STS-26 was the first flight for the redesigned blast container with the debris containment device. No structural damage was observed in the container housing

which sees a high pressure load from the pyro-technic blast. Several interior clips, which hold the spherical washer in place, had some metal removed during the blast.

The plunger mechanism functioned properly at four of the eight posts and the hole in the bottom of the container was sealed. At one post, the plunger was seated but material was missing from the container. This indicates that the hole was plugged sometime during the flight, not at the initial blast. At three other posts, a large piece of the nut prevented the plunger from seating and there was sufficient room for debris to fall out of the hole. Reconstruction of the containers and frangible nut pieces confirmed that material escaped from four of eight containers.

The failure of the plunger to plug the hole is most likely due to two factors. The first is that initial stud vibratory acceleration, due to preload lost when the frangible nut breaks, is much greater than the acceleration of the plunger due to the spring force. Since the bolt accelerates with the stud, and there is a gap between the plunger and the bolt, the bolt sees an impact force as it contacts the plunger. This force may be greater than the tensile strength of the bolt.

The other factor is that the broken frangible nut may be contacting the beveled sides of the plunger as it travels downward, thus jamming the plunger before it seats.

These possibilities are being investigated as of this writing, and a redesign of the internal blast container components, to provide better performance, is forthcoming.

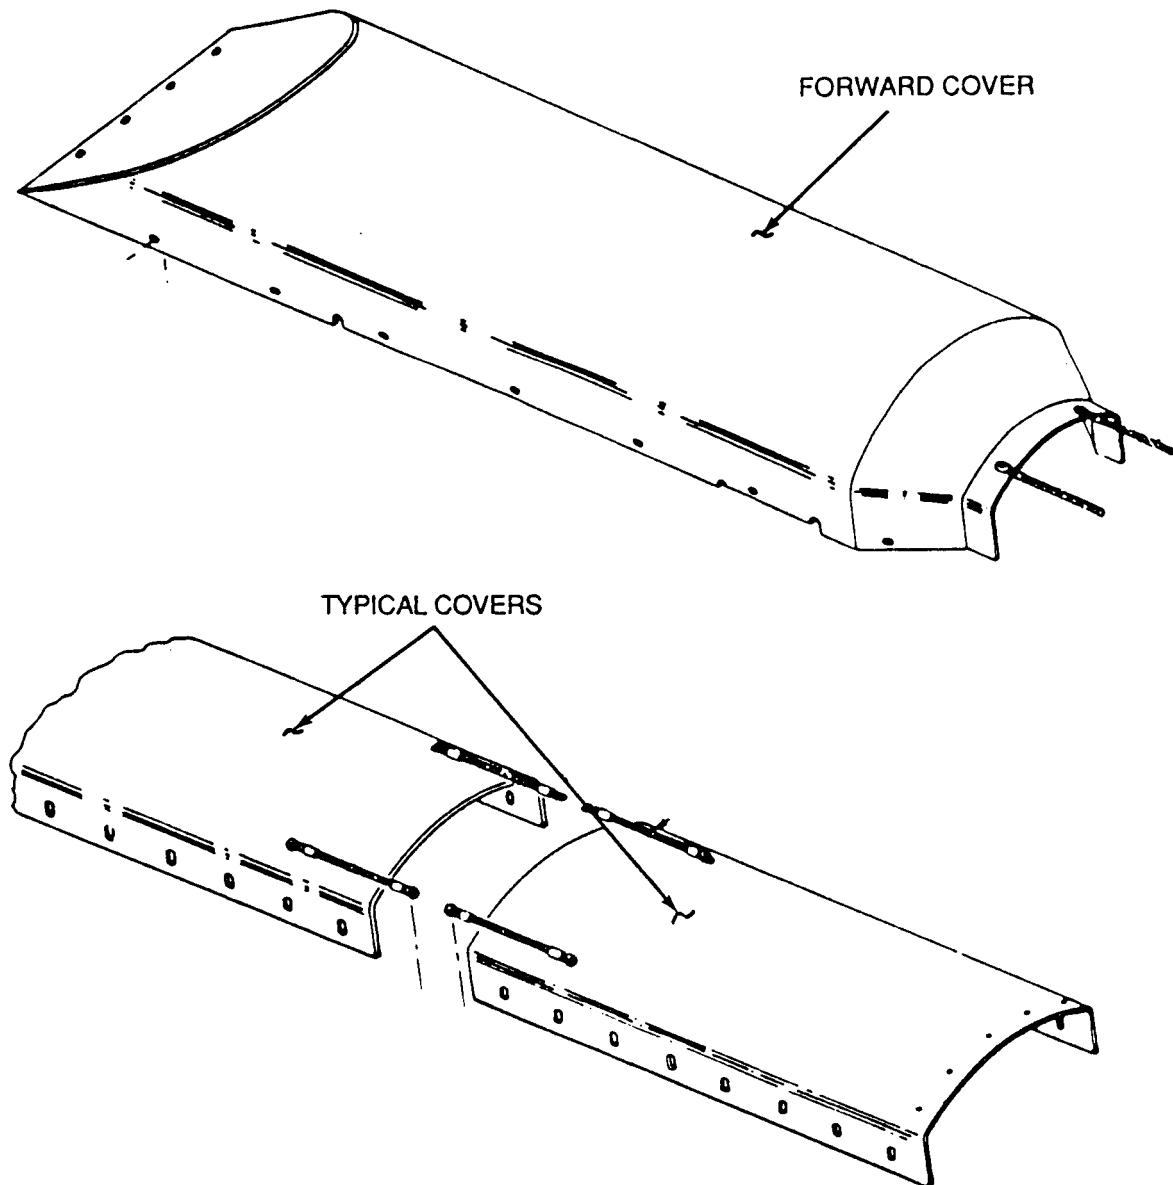
Figure 5. Systems Tunnel Covers.

3.3 Systems Tunnel (Reference Figure 5)

The systems tunnel of each SRB was visually inspected while the boosters were intact on the rail cars. No damage was observed to either tunnel prior to cover removal. The auxiliary K5NA tunnel that contained the field joint heater cables was intact. A complete inspection of the covers and floorplates after cover removal was not done. However, no obvious structural damage was reported.

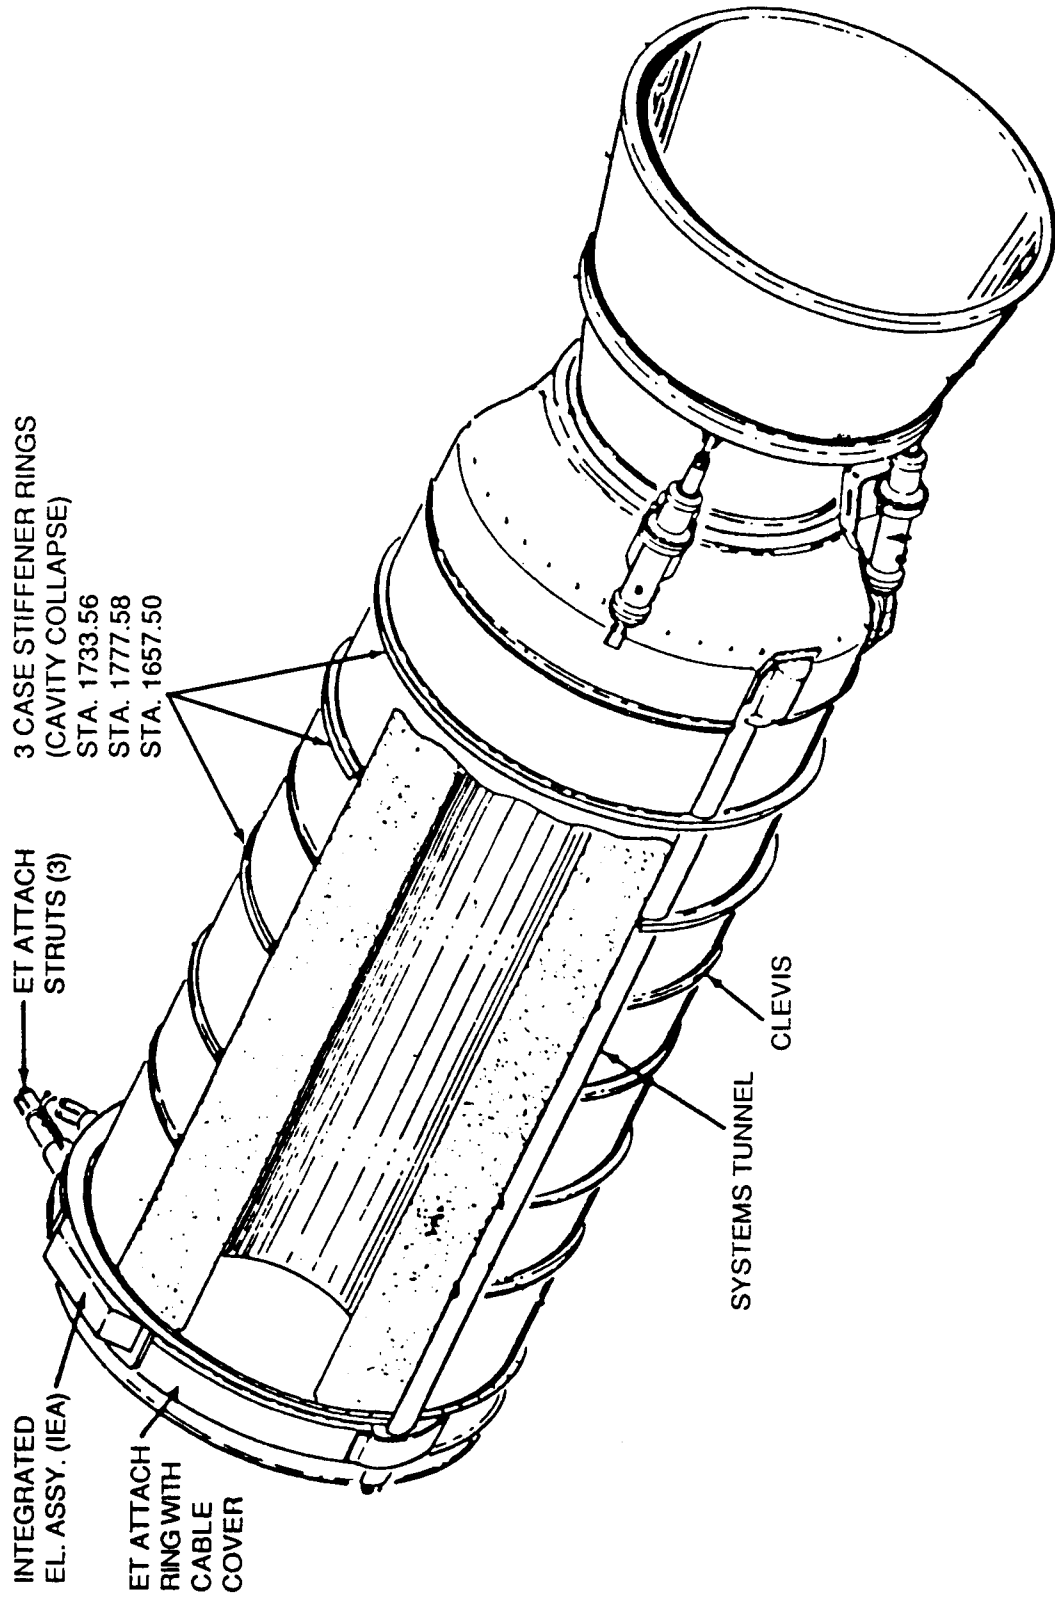
Figure 6. SRM Aft Segment.

3.4 Stiffener Rings (Reference Figure 6)

The video tape of water impact showed a large geyser of water moving up one side of the left-hand booster. The right-hand booster had a smaller, less spectacular entry. We hypothesized the left-hand booster stiffener rings would sustain more damage. The complete opposite proved to be true. On the left side, the stiffener rings and their fasteners were in good condition. No structural damage was observed. All three stiffener rings on the right-hand booster were damaged. The following is a list of the damage sustained.

1) Forward ring - The ring was bent radially inward approximately 0.50 in. at the 160-deg location. A 3-in. crack through the bolt hole was evident in the web at this location. Also, 38 fasteners in the area had failed in shear.

2) Center ring - The ring was bent radially inward approximately 0.25 in. at the 160-deg location. A 5-in. crack through the bolt hole was evident in the web at this location. A total of 30 fasteners failed in this area.

3) Aft ring - The ring had a 7-in. crack through the bolt hole and continuing along the stiffener ring web. A total of 20 fasteners failed in this area.

All three rings had local buckling on either side of the damaged area. Typically, this out-of-plane deformation of the web would occur about 20 deg away from the crack centerline. This buckling was caused by the inward displacement of the ring which put part of the web in compression. These areas corresponded to the same locations where cracks were observed on the motor case stiffener ring stubs.

Permanent deformation was observed in many of the holes on all three rings in the vicinity of the cracks and buckled regions. This indicates that the rings carried a large in-plane load which was probably caused by cavity collapse pressure on the motor case.

The insta-foam on the aft side of the three stiffener rings was missing from 130 to 190 deg. This indicates that the water impact loads were high in this location.

3.5 ET Attach Rings (Reference Figure 6)

Prior to flight, three areas were determined to have low margins of safety, as shown in USBI ET Attach Ring Stress Analysis (USBI-ANAL-32-88). They include the systems tunnel splice, cap splices, and the strut lugs. These sections were examined more closely during post-flight inspection.

The ET attach rings were visually inspected prior to removal from the motor case and after disassembly. Before removal, the condition of the insta-foam on the rings could be inspected. The foam on the forward edges was rough and discolored, but in good condition. No metal was exposed. Both rings had a section of insta-foam missing on the aft side. There was approximately 60 deg of foam missing, exposing the rings. This area was clean and not covered in soot as was the other hardware in the vicinity. The missing foam location corresponded to the foam damaged on the three stiffener rings aft of the ET attach ring. Apparently the damage was caused by cavity collapse at water impact.

The hardware on the rings was in good condition. All of the splice plates and web-to-tang holes were inspected, and no cracks or deformation were evident. The paint sealer between the cap and the web was checked for cracks, which would indicate relative motion between the parts, no cracks were noted. Some of the fasteners in the critical splice areas were saved for metallurgical examination. Visually the fasteners appeared in good condition, without deformation.

Possible damage was seen on a right-hand SRB intercostal. Paint was missing from the intercostal and the adjoining web, appearing as if there was contact between them. However, this could be the result of damage encountered during retrieval. The IEA cover was missing in this region, thus the intercostal was exposed to sea water during towback. Also, several cables were loose in this area and they could have contacted the intercostal.

The In-Harbor Tow Bracket on the left-hand SRB was bent forward about 1 in., also the six bolts which attach the bracket to the motor case tang were sheared. These bolts fasten the ET attach ring web to the tang. The adjoining lightning covers on the attach ring, which attach to the bracket, also sustained damage. This problem was the result of the SRB contacting the recovery ship during the retrieval process. As the ship was negotiating a turn, high swells pushed the SRB into the hull. The ship's fenders, designed to prevent this situation, were not adequate.

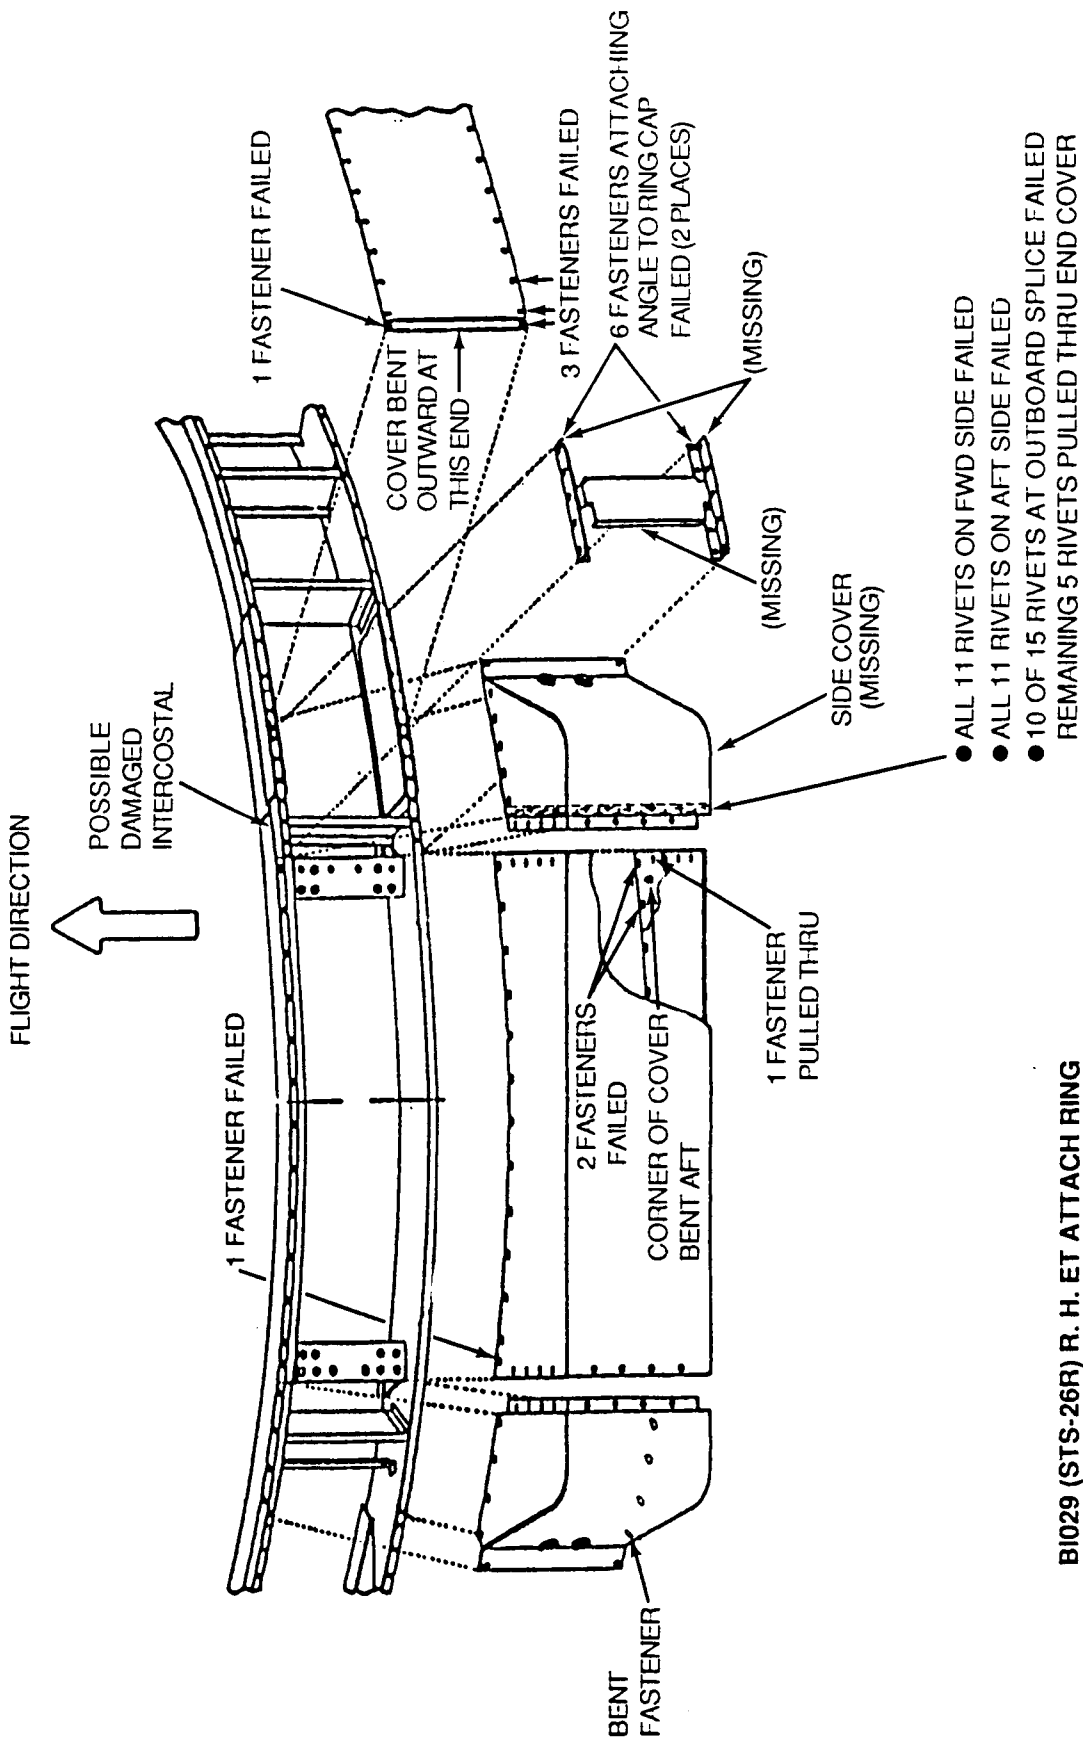
Figure 7. IEA Box damage.

3.6 Aft IEA Box

One of the IEA box side covers on the right-hand SRB was missing. This cover has the same circumferential location as the damaged stiffener rings. All 37 rivets which attach the side cover to the center cover had failed, also the twelve 0.25-in. bolts which fasten the side cover to the cap were sheared. The damage appears to have been caused by water impact. The failed fasteners indicated that the cover was moving forward; this load is what would be expected during splash down due to the water spray. The cleanliness of the IEA box and the inside surfaces of the ET attach ring also suggest water impact. This area is exposed with the side cover off. The adjacent hardware is heavily sooted in this vicinity. Other damage was also evident as a result of the cover failure. The connecting lightning cover was bent and four fasteners had failed. Also, the center portion of the IEA cover was bent with three broken fasteners. Figure 7 summarizes the damage to the IEA box area.

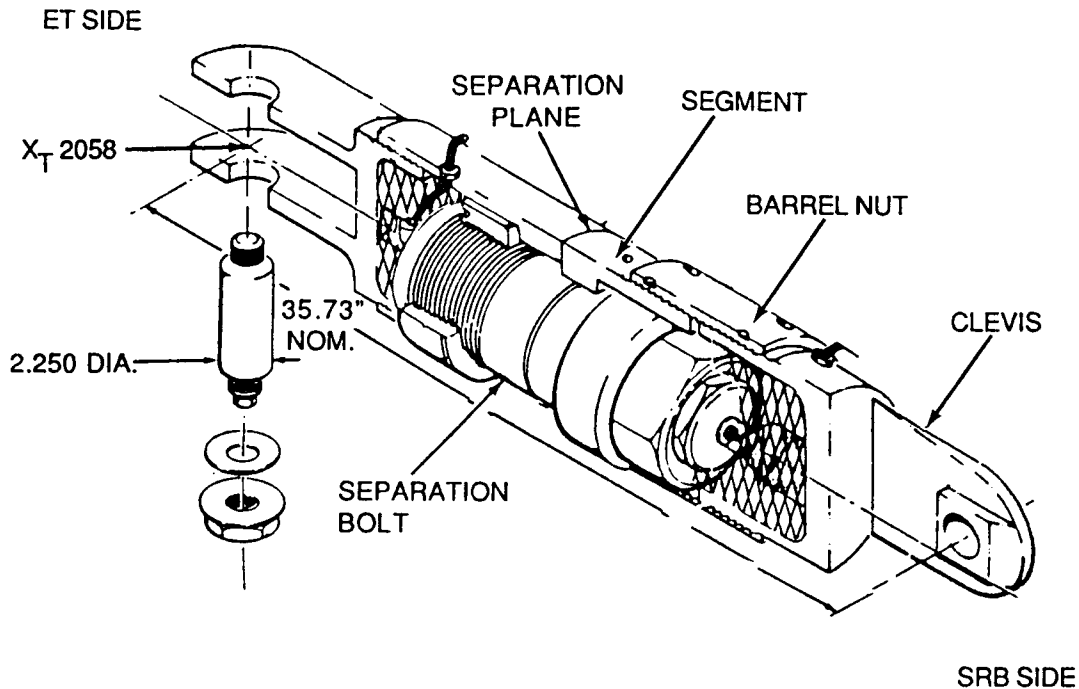
Figure 8. Typical Lower or Diagonal Strut.

3.8 Aft Attach Struts (Reference Figure 8)

The SRB half of the upper, diagonal, and lower struts are separated into three components: the clevis, the strut segment, and the barrel nut that connects the clevis to the segment. The SRB half of the separation bolt which is internal to the strut segment is recovered as well as the SRB clevis attach pin. Score lines were seen on all of the attach pins. The lines were shallow so only the surfaces of the pins were damaged. Also, some local deformation was seen on the edge of the flat bearing surfaces of several strut segments. These surfaces are in contact with the separation bolts. The deformation was very slight and was not considered to be a problem.

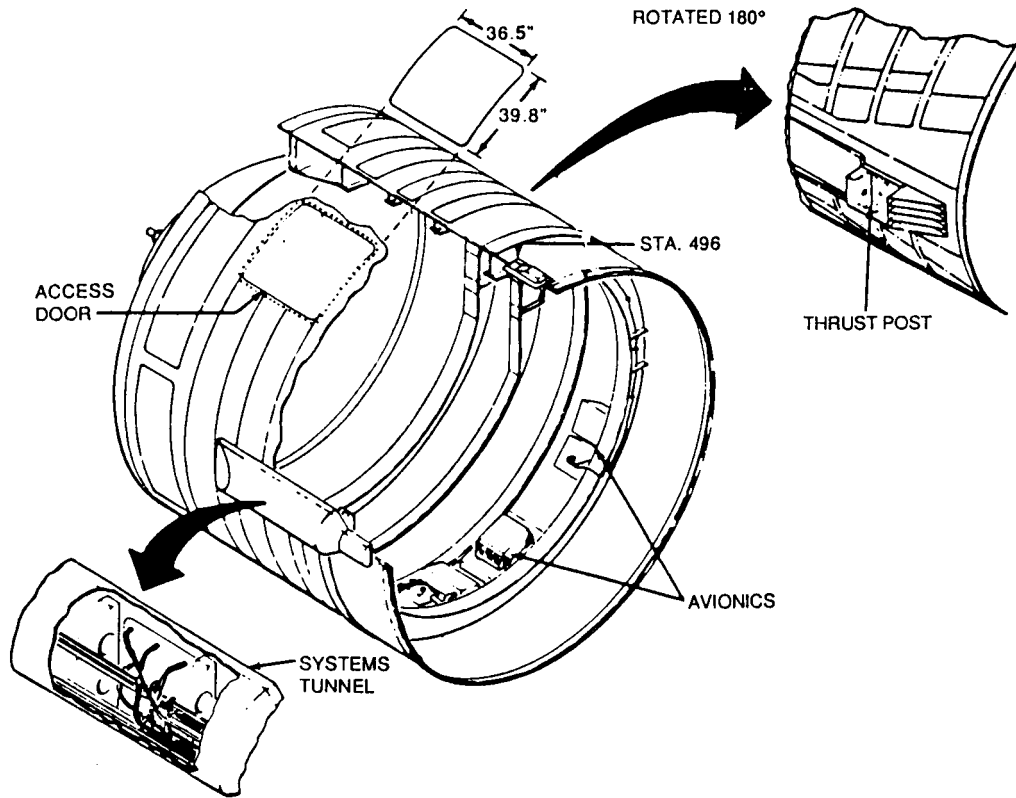
Figure 9. Forward Skirt Assembly.

3.9 Forward Skirt (Reference Figure 9)

No damage was observed to either forward skirt. The areas checked were: the dome, camera assembly, exterior thrust post, systems tunnel floor, interior skin, lower clevis pin holes, the access door area, interior structural rings and beams, interior welds, and the weld between the access door J-stiffener and the upper ring web at the parachute attach point location.

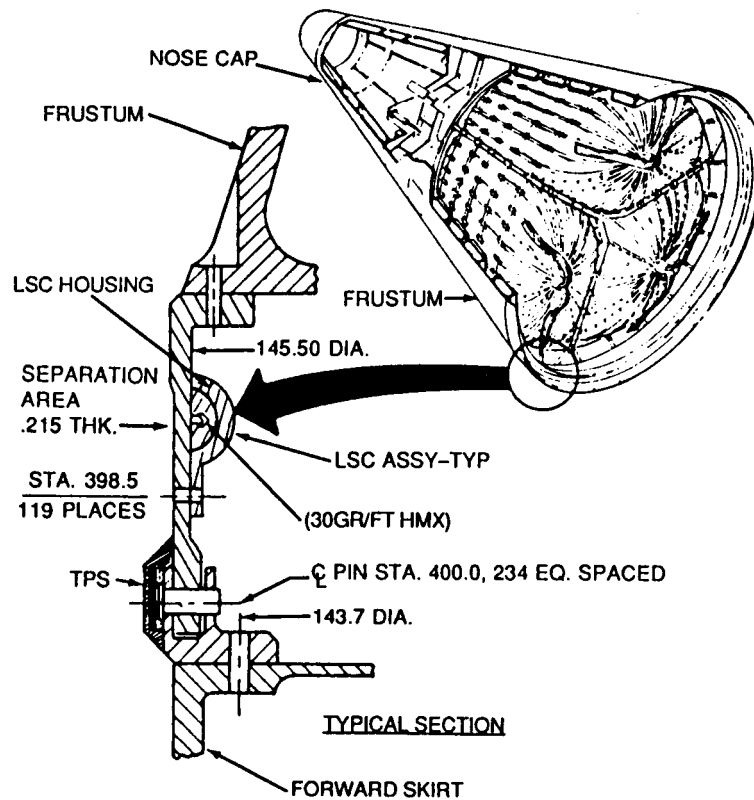
Figure 10. Ordnance Ring Assembly.

3.10 Ordnance Ring (Reference Figure 10)

The structural parts of the ordnance ring appeared to function normally. The fracture plane was clean and no obvious deformation was seen in the lower pin holes that mate with the forward skirt.

The linear-shaped charge (LSC) housing of each ring assembly was severely damaged, however. The housing failed at numerous locations around the circumference of the ring. Bolts that secure it to the ring pulled through the slotted holes in the housing in many places and the housing holes were excessively damaged.

This condition has been observed on previous flights and is caused by the blast pressure of the LSC. None of the housing sections actually came off but some almost did. This is a concern because a loose piece of metal that size could possibly cut a parachute line.

The LSC housing is reinforced intermittently by backup plates. All of the damage was seen in the spans between reinforcements. A possible fix would be to add more backup plates to shorten the unreinforced spans.

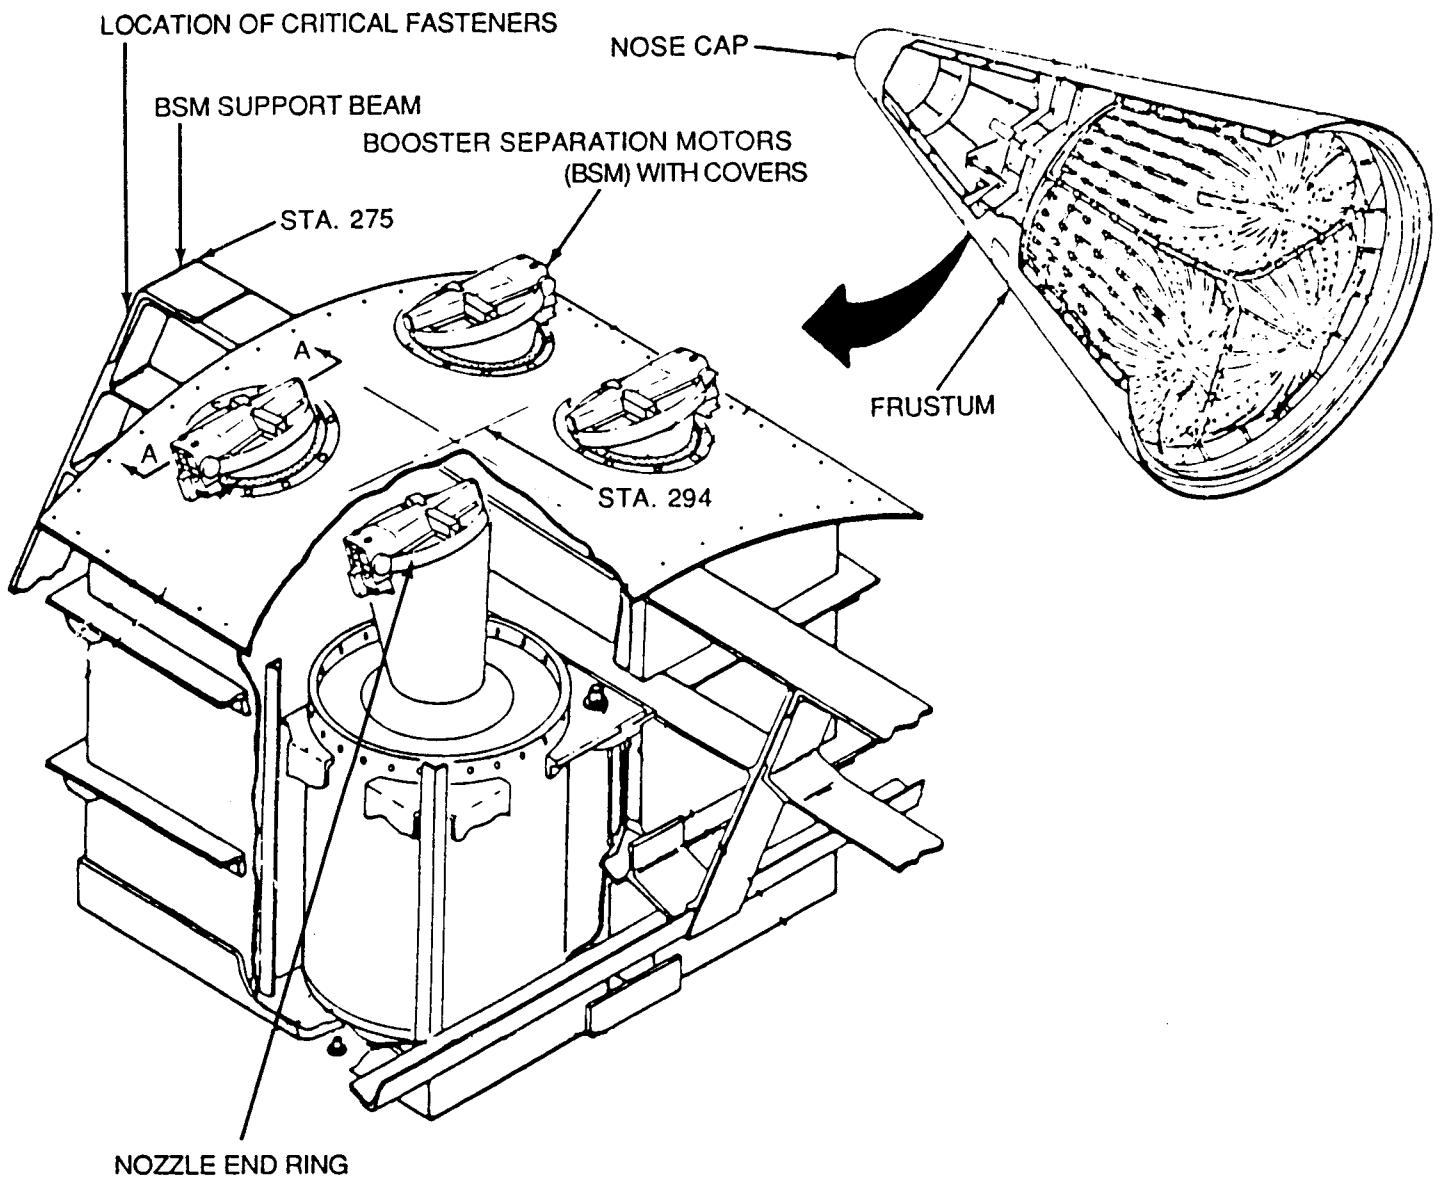
Figure 11. Frustum with Forward BSMs.

3.11.1 Frustum Structure (Reference Figure 11)

The interior of each frustum was inspected and no damage was seen. Due to low margins of safety, shown in the USBI Frustum Stress Analysis (USBI-ANAL-74-87), a request was made to remove four bolts that connect the top ring of the frustum to the BSM support beam. These fasteners are loaded in tension during flight and will be sent to USBI-Huntsville for evaluation, following removal. Sealant caps covered the fasteners during the inspection, indicating that the bolts were still in place.

3.11.2 Forward Booster Separation Motors (Reference Figure 11)

The four motors in each frustum showed significant yielding in the flange around the edge of the nozzle exit cone. No dimpling or distortion of the nozzle surface was seen, however. The end ring that bolts to the nozzle flange also showed significant yielding in the corresponding locations. This condition is expected and is caused by the torque put on the ring by the opening of the exit cone cover at BSM ignition.

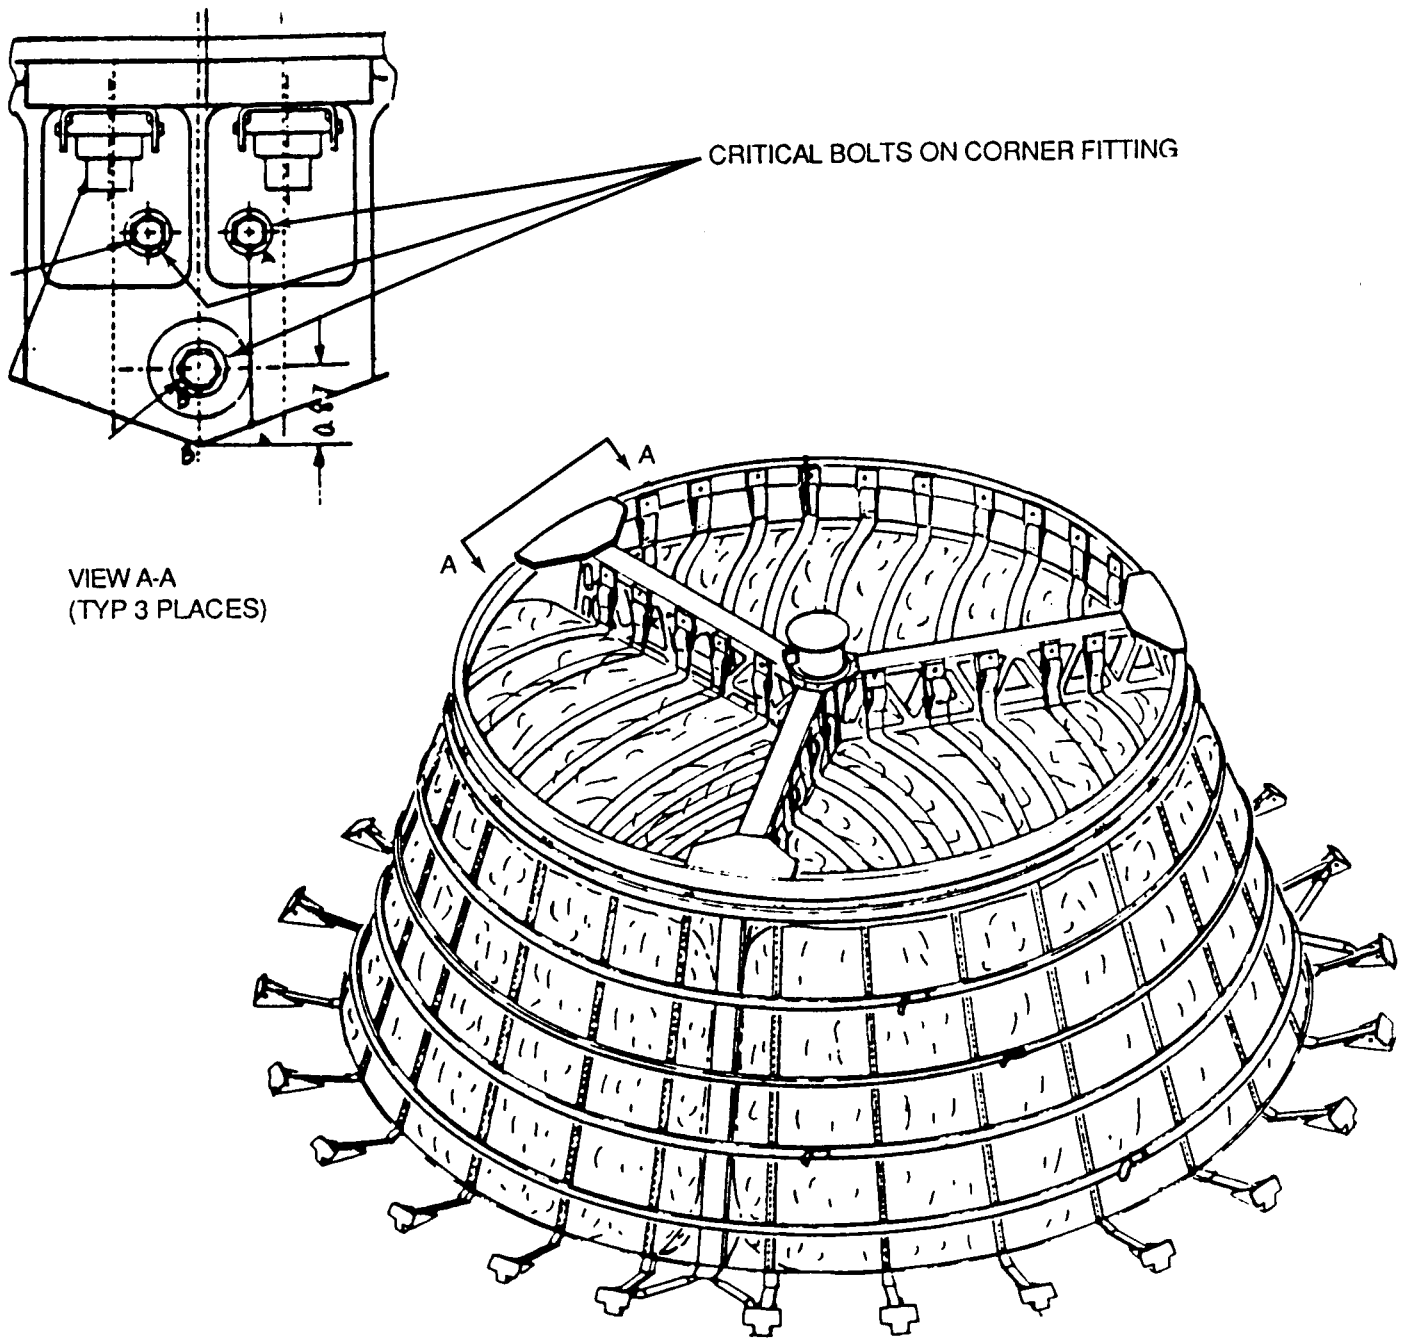
Figure 12. Main Parachute Support Structure with parachutes in place.

3.11.3 Isogrid Structure (Reference Figure 12)

The isogrid structure in each frustum supports the main parachutes prior to deployment. The corner fittings that are part of the attachment of the isogrid to the frustum see a high inertial load at frustum separation. Three fasteners at each corner fitting were shown to have negative margins of safety in shear bearing in the USBI Decelerator Subsystem Stress Analysis (BPC-ANAL-61-87). Paint cracks around the sealant caps on several of these bolts were observed and a request was made to remove nine corner fitting bolts from each isogrid assembly so that the holes could be inspected for deformation. USBI concurred with this request and the data will be sent to USBI-Huntsville and MSFC for evaluation.
