NASA Technical Memorandum 100633

Pyrotechnic System Failures: Causes and Prevention

Laurence J. Bement

June 1988

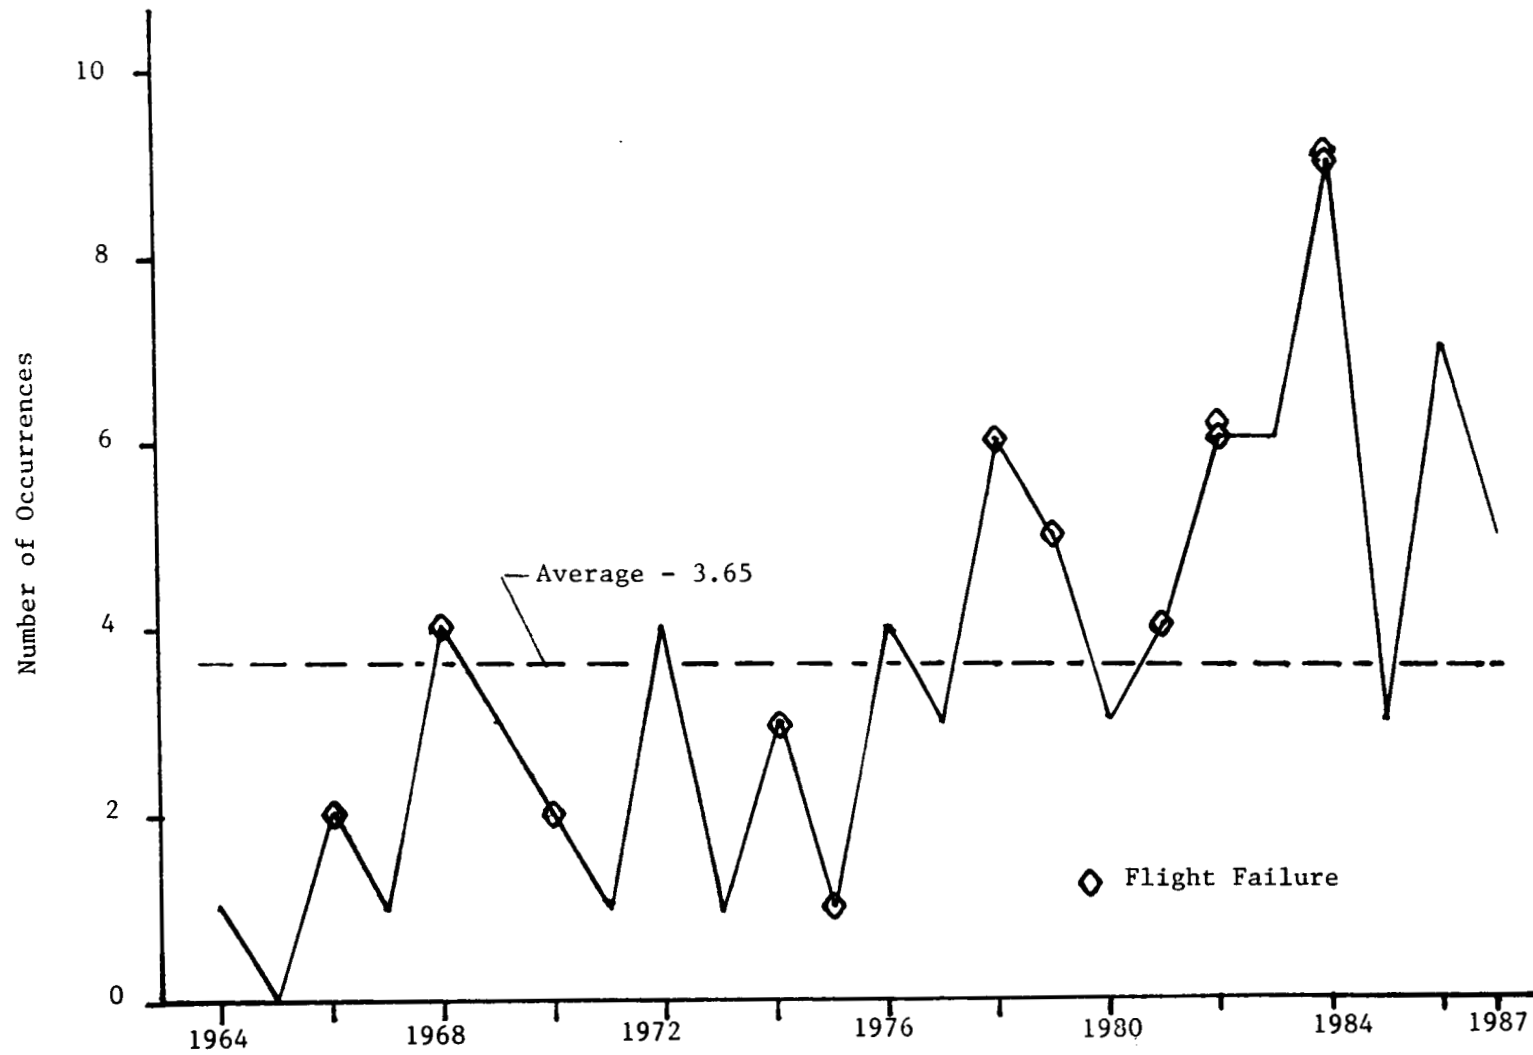
Figure 1.- Frequency of pyrotechnic failures .

Quantitative summary.- The total number of failures reported in this survey was 84. The frequency of occurrence for the 23-year period is shown in figure 1. The greatest number of failures occurred in 1984 with an average of 3.65 for the entire period. The flight failures are scattered throughout the period. The number of failures in each functional category is shown in figure 2. The number of failures in a device life cycle is shown in figure 3. Of course, the key statistic is that 12 flight failures occurred following qualification, lot acceptance testing, systems test and flight assembly. Figure 4 summarizes the pyrotechnic failure occurrences in terms of sources or causes.

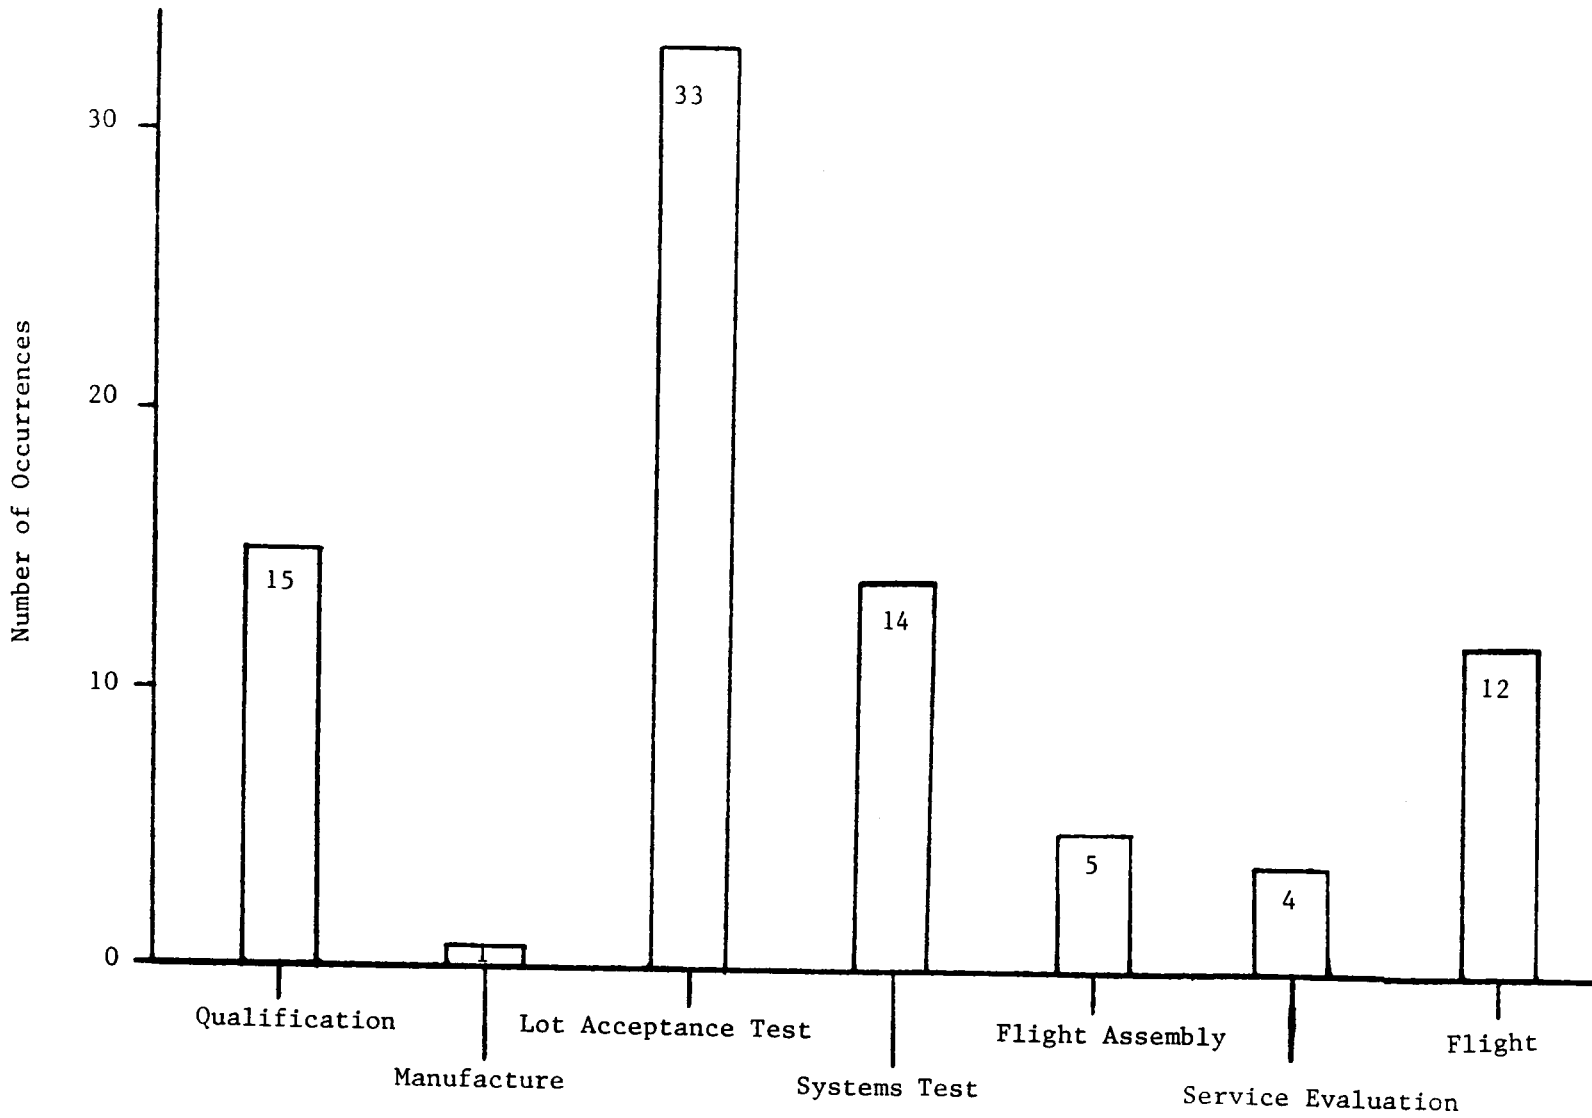
Figure 3.- Frequency of pyrotechnic failures occurring in device life cycle.

The total number of failures, including three deaths, reported in this survey was 84 for the 23-year period of the compilation with an average of 3.65 per year. The survey was an informal compilation, based on memory and limited documentation. No Center maintains a complete formal record of failures. Therefore, no technical problem data base has been established by this study. The failure rates per functional category were 32 in mechanisms, 30 in initiation, 14 in separation systems and 8 in electrical firing circuits. A total of 12, or over 14 percent, of the failures occurred in flight with 15 in qualification, 1 in manufacture following qualification, 33 in lot acceptance testing (LAT), 14 in systems tests, 5 in final assembly and 4 in service life evaluation tests. Clearly, some lot acceptance testing is adequate in discovering flaws in functional performance. However, some lot acceptance testing needs improvement, since more failures occurred after this testing than before.

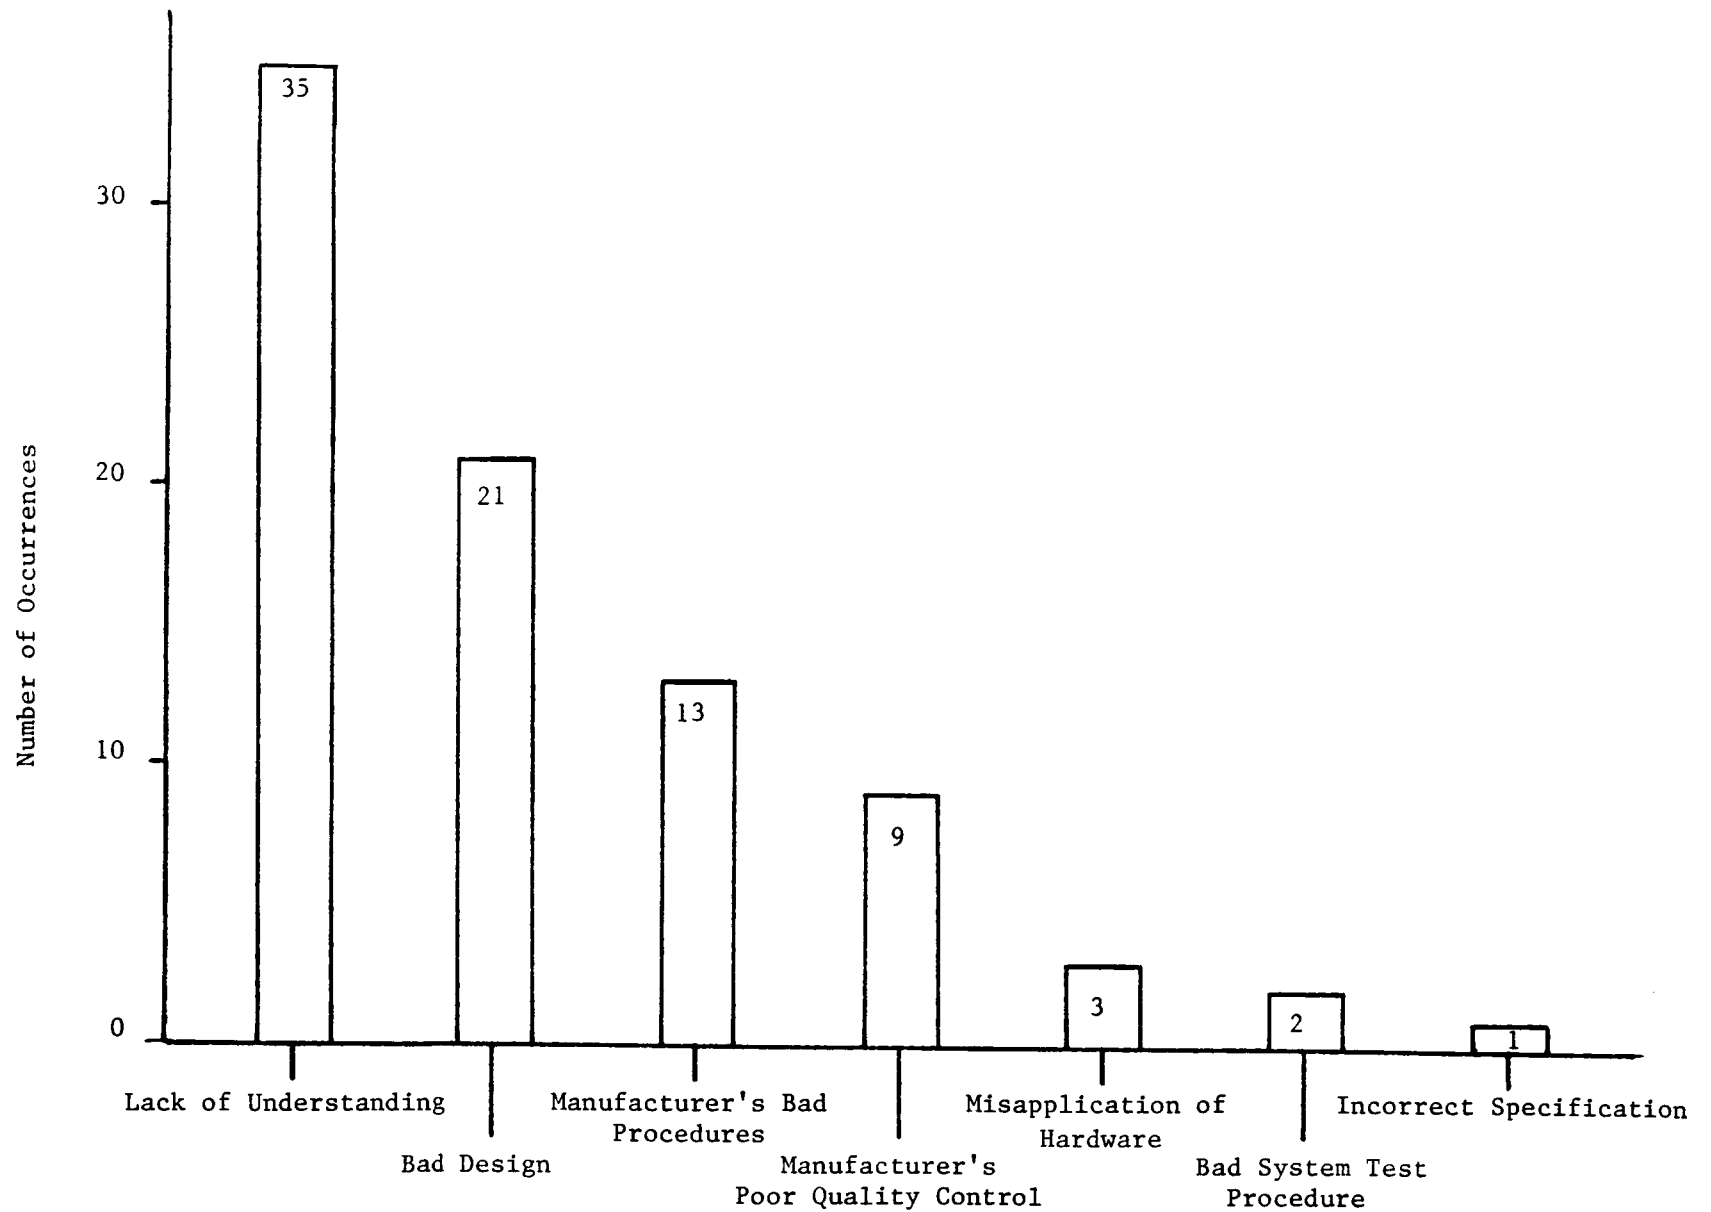
Figure 4.- Frequency of pyrotechnic failure occurring by cause.

For the source of failures, the shocking statistic is that 35 of 84 (42 percent) of the failures were caused by a lack of understanding; that is, the personnel working the problem at the time did not have the technology needed to understand and correct the failure. Unfortunately, 24 were mistakes, caused by poor designs and misapplication of hardware, which means that personnel did not apply the known technology. The next 22 failures have to be categorized as carelessness, through manufacturers' poor procedures and quality control. Program managers were at fault in three cases in not having established correct procedures and creating an incorrect specification.
