NASA Technical Memorandum 100981

Soil Erosion And Causative Factors at Vandenberg Air Force Base, California

March 1988

Joel B. Butterworth
The Bionetics Corporation, Kennedy Space Center, Florida

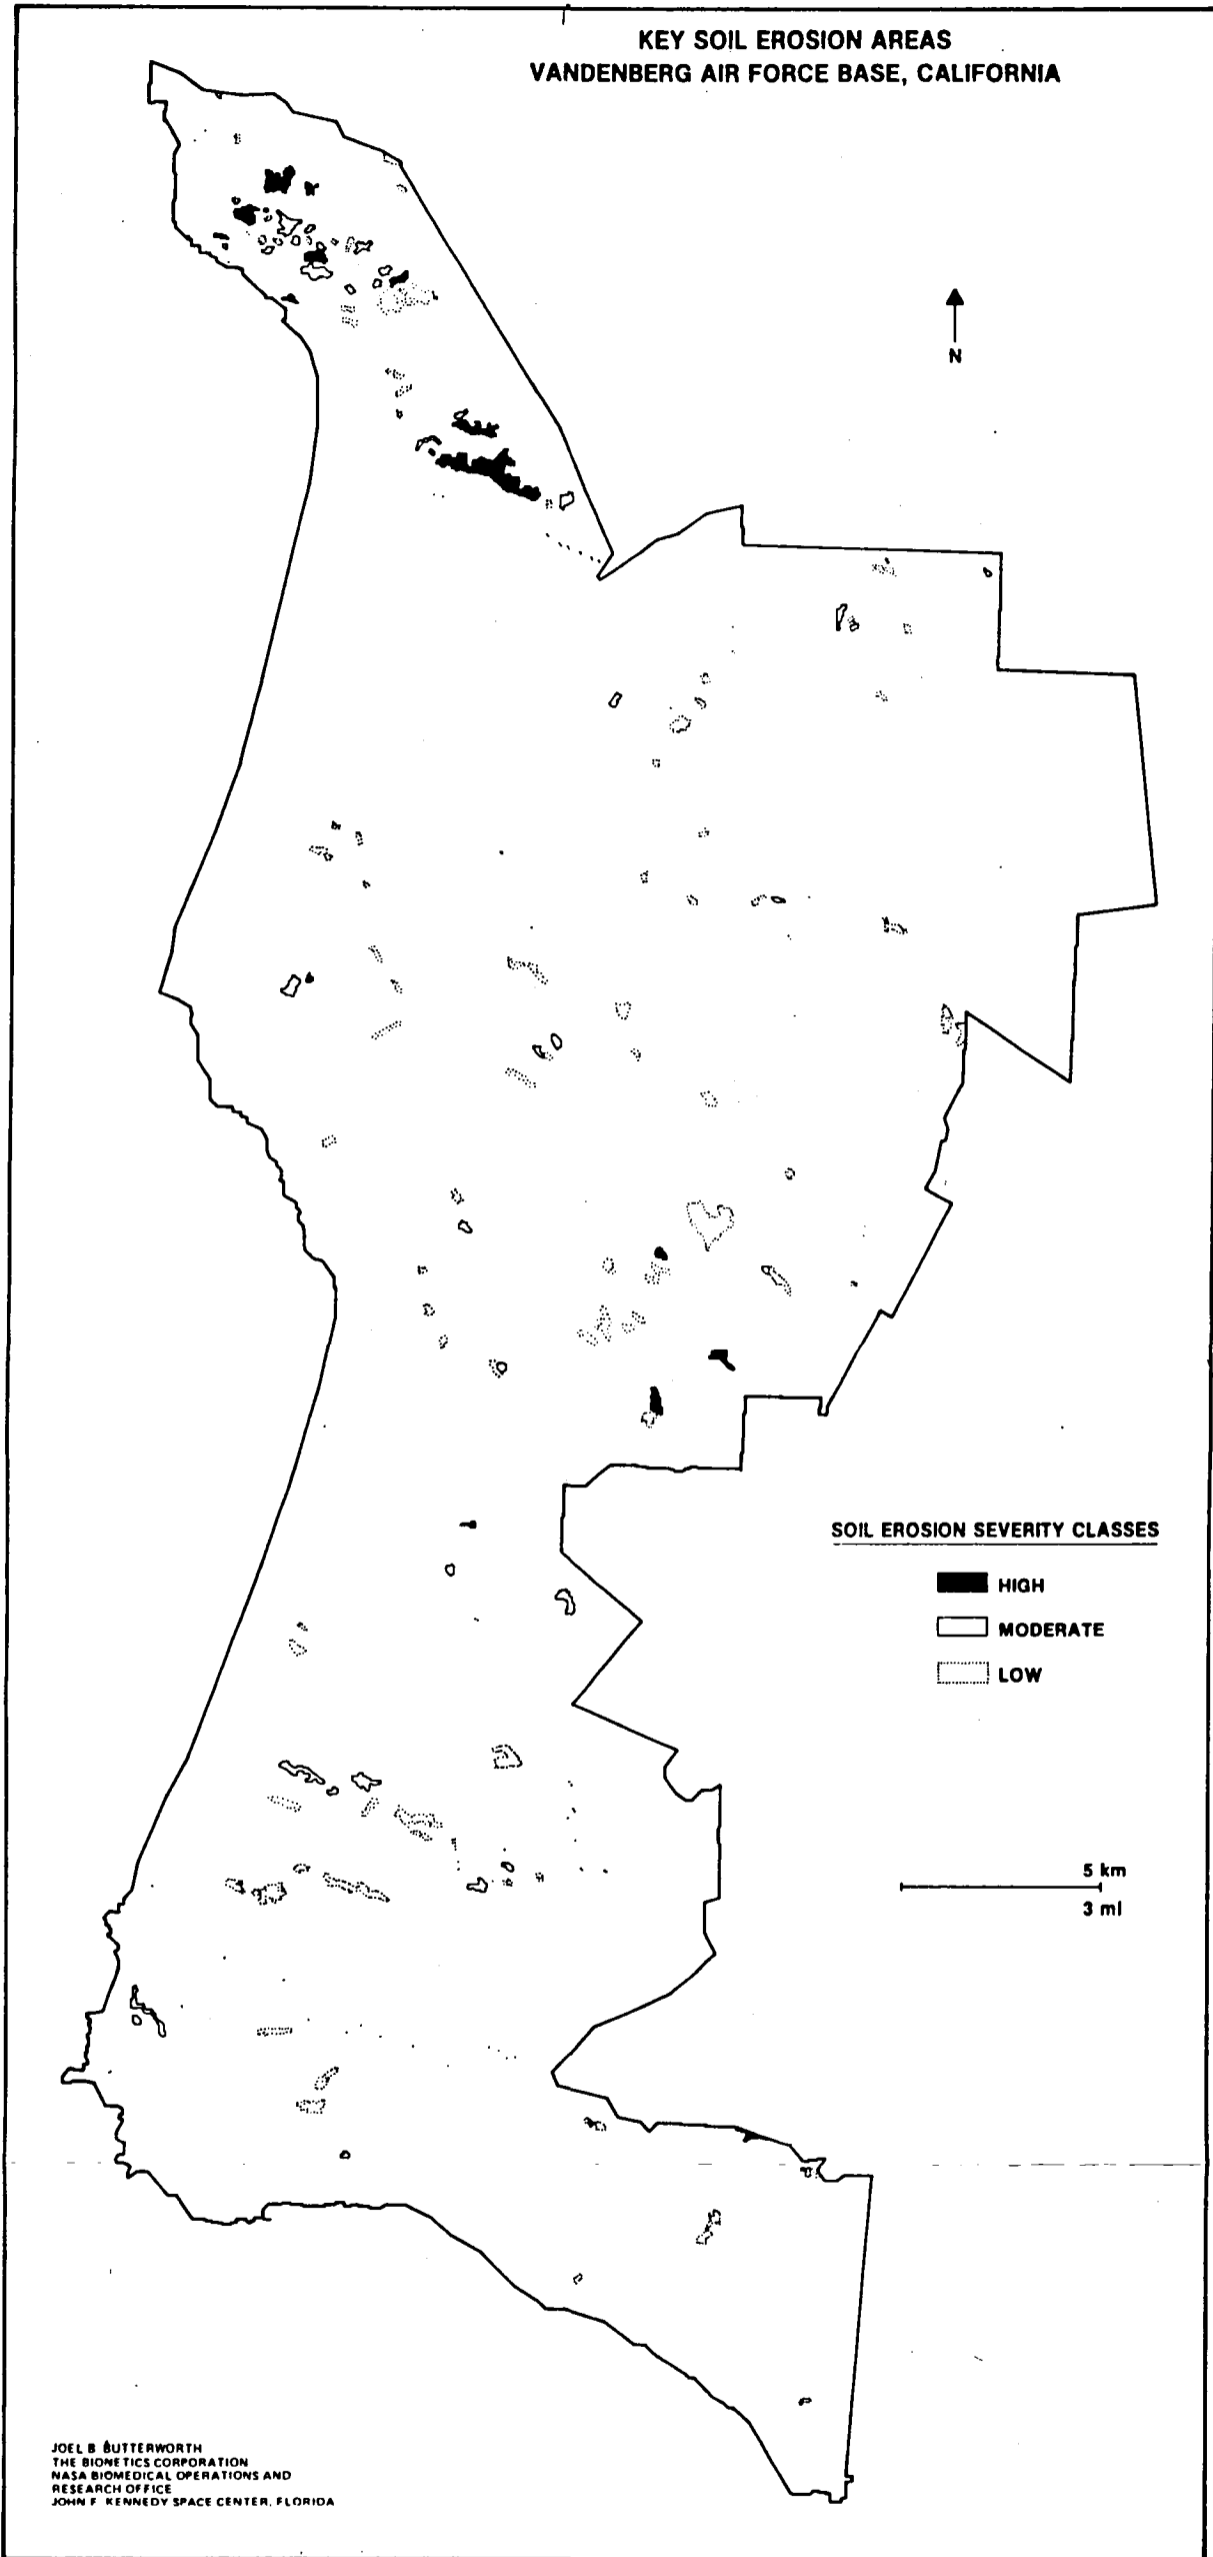
Figure 1. Map showing general distribution of eroded areas and unvegetated road cuts. Redrafted from composite ERDAS-generated map. See Butterworth (1987) for detailed maps.

One hundred ninety-three soil erosion sites were mapped; 142 were mapped as polygons, and 51 were mapped as point data (road cuts). The general distribution of these sites is shown in Figure 1.
