EVALUATION OF LOAD TRACKS AND WEAR OF  
TWO SETS OF BEARINGS FROM SPACE SHUTTLE  
MAIN ENGINE HIGH PRESSURE OXYGEN TURBOPUMPS  
(Contract No. NAS8-36192, Task 118)

NATIONAL AERONAUTICS AND  
SPACE ADMINISTRATION  
George C. Marshall Space Flight Center  
Marshall Space Flight Center, Alabama

November 20, 1985

BATTELLE  
Columbus Division  
505 King Avenue  
Columbus, Ohio 43201-2693

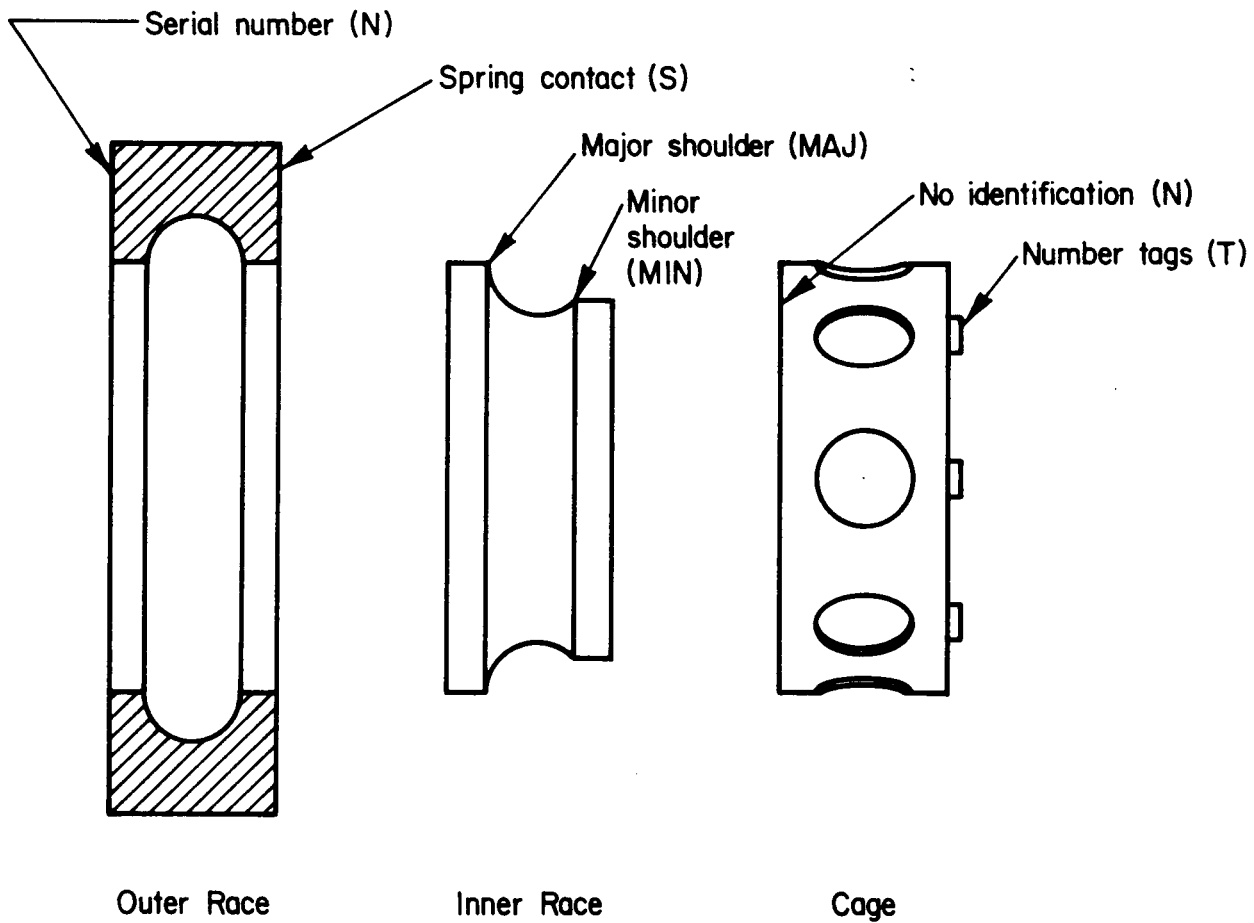
FIGURE 1. IDENTIFICATION NOMENCLATURE

Table 1 summarizes the specific observations made by the examining team. Figure 1 shows the identification nomenclature. Two bearings (2 and 4) on Unit No. 2317R1 were badly degraded. Bearing No. 2 (preburner side) had evidence of pitting (or flaking) on the inner race and evidence of wear on the outer. The outside of the outer race showed evidence of galling near the N side, which was probably the result of spinning relative to the housing. Cage pocket wear on the No. 2 bearing was fore and aft in the pocket and on the side of coolant flow, which would be expected.
