ANATOMY OF A BEARING TORQUE PROBLEM

Damon D. Phinney*

In the early 1970s, Ball Aerospace Systems Division developed an antenna despinn drive for the Messerschmitt Boelkow Blohm (MBB) solar science satellite HELIOS. This paper discusses a problem with high bearing drag torque that was encountered on the two flight models of this drive, after successful tests were completed on twelve bearings, an engineering model, and the qualification unit.

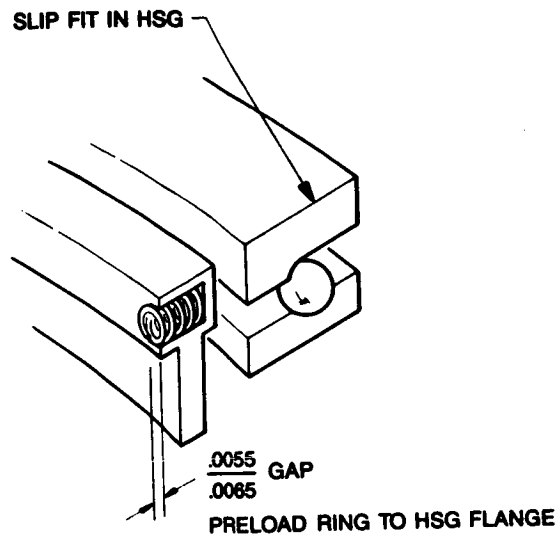
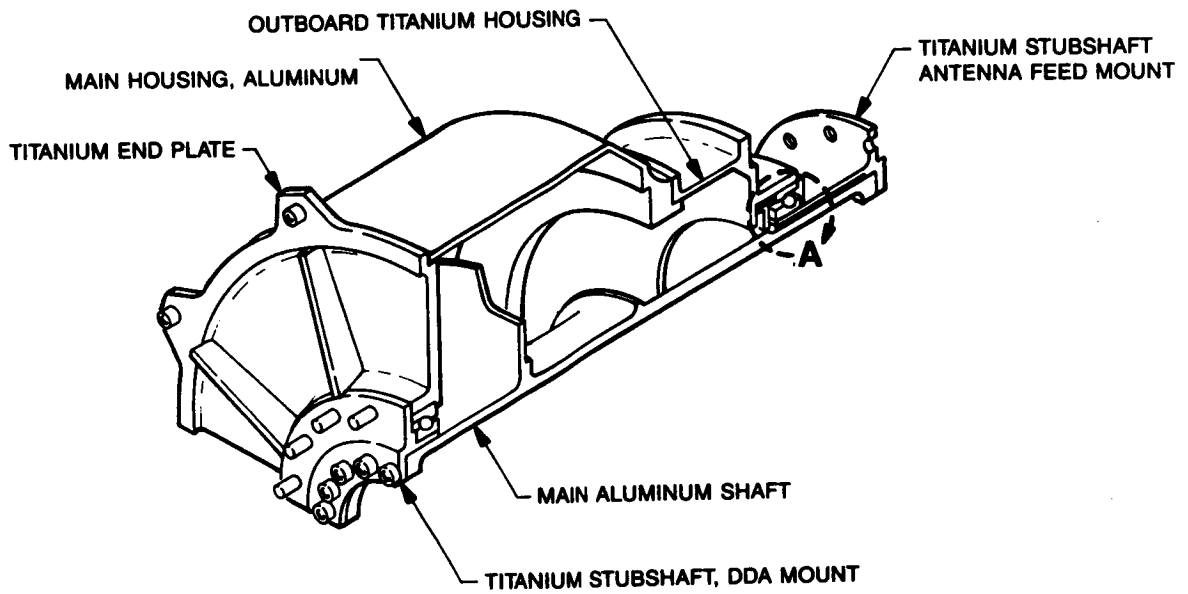
Figure 3 Bearing installations

- A three-piece shaft assembly, consisting of a 7075-T652 aluminum tube 7.8 in. long with 6Al-4V titanium stubshafts at each end. Bearing journals were on the stubshafts, whose function was to isolate the bearings from the high expansion rate of the aluminum tube. The stubshaft at the left end of Figure 3 has 16 studs on a flange outside the bearing, by which the DDA was mounted on the spacecraft.
- A three-piece housing assembly. The main housing was aluminum, with an 8-in. ribbed titanium plate at one end, and a short cylindrical titanium member at the other. The titanium pieces carried the bearing outer rings, isolating them from the aluminum member.

- Two angular contact ball bearings were spaced 6.4 in. apart with outer race thrust shoulders facing each other. All bearing rings were slight interference fits except for the outer race of the right hand bearing. This was slip-fitted and acted on by a set of coil springs with a force of 5 lb. The springs were in a carrier machined to length at assembly to produce an end play of 0.0055/0.0065 in. Because of the mix of aluminum and titanium pieces in the shaft and housing, the end play would be reduced by 4 mils at -50°C.

- The 440C bearings were lubricated with a thin film of MoS₂ approximately 1/4 micron thick, and had inner-land-riding Rulon-A separators with full cylindrical pockets. The normal ball complement was reduced from 42 to 38 to provide additional separator material between pockets and increased dimensional stability.

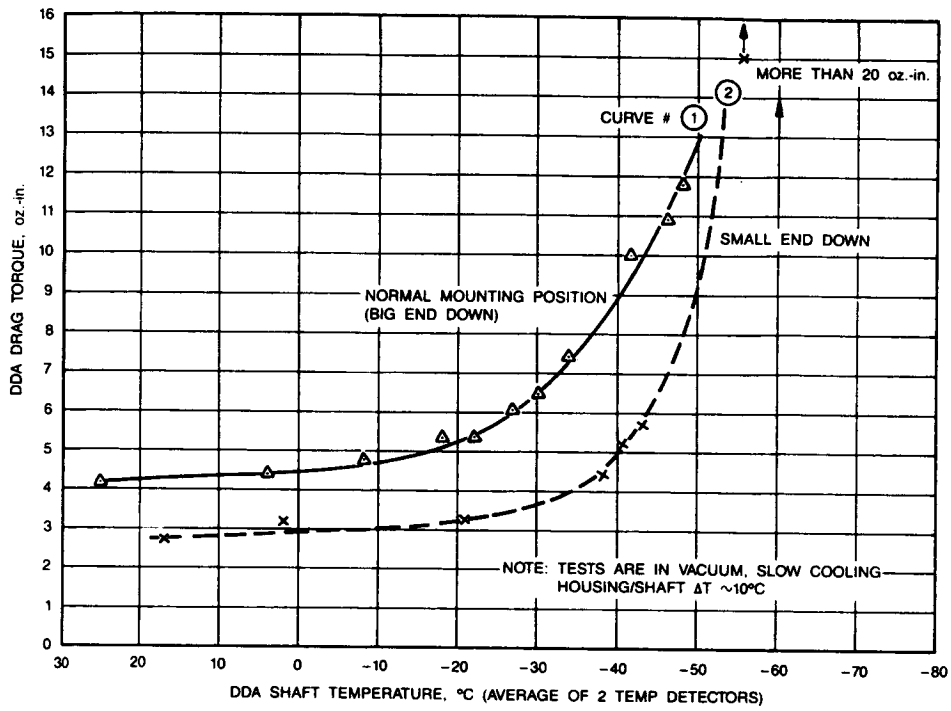
Figure 4 Torque vs. temperature, 1st flight DDA in thermal vacuum chamber

With this favorable experience preceding acceptance tests of the two flight DDAs, we were rudely surprised when drag torque climbed to 20 oz-in. on the first unit while it was being taken down to -50°C .

Curve 1 on Figure 4 shows results with the DDA in its normal mounting position, shaft vertical and big end down. In this position, the lower bearing carries the weight of the drive housing (several lb) and also the bearing preload force of 5 lb. Although this test indicates a peak torque of only 13 oz-in. at -50°C , and suggests that limiting the housing-to-shaft temperature gradient was helpful, it clearly shows a problem.

Curve 2 on Figure 4 gives results with the drive inverted. Torque exceeded 20 oz-in. at -56°C . In this position, the bearing now on top is essentially unloaded and the bottom bearing is subject to the preload force only, with the housing weight close to the preload spring force. This removes approximately 10 lb of total bearing load and explains the reduction in drag torque at room temperature, correlating well with results of bearing torque vs. preload tests. The shift in the knee of the torque curve to a lower temperature is not explained. As will be seen, our corrective actions were taken at the big end of the drive where it was usually attached to the mount, which was also a cooling plate. With the sensitive end of the shaft no longer attached to the cooling plate, it may not be surprising that response to low temperature is somewhat different.

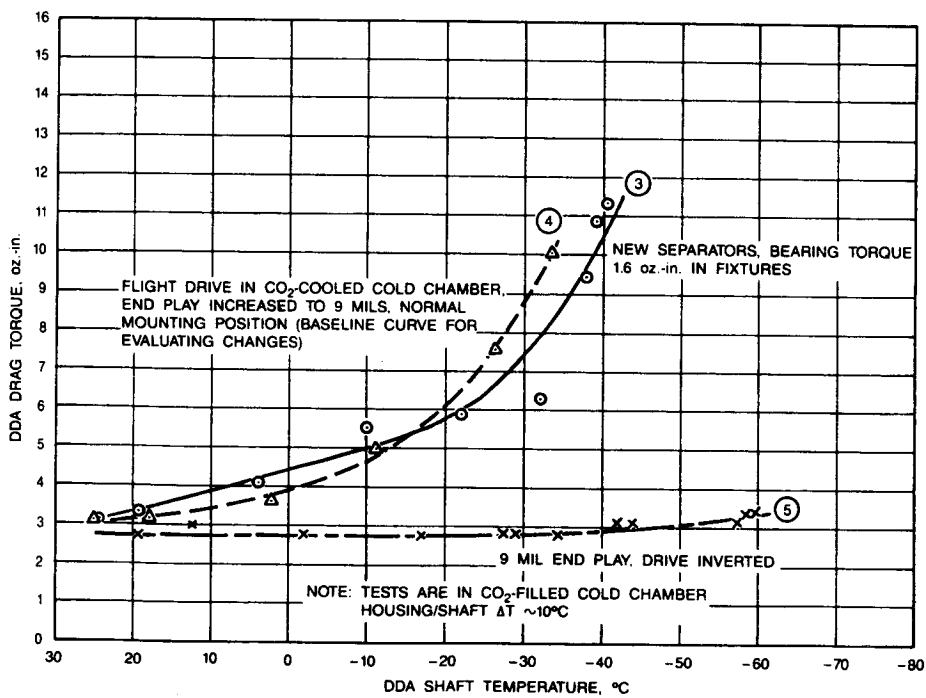
Figure 5 Cold chamber test results with new bearing separators and increased end play

This test indicated high torque again (Curve 3 on Figure 5) and proved that there was a problem other than in the bearings.

Nevertheless, a simple fixture was made with which we could manually feel end play with the drive stopped. In the first test, we could no longer detect any play at -25°C and torque was up to 8 oz-in. A new preload ring giving 9 mils of end play was installed. Now some play was still detectable at -33°C but torque had reached 10 oz-in. (see Curve 4, Figure 5). Since all subsequent tests will be run with increased end play, Curve 4 will be used as a baseline for evaluating effects of changes.

end play. Torque was only 3.5 oz-in. at -50°C (see Curve 5, Figure 5). Comparing results with Curve 2, Figure 4, when the drive was upside down in a thermal vacuum test, it appears that increased end play and/or the difference in cooling method caused a major improvement. We did not determine the reasons for this improvement.

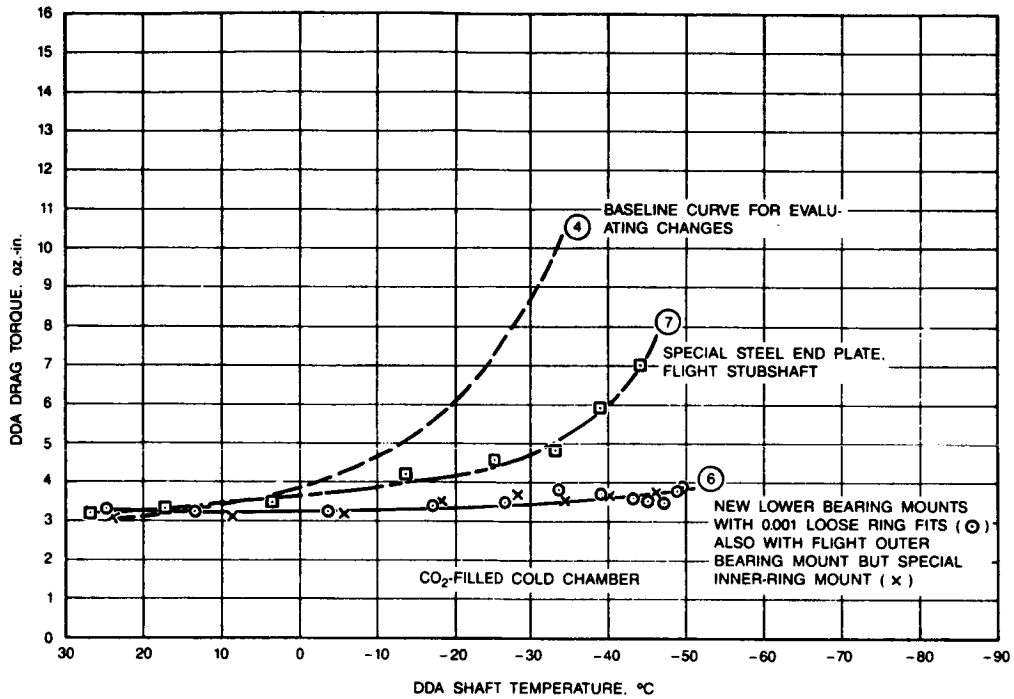
Figure 6 Performance with new lower bearing mounts

Because we now suspected the lower bearing mounting hardware, a new, simple outer ring mounting plate (end plate) was made from mild steel, and a spare engineering model stubshaft was located. Both bearing ring fits were made nominally 0.001 in. loose instead of line-to-line to tight, as on the flight hardware, and end play was adjusted to 9 mils. As shown by Curve 6 in Figure 6, these changes were magic! Torque was below 4 oz-in. at -50°C with the DDA right side up. We now had to discover why.

The next experiment was to try the new stubshaft by itself, with the flight end plate. Again torque stayed low, perfectly duplicating results of the previous test with both lower bearing mounts changed. Data points from this test (x's) mingle with the ones of the previous test (o's) on Curve 6.

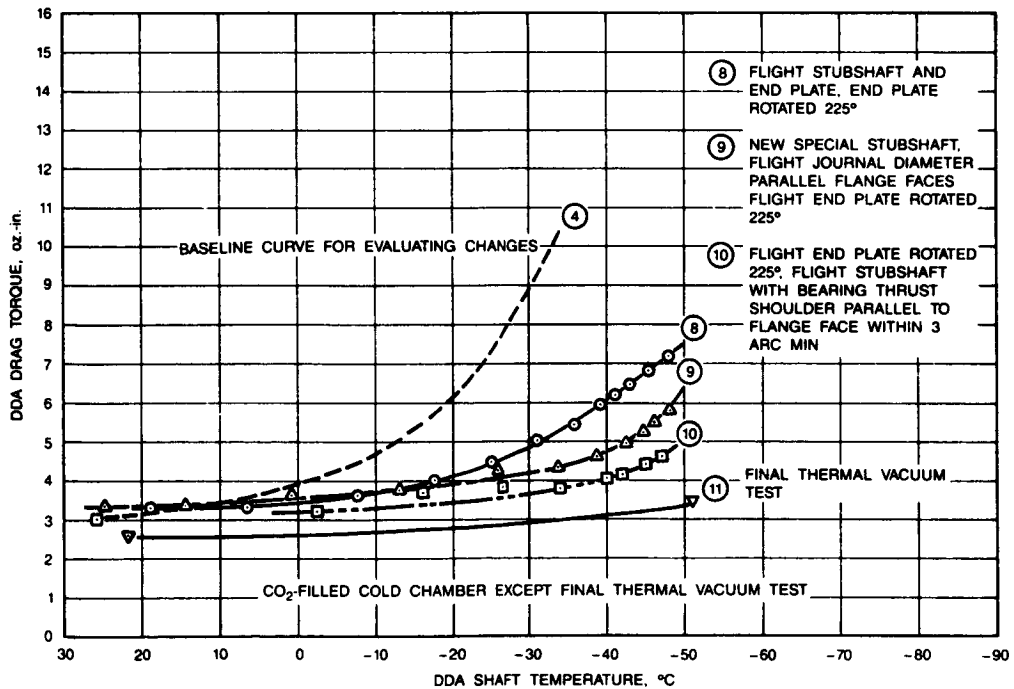
Figure 7 Performance with bearing mount changes that corrected the problem

With this new knowledge, a series of tests with the flight end plate in different angular positions was conducted. We discovered that flight end plate position did indeed affect low temperature torque, and that results at any position were quite repeatable. Furthermore, the position for the as-built DDA was the worst one - somebody's law at work! In its most favorable position, the drag torque was as shown by Curve 8, Figure 7. Instead of over 20 oz-in. at -50°C , we had only 7.5 oz-in., and the sharp knee in the curve was gone. Compare Curve 8 with baseline Curve 4, which has been repeated in Figure 7, for reference.

with the new steel stubshaft, illustrated by Curve 10, Figure 7, after being cleaned up and made ready to repeat some of the formal acceptance tests. At -50°C , torque was 5 oz-in., just meeting the original specification requirement.

During acceptance tests, drag torque was measured in vacuum at 22°C and -51°C , where it was 2.6 and 3.4 oz-in. Curve 11 on Figure 7 shows these final results.

With this finding, we had the flight stubshaft thrust face trued up on a jig grinder (measured parallel to the shaft flange within 0.3 arcminute) while removing 0.0005 in. from the journal. The DDA now tested even better than

Improving parallelism between the bearing thrust shoulder and shaft flange, and slightly opening the inner bearing ring fit, had made a further significant reduction in -50°C torque.

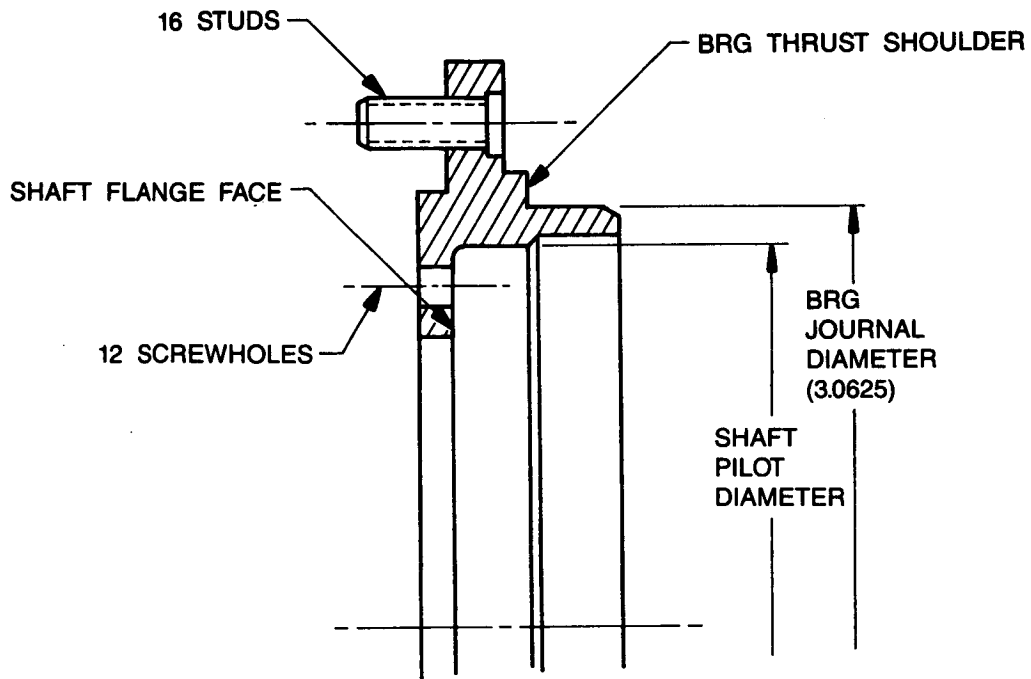
Figure 8 Lower stubshaft configuration

- Axial distortion between shaft flange and bearing thrust shoulder as temperature was reduced to -50°C . On the flight part, we found 0.0001 in. and 0.0002 in. change in two locations, while the engineering model stubshaft was worse (0.0004 in.).

- Changes in two bearing journal diameters, 90 degrees apart, between room temperature and -50°C . Both diameters on both parts changed the same amount (-0.0016 and -0.0017 in.).

- Roundness of bearing journals. The flight journal was round within 0.0001 in. while the engineering model part was off as much as 0.0004 in. Since the latter journal was intentionally undersize and a loose fit, any effect of the poor journal roundness would have been suppressed. Excellent roundness of the flight journal indicated that it could not be a problem.

- Concentricity between bearing journal and pilot diameter. Flight part concentricity was within 0.0003 in. while the engineering model part showed 0.0001 in. This difference seemed negligible.

- The flight journal was larger than the engineering model journal, and was also 0.4 mil over the drawing dimension. This diametral difference had already been discounted by test results.

- Parallelism between the shaft flange face and the bearing thrust shoulder. The engineering model stubshaft showed essential parallelism, but the flight part was off 0.0007 in. For the 3.2 in. diameter of the thrust shoulder, this corresponds to an angular deviation of 0.8 arcminute.

The only significant difference that was worse on the flight stubshaft was the seemingly insignificant reduced parallelism between flange and bearing thrust shoulder. With the bearing ring slightly tight on the journal, so that it should only bottom out on the high point of the shoulder, it hardly seemed possible that this could make any functional difference. Nevertheless, we promptly made a mild steel stubshaft, duplicating the flight bearing journal diameter with its tight fit to the flight bearing, but holding parallelism of the two critical surfaces within 0.0001 in. When this part was tried out in the DDA, Curve 9, Figure 7, we had found another piece in the puzzle. The new stubshaft was noticeably better, bringing -50°C torque down to the 6-7 oz-in. range.

The lower bearing inner race seat was not quite perpendicular to the shaft axis, after assembly. (This is presumed from the piece-part measurement.) With this bearing on top, so that it was unloaded, the small deviation made no difference. At room temperature and with a 10-lb load, there was no difference, but at -50°C the difference was significant. Improving the perpendicularity error from 0.8 arcminute to 0.3 arcminute dropped bearing drag at -50°C about 40 percent. Why?
