## INSTABILITY OF MULTISTAGE COMPRESSOR K1501

Zhou Ren-mu  
Hangzhou Steam Turbine Works  
Hangzhou Zhejiang, People's Republic of China

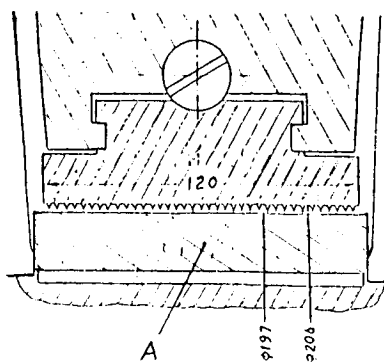
Figure 3. - Labyrinth construction.

Intensive vibration originated from the low-pressure compressor, K1501LP. Figure 2 shows the longitudinal section of its rotor. Table I shows the parameters of the tilting pad of both bearings. Figure 3 shows the gas labyrinth construction of the middle diaphragm. Figure 4 provides a critical speed map and mode shapes for the rotor.

(2) The gas labyrinth of the middle diaphragm and the ends of the cylinder were worn out. Some wear scars remained on the surface of the shaft.

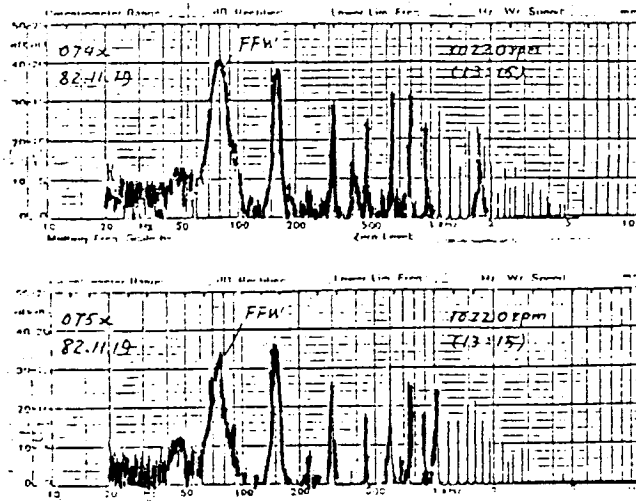
Figure 5 shows frequency spectra of the shaft vibration in direction  $x$  on bearings 074 and 075 at a speed of 10 220 rpm as measured by a transducer on November 19, 1982. From figure 5, the rotating speed was 170.3 Hz, and the frequency of fractional frequency whirl (FFW) was 80 Hz. The frequency ratio  $n_f$  equalled 0.47. The vibration amplitudes of the components in this figure are almost equal. Figure 6 shows a frequency spectra of the shaft vibration in direction  $y$  on bearing 074 and in direction  $x$  on bearing 075 at 9460 rpm on November 19, 1982. Again, the vibration amplitudes were almost equal. The frequency of FFW was 77 Hz (measured), the rotating frequency was 157.7 Hz, and the frequency ratio  $n_f$  equalled 0.488. So obviously the FFW appeared at 9460 rpm.

Figure 5. - Frequency spectrum of shaft vibration in bearings 074x and 075x at 10 220 rpm (Nov. 19, 1982).

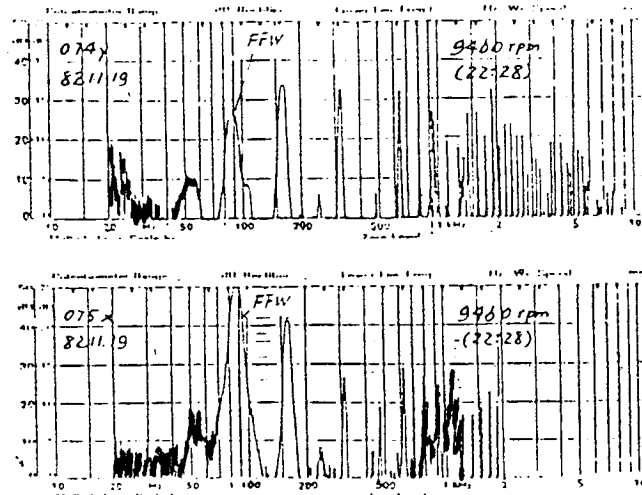
Figure 6. - Frequency spectrum of shaft vibration in bearings 074y and 075y at 9460 rpm (Nov. 19, 1982).

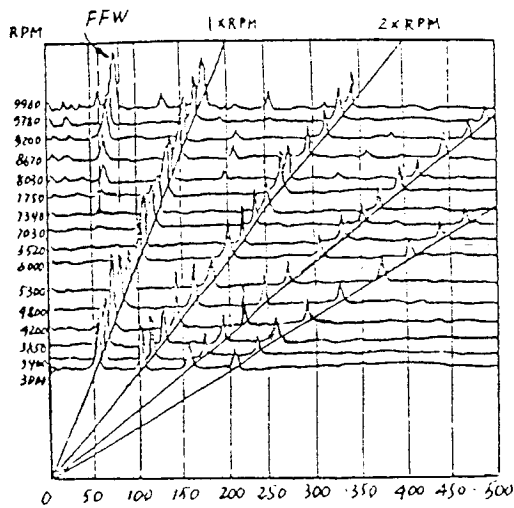
Figure 7, which gives a speed-spectrum map from an experimental recording, indicates that the FFW appeared just at 8000 rpm and that  $n_f$  equalled 0.5. Amplitude increased rapidly with increasing speed, but frequency dropped slightly.

Figure 7. - Vibration speed-spectrum map.

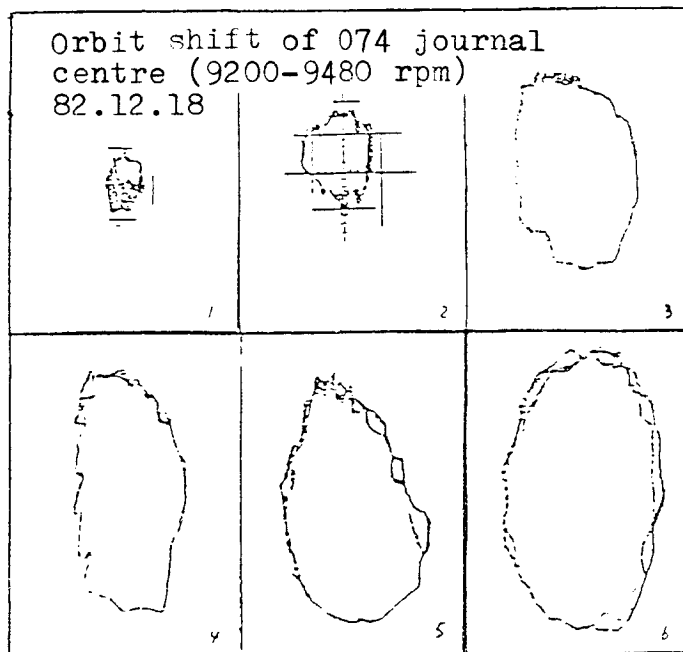
Figure 8 shows an evolution of the shaft center orbit measured on bearing 074 at 9200 to 9480 rpm on December 18, 1982. It was photographed from the cathode oscilloscope.

Figure 8. - Orbit of shaft center on bearing  
074 from 9200 to 9600 rpm.

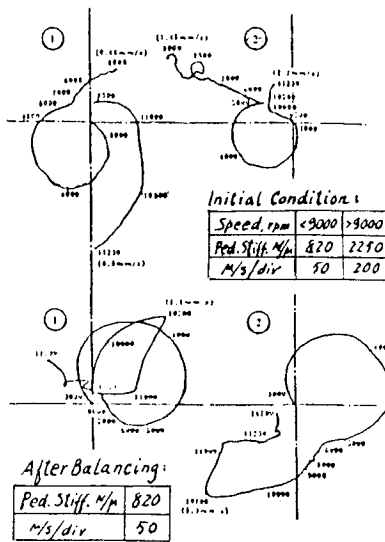
Figure 9 shows the Nyquist tracks before and after the balancing correction. Before the correction the severity of the bearing vibration increased quickly when the speed exceeded 9000 rpm. For the sake of safety the pedestal stiffness was increased from 820 to 2250 N/ $\mu$ m. When the speed reached 11 230 rpm, the two bearings were vibrating at 6.5 and 2.2 mm/sec, respectively. This result indicated poor balancing. We found that the mixed vibration of the second and third modes appeared before the second critical speed was reached. Using the method of modal separation, we corrected the unbalance of the rotor. The bearings were vibrating at only 0.3 and 0.35 mm/sec, respectively, when the pedestal stiffness was restored to 820 N/ $\mu$ m. The first

Figure 9. - Nyquist tracks before and after rotor balancing correction.

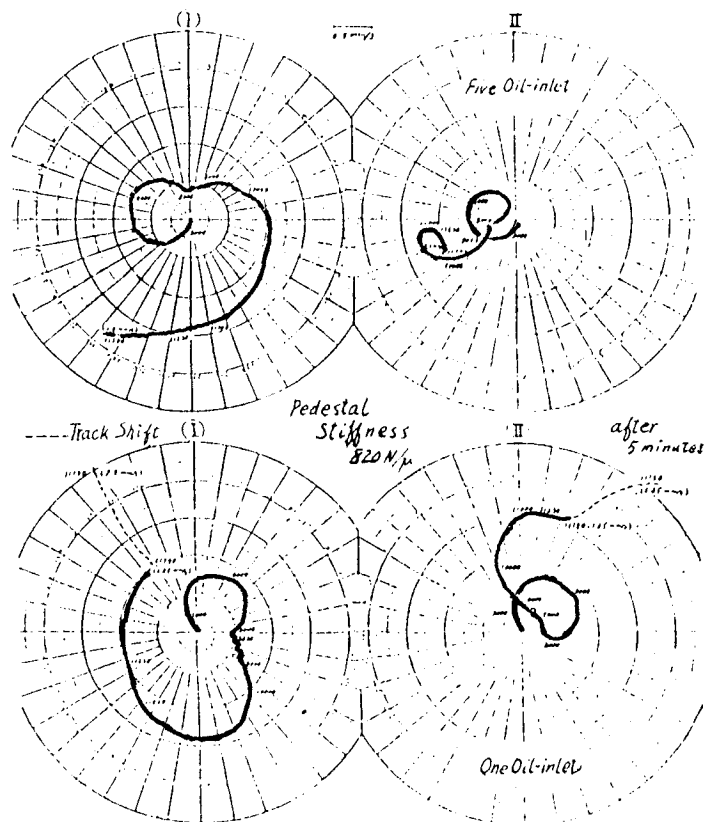
The Nyquist tracks of the rotor with one and with five oil-inlet holes (one hole for each pad) in the bearing are shown in figure 10. The dotted lines in the figure show a change of rotor vibration for one oil-inlet hole. However, oil whip did not take place. The oil clearance was increased from 0.15 to 0.20 mm, but the state of the shaft vibration did not change. It was impossible to test the labyrinth-seal excitation, for the rotor was driven in a vacuum chamber.

Figure 10. - Influence of number of oil-inlet holes on shaft vibration.

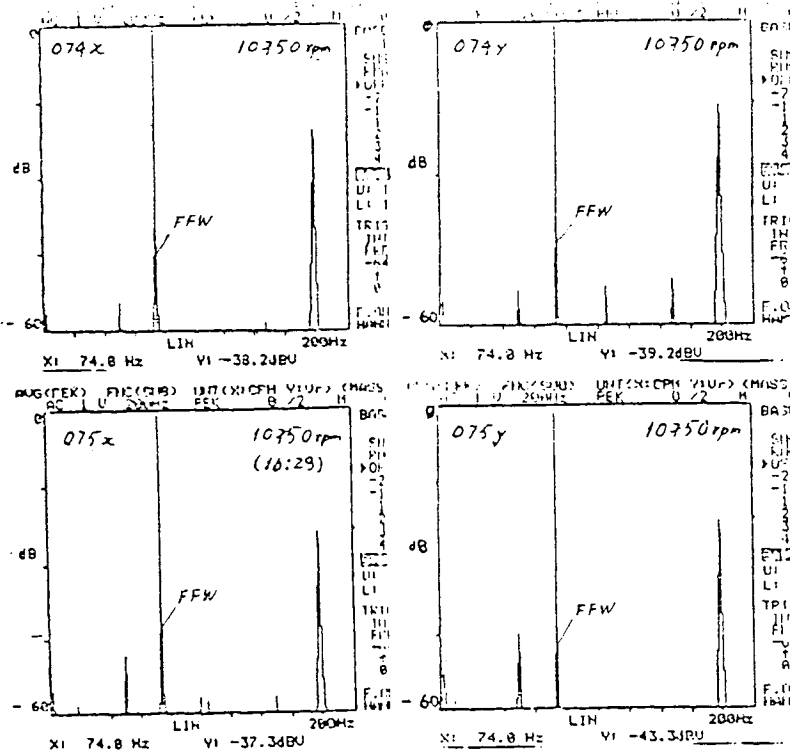
Figure 12. - Real-time analysis of shaft vibration at 10750 rpm before rotor instability.

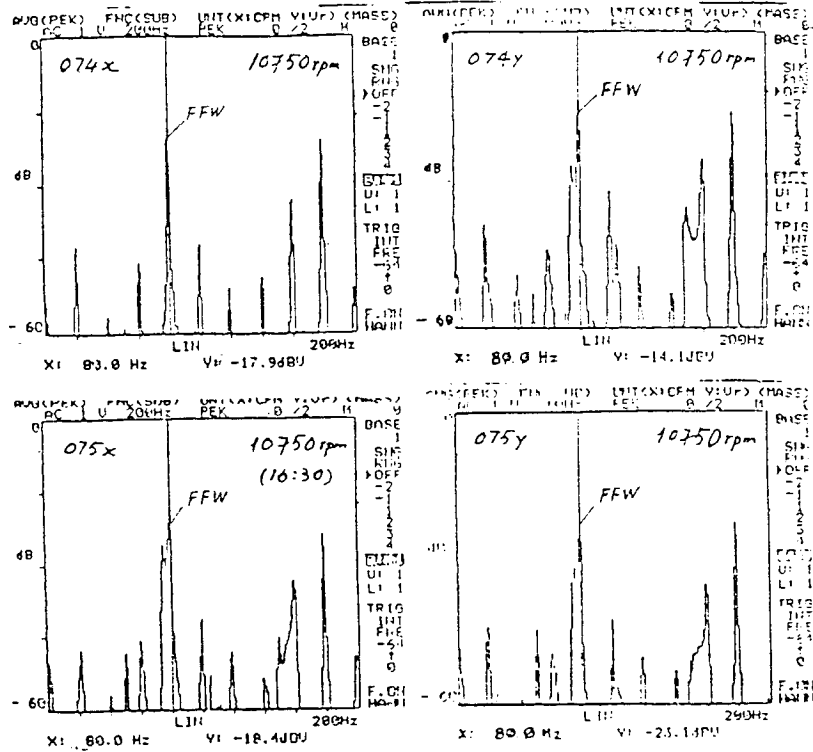
Figure 13. - Real-time analysis of shaft vibration at 10 750 rpm during rotor instability.

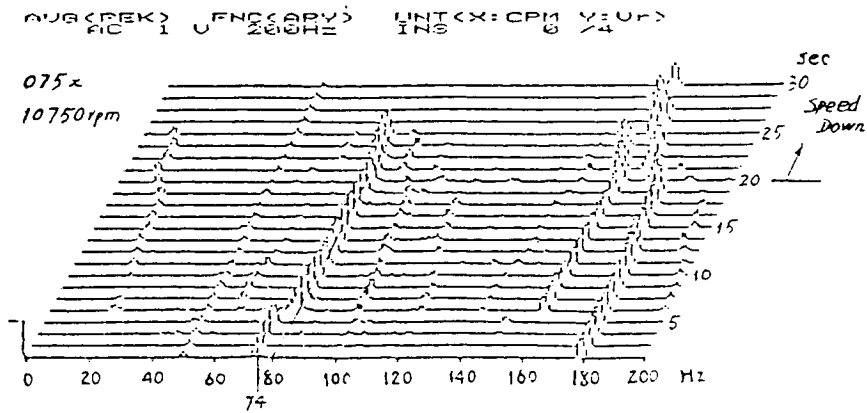
The tests just described make clear the inevitability of rotor instability. But comparisons between figures 7 and 14 show that the latter tests did not produce considerable FFW before instability appeared, and the amount was less than that of the operational speed-frequency map by 25 dB (fig. 12). Just before the rotor became unstable (fig. 14), the frequency of the FFW was 74 Hz/sec (which is the same as in fig. 12). This frequency suddenly rose to 80 Hz after 5 sec (which is in agreement with fig. 13). The frequency ratio  $n_f$  equalled 0.4465.

Figure 14. - Three-dimensional spectrum of shaft vibration in bearing 075 at 10 750 rpm during instability.

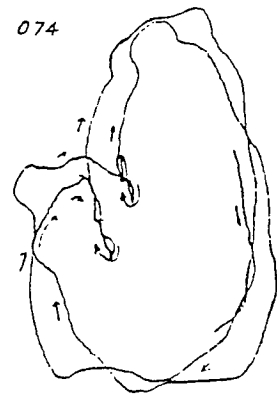
Figure 15. - Orbit of shaft center on bearing 074 at 10 750 rpm during instability.

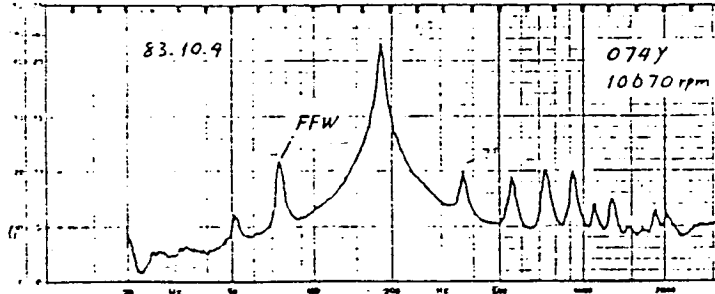
Figure 17. - Frequency spectrum of shaft vibration on bearing 074y taken with old labyrinth.

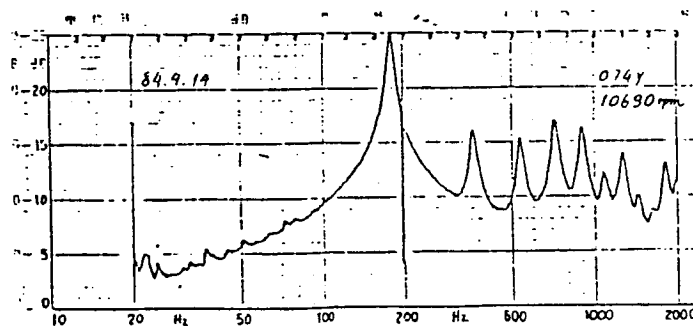
Figure 18. - Frequency spectrum of shaft vibration on bearing 074y taken with new labyrinth.

Finally, a decision was made that gas should be injected into the labyrinths of the middle diaphragm. The new construction is shown in figure 16. After this measure was taken, the instability was eliminated. Figure 17 shows a frequency spectrum of the shaft vibration on bearing 074 at 10 690 rpm before corrective measures were taken, and figure 18 shows this spectrum after corrective measures were taken. It can be seen that the FFW was eliminated.
