NASA Technical Memorandum 88974

# Fatigue Failure of Regenerator Screens in a High Frequency Stirling Engine

David R. Hull, Donald L. Alger,  
Thomas J. Moore, and Coulson M. Scheuermann  
*Lewis Research Center*  
*Cleveland, Ohio*

March 1987

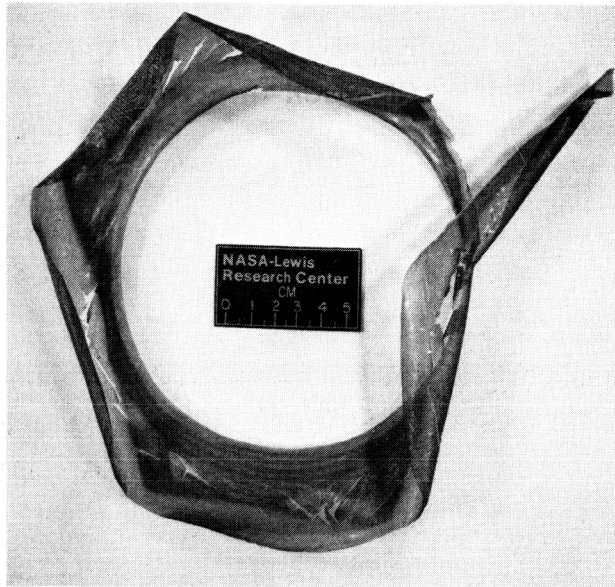
Figure 5 is a photograph of the top screen surface of the regenerator. Top screen refers to the regenerator screen surface that faces the heater tube sheet at the hot end of the regenerator. Figure 5(b) shows the surface of a screen that was deeper down in the regenerator stack - approximately two thirds through the 350 screen stack. A higher magnification photograph of the top screen (fig. 6) shows more clearly the severe damage done to the screen and the presence of particles filling some of the screen openings. Specimens of these regenerator screens and the collected debris were prepared for metallurgical examination.

(A) TOP SCREEN (CLOSEST TO HEATER TUBES).

FIGURE 5. - REGENERATOR SCREENS AFTER 80 HOURS OF ENGINE OPERATION.  
SUBSTANTIAL DAMAGE TO SCREENS IS EVIDENT.

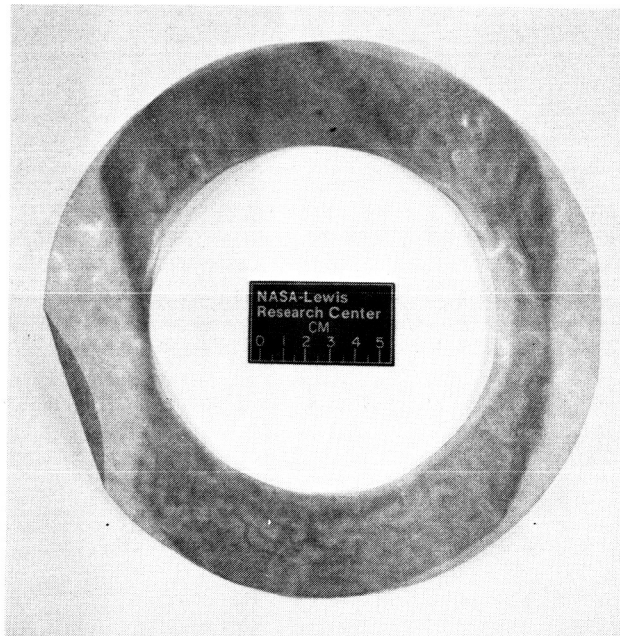
(B) INSIDE SCREEN (ABOUT 2/3 OF THE WAY INTO STACK).

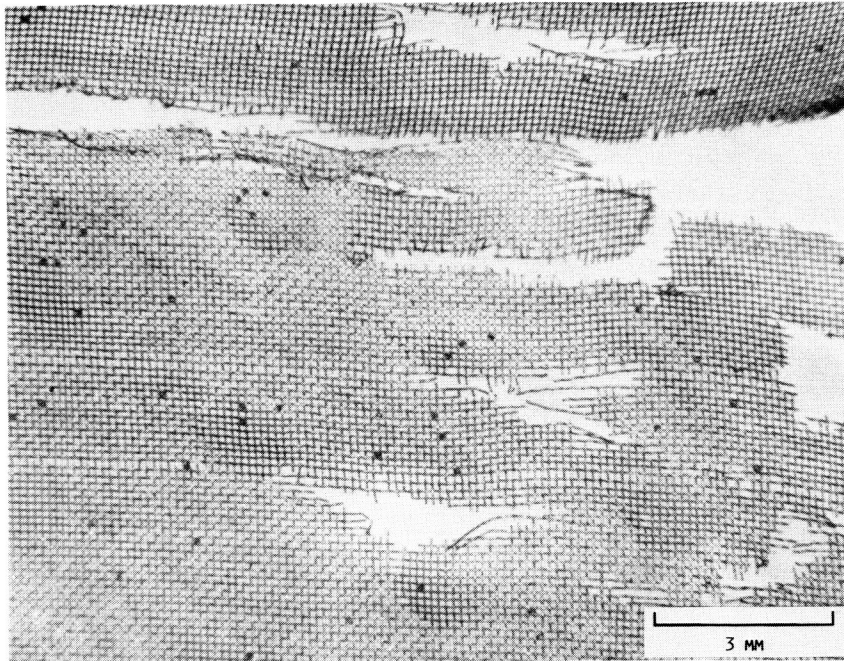
FIGURE 6. - HIGHER MAGNIFICATION OF SCREEN IN FIGURE 5(A). NOTE SEVERE LOSS OF SCREEN WIRES AND PARTICLES FILLING SCREEN OPENINGS.

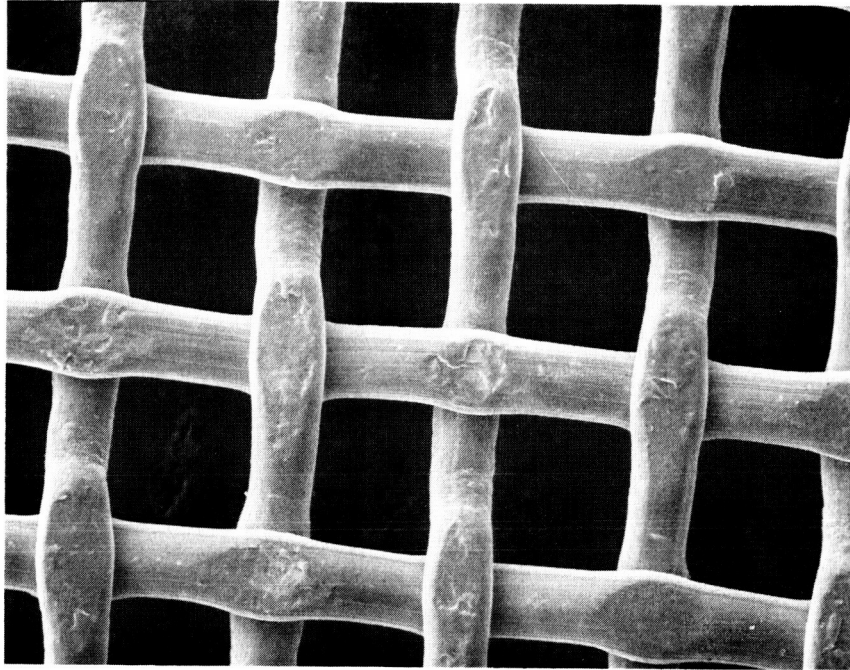
The scanning electron microscope (SEM) was used to examine the screens in three conditions; as-received, inside screen, and top screen (fig. 7). An as-received piece of screen is examined throughout the analysis to serve as a reference. Figure 7(a) shows the as-received screen to have flattened wires at crossovers due to the manufacturing process of the screens. After being run in the engine, a screen from inside the stack (fig. 7(b)) shows additional uniform damage (cratering) and "chips" of material on the wires. The top screen, closest to the heater tubes shows severe damage to the wires (fig. 7(c)), including fractures at crossovers, uniform cratering, pieces of wire missing, and wire debris filling screen openings. In looking at the fractured wires more closely there is evidence of fatigue striations (fig. 8(a) to (b)) and fatigue cracking at the saddle points of the crossover (fig. 8(c) to (d)).

(A) AS-RECEIVED, DEFORMATION AT CROSSOVERS.

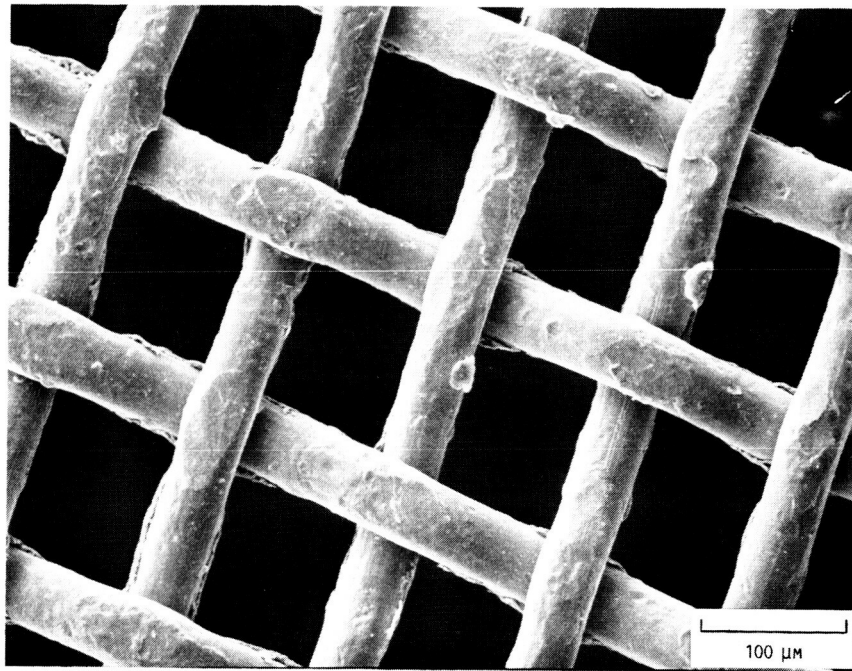
(B) INSIDE SCREEN, SLIGHT DAMAGE.

FIGURE 7. - SCANNING ELECTRON MICROGRAPHS OF REGENERATOR SCREENS. SIGNIFICANT INCREASE IN DAMAGE TO THE WIRES FROM (A) TO (C). FAILURES AT WIRE CROSSOVERS, SMALL CHIPS AND A LARGE PARTICLE CAN BE SEEN IN (C).

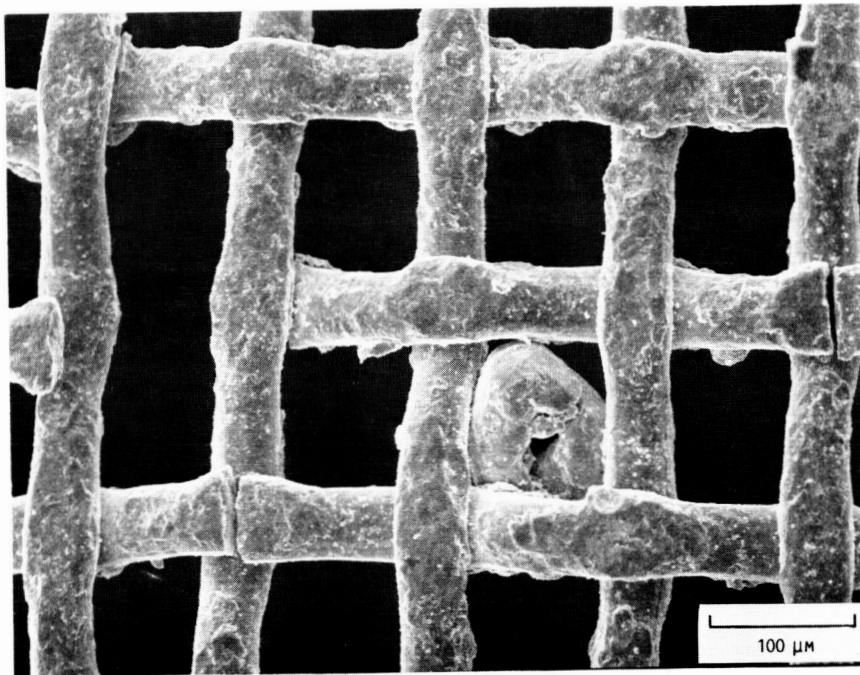
(C) TOP SCREEN, SEVERE DAMAGE.

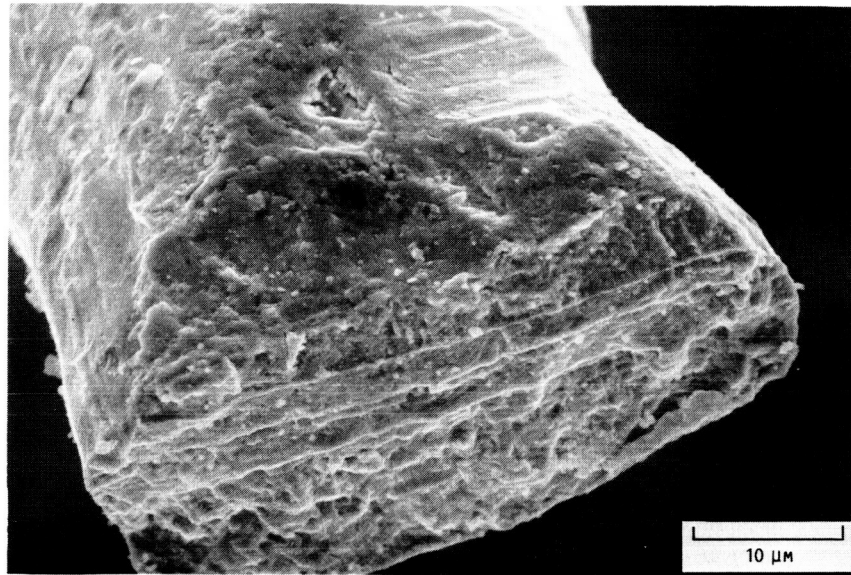
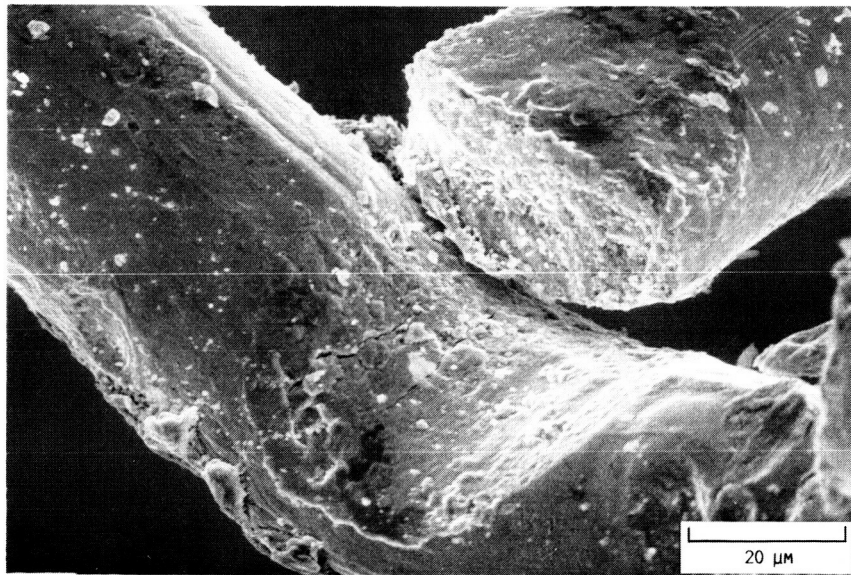
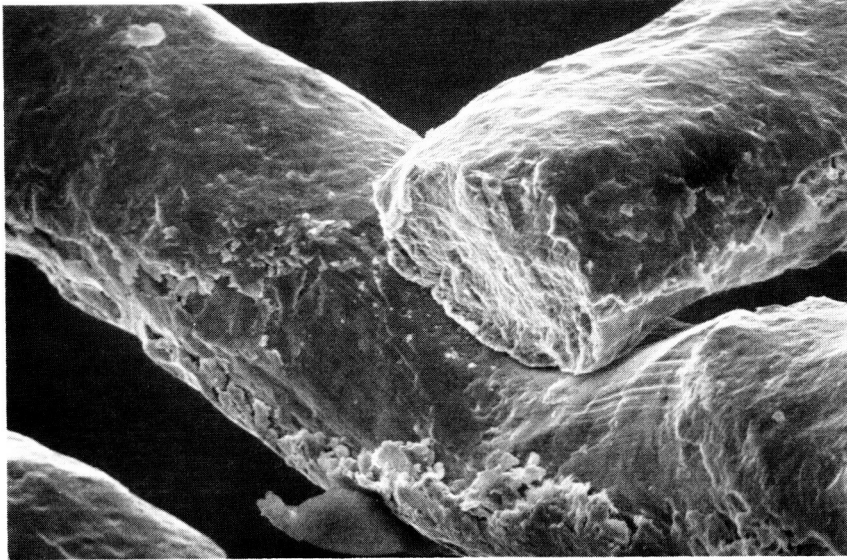
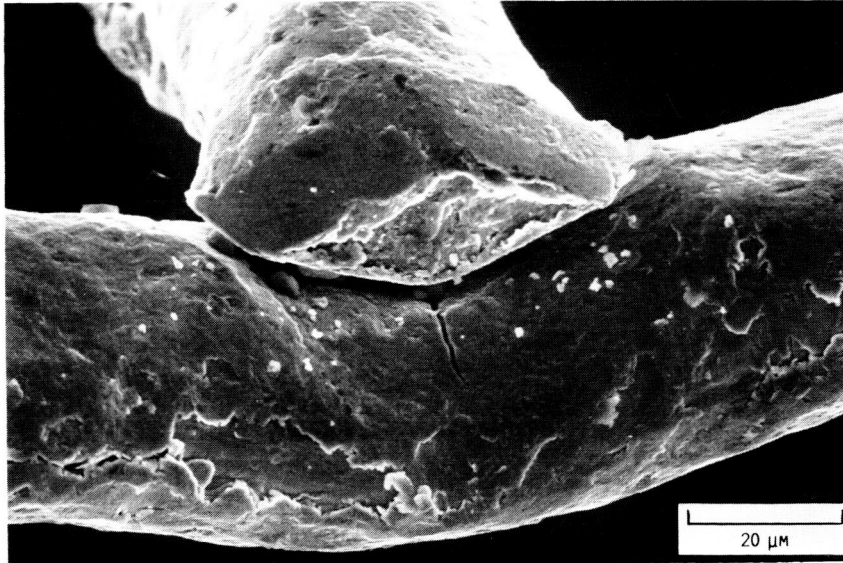
Several factors are believed to have contributed to the fatigue failures of the screen wires at crossovers. These factors include; reduction of wire thickness, stress concentration, and highly worked microstructure. The combination of the reduction in wire thickness and the ability of the individual screens to move, causes stress concentration at the wire crossovers. The highly worked microstructure was found to have a 65 percent increase in hardness (table 1) hence, an easier location for crack initiation and subsequent fatigue failure.

FIGURE 8. - SEM MICROGRAPHS OF ENDS OF FAILED WIRES SHOWING OCCURRENCE OF FAILURE AND CRACKING AT WIRE CROSSOVERS AND FATIGUE STRIATIONS.

A new permanent design of the regenerator is now being fabricated with the same Type 304 stainless steel screens sintered together and brazed into a can for insertion into the regenerator cavity as a unit. This new design will prevent individual screen movement, reducing the stress concentration at crossovers. Originally, unsintered screens were chosen over sintered screens because of an expected improvement in performance. Experimental testing of regenerator screens in lower frequency Stirling engines has shown that unsintered screen has better heat transfer and fluid friction characteristics than sintered screen. However, as has been observed, if unsintered loose-screen is used in a regenerator matrix, the screens must be packed tightly together in the regenerator cavity in order to prevent any flexing of the individual screens by the oscillating gas flow.

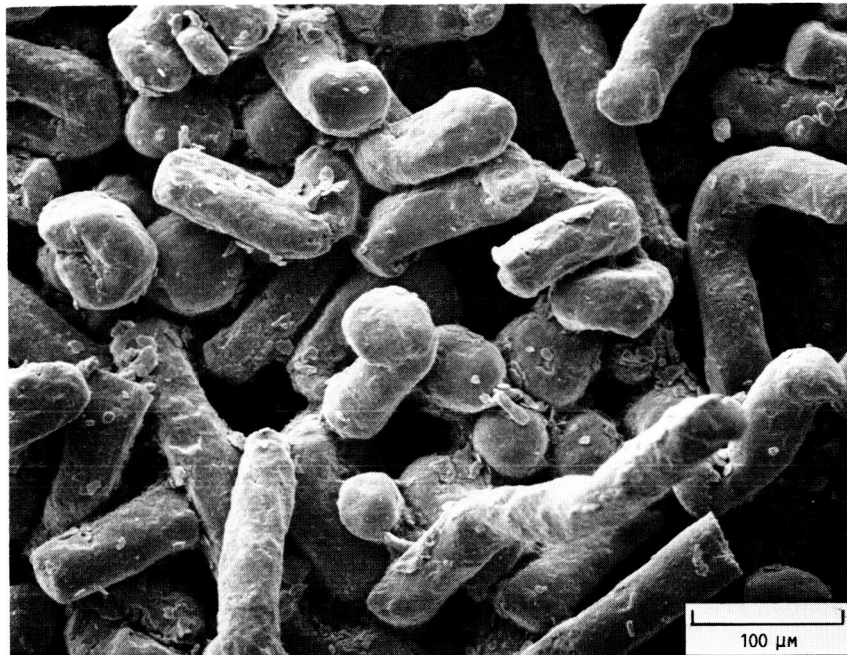
(A) COARSE DEBRIS FOUND BETWEEN SCREENS.

FIGURE 9. - DEBRIS FOUND IN ENGINE. ALL PARTICLES WERE IDENTIFIED BY XEDS AS TYPE 304 STAINLESS STEEL. THE EXTENSIVE CRATERS IN (B) CORRESPOND WITH THE PARTICLES IN (C).

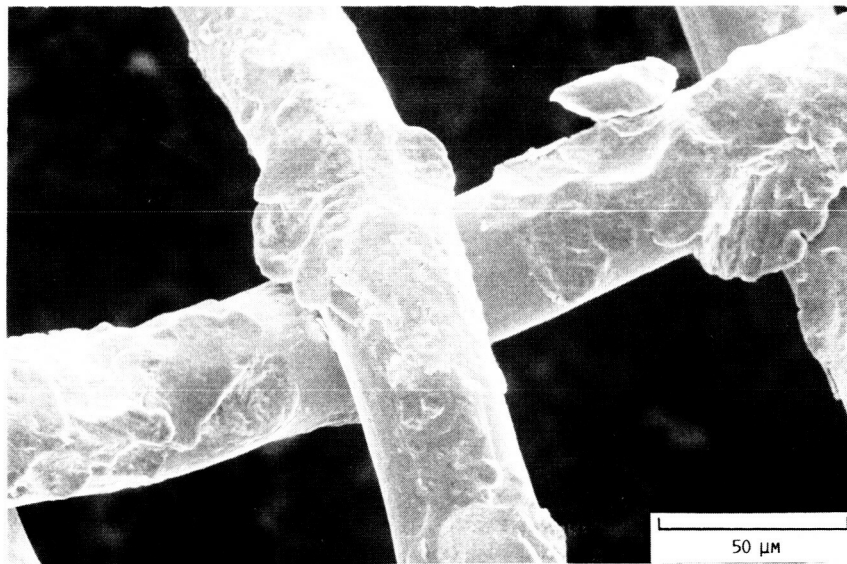
Debris found in the engine was examined by SEM and identified as Type 304 stainless steel by x-ray energy dispersive spectroscopy (XEDS). X-ray diffraction of the debris, as-run-in-engine screens, and as-received screens, were found to consist of both face-centered-cubic ( $a = 0.3607$  nm) and body-centered-cubic ( $a = 0.287$  nm) phases. The debris found in between the regenerator screens is shown to be pieces of screen (fig. 9(a) to (b)). The debris found outside the regenerator is made up of stainless steel "chips" less than  $20 \mu\text{m}$  in size (fig. 9(c)). The "chips" arise from the deformation of the wire, a chip being fractured from a wire can be seen in figure 9(b). Due to their size they were able to pass through the screen openings and exit the regenerator.

(B) SMALL PIECE OF SCREEN FOUND IN BETWEEN SCREENS.

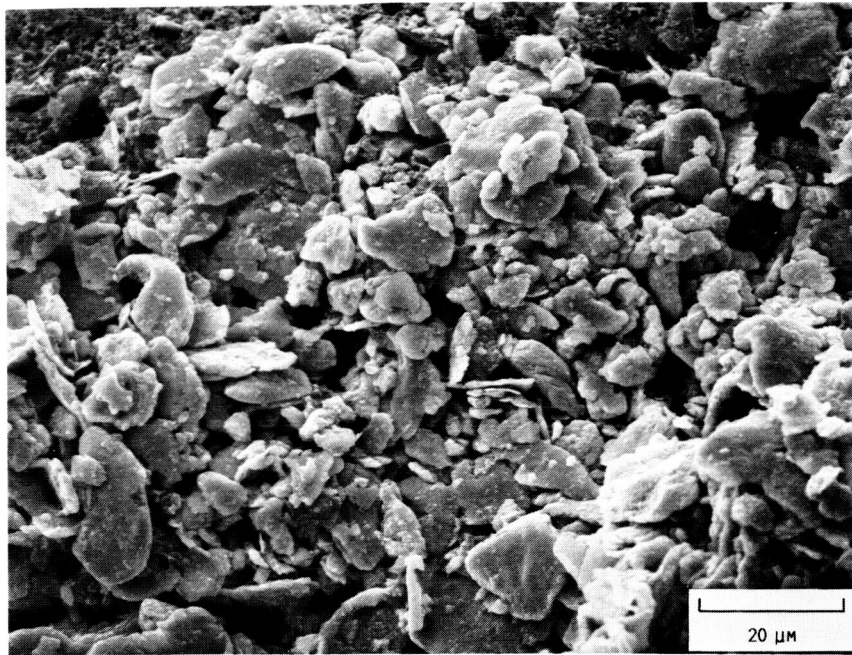
(C) FINE DEBRIS FOUND ON HEATER TUBE SHEET.

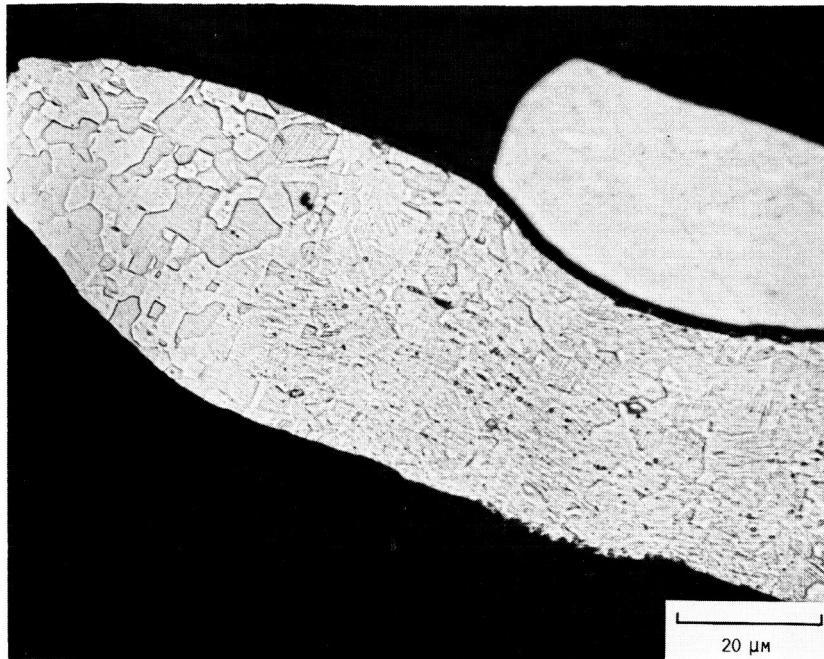
Microstructures of the as-received and run-in-engine screens were examined by performing standard metallographic techniques. Optical micrographs show the wire crossovers to contain a highly worked microstructure, while away from the crossovers the microstructure consisted of equiaxed grains (fig. 10). Transverse sections of the wires showed the worked microstructure to exist across the full thickness of the wires at crossovers (fig. 10(c)). No variation in microstructure was observed between the as-received and run-in-engine screens.

(A) LONGITUDINAL SECTION OF WIRE AT CROSSOVER.

FIGURE 10. - OPTICAL METALLOGRAPHY OF SCREEN WIRES SHOW A HIGHLY WORKED STRUCTURE AT CROSSOVERS. ETCHED ELECTROLYTICALLY USING 8 VOLTS/1 AMPERE IN A SOLUTION OF 10 PERCENT CHROMIC ACID IN WATER.

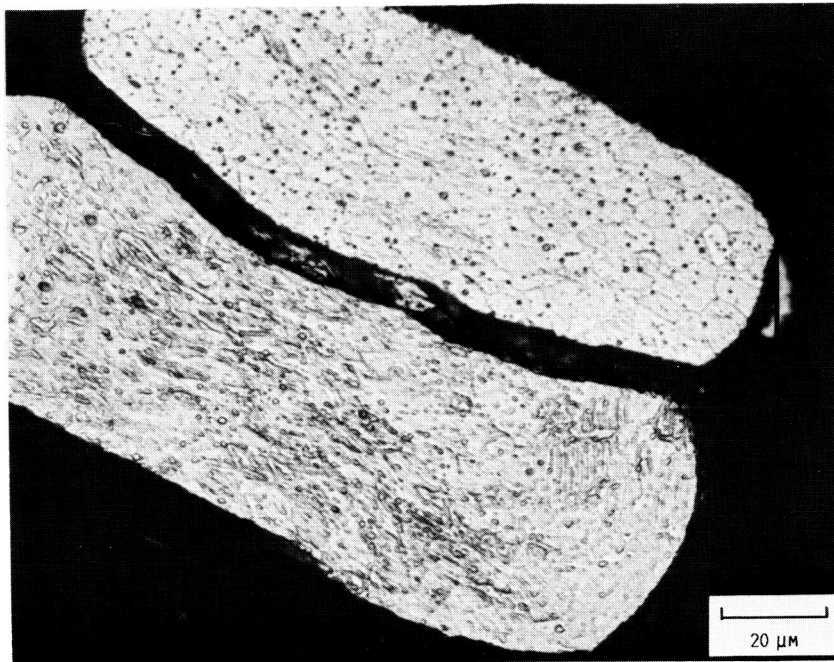
(C) TRANSVERSE SECTION OF DEFORMED WIRE CROSSOVER.

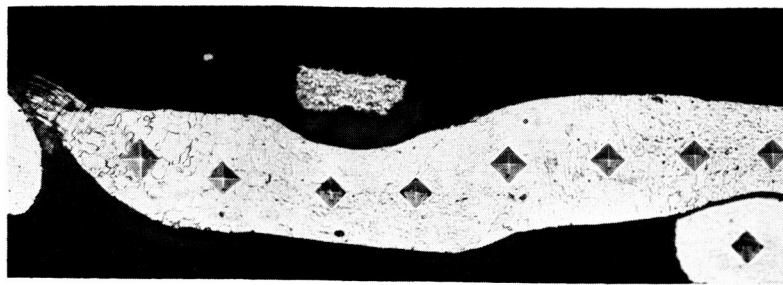
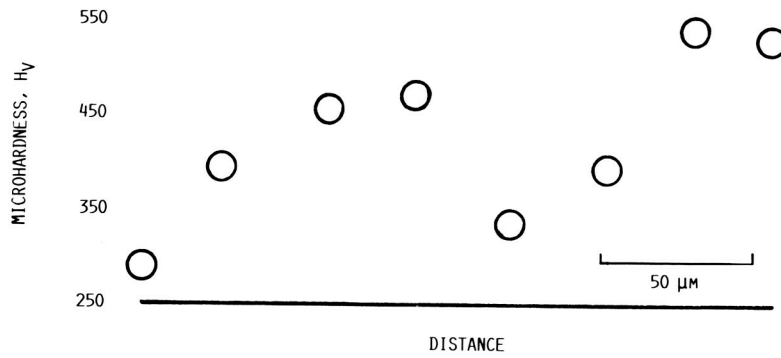
Microhardness measurements showed the highly worked microstructure at crossovers to be harder than the equiaxed structure between crossovers (fig. 11(a)). A comparison of hardnesses between as-received and run-in-engine is shown in table I. Hardness of the undeformed wire was the same for both conditions. The deformed wire in the run-in-engine sample showed a slight decrease in hardness when compared to the as-received sample. Microhardness measurements were made on transverse sections for the comparison to be sure that an adequate thickness of sample existed below the indentation for valid measurements (fig. 11(b)). Figure 11(b) also shows a 30 percent reduction of wire thickness from the undeformed wire to the deformed wire at crossover.

(A) MICROHARDNESS TRAVERSE THROUGH A WIRE CROSSOVER.

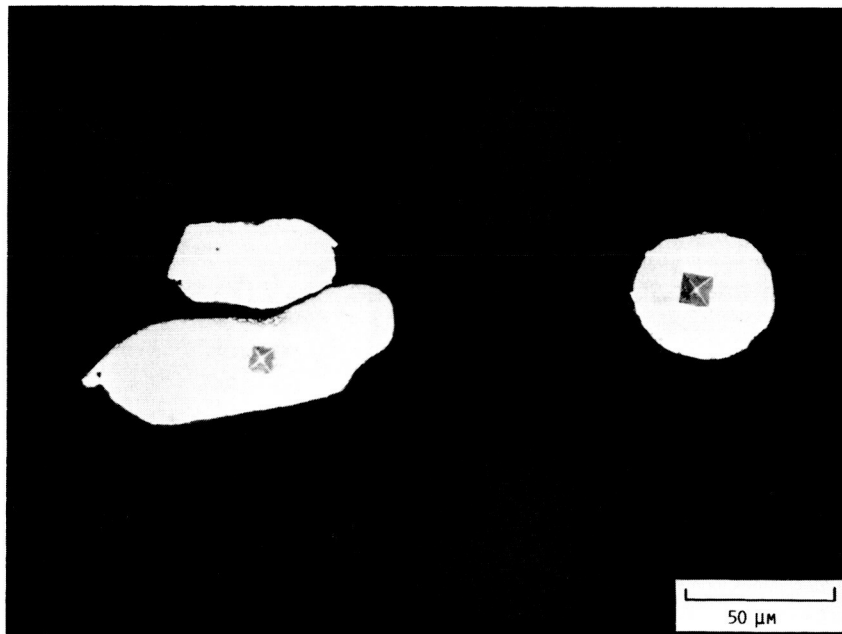
(B) MICROHARDNESS OF A DEFORMED WIRE (AT WIRE CROSSOVER) AND AN UNDEFORMED WIRE.
