DUAL WOUND DC BRUSH MOTOR GEARHEAD

This paper describes the design requirements, the design, development tests and problems, the qualification and life test and the findings of the strip examination of a dual wound DC brushed motor gearhead. At the time of writing it is the only space qualified dual wound DC brushed motor gearhead in Europe.

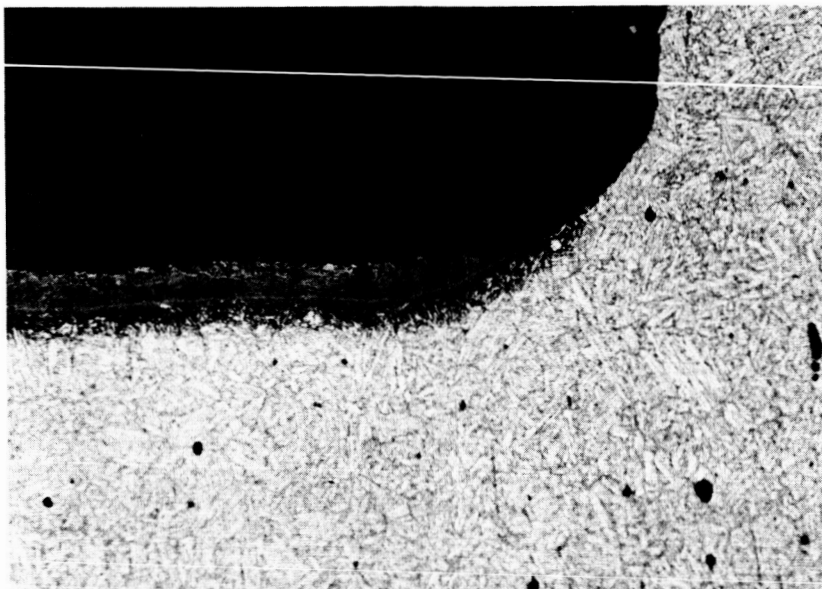
Figure 6. - Cross section of gearhead shaft.

The gearhead which had accomplished 200 hours operation was still running smoothly and it was decided to continue the test to obtain more confidence. At 240 hours a catastrophic failure occurred. The third layshaft fractured at a change in the cross-section from a gear face to the bearing spigot. This formed an almost square corner, less than 0.125 mm (0.005") radius to facilitate seating of the bearing.

A thorough metallurgical examination revealed that during final machining the Tufftride layer had been ground away on the bearing spigot. Thus at a critical change of section with a sharp radius attracting a stress concentration factor of about 4 the material properties also changed. The section and surface structure are shown in the scanning electron microscope picture, Figure 6, and the fracture line is shown in Figure 7.

The running time equated to approximately 3 million revolutions of the shaft, i.e. some 6 million stress reversals. Analysis of the load/fatigue curve indicated that the 'expected' life had been reached. Whilst the running time was some 5 times more than required for the intended application, it was considered essential to initiate design and process changes to improve the product in view of the wide variations associated with fatigue failures. The changes required were quite straightforward, viz.:

- 1) increase the blend radius from 0.125 mm (0.005") to 0.250 mm (0.010"), and thus reduce the stress concentration factor from 4 to 1.5.
- 2) finish grinding the bearing spigot prior to applying the Tufftride process because the growth in size due to the Tufftride process is insignificant.
