NASA TM-88007

DC-10 EC-DEG AIRPLANE CRASH IN MALAGA ON SEPTEMBER 13, 1982

DC-10 EC-DEG AIRPLANE CRASH
IN MALAGA ON
SEPTEMBER 13, 1982

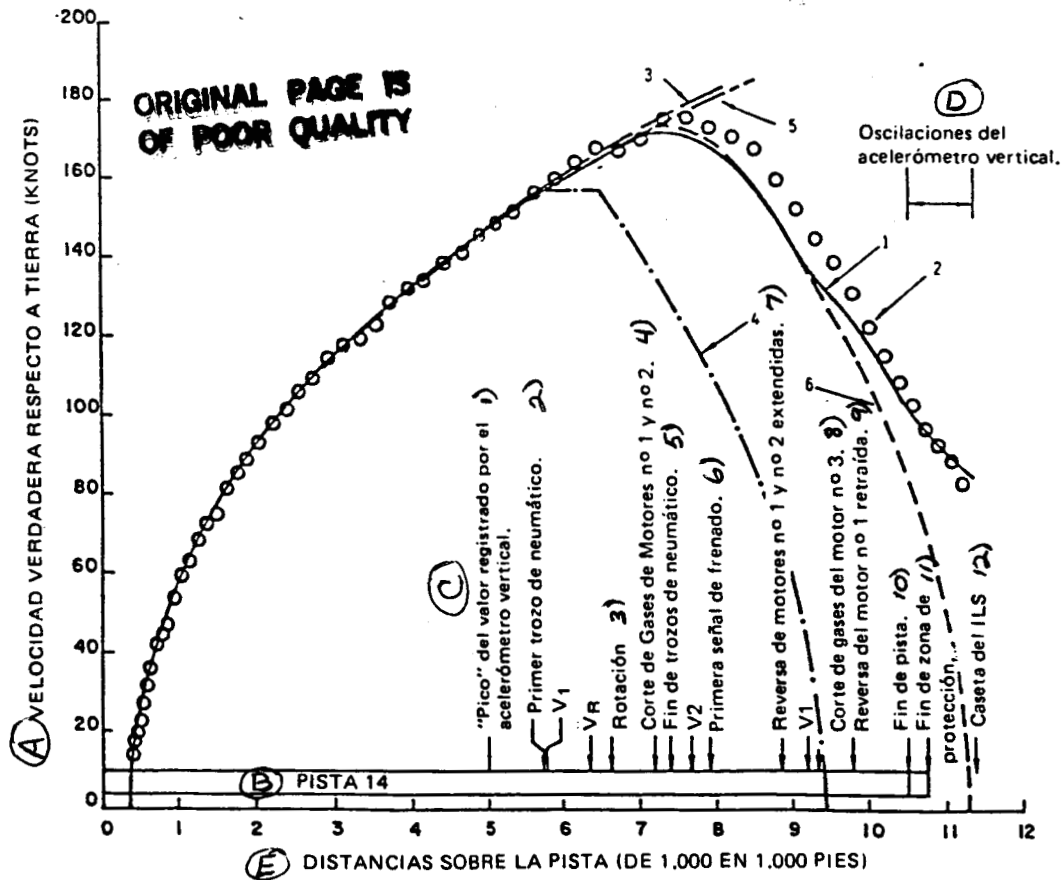
FIG. 1 - ABORTED TAKE-OFF SPEEDS RELATIVE TO DISTANCES

The study performed on the information contained in the flight data recorder has provided the data reflected in figures 1 and 2.

According to the distance/speed curve (fig. 1), the point where the aircraft stopped using the three engines' maximum reverse thrust approximately coincides with the ILS booth's position (fig. 2). Therefore it may be assumed that if the aborted take-off maneuver had been carried out without problems, the aircraft would have stopped approximately in the location of the booth, or it would have crashed against it at well below the 95 Km. actual impact speed.

C. 1) - Peak of value registered by vertical accelerometer;
2) - First piece of tire; 3) - Rotation; 4) - Gas cut-off for engines 1 and 2; 5) - Last pieces of tire; 6) - First braking signal; 7) - Engines 1 and 2 reversers extended; 8) - Gas cut-off for engine 3; 9) - Engine 1 reverser retracted; 10) - End of runway; 11) - End of protection zone; 12) - ILS booth

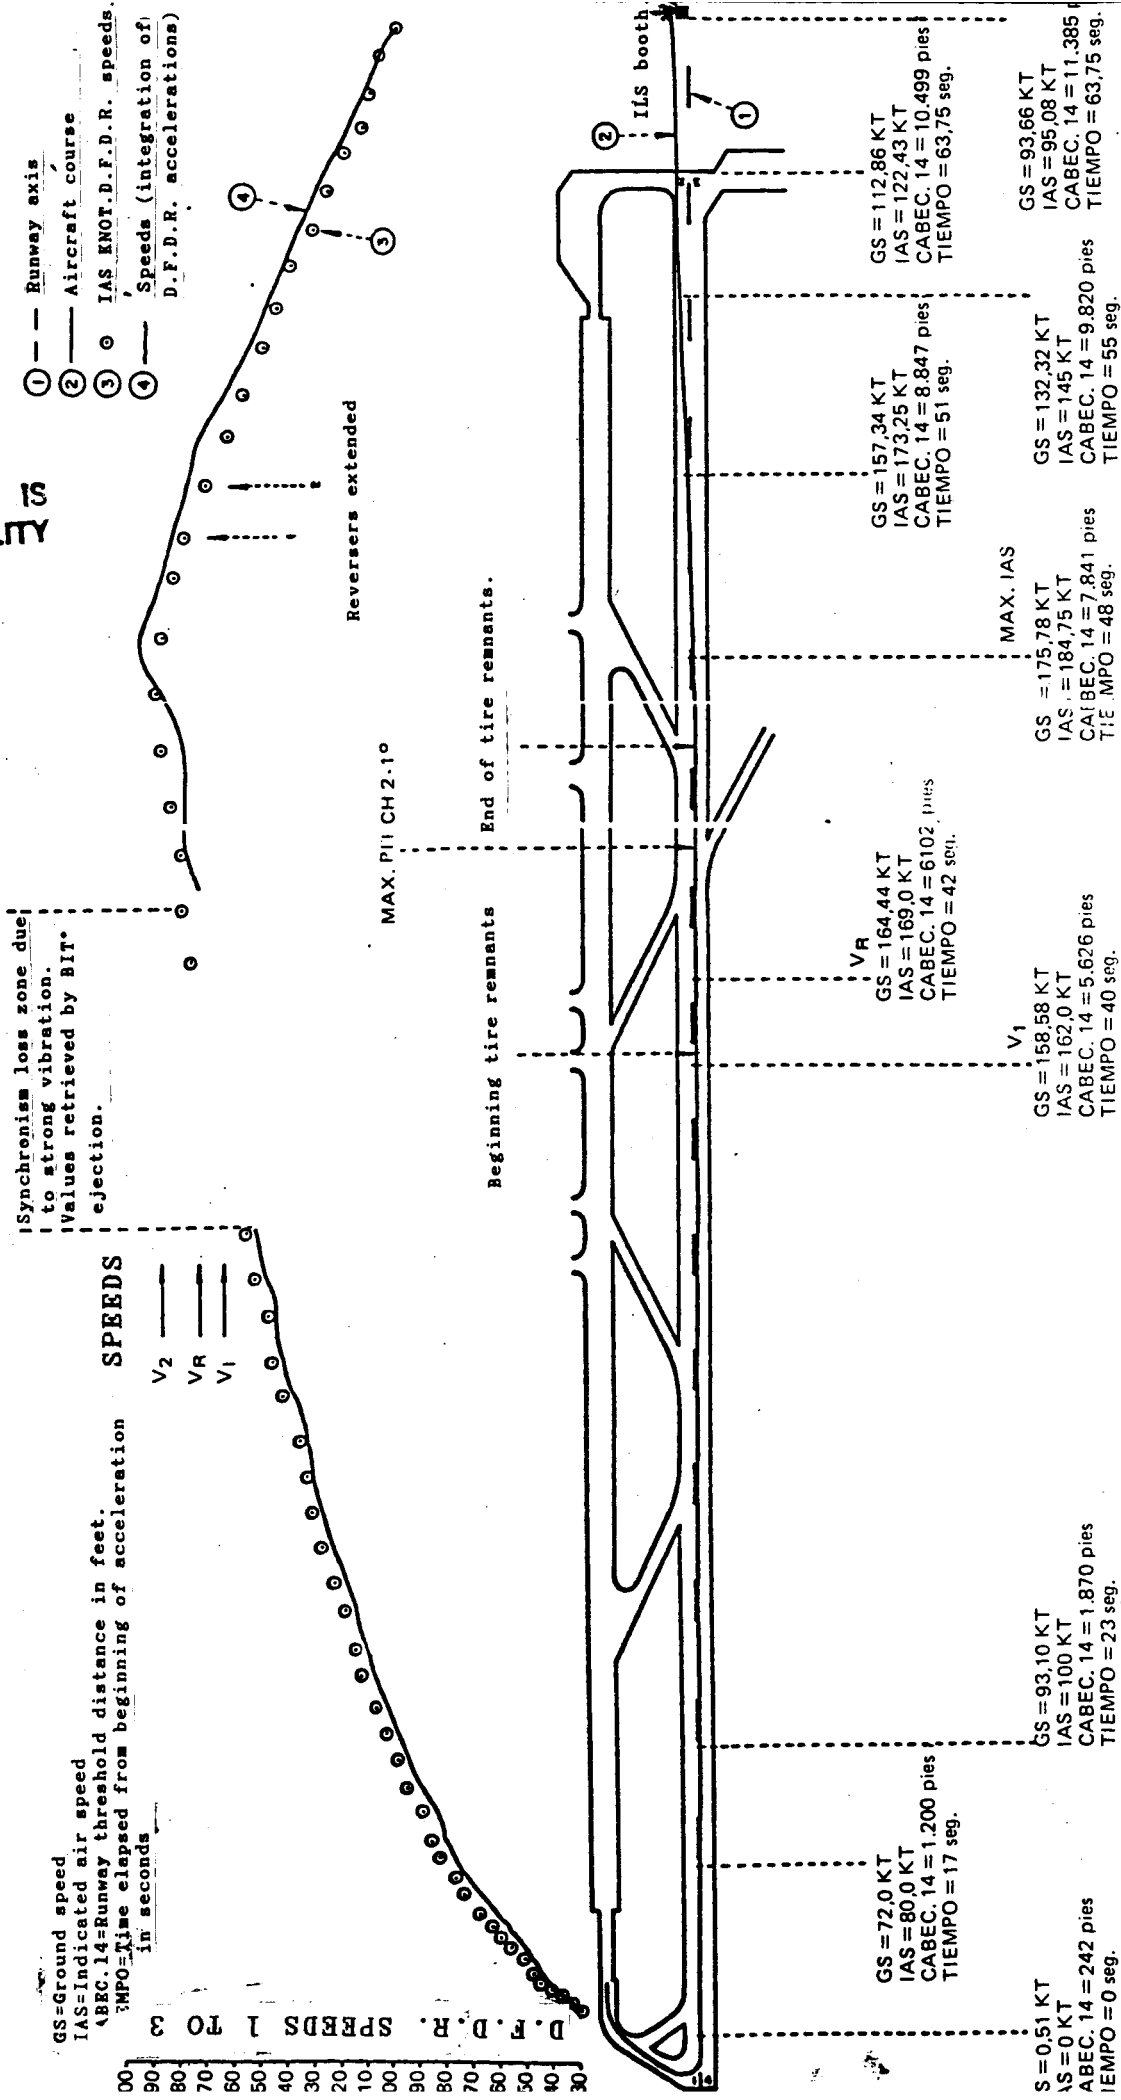
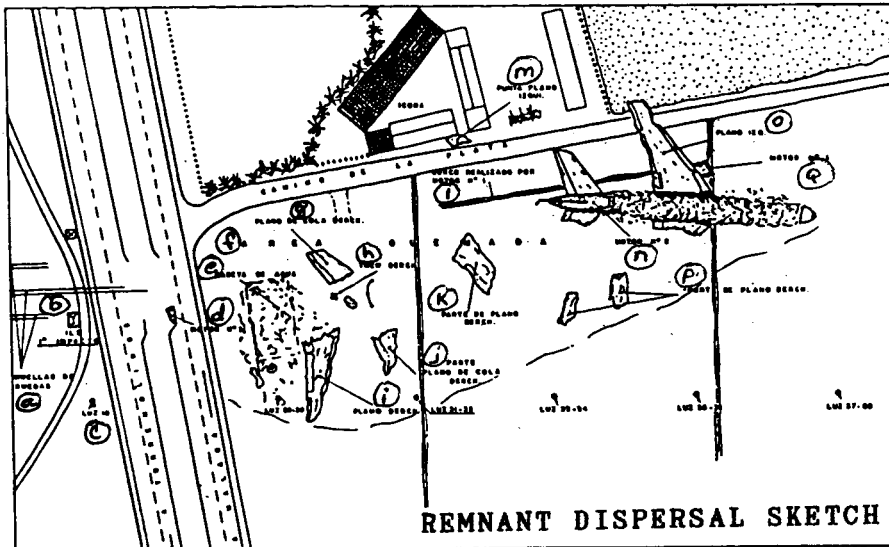
FIG. 2 - COURSE FOLLOWED BY AIRCRAFT
VELOCITY PROFILE

- a. Wheel tracks
- b. ILS-1° impact
- c. LUZ = Light
- d. No. 3 engine
- e. Water house
- f. BURNT AREA
- g. Right tailplane
- h. Right gear
- i. Right section
- j. Part of right tailplane
- k. Part of right section
- l. Furrow made by engine No. 1
- m. End of left section
- n. Engine No. 2
- o. Left section
- p. Part of right section
- q. Engine No. 1
