# **NASA Contractor Report 3715**

## **DC-10 Composite Vertical Stabilizer Ground Test Program**

**J. M. Palmer, Jr., C. O. Stephens,  
and J. O. Sutton**

**CONTRACT NAS1-14869  
AUGUST 1983**

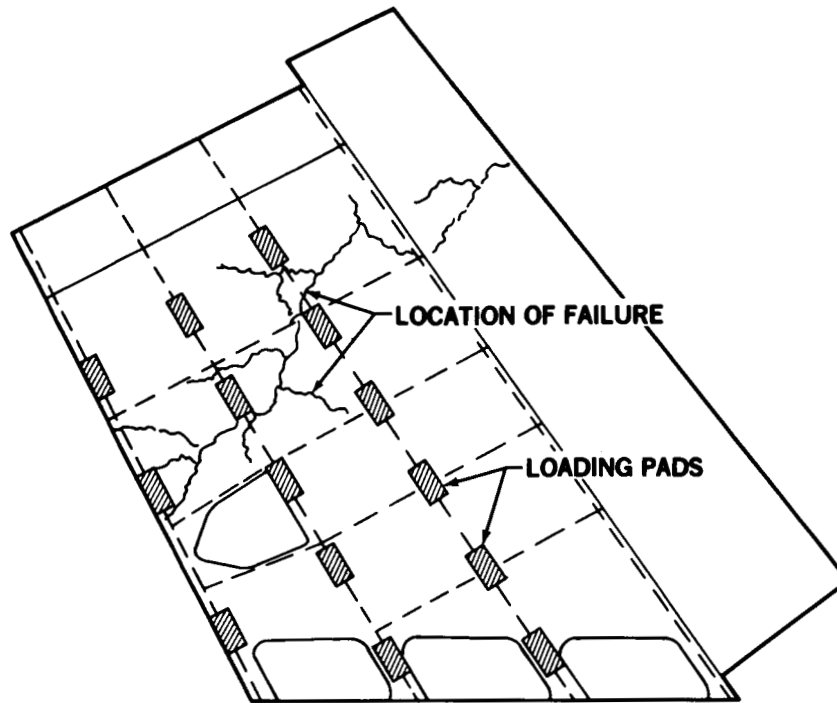
A residual strength test was performed in the critical bending condition and failure occurred at 144 percent DLL or 96 percent of ultimate, well above the requirement of limit load; however, the failure did not pass through any of the damaged areas. The failure was predominately on the compression side as shown in Figure 14. Posttest investigation showed that all of the failures in the compression skin appeared to follow around the loading pads (Figure 15), which were mechanically fastened to the structure. The differential bending between the specimens and the pads produced tension values above allowable for fastener pull through. These fasteners had pulled through the graphite laminate leaving a critical unsupported column length and precipitating the failure. (It was later found that this was not the prime cause of failure as discussed later.)

**FIGURE 15. STUB BOX SUBCOMPONENT FAILURES**

The pads for the full-scale stabilizer test were redesigned to eliminate the fasteners. A double adhesive back rubber spacer was installed between the load pad and the structure.

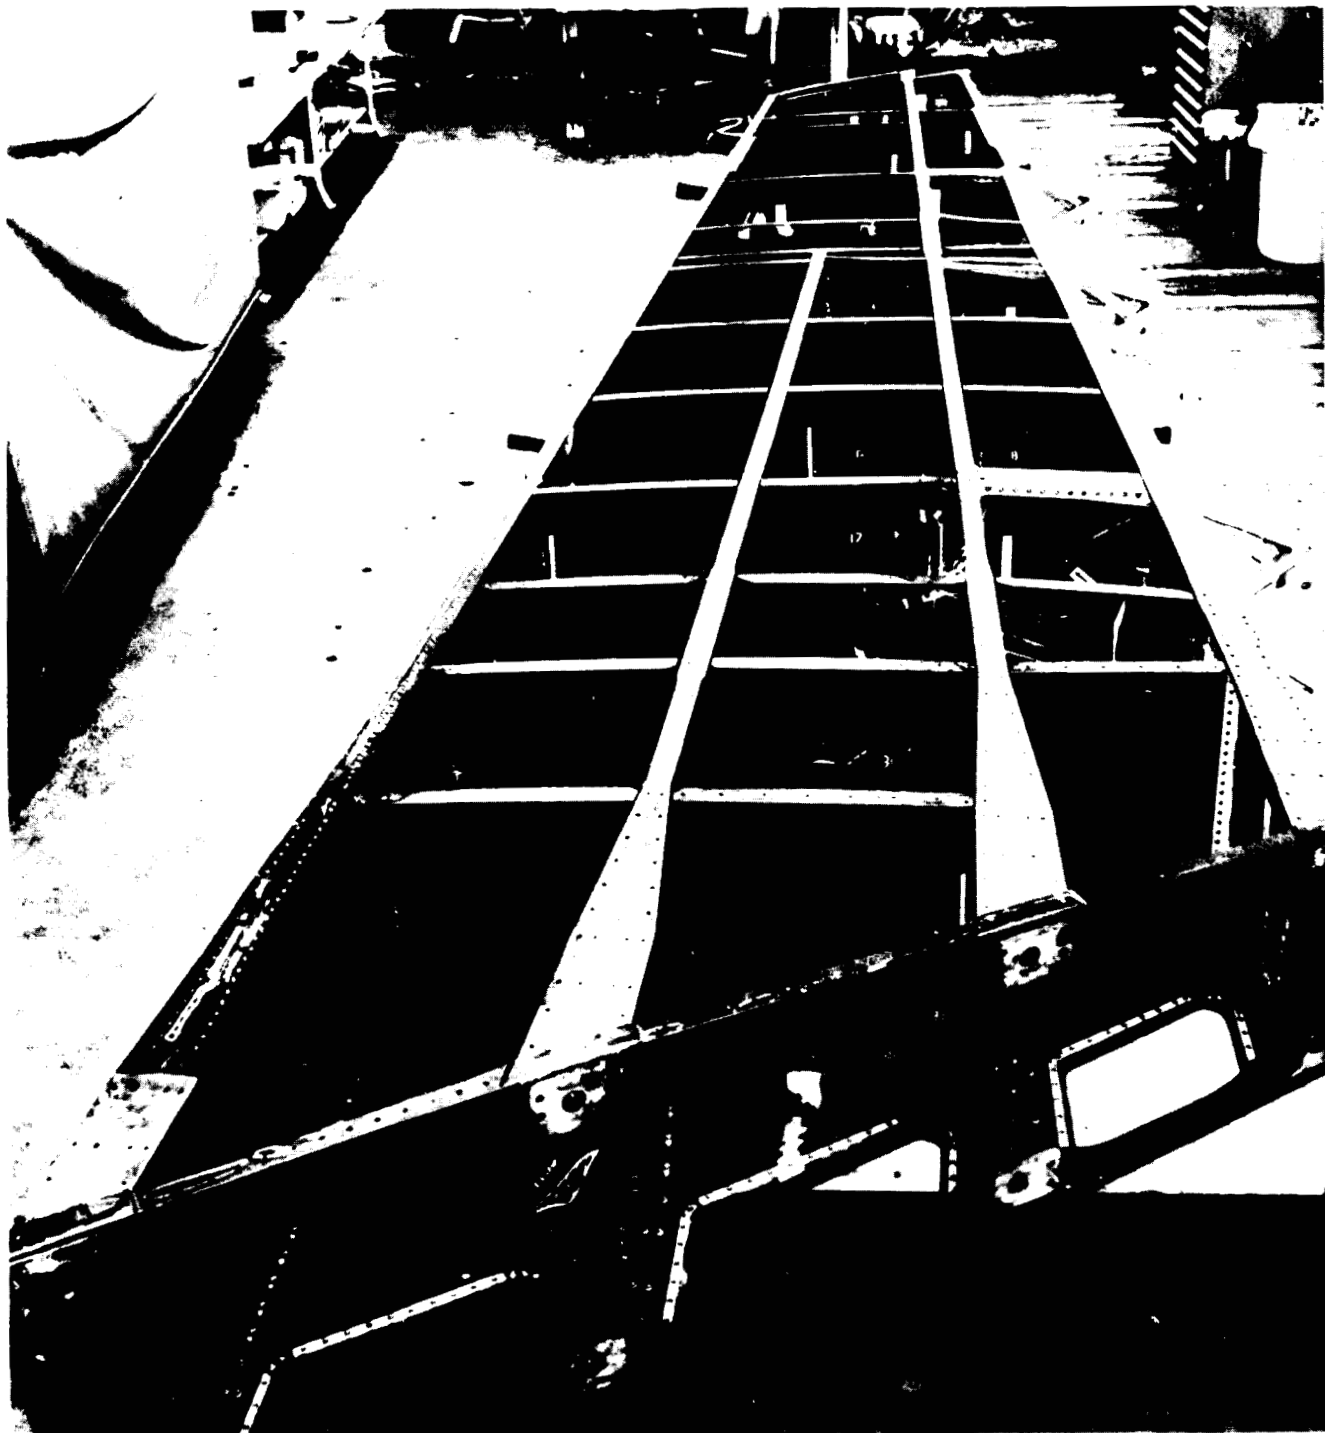
The left-hand (compression side) skin panel was first inspected ultrasonically to detect any invisible damage. No significant damage other than that apparent by visual examination was found. This skin panel was then removed to allow a more detailed inspection of the damage to the substructure. Figure 20 is a view of the substructure after removal of the skin panel.

**FIGURE 20. GROUND TEST UNIT AFTER TEST FAILURE WITH LEFT HAND SKIN REMOVED**

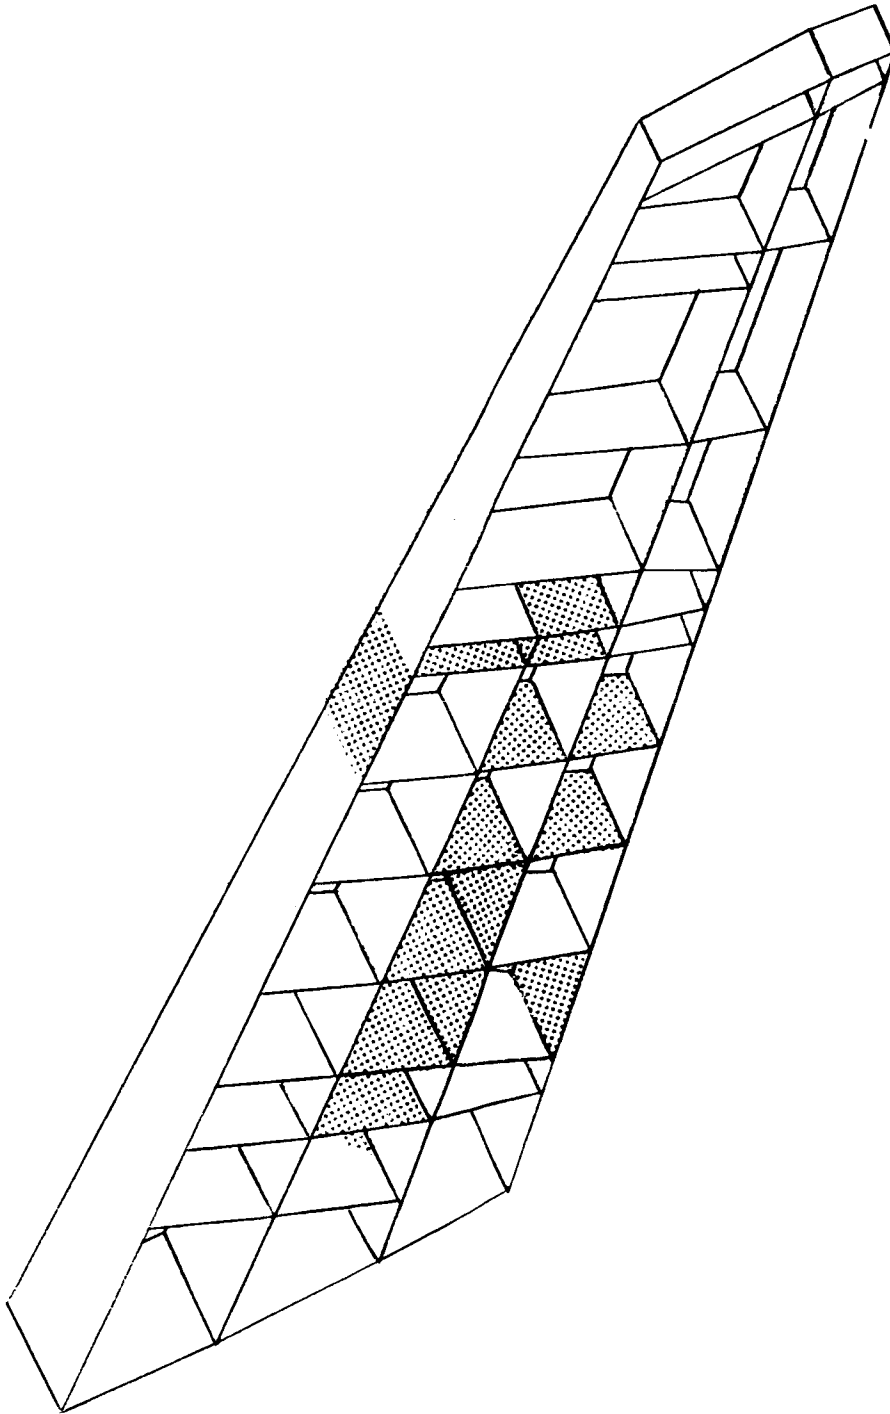
Failures were noted in the rear spar web and caps above the lower actuator cutout, the aft center spar web and caps, the forward center spar and front spar webs, and in a number of rib webs. Figure 21 is a sketch showing the location of the failed members in the substructure.

**FIGURE 21. LOCATION OF TEST FAILURES IN GTU SUBSTRUCTURE**

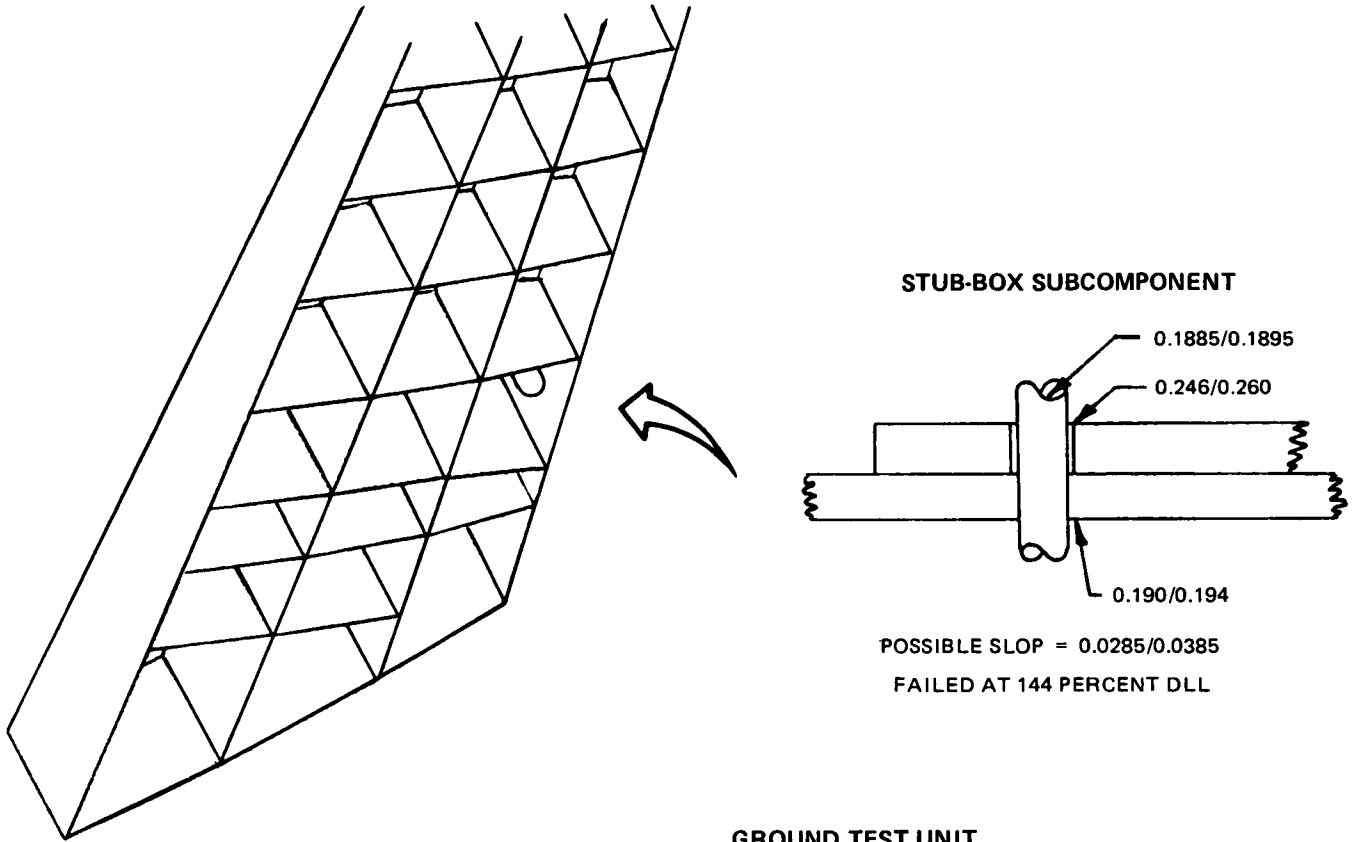
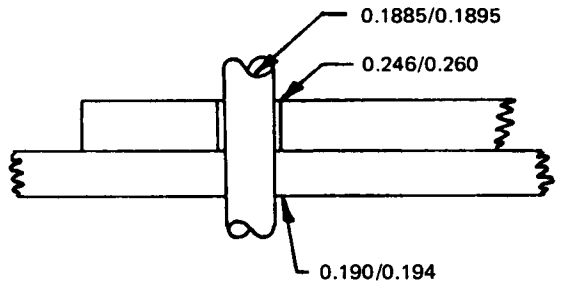
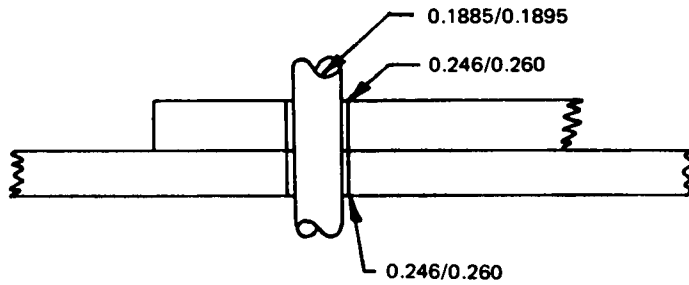
**FIGURE 22. FASTENER FIT IN CRITICAL REAR SPAR WEB DOORS**

1. The rear spar web in both specimens has a 4- by 5-inch hole at ZFR Station 342. This hole is reinforced by a cover plate attached with 12 fasteners. In the stub box, the holes in the rear spar web were of the appropriate size for the fasteners but the holes in the cover plate were 0.057- to 0.072-inch oversize. In the GTU the fastener holes in both the web and the cover plate were 0.057- to 0.072-inch oversize (Figure 22).

POSSIBLE SLOP = 0.0285/0.0385  
FAILED AT 144 PERCENT DLL

POSSIBLE SLOP = 0.0565/0.0715  
FAILED AT 100 PERCENT DLL

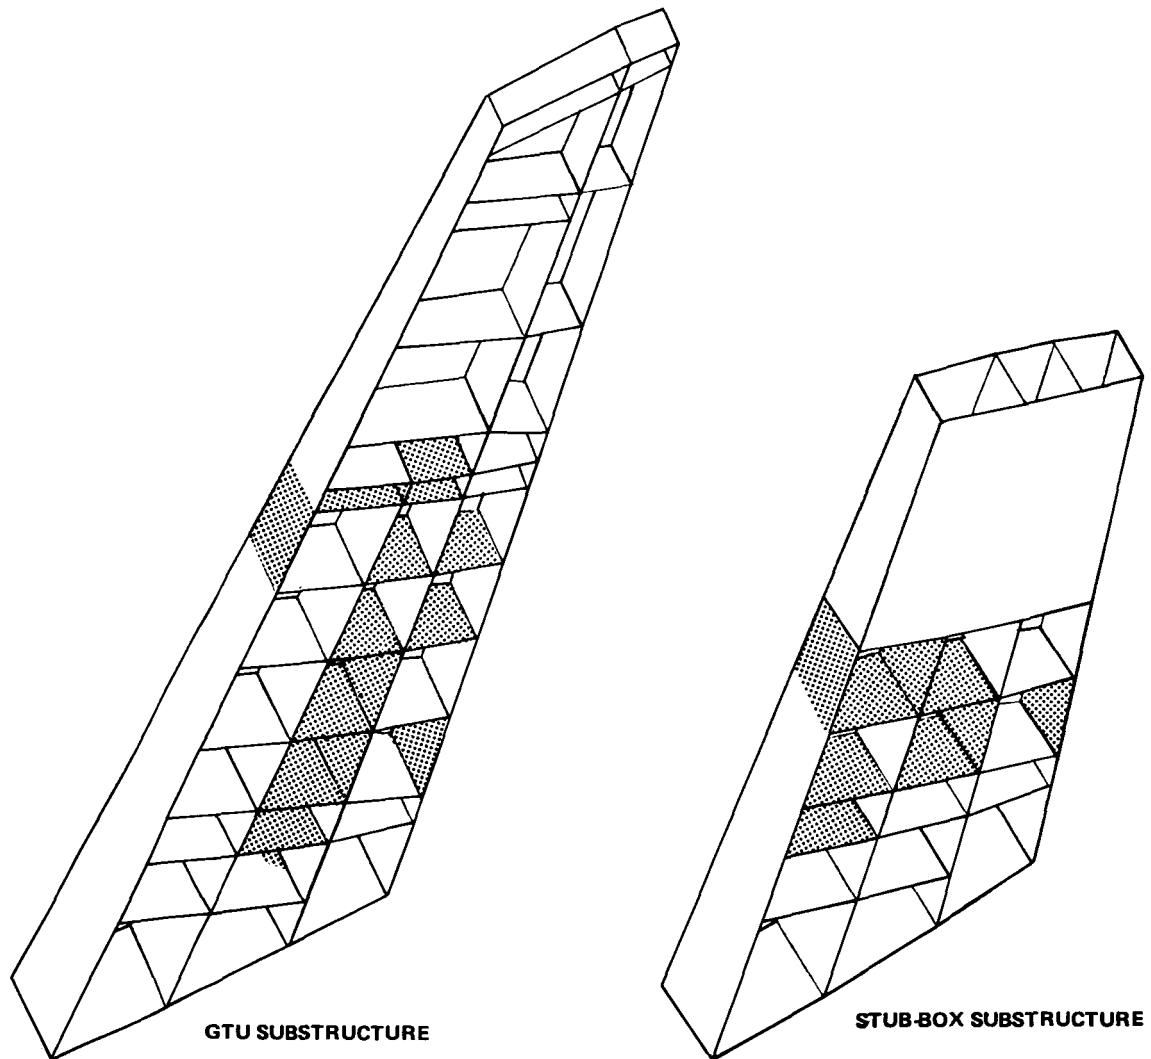
Figure 23 is a comparison of the failure locations in the GTU substructure to those in the stub box subcomponent. The failed areas are in similar locations and differ only because of the influence of the boiler-plate dummy extension structure in the stub box.

**FIGURE 23. COMPARISON OF TEST FAILURE LOCATIONS IN STUB-BOX AND GTU SUBSTRUCTURES**

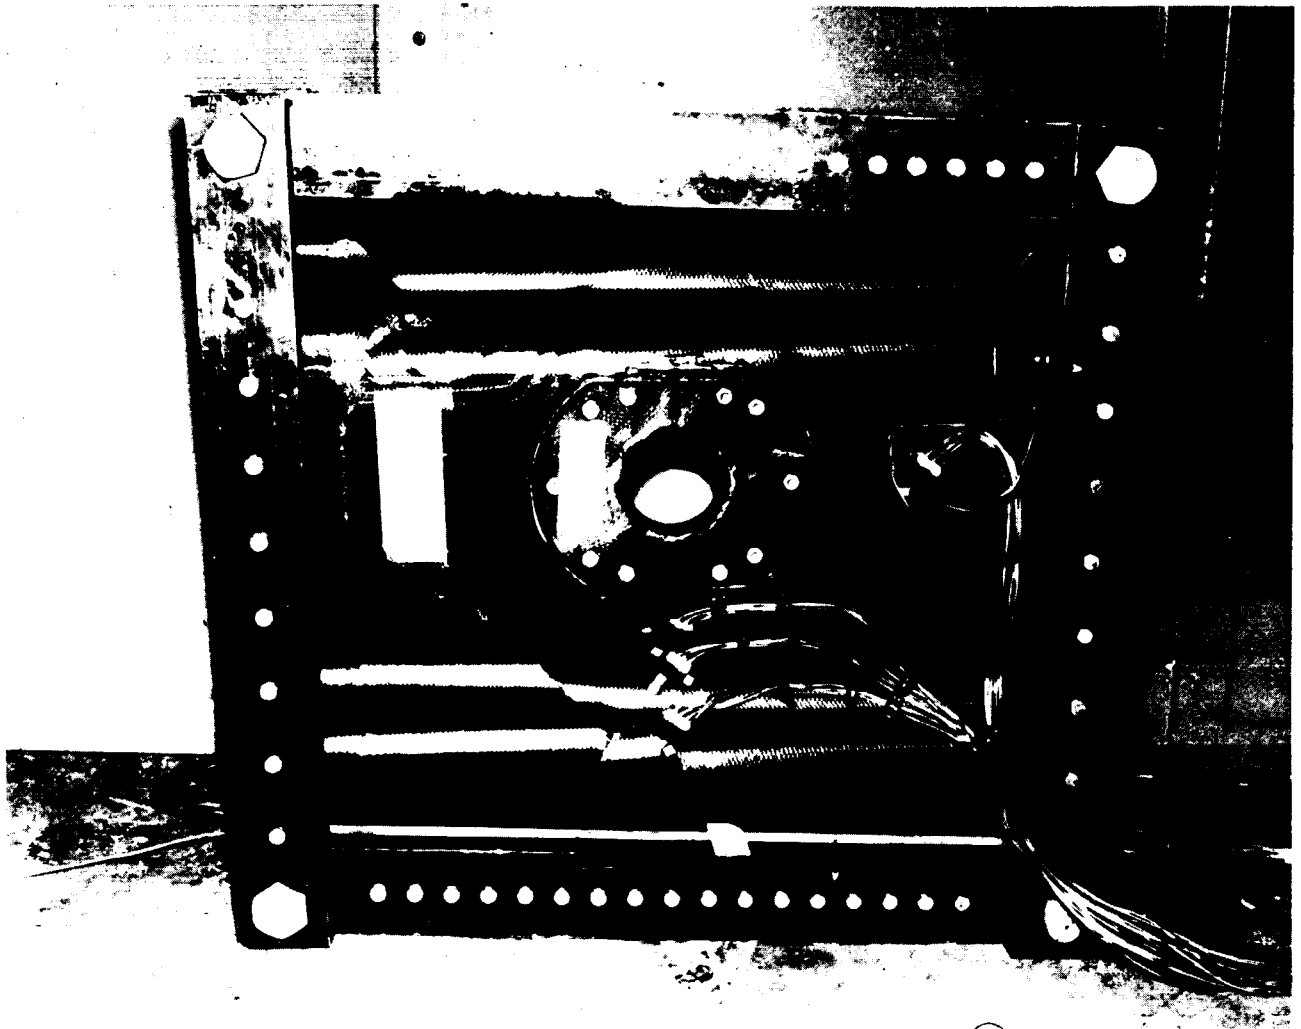
To test the validity of the concept, a flanged plate was made and installed on the AMC7855-5 rib test specimen (Figure 31). The panel was tested to failure, with failure occurring in the basic sine-wave web, well away from the opening (Figure 32). The strains measured at the perimeter of the hole with the bonded cover in place are shown in Figure 33.

**FIGURE 32. AMC7855-5 RIB COMPONENT AFTER TEST SHOWING WEB FAILURE**

The rework required to correct the initial failure condition had to eliminate the fastener fit sensitivity (including the effects of in-service wear) while retaining both the inspection access and weather protection features. At the same time, the rework had to be usable on parts that had already been built. The configuration that satisfied these constraints was a flat cover plate with a small reinforced flanged hole, bonded in place over each unreinforced access hole (Figure 30). By bonding the plate to the web, the effects of wear are eliminated, while the existing attachment fasteners, with improved fit quality, provided a fail-safe load path to protect against possible environmental degradation of the bond line.
