**FLIGHT SERVICE EVALUATION  
OF COMPOSITE COMPONENTS ON THE  
BELL HELICOPTER MODEL 206L**

**SECOND ANNUAL FLIGHT SERVICE REPORT  
AUGUST 1983 THROUGH DECEMBER 1985**

**H. E. WILSON, II**

**BELL HELICOPTER TEXTRON, INC.  
FORT WORTH, TEXAS 76101**

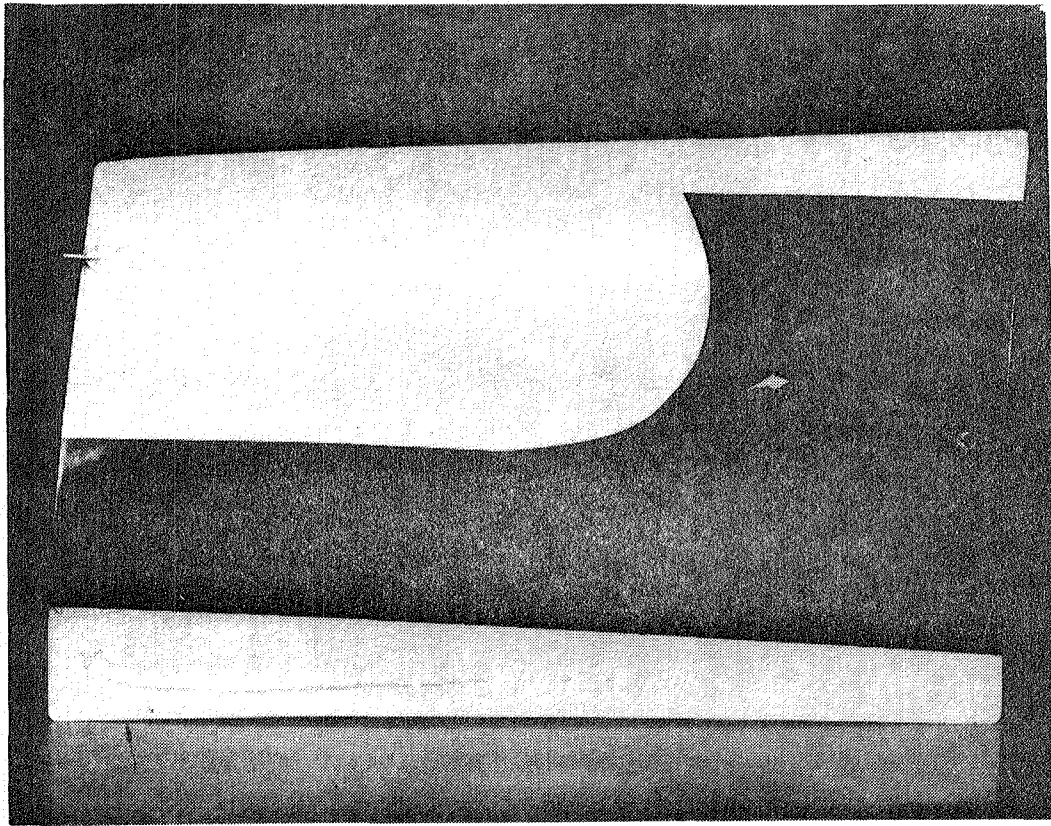
Of the four components, the baggage door has the poorest record of service. The adhesive used in the Kevlar doors has not maintained its integrity. There were several cases of a large number of voids in the door. One reason that added to the problem was the fact that the outside face sheet was co-cured with nomex core. There was very little adhesive present between the nomex core and the fuse sheet. This left a poor bond between the outside skin and the core. Figure 2-1 is a picture of a door that was struck under "normal operating environment" in the New York City area. Figure 2-2 shows cracks in the laminate. A close examination of the door yielded large areas of disbond between the outer face and the core. This door is of the same manufacturing lot that was tested after one year of service. The previous report said the door failed prematurely and it might be due to the year of service. It is believed, now, that it was due strictly to a poor resin and

Figure 2-1. Baggage door struck during "normal operating environment" in the New York City area.

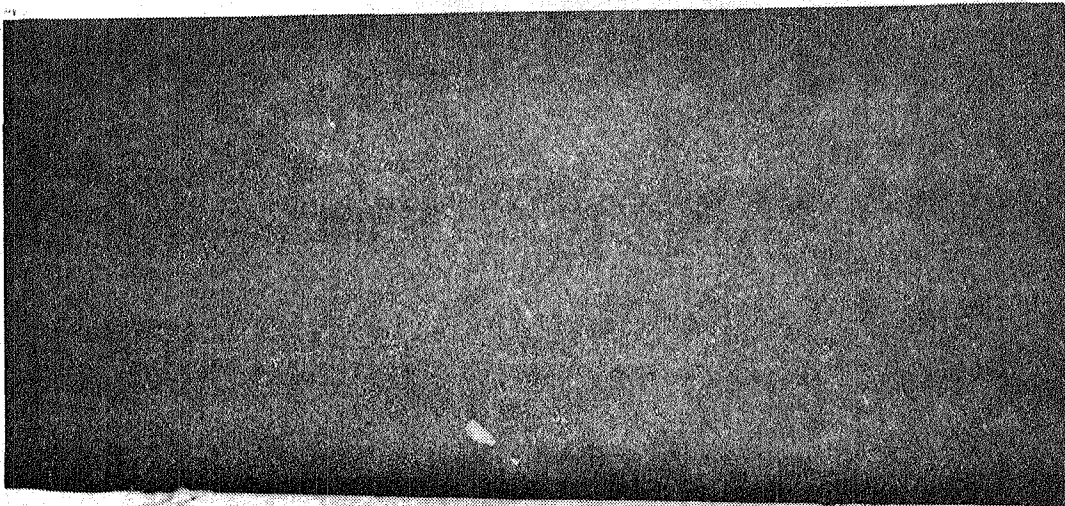
Figure 2-2. Cracks in the laminate of the baggage door.

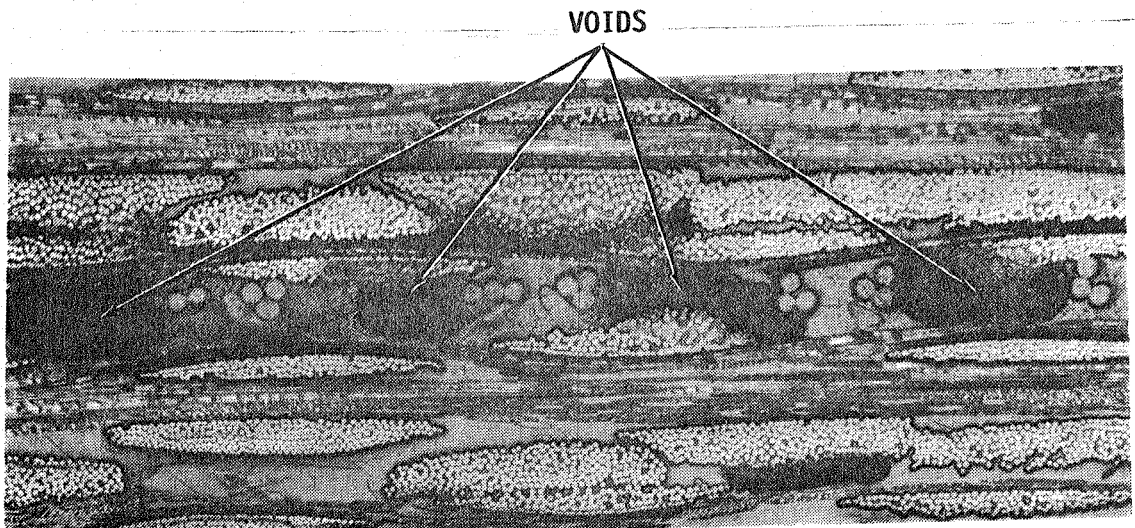
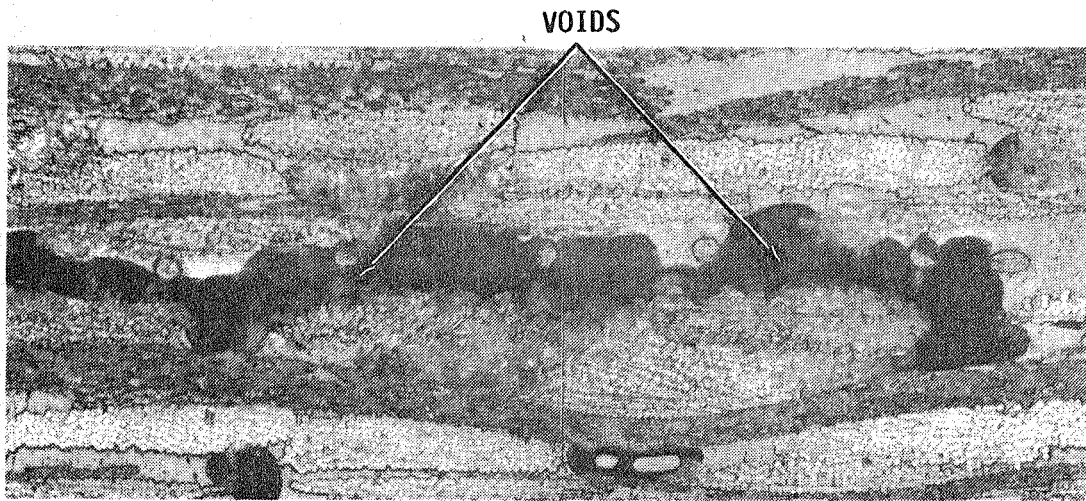
poor construction. Figure 2-3 is a 100X photo of a cross section of the laminate through the door. There are large areas of voids indicated on the photographs.

Figure 2-3. 100x magnification of a cross section of the laminate through the door.

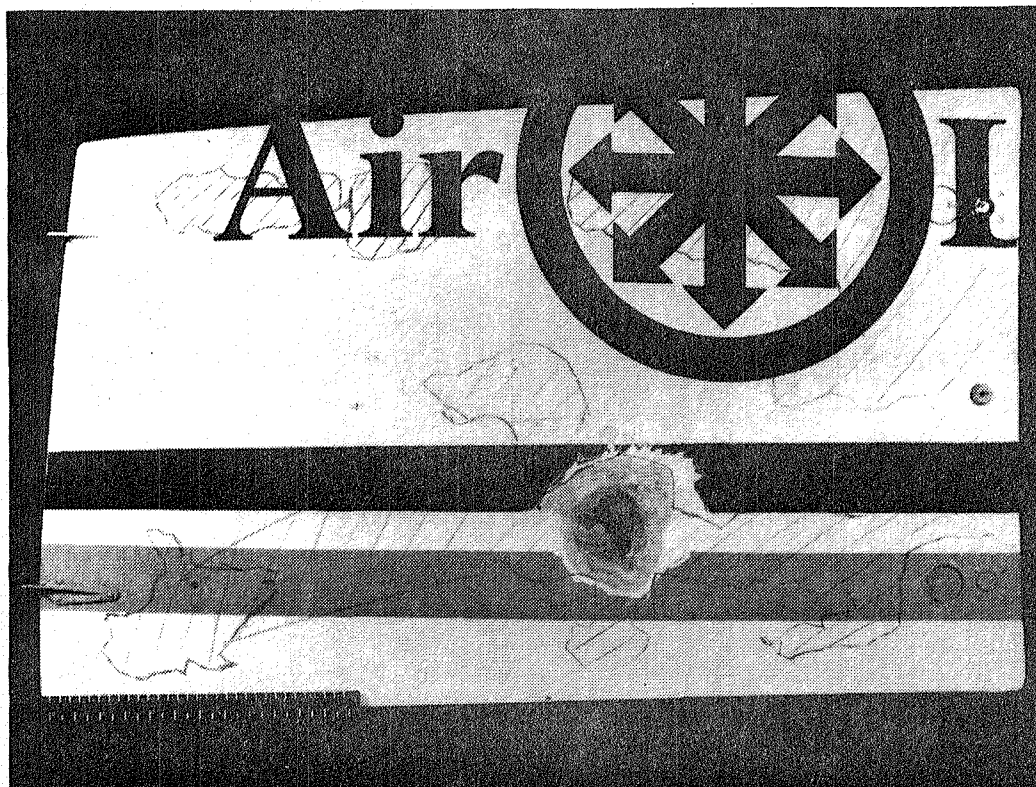
Another baggage door was returned due to delaminations between the core and the exterior skin. It is shown in Figure 2-4. A repair at the operator's facility was attempted by identifying the voids, and then using a grinding wheel to remove the skin. The technician was then going to repair the door with a fiberglass patch. After he had frayed the skin, he discovered other areas of disbond. He then marked the zones and sent it back to Bell. Figure 2-5 shows the voids on the composite door.

Figure 2-4. Baggage door returned due to delaminations.

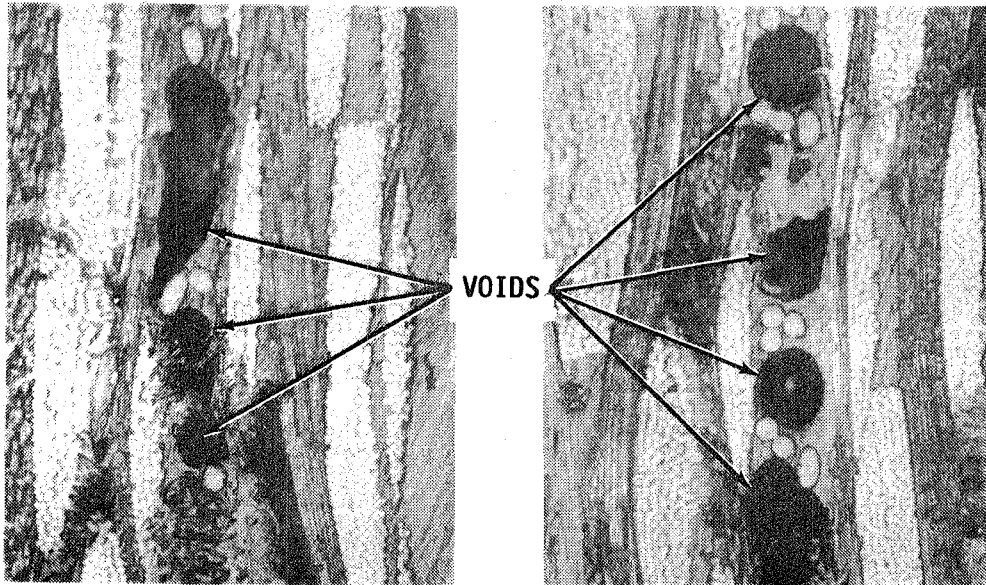
Figure 2-5. VOIDS on the composite door.

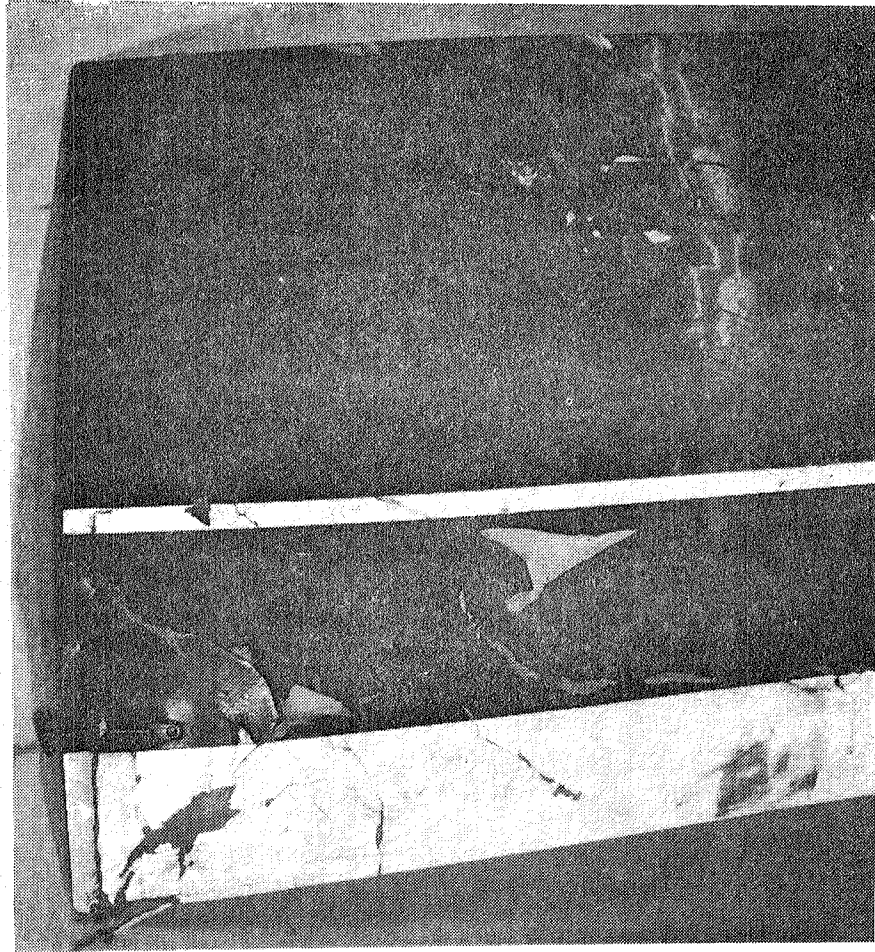
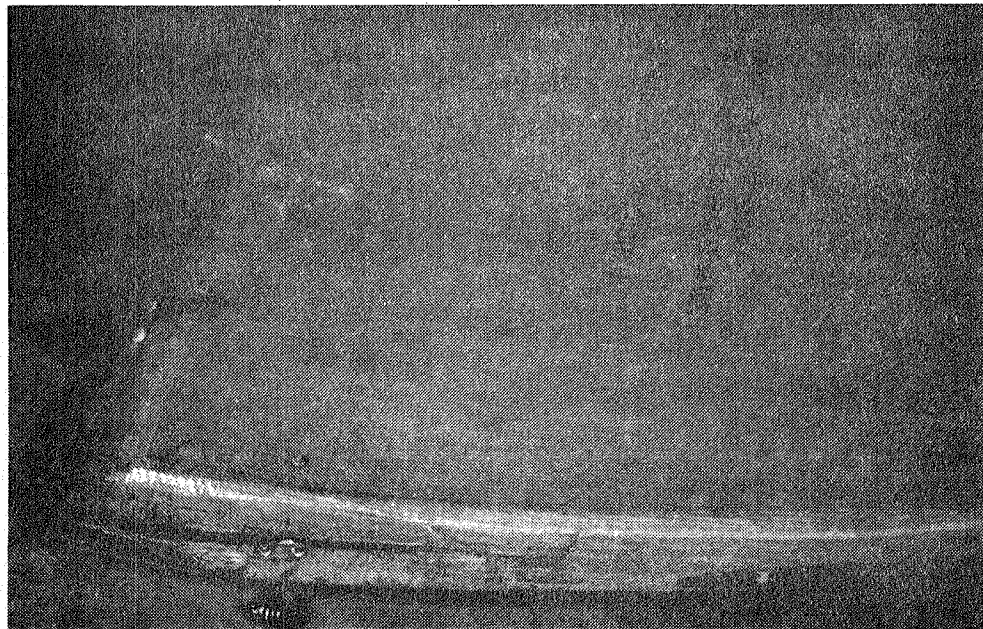
A baggage door was destroyed in a hard landing when a helicopter rolled into a ravine. Figures 2-6 and 2-7 show the damaged baggage door.

Figure 2-6. Baggage door damaged due to a hard landing.

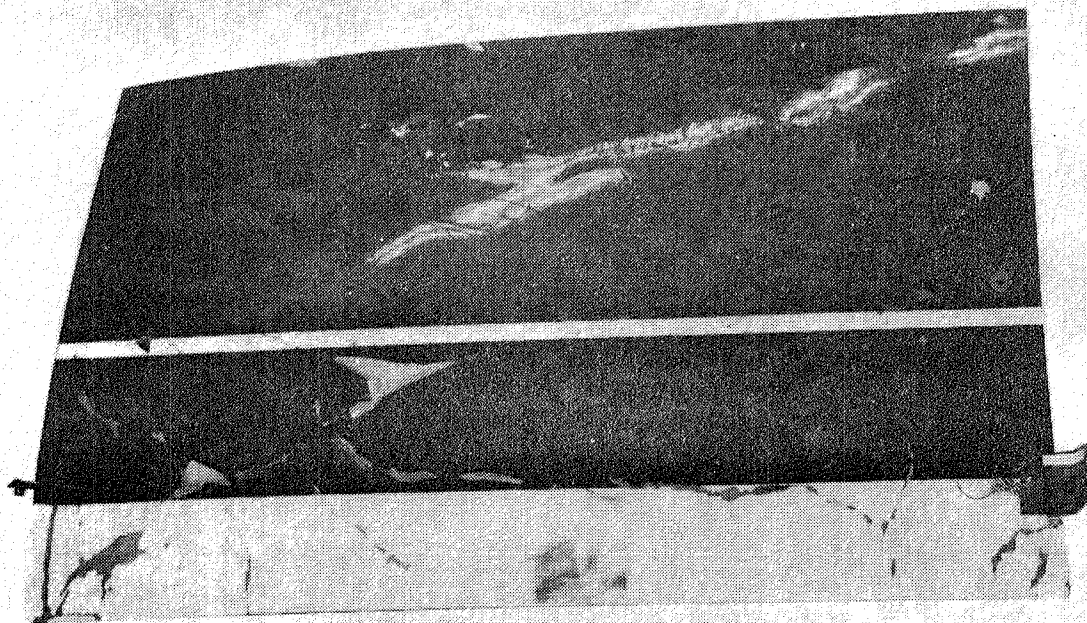
Figure 2-7. Damage to baggage door caused by a hard landing.

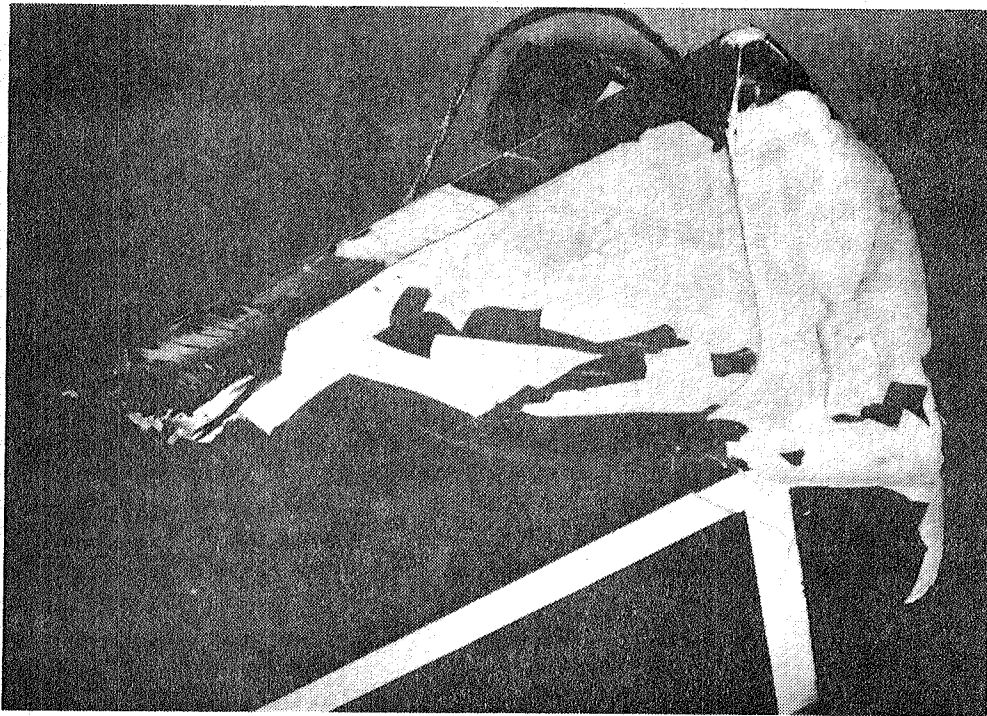
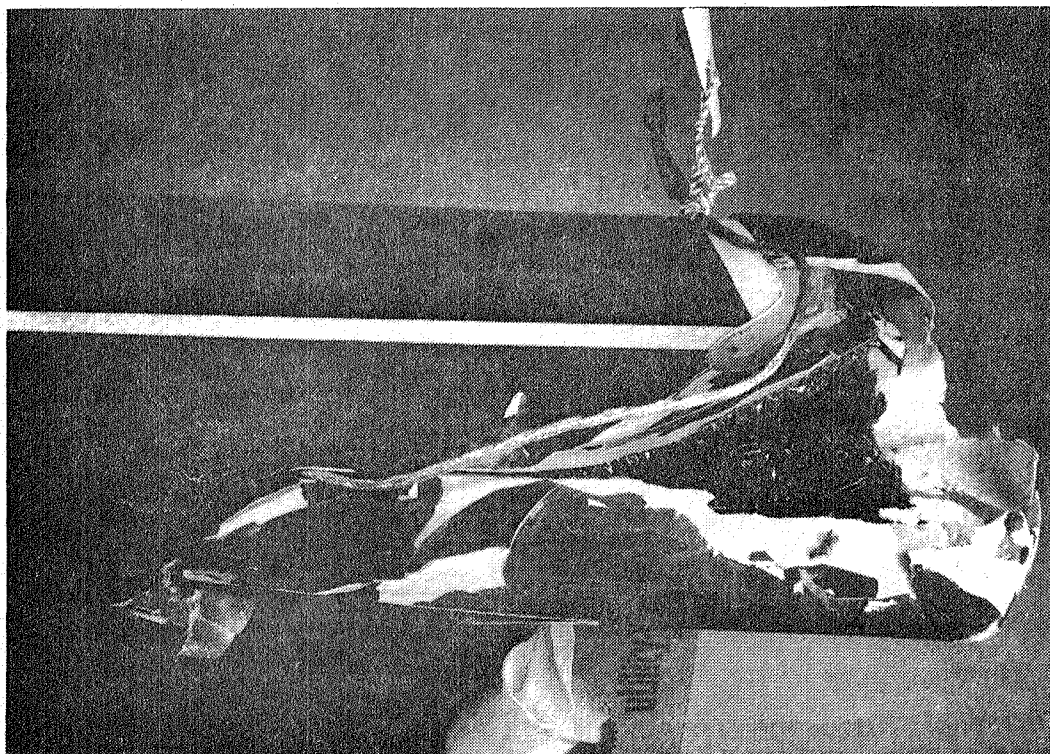
One fin was destroyed in the same hard landing mentioned in Section 2.3 when a helicopter rolled into a ravine. Figures 2-8 and 2-9 show the damage to the fin. The forward fairing and litter door were undamaged.

Figure 2-8. Fin damaged during hard landing.

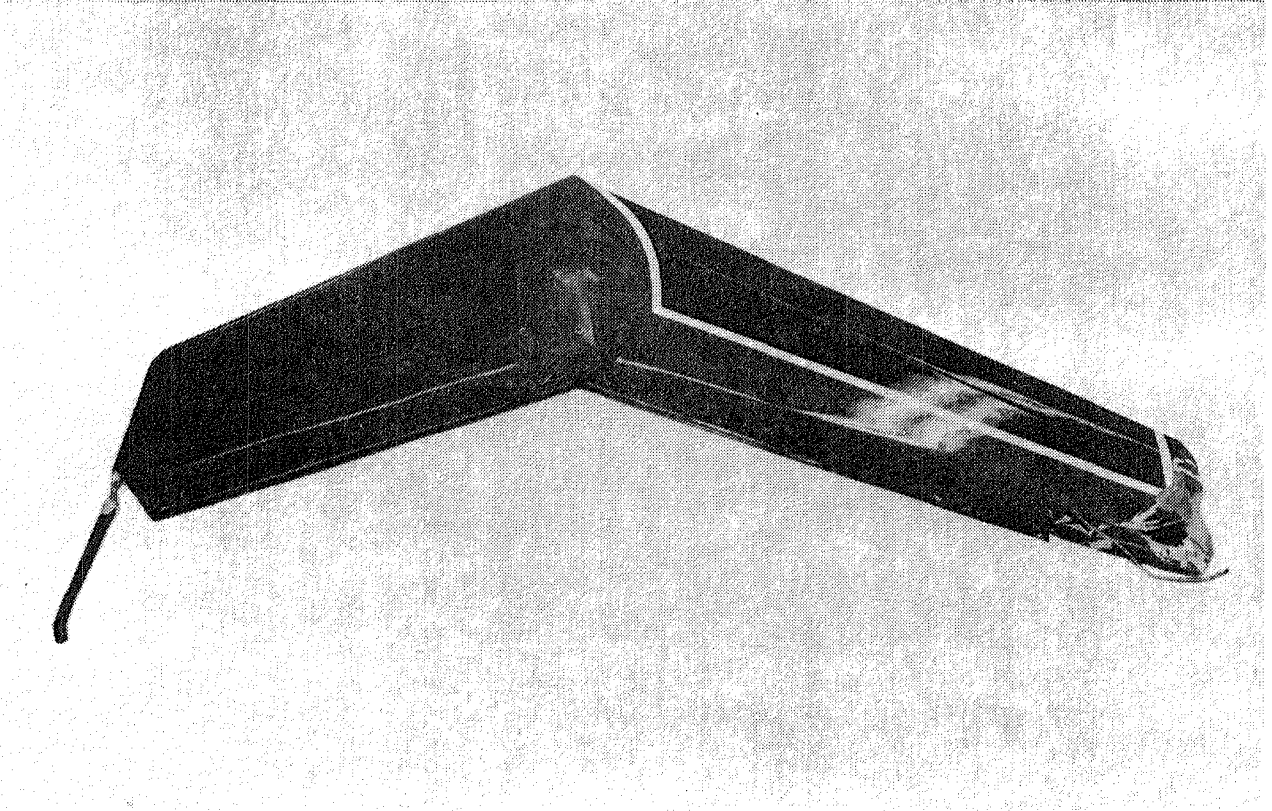
Figure 2-9. Damage to fin caused by a hard landing.

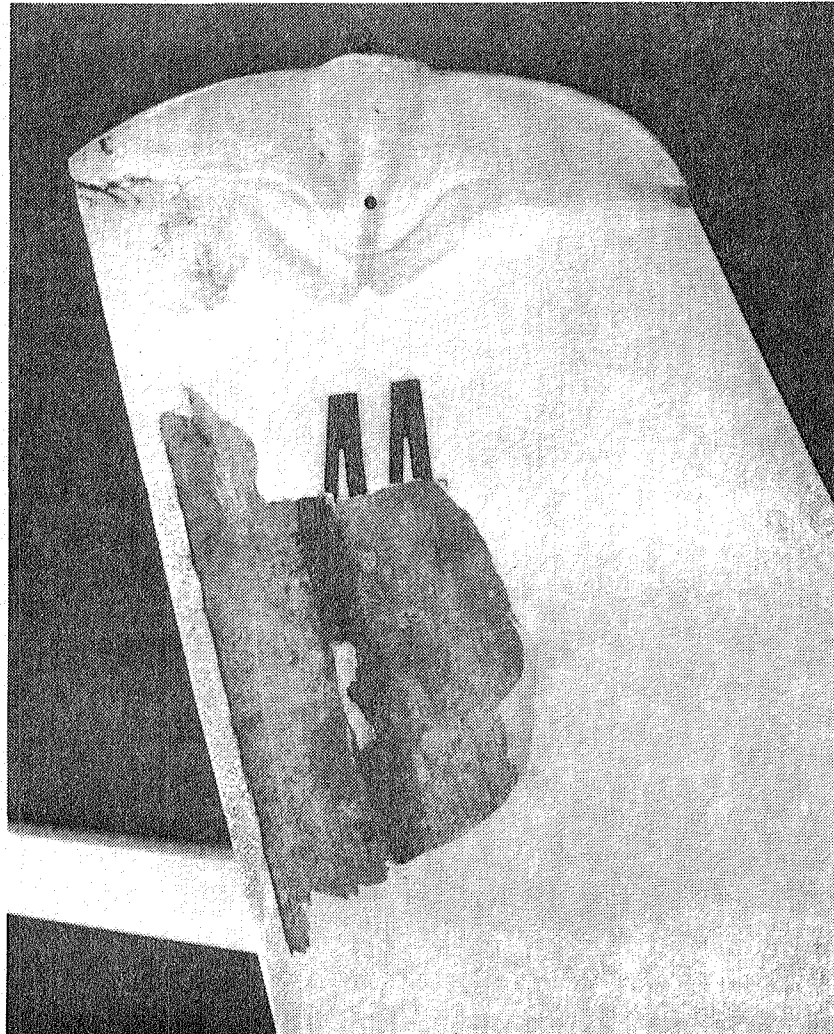
An inspection of the fin did not show any laminate delamination, but rather a peeling of the paint and a corrosion of the wire mesh used for lightning protection. Closer examination showed evidence that an electrical charge had been transmitted through the fin and exited at the fin to tailboom attachment locations. It was determined at that time that the fin had been struck by lightning.

Figure 5-1. Corrosion on the wire mesh on the fin struck by lightning.

to separate the wire mesh and the graphite. Instead, the adhesive was applied on the outside of the mesh between the mesh and the paint. Had the FM1000 been correctly applied, the corrosion might not have occurred and the fin could have been easily repaired.

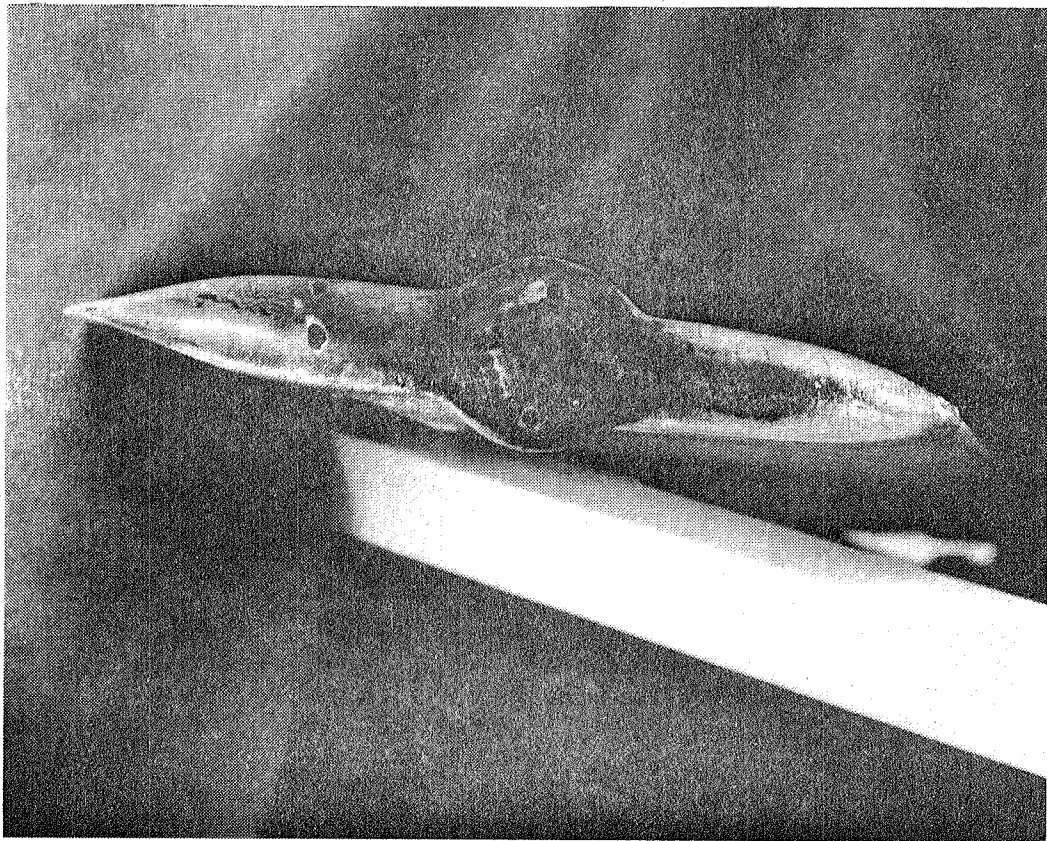
Figure 5-2. Charred top of fin struck by lightning.

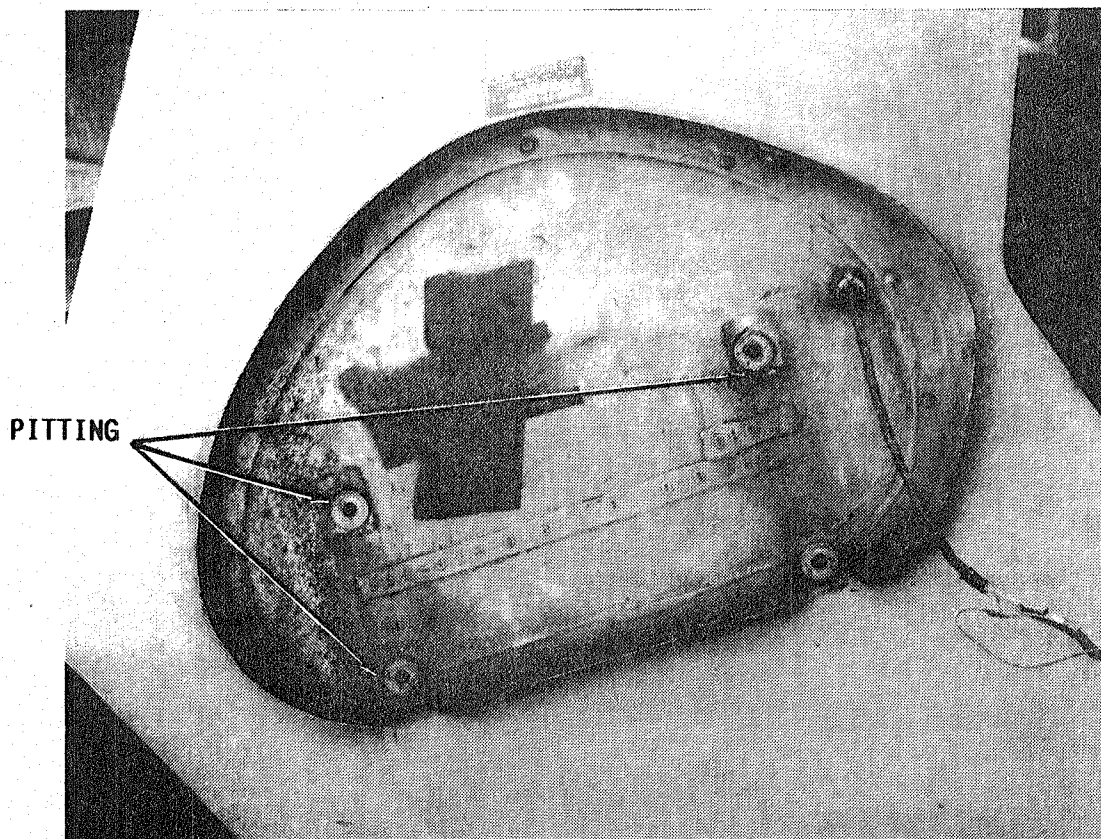
Figure 5-3. Tailboom attachment fittings of fin struck by lightning.

The fasteners were examined and the pitting was determined to be caused from electric arcing. No other effects or degradation were found with the fasteners.

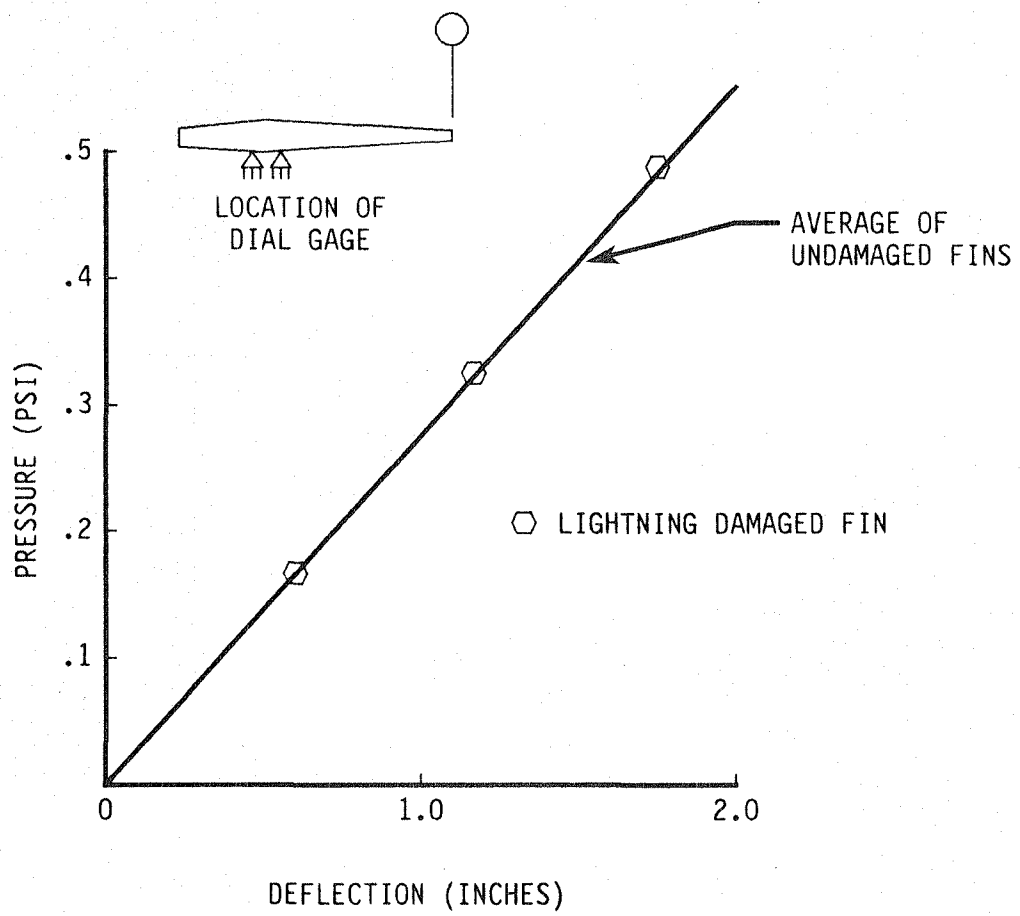
As reported in Section 4, the lightning damaged fin showed no effects on its stiffness or strength. Figure 5-4 shows the deflection measurements compared with the average of the other fins.

The strength of the damaged fin is only 1.25 standard deviations away from the mean of the sample. Therefore, there is no strength degradation attributable to the lightning damage.

Figure 5-4. Deflection of the lightning damaged fin.

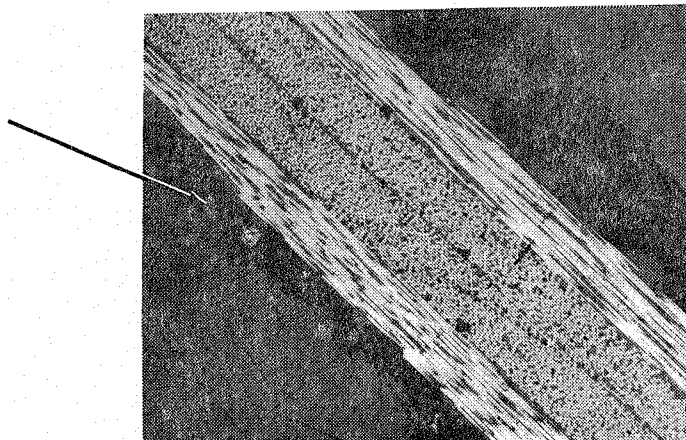
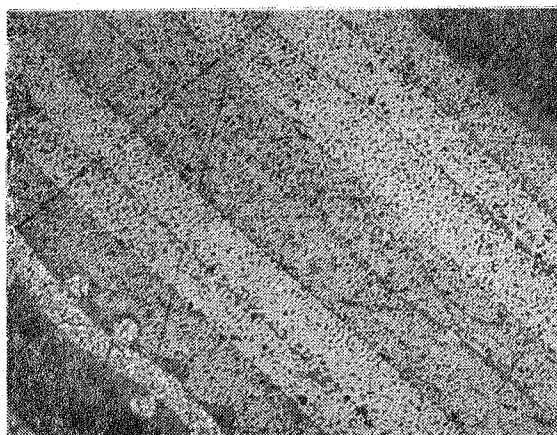
Figure 5-6 shows a 100X photograph of a cross section of the damaged and undamaged laminate. The laminates were of a different orientation and number of plys. The only degradation noticable on the photographs is the wire mesh which had corroded.

Figure 5-6. 100X magnification of a cross section of the damaged and undamaged specimen.
