ROTOR-TO-STATOR RUB VIBRATION IN CENTRIFUGAL COMPRESSOR

**Gao Jin Ji and Qi Qi Min
Liaoyang Petrochemical Fiber Company
Liaoning, The People's Republic of China**

This paper discusses one example of excessive vibration encountered during loading of a centrifugal compressor train (H type compressor with HP casing).

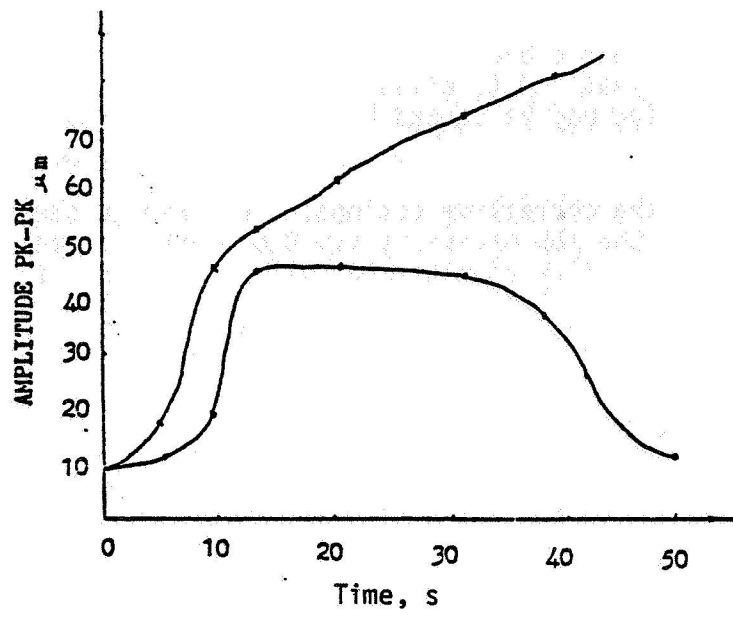
Figure 2.- Vibration versus time during startup. November 30, 1981.

This machine was commissioned on August 1, 1980, and put into operation smoothly. On October 28, 1981, the machine incurred an excessive vibration condition on #3 bearing. Usually high rotor vibration occurs near the #3 bearing. Maximum amplitude of the rotor vibration was 45 μm and continued 45 seconds with increase in opening the guide vane after start-up, then soon dropped. But in the malfunction condition, maximum rotor vibration amplitude was more than 125 μm and didn't drop with continuous increase in opening the vane. As a result, the machine couldn't be put into operation (Fig. 2).

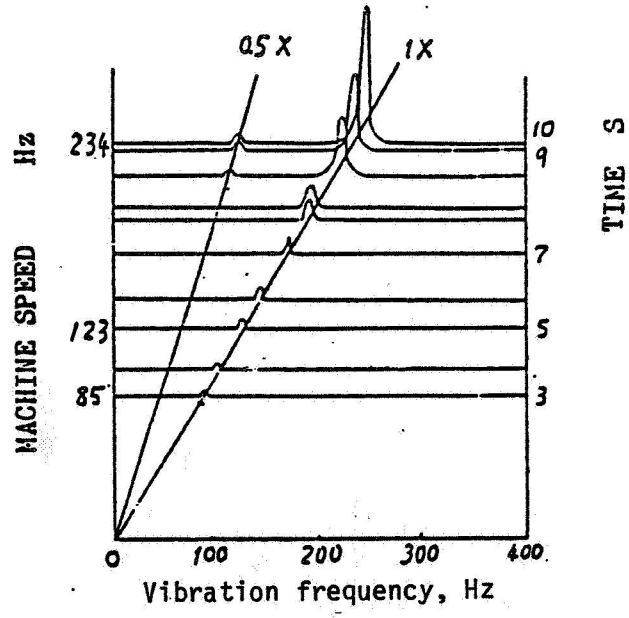
Figure 3.- Spectrum cascade during startup. February 10, 1983.

To detect the exact moment and cause of this high rotor vibration, the spectrum cascade during start-up and the curve of amplitude vs. degrees of the opened van had been recorded (see Figs. 3 and 4). Obviously, there is no amplitude peak in machine speed from 0 rpm to 13987 rpm. This means that the machine did not pass through a critical speed during start-up. But, with an increase in opening the vane, an amplitude peak occurred.

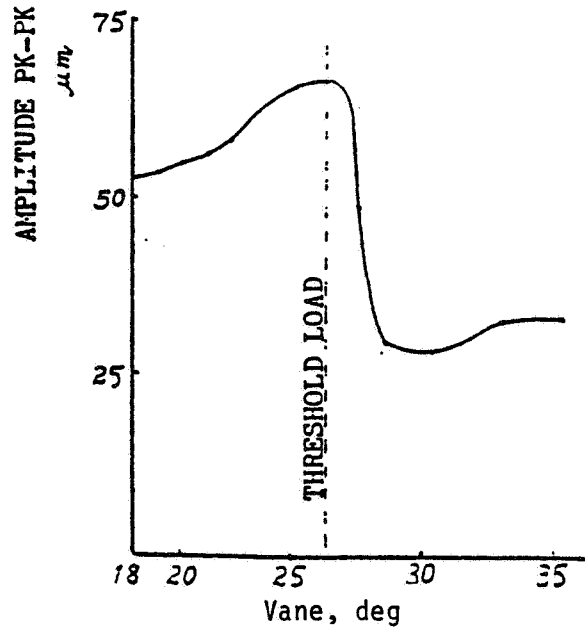
Figure 4.- Effect of dynamic load on vibration. February 10, 1982.

The results of calculation and analysis show that the high speed rotor and the #3, #4 bearings in the LP casing belong in the variable stiffness bearing system. It is different from most compressors. With an increase in dynamic load during opening the guide vane, both machine power and load of the #3, #4 bearings are increased. Fig. 5 shows radial load of the #3 bearing and direction angle vs. power of the machine. Because the bearing stiffness directly affects the critical speed of the rotor-bearing system (Fig. 6), at the moment when the dynamic load reaches a certain value, the critical speed can coincide with the operation speed, and the resonance will occur. This value of dynamic load is called "threshold load." In normal cases the machine runs smoothly as soon as it passes through the threshold load (Ref. 2).

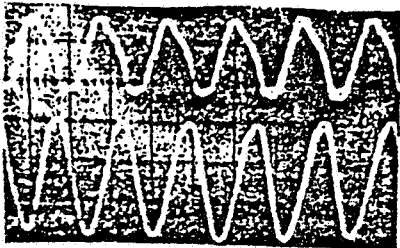
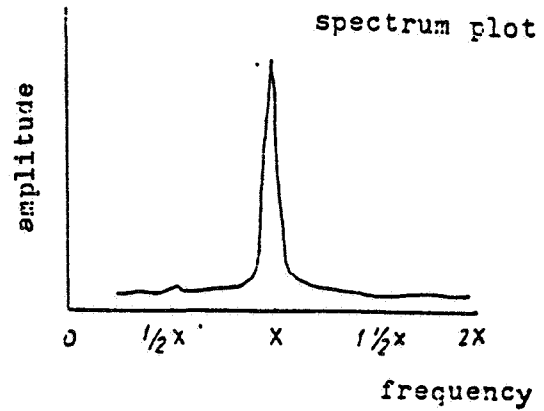
(a) Full-rub, reverse-precession vibration.

At the moment of passing through the critical speed on the threshold load, $1\times$ rpm high vibration occurred and soon dropped, but in the malfunction condition, excessive vibration did not drop even if passed through the threshold load. As shown in the Fig. 7 (A), the rotor motion orbit plot was elliptical with one fixed bright spot. During dismantling the machine, some wearing plots were discovered in the exact same direction on the #3 bearing. And at the moment when the excessive $1\times$ rpm vibration was dropping, the change of 720° in phase angle had been recorded by chance (see Fig. 8). It shows the excessive vibration was reverse precession due to full rub, because high friction forces may cause a dramatic change of the precession direction from forward to continuous backward whirl (Ref. 3). This is self-excited vibration. If harmful energy accumulates long enough, the orbit plots will diffuse (see Fig. 7 (A)). At this moment the machine must be shut down immediately.

Rotor rub against the bearing generates very complex rotor vibration. Rubs are created in machines by introducing a contact between the rotor and the bearing. The contact may be initiated by displacement of rotor center to stator center, which is caused by misalignment, foundation deformation, unparallel between gear shafts and eccentricity of the bearings. Displacement is prerequisite to introduction of rubs. That is why the machine may be put into operation by chance after remounting the bearings and exact alignment even in the oversize bearing condition. But in most cases, full rubs or partial rubs in the oversize bearing frequently occur due to rotor center displacement.

(1) The top clearances of both #3, #4 bearings were reduced from 0.48 mm to 0.31 mm on November 2, 1984.

(2) To increase oil viscosity the PRESLIA 20 type lub oil was replaced by PRESLIA 30 and oil temperature was reduced from 42°C to 28-30°C on November 3, 1984.

(3) The gear coupling was replaced by a new one and exact alignment was taken in December 1984.

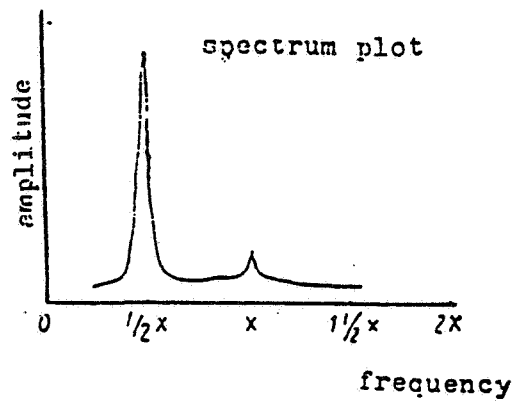
(b) Exact 1/2 subharmonic vibration.

Oil whirl (hydrodynamic instability of bearings) is the most popular forced sub-rotative speed mechanism, but in this case according to the instability threshold curves of offset halves bearing (Ref. 4) and the results of the calculation of speed term and clearance term, the operation condition point on the #3 bearing was far from the region of instability. And it was exact $1/2\times$ rpm but not less than $1/2$ rpm vibration, which often occurs during oil whirl. In addition, the vibration wave was different from oil whirl and coinciding with subharmonic vibration (Ref. 5), so that the failure was not caused by oil whirl.

Exact $1/2$ subrotative vibration may be caused by partial rub or by a loose non-rotating part (Ref. 3 and 6). During dismantling the machine, no loose part was found on the bearing shell, bearing housing, or pedestal support. As observed in the performance of many machines, the partial rotor to stator rub, or rub in oversized or poorly lubricated bearings, often causes steady subharmonic vibration of the frequency equal to exactly half of the rotating speed (Ref. 3). In the subject machine, the top clearances of the #3 and #4 offset halves bearings was 0.48 mm.

The diameter of the bearings was 120 mm, the ratio of the diameter to the clearance was 0.4%; obviously it is too excessive. For this reason, the failure can be attributed mainly to the oversized bearings.

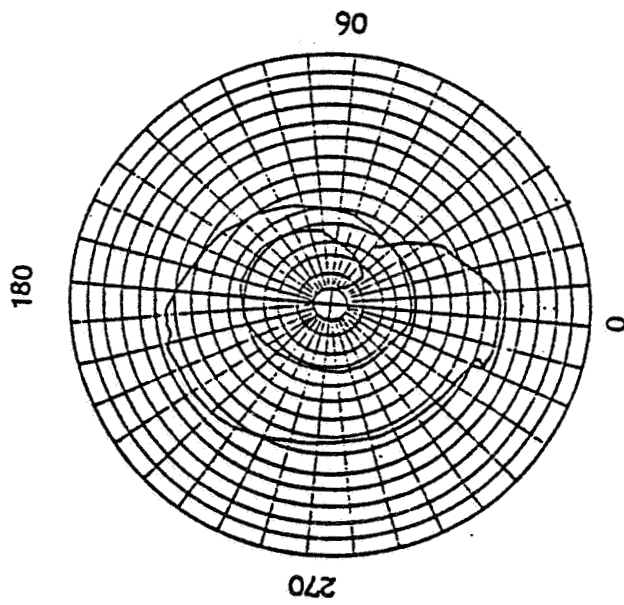
Figure 8.- Polar plot. February 13, 1982.

At the moment when excessive $1\times$ rpm vibration was dropping, the phase angle changed 720° (see Fig. 8).
