5105-146
Solar Thermal Power Systems Project
Parabolic Dish Systems Development

Bearing Development Program for a 25-kWe Solar-Powered Organic Rankine-Cycle Engine

September 15, 1985

JPL Publication 85-81

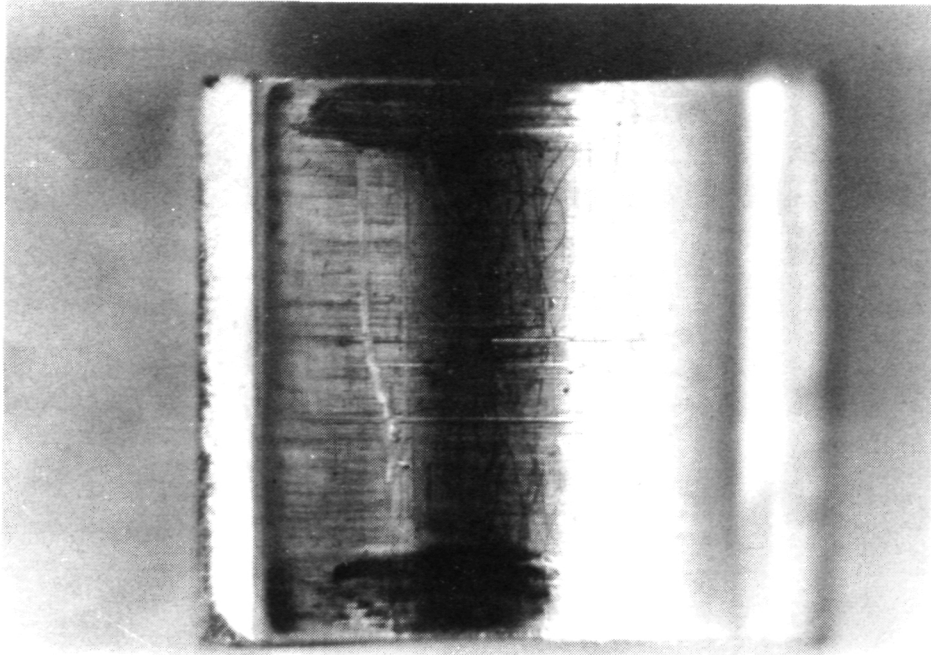
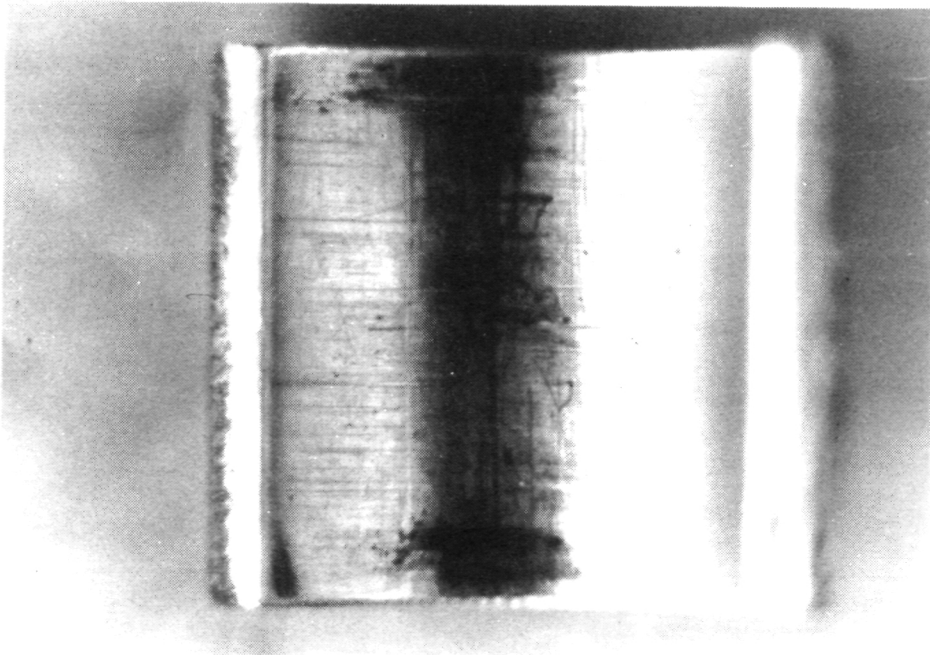
Figure 3-3. Edge Wear on Tilting Pads, Possibly Caused by Excessive Yaw Motion

Tin-antimony babbitt provided a more forgiving metal-to-metal contact surface than bronze for initial start-up and lift-off of the pads. The two most severe wear patterns on the turbine end thrust bearing coincided with the two gimbal pin locations on the bearing. This raised a suspicion that the thrust bearing was deflected under load at all locations except where supported by the gimbal pins. The locations of the thrust bearing gimbal pins were changed so that they would not coincide with the lubrication grooves in each thrust bearing. Because there was no measurable improvement in PCS performance in builds 4 or 5, the slinger ring was removed. Immediately upon reaching design speed for the first run of TAP build 6, the turbine wheel rubbed the turbine housing because of plastic deformation of the wheel at high speed. Apparently at high operating speeds the wheel plastically deformed and redistributed the mass of the wheel, thus continuously changing the rotor balance. The excessive imbalance caused severe bearing loads that resulted in pounded and worn journal bearings. Barber-Nichols followed the Inconel 718 supplier's recommendations by heat treating and brazing the turbine wheel and shroud in two separate consecutive processes; unfortunately, this technique resulted in excessive grain growth and an overall reduction in material strength. The process was corrected by simultaneously heat treating and brazing in a single process to minimize grain growth and increase material strength.

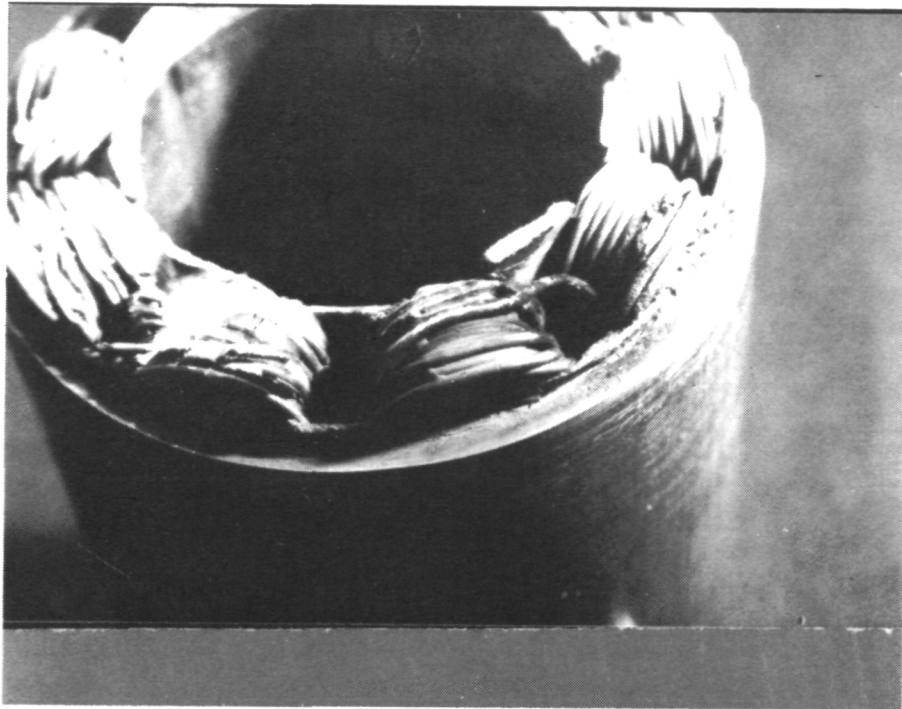
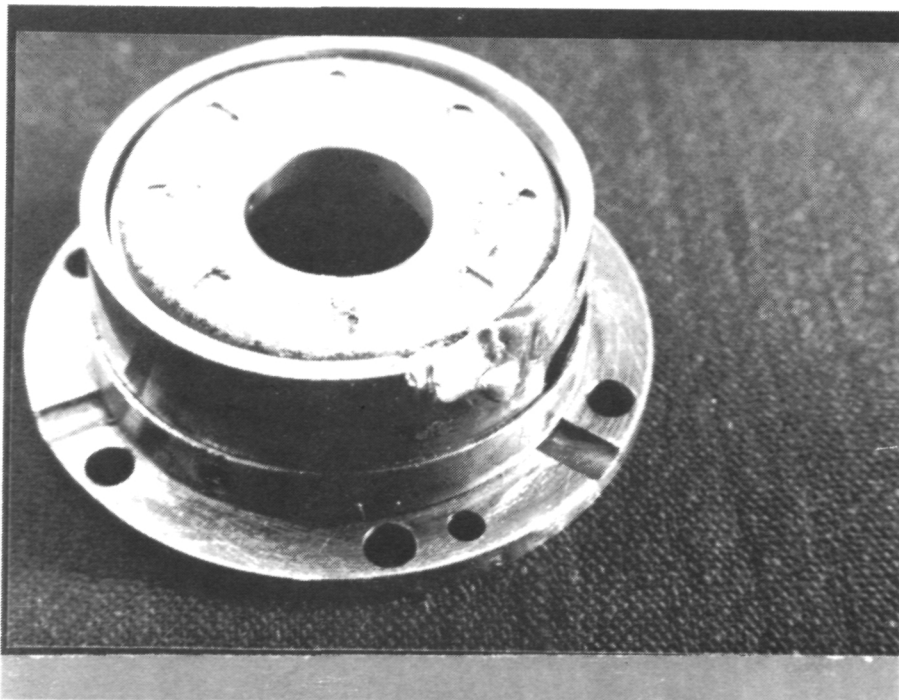
Inspection of TAP build 11 revealed severe electrical arcing between the PMA stator end turns and the outside diameter of the turbine end thrust bearing (Figure 5-6). The arcing was severe enough to melt and remove a section of the turbine end bearing carrier. The outer diameter surface of the thrust bearing was severely worn, and deep pits were observed in the center of

Figure 5-6. Electrical Arcing Damage between (a) the PMA End Turns and (b) the Turbine End Thrust Bearing Carrier

A number of concurrent tasks were initiated to resolve the problems discovered in TAP build 11. A Rayleigh step thrust bearing was designed and installed on the turbine end for all future builds to replace the relatively lower load-carrying flat pad (Fogg) bearing currently used. A second-generation bearing test stand was fabricated to verify the maximum load-carrying capacity of both radial and thrust bearing designs with internal shaft-fed lubrication and with external flooded lubrication. The failed PMA stator was rewound with upgraded insulation wire, potted with insulating material, and finally encapsulated in an additional toluene-resistant black stycast 2850 material (Figure 5-7). The unused spare PMA stator was only encapsulated in stycast material for future use. A TAP test stand was developed that could measure the applied torque on the tap, which in turn could be used to derive the efficiency of each tap component as it is added or removed to determine the cause of the lower-than-predicted performance. The feed pump was to be performance-tested with various back clearances to determine the effect of increased clearance on pump efficiency. It was hoped that the larger feed pump impeller back clearance would reduce the probability of contacting the TAP housing without significantly reducing the pump efficiency.

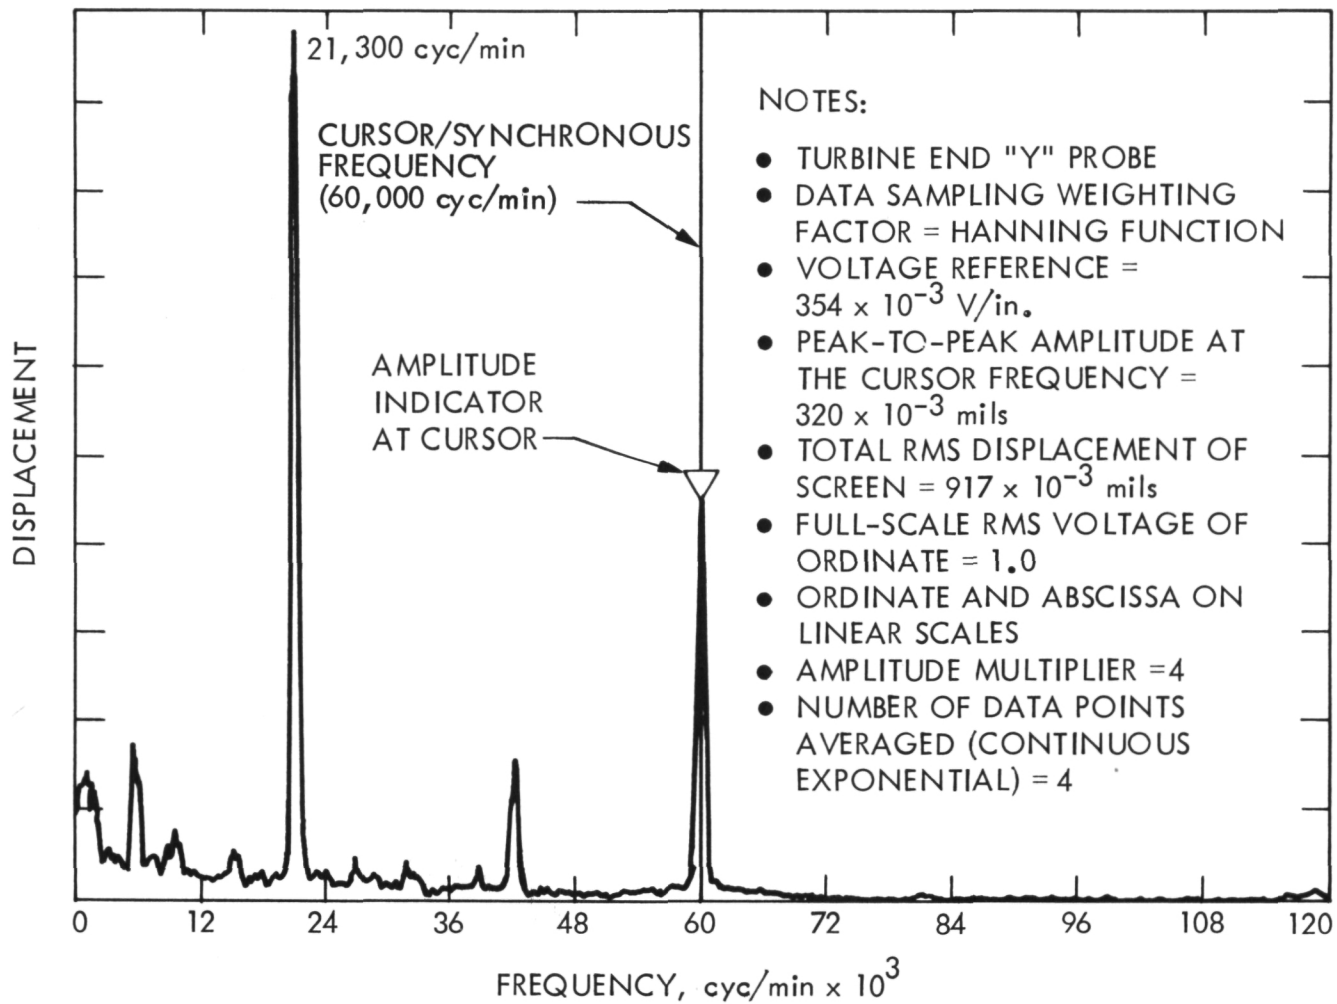
During operation of TAP build 14, the proximity probe data indicated a serious subsynchronous rotordynamic instability. Figure 7-3 gives the spectrum plot from a TAP optical proximity probe showing this effect. Disassembly and inspection revealed wear on the trailing edge of each tilting pad and polishing on the turbine end thrust bearing.

Figure 7-3. Spectrum Plot from Tests of a Barber-Nichols Three-Pad Tilting-Pad Bearing

After extensive analysis of the proximity probe data, three concurrent courses of action were initiated in an attempt to resolve the rotordynamic instability problem. The squeeze-film-damped journal bearings (designed, installed, and tested by B-N) were the first to be tested because they had the shortest lead time (Figure 7-4). It was thought that by providing the proper amount of external damping to a simple journal bearing, the rotor bearing system could be stabilized. This was considered to be only a temporary fix to continue testing because vertical operation eventually would be required, and the journal bearing would probably be unstable in that position. The second parallel approach was a fully flooded five-pad tilting-pad journal bearing (from Waukesha Bearings Corporation) that was lubricated by externally supplied fluid from a dedicated bearing lube pump. This more conventional approach would eliminate all bearing and shaft dynamic uncertainties introduced by the lubrication system. A final backup approach was for Mechanical Technology, Inc. (MTI) to analyze and design a four-pad tilting-pad bearing and deliver drawings to Centritek for fabrication if the first two approaches failed.

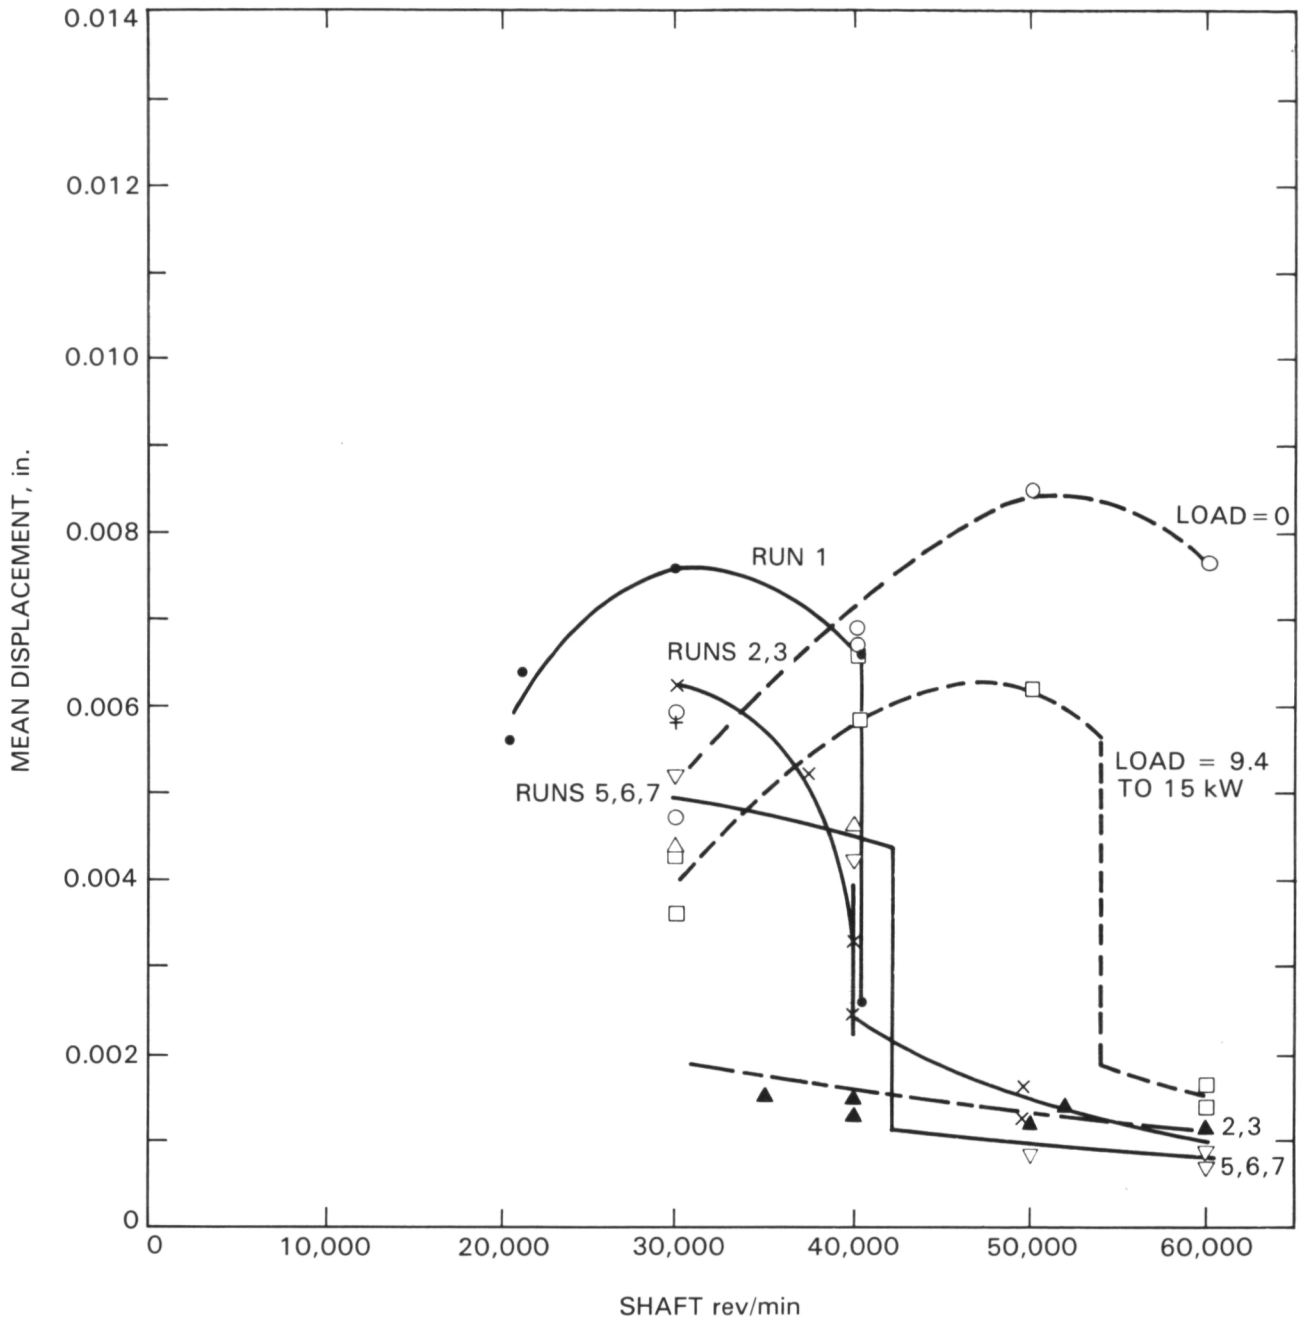
The damping coefficient of the journal bearings was adjusted by changing the fluid leakage resistance path out of the damper section. This was essentially a trial-and-error process to minimize the total shaft displacement, which was a strong function of shaft speed and loading. Radial displacements as high as 8 mils observed in build 15 were reduced to between 1 and 2 mils in build 19 (Figure 7-6). The subsynchronous instability was never eliminated; however, the frequency and amplitude were decreased by adjustments to the squeeze-film-damped journal bearings. The compliance in the damper made the total displacement of the shaft greater for the squeeze-film-damped journal bearing than for the tilting-pad bearing. This resulted in thrust bearing wear caused by excessive angular displacement of the shaft.

Figure 7-6. Total Shaft Displacement with the Squeeze-Film-Damped Journal Bearing

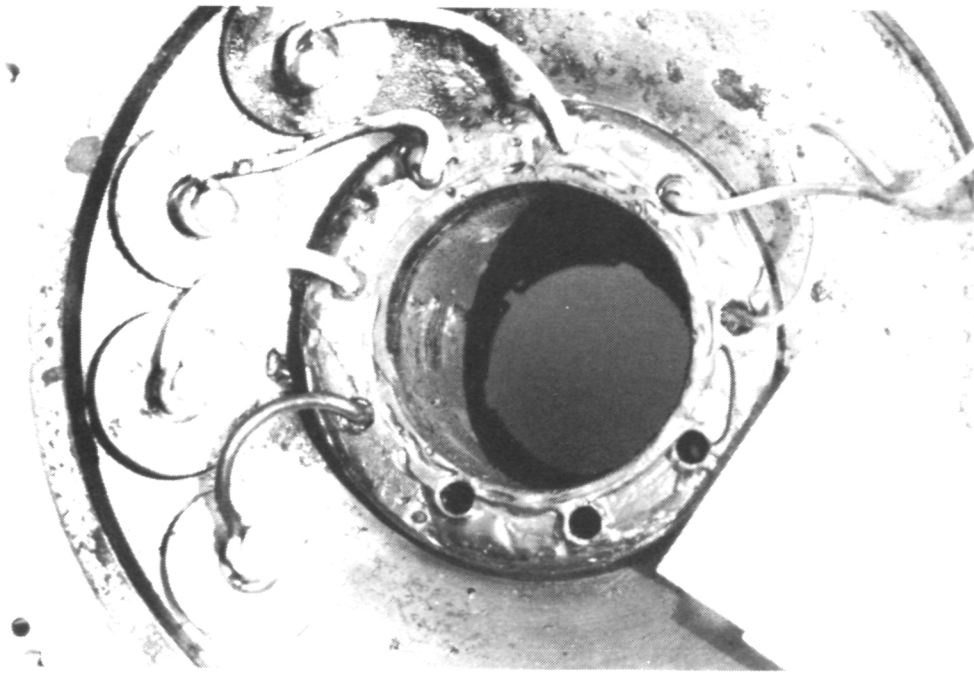
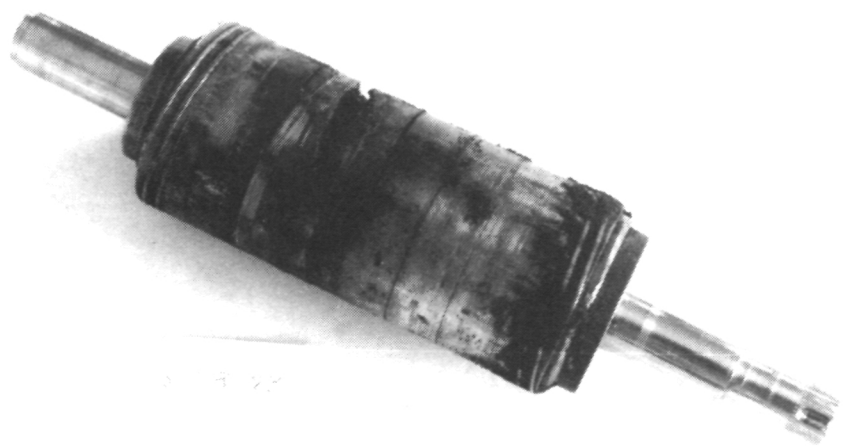
Figure 7-7. Permanent Magnet Alternator Failure Caused by Arcing between Adjacent Stator Coils

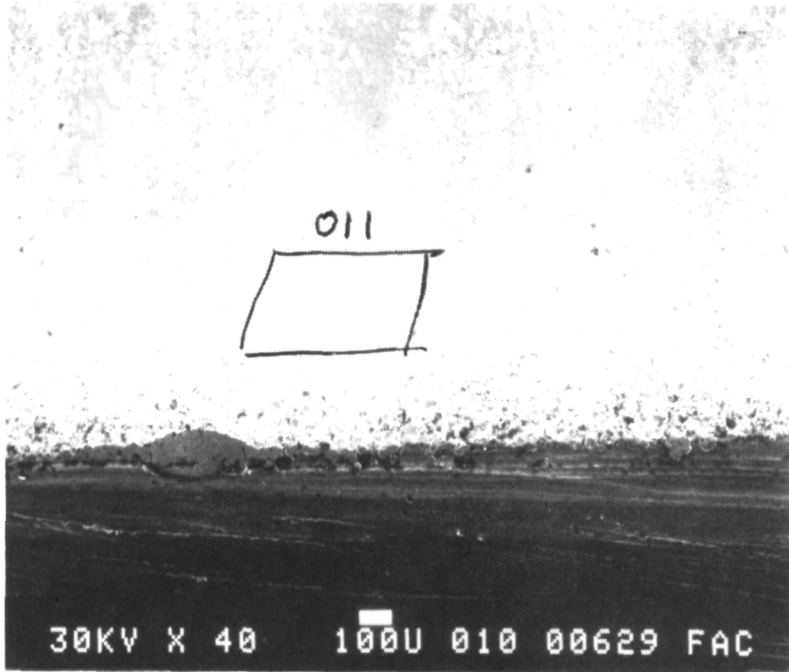
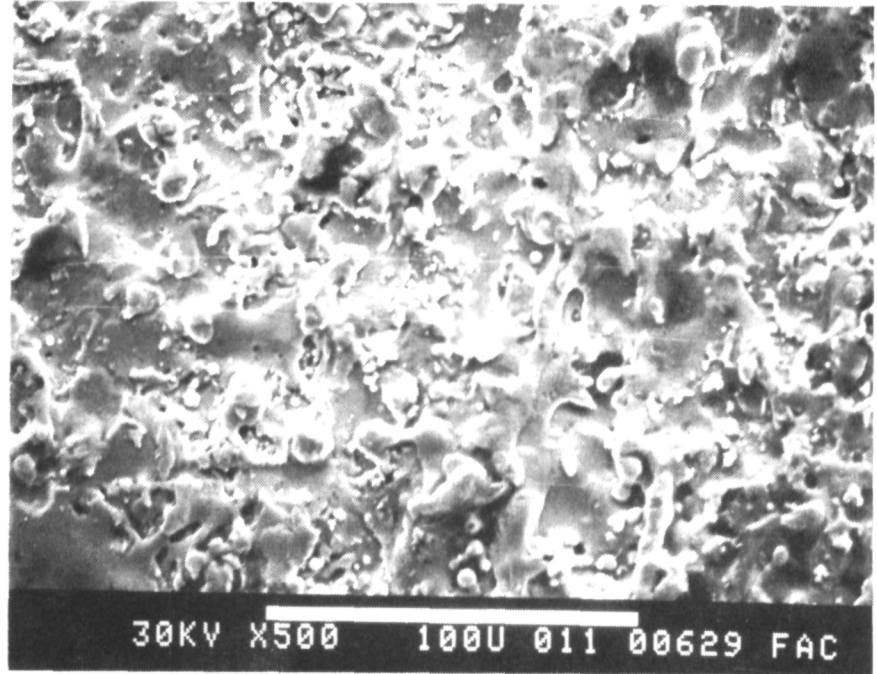
An extensive analysis of the build 21 damaged bearing surfaces was conducted by FACC using an electron beam microscope. The damaged surface on each pad had a frosted appearance, which was determined to be a number of separate but closely packed pits. Figures 7-12 and 7-13 show various magnifications of the pitted surfaces and compare them to unpitted zones. A chemical analysis inside the pits revealed high concentrations of zinc and chlorine, which were not present in the virgin babbitt or bearing material. This change is shown in Figure 7-14 where the virgin material analysis and an analysis inside a single pit are compared on one plot.

Figure 7-12. Trailing Edge Surface of a Waukesha Pad with Electrical Discharge Pitting

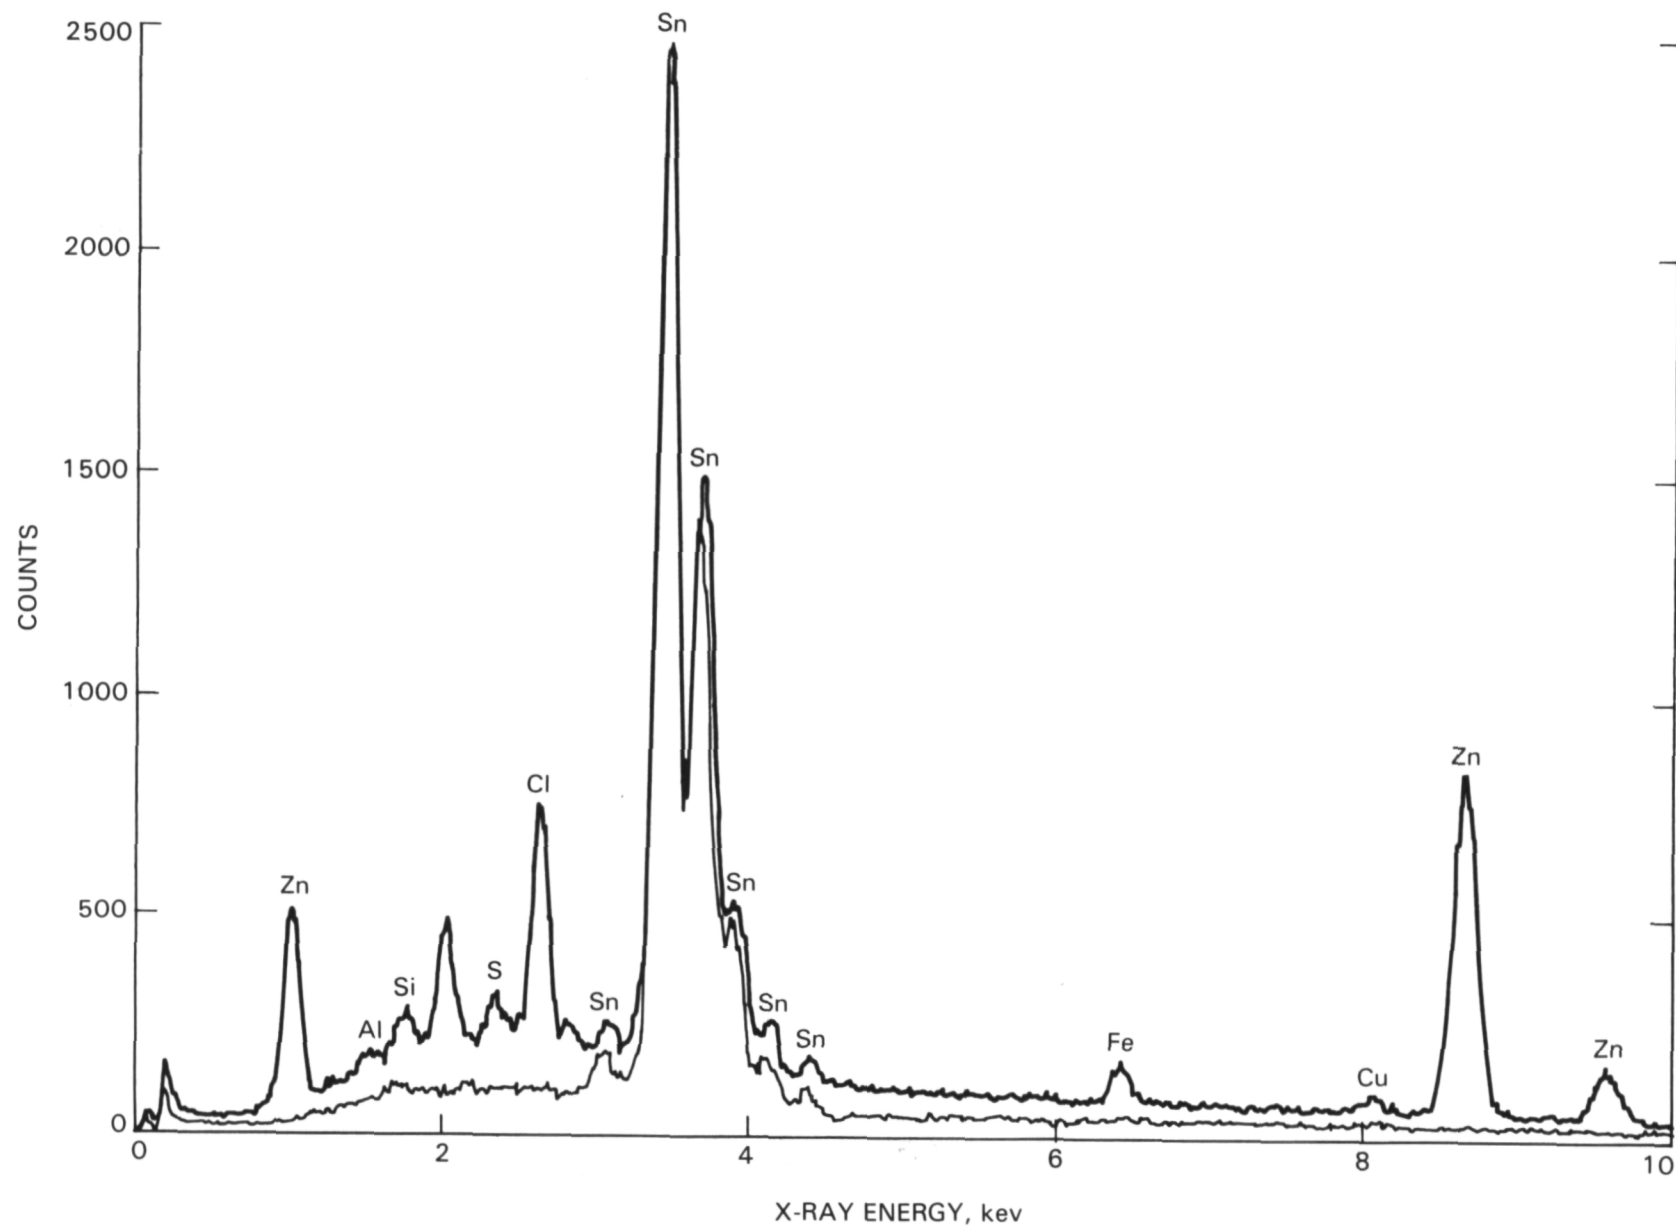
Determining the source and mechanism of transferring zinc to the bearing surface became the primary concern (a grounding strap was placed on the shaft turbine end center line prior to TAP build 2, and it remained intact for all PCS tests). Similarly, all test stand testing required an external drive shaft, which was grounded to the test stand. These two facts were the primary reasons for dismissing electrical discharge as a failure mechanism in earlier TAP builds. It also seemed apparent that the subsynchronous whirl and subsequent bearing wear may have destroyed most of the evidence of the frosted and pitted surface. The evidence was overwhelming, pointing to some form of electrical discharge as the mechanism of zinc transfer and the source of the material seemed to be the brass end seals. These seals maintained the lubricant around the bearings and operated in close proximity to the rotating shaft and the non-rotating bearings. Further analysis indicated that the grounded shaft would prevent electrostatic buildup and discharge but would not necessarily prevent electrodynamic discharges generated by the PMA. It was suspected that the PMA was generating and circulating stray current around a closed loop from the PMA stator to one set of bearings, to the shaft (or ground) to the other set of bearings, then back to the PMA stator.

Figure 7-14. Comparison of Pitted (upper line) and Unpitted (lower line) Surface X-ray Spectrums from a Scanning Electron Microscope in Spot Mode. Note the Higher Zn and Cl Concentration in Pitted Surface

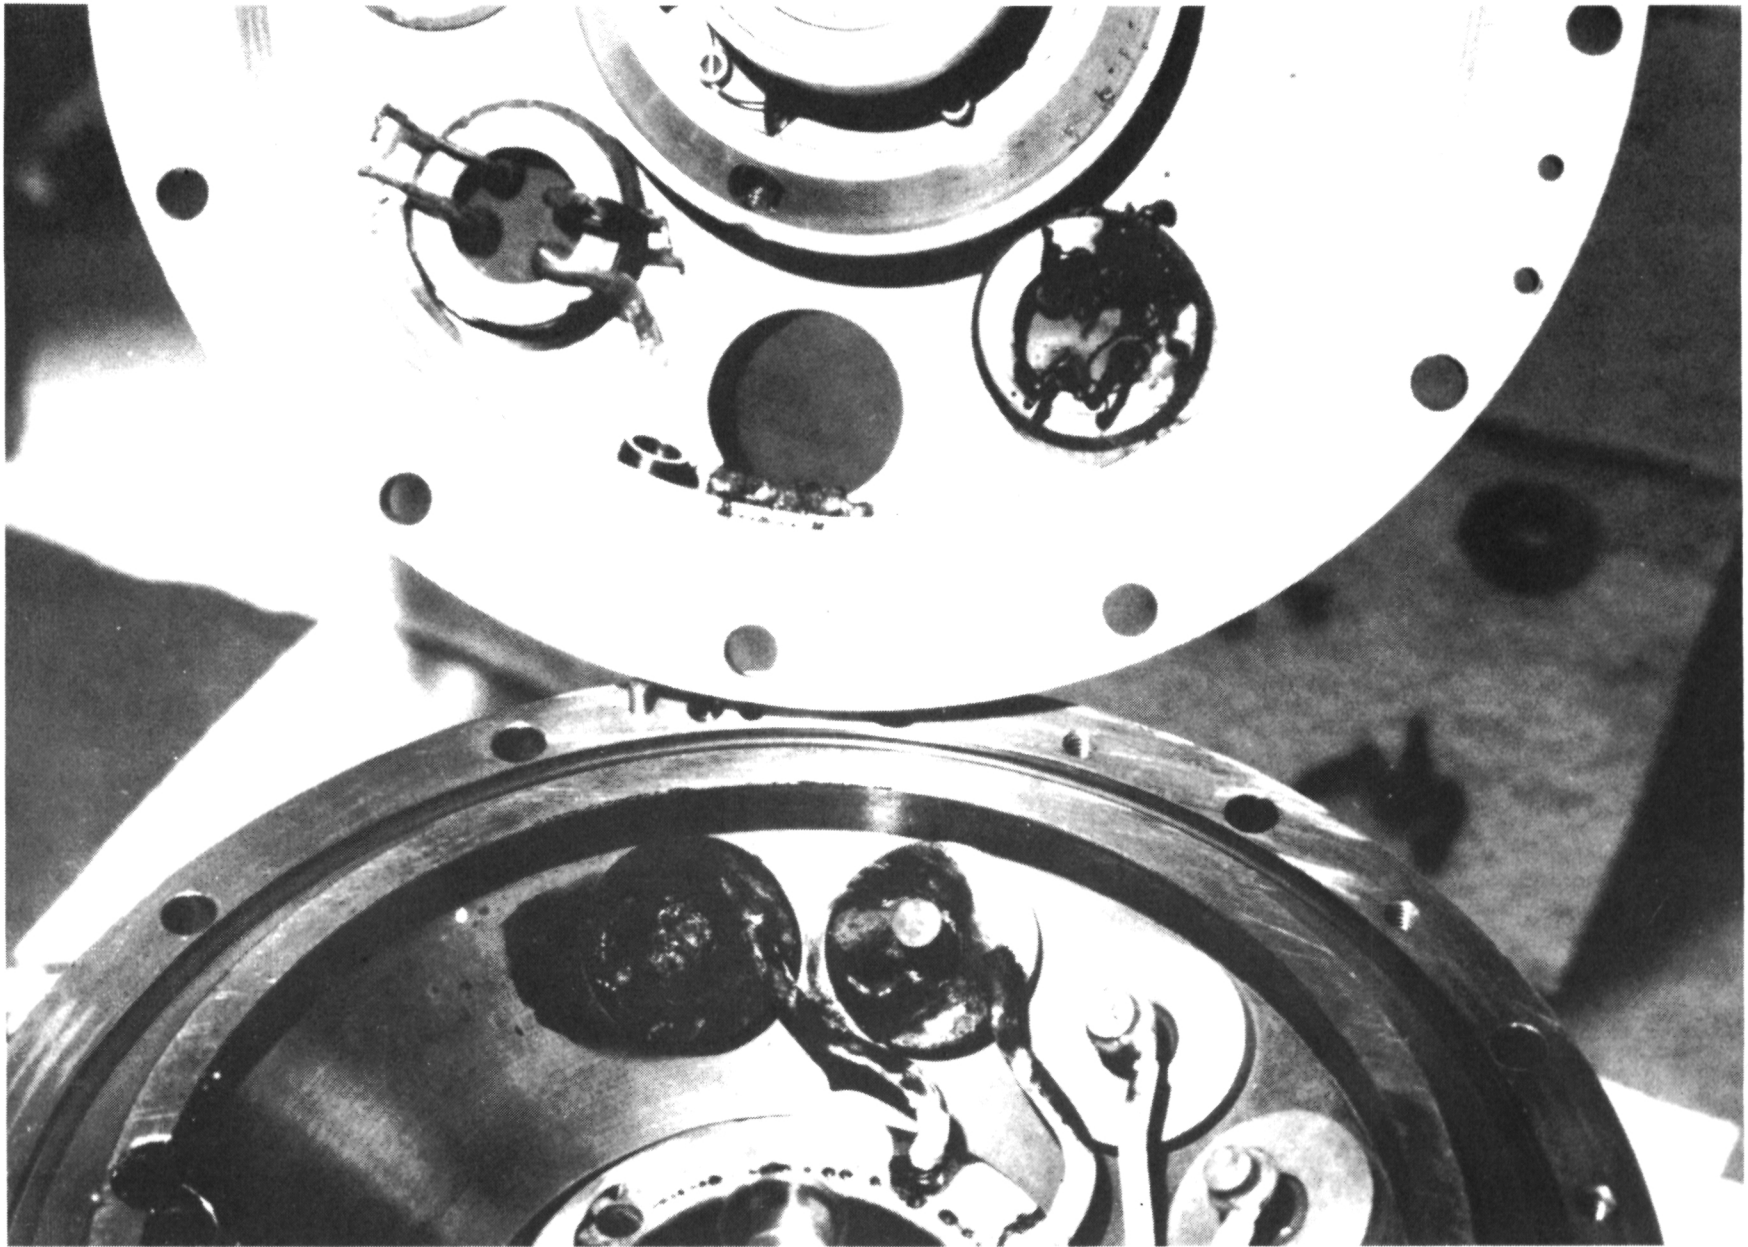
Figure 7-15. TAP Build 23 Electrical Feed-Through Failures of the Neutral and One of Three Phases from the Permanent Magnet Alternator

power phase may have dripped material onto the neutral, causing a simultaneous failure. Unfortunately, the failure damaged the bearings and invalidated the test to determine if and in what manner the magnetic rotor effected bearing wear.
