CID-720 AIRCRAFT
LaRC PREFLIGHT HARDWARE TESTS:
DEVELOPMENT, FLIGHT ACCEPTANCE AND QUALIFICATION

J. D. Pride
NASA Langley Research Center
Hampton, Virginia

NASA/FAA Government/Industry CID Workshop
NASA Langley Research Center
April 10, 1985

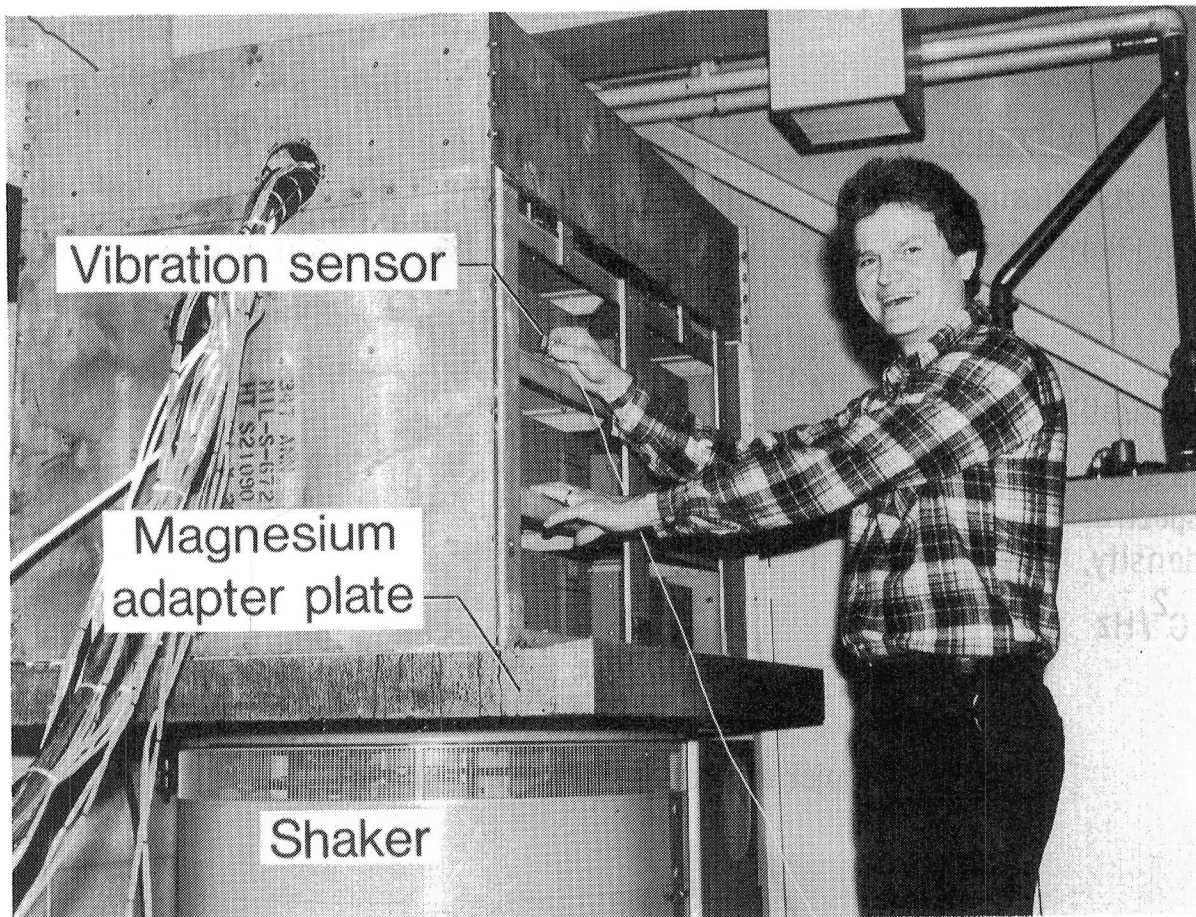
VIBRATION TEST
DAS - MAIN ELECTRONIC PALLET

The vibration test profile was input to the test article, mounted to a damped 4 inch thick magnesium adapter plate. The 17,000 force-pound shaker is shown in the vertical position with the adapter plate and approximately 900 pound DAS main electronic pallet mounted. The technician is shown placing accelerometers on each of the four shelves of the pallet unit, which has one heat shield side cover removed. The shaker was rotated 90 degrees and attached to a large slippery table for vibration of the longitudinal and transverse axes. The multicable harness was attached to the pallet components and the system was under power during the complete vibration test series. No major resonance conditions or abnormalities were evidenced during this test series.

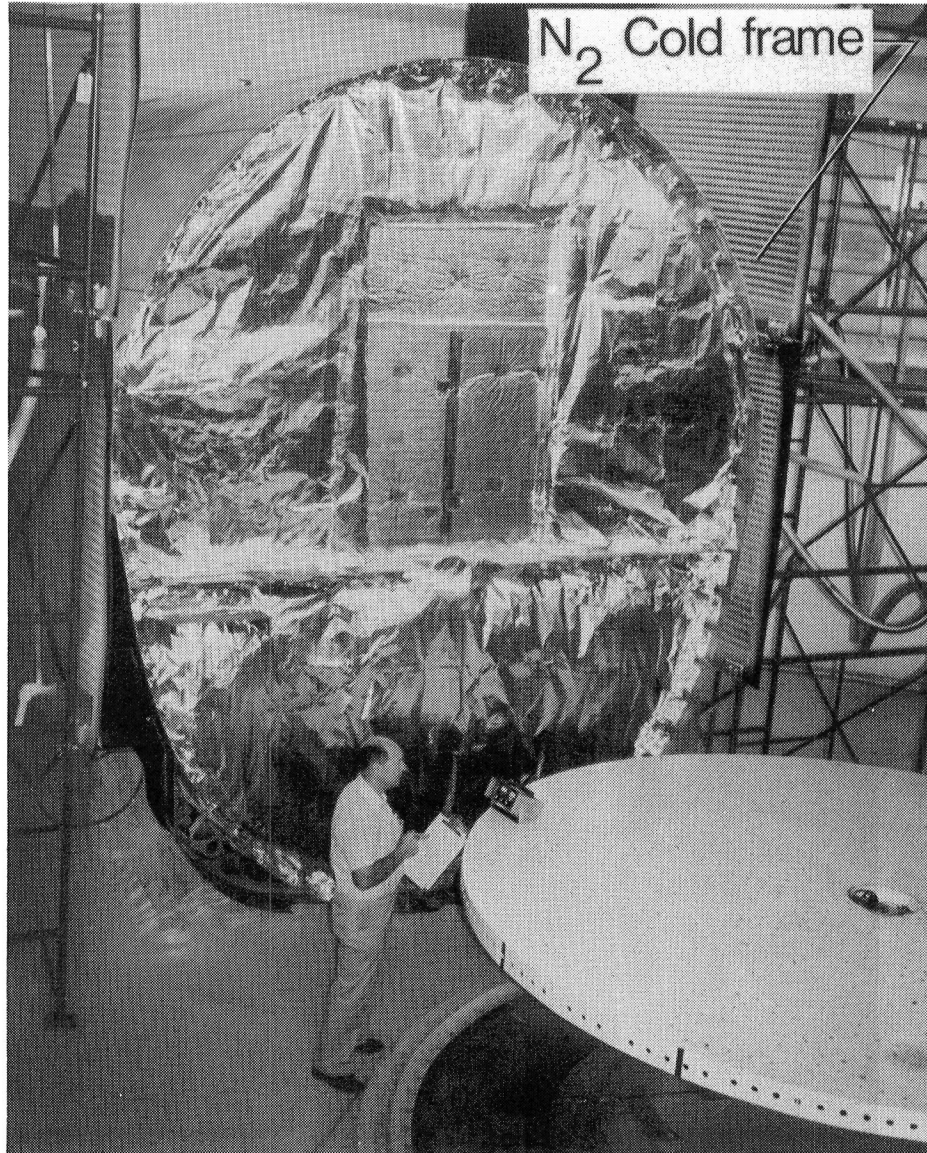
THERMAL (COLD) TEST

The full-size B-720 fuselage section was also used for the thermal (cold) test in the thermal vacuum facility. Large nitrogen cold frames were positioned adjacent to the fuselage section and temperature inside the fuselage was chilled by radiating heat away from the fuselage section to the cold frames. All of the test articles were operational through the cold temperature test environment. No major discrepancies or failures were detected throughout the thermal testing.

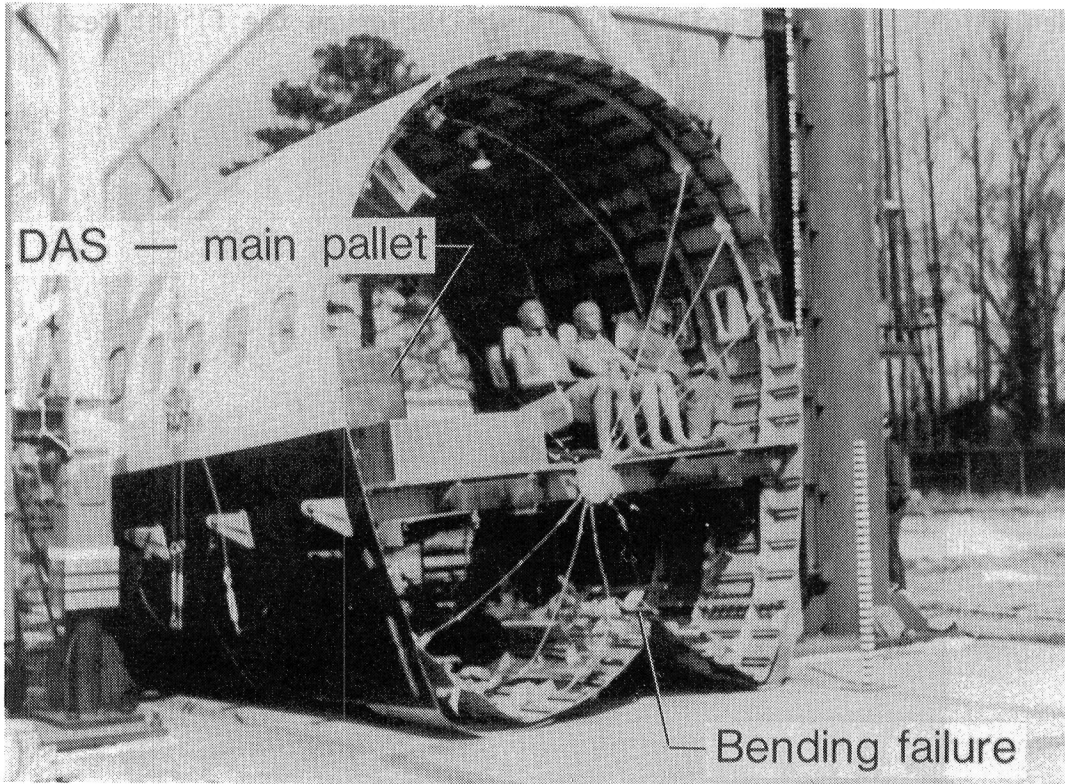
720 FUSELAGE (AFTERBODY) DROP TEST SHELL FAILURE
FLIGHT SYSTEMS OPERATIONAL

At impact, the lower fuselage shell failed where keel formers sheared and local bending occurred. A secondary bending and buckling occurred along the cargo shell sidewall. These structural failures absorbed considerable impact energy and contributed to reduced shock levels along the floor line where seats and pallets are mounted. All units were inspected after this test and shown to be qualified for flight test service.
