NASA Technical Memorandum 87636

EARTH RADIATION BUDGET EXPERIMENT (ERBE)
SCANNER INSTRUMENT ANOMALY INVESTIGATION

OCTOBER 1985

Langley Research Center

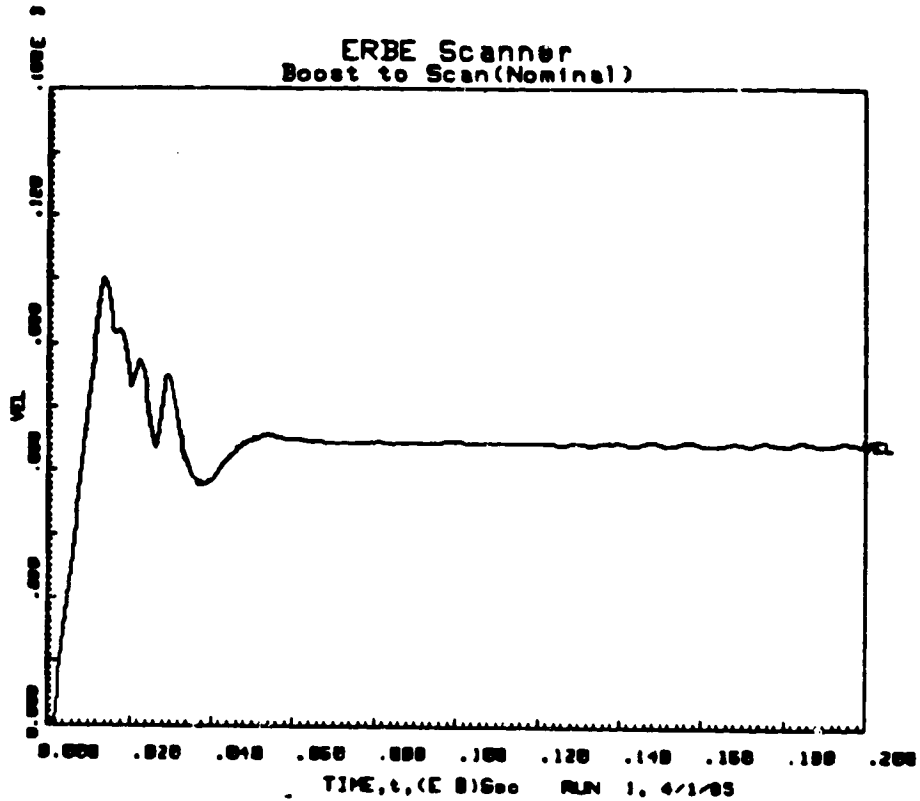
SIMULATION WITH NOMINAL FRICTION
FIGURE 1a

There were two cases which produced the proper direction and magnitude of shift in the first Earth scan point, essentially continuous high power consumption and a nominal $66.67^\circ/\text{sec}$ Earth scan velocity. These two cases were: (1) an increase in mechanical friction and (2) an offset in motor driver current output. These conditions are analogous in nature and produce very similar response in the instrument simulations. The nature of the response is not a simple retardation of the instrument during Boost Mode but is a significant change in the nature of the transition from Boost Mode to closed loop velocity control as shown in figure 1. In addition to the fact that increased friction or electrical offset simulations match the three observed conditions on the flight units, a plot of change of the first earth scan data point versus friction, figure 2, may partially explain the 60 day period of nominal operation and the sudden occurrence and disappearance of the anomalous conditions. There is little change in the first earth scan count and the unit maintains essentially nominal power usage as the friction increases from the nominal value (0.5 in-oz) to approximately 5.5 in-oz. At approximately 5.5 in-oz. of frictional torque the unit abruptly shifts into high power usage with little or no transition region. At approximately the same point there is a sharp knee in the curve and the first earth scan count changes very rapidly for small variations in friction. This suggests that friction could have been increasing over the the 60 day period without causing any detectable change in performance, and that when the threshold level was reached the anomaly became apparent. This also suggests that it is not necessary for the scanner to "restore" itself to a like new condition for the anomaly to apparently disappear. The disappearance may represent only a small drop in friction below the threshold value.

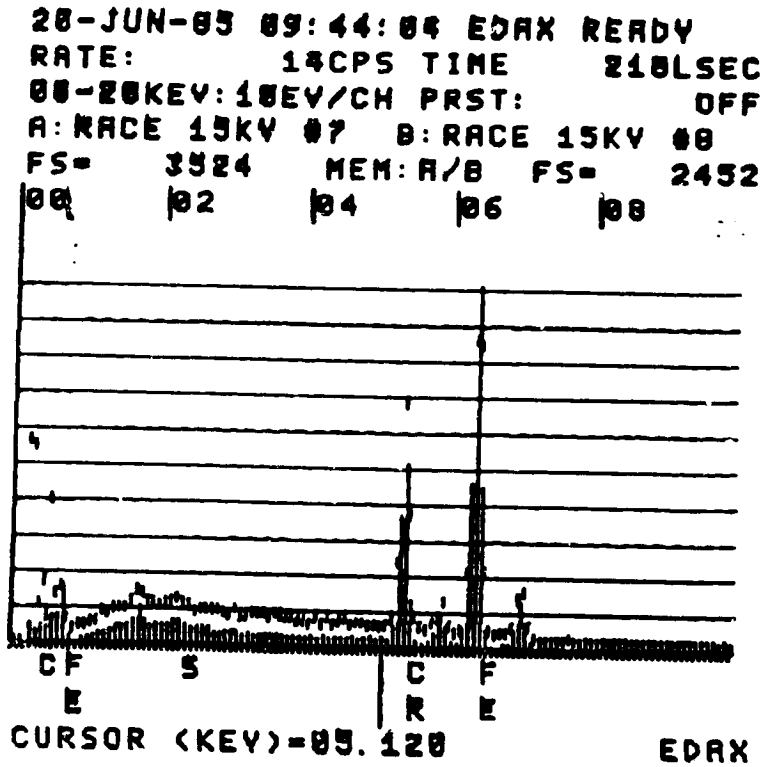
In light of the low vacuum (10^{-3} Torr) used in the scanner life test, it is possible that the deposit found on the outer race could have resulted from a oxygen reaction at the wearing surfaces.

Fig. 6- EDX analysis of outer race

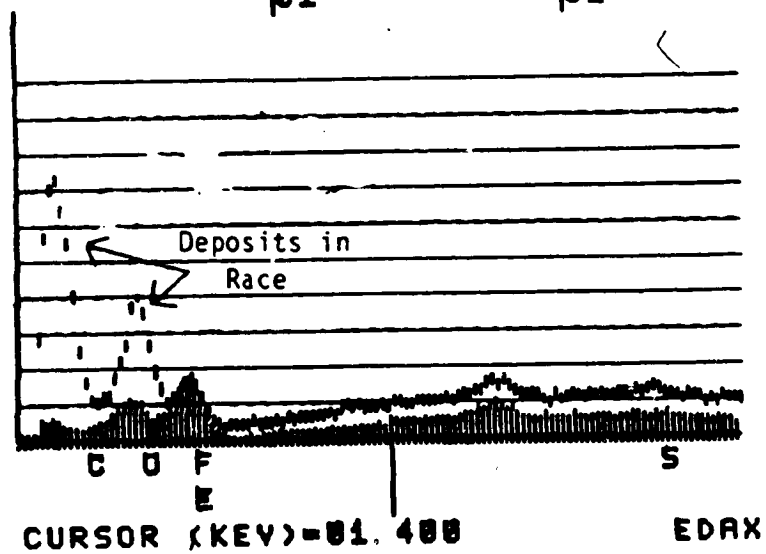
Fig. 7- EDX analysis of deposit
