LMSC-HREC TM D784769

SRB ATTACH RING PHENOLIC
TPS FISHTAIL SEAL EVALUATION
TESTS

February 1982

Contract NAS8-32982

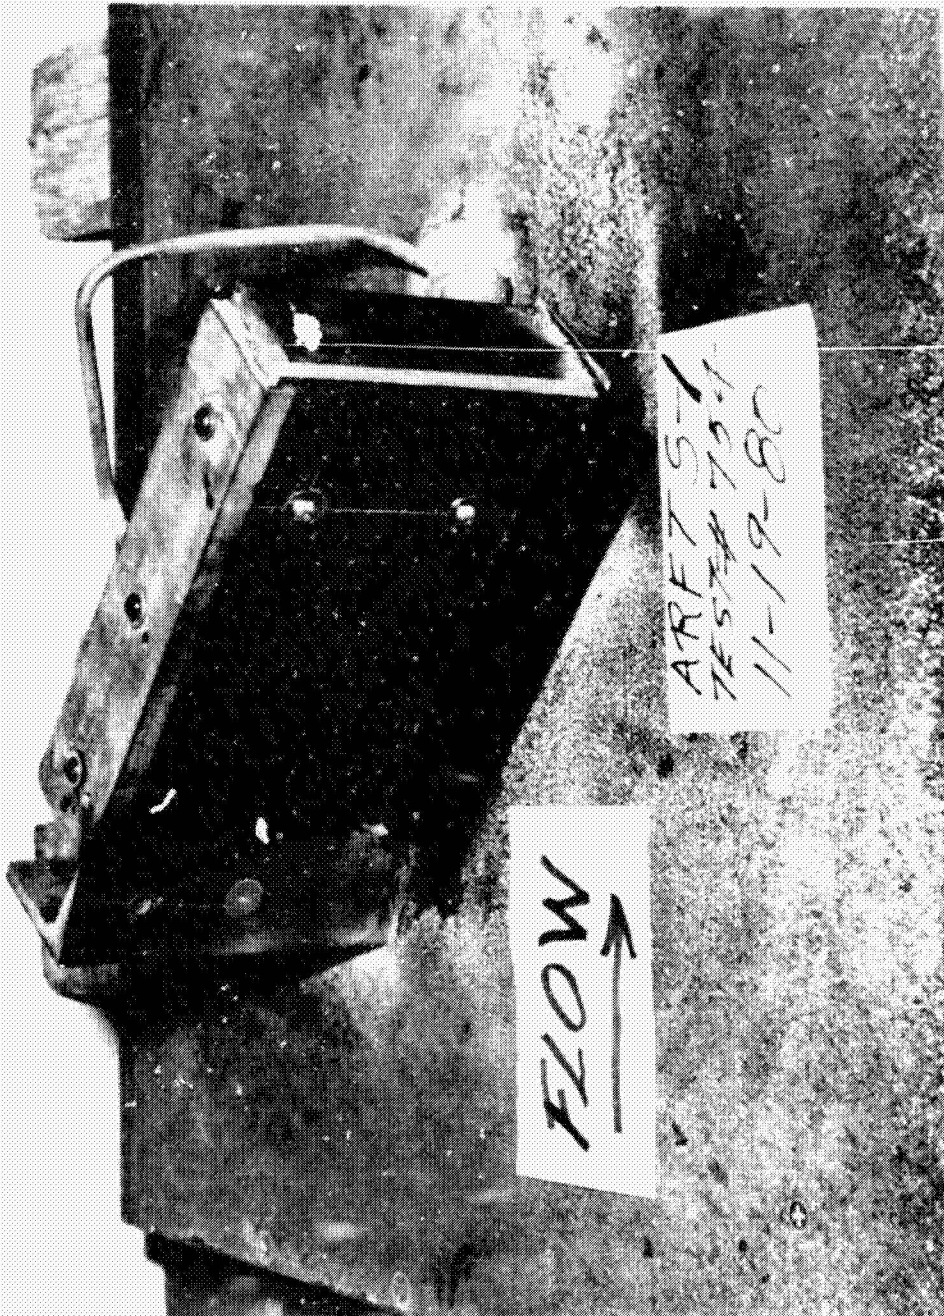
Fig. 1 - Attach Ring Phenolic TPS Fishtail Seal Test on Fixture Mounted at 41 deg to Flow (Material of Seal is E60C Viton Fluorinated)

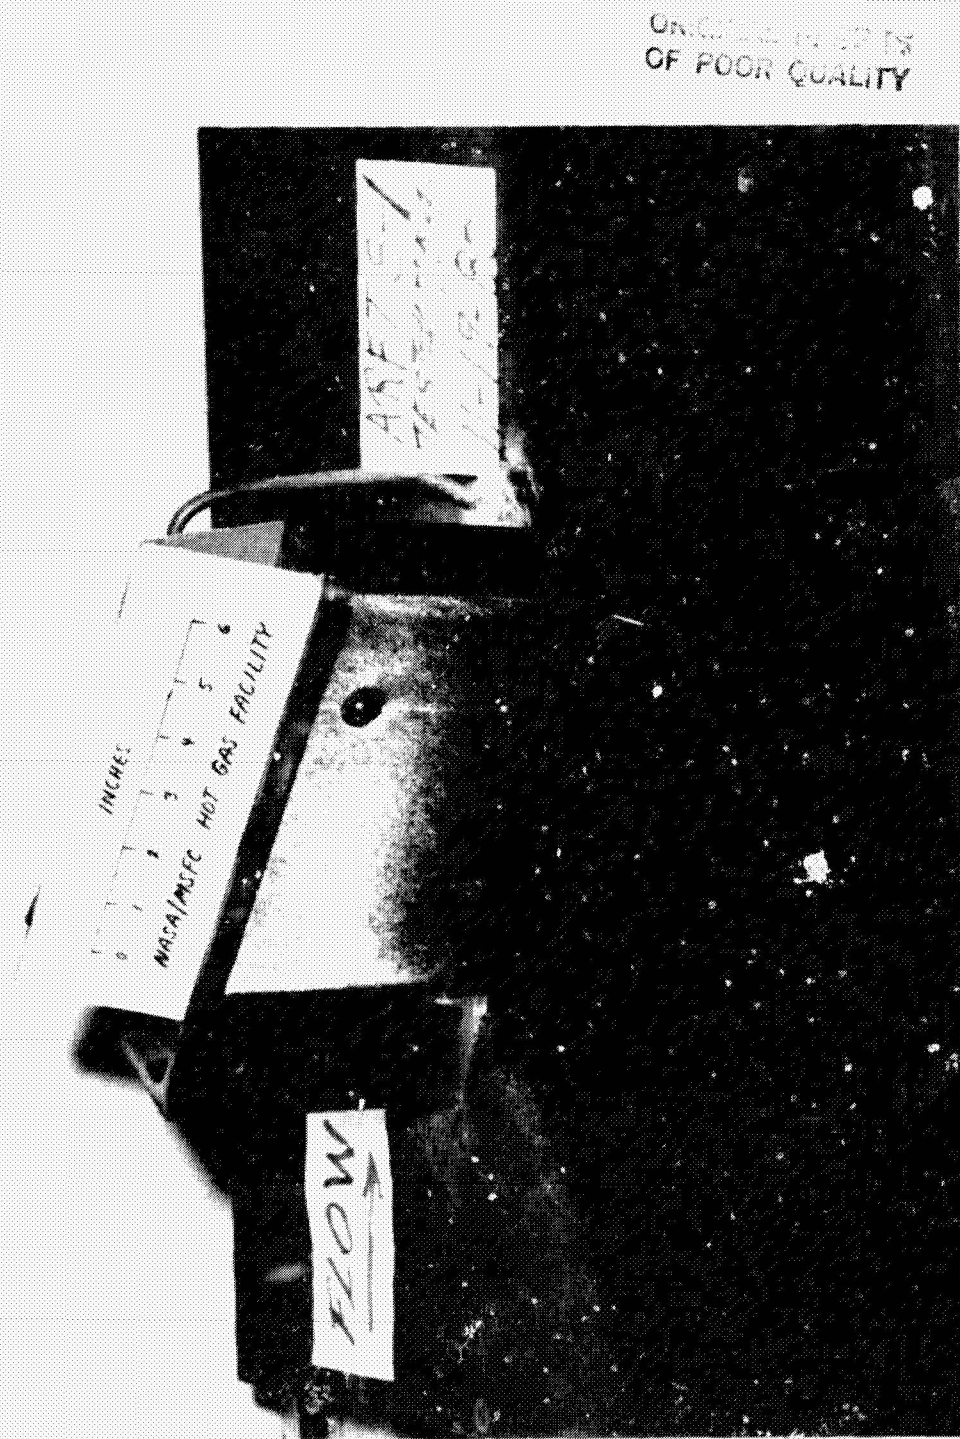
Fig. 2 - E60C Viton Rubber Seal Performed Well But the Material is Seen to Have Melted and the Residue Spread Onto the Bottom Panel

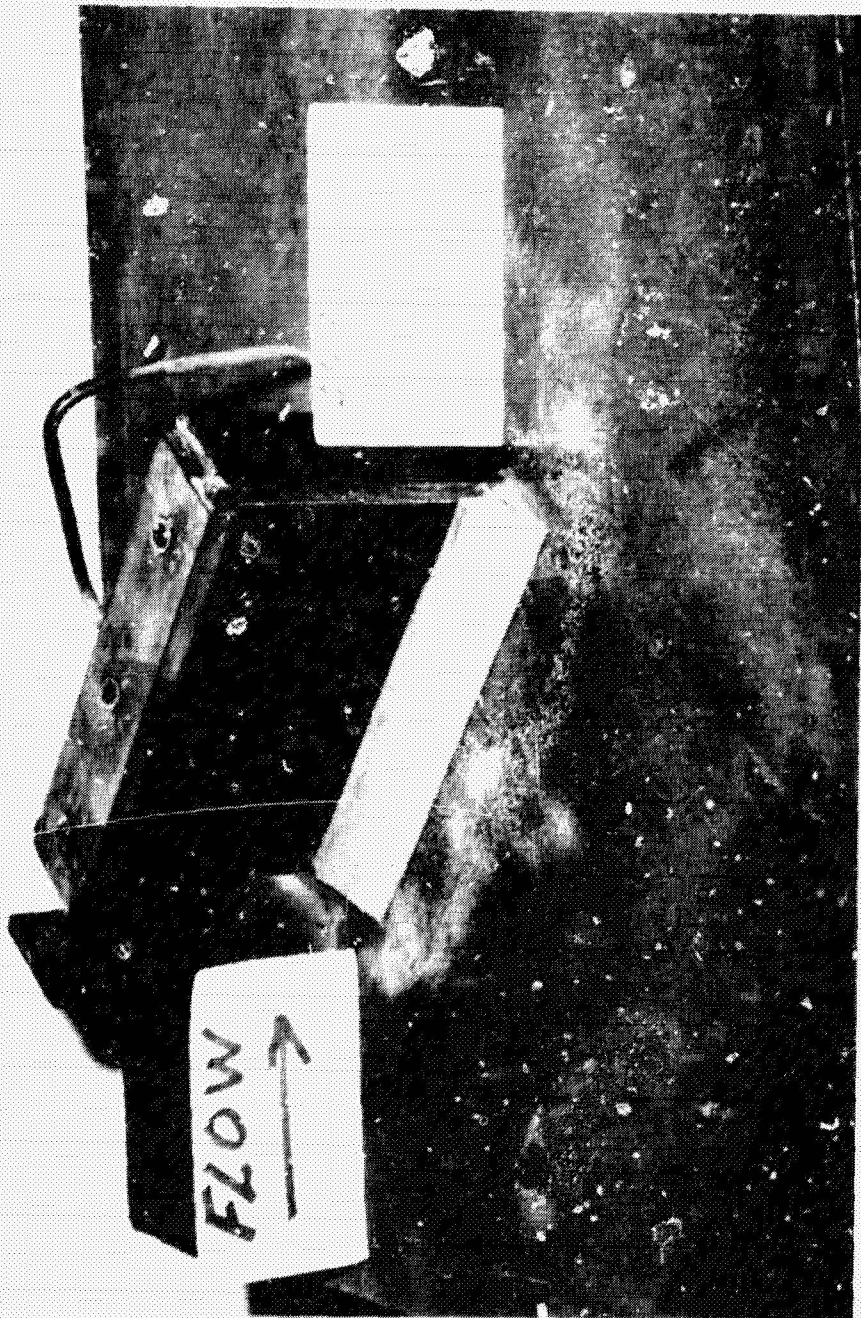
Fig. 3 - Initial Test Setup for Evaluation Testing of Small Fistail Seal with Design 0.375 in. Gap Under Phenolic

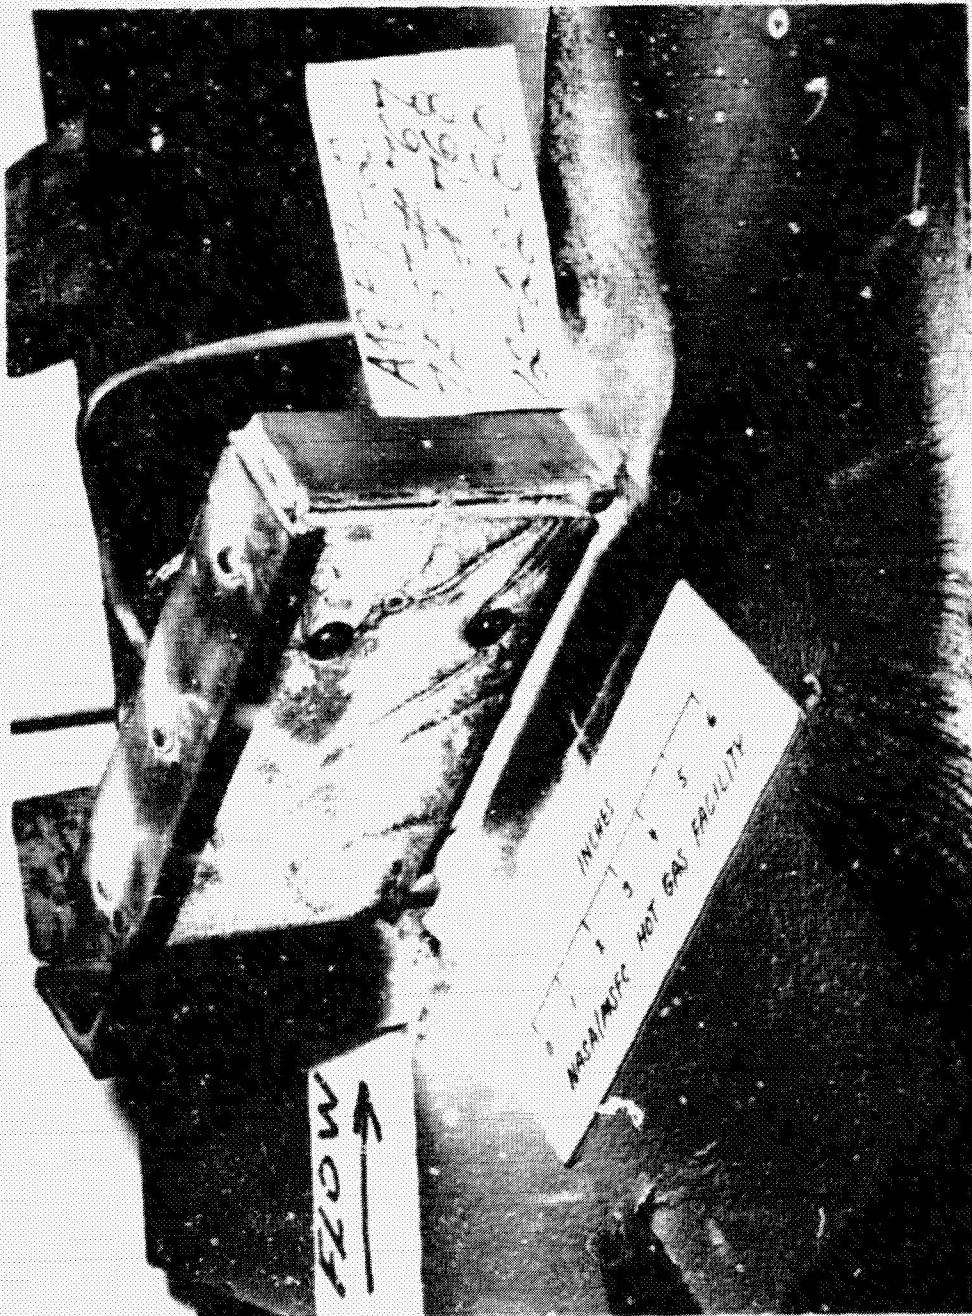
Fig. 4 - Seal Is Lost Due to High Shear Environment in This Test Configuration

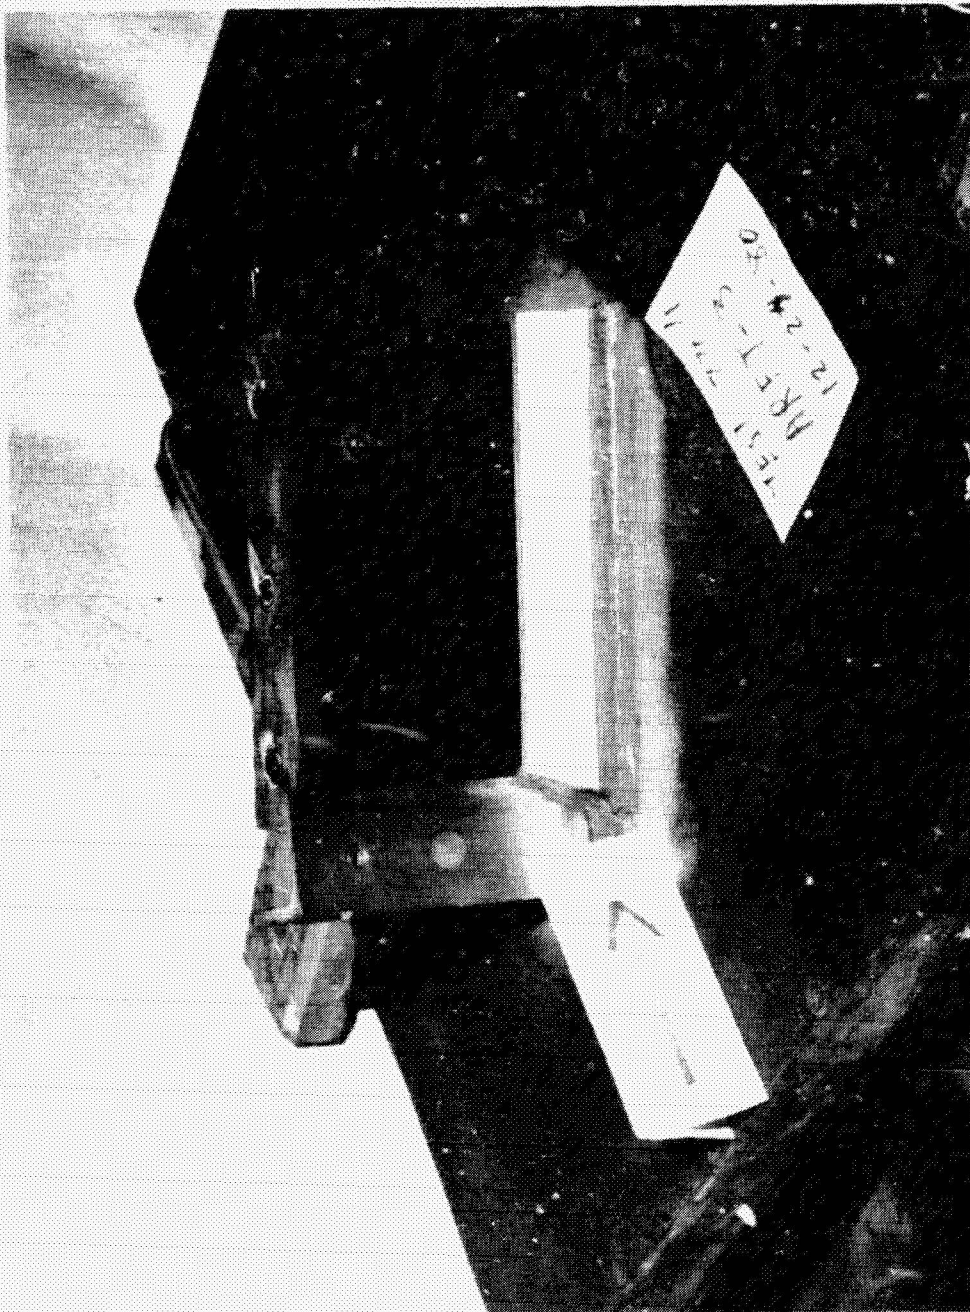
Fig. 5 - Test Setup Similar to That of Fig. 3

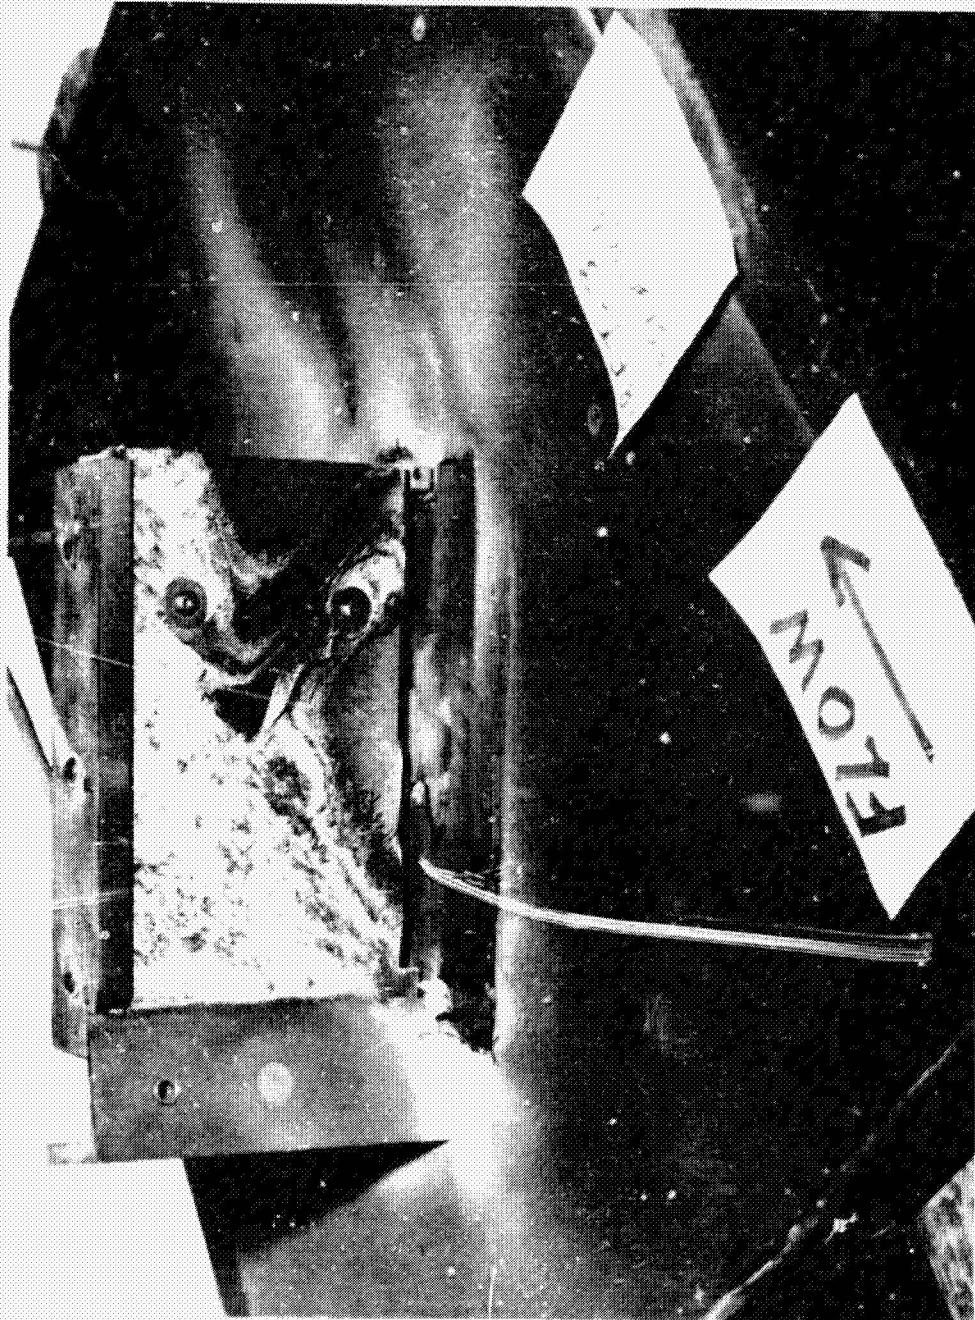
Fig. 6 - Results of This Test Are Similar to Those of Test in Fig. 4

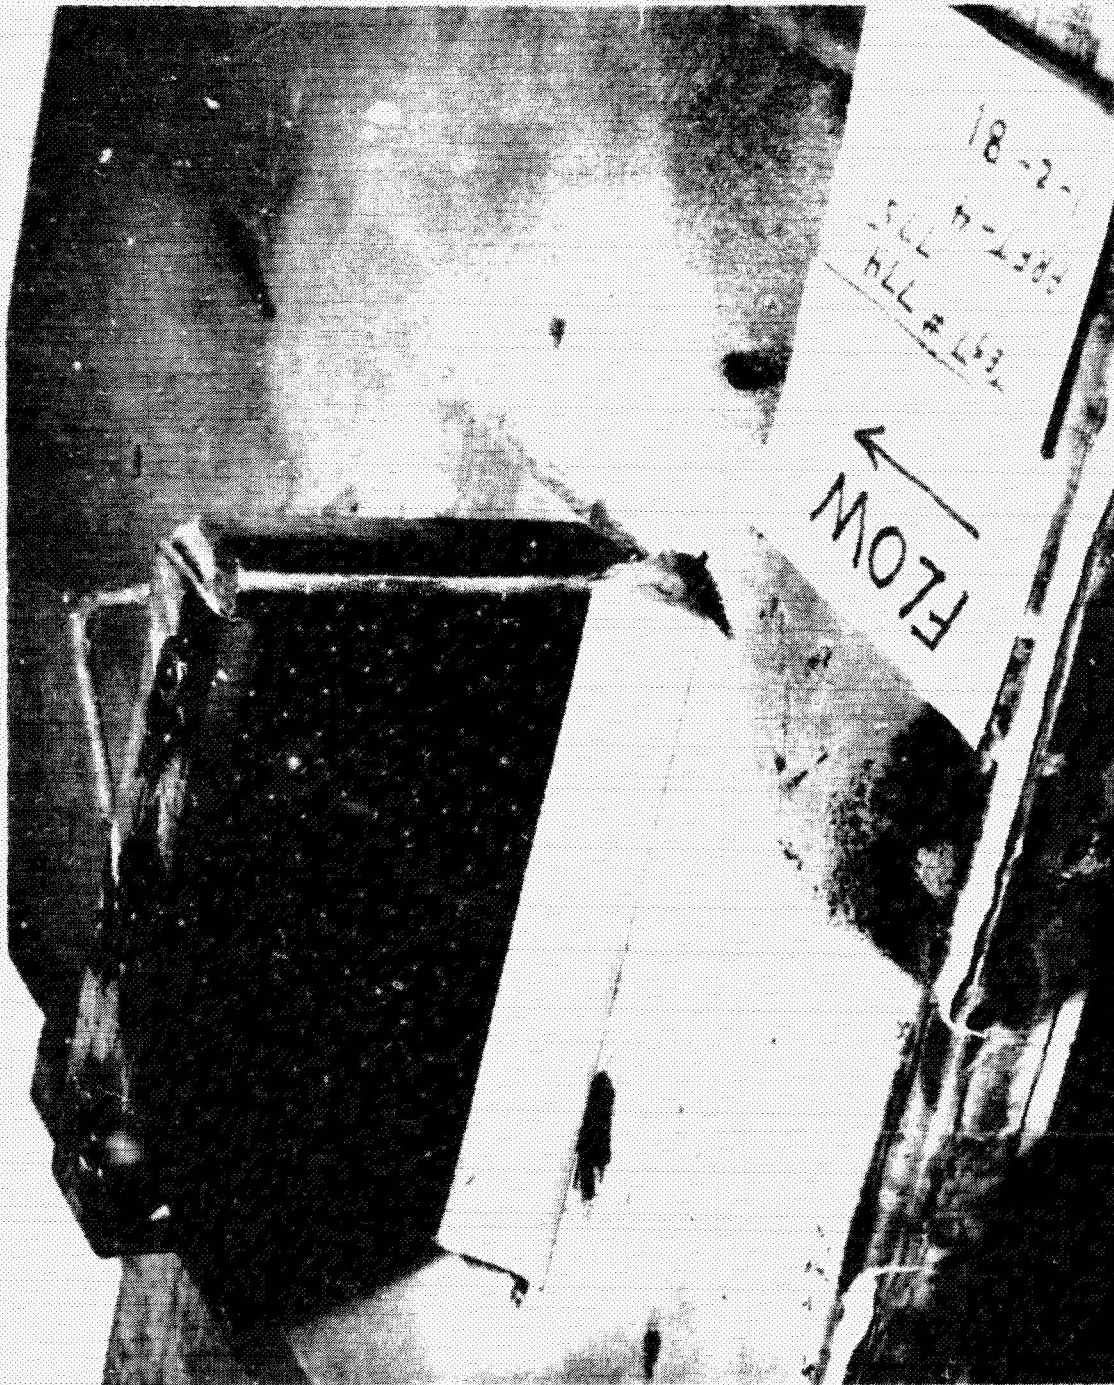
Fig. 7 - Test Fixture Mounted at 90 deg to Flow to Reduce Shear Environment on Rubber Seal

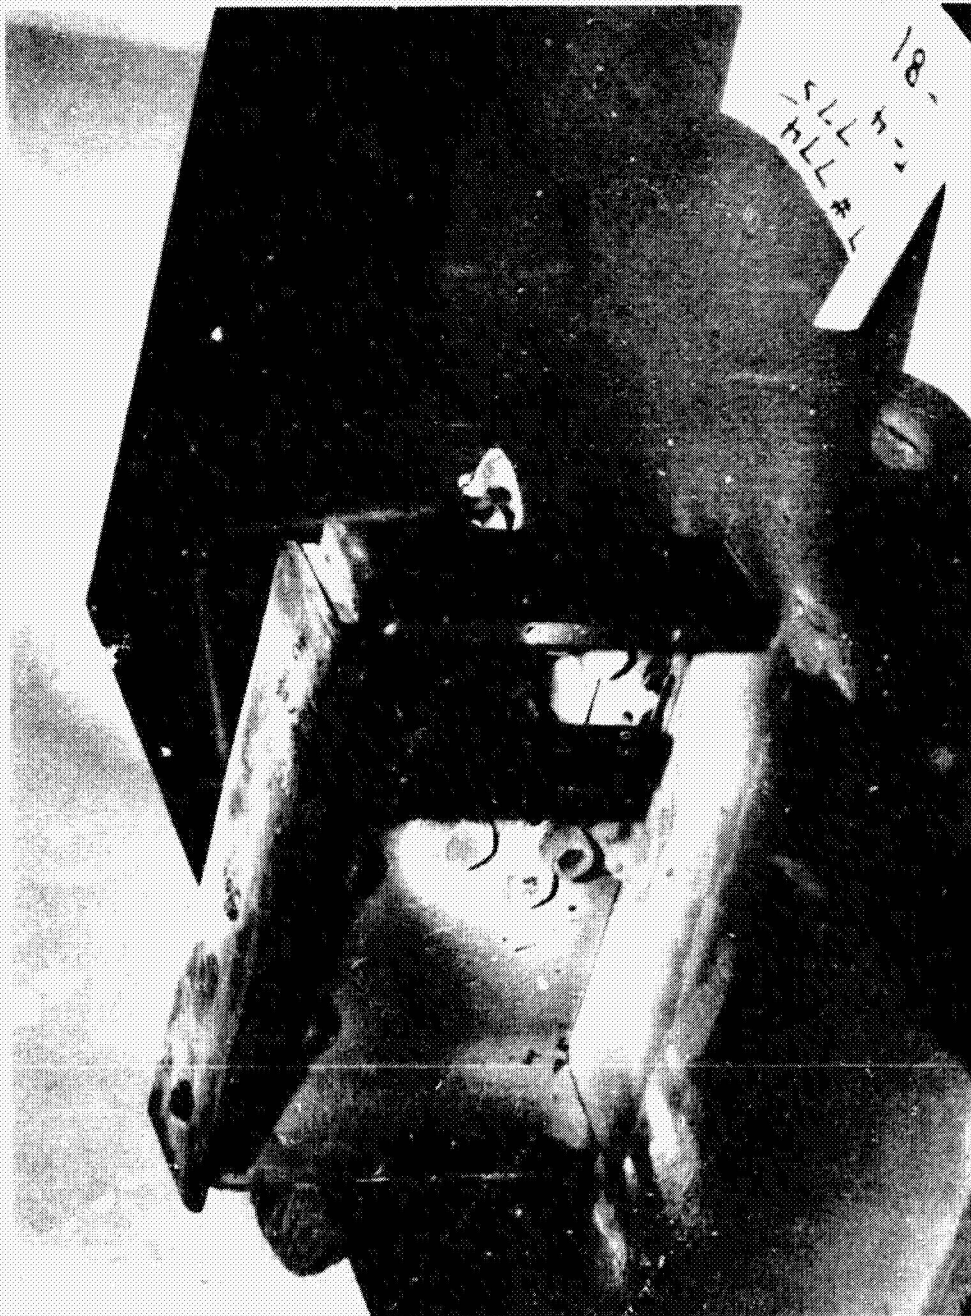
Fig. 8 - This Orientation of the Test Fixture Stagnated the Flow, Produced Severe Heating Along the Top Edge and Failed the Phenolic TPS

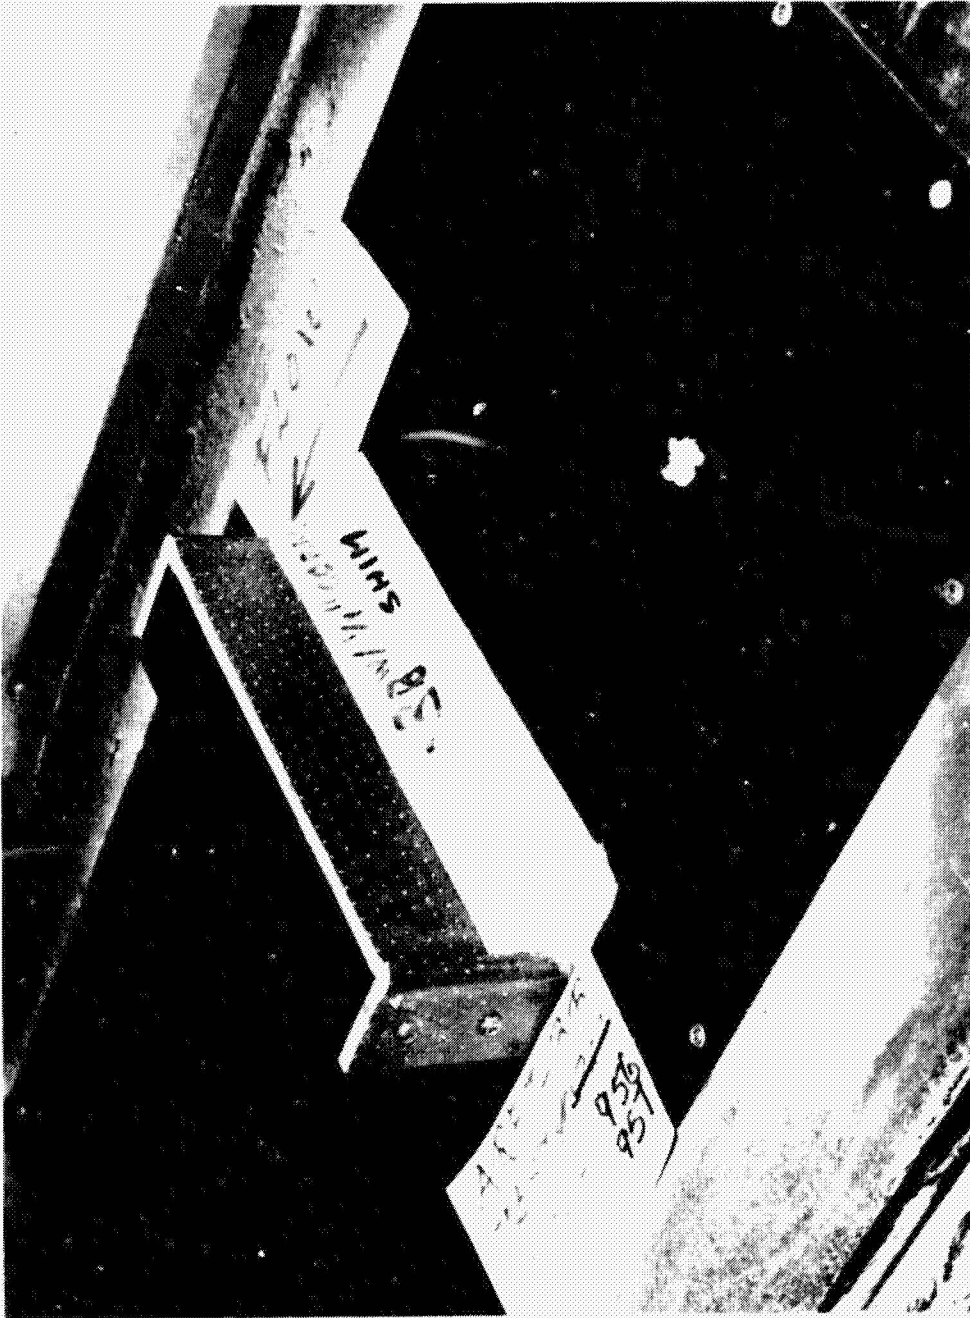
The series of tests to evaluate the performance of the seals was started with the small fishtail seal bonded to the phenolic in the standard usual way, i.e., at the back and bottom of the seal groove. The gap left under the phenolic was 0.60 in. and a 0.25 in. thick shim of cork was placed under the seal to provide the designed compression (see Fig. 12). This configuration proved adequate as seen by the performance of the seal which has eroded fairly uniformly in Fig. 13. Figs. 14 and 15 are for the repeat test of this configuration and here the seal is seen to be affected a little more. A cavity pressure pickup was installed beginning this test and the pressure held in the first 55 sec test indicating that the seal performed well at least for half of the required heat load.

Fig. 12 - Small Fishtail Seal Bonded to Phenolic TPS With 0.60 in. Gap Under it. A 0.25 in. Thick Cork Shim is Seen Placed Under the Seal to Provide Necessary Compression for Sealing

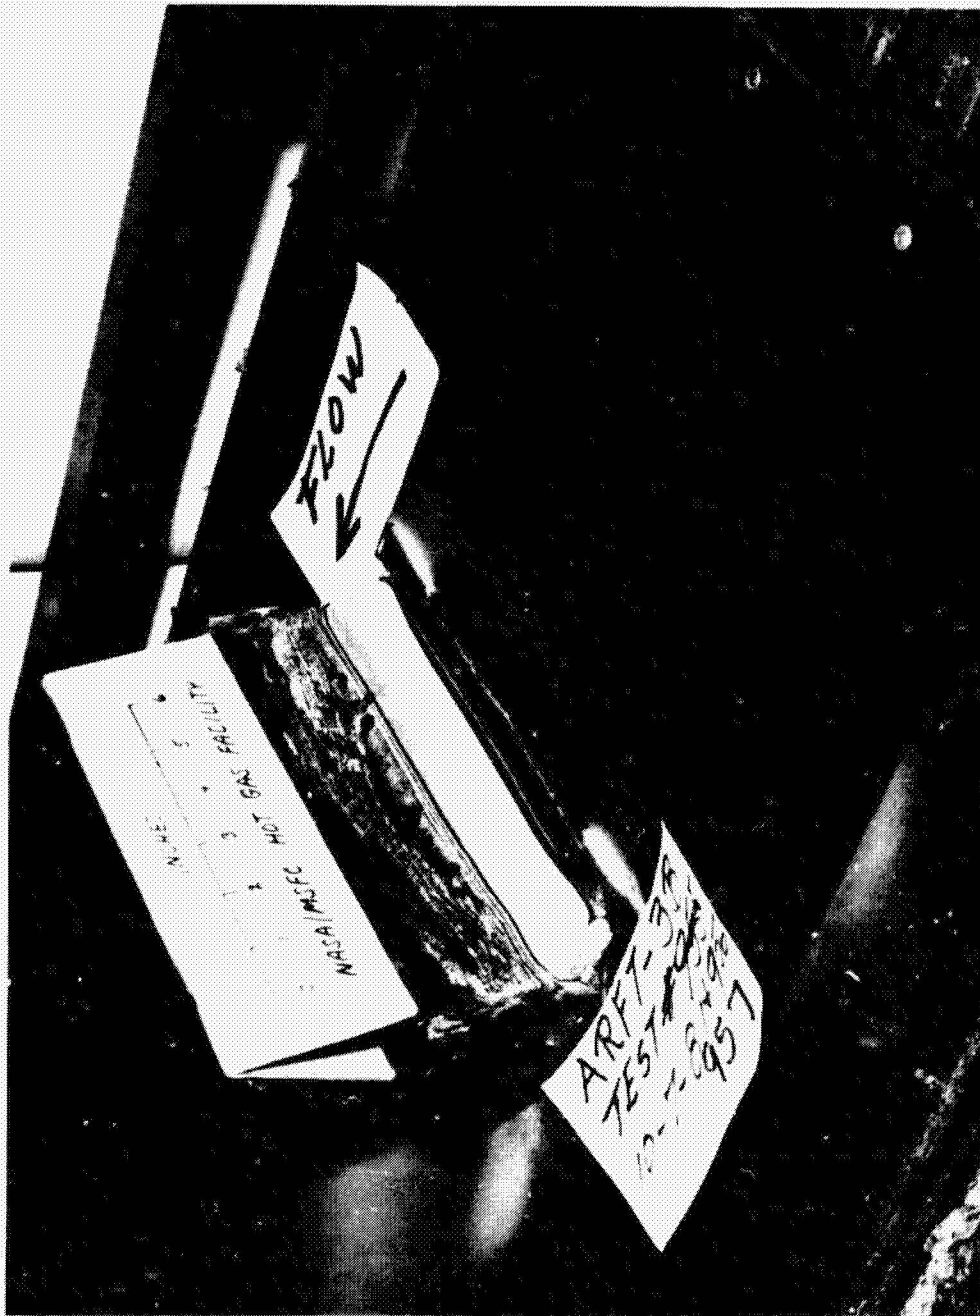
Fig. 13 - Phenolic TPS Burned Through But Seal Looks Good

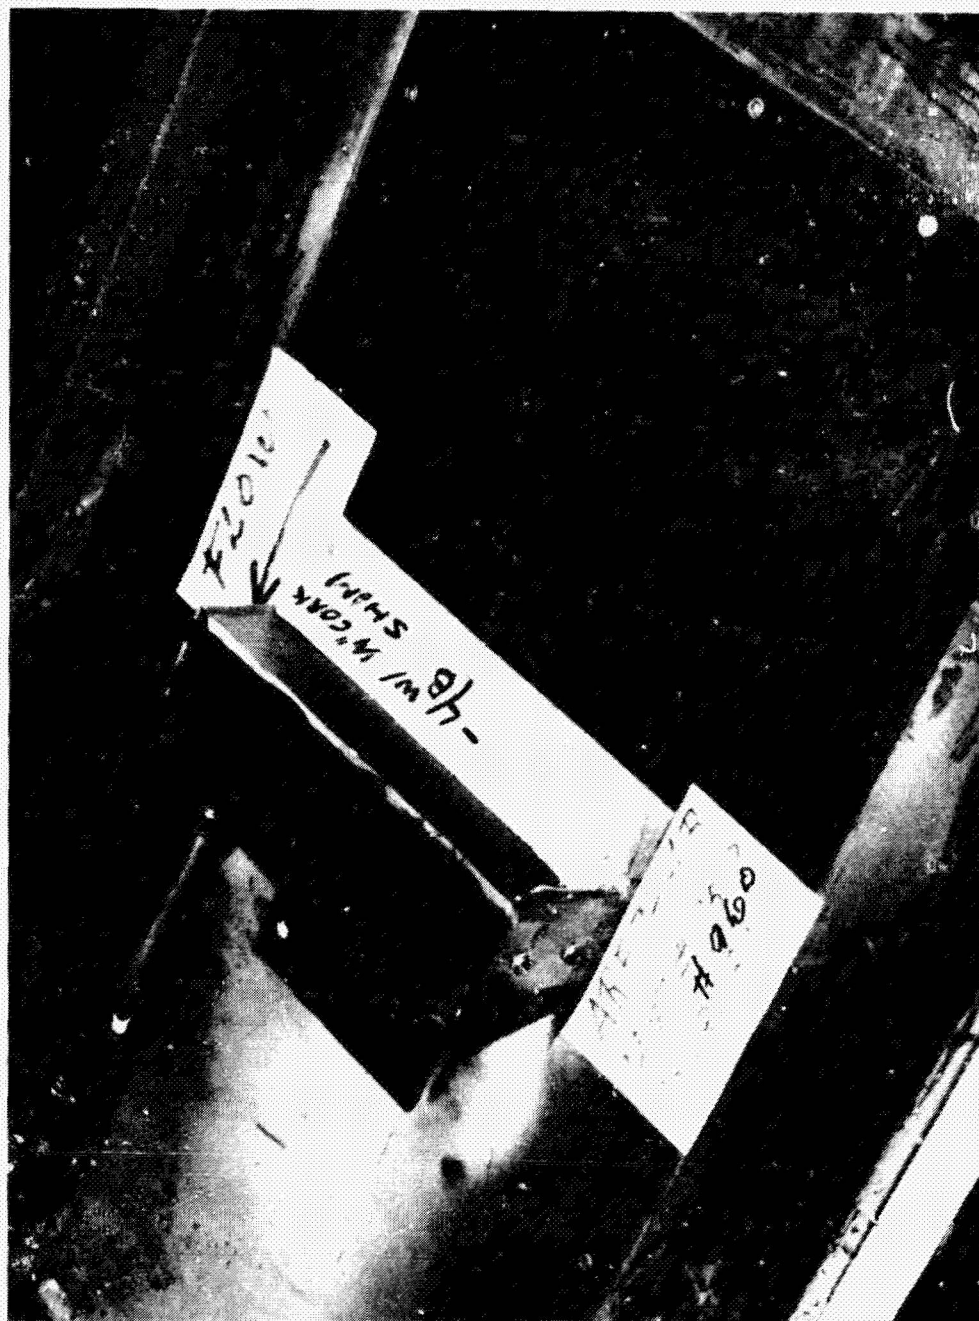
Fig. 14 - Repeat of Test of Fig. 12.

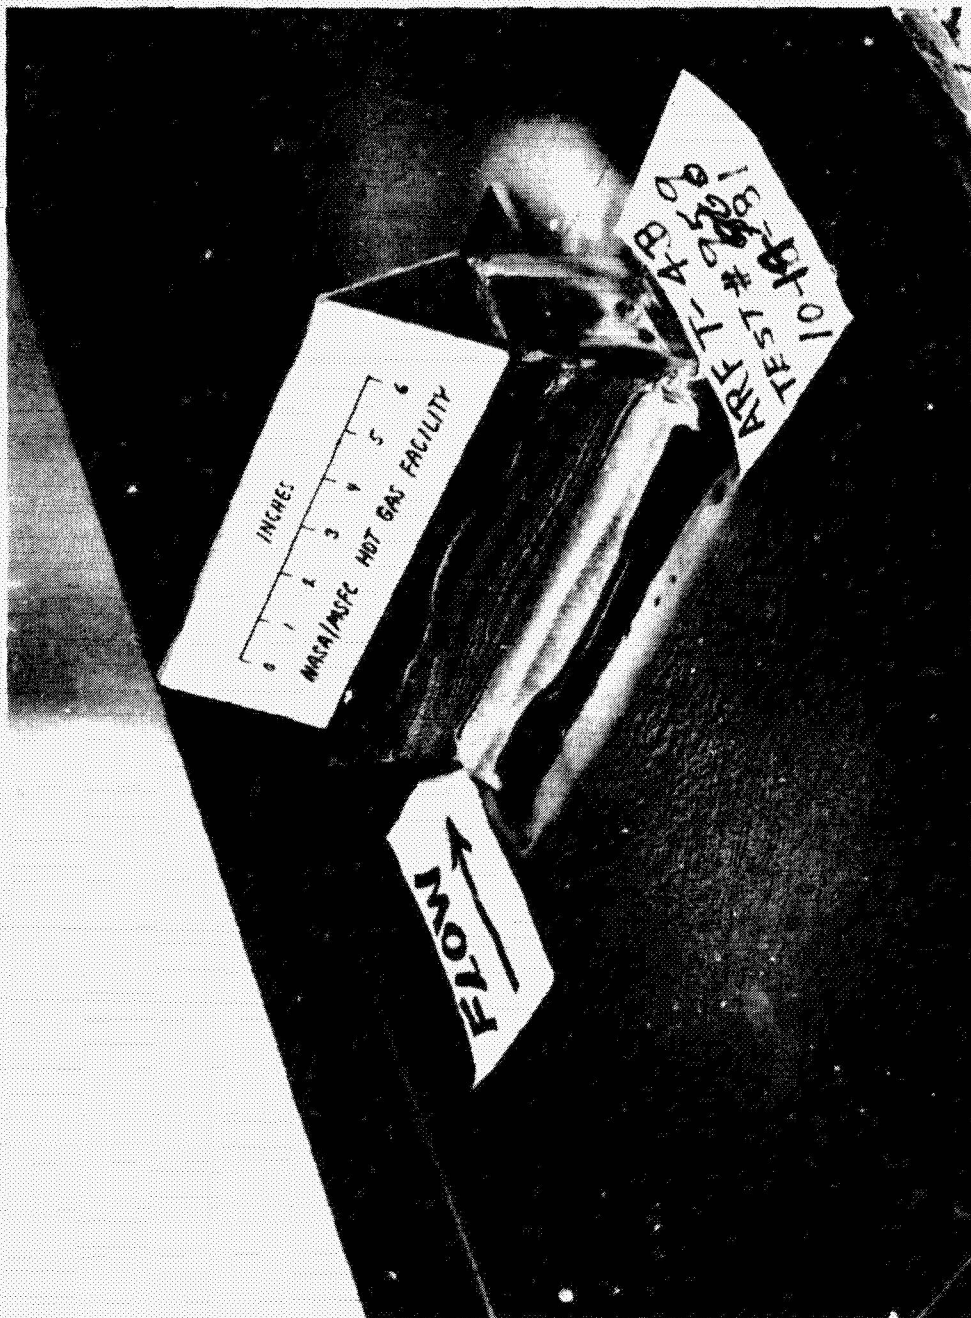
Fig. 15 - Phenolic and Seal Performance in This Test Was Similar to That of Fig. 13

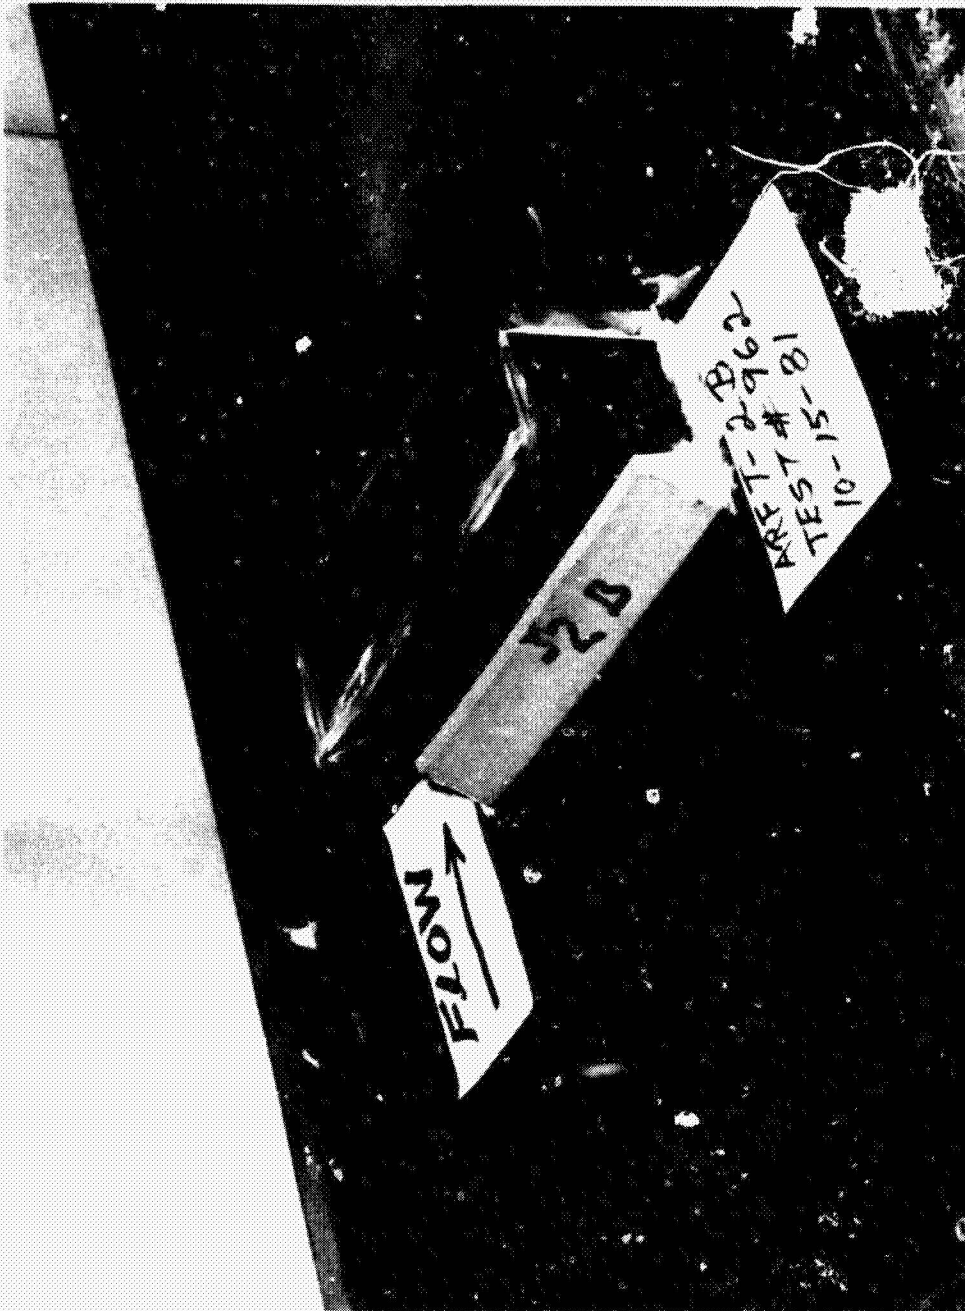
Figures 16 and 17 represent an identical test setup except for the cork shim which is left out to see if the seal would perform or not. Movies indicated that the seal was very weak and could not stay firmly on the bottom surface, allowing flow to get under it till it finally broke in the middle of the second 55 sec test. This configuration without the cork shim is not adequate as indicated by the broken seal of the repeat test also, shown in Figs. 18 and 19.

Fig. 16 - Small Fish-tail Seal With 0.60 in. Gap Under Phenolic But Without the Cork Shim to Provide Required Compression of Seal

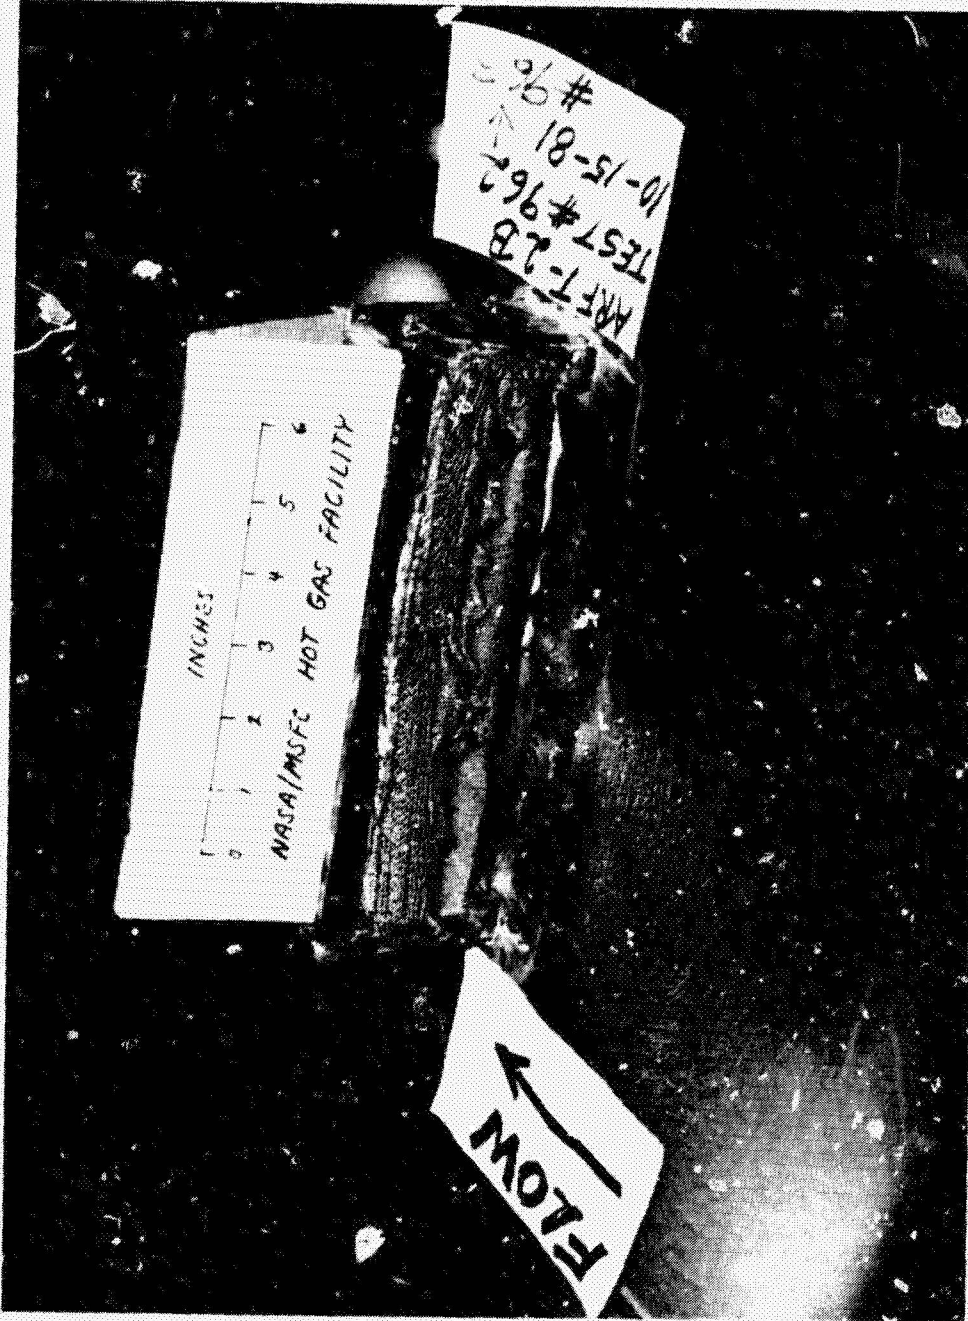
Fig. 17 - Seal Did Not Survive Test Since It Did Not Have Sufficient
Compression to Be Held Down Firmly Against Bottom Plate

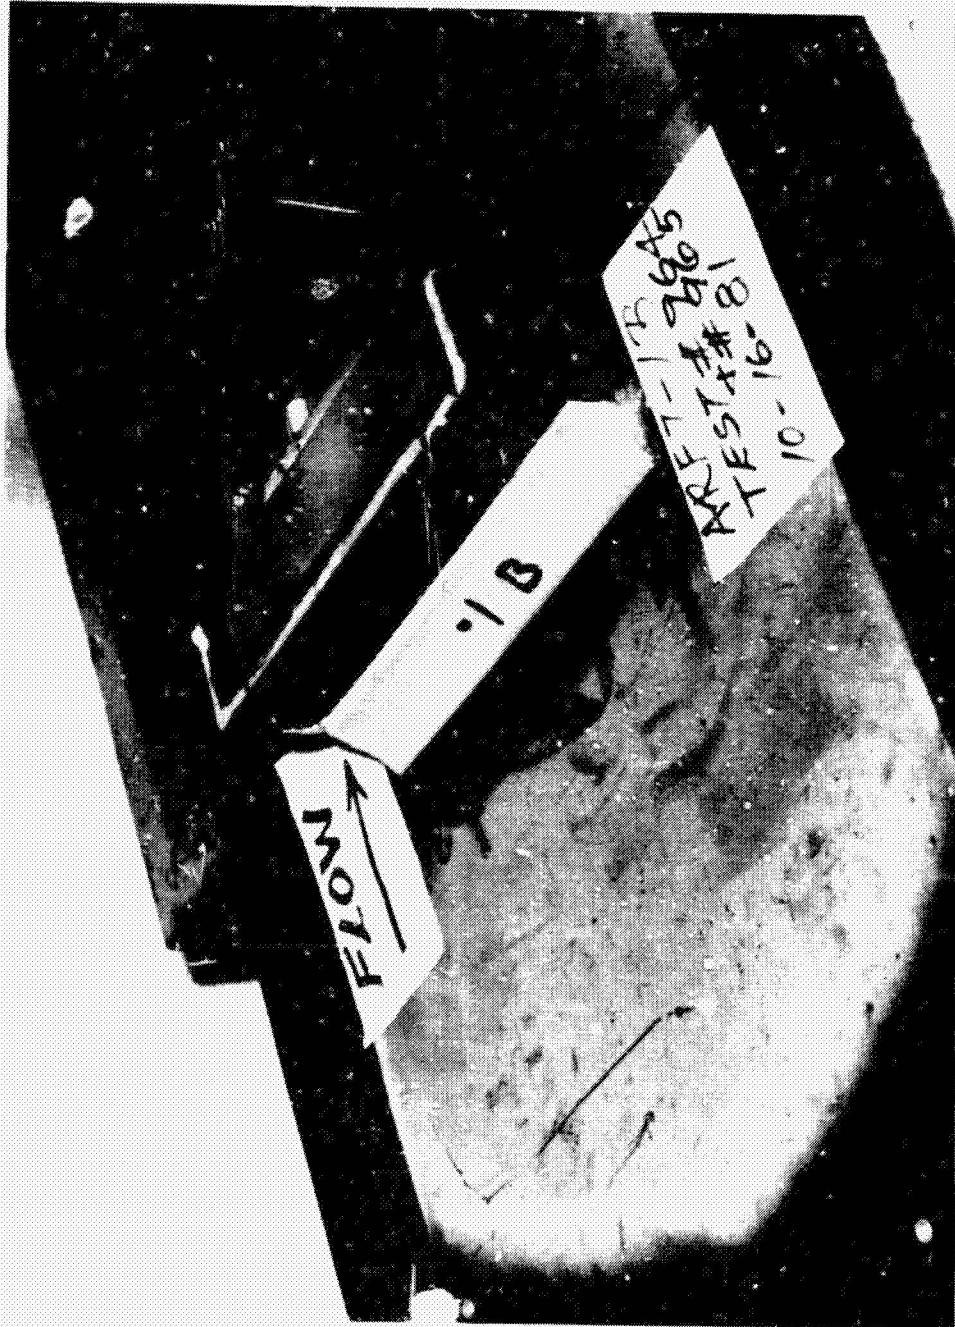
Fig. 18 - Repeat Test on Model Similar to That Shown in Fig. 16

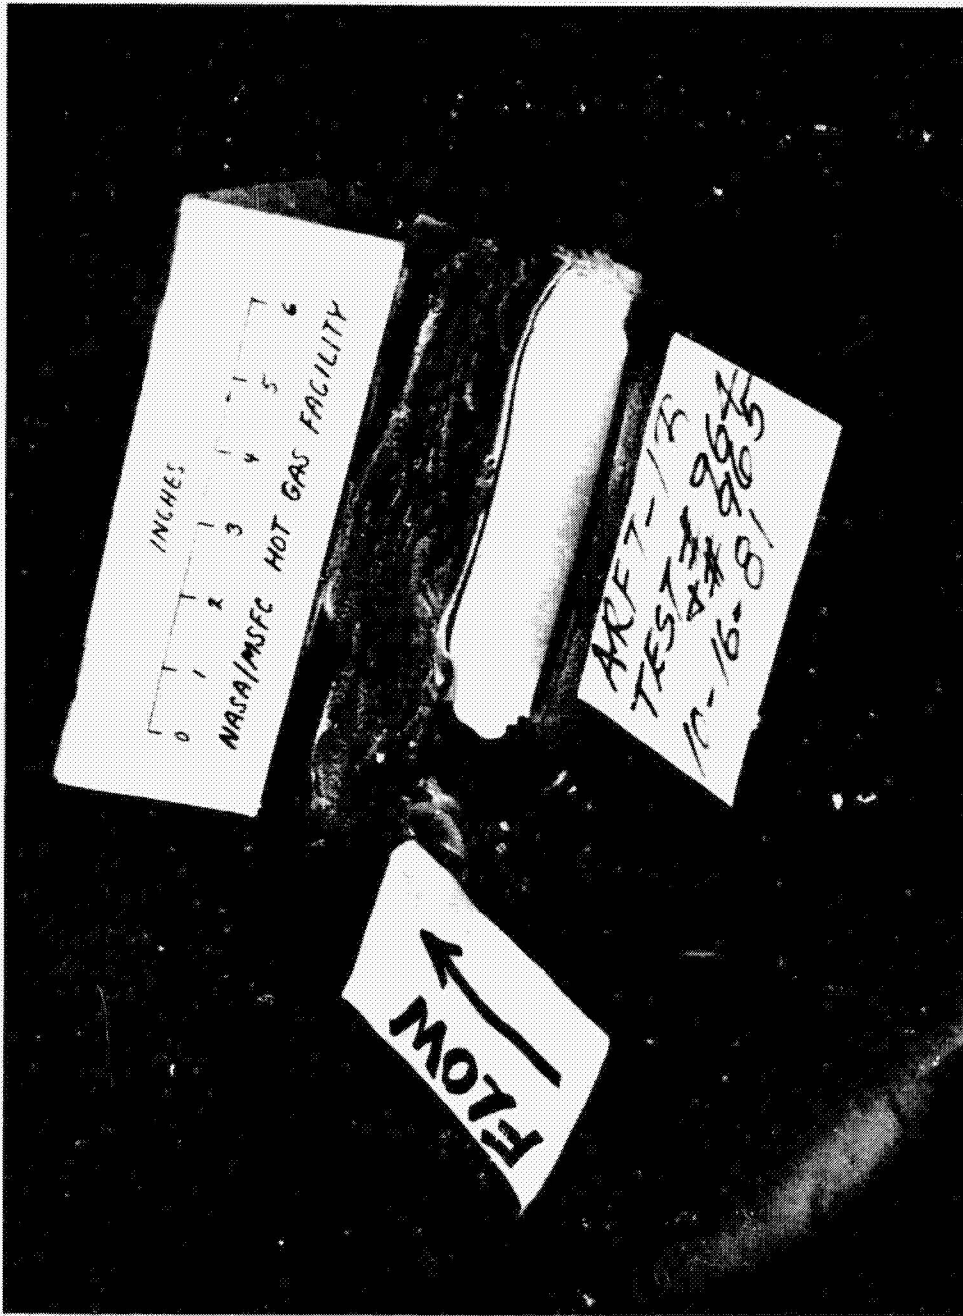
Fig. 19 - Though The Seal Has Not Been Completely Lost, It Has Nevertheless Failed Due to Lack of Sufficient Compression to Give It Strength

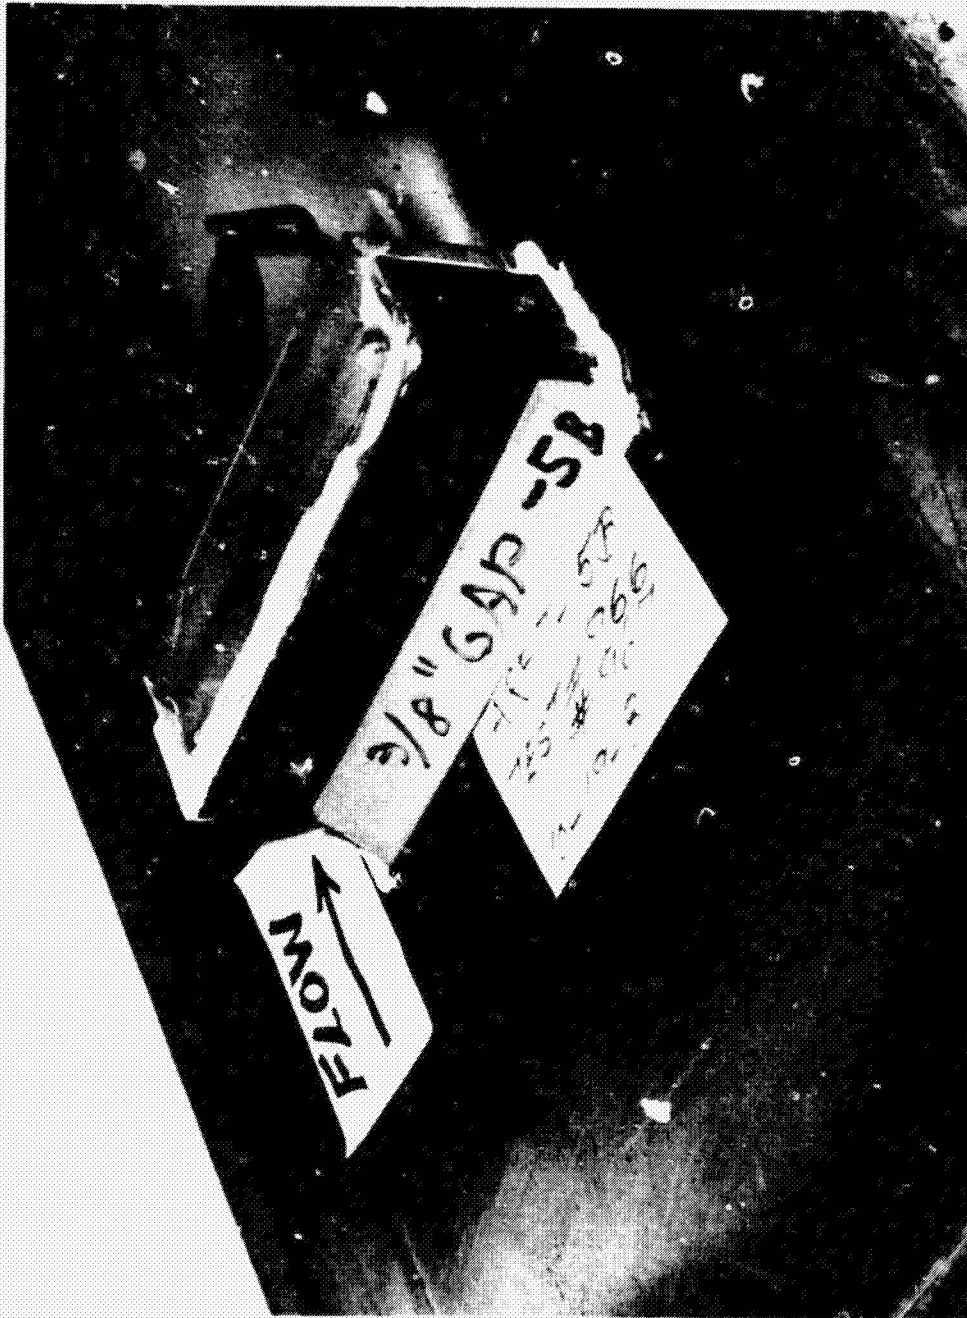
Figures 20 and 21 are for the seal test of the original design configuration with 0.375 in. gap under phenolic. As per design requirements, the seal performed well. The cavity pressure held until about 45 sec into the first test. This type configuration was not repeated.

Fig. 20 - Small Fishtail Seal with 0.375 in. Gap Under Phenolic. (The Seal is Designed for This Nominal Gap)
