LMSC-HREC TM D784769

SRB ATTACH RING PHENOLIC
TPS FISHTAIL SEAL EVALUATION
TESTS

February 1982

Contract NAS8-32982

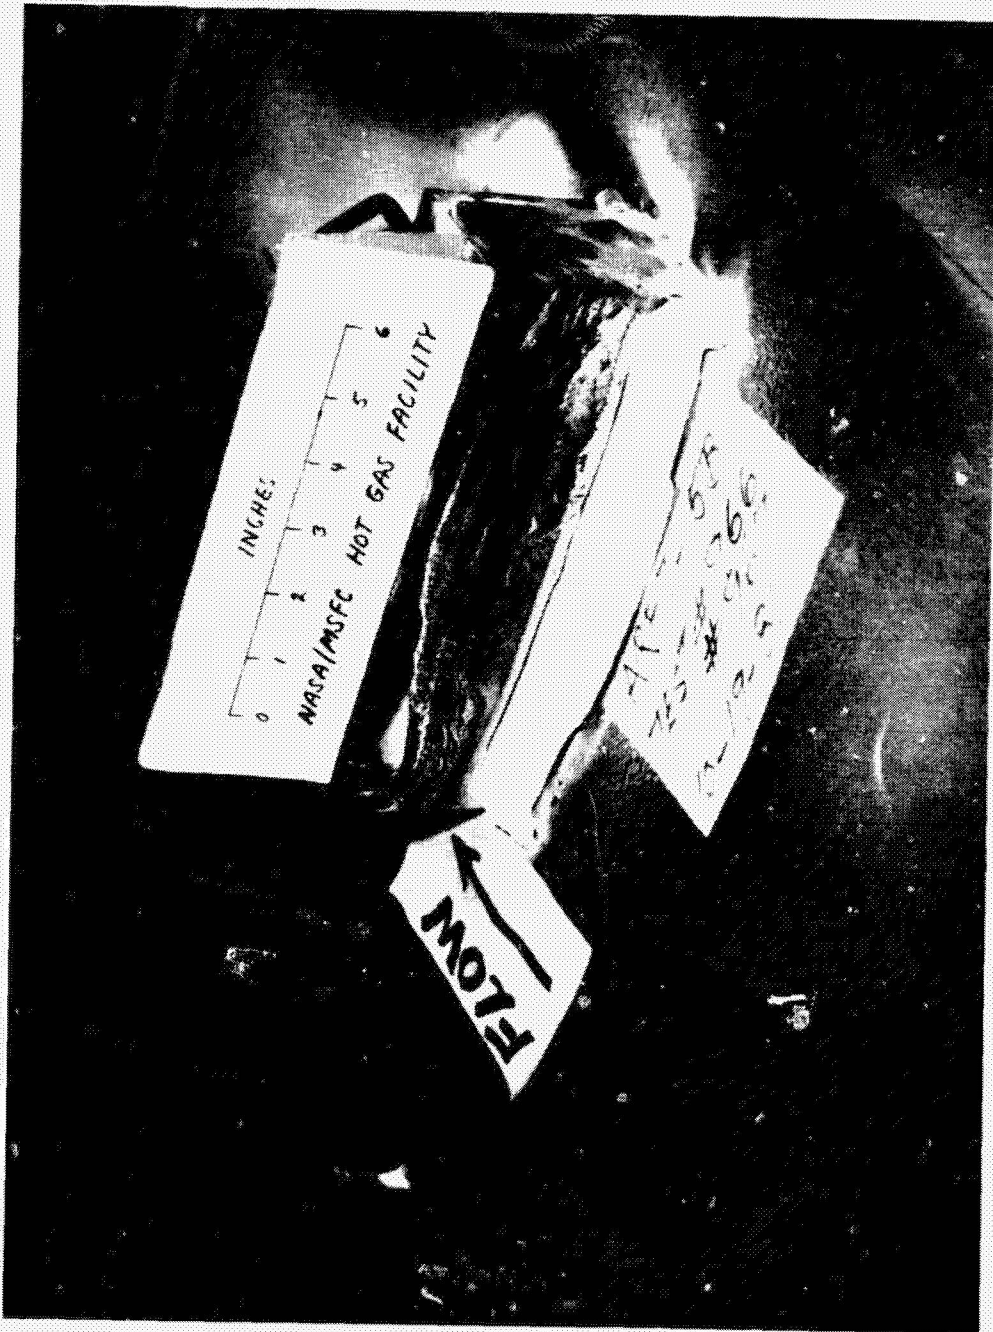
Fig. 21 - Though the Phenolic Has Burned Through at the Top, the Seal Has Performed Adequately

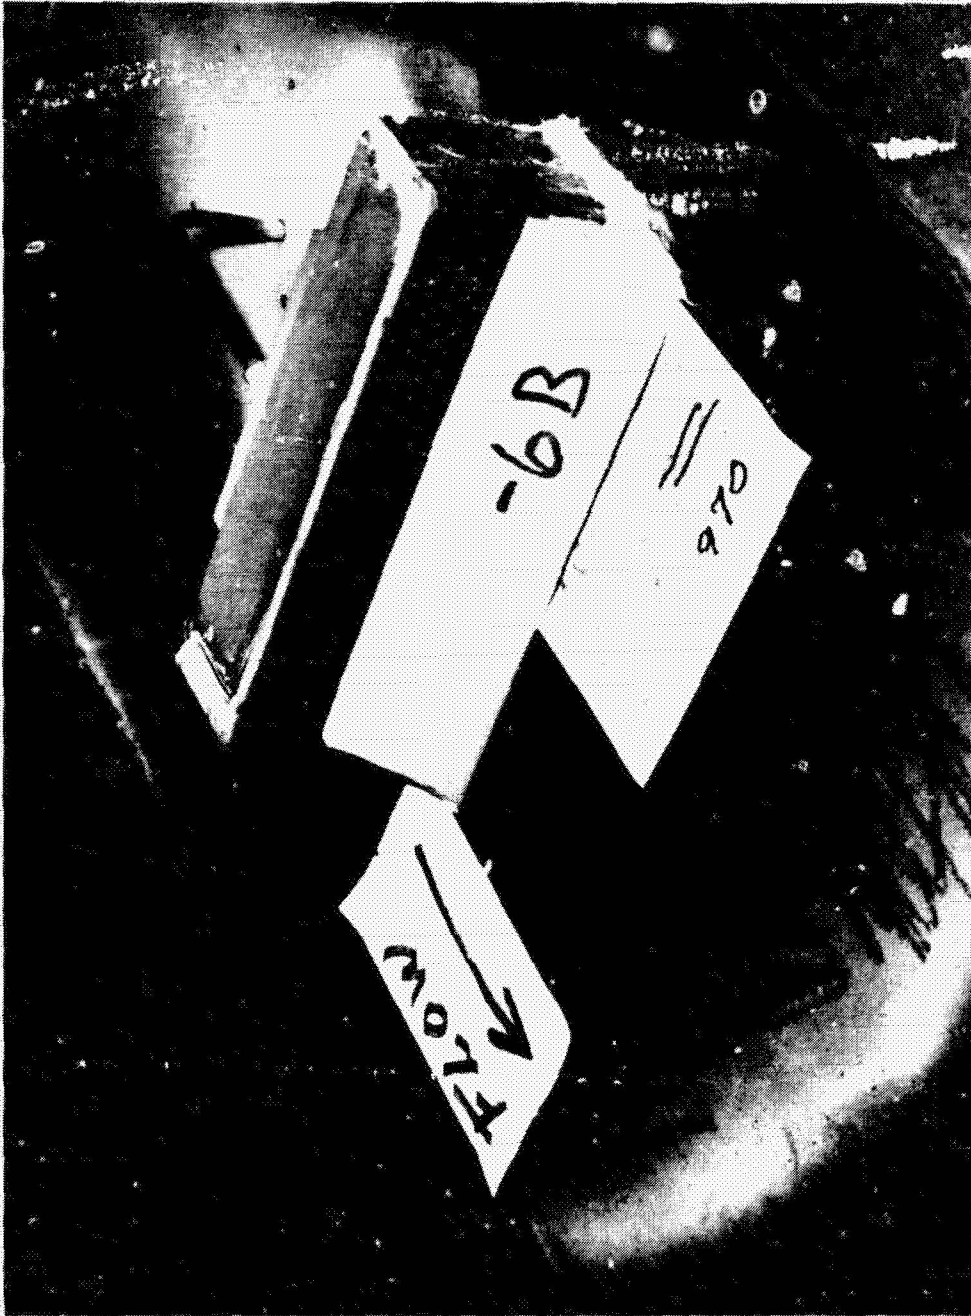
The harder (Class3/grade 50) silicone material "large" fishtail seal was tested next. The large fishtail seal was made so that it could fit firmly under the maximum gap of 0.60 in. under the phenolic TPS as shown in Fig. 22. About

Fig. 22 - Large Fishtail Seal Was Designed to Cover the 0.60 in. Gap Under the Iolic TPS Without Need of Installing a Cork Shim Under It. In This Model the Seal is of The Type Class 3/Grade 50 Which is Harder of the Two Types Evaluated

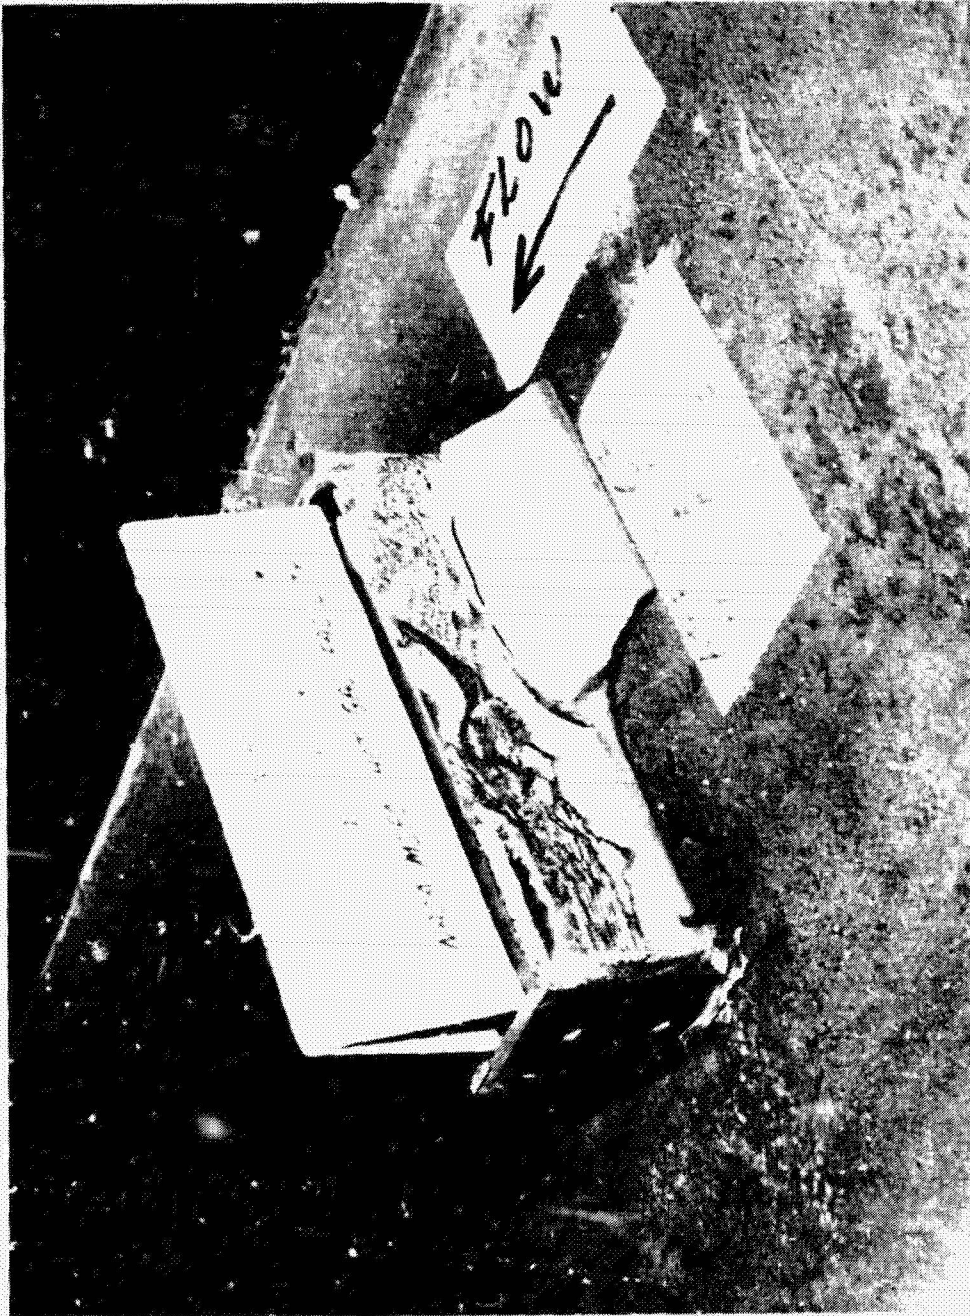
50% of the front half of the seal was lost during the second exposure to the flow (Fig. 23). The first exposure had lasted only 29.62 sec due to facility problems. It is not known why the large chunk of seal was lost on this model. The repeat run of Figs. 24 and 25 was to throw more light on this problem. During the repeat test, the seal performed very well with the cavity pressure holding throughout the first run of 55 sec.

Although the large seal of Figure 23 failed during its second exposure, it was decided that this seal was acceptable because it performed well during the repeat test.

Fig. 23 - Front Half of the Seal Was Lost Near the End of Test

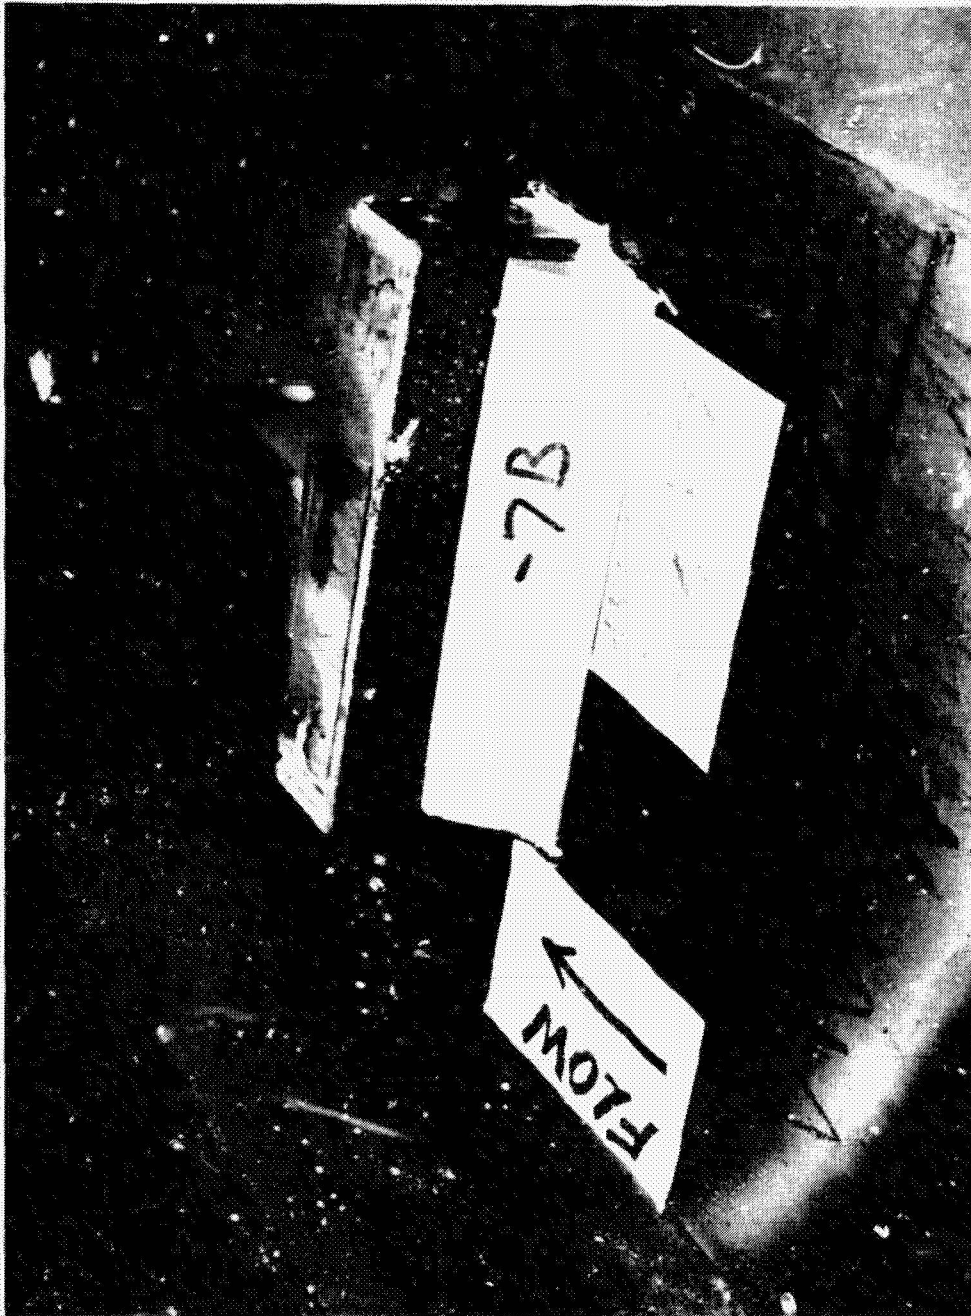
Fig. 24 - Repeat Test of Seal Configuration and Material Hardness of That Shown in Fig. 22

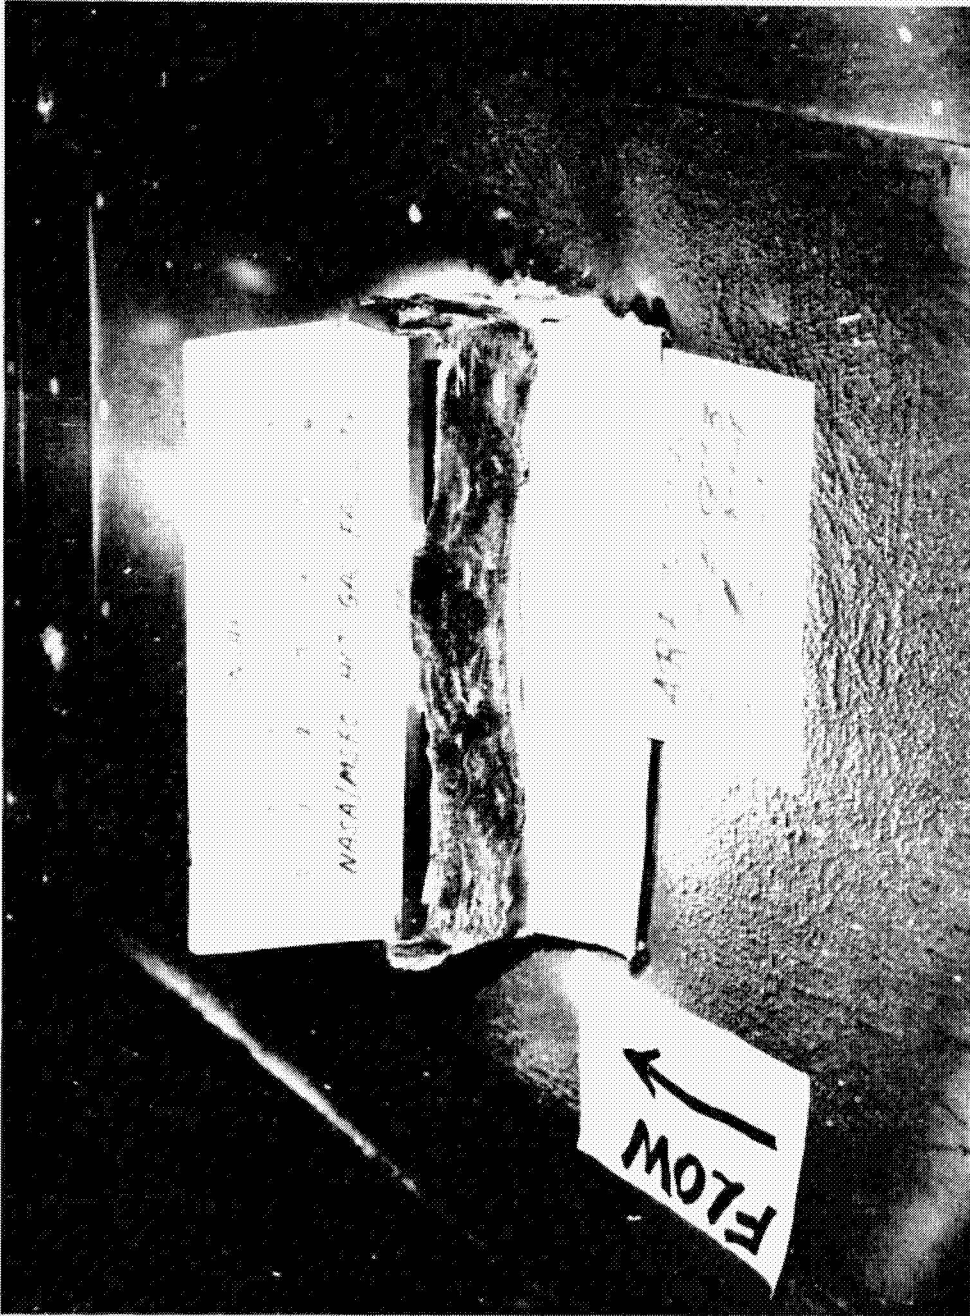
Fig. 25 - Seal Performed Well Unlike the Previous Identical Type Shown in Fig. 23

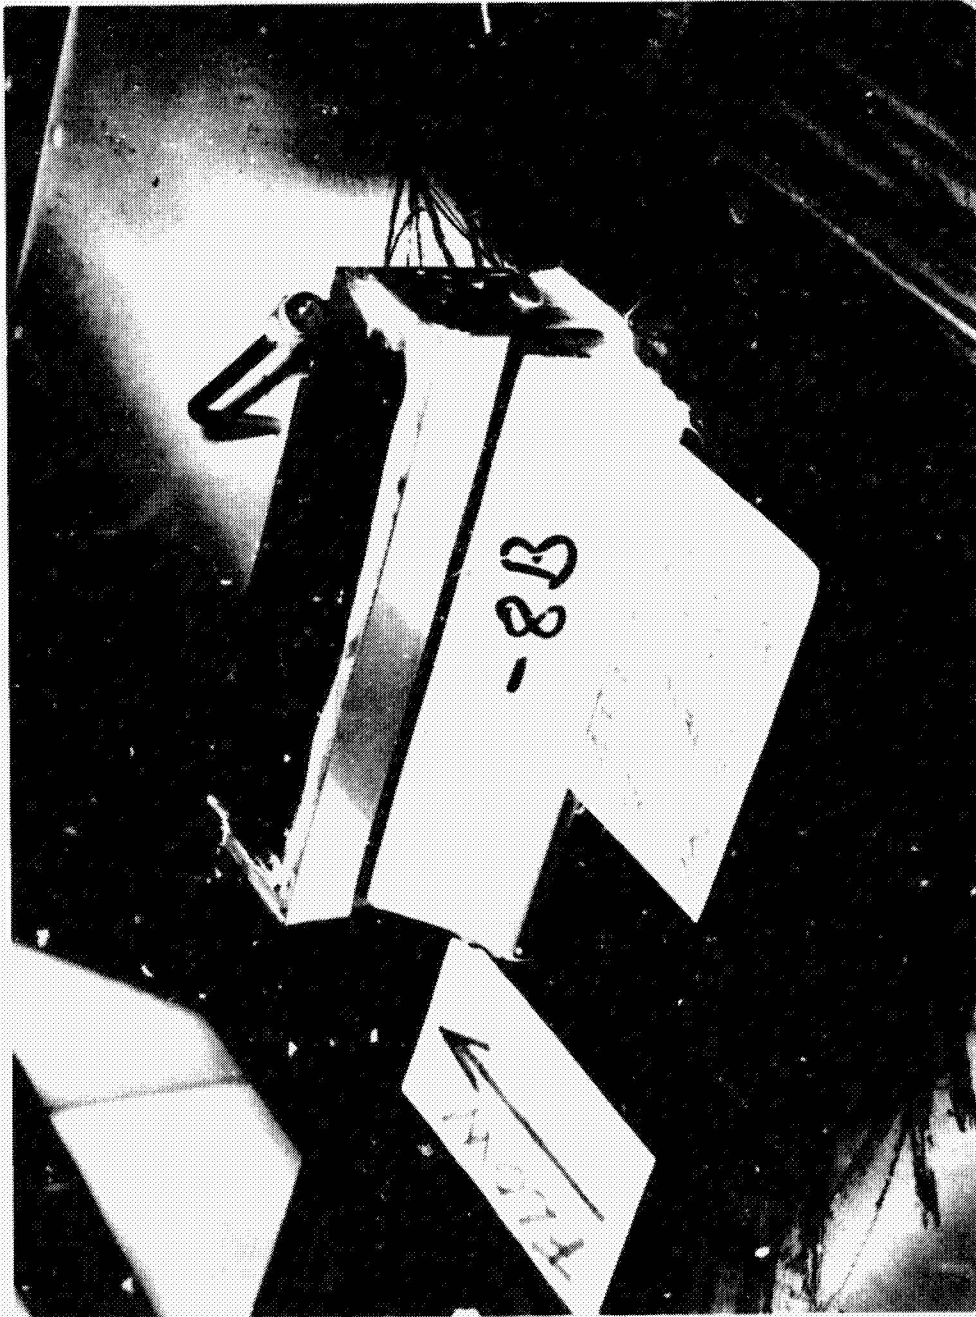
The other hardness type (Class 2B/grade 40), which is less hard, of silicone rubber large seal was tested. To prevent the phenolic TPS from burning through at the top of the model, a protective steel strip was installed over the phenolic upper edge as seen in Fig. 26. This protection helped the phenolic TPS stay together (Fig. 27) and hence the cavity pressure held up throughout both the runs indicating a perfect function of the seal. The repeat run of Figs. 28 and 29 performed identically.

Fig. 26 - Seal Configuration Identical to Previous Large Fishtail Seal Tests
Except the Seal Material Was of Class 2B/Grade 40. (Note Protective
Steel Strip Along Top Edge of the Phenolic).

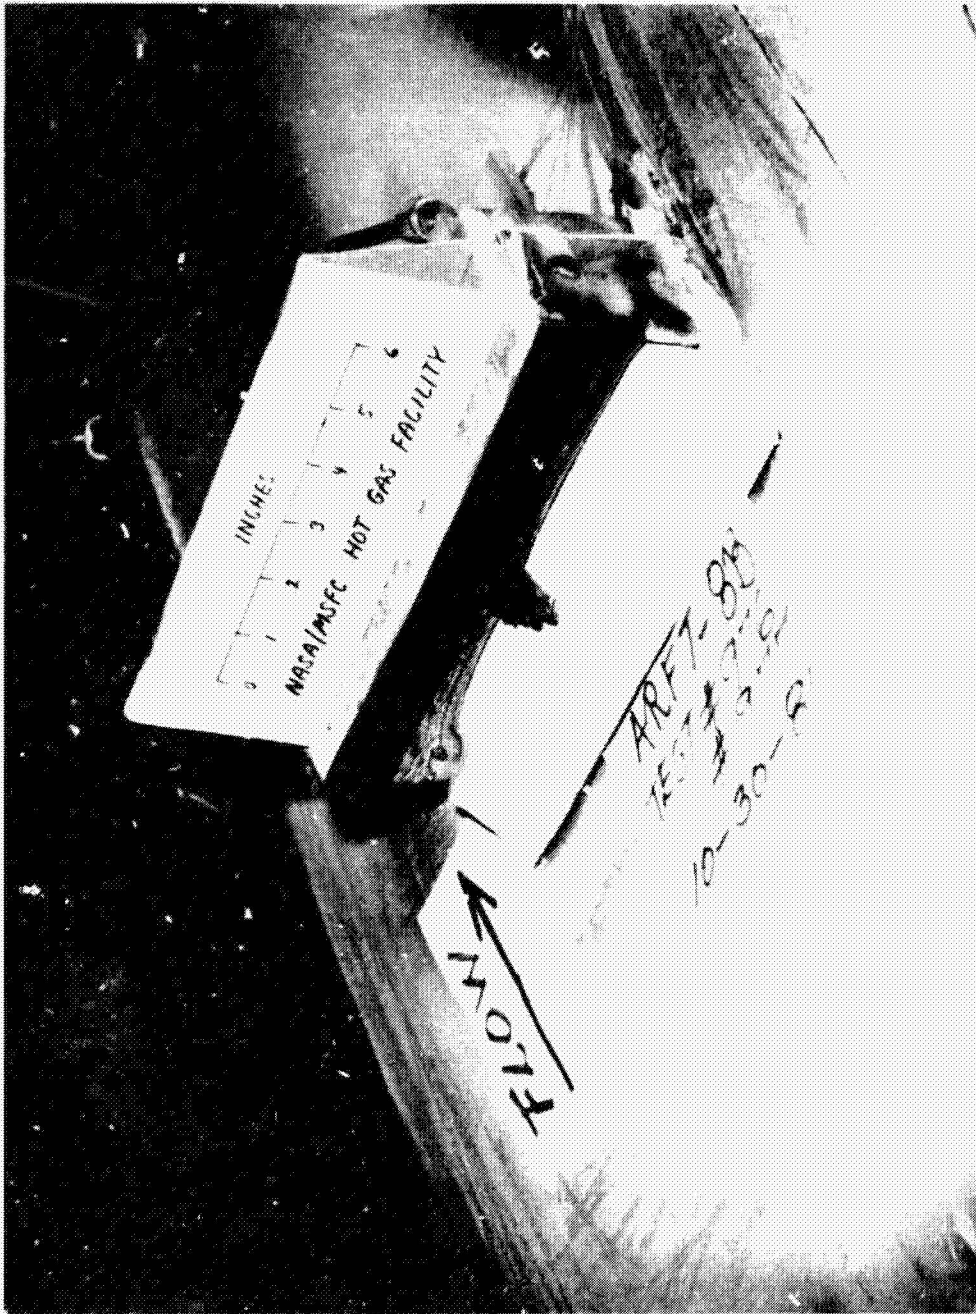
Fig. 27 - Seal Performed Well and Due to the Protective Strip on the Phenolic, Model Cavity Pressure Held Up

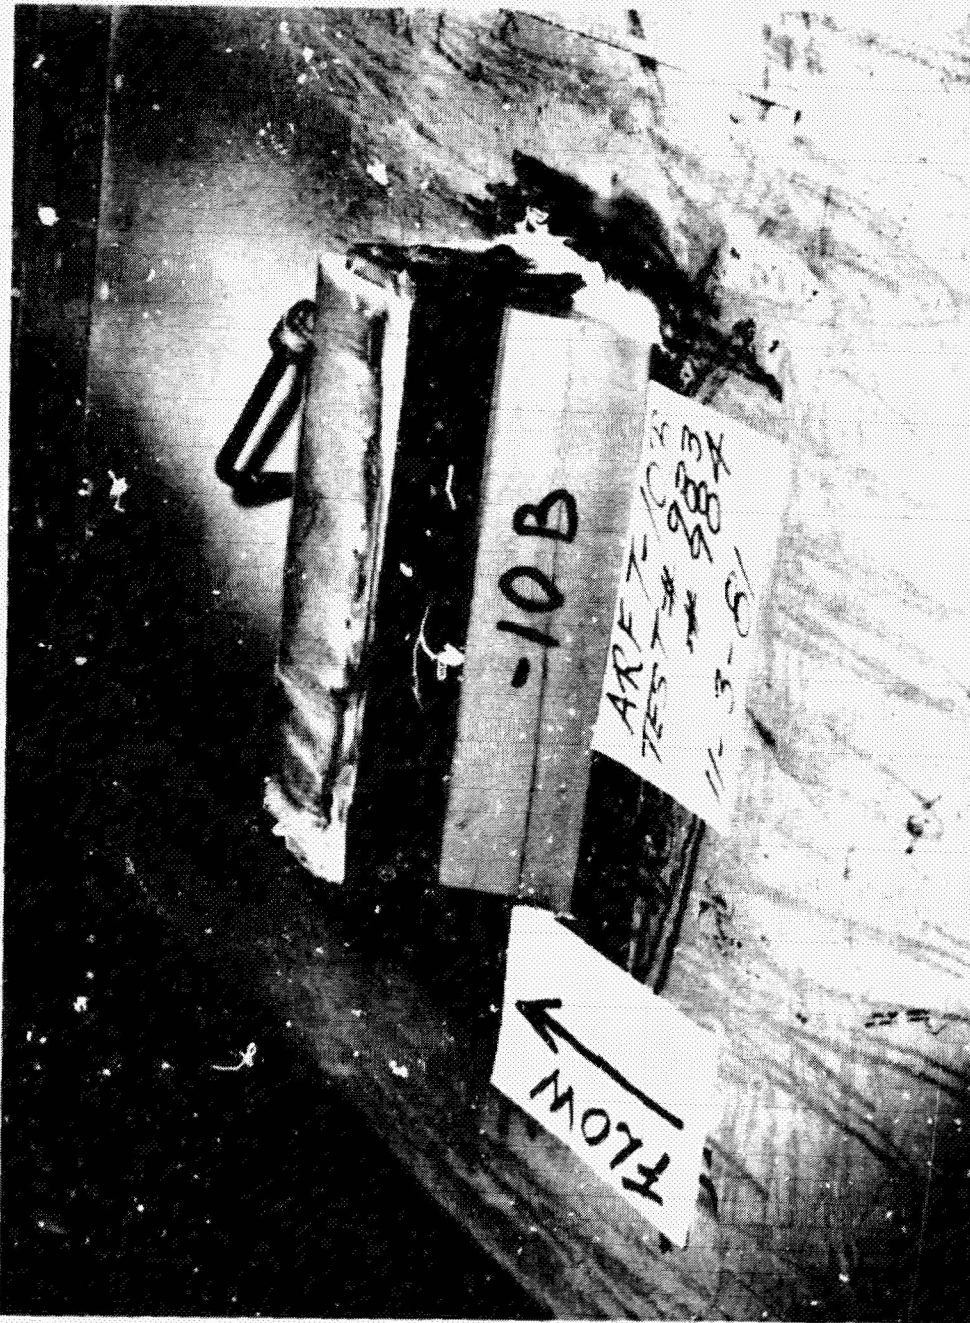
The test setup for the next model (Fig. 30) is similar to the previous one except that the seal is bonded to the phenolic at the front of the seal groove also. The seal is of the harder (Class 3/grade 50) of the two types under evaluation. The seal performed very well once again with no gain of cavity pressure (see Fig. 31). For the repeat test, the steel protection strip lining the top edge of the phenolic TPS was omitted (Fig. 32) because it was necessary to observe what would happen to the seal when the phenolic, which is bonded to the seal at front, charred and delaminated. The performance was not any different from before as seen in Fig. 33 except cavity pressure change was indicated as expected due to phenolic upper edge burn-through.

Fig. 30 - Seal (Material Type Class3/Grade 50) is Bonded to the Phenolic at Front of Seal Groove Also in This Test

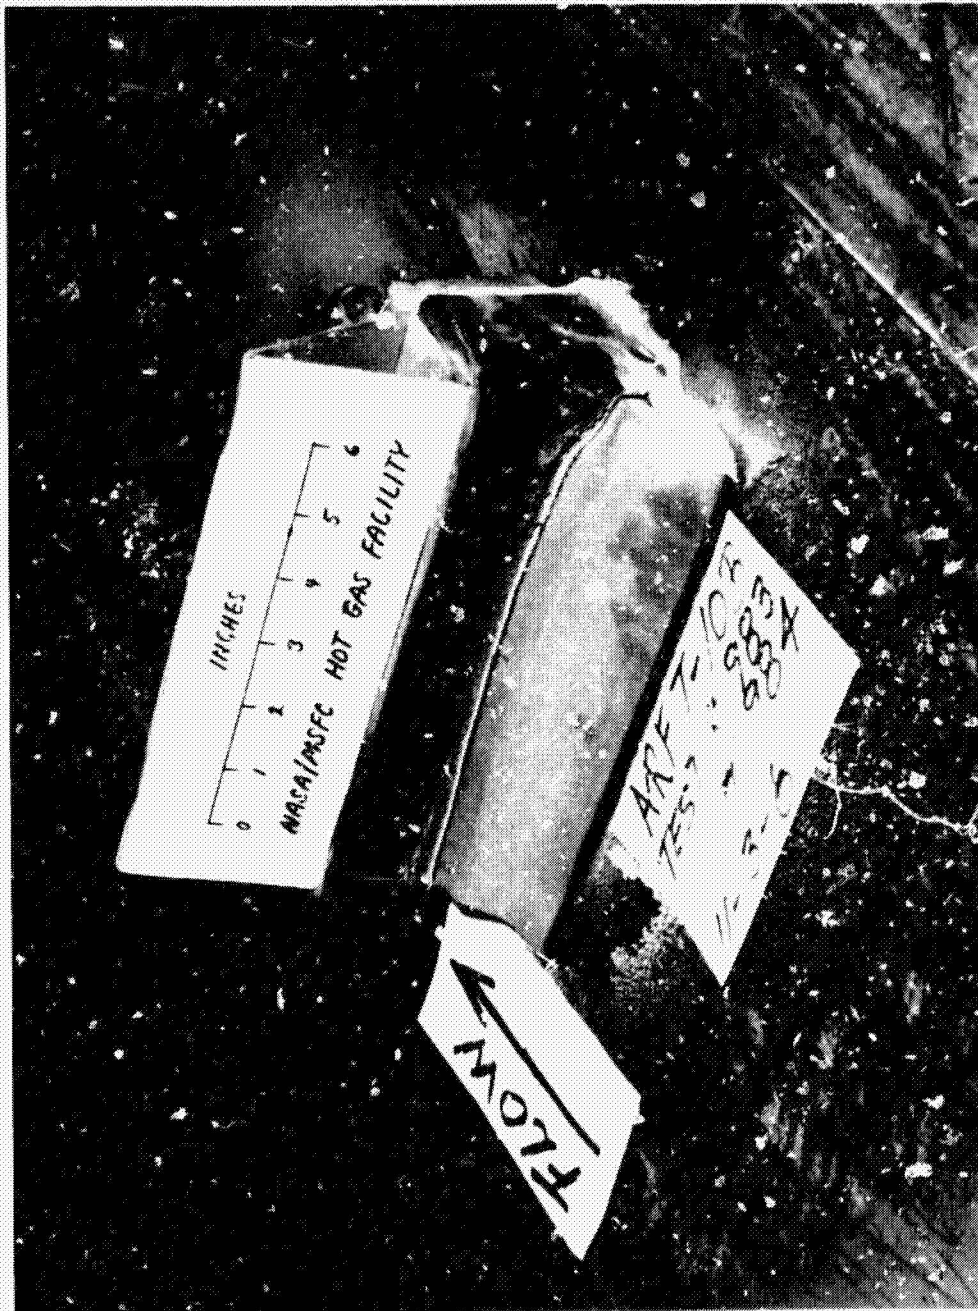
Fig. 31 - Seal Performance Identical to Its Performance When Seal Not Bonded to the Phenolic at the Front of Seal Groove

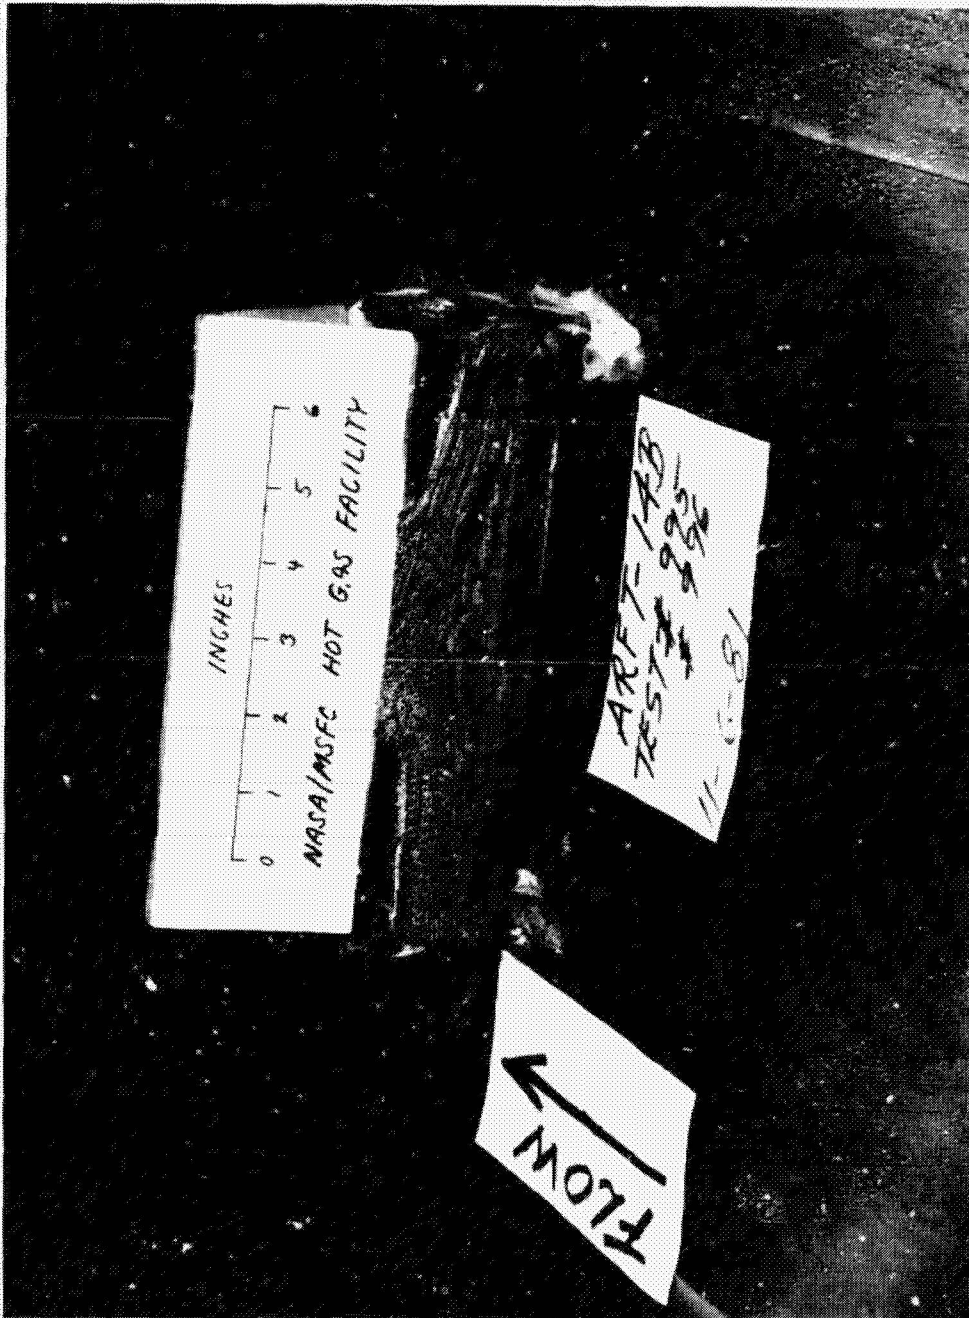
Lastly, a run was made with the small fishtail seal which had not been tested earlier with the seal bonded to phenolic at the front of the seal groove. The gap under the phenolic was 0.60 in. and there was no cork shim under the seal. Because of the lack of the cork shim, the seal did not survive (see Fig. 38) as in the similar tests of Figs. 16 through 19.

Fig. 38 - Post-Test Photograph of Small Fishtail Seal with 0.60 in. Gap Under Phenolic and Seal Bonded to the Phenolic at Front of Seal Groove Also. As in Tests of Figs. 16 and 17, the Seal Did Not Have Sufficient Compression to Provide Strength Necessary to Withstand Aerodynamic Forces.
