## NICKEL-HYDROGEN CELL TEST PROGRAM SUMMARY

Vernon C. Mueller

McDonnell Douglas Astronautics Company - St. Louis Division

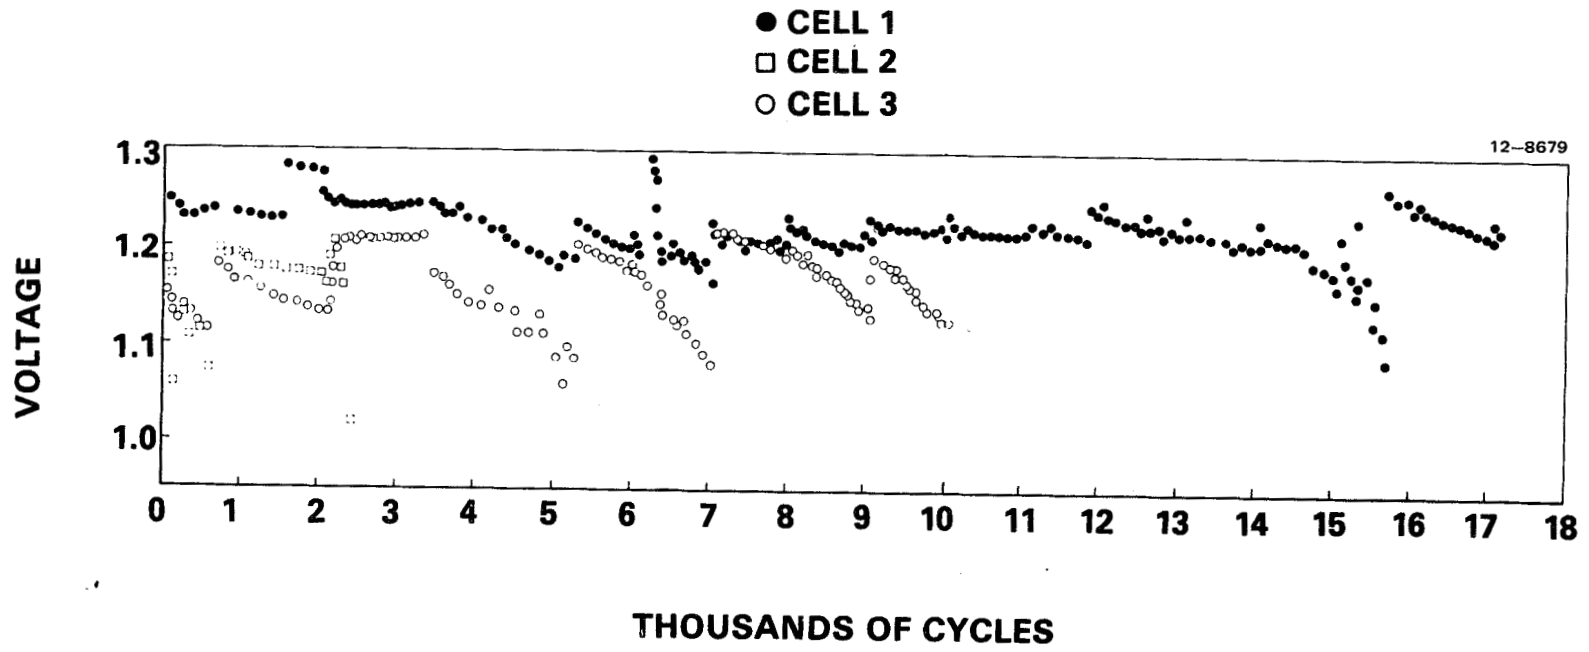
Figure 4. Cell End-of-Discharge Voltage versus Cycles

Cycling test trend data is shown in Figures 4 and 5. Cell 2 had recurring problems with low EOD voltage. At cycle 2473, cycling was stopped to perform a capacity check. Following the capacity check, Cell 2 failed to recharge. Three days later, a 5-ampere charge was again attempted, but Cell 2 failed to respond. Apparently an internal short had developed and the cell was removed from test. Cells 1 and 3 continued to cycle with relatively few problems. Degradation of EOD voltage and reduction of measured capacity was observed, as noted in Figures 4 and 5. Cell 3 failed abruptly after completing 10,080 charge/discharge cycles. Evidently, a massive short had developed, as evidenced by a high cell temperature. At this point, the cell was disconnected electrically, but physically left in the test fixture.

Cell EOD voltage was degrading on Cell 1 at approximately 15,000 cycles. The charge limit voltage was increased slightly, but the voltage continued to degrade and an undervoltage alarm caused shut down at Cycle 15690. At this time, the cell was recharged and a capacity check was performed. Measured capacity was only 23.9 ampere-hours, so the discharge energy was reduced from 25 to 15 ampere-hours. The effect on EOD voltage is reflected in Figure 4. As shown in Figure 5, measured capacity improved considerably after the low reading of 23.9 ampere-hours. Reasons for the behavior are not known. Cycling continued smoothly until failure occurred at Cycle 17168. Failure occurred about 20 minutes into the discharge of Cycle 17168 and was accompanied by a high-cell temperature pulse.

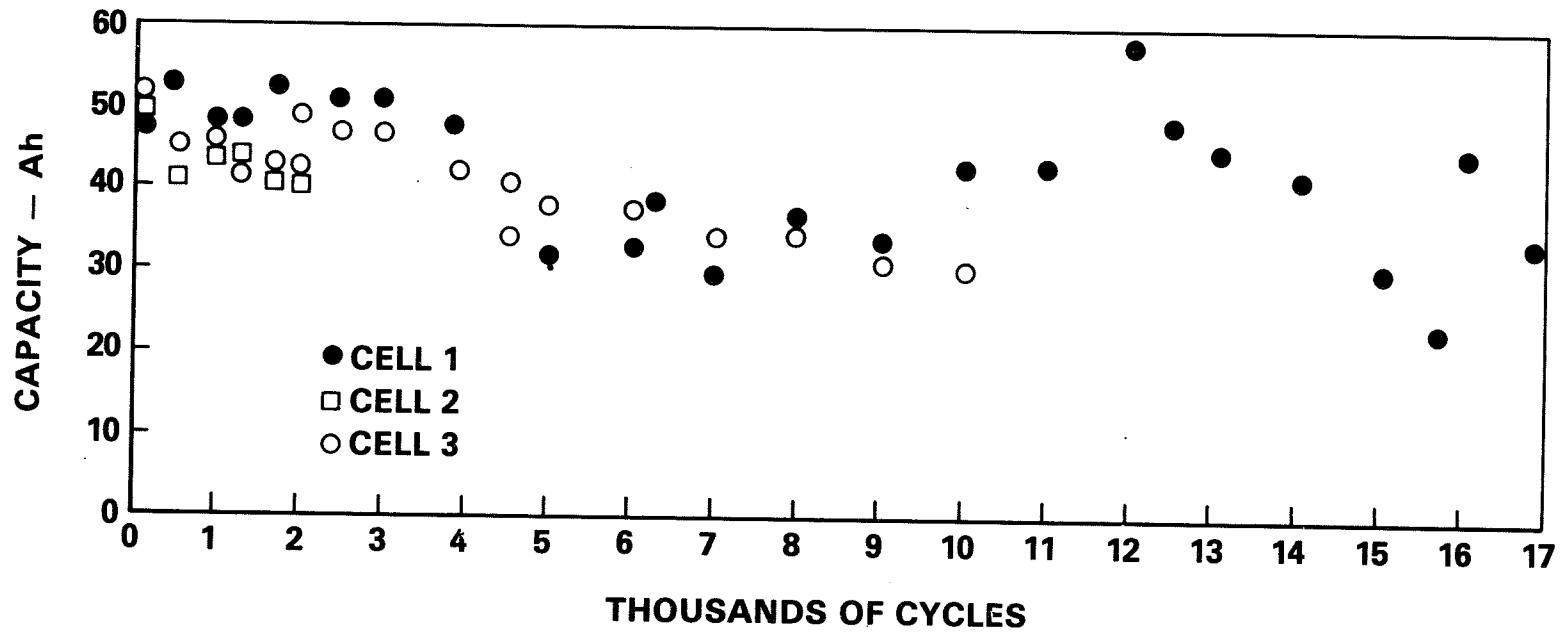
Figure 5. Cell Measured Capacity versus Cycles

At Cycle 11891, Cell 1 was inadvertently overcharged for 20 hours, with a total input energy of 118.4 ampere-hours due to an equipment malfunction. There was no apparent cell damage; therefore, the cell was returned to cycling after equipment repair. The effect of this long overcharge can be seen in the increase in measured capacity after Cycle 12015. Measured capacity was 59 ampere-hours at this point.

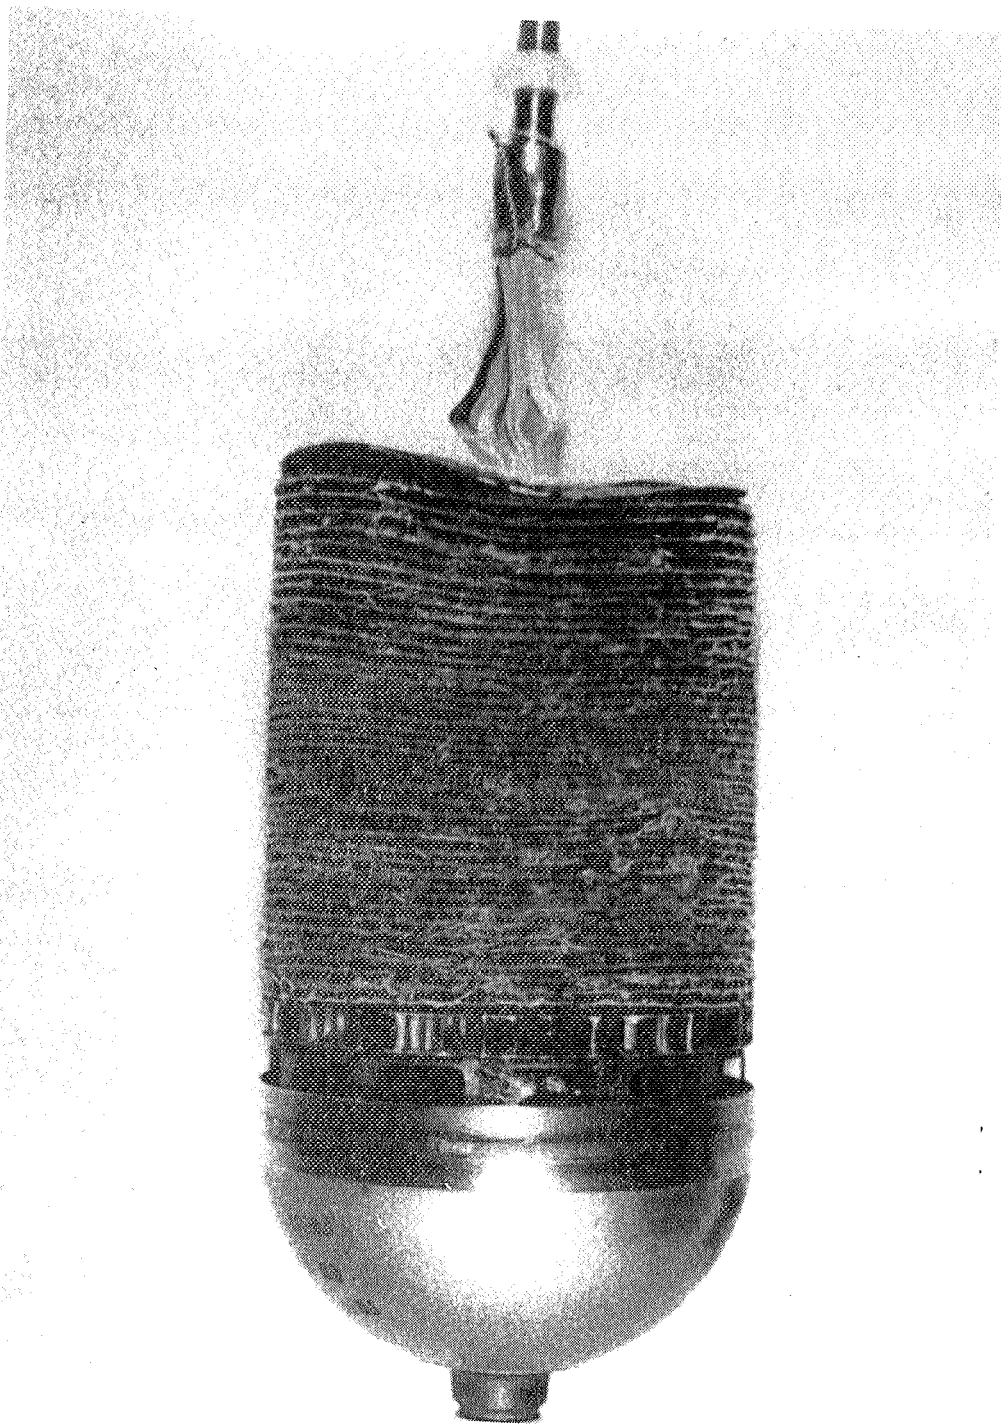
Figure 7. Cell 1 Electrode Stack Assembly

The ceramic washer from the negative terminal was found fractured into five segments inside the cell when the negative end of the pressure vessel was removed, which caused the rattling noise. Again, the shoulder of the polysulfone core had fractured completely around the intersection with the core. The shoulder, end plate, and belleville washer were retained by the negative leads. The electrode stack had relieved with the first negative electrode extending slightly past the fractured end of the core. Also the

electrodes were indented along an axis corresponding to the axis in which the plate tab to positive and negative leads is made. This depression is believed to have been caused by forces exerted through the leads when the stack relieved. Figure 7 is a view of the electrode stack prior to disassembly showing the indentation. Also, the negative reservoir had shrunk and necked in at one point, probably due to heating. Visual examination of the fractured end of the core showed striations similar to that seen in fatigue failure of metals.

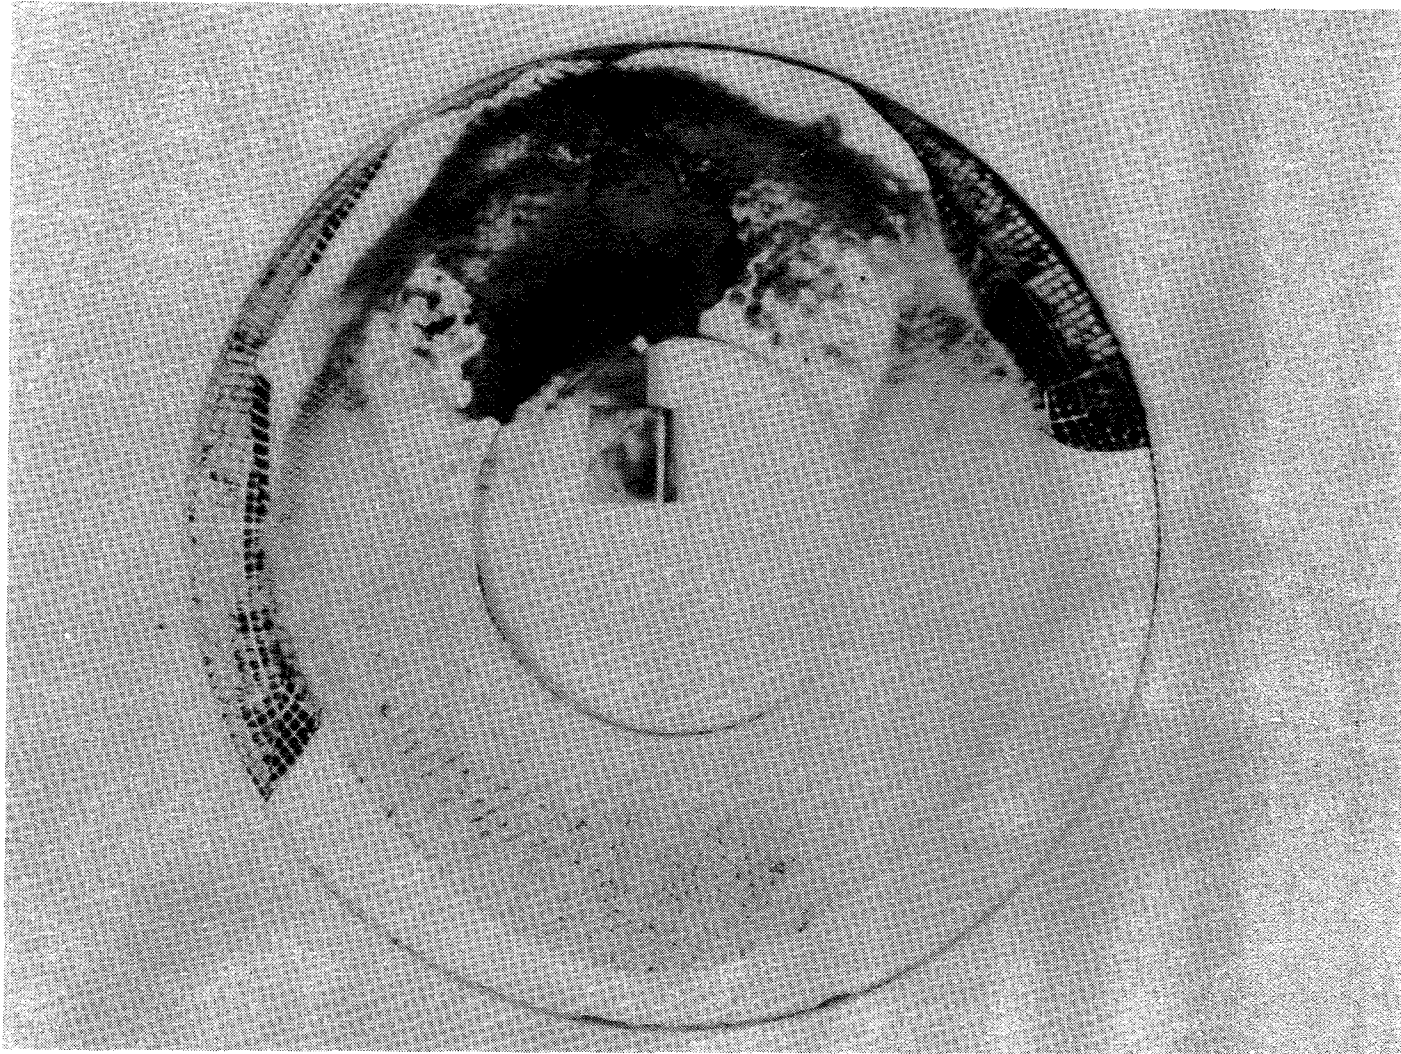
Figure 8. Cell 1 Negative Plate 35 and Gas Screen

An electrode-by-electrode disassembly revealed shorting of adjacent positive and negative plates at the inner perimeter of the plates in the area where the negative leads attach. Active material from the positive plate was imbedded in the adjacent negative in many cases. Also, the gas screen between negative and positive plates had melted and shrunk and was fused to the teflon coated side of the negative plate. Most severe damage to the gas screen was at a point where shorting had occurred at the negative lead to plate attachment. As the gas screen shrunk, it apparently fused to the outer periphery of the negative plate and peeled the teflon backing away from the underlying screen structure. Figure 8 is a photograph of negative plate 35 showing active material from positive plate 34 imbedded at the inner periphery where the negative lead attaches to the tab. Note also how the gas screen peeled back the teflon coating as it shrank due to heating. Gas screen shrinkage, melting, and fusing to the negative plate, and shorting of positive and negative electrodes extended throughout the stack assembly. Pin holes were found in many of the negative plates, indicating that "popping" occurred. As disassembly progressed toward the positive end of the electrode stack assembly, the plates became more planar.

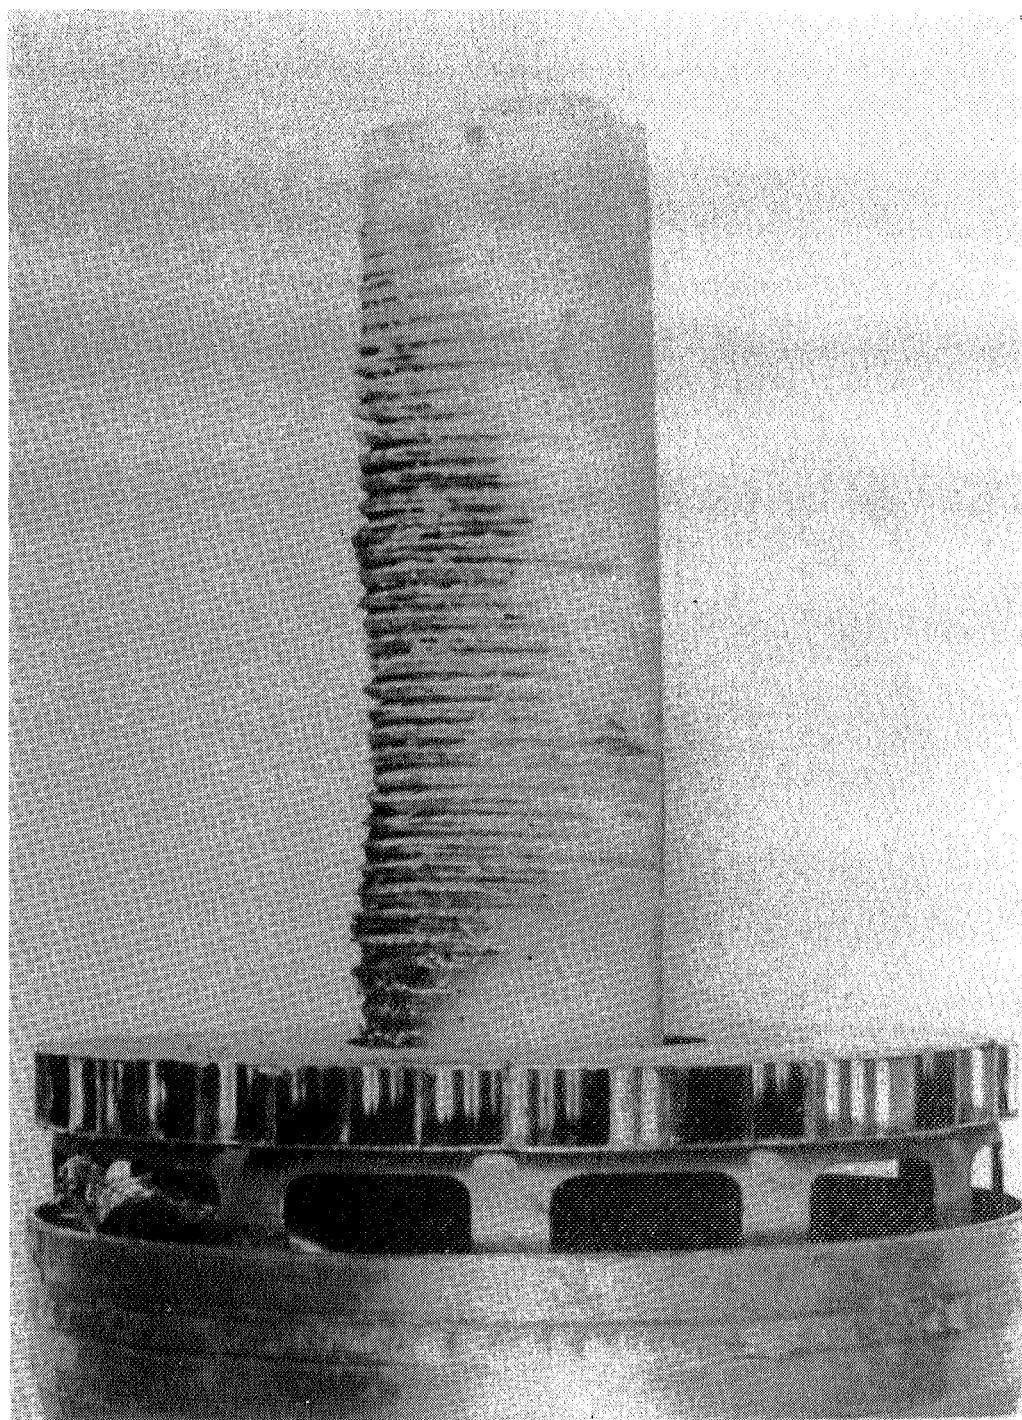
Figure 9. Cell 1 Polysulfone Core

Examination of the polysulfone core after disassembly showed the discoloration and swelling which is apparently caused by the heat pulse generated when shorting occurs. Figure 9 shows the polysulfone core attached to the positive hemisphere after the electrode stack elements have been removed. The degree of discoloration is believed to be proportional to the heat generated at that point. Applying that premise, the short is believed to have occurred first at a point approximately one-third of the stack thickness from the positive end and progressed outward in both directions. The swelling of the core causes a ribbed appearance and a black deposit is left where the positive plates restrict the swelling. The dimension from the fractured end of the core to the first indentation caused by a positive plate is less than the combined thickness of the end plate and Belleville washer, which implies that the shoulder fractured from the end of the core prior to the occurrence of the short.

Positive plate thicknesses were measured during disassembly and ranged from 0.038 to 0.048 inches. Assuming that each positive plate was fabricated at the maximum dimension of 0.032 inches, the thickness of the electrode stack assembly increased by 0.451 inches during cycling. The cell failed in a nearly identical manner to Cell 3, and we believe the failure history was also the same. Positive plate growth of this magnitude cannot be accommodated; and, after the stack relieves, a short occurs at a pressure point between adjacent pairs of electrodes which ultimately results in the massive internal damage observed.
