DOE/NASA/20320-63
NASA TM-86983

Government Review of the Mod-2 Wind Turbine (As-Built)

June 1985

A Government committee was formed to conduct an as-built review of the three Mod-2 wind turbine units at Goldendale, Washington. The purpose of the review was (1) to identify any critical components and subassemblies which may be deficient in either strength or predicted service life, the failure of which would cause safety hazards or significant downtime and expensive repairs; and (2) to recommend any corrective action necessary to enable continued safe attended and unattended machine operation.

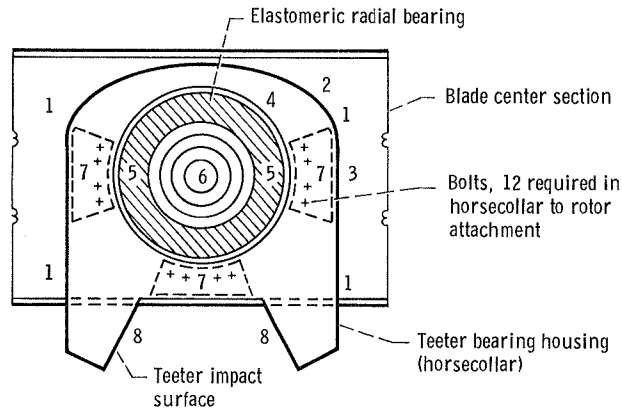
Figure 5. - Teeter bearing housing.

- (1) Iron oxide stains, indicating fretting at the horsecollar-to-rotor spar interface, were observed at location 1, figure 5, on all five Mod-2's.
- (2) Evidence of plastic shim failure was observed at location 7, figure 5, on WT4 and WT5.

- (3) Poor fit up (gap) at horsecollar-to-rotor spar interface was observed at location 3, figure 5, on WT5.
- (4) Weld flaws were observed at location 4, figure 5, on WT4; and a possible weld crack at the same location on WT2.

- (5) Surface cracks were observed on the elastomeric radial bearing at location 5, figure 5, on WT4.
- (6) A gap was observed at location 6, (see fig. 5) on WT4 between the elastomeric thrust bearing and rotor spar for the lower thrust bearing with the rotor horizontal, indicating a significant reduction in preload.

- (8) Evidence of high teeter-stop loads at location 8, figure 5, were observed on WT5. This was presumably a result of nonoperating rotor-teeter motion in winds above cut-out velocity.

- (1) Design, fabricate, and install a teeter motion damper
- (2) Replace plastic shim between horsecollar and rotor with steel shim
- (3) Determine cause of loss of preload in thrust bearing and take corrective action

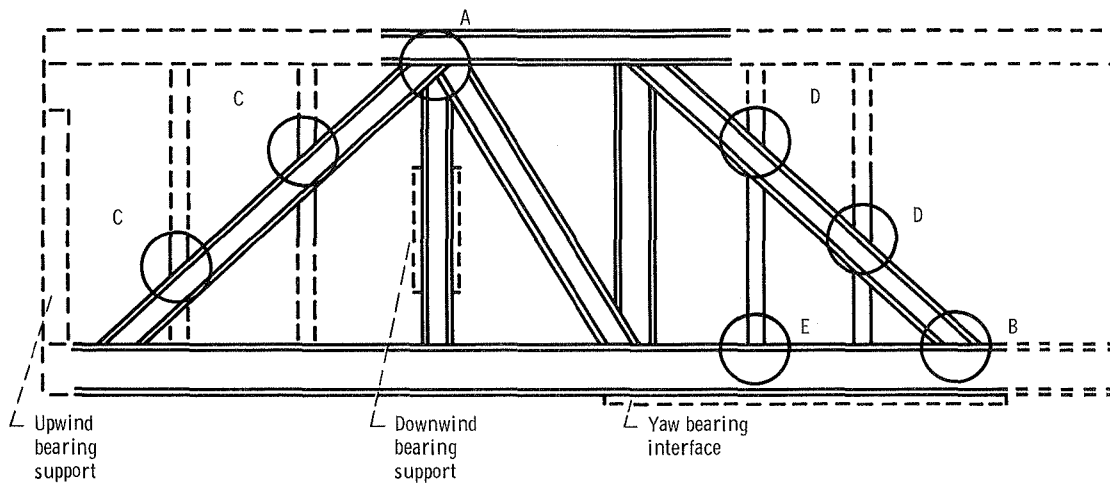
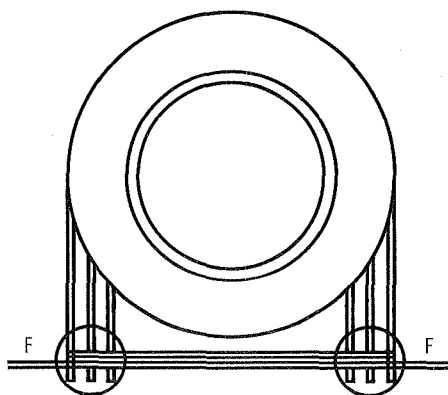
Figure 8. - Nacelle and major bearing support details.

- (1) Two out of the eight bolts were undertorqued by 20 percent on WT3.
- (2) Undesirable gaps existed at bolt clamp up interfaces on all units.
- (3) Cracked paint was present at the edges of shims indicating possible working on all units.
- (4) In WT5 there was an apparent 0.060-in upwind shift of the downwind bearing support.

A visual inspection of critical weld areas in the nacelle did not identify any failures. The fatigue analysis estimated "time to repair" values varying from 6 mo to 10 yr as shown in figure 8. The analysis was based on the assumptions listed in appendix D.

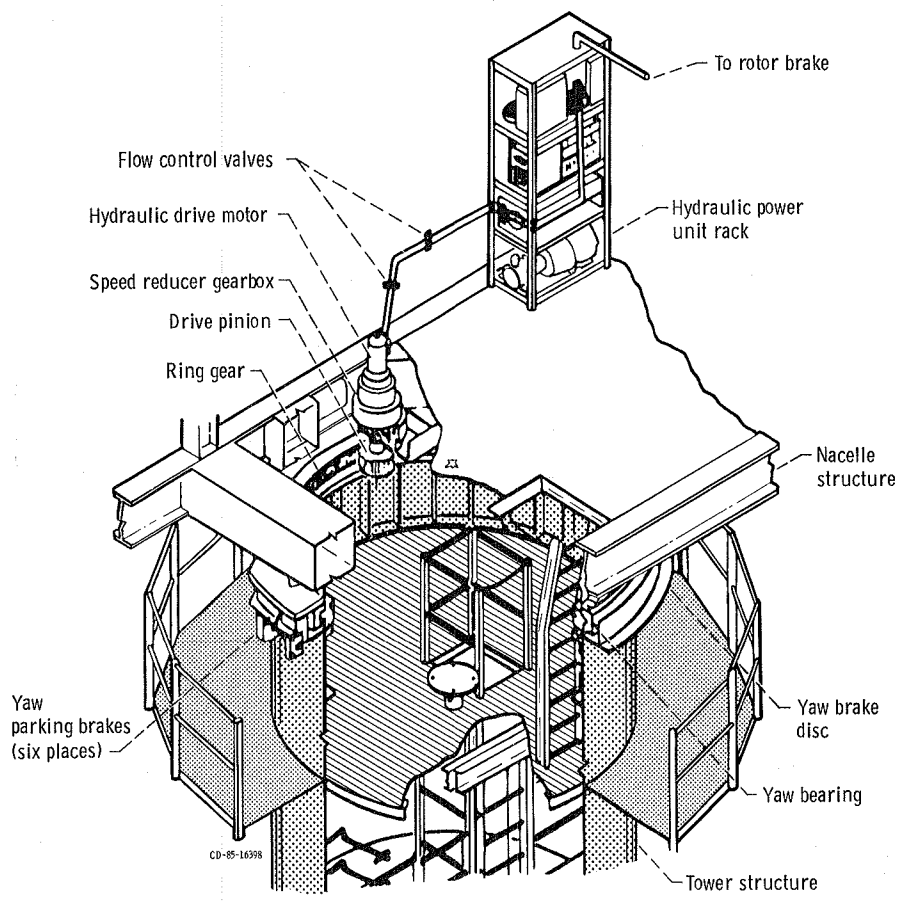
Figure 9. - Yaw drive system.

Findings: By using BEC nonconformance reports the following history was developed: Evidence that the yaw drive was being overloaded began to be observed in June of 1981 on WT2 after 122 hr of operation. Tapered dowel pins in the yaw drive retaining plate were found to be loose. Further examination revealed that most of the retainer bolts were loose. Additional dowel pins were inserted and the bolts retorqued. In March of 1982 these same bolts were

again found to be loose in WT2 and WT3 after a total of about 250 hr of operation on each machine. The bolts were replaced with longer bolts so that lock nuts could be installed. At about this same time, after a history of numerous problems, the yaw drag brake was disconnected because tower torque measurements showed that it was ineffective in damping yaw motions. On August 24, 1982, after about 120 hr of operation, a crack was found in the yaw drive gearbox case of WT5 and the gearbox was replaced.

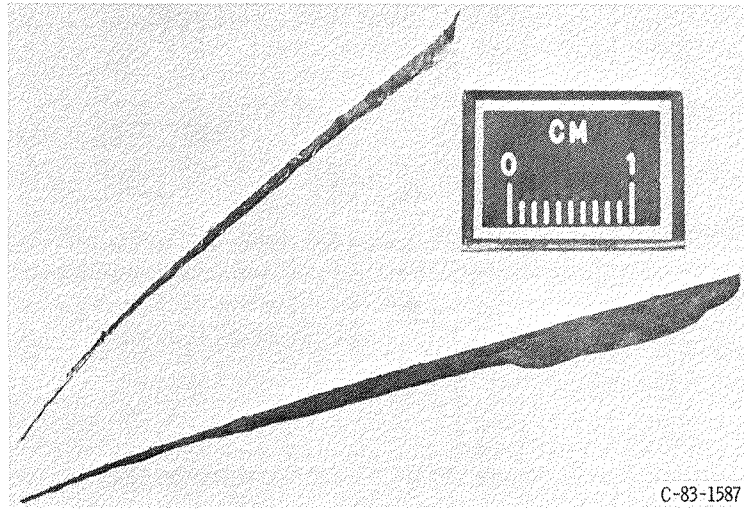
Figure 10. - Metal slivers removed from yaw ring gear.

Of all the components examined during the Government inspection of the Goldendale site, the yaw drive system showed the most obvious signs of damage and improper installation. Examination of the ring gear showed yielding and wear of the teeth over a sector of about 25°. Because of the predominant directionality of the winds at this site, the pinion works the ring gear over a relatively small sector most of the time. Alignment between the pinion and ring gear was such that contact between these two gears was maintained along only about one-third of the tooth width. The manufacturer of these gears recommends a minimum of 85 percent tooth surface contact. BEC measured backlash values between pinion and ring gear as large as 0.110 in. The manufacturer recommends backlash of 0.023-in minimum to 0.044-in maximum.

The pinion gear specification calls for heat treatment to BHN 350/425. The ring gear specification calls for heat treatment to BHN 250/300. With the pinion gear having the harder surface, alignment and tooth surface contact become very important. Without proper alignment and tooth contact, excessive wear and possible tooth breakage can occur. Slivers of metal, as shown in figure 10, were removed from one ring gear.

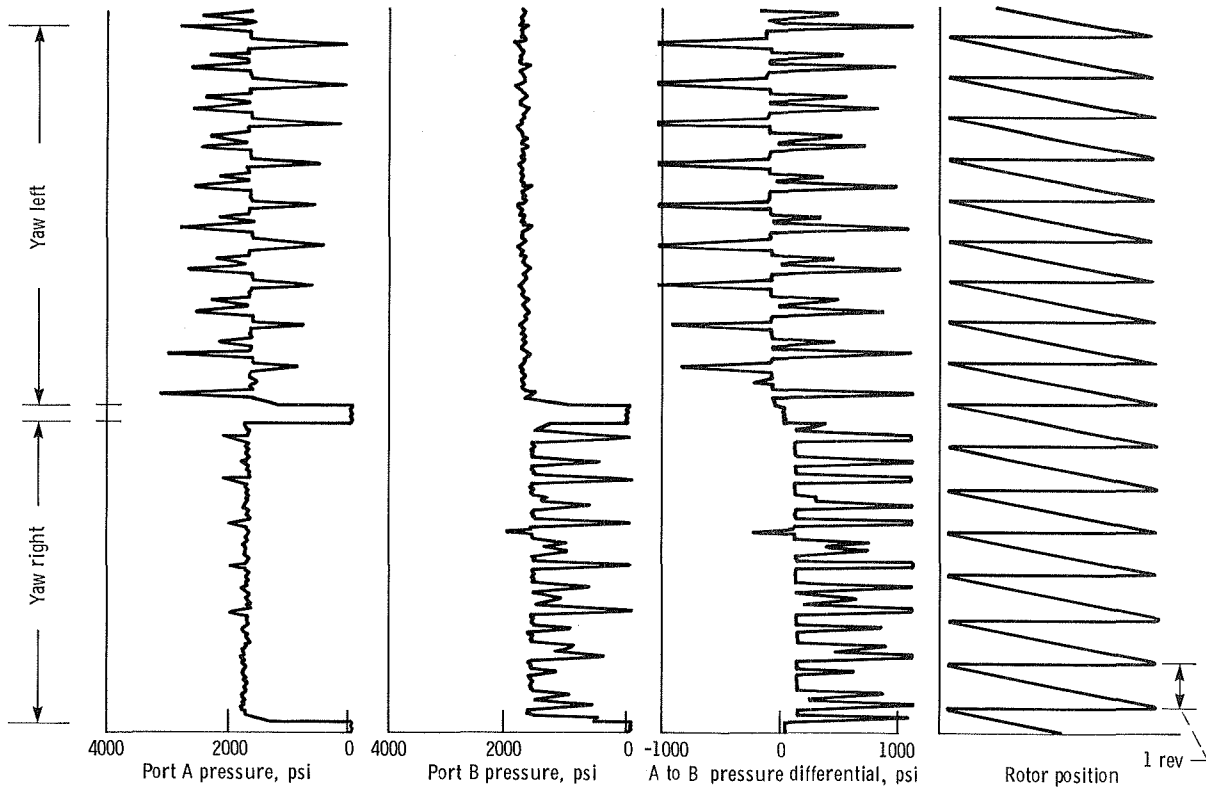
Figure 11. - Yaw drive motor pressures during yaw corrections. (Rotor speed = 17.5 rpm.)

During Mod-2 operation, just prior to the low-speed shaft failure, measurements of hydraulic pressure at the yaw drive motor ports were made. These measurements, shown in figure 11, showed pressure impulses of close to 2000 psi (system design pressure) when yawing took place while the rotor was at normal operating speed (17.5 rpm). If yawing took place when the rotor was coming up to operating speed, higher peak impulse pressures were observed. The impulsive nature of the pressure measurements is a result of the cyclic yawing moments produced by the rotor and backlash in the gear teeth. Because of the backlash, the nacelle can rotate through a small angle unrestrained except for friction in the yaw bearing. This motion continues until the ring gear impacts the pinion gear causing a pressure spike in the drive motor.

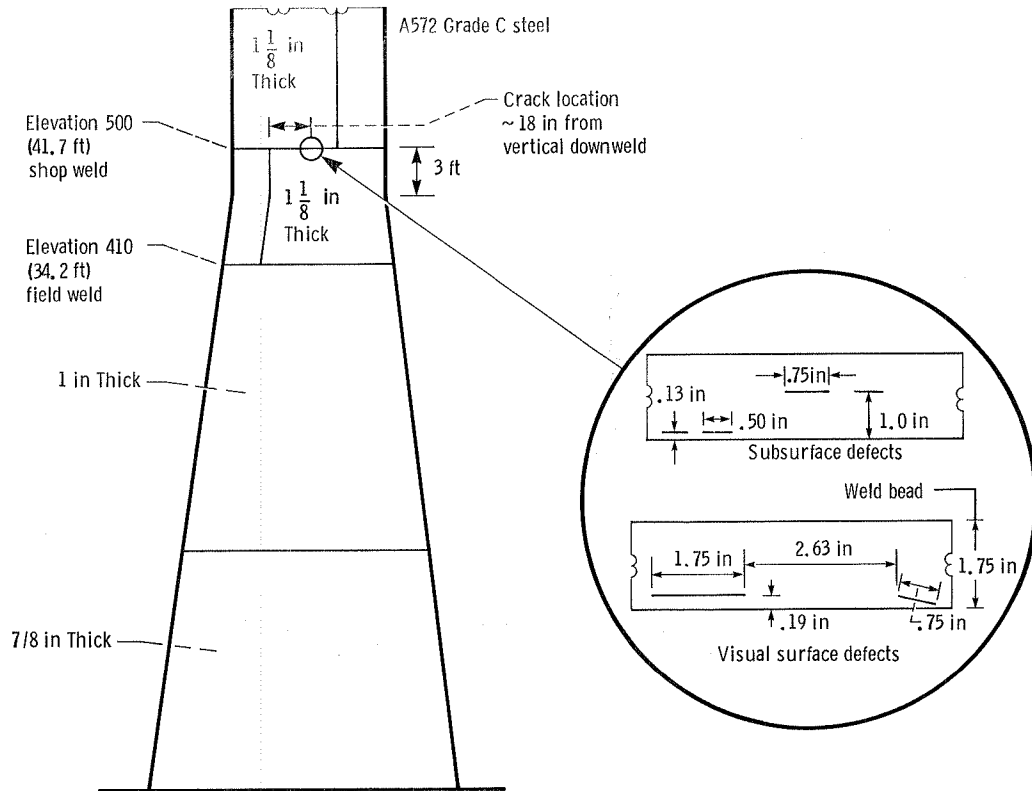
Figure 12. - Solano (WT5) tower crack, view looking east. (Subsurface defects are directly below surface defects.)

Concern: Boeing reported that the WT5 tower had experienced fatigue crack growth from a large slag inclusion located at the 500-in station shop weld. Undetected cracks in the tower could eventually contribute to a catastrophic failure.

Findings: It is important to note that the Solano flaw, shown in figure 12, was first detected by an observation of rust stains on the exterior surface of the weld. Furthermore, this observation made by a BEC individual involved in another site assignment, proves that a 1.75-in crack can be detected by a visual inspection.

The WT5 experience proved that simply inspecting the towers visually is an effective method of detecting crack lengths even under 2 in. Fracture mechanics predicts that the critical crack size for this particular location is 24 in for a 120-mph wind. The predicted tower crack growth rate is shown in figure 13. Thus, planned inspections at 600 hr intervals would give ample time to identify a crack before it became critical. Visual inspections of the inside of the towers for units WT1 through WT4 did not reveal any cracks in the welds. However, there was some mismatch detected that was in excess of drawing tolerance.
