NASA
Technical Memorandum 86939

Experimental Study of Ceramic-Coated Tip Seals for Turbojet Engines

Prepared for the
Ninth Annual Conference on Composites and Advanced Ceramic Materials
sponsored by the American Ceramic Society
Cocoa Beach, Florida, January 20-24, 1985

EXPERIMENTAL STUDY OF CERAMIC-COATED TIP SEALS FOR TURBOJET ENGINES

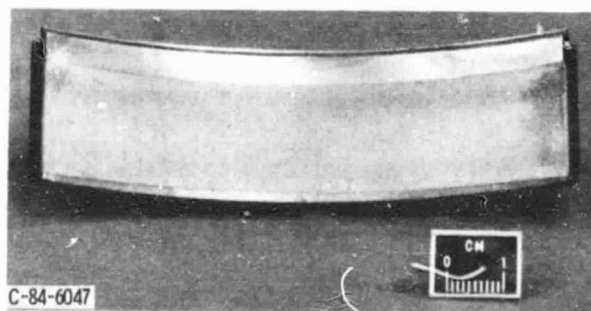
One $ZrO_2-8Y_2O_3$ ceramic shroud section (position 6) along with a typical cross section, has been metallographically examined (by Gary Liotta of General Electric, Lynn, Mass.). The front surface of shroud 6 was reasonably smooth without visible defects (fig. 9). Some slight erosion was evident, along with a small amount of ceramic darkening. At a magnification of 32 (fig. 14), the back surface showed cracking in the bond coat along the trailing edge and extending back into the ceramic flowpath surface. Some ceramic cracking was also evident along the leading edge, along with some "micro" surface cracks. The right end of the shroud showed both vertical and bond-line cracking. Of the total perimeter length of 24.4 cm (9.6 in), 9 cm (3.6 in), or approximately 37.5 percent, was cracked.

Figure 9. - Shroud segment 6 after 1001 cycles - hot-gas side.

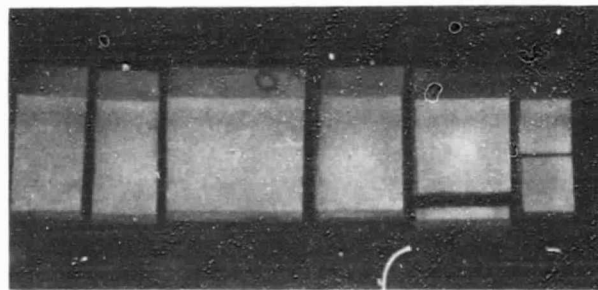
Examination of several sections through the ceramic shroud components (e.g., fig. 11) revealed nonuniform ceramic coating thicknesses as a result of spraying and grinding.²

Figure 11. - Shroud sections used in metallographic analysis.

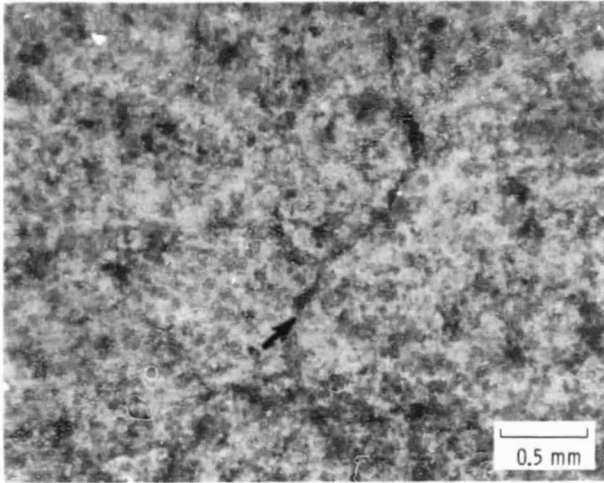
A macrograph of a shroud section (fig. 12(a)) shows surface cracking. On an average the "mudflat" cracks were hexagonally spaced by about 1.5 mm. Such large cracks probably were preceded by microfracturing. These cracks tended to penetrate to the bond-coat interface (fig. 12(b)), where cracking appeared either to terminate or, in some instances, to spread axially and perhaps circumferentially. These cracks are probably responsible for the shroud's ability to withstand thermal cycling when an elastic analysis produces stresses beyond the rupture limit. Such inelastic behavior also limits the life of the component: as microfracturing effects become prominent, the structure weakens and eventually fails.

(a) Typical flow path crack.

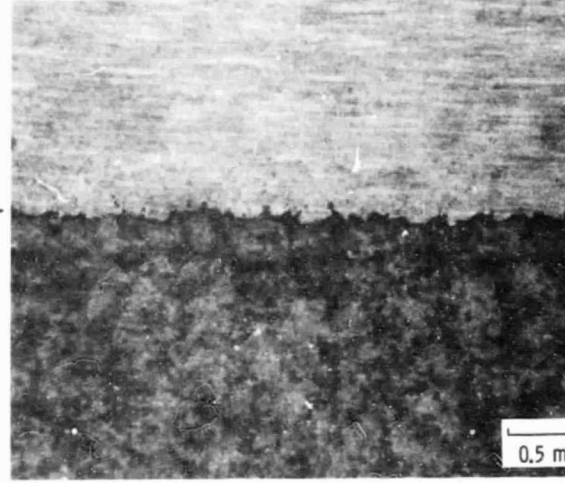
(b) Ceramic crack leading edge.

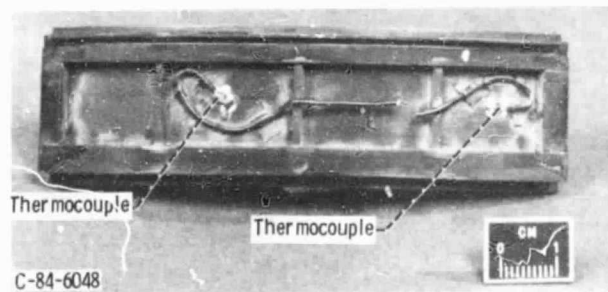
²The wet grind left a residue on the coolant passage that provided flow visualization of jet impingement patterns (e.g., see fig. 13).

Figure 13. - Shroud segment 6 after 1001 cycles - back side.

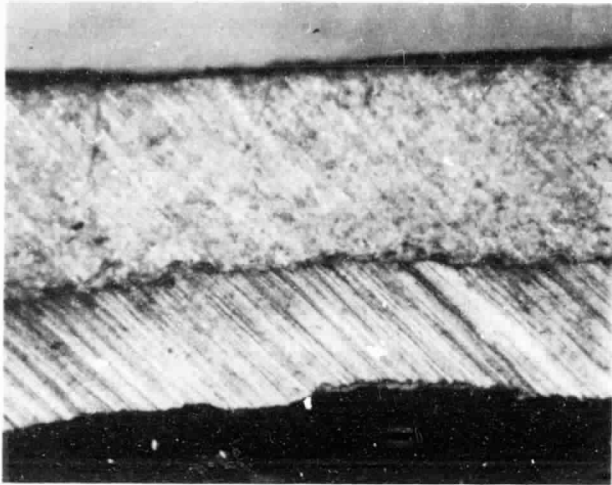
(a) Ceramic and frame crack trailing edge.

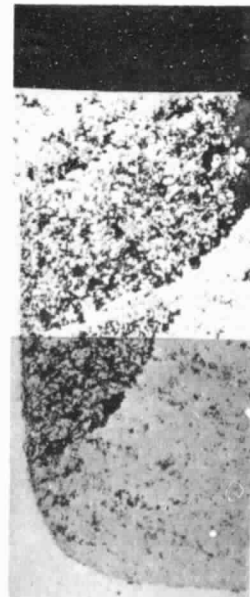
For the sectioned shroud (fig. 11), the bond coat was 1.14 to 1.27 mm (0.045 to 0.050 in) thick. Adjacent to the leading and trailing edges the bond coat was about 50 percent dense (fig. 15). Vertical cracking was also evident in the bond coat.

The ceramic top coat was 0.76 to 0.98 mm (0.030 to 0.039 in) thick. Probably this was closer to 1.27 mm (0.050 in) before grinding. The bond coat had cracked at the trailing edge (fig. 15(b)); the crack extended almost 1.9 mm (0.075 in) from the trailing edge to the leading edge and 12.7 mm (0.500 in) from right to left.

Figure 15. - Low density in bond coat adjacent to leading and trailing-edge frames.

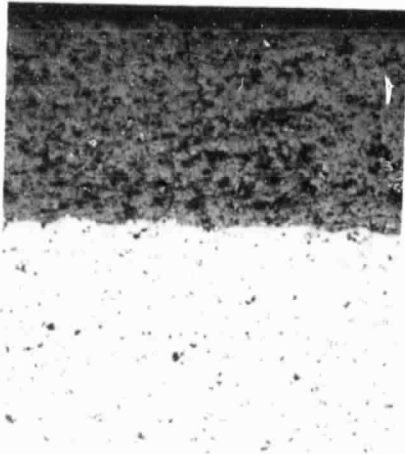
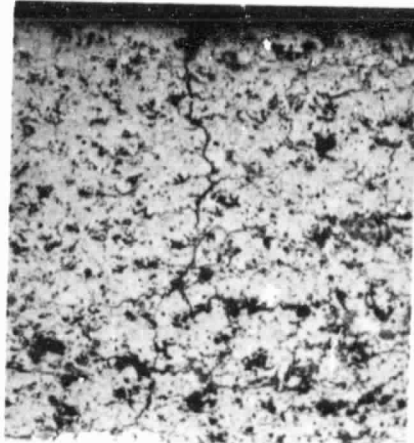
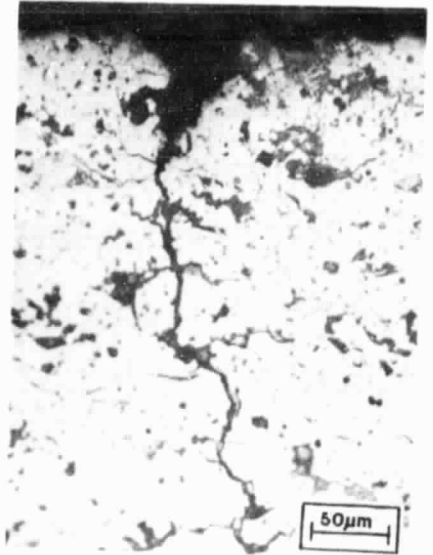
A pretest micrograph (fig. 17(a)) of a quality control specimen that was not run in the engine revealed some vertical cracking, which provides strain relief. The post-test ceramic coating microstructure (figs. 17(b) and (c)) revealed extensive segmentation, commonly called mudflat cracking, and some local areas of lateral cracking and large porosity. Apparently some densification of the ceramic occurred. However, caution must be exercised as microstructures are very dependent on metallographic polishing methods.

(b) Post-test microstructure; cross section A-A.

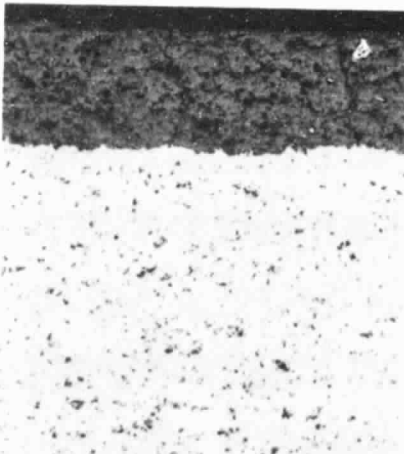
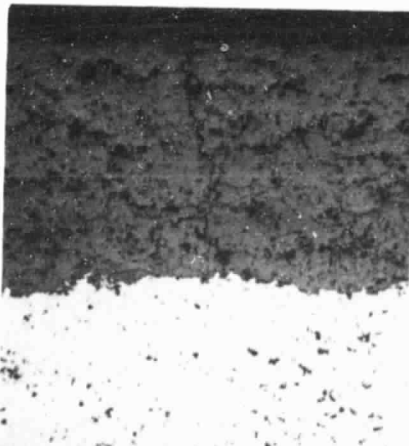
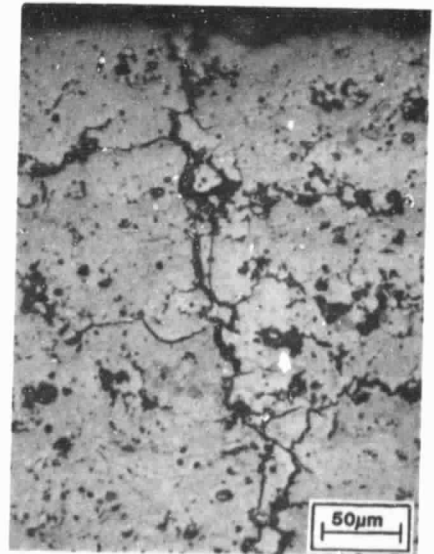
(c) Post-test microstructure; cross section B-B.
