NASA-CR-167993

Materials for Advanced Turbine Engines

Project Completion Report Project 2

René 150 Directionally Solidified Superalloy Turbine Blades

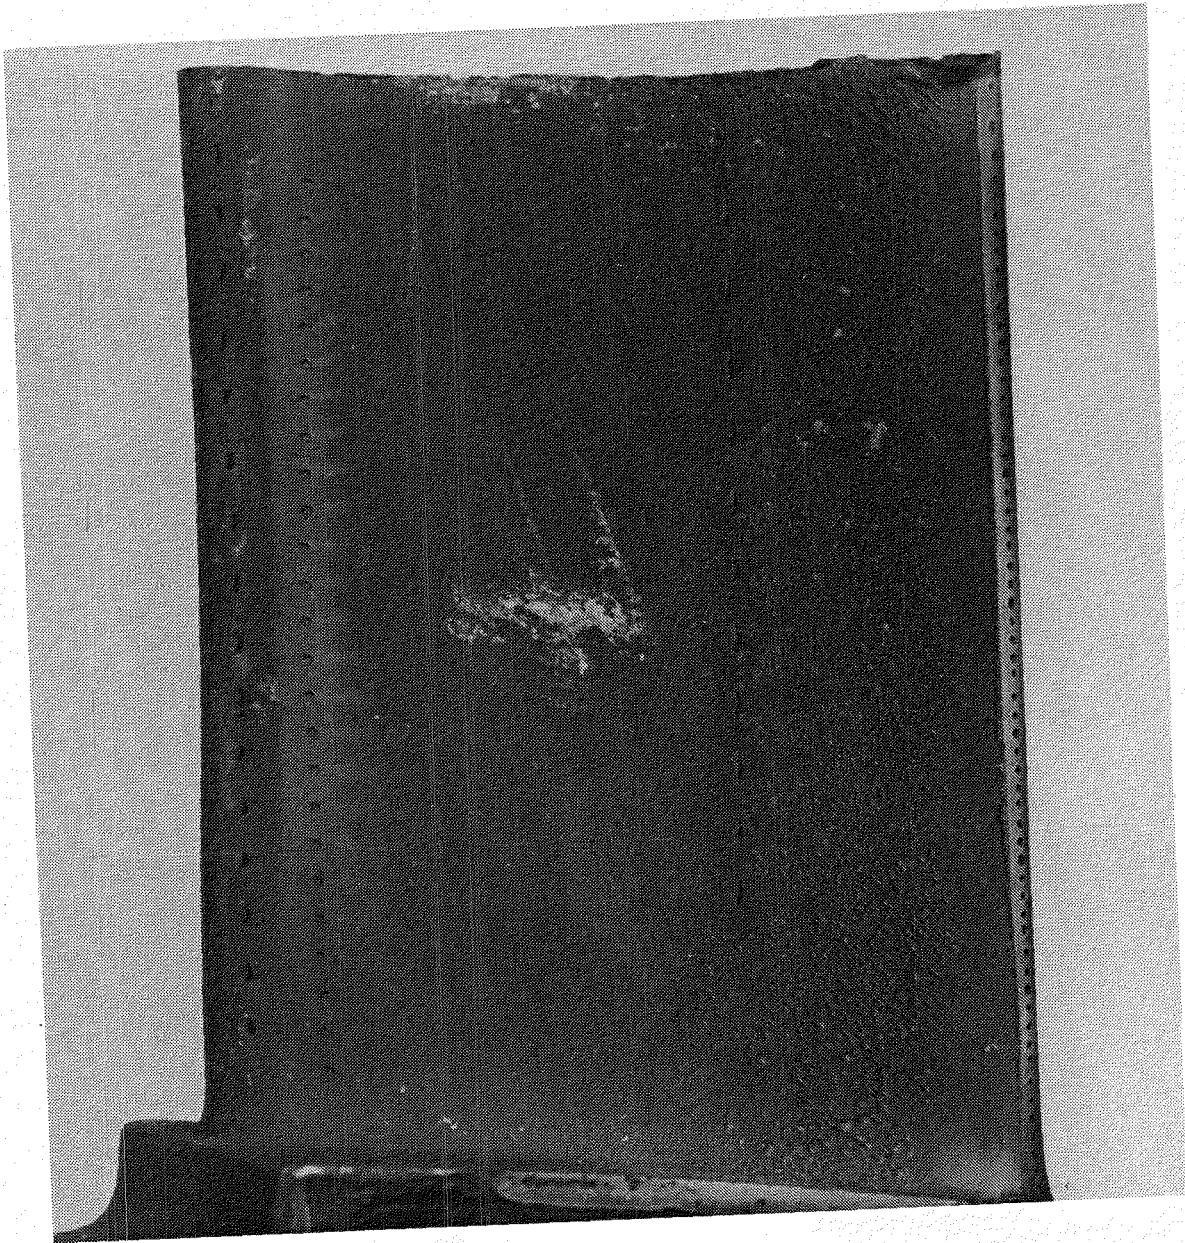
Figure 9. Typical René 150 HPT Blade After 1000 "C" Cycle Engine Test.

The visual examination was performed on all of the blades from the rotor using 40X binoculars. The blades were inspected for oxidation, cracking, coating distress, and dovetail wear patterns. Figure 9 shows a typical René 150 HPT blade following the completion of the fan engine test. All of the blade airfoils were covered by a very thin iron oxide deposit; this is a normal occurrence in Evendale factory engine tests. All blades exhibited evidence of distress.

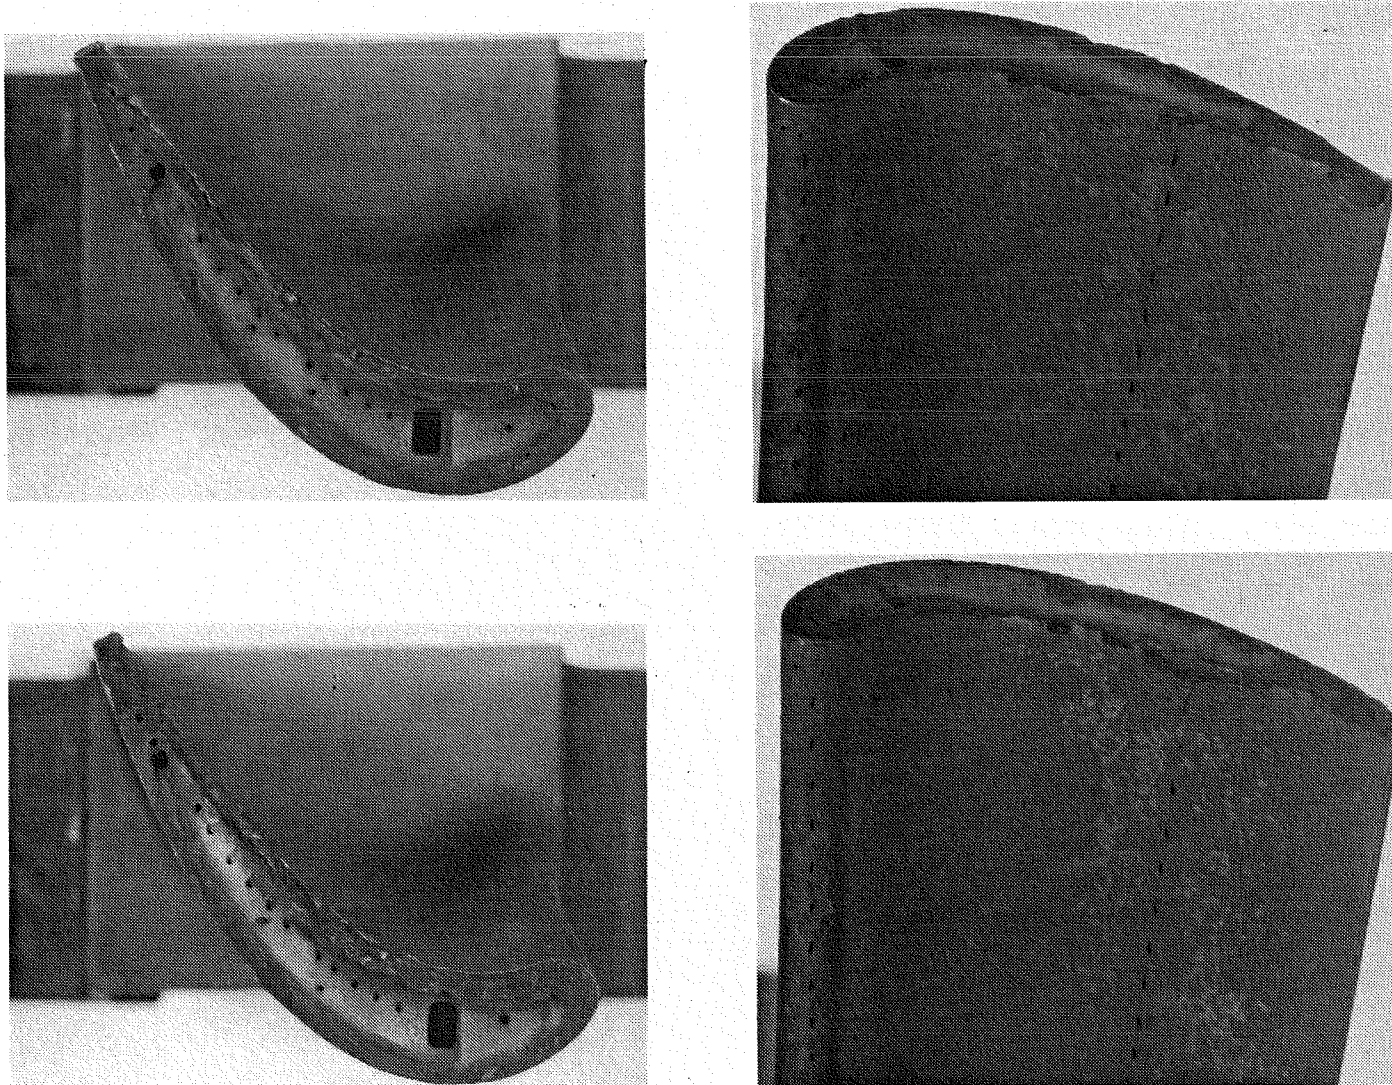
Figure 10. Typical René 150 HPT Blade Tip After 1000 "C" Cycle Engine Test.

As expected, the René 150 blades exhibited much more tip oxidation than the René 80 blades. Figure 10 illustrates the extensive metal loss that occurred on the René 150 blades and left the coating in relief in a worst-case situation. In addition, the René 150 blade platforms and shanks were oxidized on the pressure side of the blade. The René 80 blades exhibited no oxidation in this region. The AC 402 blade coating showed no obvious signs of distress.

The fan engine test was successfully run, and the René 150 HPT blades operated at the desired 56° C (100° F) temperature increment above the René 80 blades; however, the posttest analysis of the blades revealed several potential long-term problems with the blade design utilized in this project. A long-life blade design would have to be coated on the inside and outside including the shank and dovetail regions. In addition, an oxidation-resistant tip would be required.

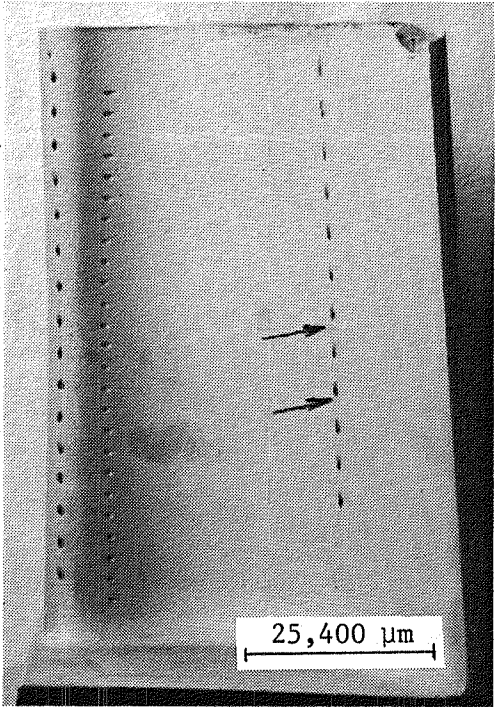
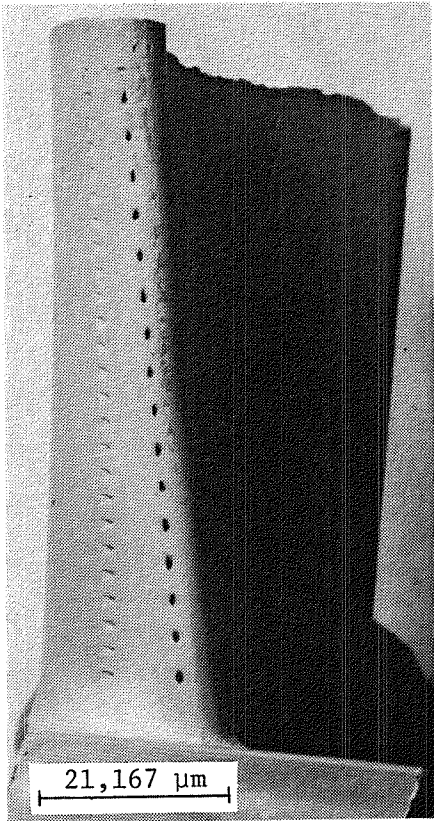
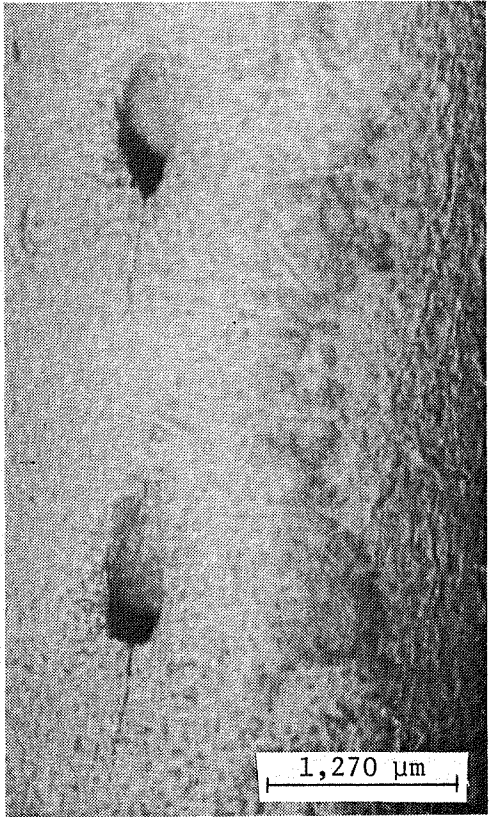
Figure 11. Nose-Hole and Pressure-Side, Film-Hole Cracking.

All of the blades in the rotor contained radial cracks emanating from the nose, concave film and concave gill holes; however, the cracks in the René 150 blades were more frequent and extensive. Table II presents the cracking summary for the René 150 HPT blade. Figures 11, 12, and 13 show typical examples of the observed cracking. The René 150 and the René 80 blades exhibited similar platform cracking in terms of location and extent. Several examples of this are shown in Figures 14 and 15. The dovetail wear patterns were similar on both the René 150 and René 80 blades.

Concave - Note Cracks at Pressure Side Holes

Leading Edge Hole Cracks

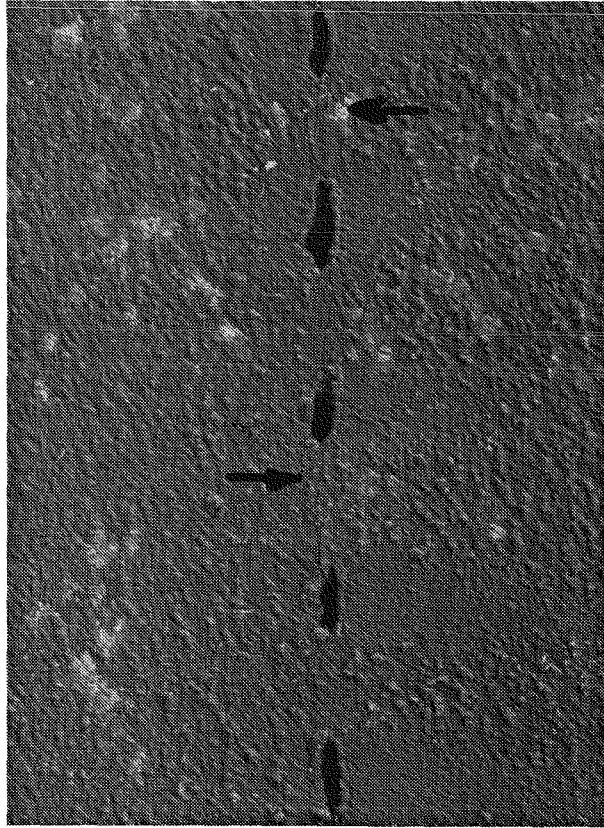
Figure 12. Typical Radial Cracks at Pressure-Side, Film-Cooling Holes.

3. Pressure-Side Film Holes	All 13 blades exhibited radial cracking. Holes below No. 8 generally cracked from top and bottom of hole; above No. 8 cracked from bottom only. Total number of cracked holes varied from 7 to 12. Six blades had two or more holes connected by cracks, and these were found between holes 5 to 8 only.

Metallographic evaluation of the cracks observed at the nose holes, concave cooling holes, and in the platform showed that they were typical thermal-fatigue cracks. They were characterized by a predominantly transgranular crack path and associated oxidation and alloy depletion as shown in Figures 22, 23, and 24. A fractographic evaluation of several of the cracks was performed by breaking open the blade and examining the fracture surface with a scanning electron microscope (SEM). Even though the crack fracture surfaces were heavily oxidized, it was possible to observe evidence of fatigue propagation near the crack extremities as shown in Figures 25 and 26. The airfoil cracks did not extend through the wall thickness in any location. The platform cracks extended completely through the platform edges. These exhibited less alloy depletion and oxidation than the airfoil cracks (indicative of a lower operating temperature).

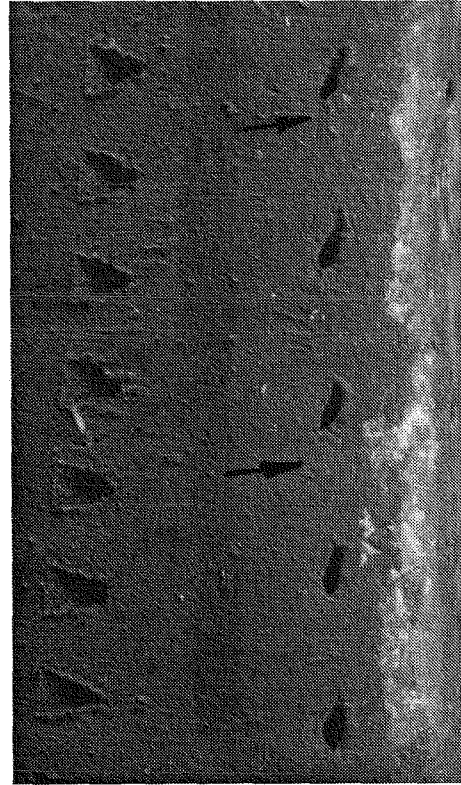
Figure 13. Typical Radial Cracks at Leading-Edge Nose Holes.

Location	Cracking Observed
1. Leading-Edge Nose Holes	All 13 blades exhibited radial cracking in convex row of nose holes. Total number varied from 5 to 16 cracks with the most severe cracks between holes 8 to 12. Two blades had a cracked hole in the concave row.

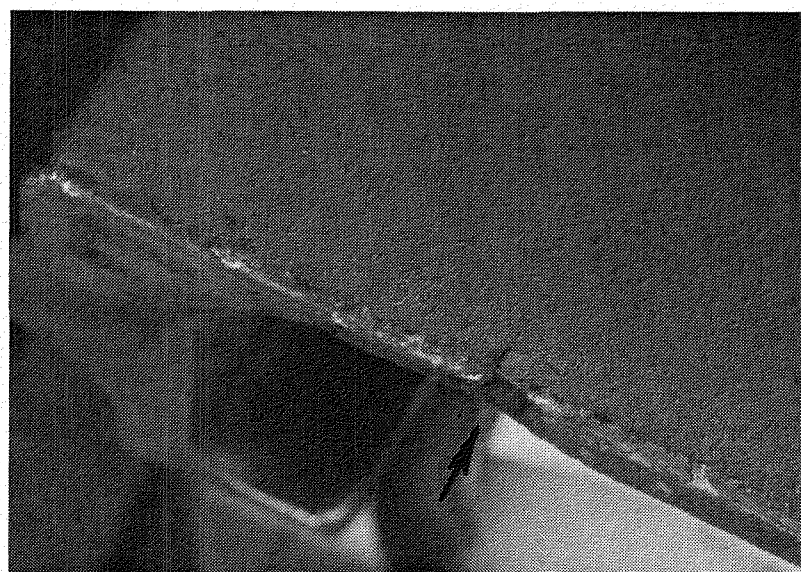
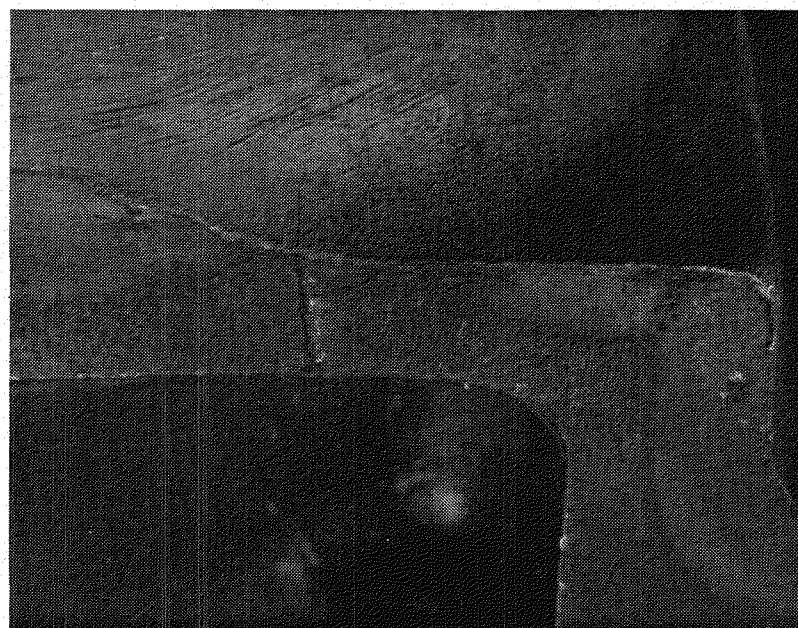
Figure 14. Platform Cracks.

4. Suction-Side Gill Holes	No apparent cracking.
5. Platform	Ten blades contained cracks on the convex side platform. Six blades were cracked just forward of the high C location and four just aft. On seven of the blades, the cracks extended to the airfoil fillet radius.

Platform Crack on Concave Side Near Leading Edge

Platform Crack on Convex Side Near Leading Edge

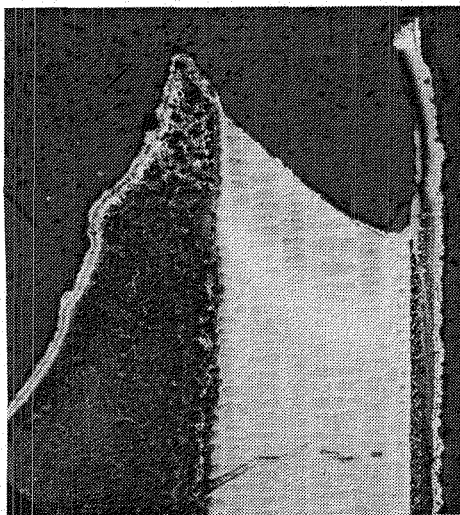
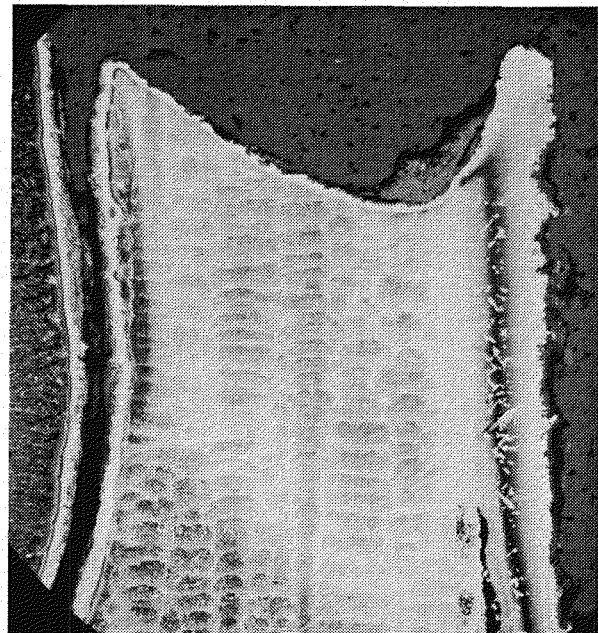
Figure 16. Typical Photomicrographs of Tip Oxidation.

The tip oxidation progressed radially downward from the tip, Figure 16, and was present on all tip sections. It was heaviest on the concave side of the blade near the trailing edge where it reached apparent depths of 40 mils or more. The oxidation was usually most extensive nearest the blade external surface and did not entirely consume the coating.

Forward of Trailing Edge/
Concave Side
Phosphoric Etch

Midchord Concave Side
Phosphoric Etch

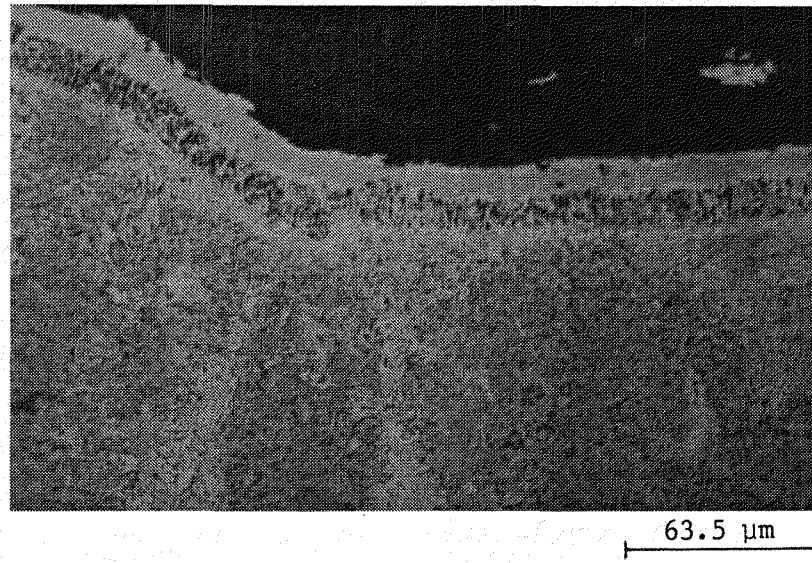
Figure 17. Internal Blade Surface with Aluminide Coating.

The internal blade surfaces that were aluminide, as a consequence of the coating operation exhibited no base-metal attack and minimal coating attack as shown in Figure 17. However, the uncoated internal surfaces were oxidized to various degrees as shown in Figure 18. The heaviest oxidation, approximately 3 mils deep, was observed in the concave side midspan/midchord area of the blade.

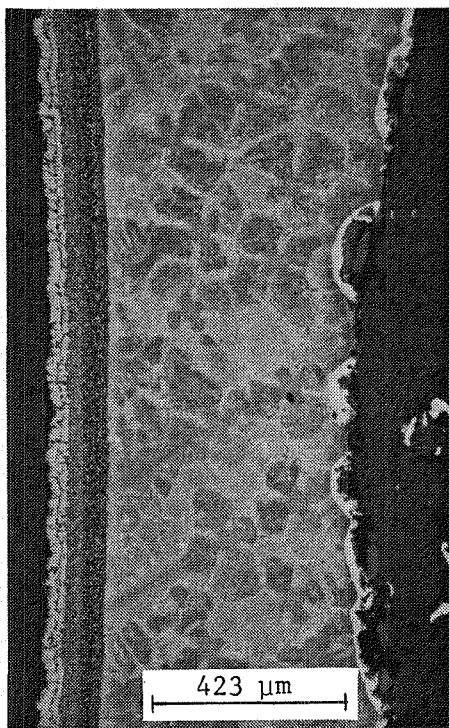
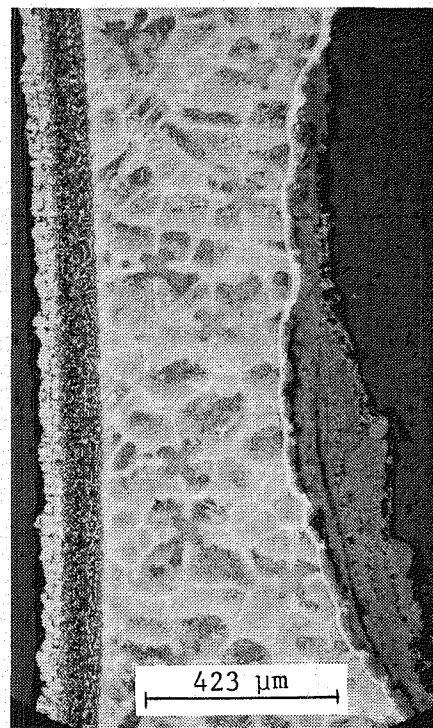
Figure 18. Uncoated Internal Blade Surface.

Concave/Tip Area

Concave/Midspan

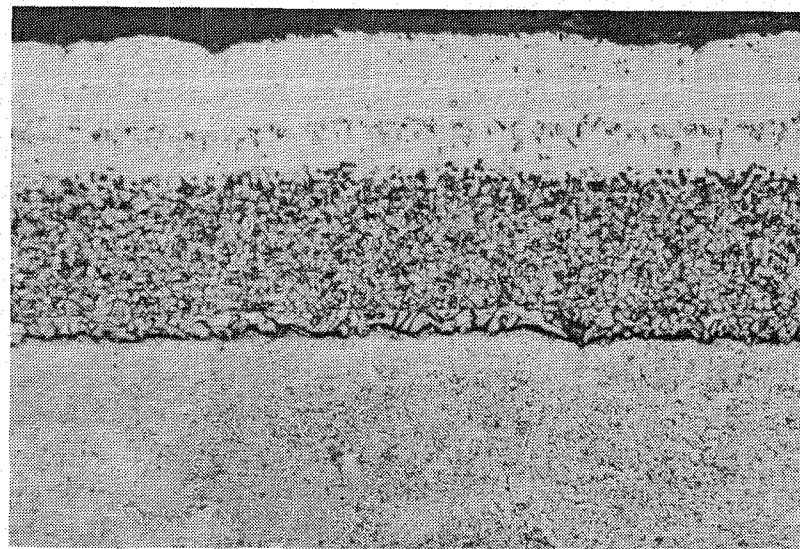
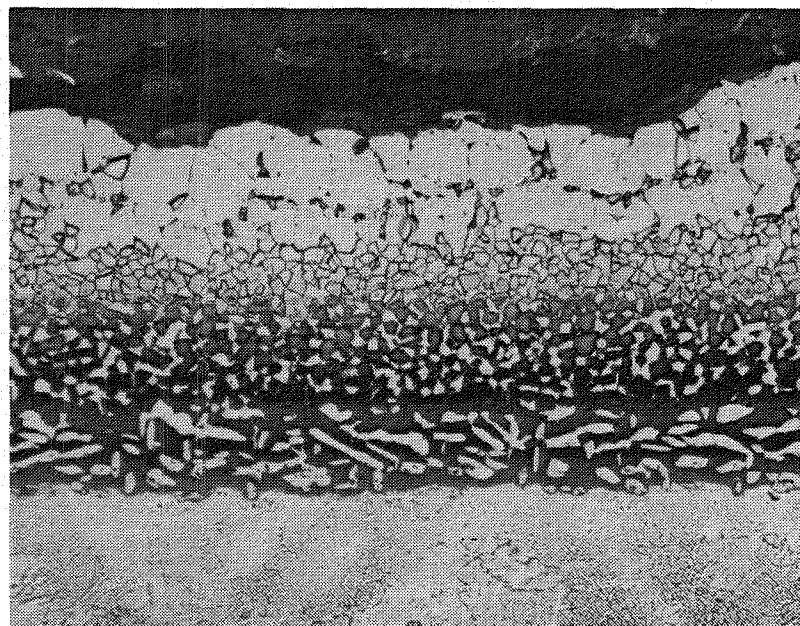
Figure 19. Upper: Typical AC402 Coating in Cooler Regions
Lower: AC402 Coating in Intermediate Temperature Regions.

The AC 402 coating was in generally good condition with a typical thickness of 3 to 4 mils. The airfoil operating temperature was characterized by the pattern of coating changes as shown in Figures 19 and 20. The hottest regions of the blade exhibited the more extensive coating transformation; the coolest regions exhibited negligible transformation. No coating/base-metal separations were evident. Aside from the slight surface oxidation and tip attack discussed previously, there was no significant environmental attack of the coating.

(Note Transformation to γ Particularly in Inner Layer and Increase in Coating Thickness Due to Diffusion).

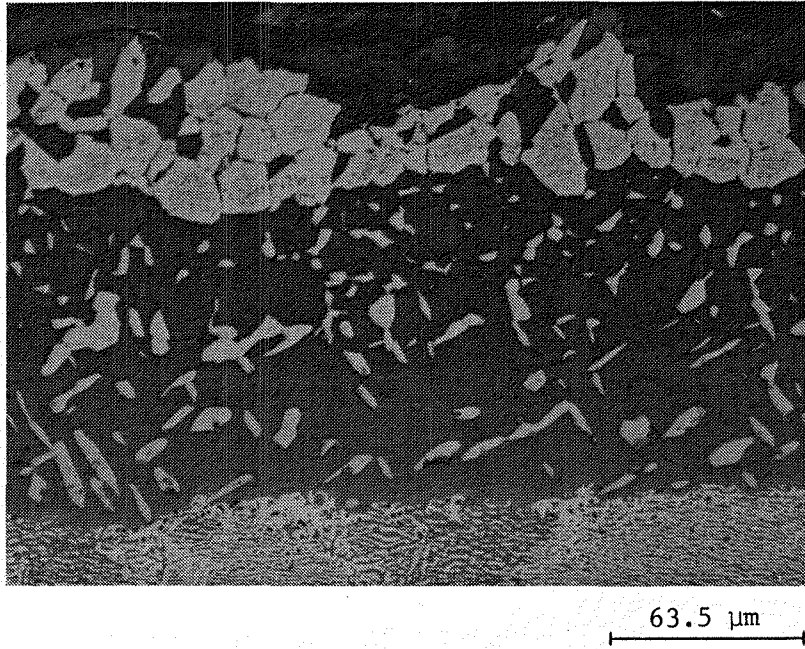
Figure 20. AC402 Coating in Hottest Regions.

(Note Significant Transformation to γ and Increase in Thickness).

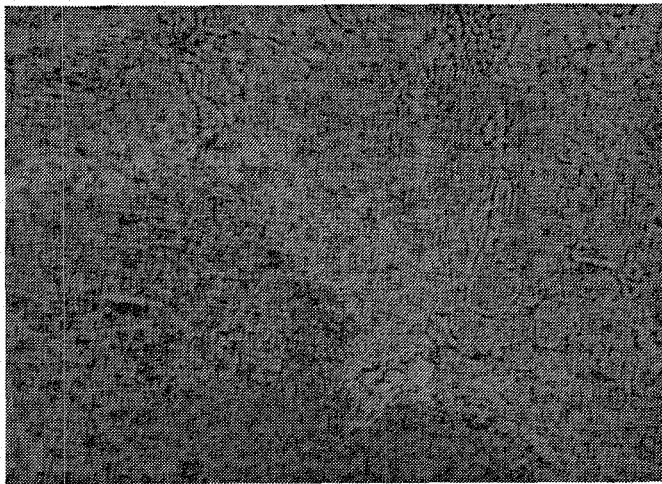
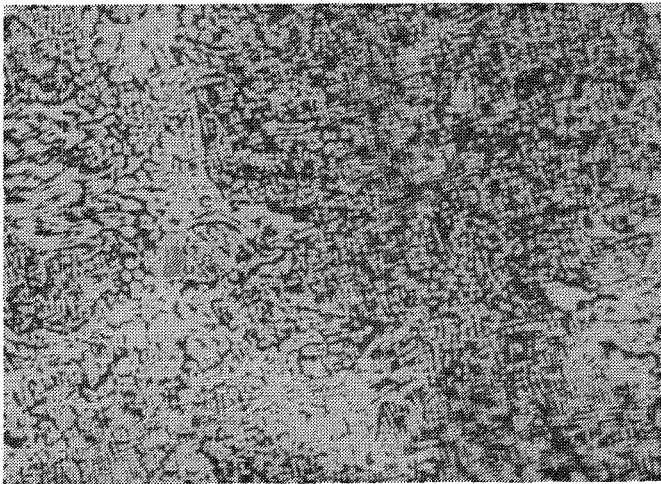
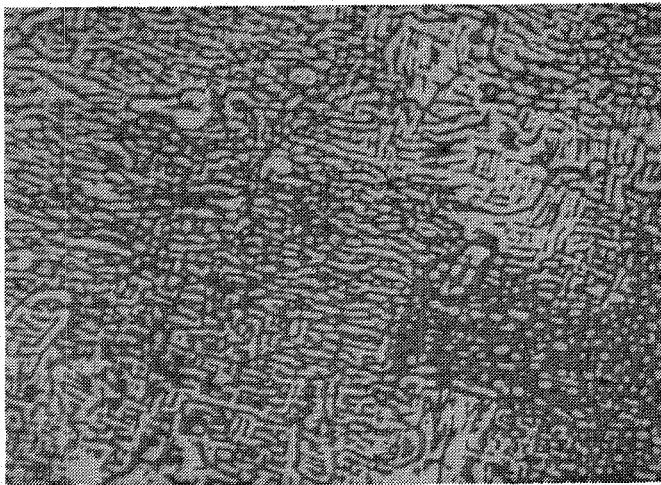
Figure 21. Rene' 150 Base Metal Gamma Prime Morphology As A Function of Increasing Temperature.

The actual base-metal temperatures attained during the test were not determinable; however, a microstructural pattern was observed in the René 150 which was consistent with that described for the coating. As shown in Figure 21, the hottest regions of the blade exhibited the coarsest γ' , and the coolest areas exhibited normal γ' size and morphology.

Coarser γ' (Concave - Midchord/
Trailing Edge, Mid-Span to Near
Tip and Convex - Tip/Trailing
Edge Area)

Coarsest γ' (Concave - Midchord/
Trailing Edge Area)

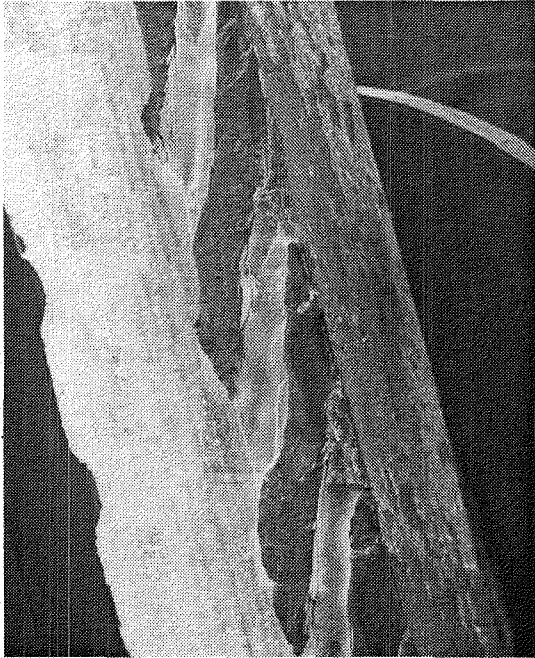
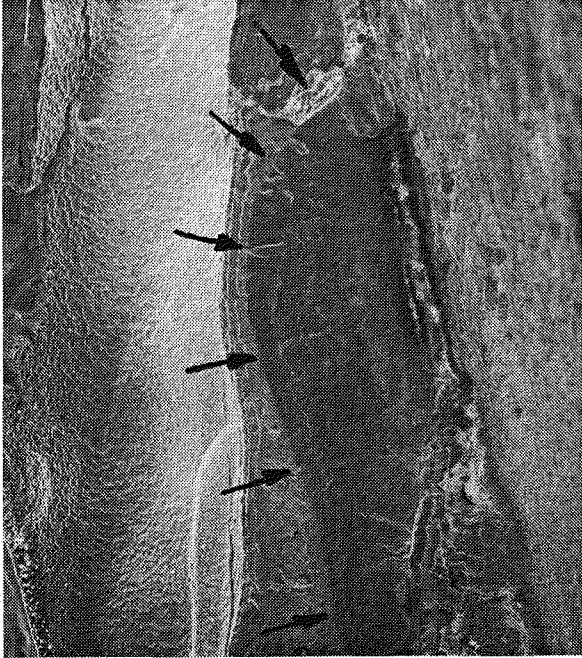
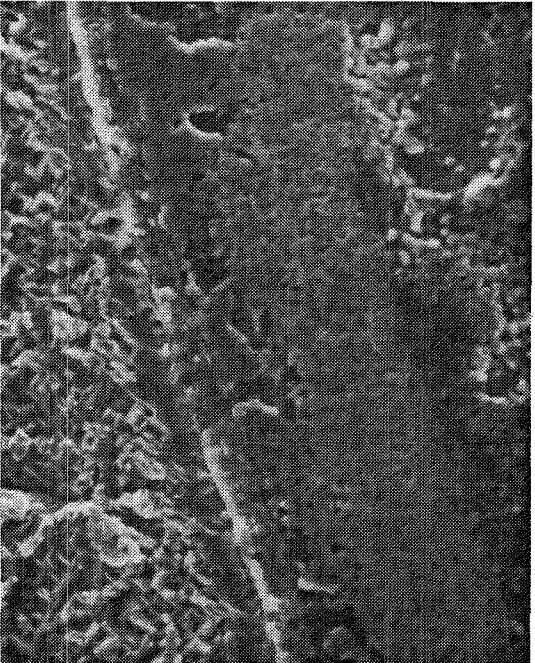
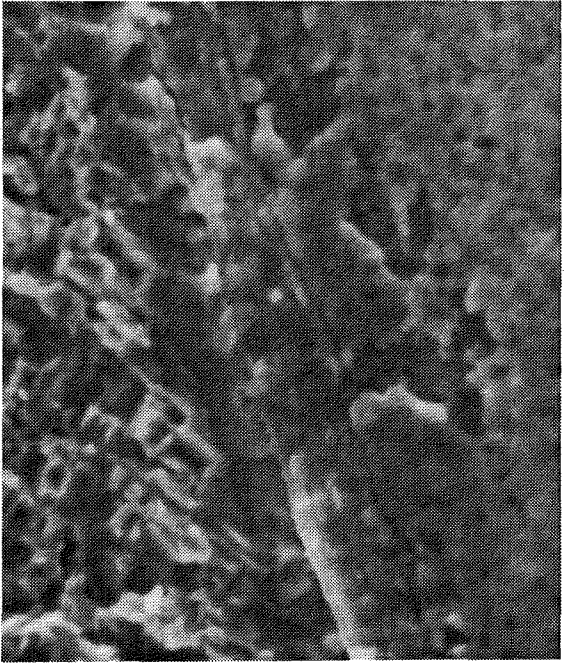
Figure 25. Scanning Electron Micrographs of Fracture Surface of Radial Pressure-Side, Film-Hole Crack.

Arrows Denote Depth of Crack (Rest is Lab Break)

External Airfoil Surface is to the Right; Direction of Crack Propagation is to Left. Note Evidence of Fatigue Propagation Near Crack Extremity.

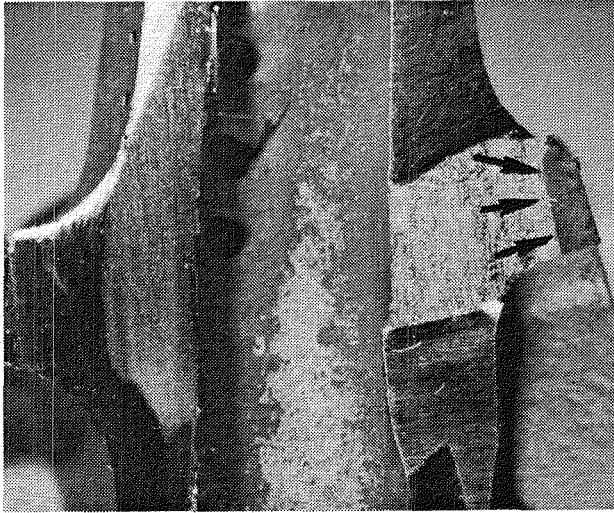
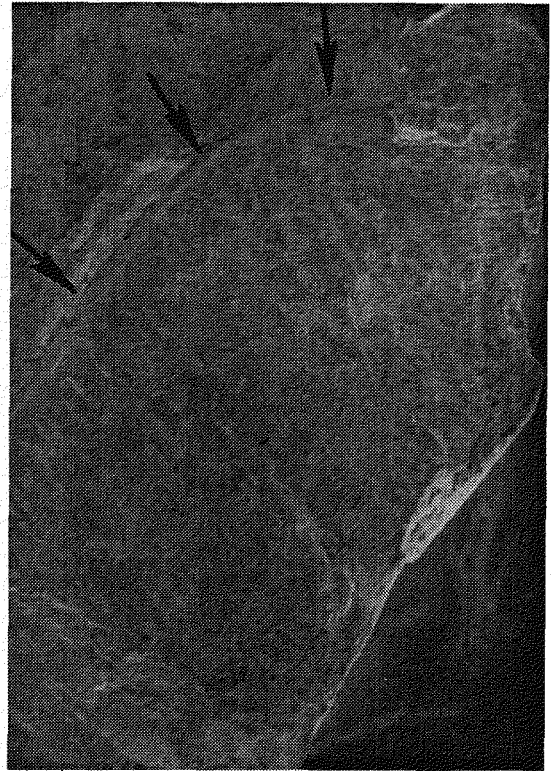
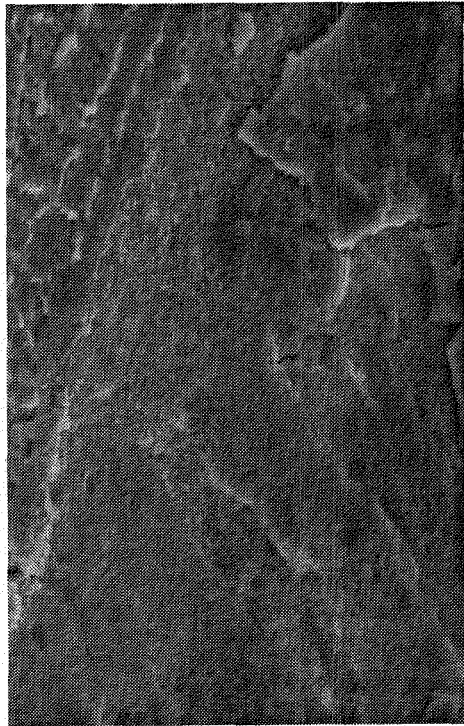
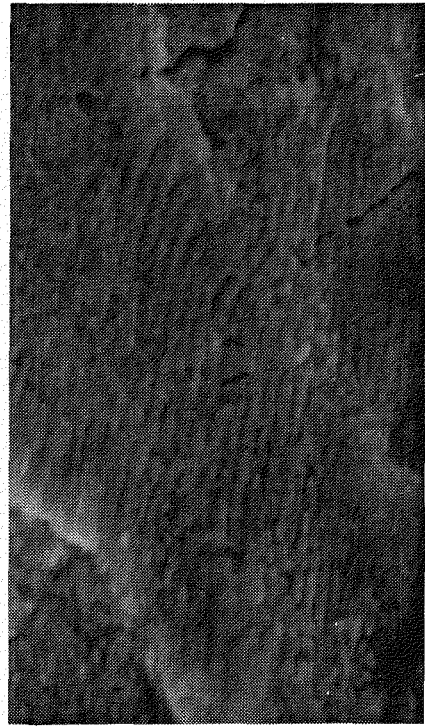
Figure 26. Scanning Electron Micrographs of Fracture Surface of a
Platform Crack.

Convex Platform Crack Fracture Surface
- Depth Denoted by Arrows (Rest is Lab
Break and Saw Cuts).

Note Evidence of Fatigue Propagation in Area of Maximum Crack Depth (Arrows).
