# NASA Technical Memorandum 86306

## INVESTIGATING COMPRESSION FAILURE MECHANISMS IN COMPOSITE LAMINATES WITH A TRANSPARENT FIBERGLASS-EPOXY BIREFRINGENT MATERIAL

MARK J. SHUART AND JERRY G. WILLIAMS

AUGUST 1984

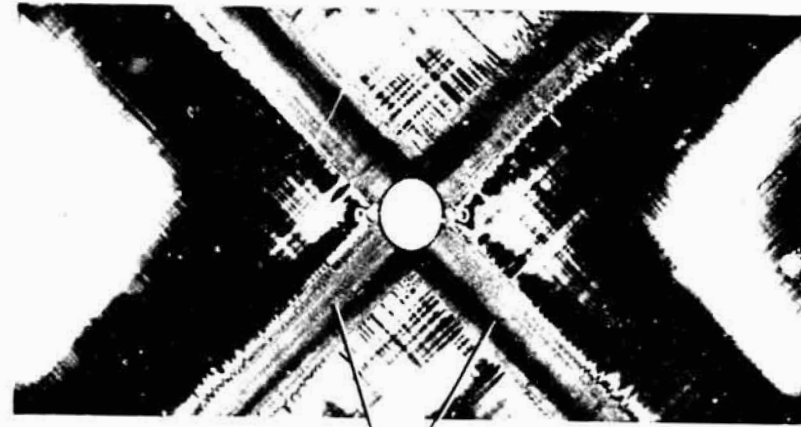
b. specimen with 0.50-in. -  
diameter hole

Experimental results presented in figures 2 and 3 illustrate the value of the birefringent material for observing failure of composite specimens. The specimens shown in figure 2 were loaded and then unloaded. When these unloaded specimens are illuminated with polarized light, the isochromatic fringe patterns on the specimens indicate that plastic deformation has occurred. The pattern on the specimen in figure 2a indicates that high stresses exist in bands oriented at  $\pm 45^\circ$  to the load axis. Using the transformation of stresses for this

Figure 2. Fiberglass epoxy birefringent specimens after being loaded beyond the elastic limit. Both specimens are illuminated with polarized light.

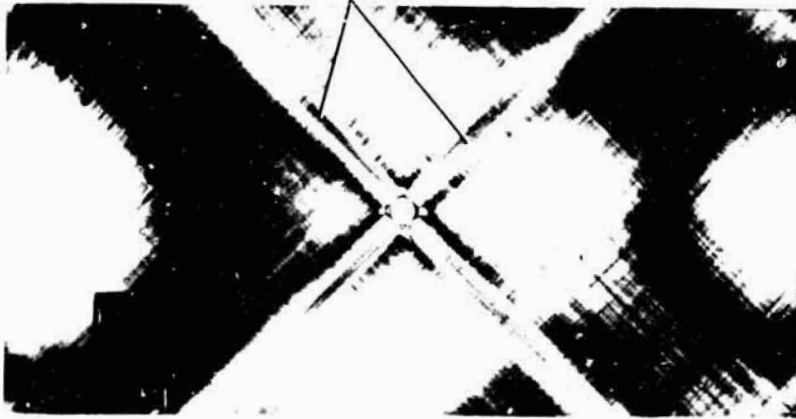
a. specimen with 0.19-in. -  
diameter hole

uniaxially loaded laminate, the inplane shear stress  $\tau_{12}$  is a maximum on elements oriented  $45^\circ$  to the applied load which results in high stresses in the epoxy matrix between fibers. The high stresses in the bands in figure 2a are caused by inplane fiber-matrix shearing in these regions and are identified as matrix-shearing bands in the figure. While the specimen was being loaded, these bands initiated at the hole boundary and grew toward the specimen edges. The specimen shown in figure 2b was loaded further into the plastic range than the specimen shown in figure 2a. This specimen also has matrix-shearing bands, but the isochromatic fringes are not observed in the region of these bands. While the specimen was being loaded, severe internal damage occurred within the bands which disrupted the light path and destroyed the birefringency property. The damage was caused by local delamination and inplane shearing failure mechanisms. When this specimen was illuminated with white light (fig. 3), the damage in the matrix-shearing bands is indicated by the  $\pm 45^\circ$  dark bands. The damage is most severe at the two locations where the hole boundary intersects the horizontal centerline of the specimen, the locations where damage initiated. Closer inspection of the damaged regions reveals a fiber-kinking mechanism that occurs at the boundaries of the matrix-shearing bands. A sketch illustrating this fiber-kinking mechanism in the hole-boundary region is shown in figure 3. The kinking results from a  $+45^\circ$  layer partially restraining the inplane shearing occurring in an adjacent  $-45^\circ$  layer or vice versa. The fiber kinking occurs without fiber breakage due to the flexibility in the matrix provided by extensive shear failures.

MATRIX-SHEARING  
BANDS

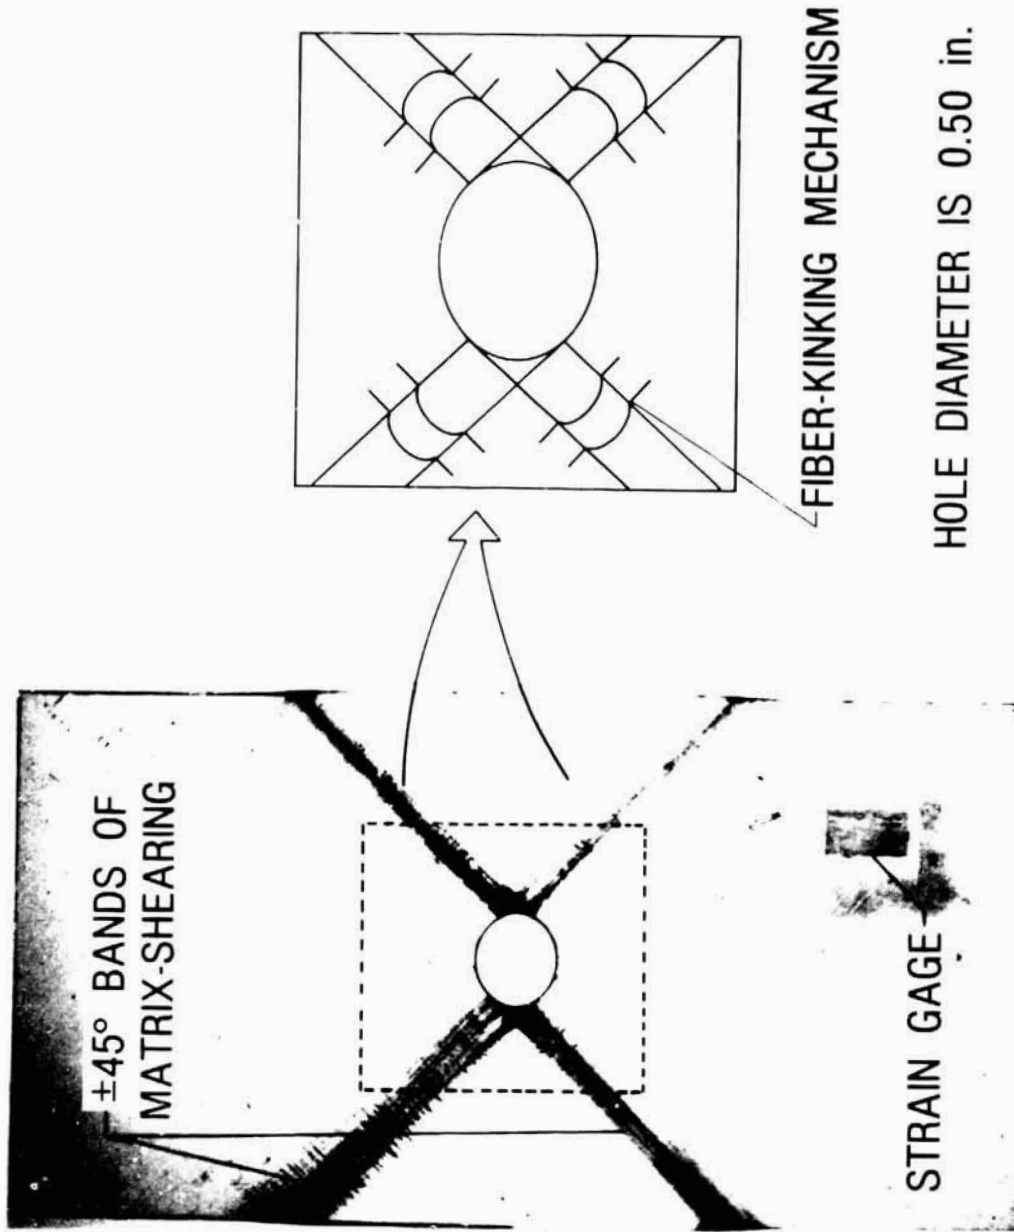
Figure 3. Failed fiberglass-epoxy specimen illuminated with white light.
