EFFECTS OF SURFACE CHEMISTRY ON HOT CORROSION LIFE

FIRST ANNUAL REPORT

**General Electric Company
Aircraft Engine Business Group
Cincinnati, Ohio 45215**

**Lewis Research Center
Contract NAS3-23926**

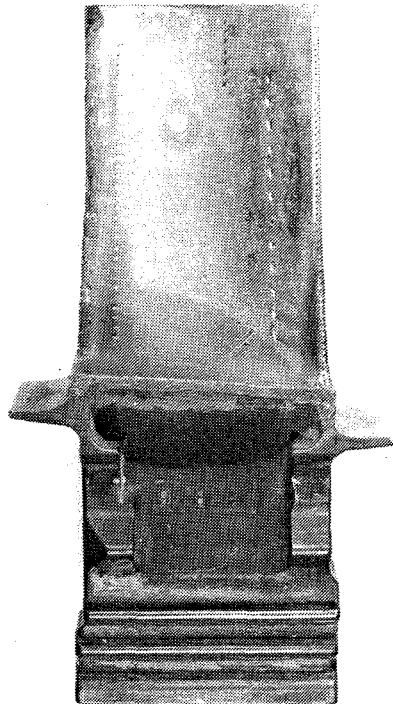
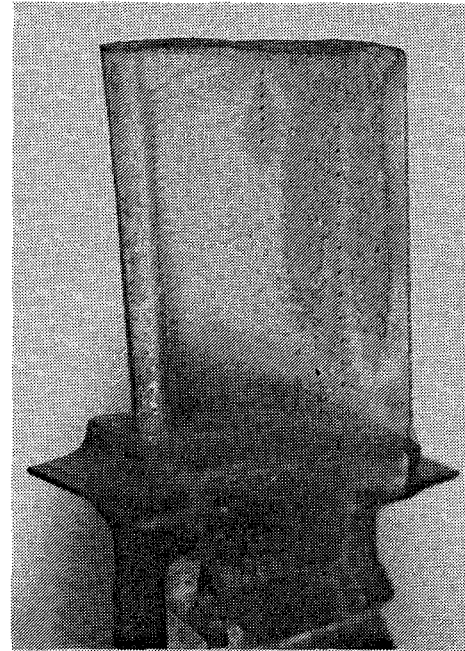
Figure 1a. Stage 1 High Pressure Turbine Blades from CF6-50 Engines.

Southern Asia: A300B
2694 hours, 1560 Cycles

Nothern Africa: A300B
4641 hours, 2169 Cycles

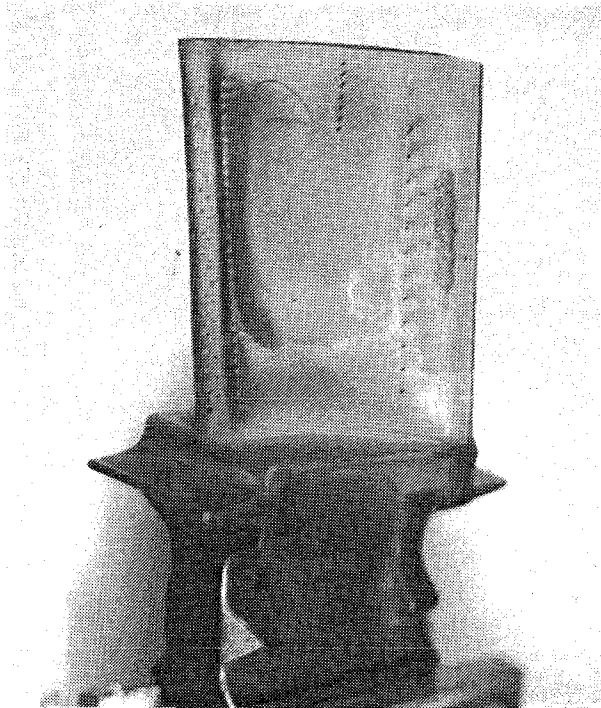
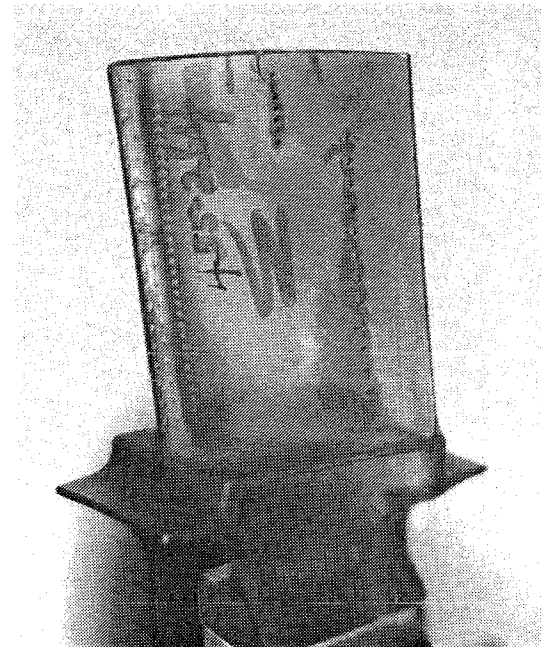
Figure 1b. Stage 1 High Pressure Turbine Blades from CF6-50 Engine.

Southern Africa: A300B
1830 hours, 1471 Cycles

Western Europe: DC10-30
2625 hours, 610 Cycles

This was the least distressed of the four CF6-50 turbine blades. There was faint visual evidence for Type 1 sulfidation within the coating (which was not breached) in the 10% section, at the leading edge and at 60-80% chord, maximum penetration about 45 μm (0.0018 inch). EDAX analysis of the scale showed strong Al and lesser amounts of Ti and Cr. Sulfur was, however, not confirmed.

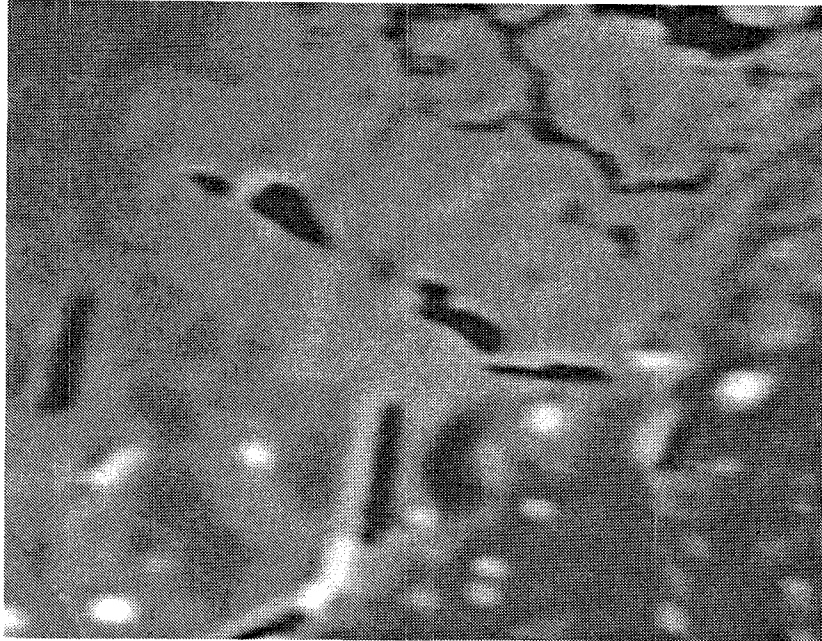
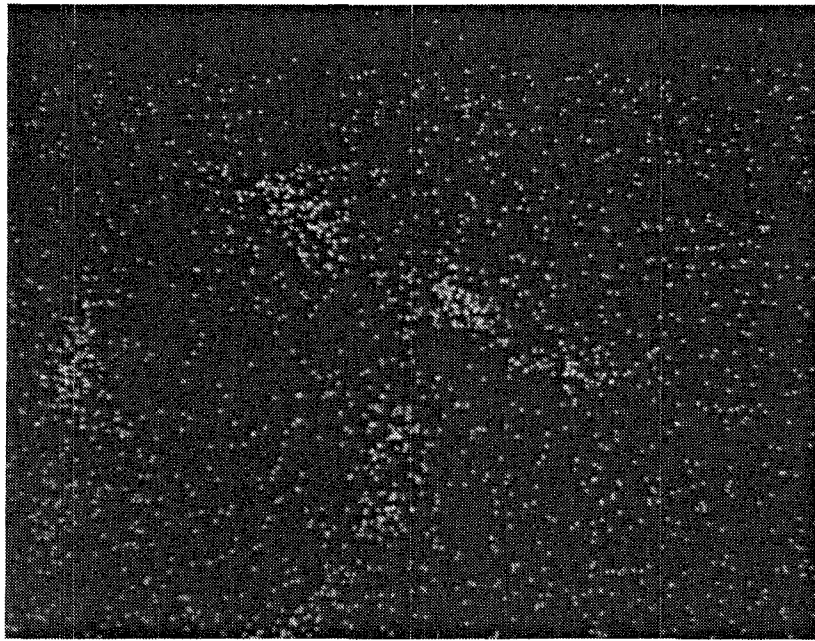
Figure 3. EMP Configuration of Sulfides in the Gray Subsurface Particles Shown in Figure 2. Stage 1 High Pressure Turbine Blade from a Southern Asia CF6-50 Engine (5000X).

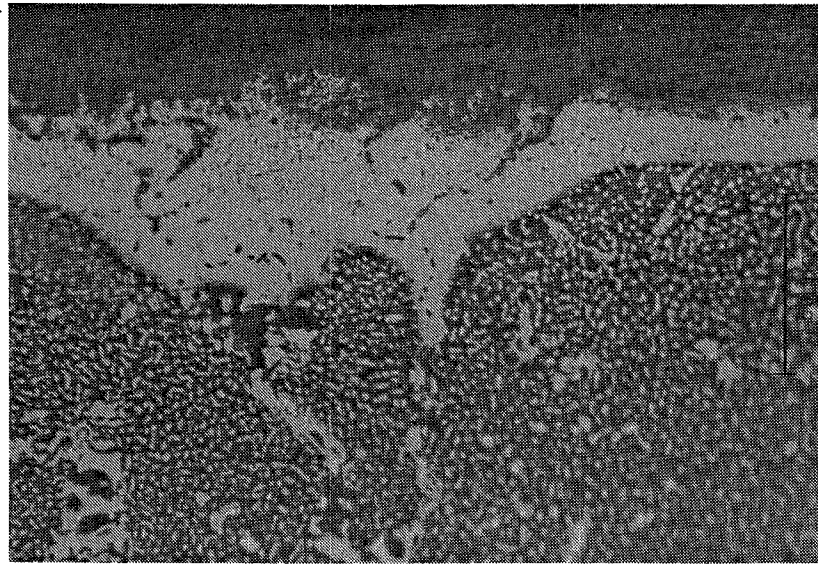
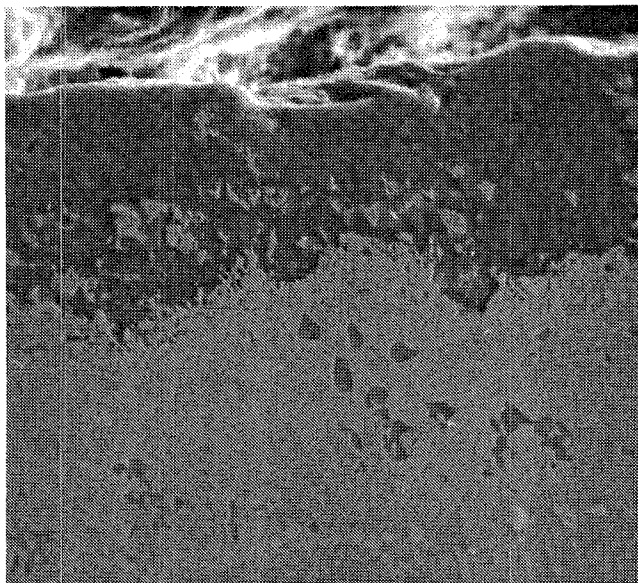
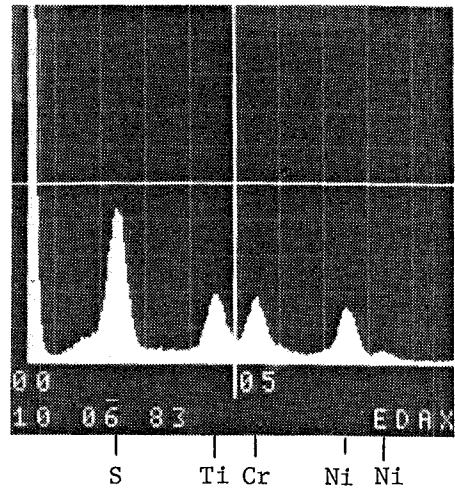
At the 50%/60-90% location, the coating was breached and considerable loss of the substrate alloy had occurred to a total depth of about 230 μm (0.009 inch) including a depletion layer. Type 1 subsurface sulfides were clearly visible as shown in Figure 4, together with strong EDAX confirmation of sulfur, combined with Ti, Cr, and Ni. The scale was Cr and Al rich with some Ti. Although Ca was not observed by EDAX, CaSO_4 was identified by X-ray diffraction from a scale specimen adjacent to the cut region. The depletion zone in the substrate showed lower levels of Cr, Al, and Ti than in the unaffected René 80. At the 80%/50-80% location, similar structures were observed, again to a maximum depth of about 230 μm (0.009 inch).

Figure 4. Photomicrographs at the 50%/60-90% Location on the Concave Airfoil of a Stage 1 High Pressure Turbine Blade from a Northern Africa CF6-50 Engine. The Gray Subsurface Particles in (b) were Identified by EDAX as Sulfides Containing Ni, Cr, and Ti.

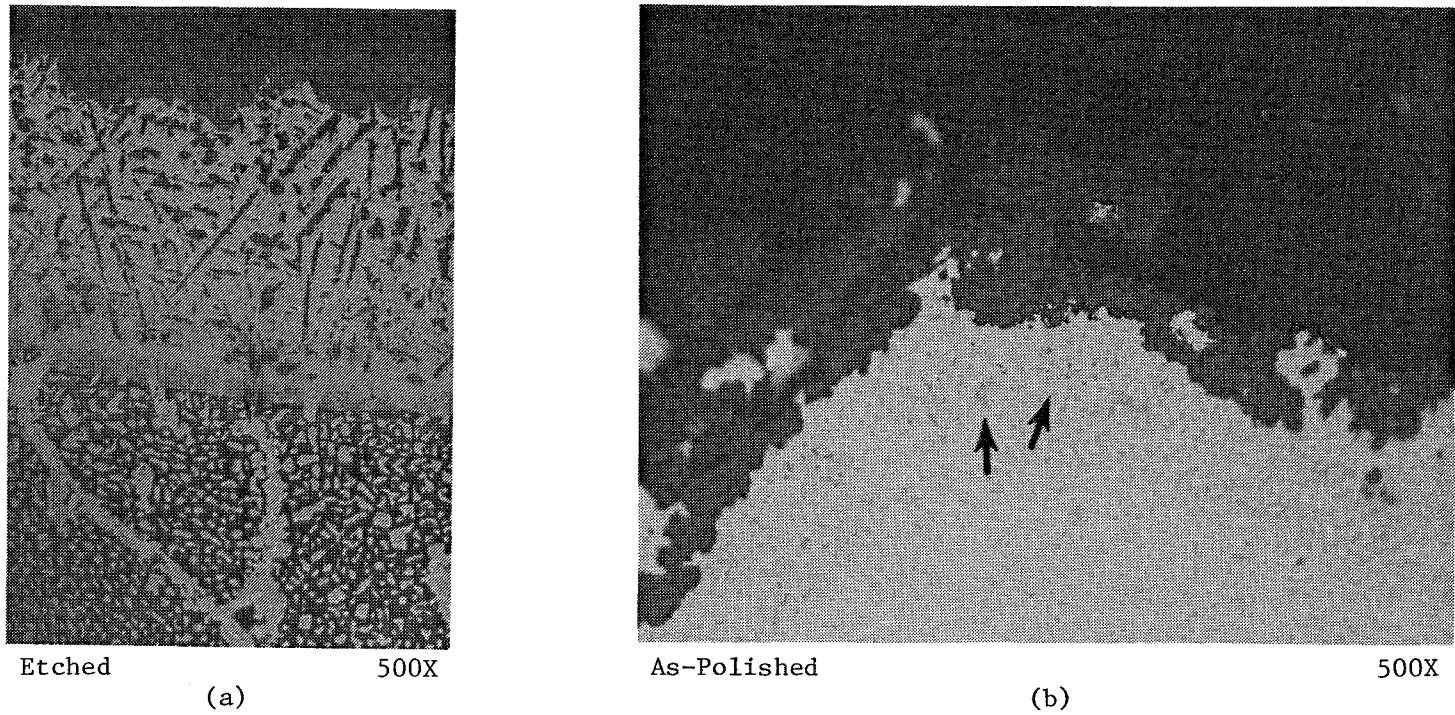
For this blade, the maximum distress of about 180 μm (0.007 inch) was observed at the 60%/90% location and showed the structural features of oxidation only (Figure 5a). No sulfides were found by EDAX examination. The scale contained substantial amounts of Ca and some Fe (from the environment) as well as Al.

Figure 5. Photomicrographs at the (a) 60%/90% Location on the Concave Airfoil and (b) 10%/LE Location of a Stage 1 High Pressure Turbine Blade from a Southern Africa CF6-50 Engine.

(a) Conventional Oxidation with No Evidence of Sulfides

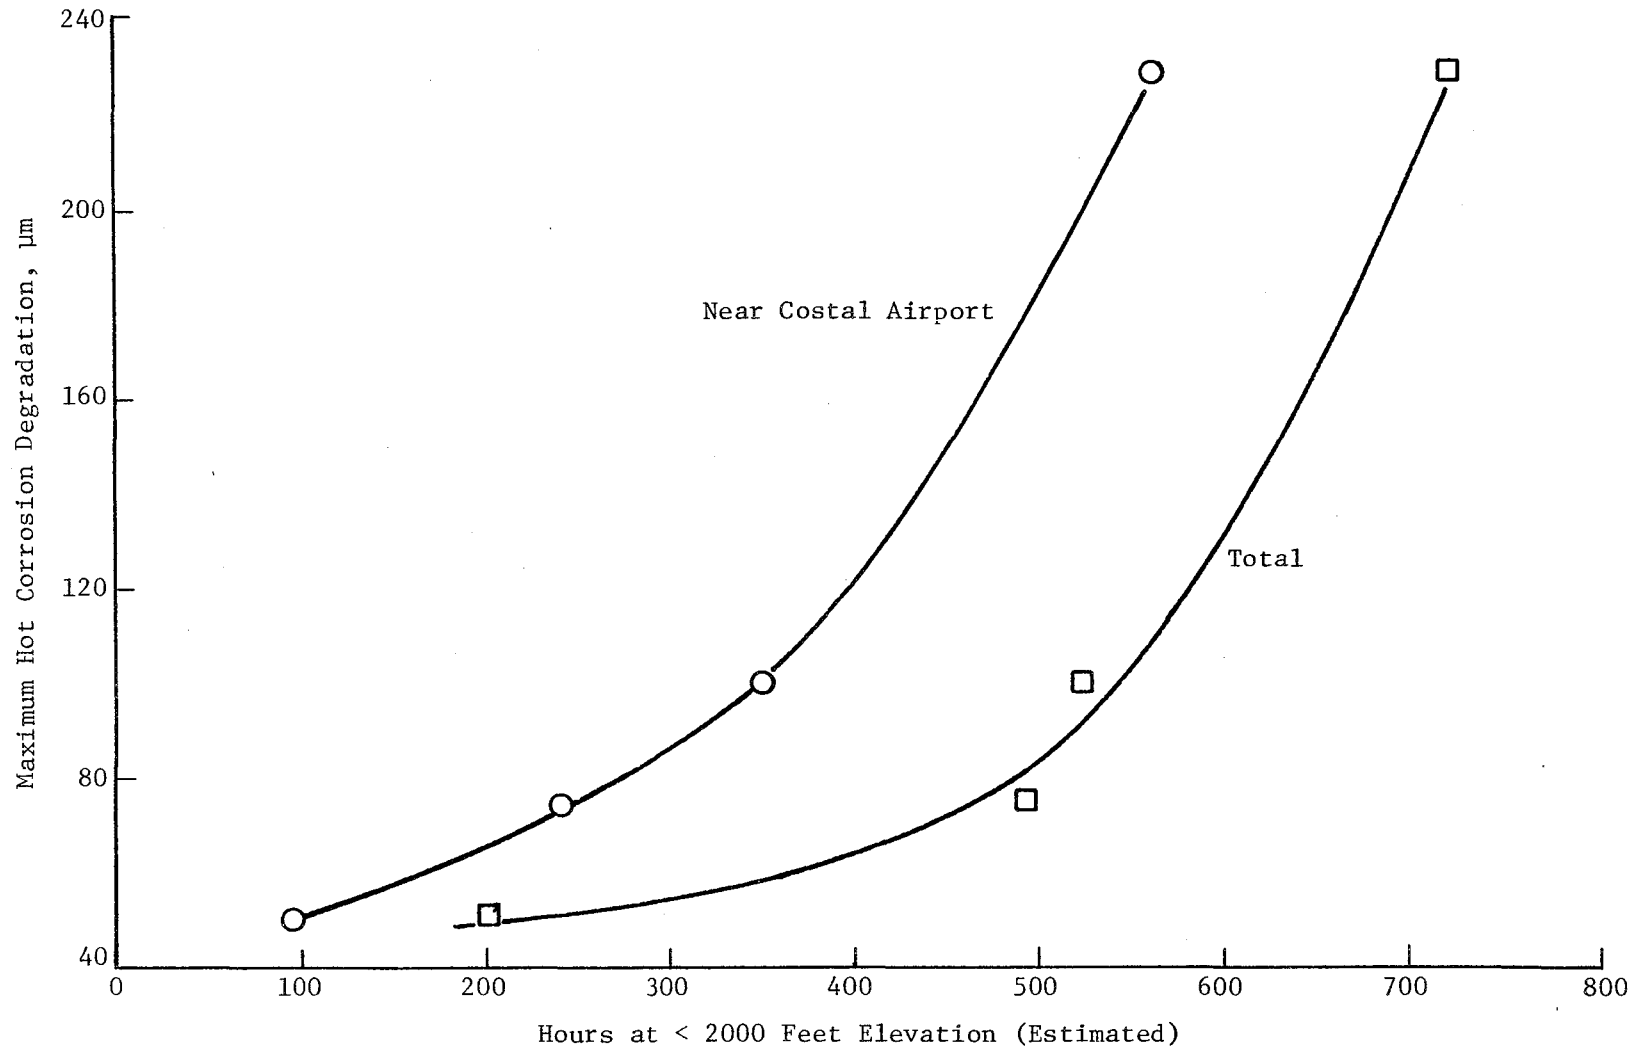
Alternatively, the trends shown in Figure 7 may reflect total times at takeoff/thrust reverse (higher) temperatures, a parameter which is clearly related to total hours at low altitudes. This is shown in rate units (Figure

Figure 7. Hot Corrosion Degradation for CF6-50 Stage 1 High Pressure Turbine Blades as Function of Time at Less Than 2000 Feet Elevation.

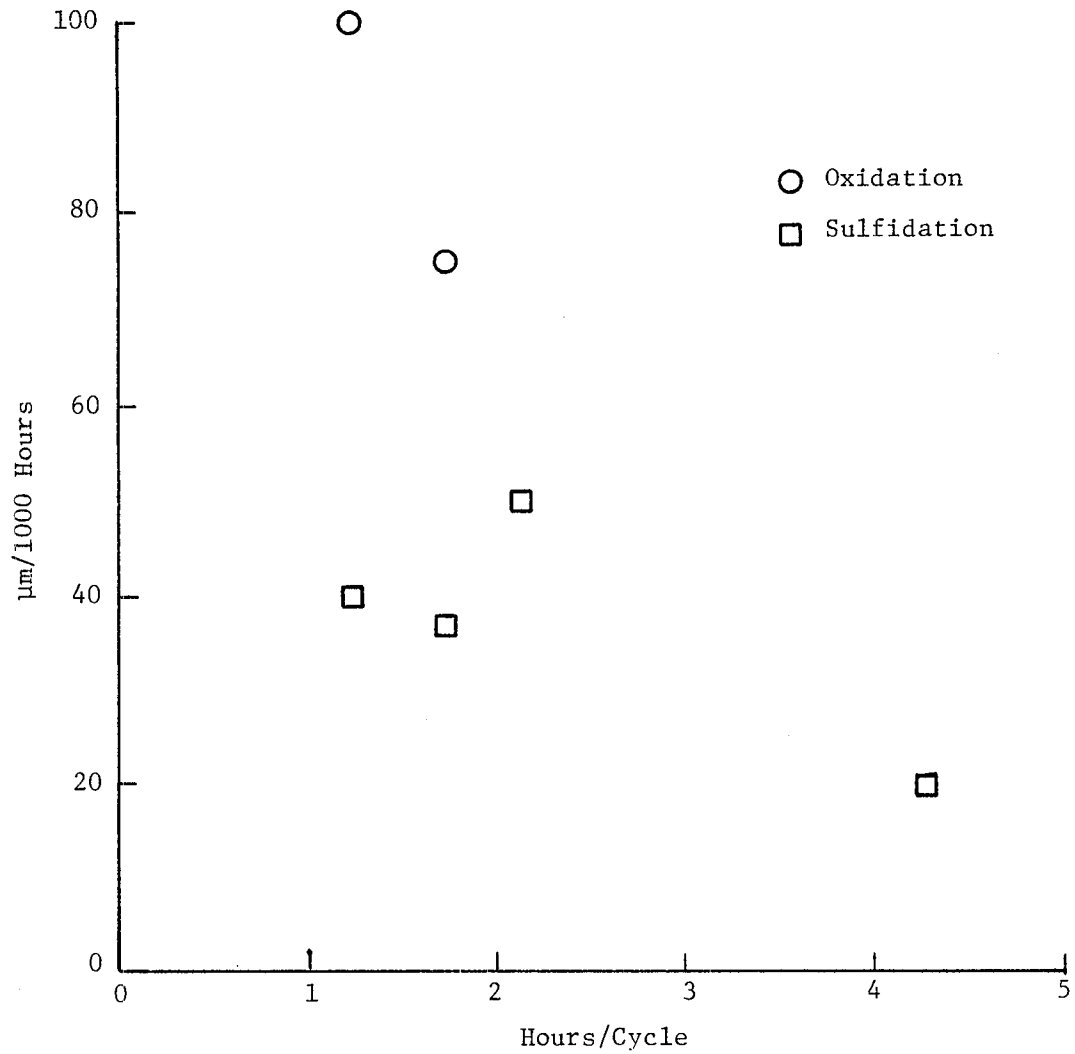
Figure 8. Maximum Degradation Rates for CF6-50 Stage 1 High Pressure Turbine Blades as Function of Average Mission Duration.

8). The highest rates correspond to the shortest lengths of mission for which the percentage of time at higher temperatures (or lower altitude) is greater.

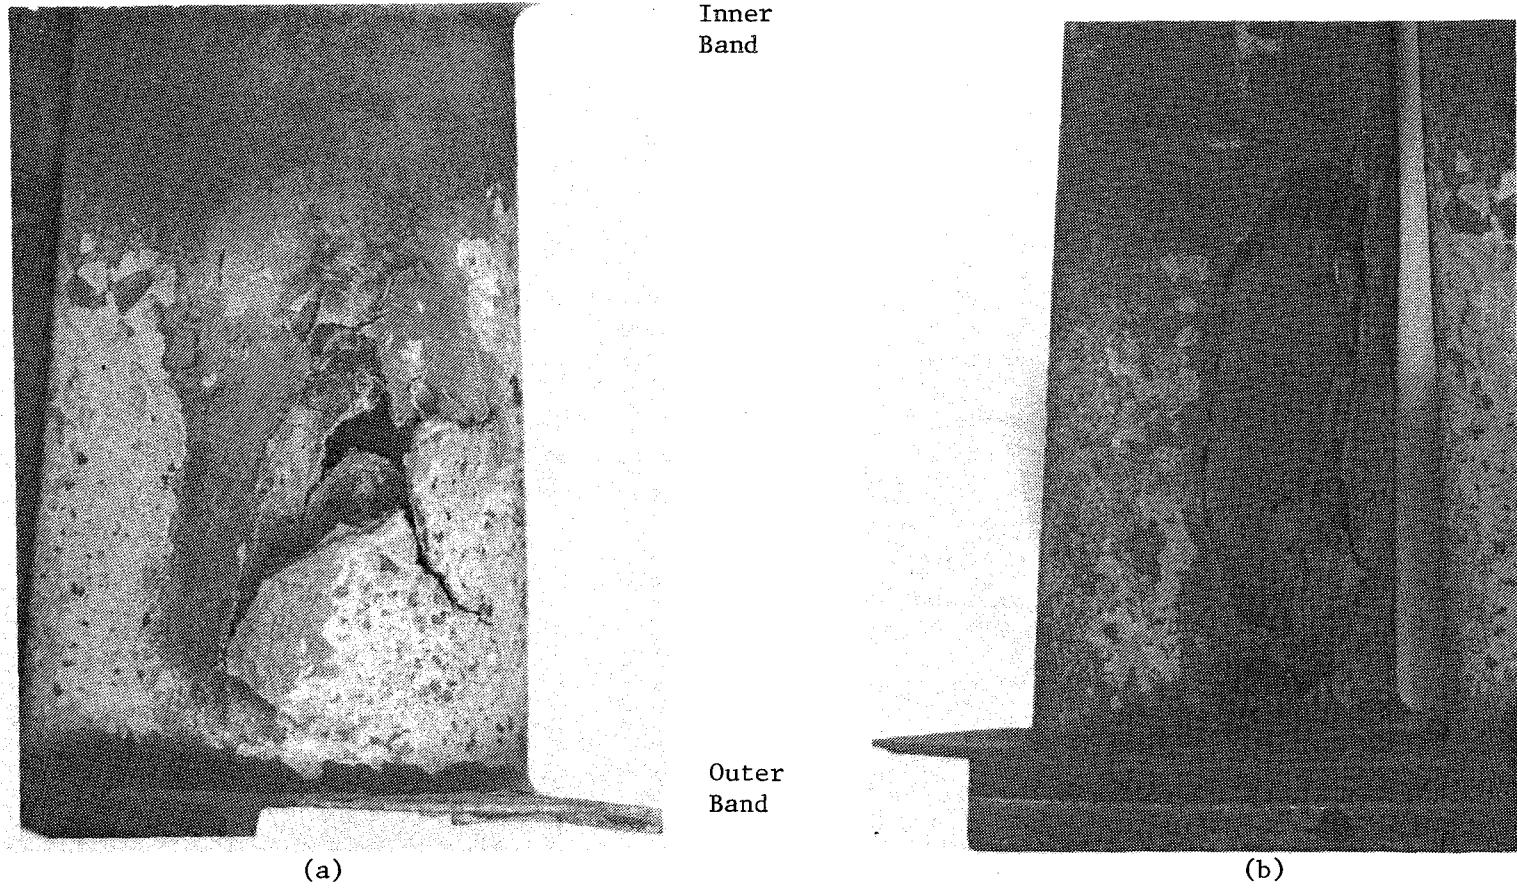
may not evaporate during high altitude operation in subsequent missions. This is particularly true of the relatively stagnant internal cavities. In the present example, inside-out corrosion from such deposits was so severe as to penetrate through the airfoil in some locations. The present evaluation, however, is confined to external surfaces which can be unambiguously related to operating parameters and to degradation of other components elsewhere in the engine. Photographs of two adjacent vanes are shown in Figure 9.

Figure 9. Stage 1 Low Pressure Turbine Vanes from a South America CF6-50 Engine, 15,155 hours of Service.

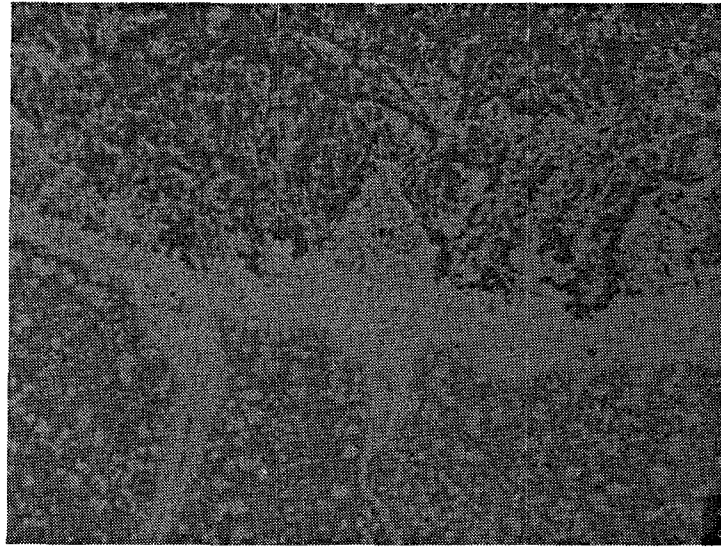
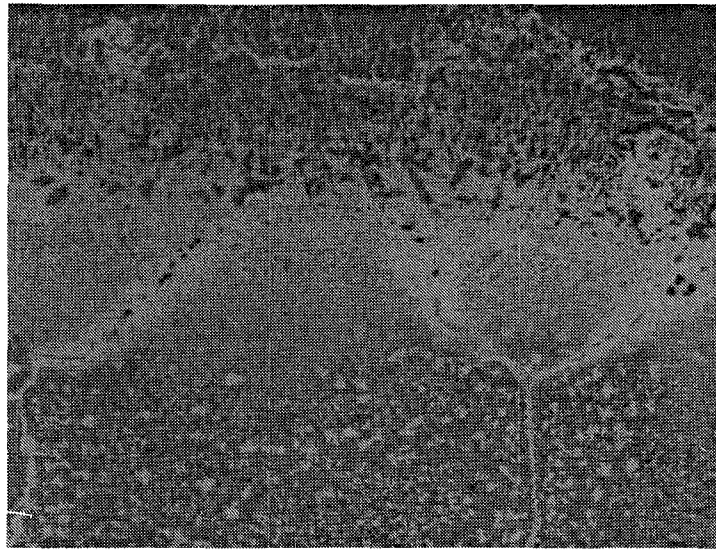
Metallographic sections were prepared for the 80% span of both of these vanes (measured outwards from the inner flange). Type 1 sulfidation was prevalent and extensive at many locations on both concave and convex surfaces - unlike high pressure turbine blades where very little degradation occurs on the convex surface. Maximum attack was about 400 μm (0.016 inch), including depletion zone, at several locations on both sections examined. There was no evidence of Type 2 corrosion. Typical microstructures are shown in Figure 10, and EMP evidence for subsurface sulfides in Figure 11. The scale is rich in Ni and Cr, low in Al, and the γ' -free region of the René 77 is typically depressed in Cr, Al, and Ti.

Figure 10. Photomicrographs Showing Type/Sulfidation on a Stage 1 Low Pressure Turbine Vane from a South American CF6-50 Engine.

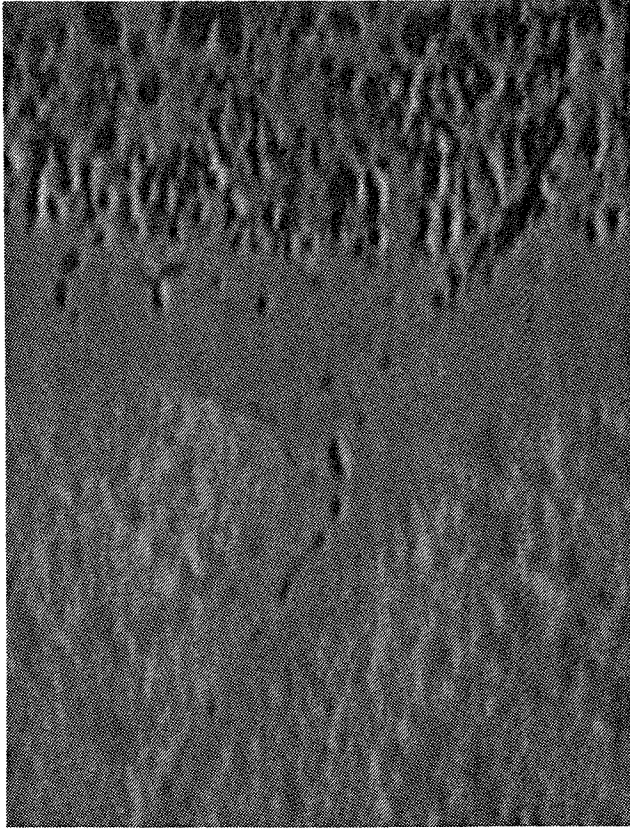
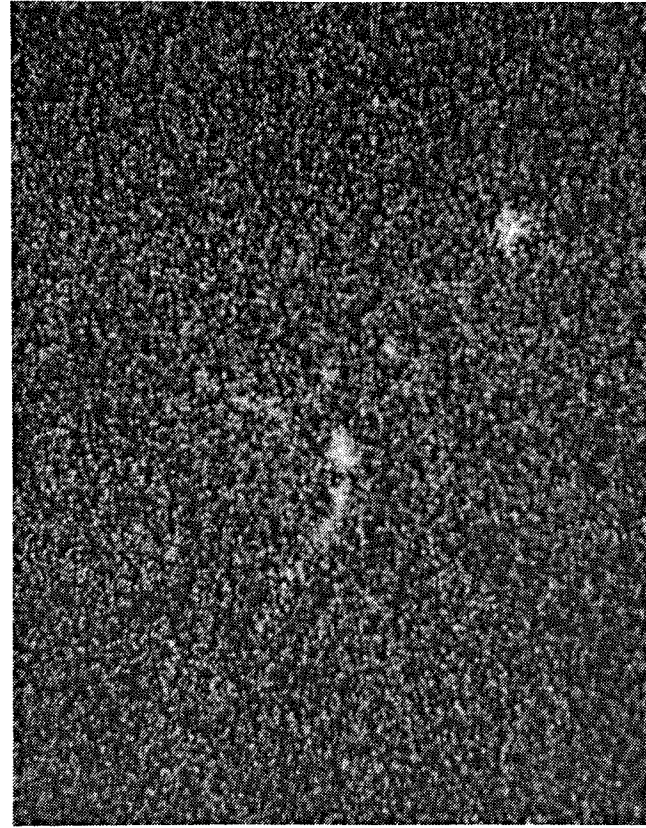
Figure 11. EMP Confirmation of Sulfides in the Gray Subsurface Particles Shown in Figure 10. Stage 1 Low Pressure Turbine Vane from a South America CF6-50 Engine (2000X).

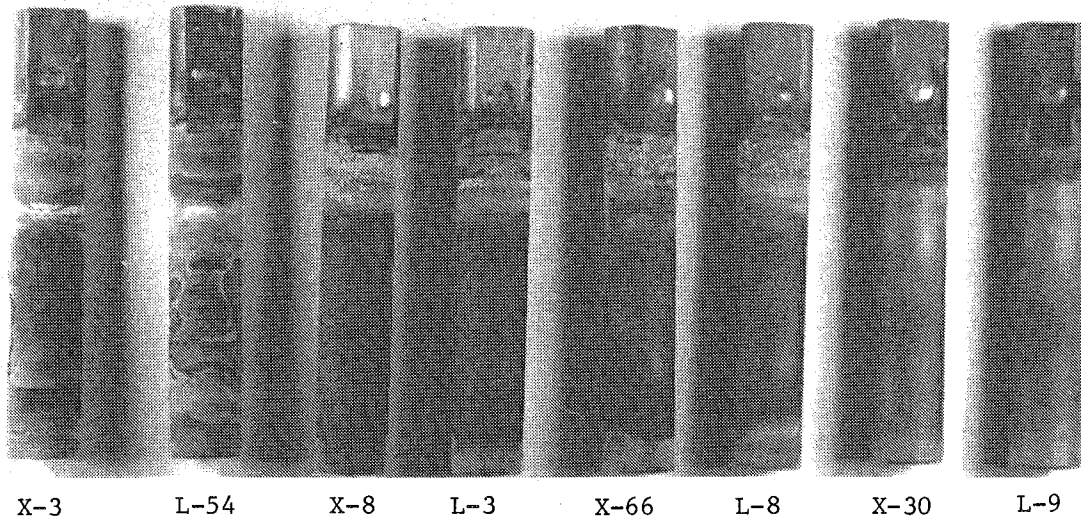
Figure 22. Uncoated U700 (X-3) Removed from Test After 142.65 hours, Rig 1.

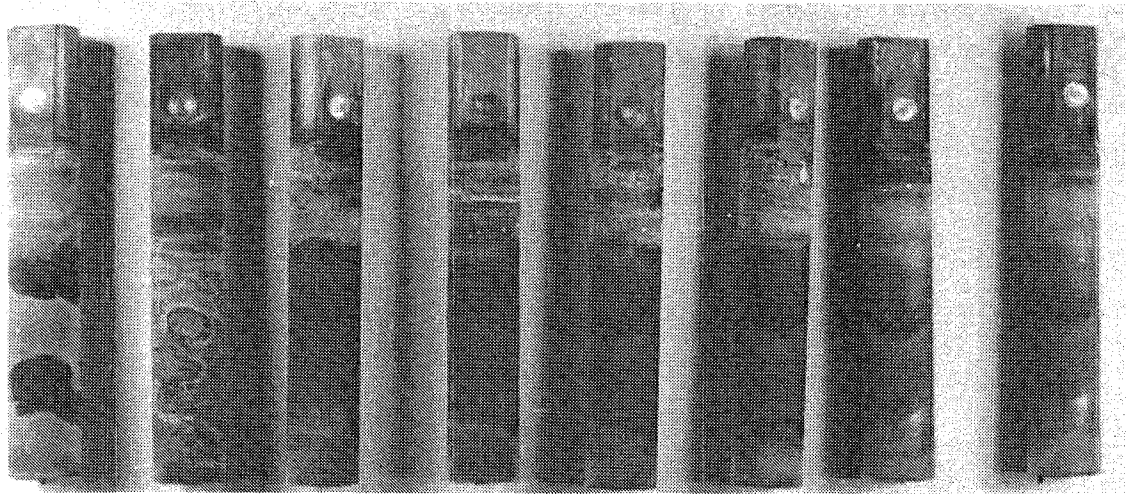
Figure 23. Uncoated René 80 (L-77) Removed from Test after 167.7 hours, Rig 2.

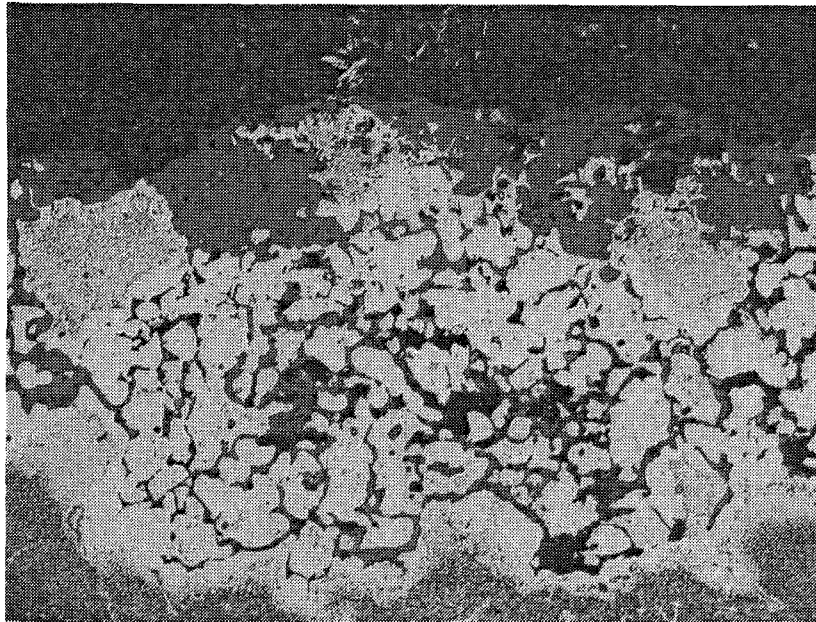
(a) U700, 142.65 hours

(b) René 80, 167.7 hours

Figure 24. Photomicrographs of Specimens from Burner Rig Tests. Type 1 Sulfides are Present (Etched, 200X).
