FIELD TEST EXPERIENCE

R.W. Weaver
Jet Propulsion Laboratory
California Institute of Technology
Pasadena, California 91109

As a part of the Flat-Plate Solar Array Project (FSA), a field-test program was developed to obtain solar photovoltaic (PV) module performance and endurance data. These data are used to identify the specific characteristics of module designs under various environmental conditions. The information obtained from field testing is useful to all participants in the National Photovoltaics Program, from the research planner to the life-cycle cost analyst.

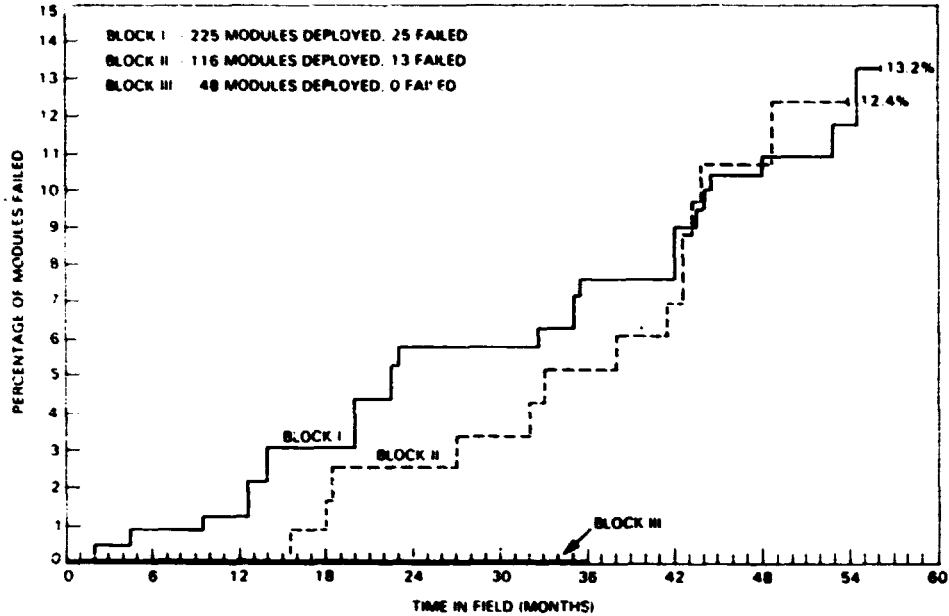
Figure 5. Blocks I, II and III Results

In the nearly five years of field testing Blocks I, II and III modules, almost 10% failed the performance test. Many more experienced physical degradation that did, or would eventually, result in an unserviceable module. The plot in Figure 5 depicts performance failures as a function of time in the field. The curves show that for the Blocks I and II modules failure rate increased over the last 18 to 24 months. This means that more modules (per module deployed) were failing after the first three years than before that time. This leads to the conclusion that there is definitely a time-versus-design correlation for field failures.

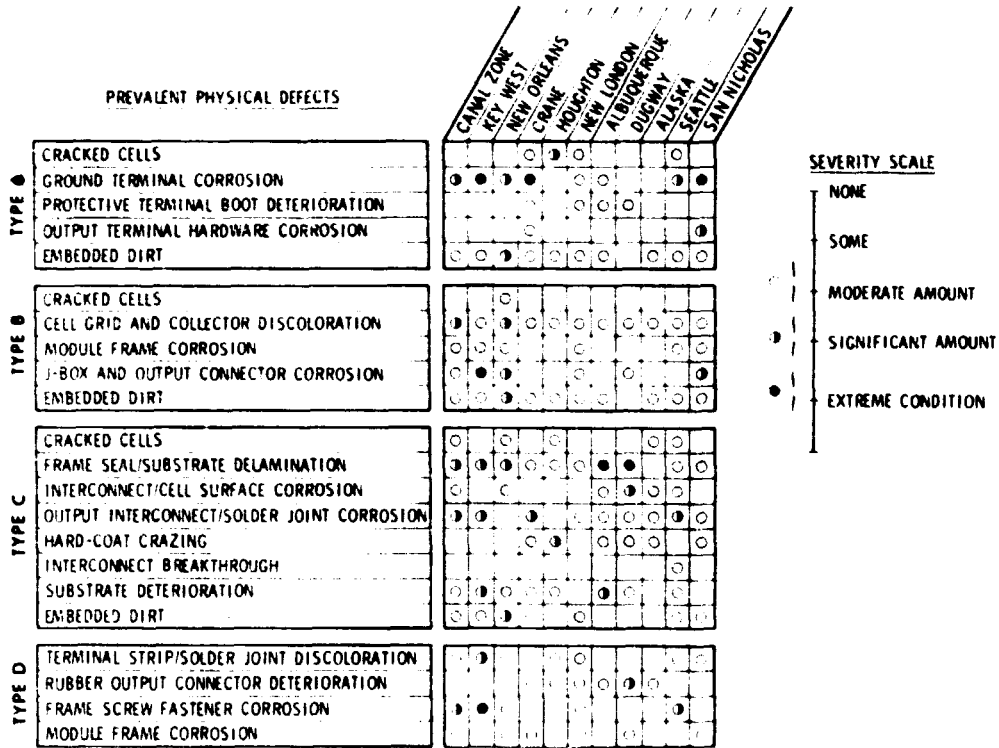
Figure 6. Physical Inspection Summary of Remote-Site Modules

The results of the physical inspections are shown in the chart in Figure 6 for the Blocks I and II modules (type refers to manufacturer). The defects are ranked by severity for each site and type. No site stands out as being more severe than any other in the chart. However, when the performance data are also considered, the sites with hot-humid climates clearly have more severe environments.
