NASA Technical Memorandum 85679

VERTICAL DROP TEST OF A TRANSPORT FUSELAGE SECTION LOCATED FORWARD OF THE WING

M. Susan Williams
Robert J. Hayduk

August 1983

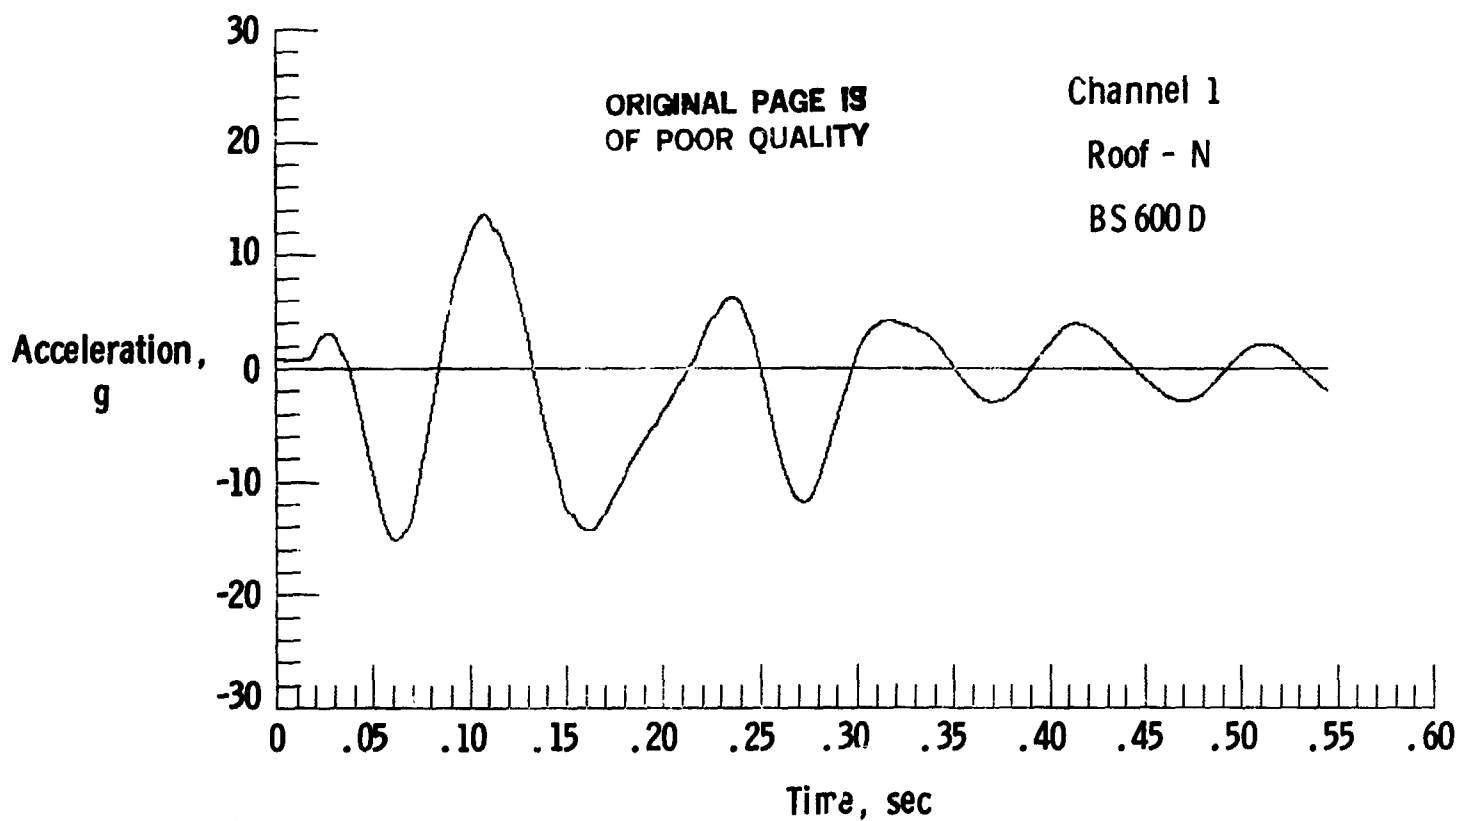
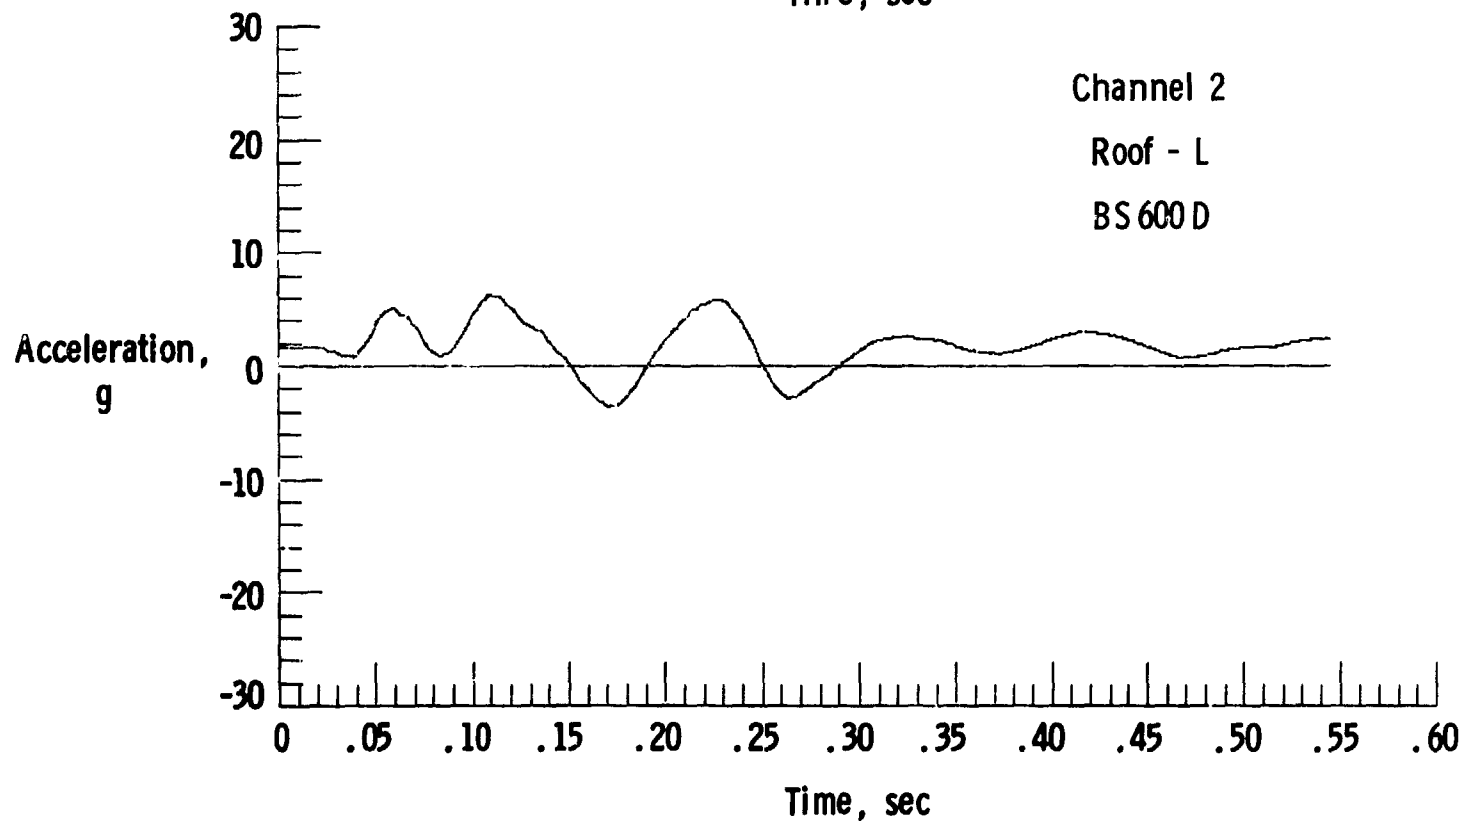
The highest normal acceleration level measured occurred, surprisingly, at the roof. The roof normal accelerometers at BS 600D and 600H (figures 9r and 9s) show an oscillatory rather than pulse response, as exhibited on the floor and undercarriage. Nearly 24 g for 0.04 sec was measured during the first half wave at BS 600H. This oscillatory response at the roof is in the 10 to 12 cycle per second range, clearly at structural vibration levels.

(r) Structural acceleration time histories.
Figure 9.- Continued.

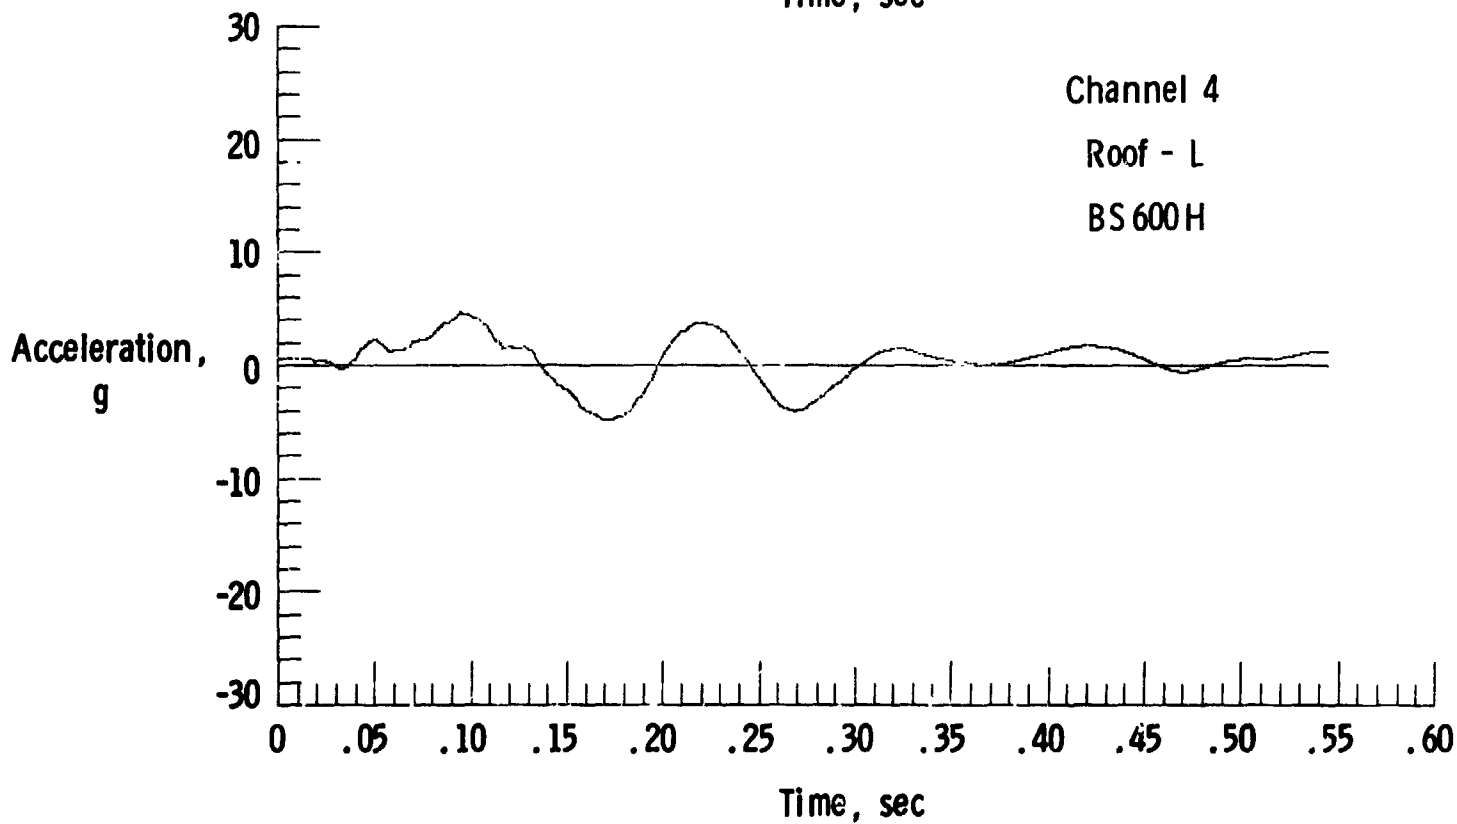
(s) Structural acceleration time histories.
Figure 9.- Concluded.
