Flight Service Evaluation of Kevlar-49 Epoxy Composite Panels in Wide-bodied Commercial Transport Aircraft

Ninth Annual Flight Service Report

R.H. Stone

LOCKHEED-CALIFORNIA COMPANY
BURBANK, CALIFORNIA

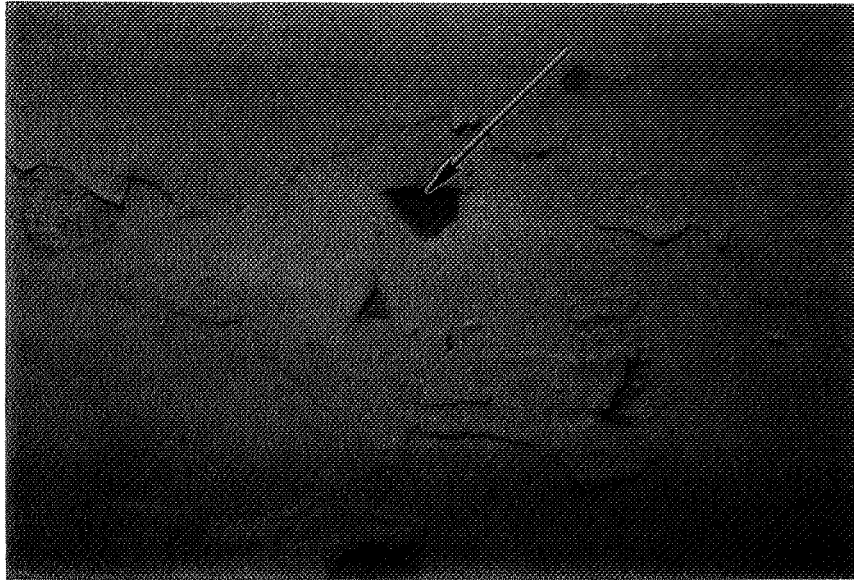
1. A deep gouge in the upper center area of the panel exterior, 0.4 by 0.6 cm (5/32 by 1/4 in.), had not changed in size or appearance since the previous inspection (figure A-1). This was first observed in 1978.

Figure A-1. - Air Canada left-hand wing-body fairing -
deep gouge on exterior.

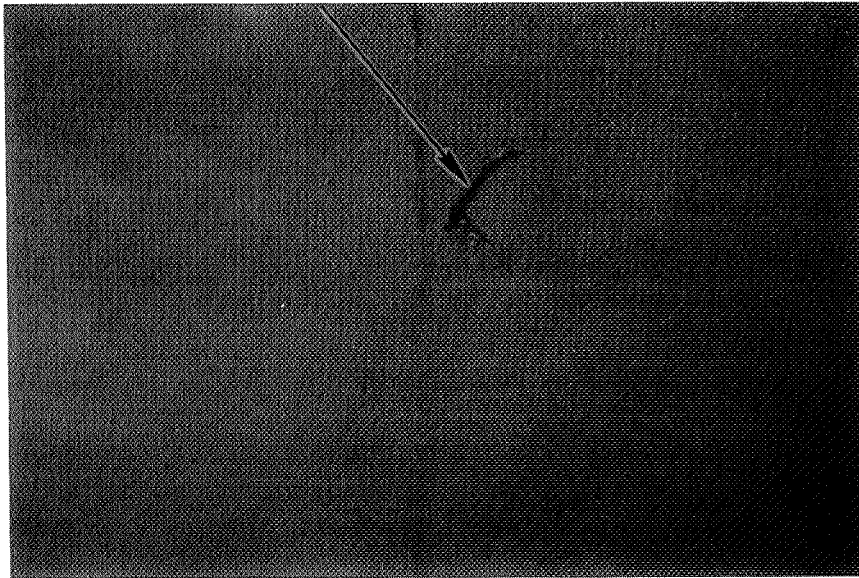
4. Two cracks on the inner surface had not changed in size or appearance since the previous inspection of the inner skin in 1980. One was a 0.8 cm (5/16 in.) crack in the upper forward area first observed in 1978; and the other was a 1.3 cm (1/2 in.) crack first observed in 1980 (figure A-2).

Figure A-2. - Air Canada left-hand wing-body
fairing - 1.3 cm (1/2 in.)
crack on inner skin.

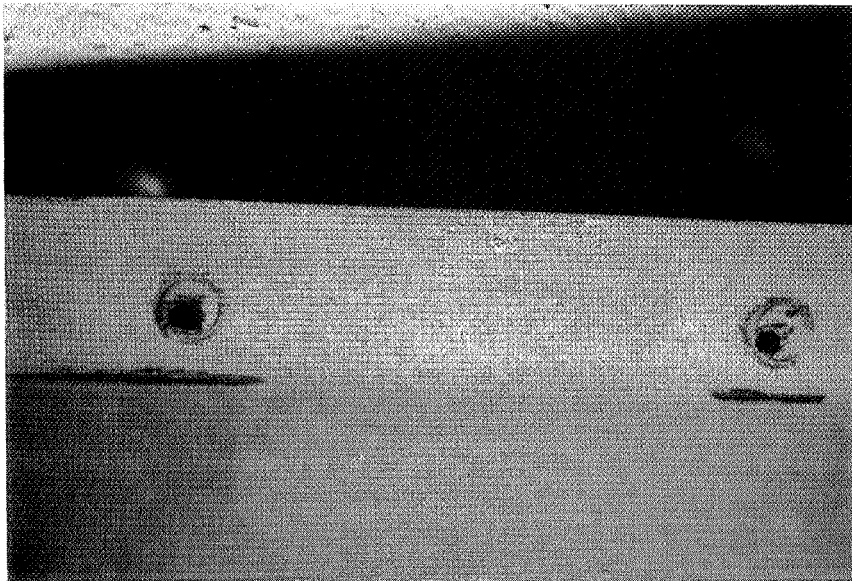
6. Slight fraying was observed on all fastener holes, with a greater degree of fraying noted on the aft and lower edges. Slight elongation

was noted on several holes on the upper, aft, and lower edges. These included five holes elongated to 0.55 cm (7/32 in.) from the original 0.5 cm (3/16 in.) dimension, and four holes elongated to 0.6 cm (1/4 in.). The holes on the lower edge had the greatest degree of fraying along with a distinct fastener mark-off (figure A-3). These conditions have not changed significantly since the previous inspections.

Figure A-3. - Air Canada left-hand wing-body fairing - frayed holes on lower edge with mark-off.

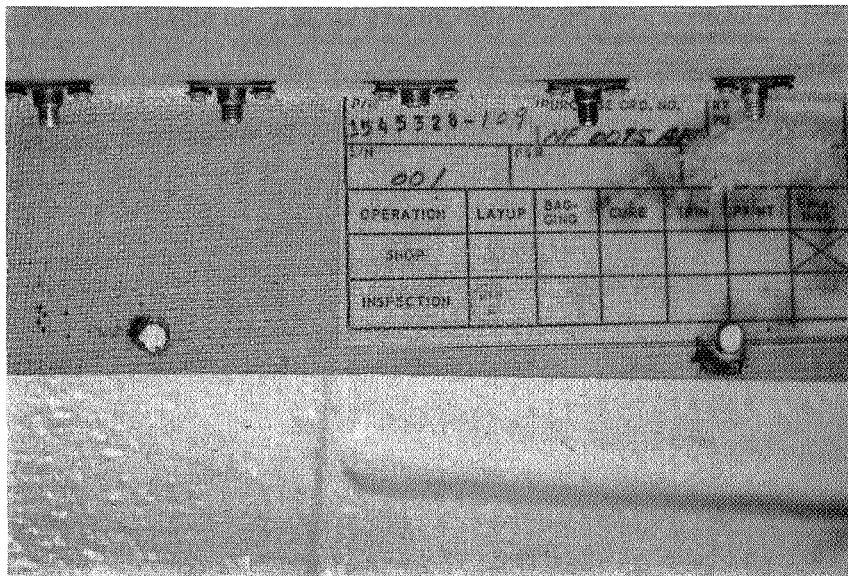
Figure A-4. - Air Canada left-hand underwing fillet - frayed and elongated fastener holes.

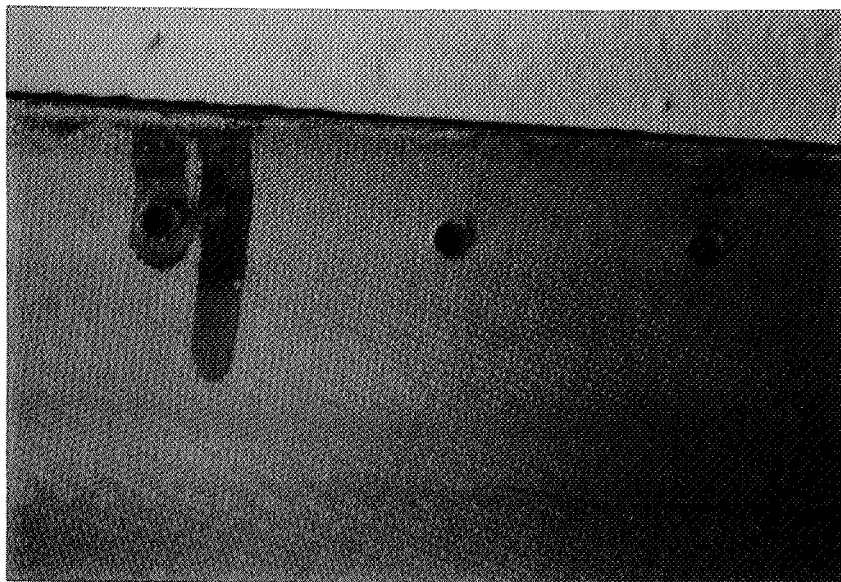
3. Slight fraying was observed on all fastener holes, but the degree of fraying on this component is less than other Kevlar-49 aft engine fairings. About one-third of the fastener holes are noticeably more frayed than the other holes (figure A-5).

Figure A-5. - Air Canada right-hand aft engine fairing - frayed holes.

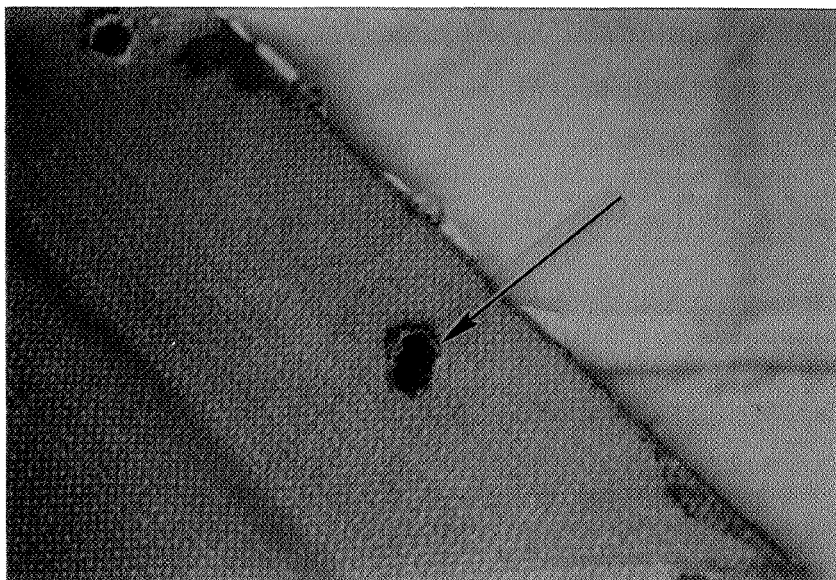
4. Several holes had a slight amount of elongation. Three holes were elongated to 0.55 cm (7/32 in.) from the original 0.5 cm (3/16 in.) diameter, and one hole was noted to be a double hole with a maximum 0.7 cm (9/32 in.) dimension (figure A-6). This was out of approximately 110 fastener holes on the aft engine fairing, so the incidence of hole elongation was very minor.

Figure A-6. - Air Canada right-hand aft engine fairing - badly elongated hole.

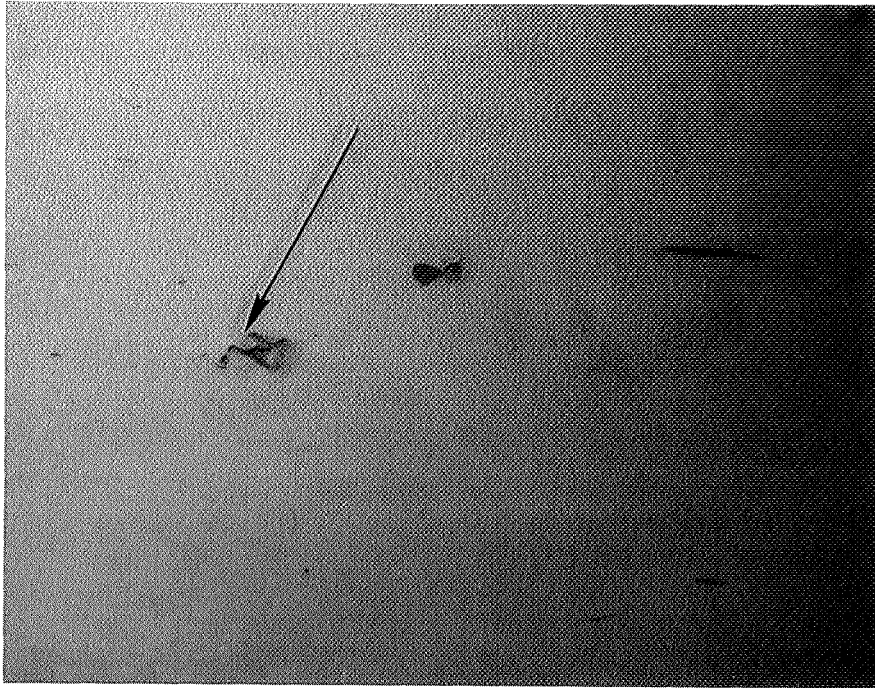
1. Two cracks were observed on the exterior surface: a deep gouge in the upper aft area first noted in 1981 (figure B-1), and a small 0.3 cm (1/8 in.) crack in the same area which was also first noted in 1981. The deep gouge was measured at 0.8 cm (5/16 in.) length with delamination extending about 0.3 cm (1/8 in.) beyond the crack. Repainting made visual comparisons with the 1981 inspection difficult.

Figure B-1. - TWA right-hand wing-body fairing,
gouge on exterior surface.

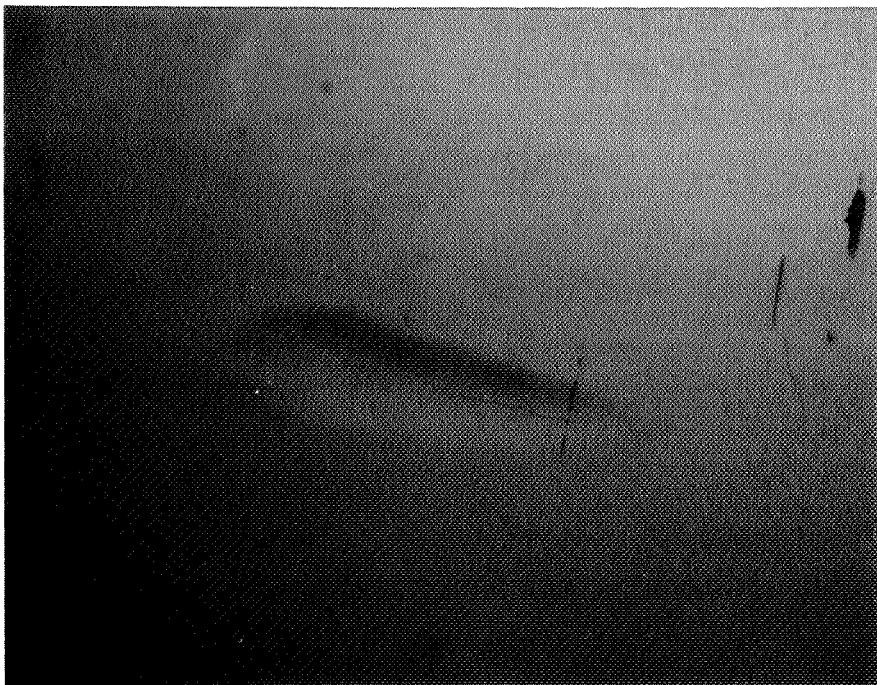
2. Two other small cracks observed in previous inspections were not detected indicating they had been only in the paint.
3. A large teardrop shaped disbonded and crushed area, 11.4 by 2.5 cm (4-1/2 by 1 in.) had not changed in size or appearance since the previous inspection (figure B-2). This was first observed in 1977, and is in the lower forward area of the exterior surface at the probable location of a repair. A small depressed area in the lower forward area of the exterior surface, first observed in 1978, had not changed since the previous inspection. These may represent areas where some force has caused core crushing without skin penetration, and in the smaller area without a skin-core disbond.

Figure B-2. - TWA right-hand wing-body fairing -
disbonded and crushed area.

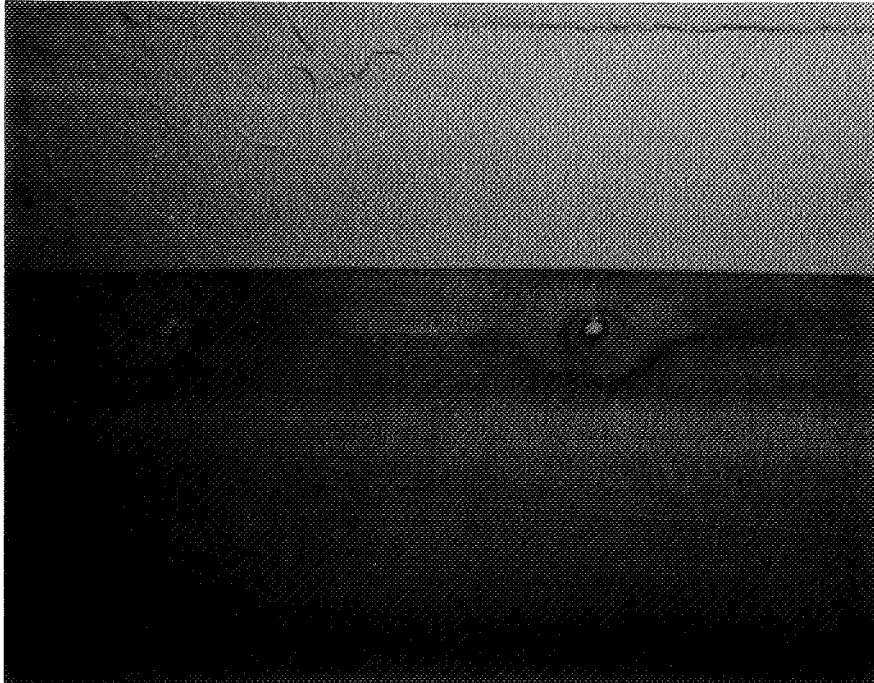
7. Fraying was observed on most of the fastener holes to a slight degree (figure B-3). Fraying was more pronounced on the lower edge, and the five aft holes on the lower edge were very badly frayed.

Figure B-3. - TWA right-hand wing-body fairing -
typical slight fraying of
fastener holes.

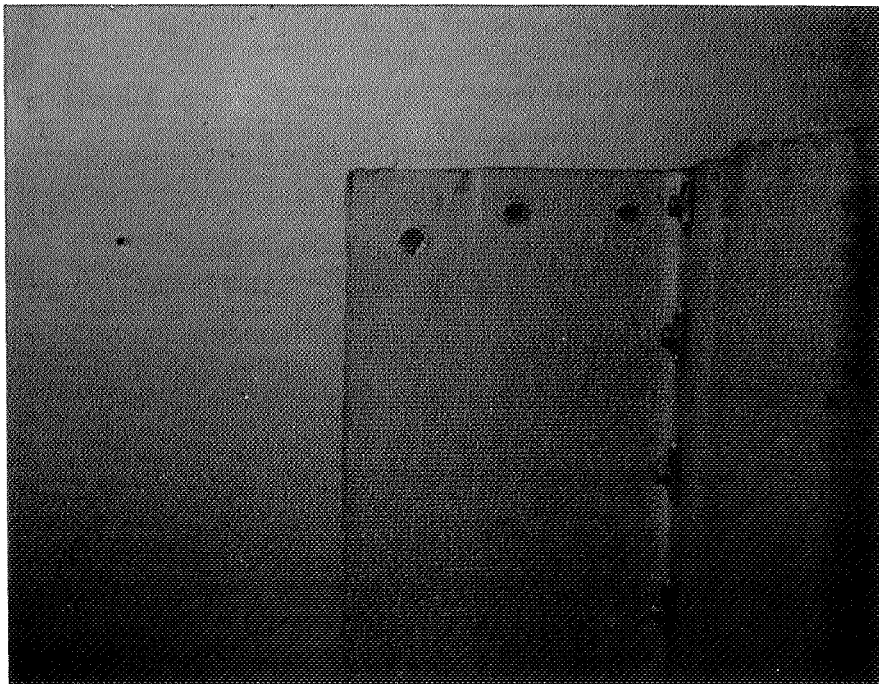
Figure B-4. - TWA right-hand underwing fillet -
frayed fastener holes.

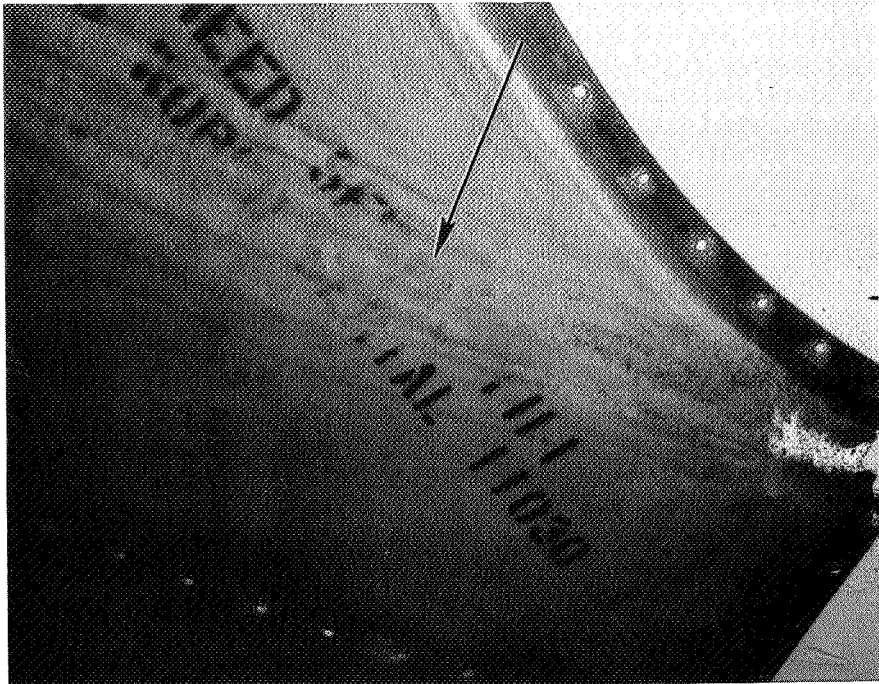
2. There was considerable degradation of the vapor barrier coating on the inner surface by Skydrol, particularly in the aft area (figure B-5).
3. The fastener holes showed very little fraying. All of the fastener holes were redrilled when this part was reinstalled (reference 2), and the drilling was performed after curing an outer layer of 120 fiberglass over both Kevlar-49 surfaces. The glass completely prevents the typical frayed condition of Kevlar-49 fastener holes.

Figure B-5. - TWA left-hand aft engine fairing -
Skydrol attack on vapor barrier

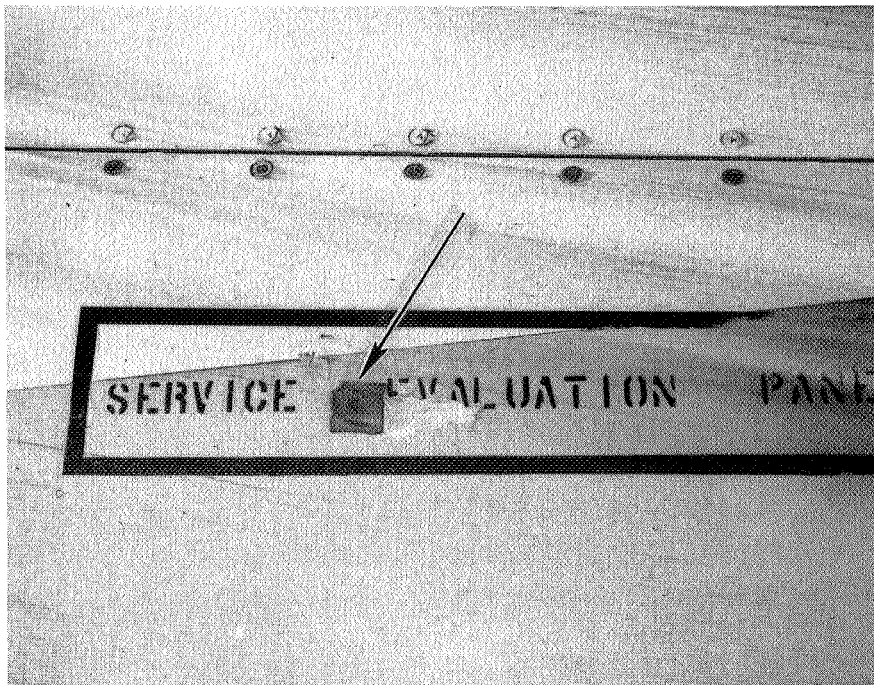
1. A tape patch repair of a deep gouge, first observed in 1980, was still in place with no changes in appearance since the previous inspection (figure B-6). There was some paint loss near the patch, but no delamination or evidence of damage growth.
2. Another repair, also observed in 1980, in which a 0.3 cm (1/8 in.) crack was filled with resin, was undetectable after repainting.
3. Two other cracks and an associated delamination were no longer detectable after repainting. These conditions were therefore only the result of loose paint.
4. An area of extensive paint loss along the forward edge was still present even though the panel had been repainted since the previous inspection. This indicates possible Skydrol exposure.

Figure B-6. - TWA left-hand wing-body fairing -
tape patch repair.

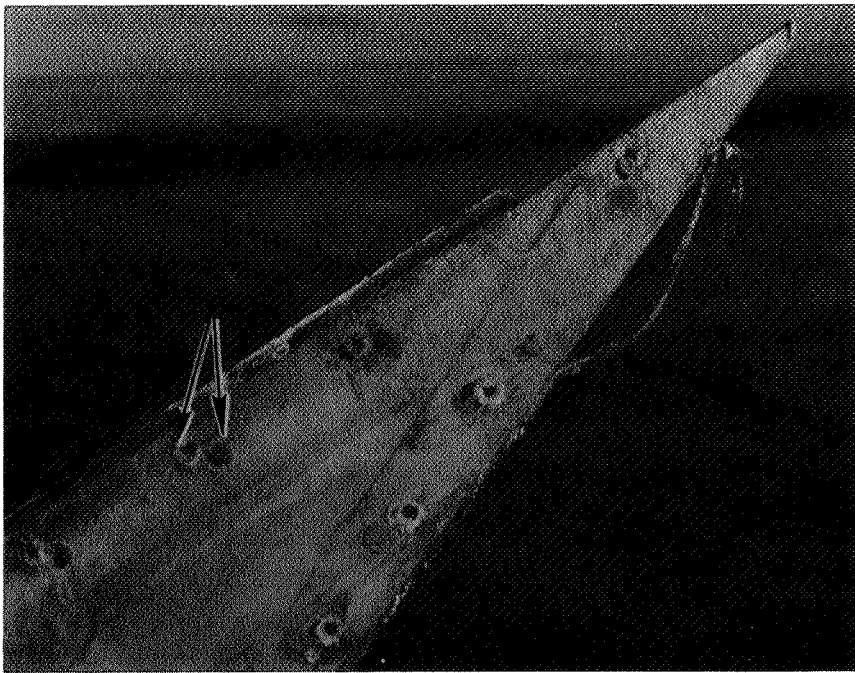
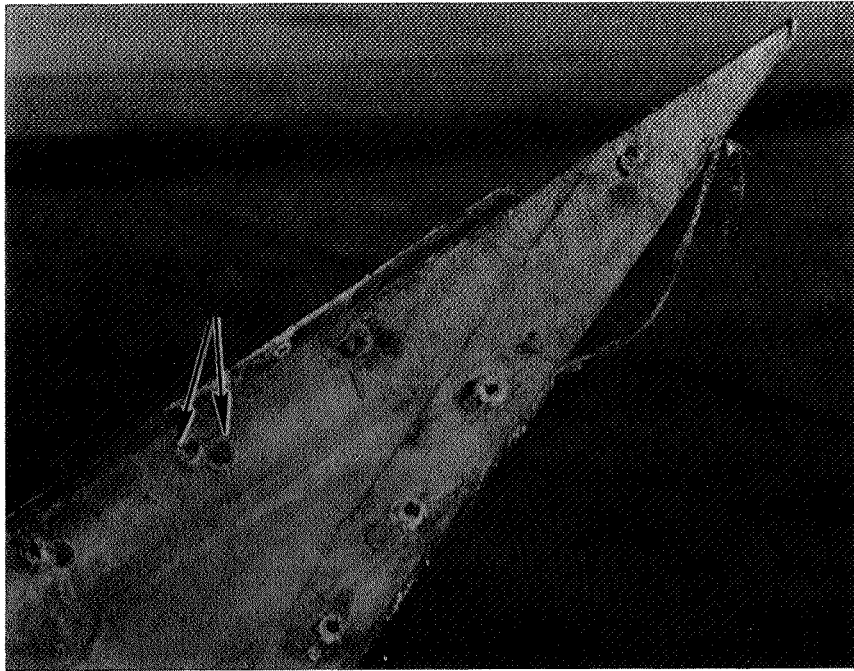
The fastener holes on the right-hand Eastern fairings were observed for the first time since their reinstallation which involved relocation of all fastener holes. The original fastener holes were filled, and new holes were drilled. These new fastener holes were observed to have a great amount of fuzz which creates the frayed appearance noted in other inspections. This

condition was much more pronounced than in any of the other Kevlar-49 parts (including the original fastener holes on the Eastern panels). As mentioned in the preceding paragraph, the frayed appearance is the result of the initial drilling operation. This condition therefore indicates that nonoptimum procedures and tools were used in the drilling of the relocated holes. Some holes were drilled partially through the chopped glass filled epoxy filler. These areas had no fuzz, but did have a greater incidence of elongation than has been noted for holes drilled through the Kevlar-49. No elongation was observed in any of the relocated holes drilled through the Kevlar-49. The frayed condition does not appear therefore to significantly affect performance of these parts. The fuzz was observed to be almost entirely on the inner surface.

Figure C-3. - Eastern right-hand aft engine fairing - badly frayed holes after re-installation; filler in original holes.

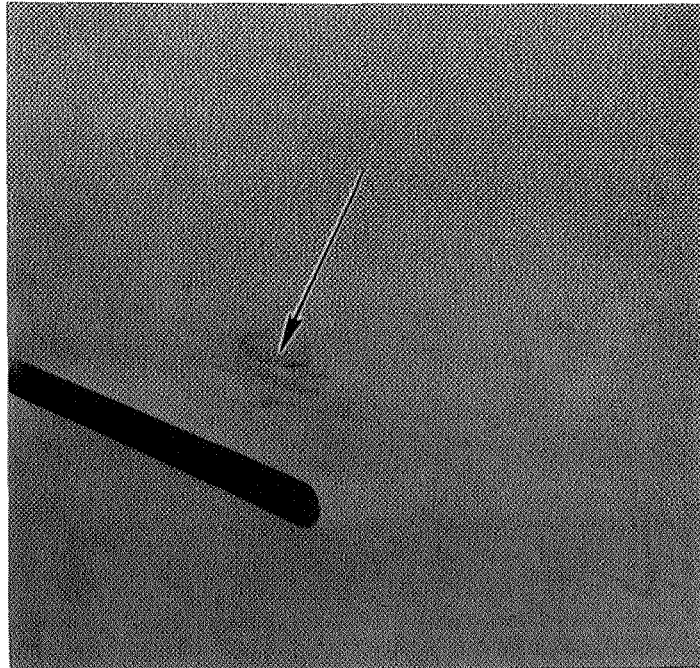
Figure C-1. - Eastern right-hand wing-body fairing - crack 2.5 cm (1 in.) long on inner surface.

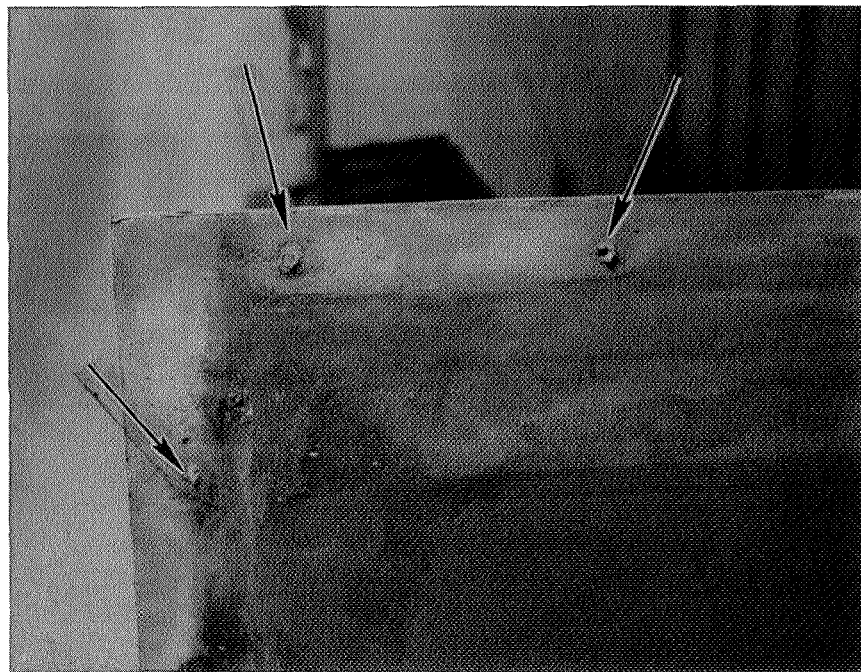
Figure C-2. - Eastern right-hand wing-body fairing - badly frayed holes.

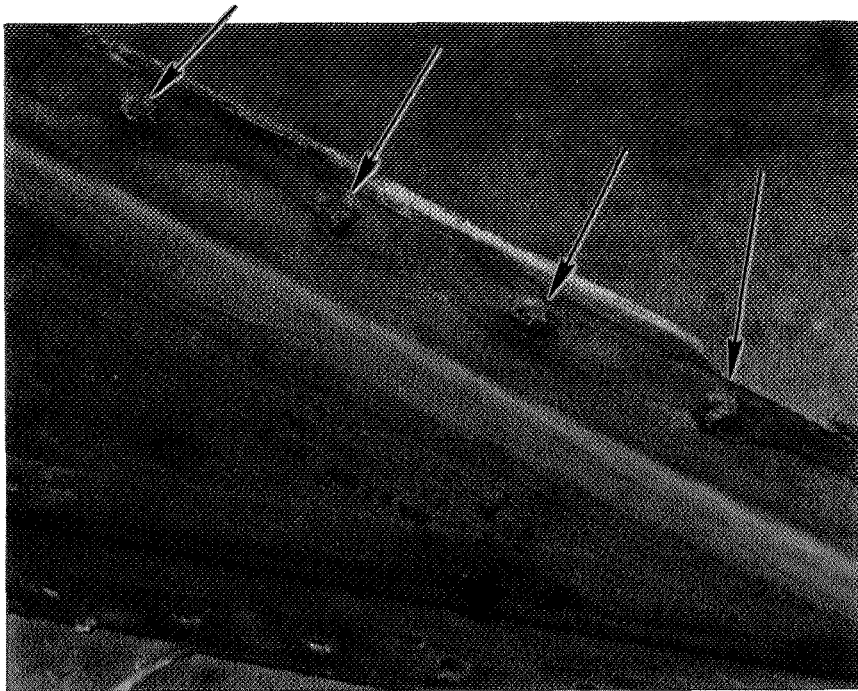
3. A significant degree of elongation was observed in about 1/5 of the holes, principally at locations where the hole was drilled through the filler (which is chopped glass fiber filled epoxy) (figure C-4). Eleven holes were elongated to a maximum 0.55 cm (7/32 in.) dimension from the original 0.5 cm (3/16 in.); twelve holes were elongated to 0.6 cm (1/4 in.); and one hole was elongated very badly to 0.8 cm (5/16 in.).

Figure C-4. - Eastern right-hand aft engine fairing - elongated holes partially drilled through filler.
