FINAL REPORT FOR JUNE 1982 TO JULY 1983
ORBITER GLOBAL POSITIONING SYSTEM DESIGN
AND KU-BAND PROBLEM INVESTIGATIONS
EXHIBIT B - REVISION 1

INTEROFFICE MEMORANDUM
TM-1080-1182

Subject: Shuttle Ku-Band Forward Link Costas Demodulator Lock Indicator
Blinking Problem

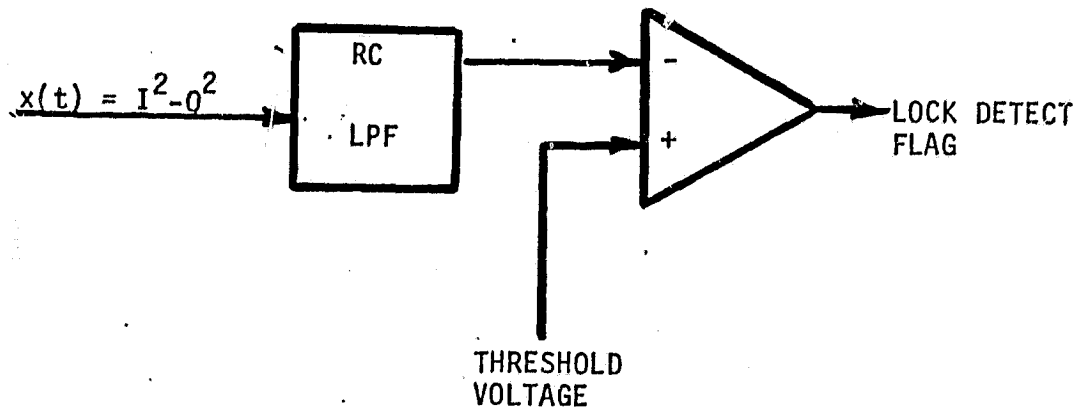
Figure 1. Costas Loop Lock Detector.

The signal $x(t)$ input to the low pass filter is of the form $I^2 - Q^2$, where $I(t)$ and $Q(t)$ are respectively output of the in-phase and quadrature arm filters of the Costas Loop, Fig. 1. During acquisition the signals $I(t)$ and $Q(t)$ is of the form
