**NASA  
Technical  
Paper  
2190**

# **Crash Tests of Three Identical Low-Wing Single-Engine Airplanes**

**Claude B. Castle  
and Emilio Alfaro-Bou**

**Claude B. Castle  
and Emilio Alfaro-Bou**  
*Langley Research Center  
Hampton, Virginia*

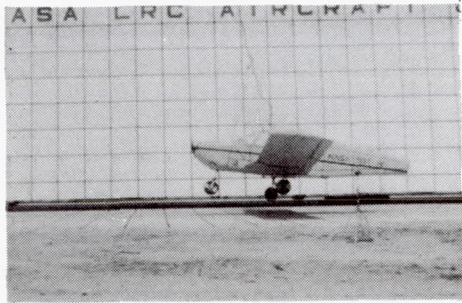
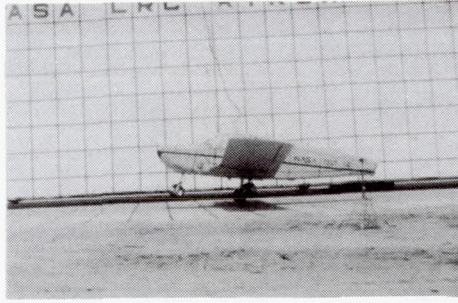
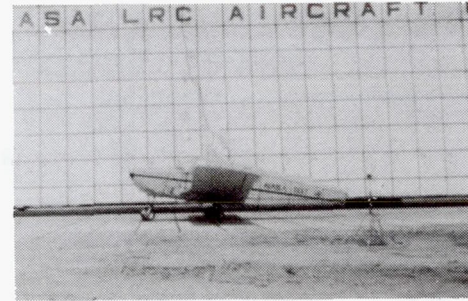
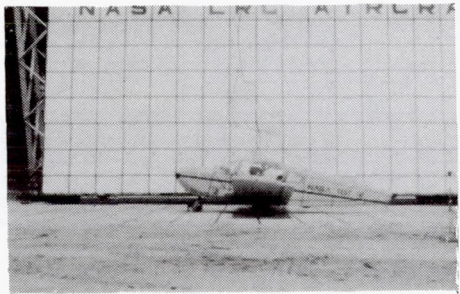
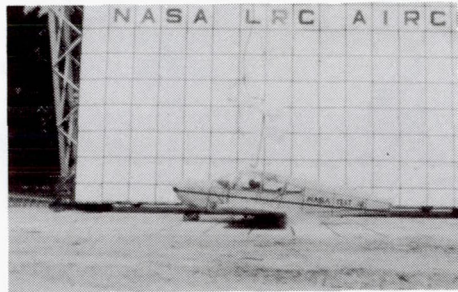
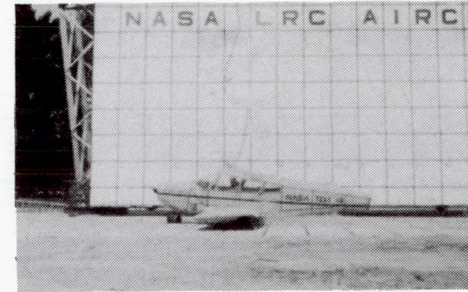
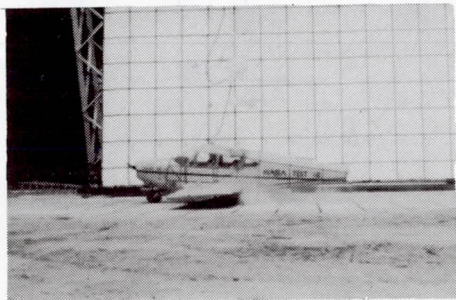
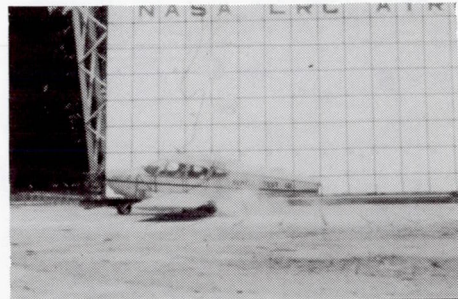
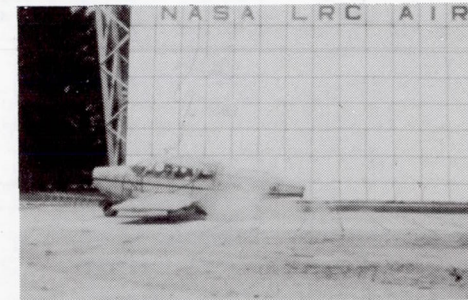
Figure 9.- Crash-sequence photographs of 10° test on concrete (hard landing).

Crash sequence.- The photographs in figure 9 illustrate the crash sequence of a simulated 10° test on concrete (hard landing) from prior to touchdown through initial slide-out. The airplane specimen contacted the concrete impact surface on its main landing gear at a flight-path velocity of 24.6 m/sec along a flight-path angle of -15°, resulting in a sink velocity of 6.4 m/sec. The nose gear then contacted the ground. The airplane settled on the landing gears which caused them to stroke completely and to fracture the left gear (frame 5) and then it continued to slide out at approximately the same attitude as at impact. Inside the cabin, a slight movement of the dummies was seen.

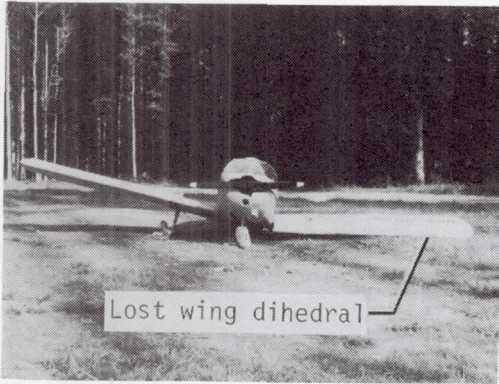
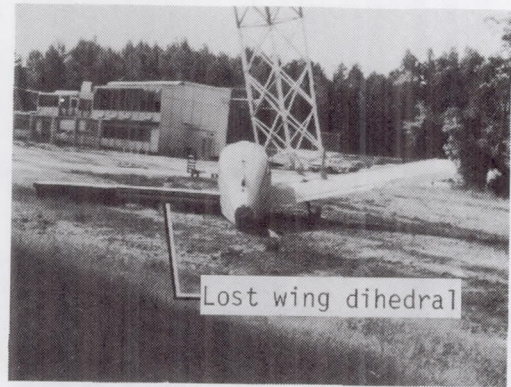
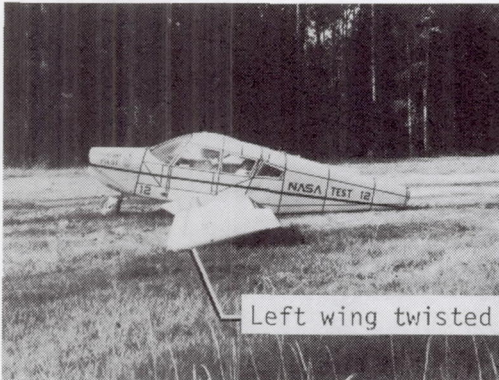
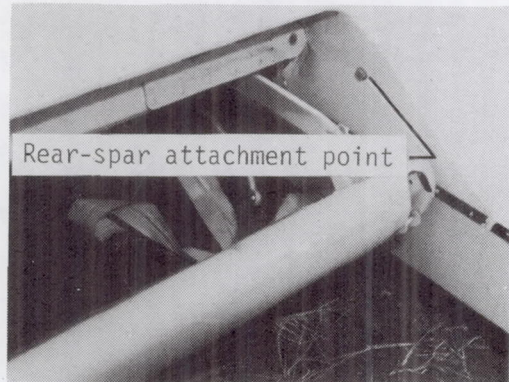
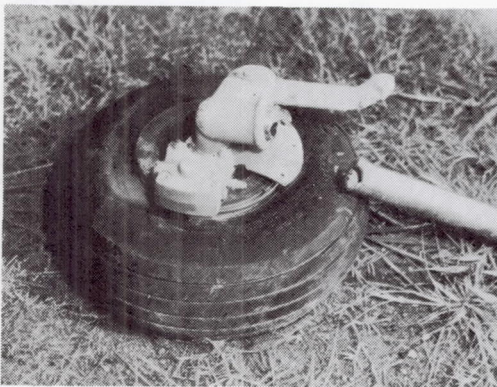
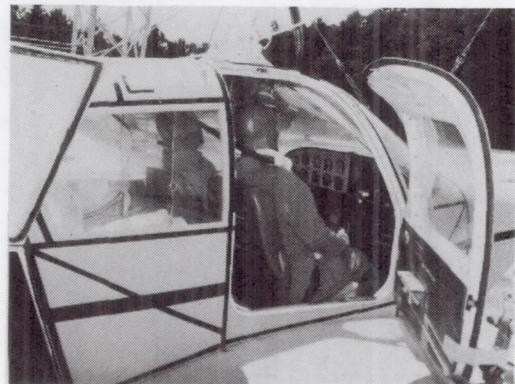
Figure 10.- Postcrash external damage to test specimen in 10° test on concrete (hard landing).

Assessment of damage.- Postcrash photographs of the external damage sustained by the airplane test specimen are presented in figure 10. The livable cabin volume (a volume sufficient in size to maintain space between the occupants and the structure) was maintained during the crash impact. In figure 10(a), the airplane is shown resting on its left wing, right landing gear, and nose wheel. All three tires experienced a blowout. The nose-gear fork bent and twisted as shown in figures 10(a) and (c). The twisted left wing, with no dihedral, the broken linkage for the inboard flap, the sheared rear-spar attachment bolt, and the sheared fore-wing attachment to the fuselage are shown in figures 10(a), (b), (c), and (d), respectively. The fuselage is shown to be in good overall condition except for a slight deformation at the interface with the inboard left-wing flap. Figure 10(e) shows the damaged left land-

ing gear with the fractured shock absorber. Figure 10(f) shows the crew compartment, the pilot and copilot dummies, and their restraints. The overall lack of structural damage by this test is also shown in figure 10(f).

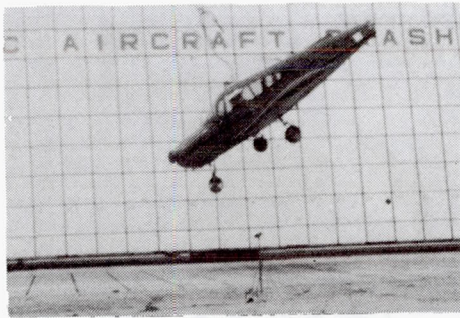
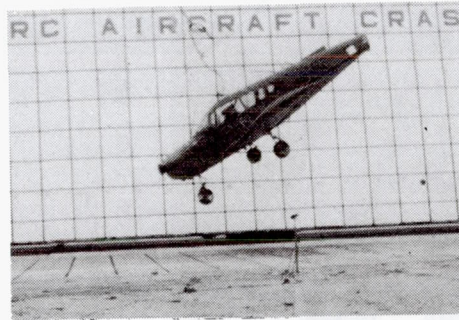
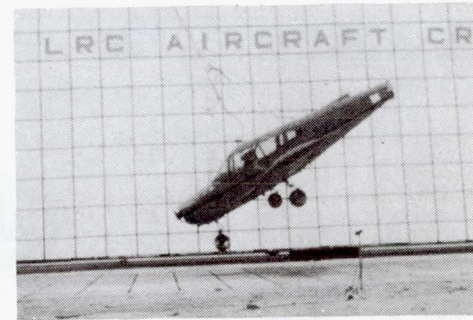
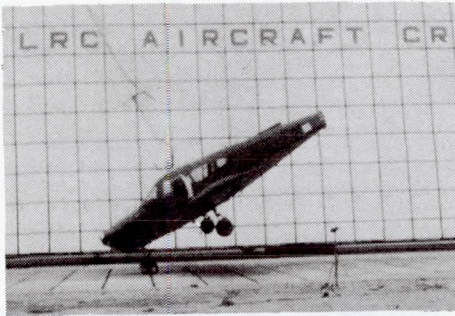
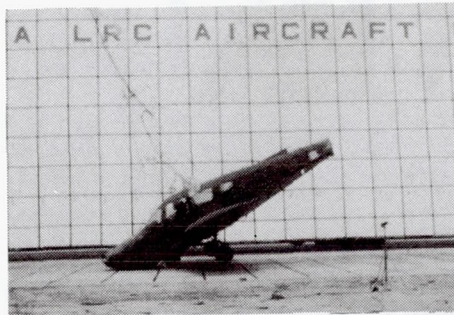
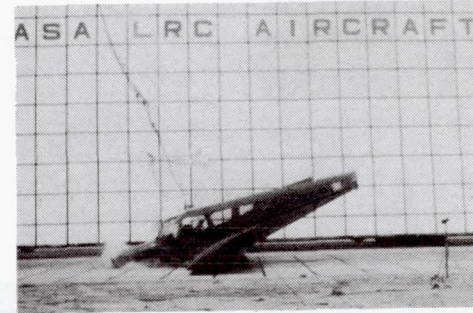
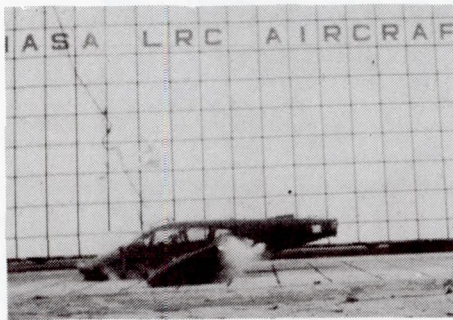
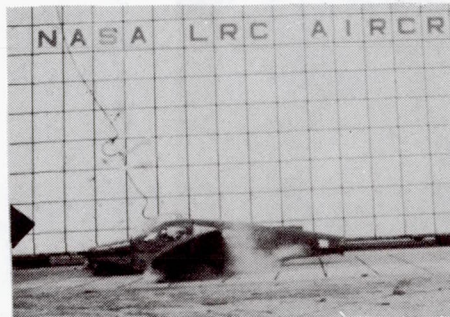
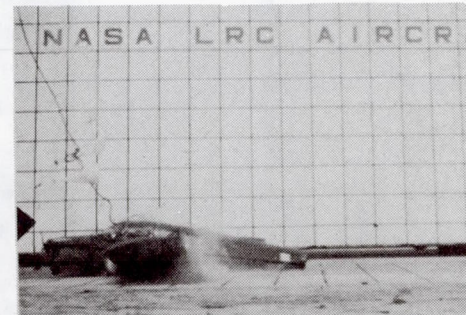
Figure 11.- Crash-sequence photographs of  $-30^\circ$  (nose-down) test on concrete.

Crash sequence.- The photographs in figure 11 illustrate the crash sequence of a -30° pitch (nose-down) impact test starting prior to touchdown through a part of the slide-out. The airplane specimen contacted the concrete impact surface on its nose wheel at a flight-path velocity of 24.6 m/sec (sink velocity of 11.9 m/sec (frame 4)). The nose gear then collapsed (frame 5) and finally embedded in the floor in the baggage compartment (cabin cargo area). Afterwards, the airplane nose, followed by the main landing gears, contacted the ground. As the airplane continued its travel, the fuselage rotated downward, the airplane nose crushed, and the main landing gears collapsed which forced the wings to twist (frame 6). At the onset of the decelerating forces (frame 5), the pilot and copilot started to pitch forward and their upper torso lurched toward the instrument panel (frames 6 and 7). Most of the crushing and damage to the airplane took place at the time recorded in frame 6. Frames 7, 8, and 9 show the airplane settling on the impact surface and sliding out.

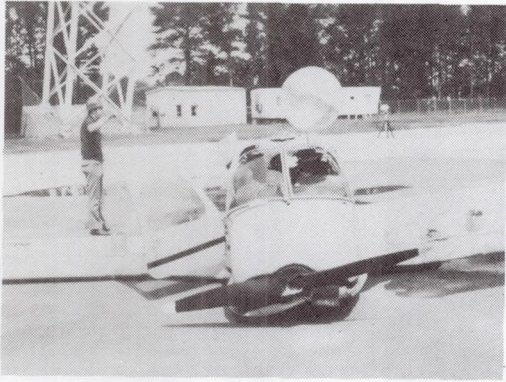
(a) Overall view from front.

Assessment of damage.- Postcrash photographs of the damage sustained by the airplane specimen are shown in figure 12. Figure 12(a) shows the airplane in its final position resting on the fuselage and wings. The nose and main landing gears fractured and collapsed and the tires blew out during the impact. Both windshields broke and the center post between the windshields bent. Some of the front damage can be seen under the engine cowling. The impact force caused part of the lower fire wall to protrude about 20 cm into the cabin. Both wings lost their dihedral, and the left wing is shown propped by the collapsed landing gear. The balloon seen in figure 12(a) was part of an Emergency Locator Transducer (ELT) experiment for locating a crashed airplane by visible means.

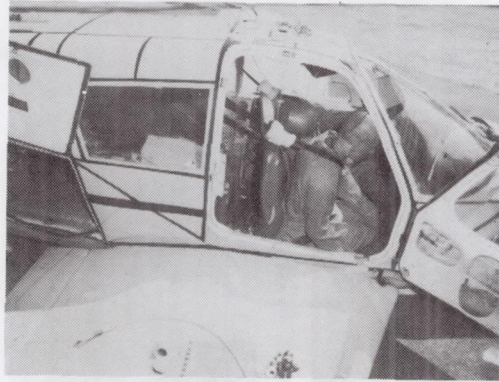
(b) Close-up view of forward section from right side.

Figure 12(b) shows the pilot and copilot dummies restrained to their seats after the airplane came to a stop. Also shown is buckling of the airplane nose and side panel over the wing. The space between the seats and instrument panel, as well as the livable cabin volume, was maintained. Figure 12(c) shows the left inboard-flap control broken, the rear-spar attachment pin sheared off, and some buckling in the fuselage skin. Figure 12(d) shows a collapsed landing gear and buckling of the skin under and aft of the cargo door. In figure 12(e), the nose wheel is seen embedded in the floor of the rear cabin. Also shown is the rear-cabin-floor upheaval aft of the passenger compartment, the transducer junction box, and the pyrotechnic programmer box. Figure 12(f) shows a slight deformation in the aft member of the doorframe and a fracture in the lower front corner. Other damage to the airplane, not shown in these photographs, was buckled skin from the airplane nose to the third left window, a buckled wing at the attachment point to the fuselage forward of the main spar, a cracked first-passenger window, a collapsed left landing gear, and a failed copilot seat rail at the rear-legs attachment point.

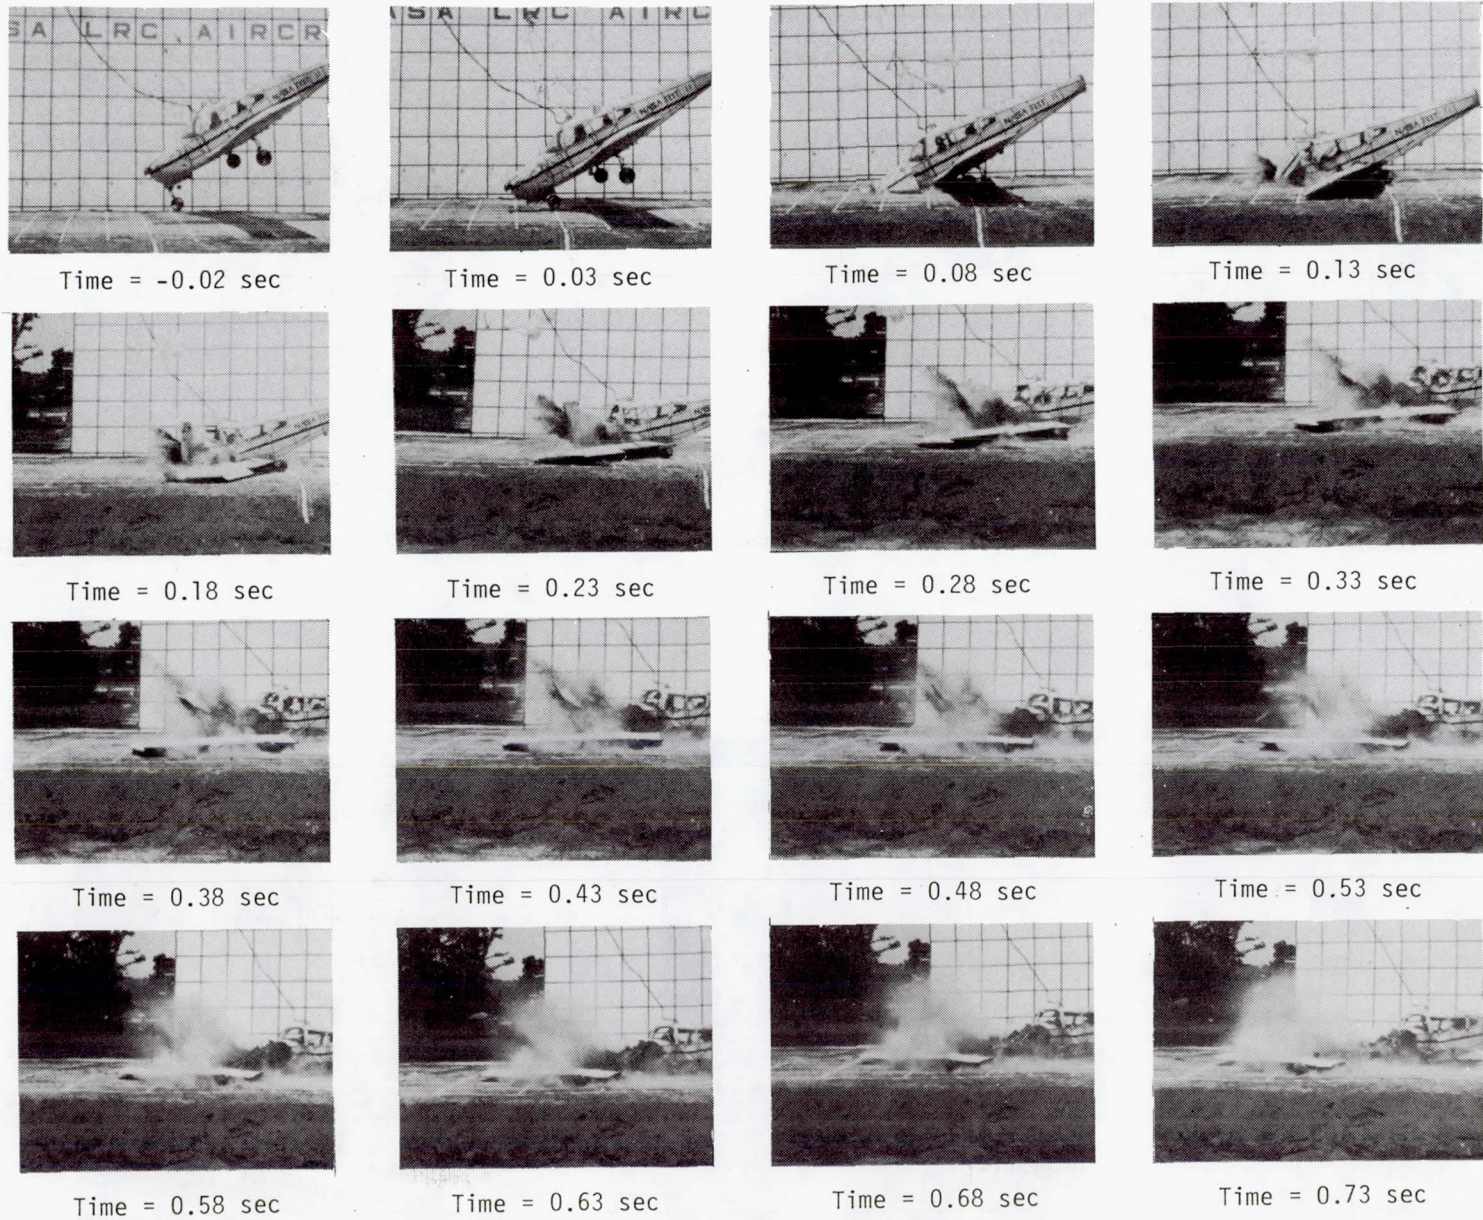
Figure 13.- Crash-sequence photographs of  $-30^\circ$  (nose-down) test on soil.

Crash sequence.- The crash sequence of a -30° pitch (nose-down) impact test on a soil surface is illustrated in figure 13. The sequence starts prior to touchdown and ends when the scattered soil starts to settle after the abrupt impact. The airplane specimen contacted the soil impact surface on its nose wheel at a flight-path veloc-

ity of 24.6 m/sec (a sink velocity of 12.9 m/sec). The nose gear then collapsed (frame 2) and later lodged in the lower half of the fire wall during crushing of the airplane nose. The nose of the airplane started to crush (frame 3), and the main landing gears contacted the ground.

As the airplane decelerated, the dummies started to pitch forward (frame 3) and lurched forward out of the view in frame 4. The pilot's shoulder harness can be seen taut and fully extended holding the displaced dummy (frame 4). Frame 4 also shows that the nose of the airplane has crushed to the fire wall, the engine cowling has come off, the landing gears have collapsed, the wings have contacted the ground, and buckling of the structure has occurred on the top and side of the fuselage.

Frame 5 shows further compression of the fuselage with heavy damage extending up to the pilot's window. The aft part of the left wing has started to separate from the fuselage. Bending of the roof has occurred aft of the pilot's window, and the engine cowling has completely separated from the airplane. The pilot and copilot dummies have bounced back to the seated position, and fire wall has protruded into the crew area, thus reducing the space between the fire wall and the crew seats. The first-passenger dummy is bent forward over its knees and, in frame 6, has started to rebound. The left wing continues to separate from the fuselage at the main spar while pivoting forward. In frame 7, the wing has separated from the main spar and more recovery in the first-passenger dummy is shown. Frame 8 shows the pilot dummy flexing forward, the first-passenger dummy slanted forward at 45° and moving rearward, and the left wing completely detached from the fuselage. In frame 9, the pilot dummy is flexing rearward and the first-passenger dummy is bouncing upward and rearward.

In frames 10 and 11, the first-passenger-dummy's head has hit the roof while moving rearward in an arc. In frames 12 and 13, the first-passenger-dummy's head is no longer in contact with the roof and the upper torso continues to rotate rearward. The pilot dummy is seen flexing forward. In frames 14, 15, and 16, the pilot and copilot dummies are shown pitched forward into the instrument panel. The first-passenger dummy is shown against the seat back.

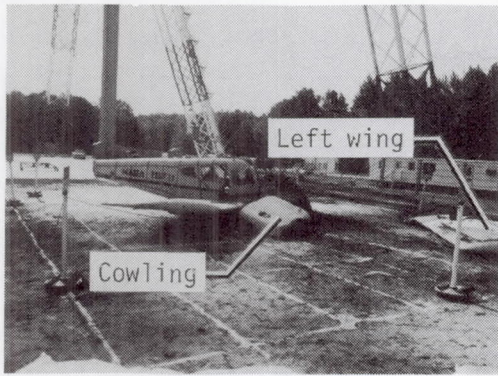
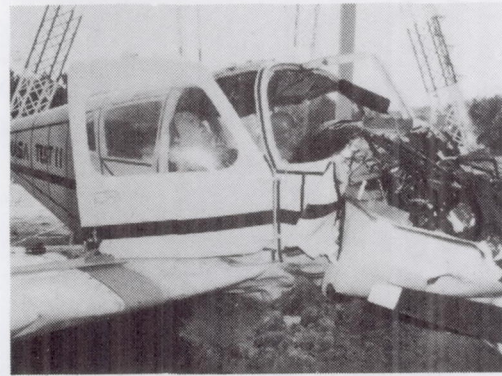
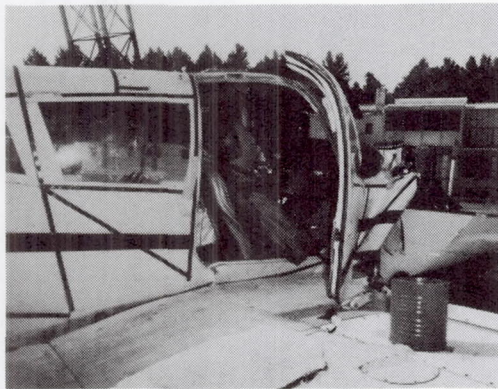
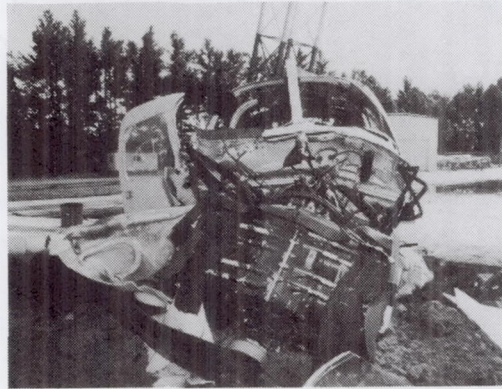
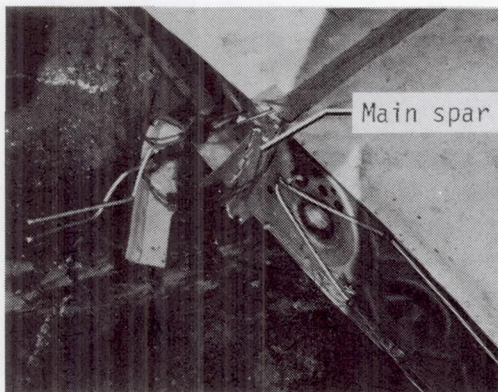
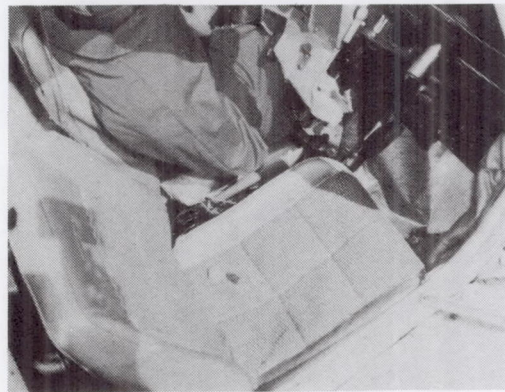
Figure 14.- Postcrash damage to test specimen in  $-30^\circ$  (nose-down) test on soil.

Assessment of damage.- Postcrash photographs of the damage sustained by the airplane specimen are shown in figure 14. The livable cabin volume, although reduced, was maintained during the crash impact. Figure 14(a) shows the airplane in its final position resting on the fuselage and right wing. The left wing is shown detached and in front of the airplane. The engine top cowling has come off and is shown on the right side ahead of the wing. Figure 14(b) shows buckles on the wing leading edge and on the side panel ahead of the door, and also shows damage to the nose, windshields, and center post of the airplane. The degree of center-post bend is an indication of the protrusion of the fire wall into the cabin. The protrusion of the lower half of the fire wall into the cabin measured up to 51 cm and was more severe than the top half. Figure 14(c) shows a tear on the wing over the landing gear, separation of the right wing from the fuselage aft of the main spar, a fracture in the lower rear of the doorframe, and the copilot-dummy's knees bent up due to the reduced space from the seat to the fire wall. Figure 14(d) shows a bent propeller, a bent and fractured engine mount, a torn lower engine cowling, and a deformed fire wall. Figure 14(e) shows a fractured main-spar attachment to the wing and the broken hydraulic lines in the left wing. Figure 14(f) shows the floor and foot-control deformations in the copilot's side of the fuselage.

Other damage not shown in figure 14 were heavy buckling in the pilot's side of the fuselage and shearing of rivets in the left part of the roof to the left of the

pilot's window. It was also noticed that the pilot's window broke off, the pilot's seat pan tore through, and part of the pilot's control wheel fractured off.
