Report To
JET PROPULSION LABORATORY
California Institute of Technology
Pasadena, California
JPL Contract No. 956493

EVALUATION OF DSS-14
PEDESTAL-REVIEW OF TOP SURFACE
REPAIR PROCEDURES

CONSTRUCTION TECHNOLOGY LABORATORIES
A Division of the Portland Cement Association
5420 Old Orchard Road
Skokie, Illinois 60077

May 1983

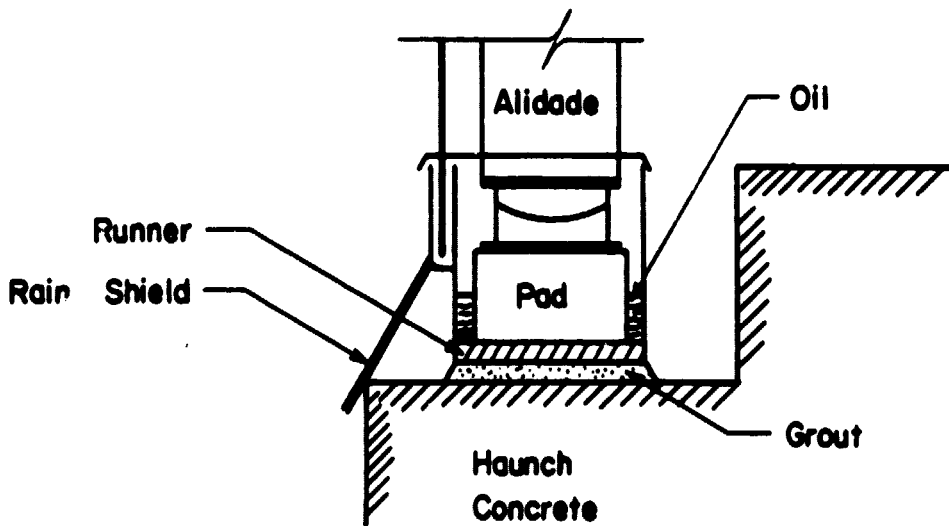
Fig. 3 Cross Section Through Hydrostatic Bearing

Proper operation of the hydrostatic bearing requires extremely small tolerances in oil film thickness. Therefore, the runner plate must be set in a very "flat" position. The design permitted a maximum "out-of-flatness" of 0.003 in. over a pad length of 60 in. Maintaining "flatness" of the runner has been a continuing problem almost from the beginning of operation of the antenna. A special non-shrink grout used in the initial installation of the runner apparently promoted corrosion of the

underside of the runner with resulting expansion and loss of "flatness." The original grout was removed after approximately two years of operation. Grout was removed by coring horizontally from the side. The original grout was replaced with dry packed Portland Cement material. The Portland Cement grout system performed satisfactorily for several years but eventually was replaced in local regions under the runner. Regions requiring repair are determined from instrumentation continually monitoring the bearing oil film thickness. When the film thickness is below a certain tolerance, re-grouting is performed. Re-grouting operations have been combined with extremely "fine tuned" shimming between the sole plates and runner.
