NASA TM-82540

MATERIALS INVESTIGATION OF STS-3 PARACHUTE FAILURE

By Ronald L. Nichols
Materials and Processes Laboratory

July 1983

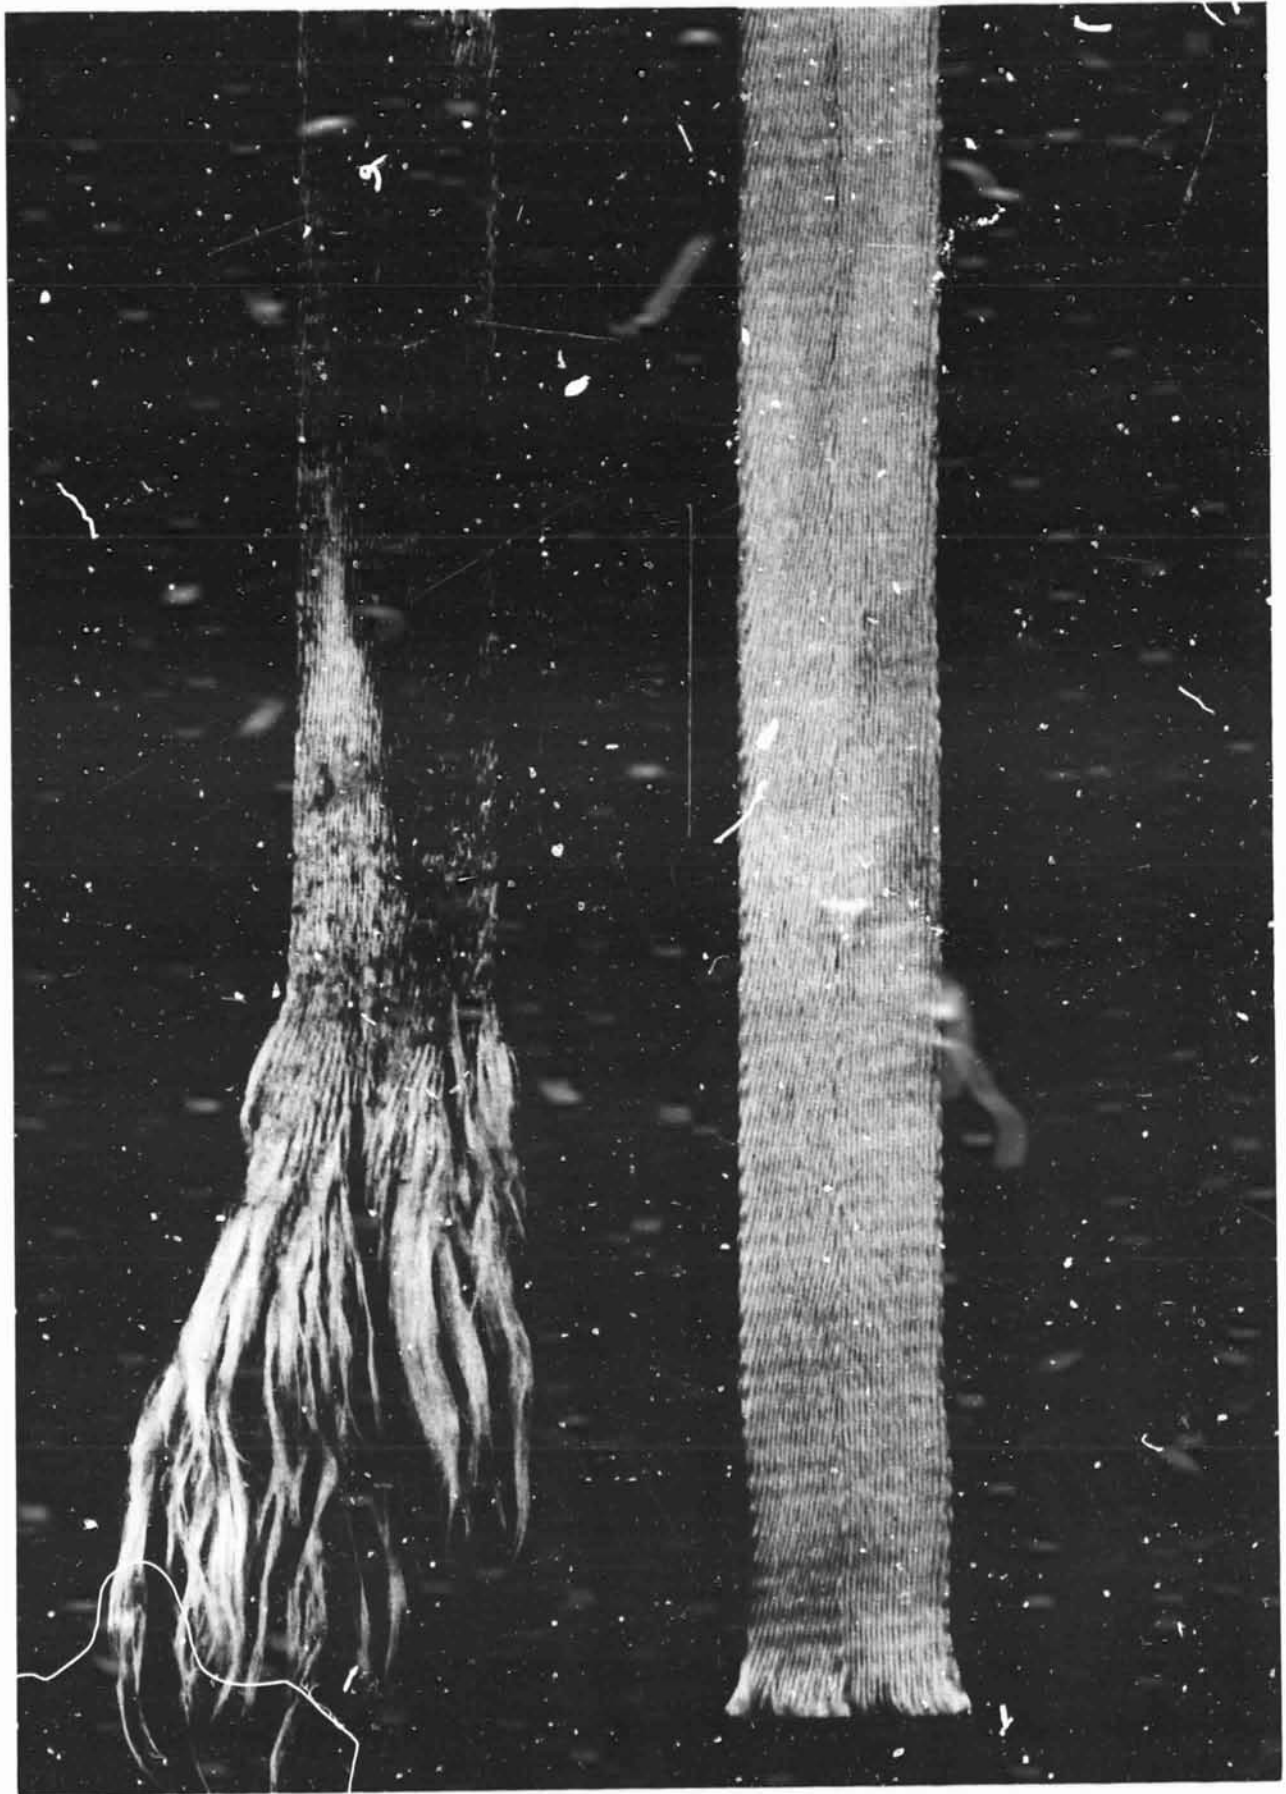
The vent lines are extensions of the radial structural components and extend across the apex of the canopy above the vent. One vent line that connects radials 3 and 51 together was completely severed. A green stain was apparent on the vent lines extending from the radial No. 42 to No. 59 forming a triangular pattern near the vent band. A vent band was broken at approximately 3 in. from the intersection of radial No. 51. The broken vent line is heavily stained with a green color. Figure 2 shows the failed vent line and the heavily stained area.

Tensile specimens were made from the broken vent line from the failed parachute. The average breaking strength of these samples was 3300 lb when pulled to failure on an Instron tensile testing machine at 10 in./min. The vent line material is initially rated at 6000 lb.

Based on green stains found on the vent bands and motion photograph obtained during SRB reentry, it appears that the parachute failure was initiated by overloading a vent line when the parachute flotation bags of parachutes No. 1 and No. 2 became entangled. This entanglement probably resulted in stretching of the vent line beyond its elastic limit. When it failed, the load was transferred first to the vent band and, after vent band failure, to the horizontal ribbons as the radial contracted, resulting in failure of the horizontal ribbons. The available evidence indicates that the horizontal ribbons near the vent band were severed early in the failure sequence with propagation toward the skirt band from aerodynamic loads during the continuation of descent. This conclusion is derived from matching stains and fibers found on the broken vent line to those of the flotation bag lanyard, the loads data obtained during flight on the SRB tape recorder, and long range motion picture coverage of the reentry of the A-12 hardware.

Figure 2. Broken parachute vent line.

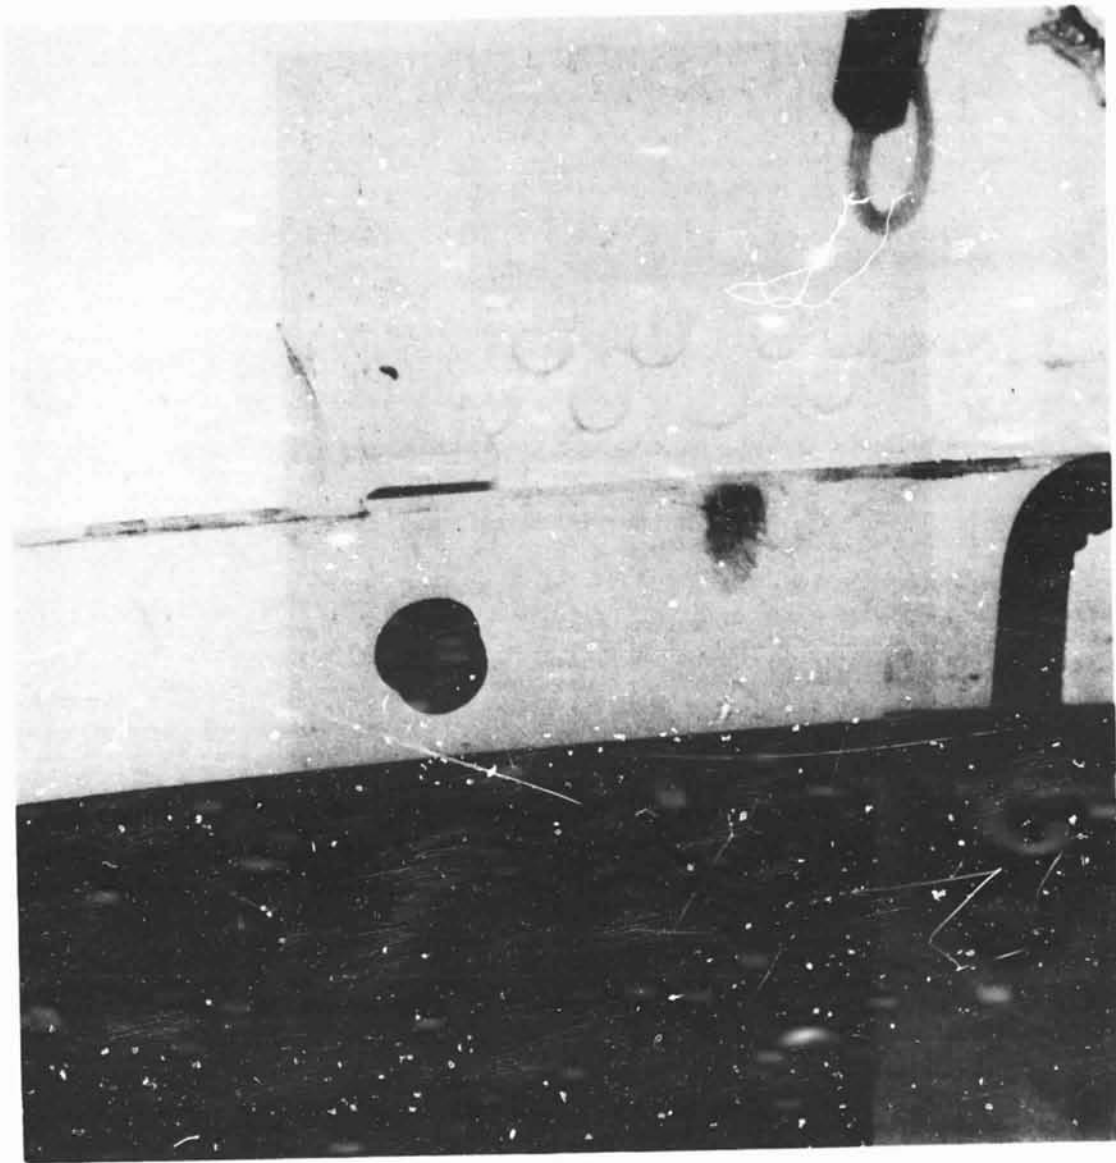
A rubber bumper is located on the lower rim of the frustrum to serve as a bumper for the frustrum location aid (FLA). The rubber bumper shown in Figure 5 has significant stains on its upper surfaces that may have been caused by rubbing contact with the parachute as it was deployed. Viewing of the films to determine the angle of the frustrum during deployment indicates that parachute No. 2 may have contacted the rubber bumper. Figure 6 shows the stains on the rubber bumper. They appear to be deposits of molten material characteristic of nylon. Efforts expended did not result in the positive identification of the source of these stains.

It appears at this point that the FLA bumper damage did not contribute to the parachute failure. Additionally, no evidence was found in the build records nor from testing of materials from main parachute No. 2 that indicated that any substandard materials contributed to the parachute's failure.

Figure 5. Frustrum location aid bumper.
